Expertise

Protocol number: 46279306  
Order No. / Reference: 26673867  
Inspection date: 2 Jul 2026

Manufacturer: Ford

Model: Kuga 2.5 Duratec FHEV ST-LINE X

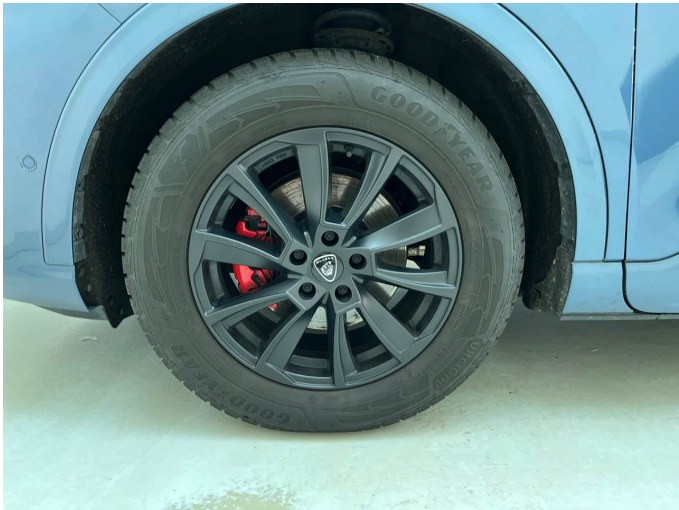
Figure 12: Mounted tyres

| No. | Component group | Description |
|---|---|---|
| 1 | Wheel / tyres | Tyre - front - Does not meet the leasing specifications - No deduction |

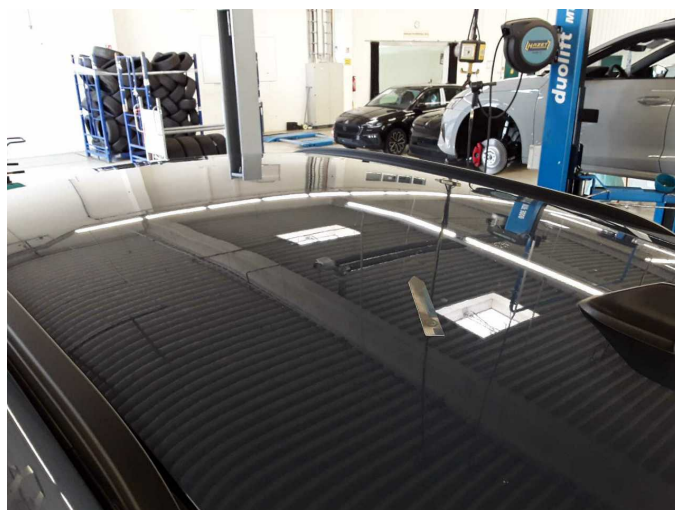
| No. | Component group | Description |
|---|---|---|
| 1 | Roof | Roof - dent(s) - Smart repair |

**Damage 1:** Roof: Roof - dent(s) - Smart repair

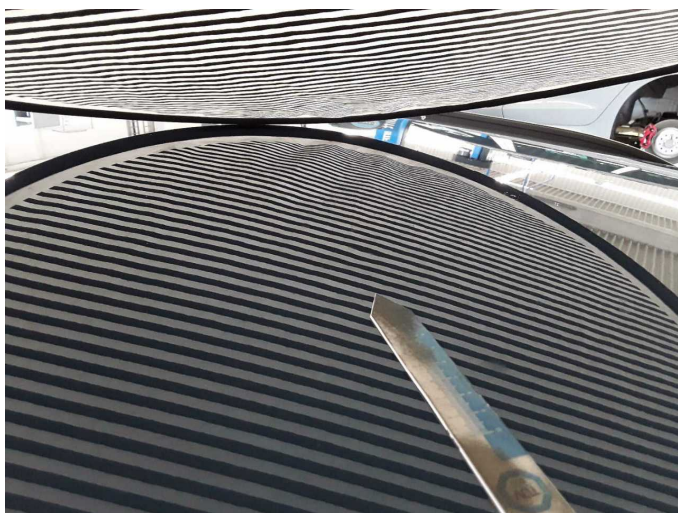
**Damage 1:** Roof: Roof - dent(s) - Smart repair

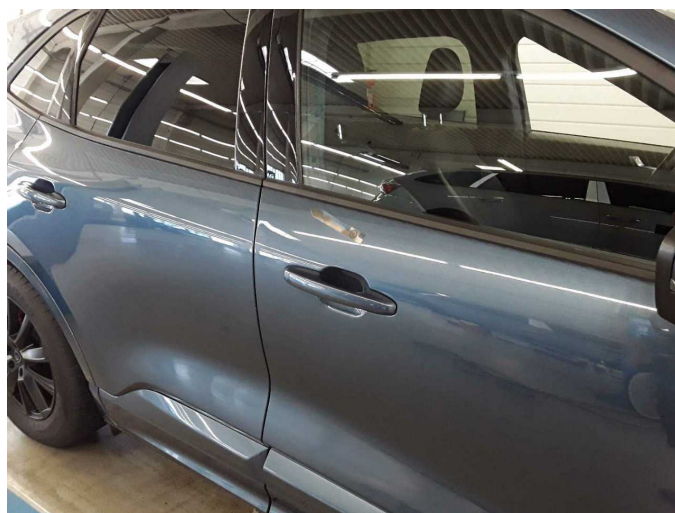
| No. | Component group | Description |
|---|---|---|
| 2 | Door - front right side | Door - dent(s) - Smart repair |

**Damage 2:** Door - front right side: Door - dent(s) - Smart repair

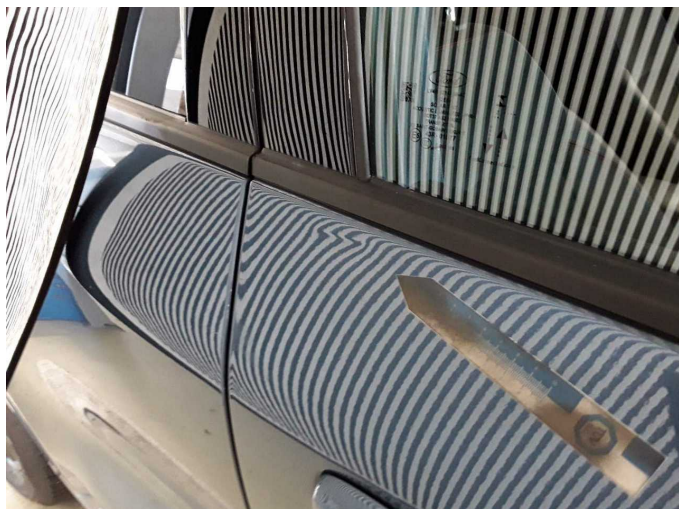
**Damage 2:** Door - front right side: Door - dent(s) - Smart repair

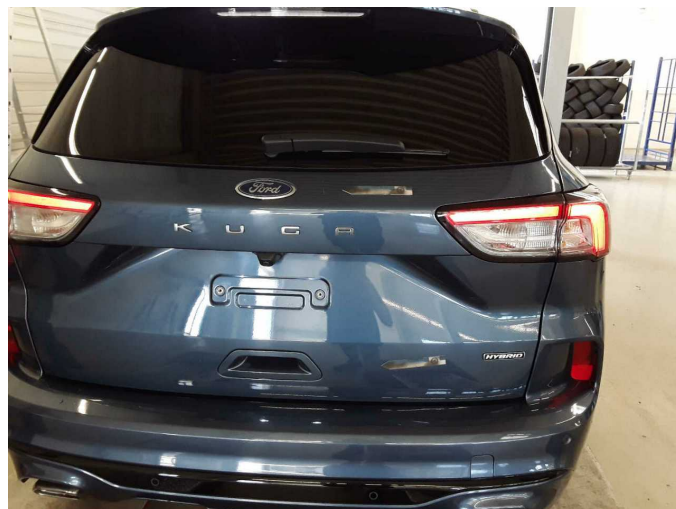
| No. | Component group | Description |
|---|---|---|
| 3 | Boot lid / rear door | Boot lid glazed - Dent / paintcoat damage - Smart repair |

**Damage 3:** Boot lid / rear door: Boot lid glazed - Dent / paintcoat damage - Smart repair

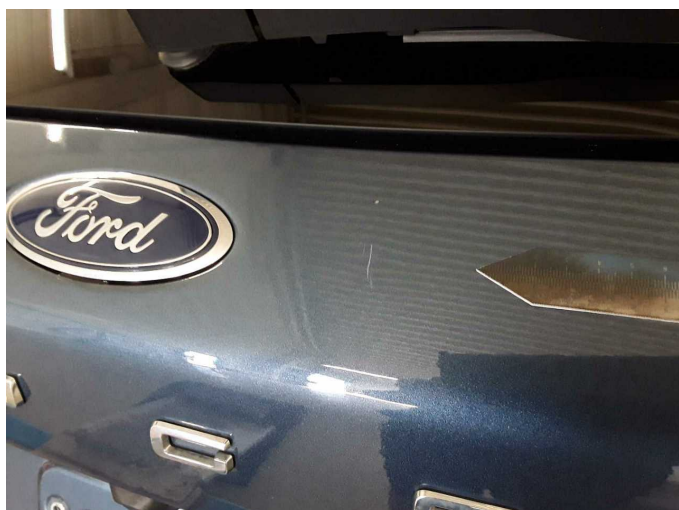
**Damage 3:** Boot lid / rear door: Boot lid glazed - Dent / paintcoat damage - Smart repair

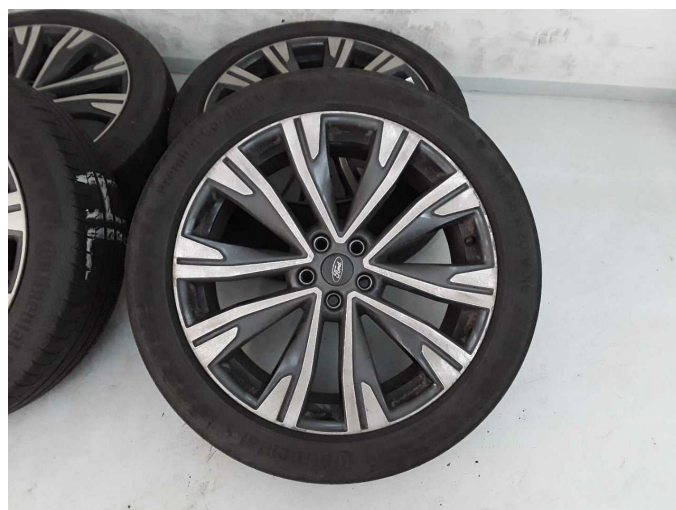
| No. | Component group | Description |
|---|---|---|
| 4 | 2nd wheel set | 1 alloy rim - Scratch(es) - Loss in value |

**Damage 4:** 2nd wheel set: 1 alloy rim - Scratch(es) - Loss in value

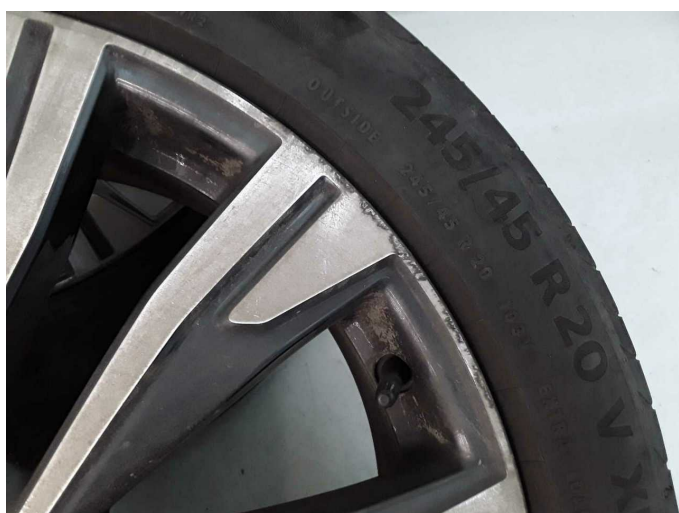
**Damage 4:** 2nd wheel set: 1 alloy rim - Scratch(es) - Loss in value

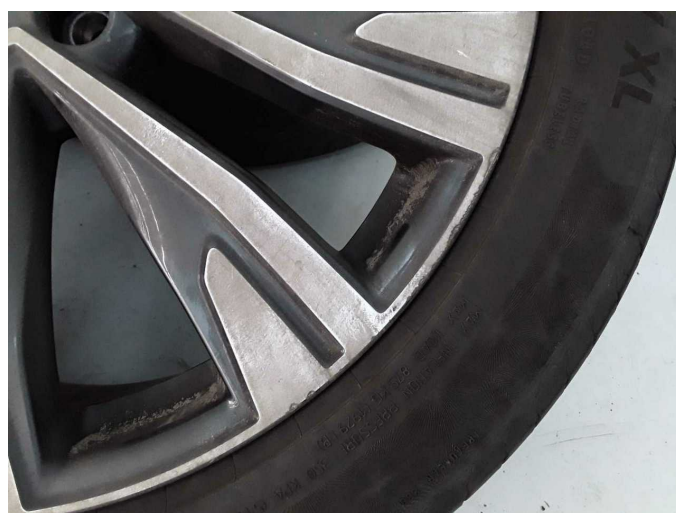
**Damage 4:** 2nd wheel set: 1 alloy rim - Scratch(es) - Loss in value

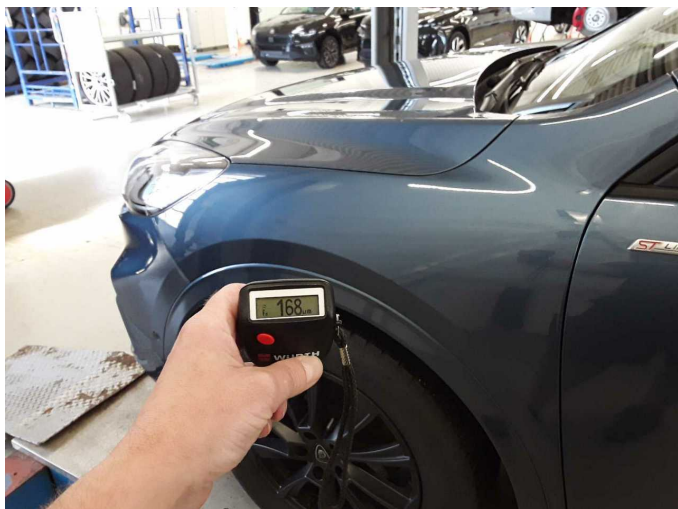
1 Mudguard - left side, Mudguard - right side, Professionally carried out

**Mudguard - left side: 168  $\mu\text{m}$**

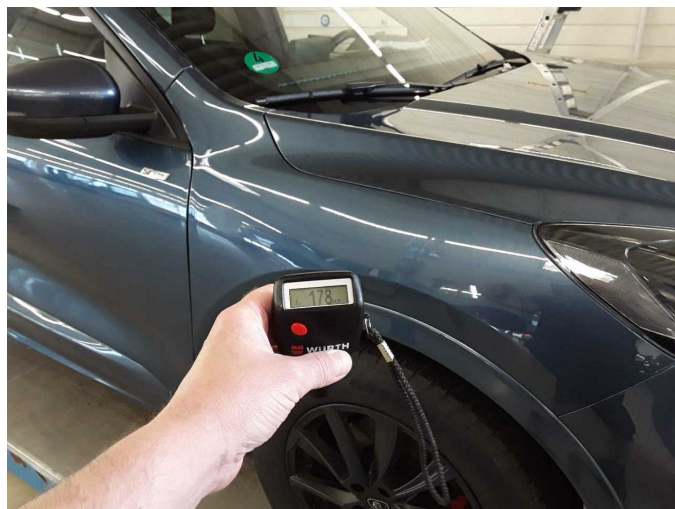
**Mudguard - right side: 178  $\mu\text{m}$**
