## Expertise

Protocol number: 46148488  
Order No. / Reference: 26509101  
Inspection date: 24 Jun 2026

Model: Grandland 1.5 D Automatik Business Elegance

VIN: W0VZCYHZ8N6828999

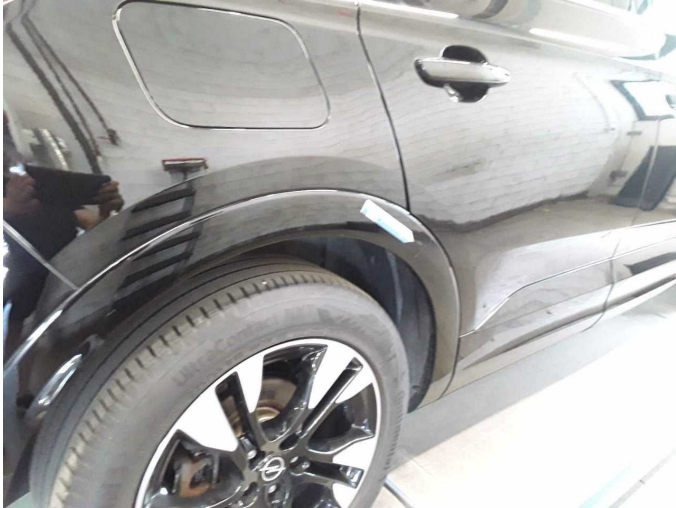
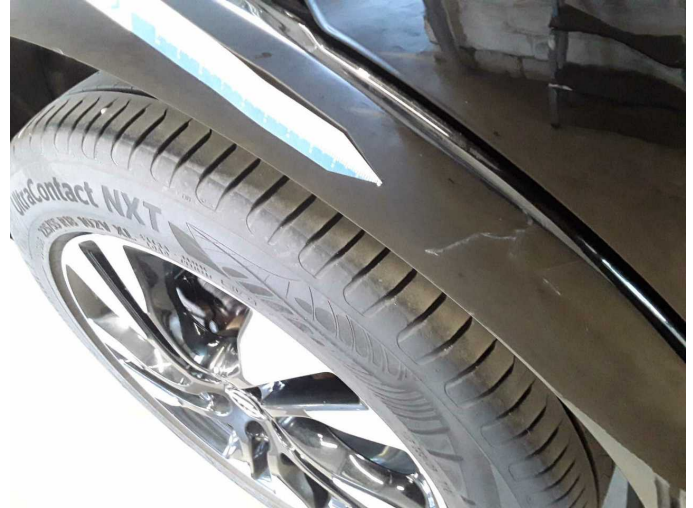
**Damage 1:** Side panel - rear right side: Wheel arch - Scratch(es) - Smart repair

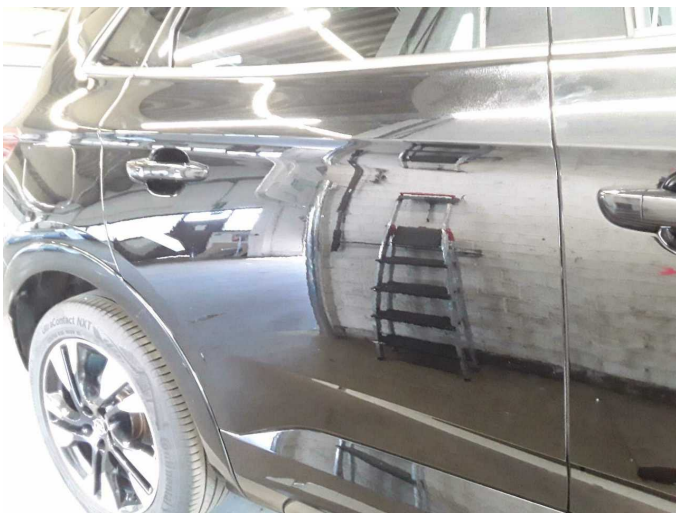
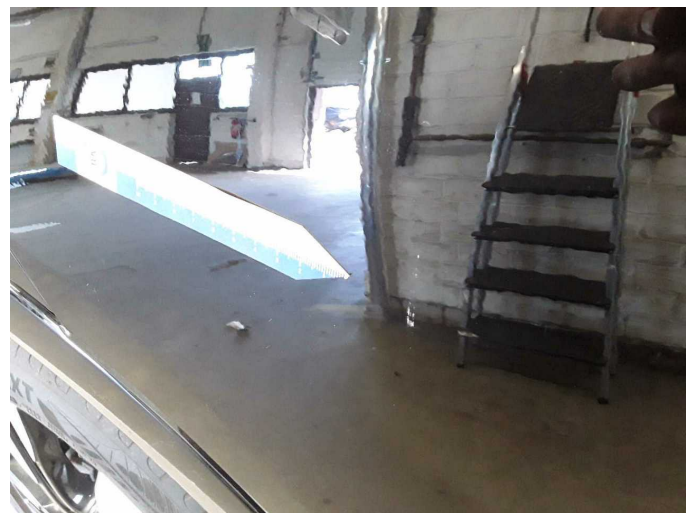
**Damage 2:** Door - rear right side: Door - Scratch(es) - Smart repair

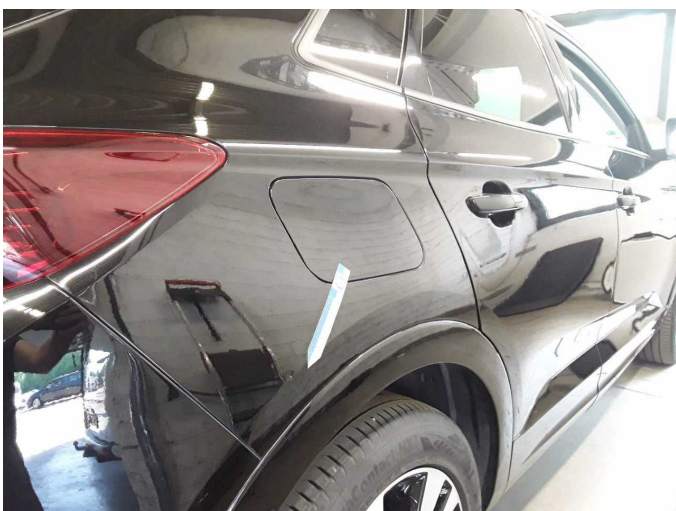
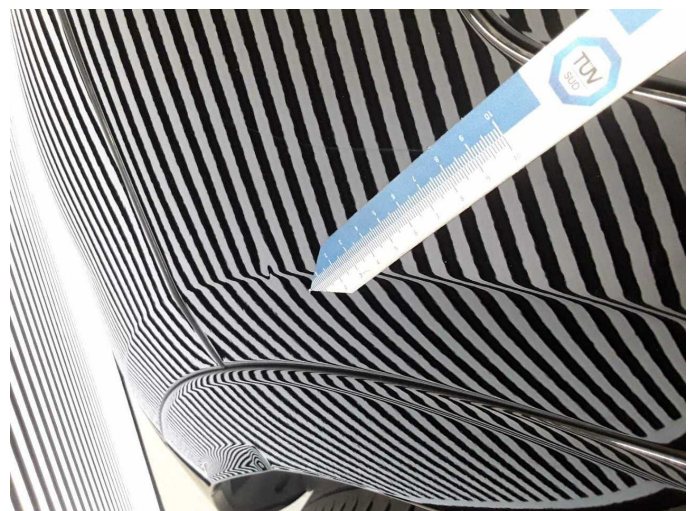
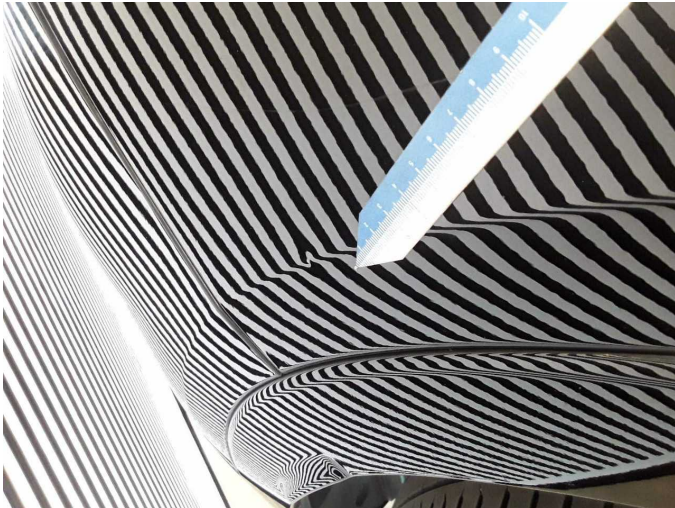
**Damage 3:** Side panel - rear right side: Side panel - Dent / paintcoat damage - Smart repair

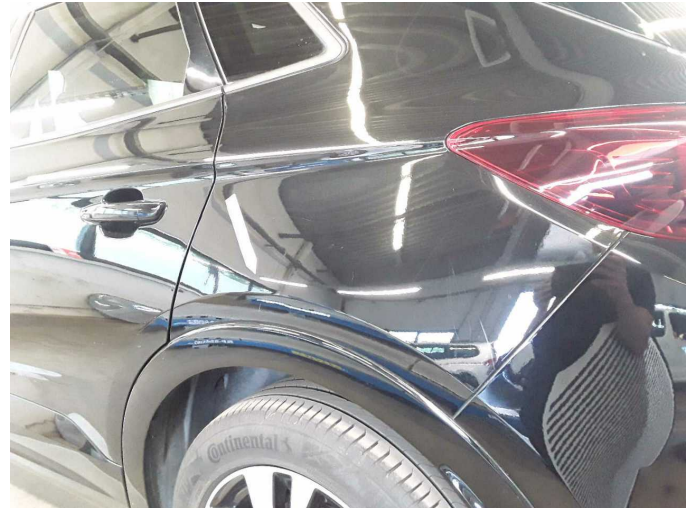
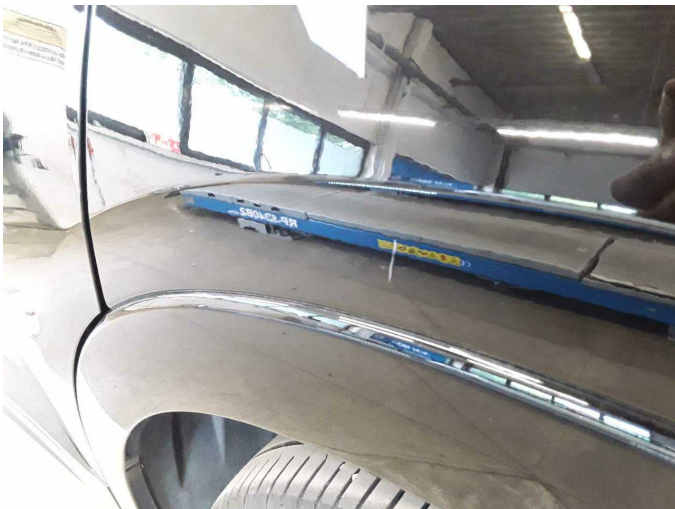
**Damage 4:** Side panel - rear left side: Side panel - Scratch(es) - Paint

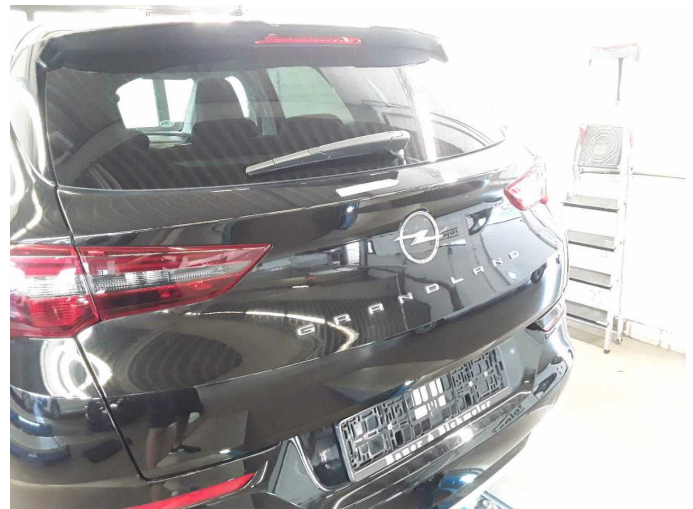
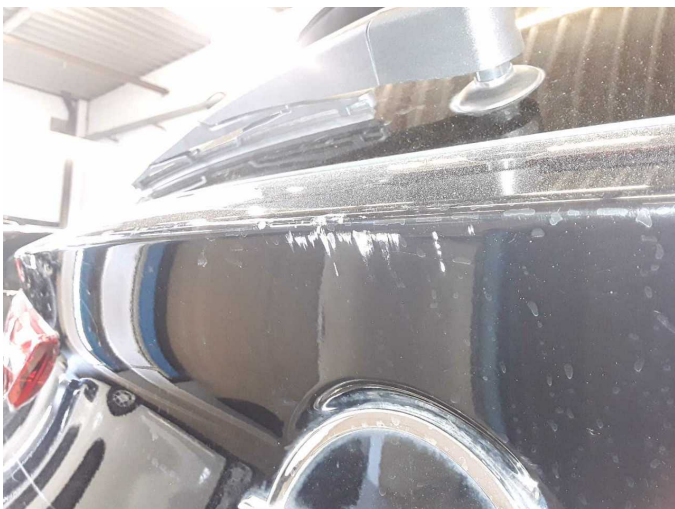
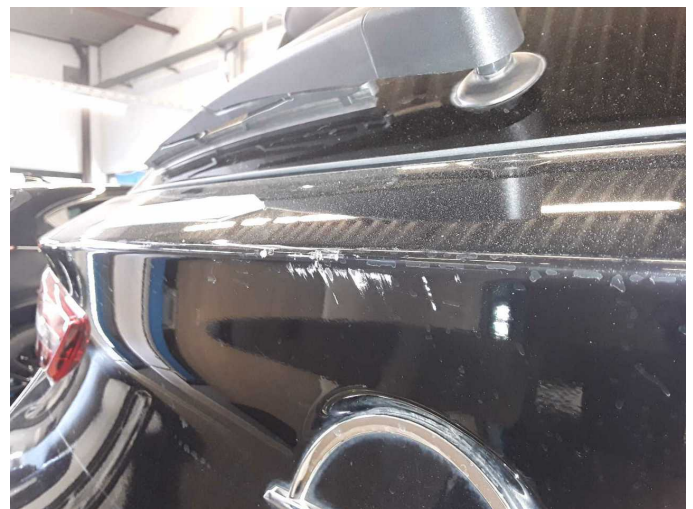
**Damage 5:** Boot lid / rear door: Boot lid - Scratched - Paint

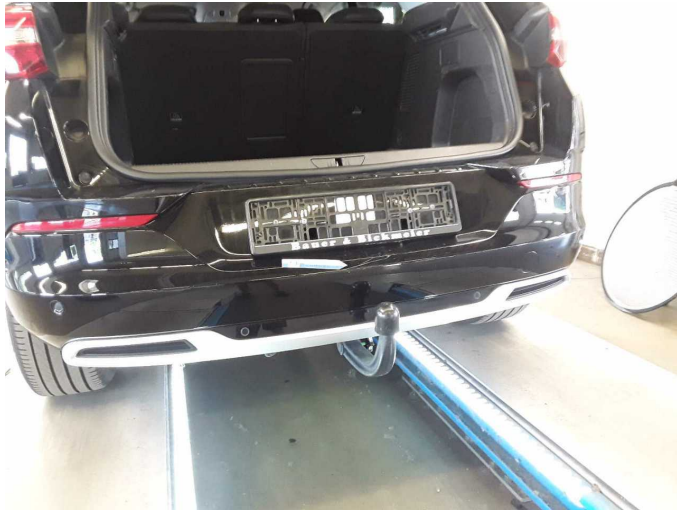
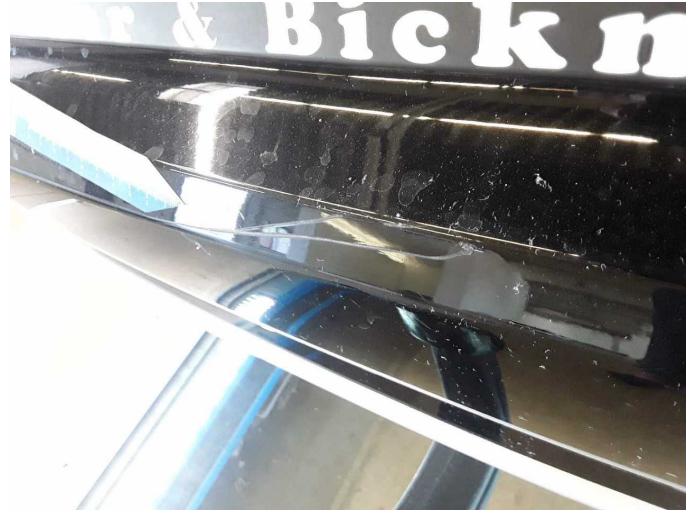
**Damage 6:** Rear bumper: Rear bumper - Scratch(es) - Paint

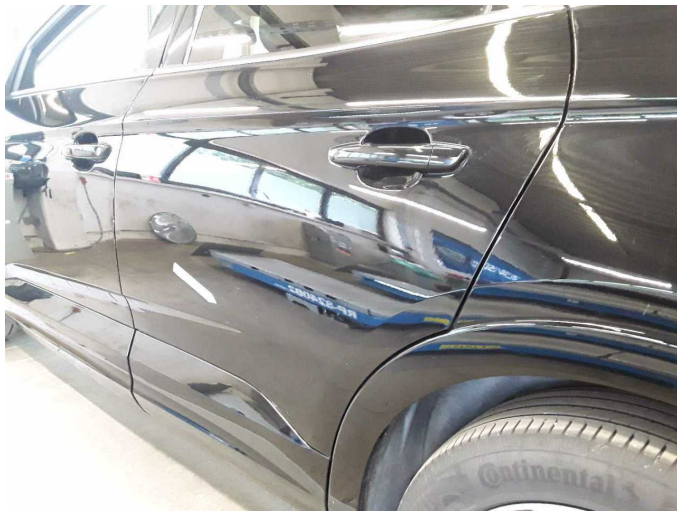
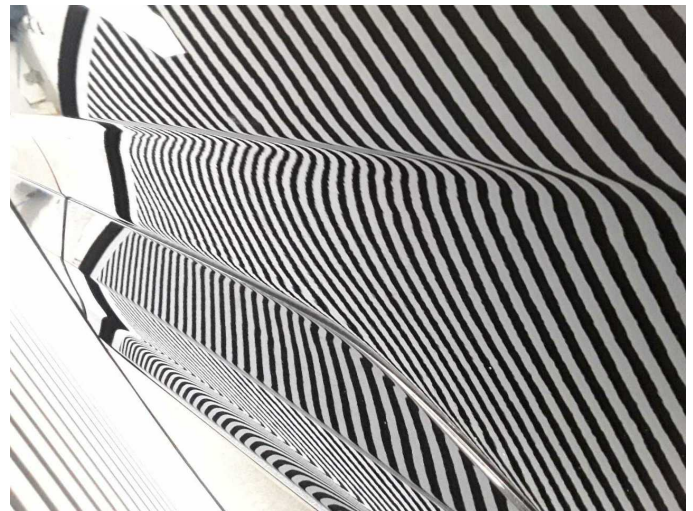
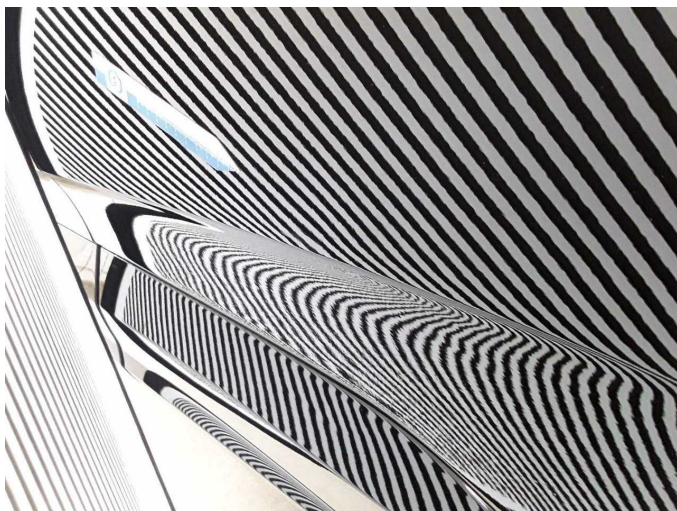
**Damage 7:** Door - rear left side: Door - Deformed - Repair and paint

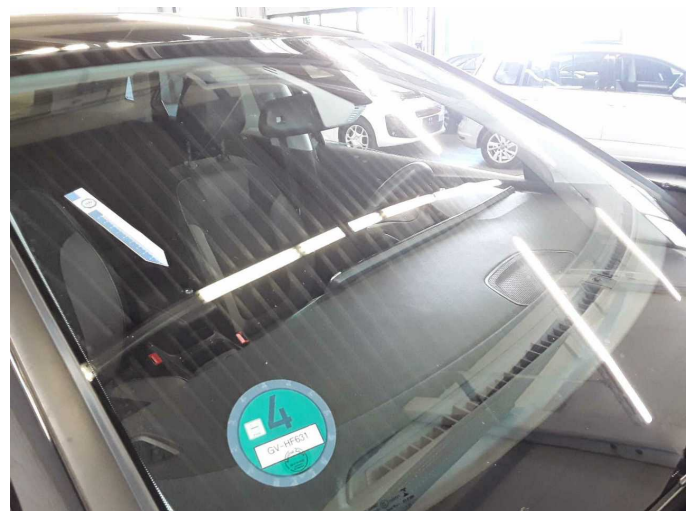
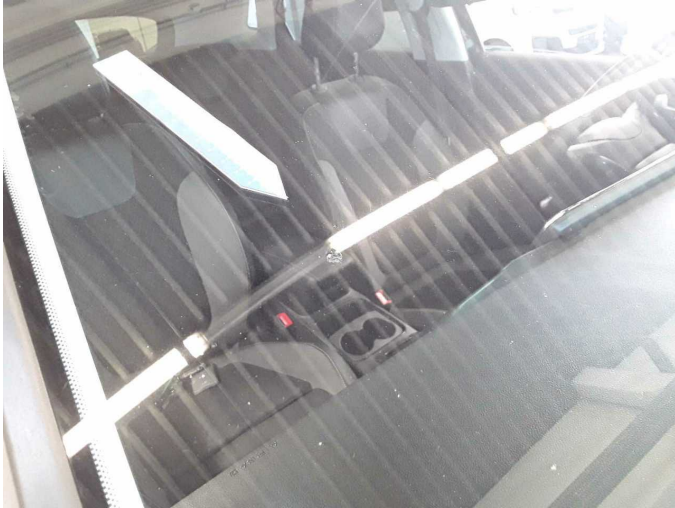
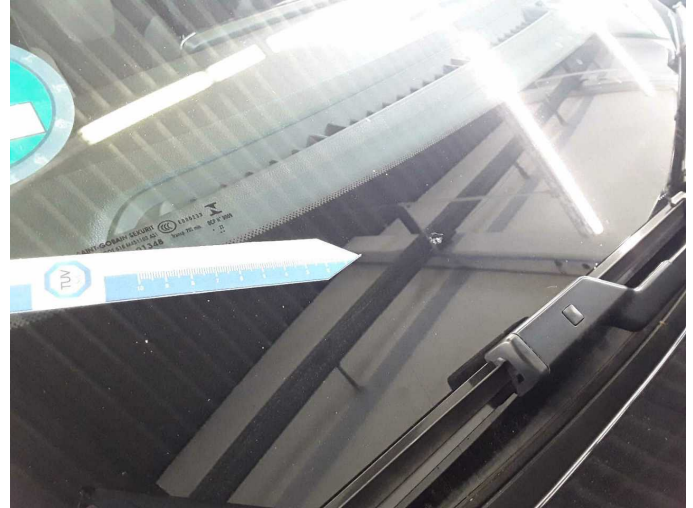
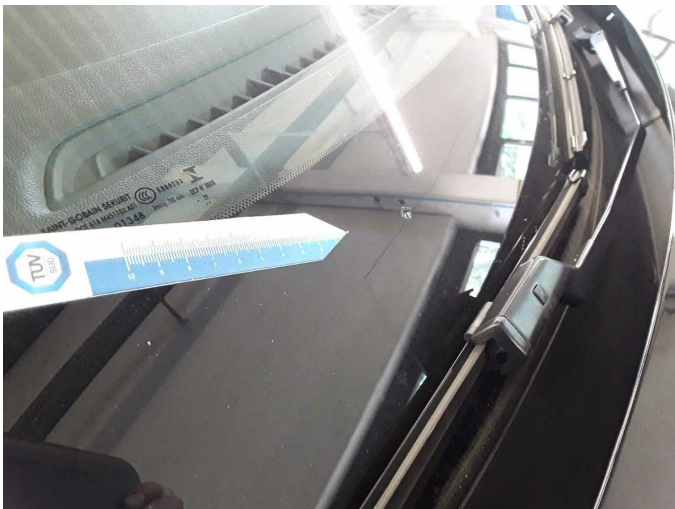
**Damage 8:** Vehicle glazing: Windscreen (kein Staubschutz) - Broken / torn - Replace

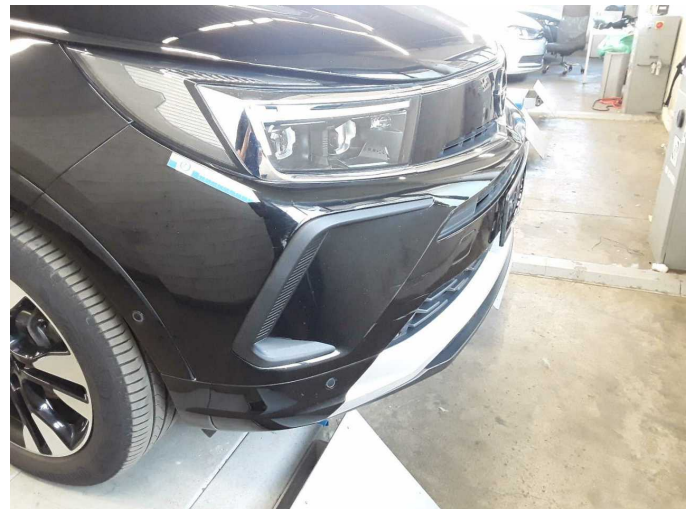
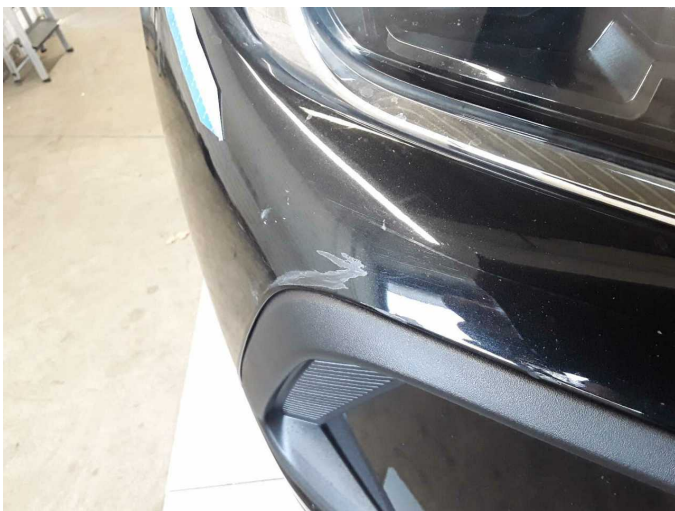
**Damage 9:** Front bumper: Front bumper - Scratched - Paint

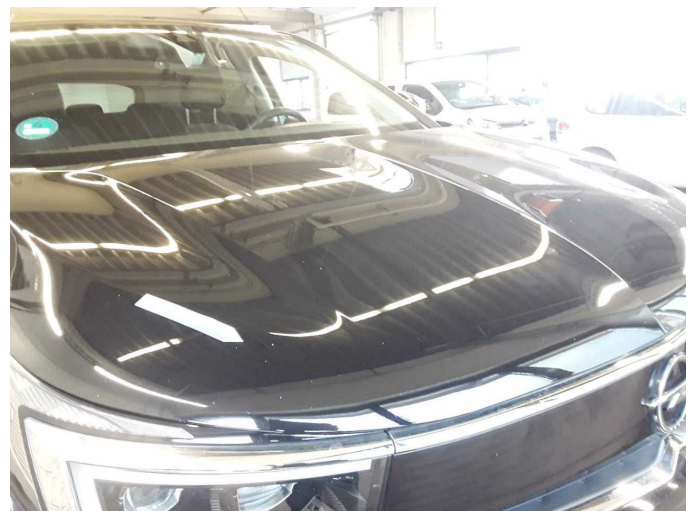
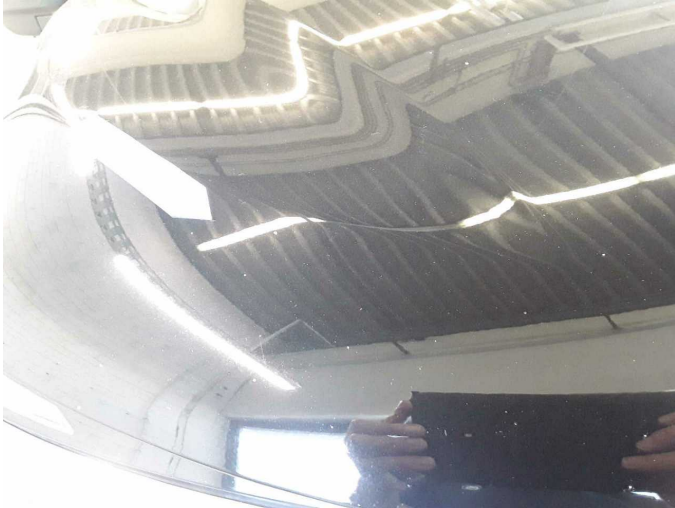
**Wear and tear 1:** Bonnet: Bonnet - Stone chips - No deduction

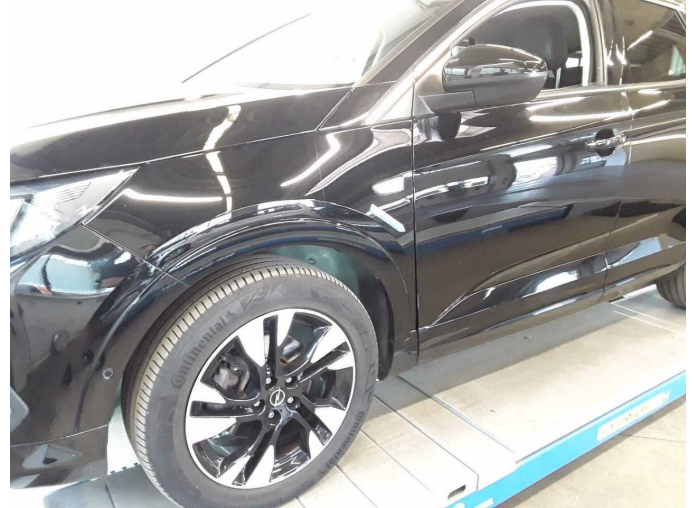
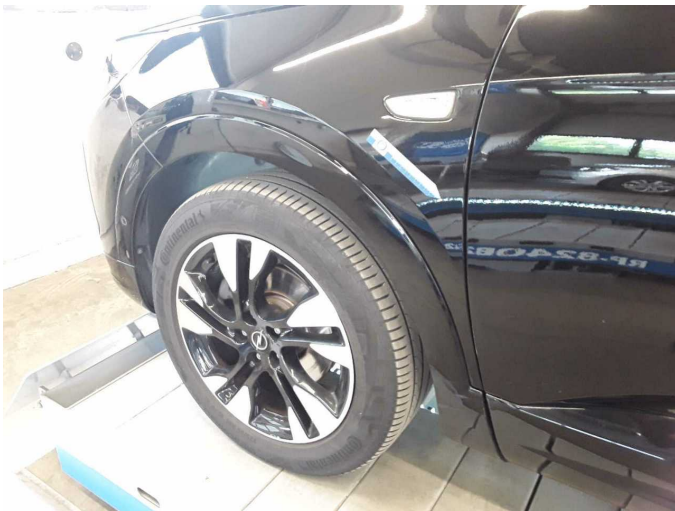
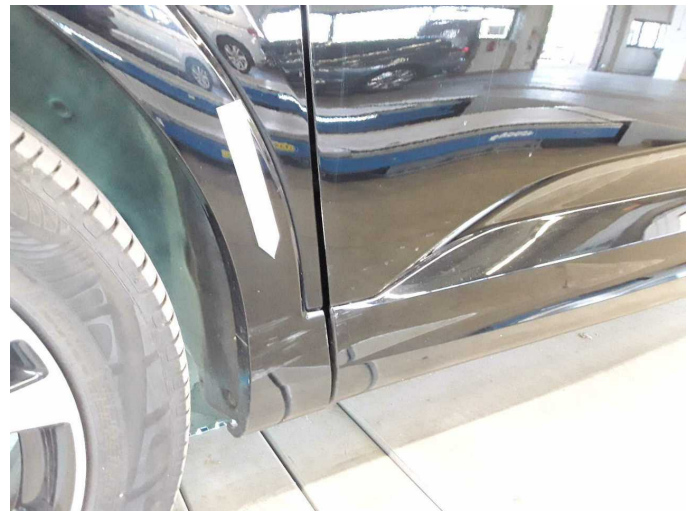
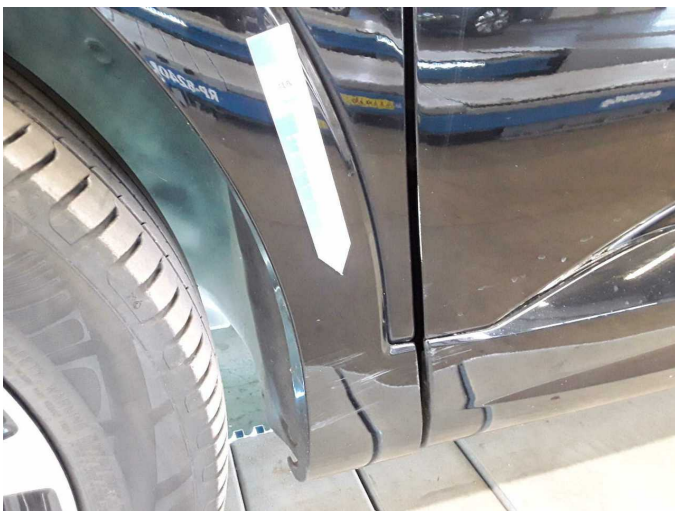
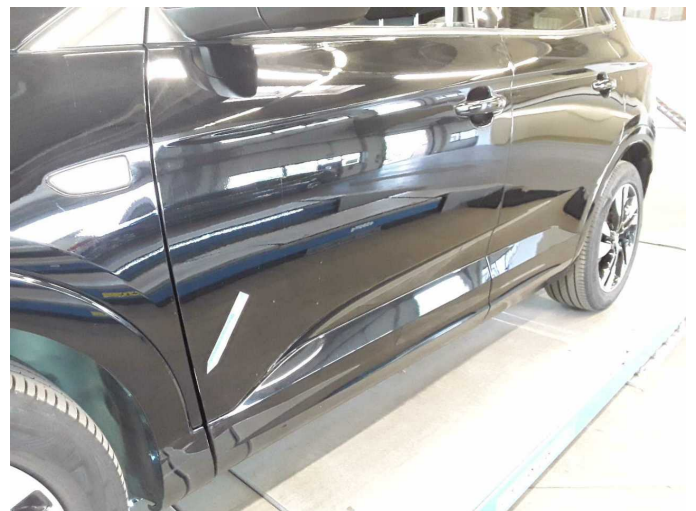
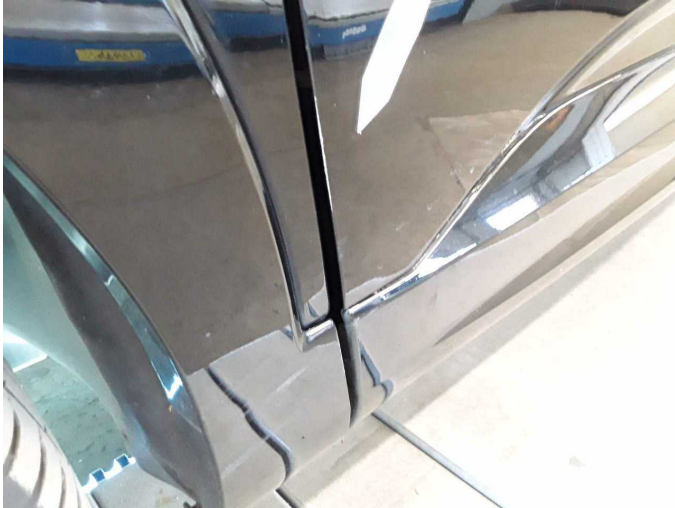
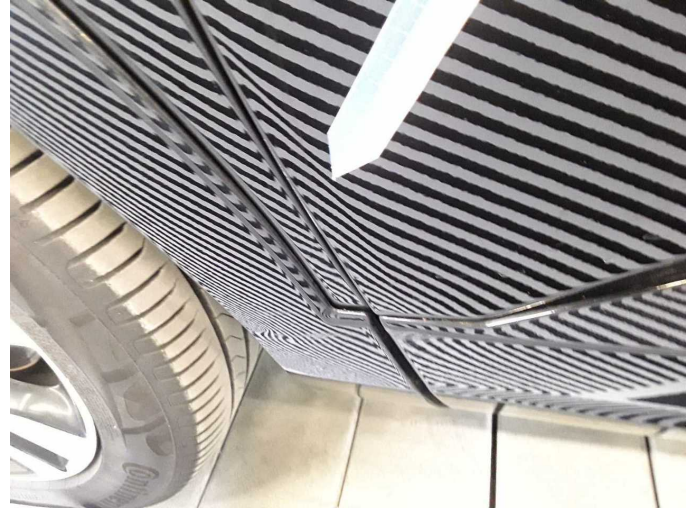
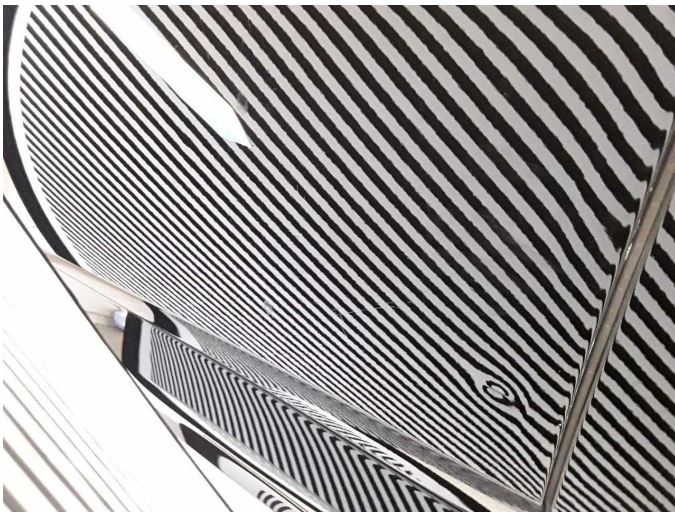
No.	Accident
1	Side - left

**Accident 1:** Side - left

**Accident 1: Side - left**

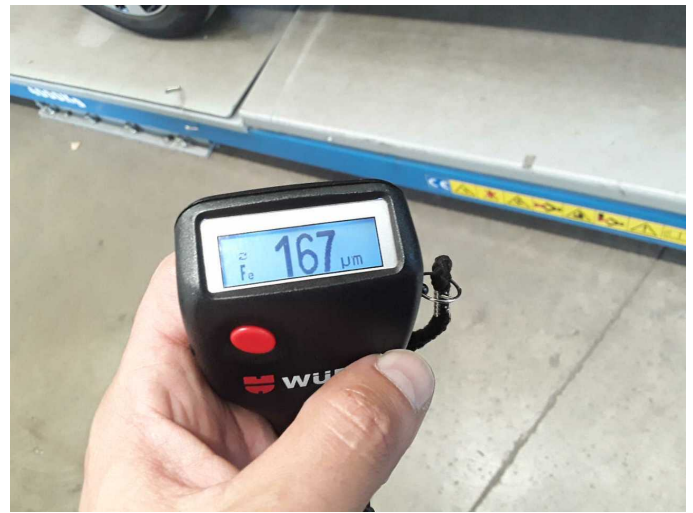
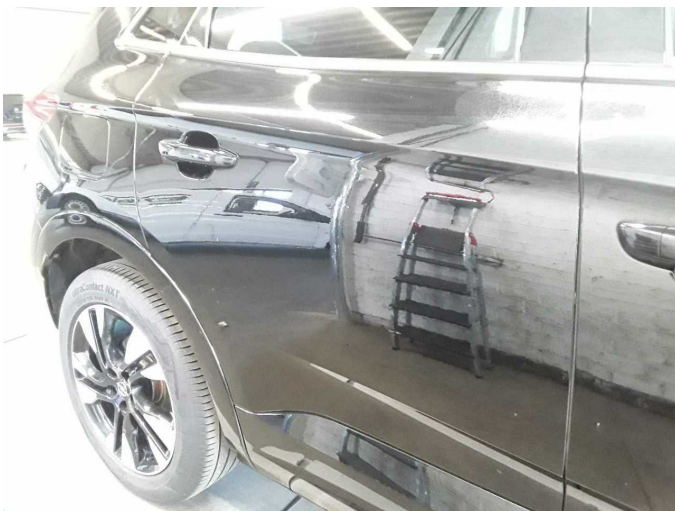
No.	Repainting
1	Door - rear right side, Professionally carried out, Invoice of repair done Non-existent

**Repainting 1: Door - rear right side**
