Expertise

Protocol number: 46328397
Order No. / Reference: 26631764
Inspection date: 2 Jul 2026

Manufacturer: Audi

Model: S6 Avant TDI quattro tiptronic

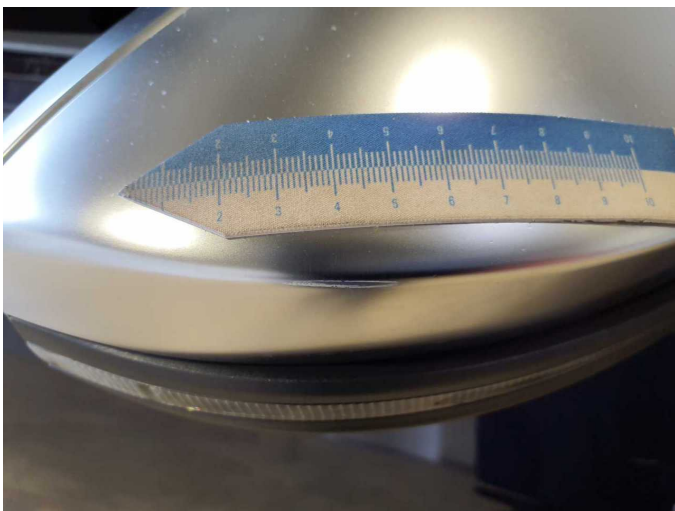
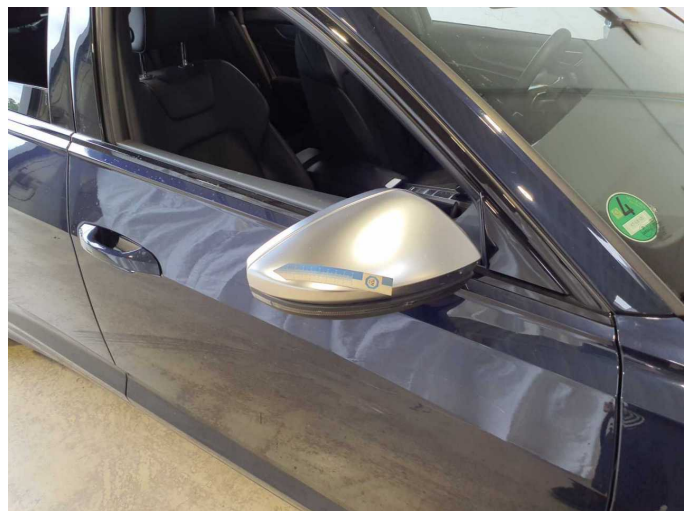
Damage 3: Wing mirror - right side: Cap - Scratch(es) - Smart repair

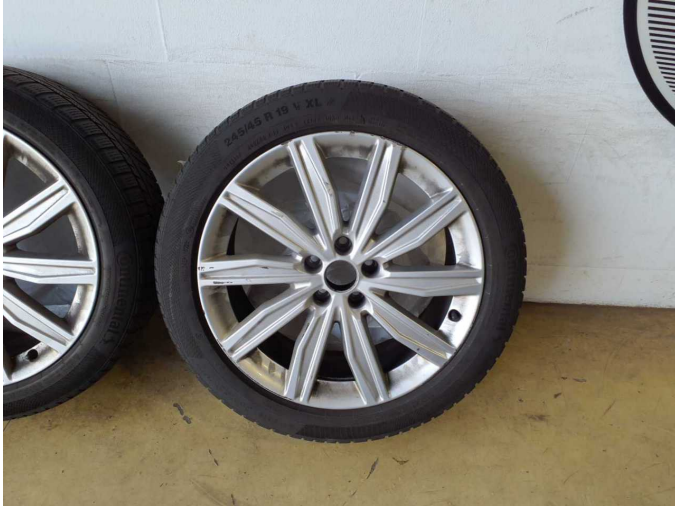
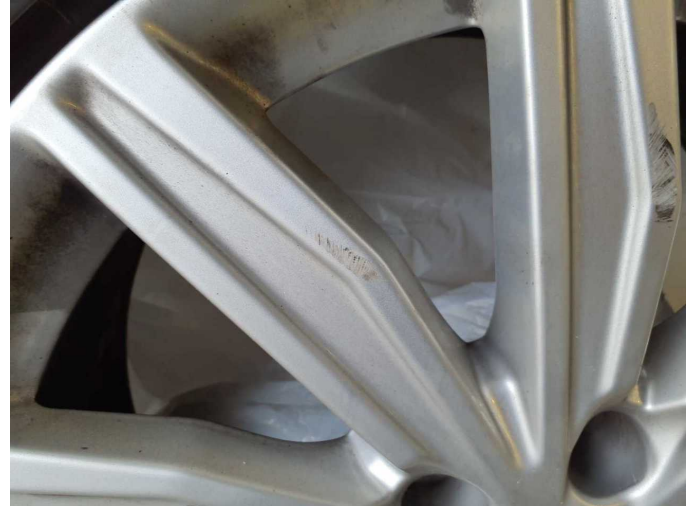
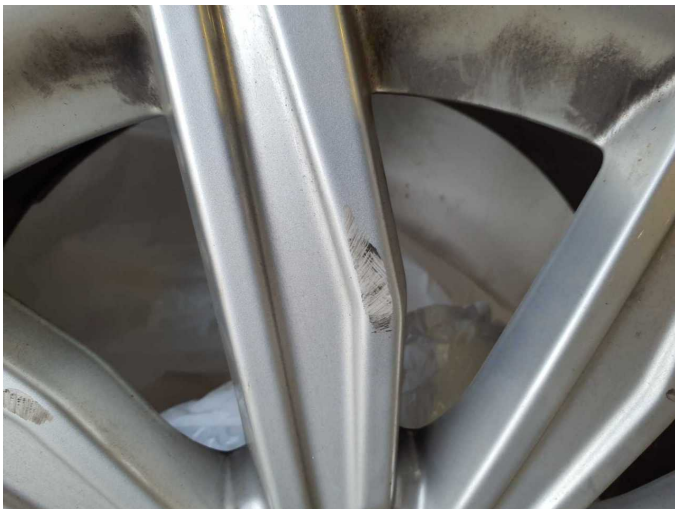
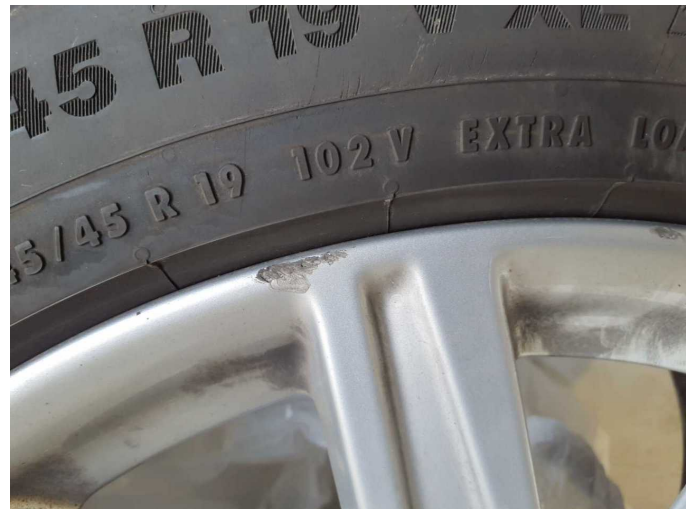
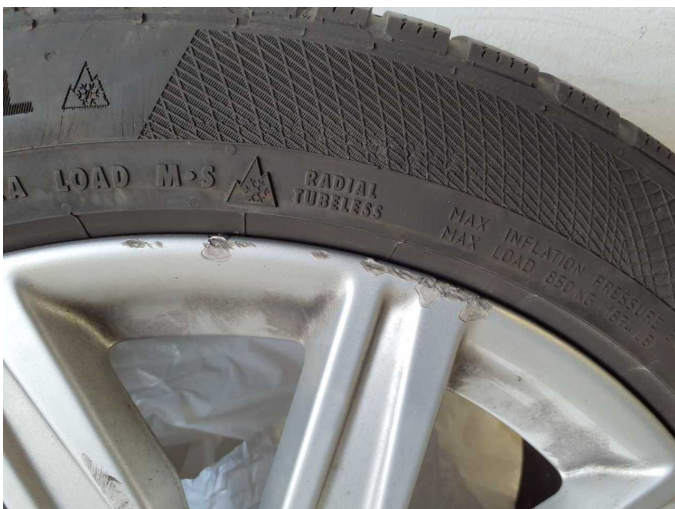
Damage 4: 2nd wheel set: 1 alloy rim - Scratch(es) - Loss in value

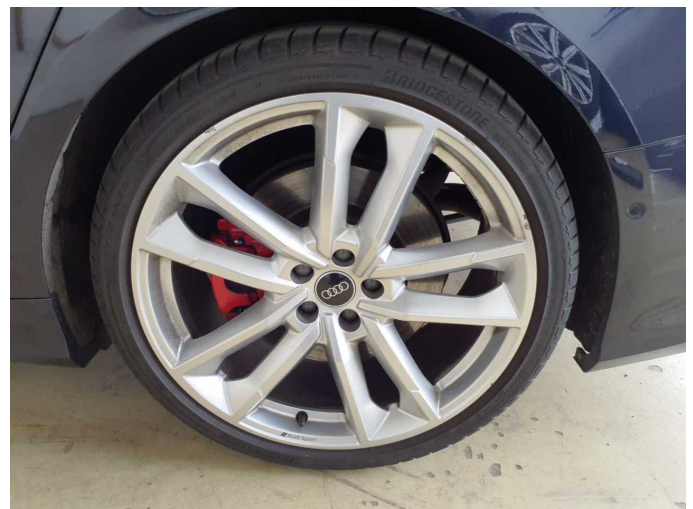
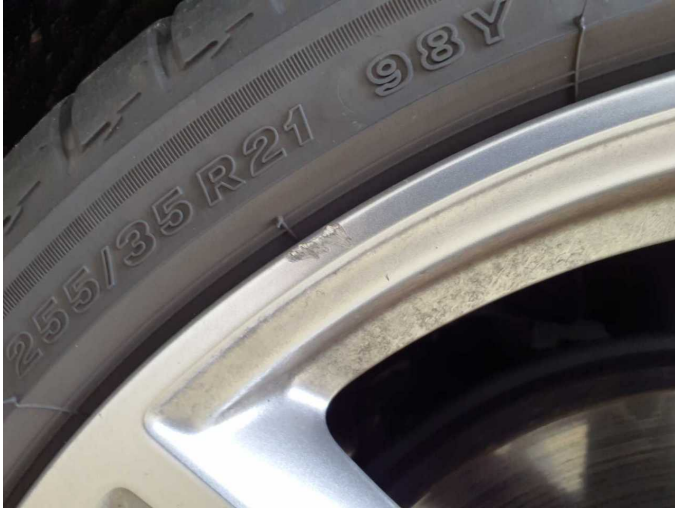
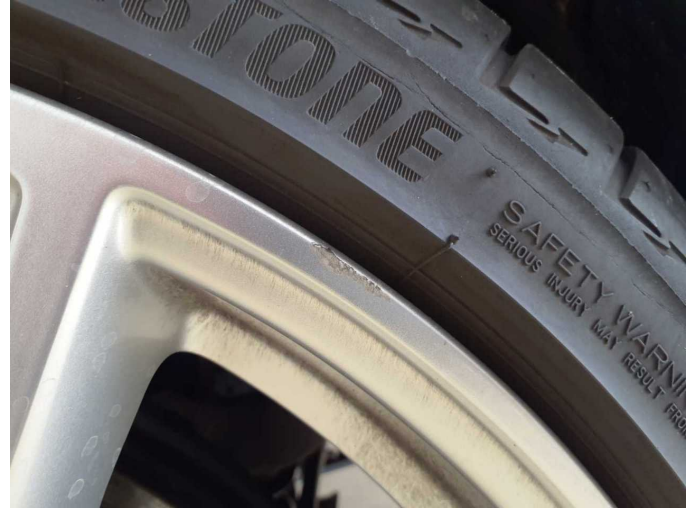
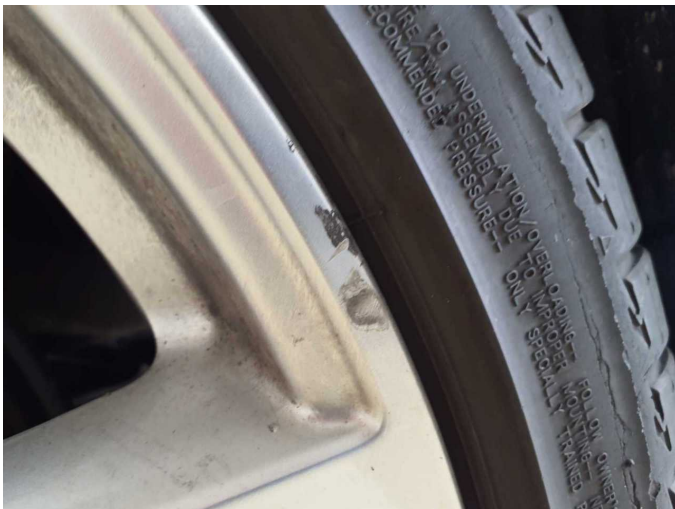
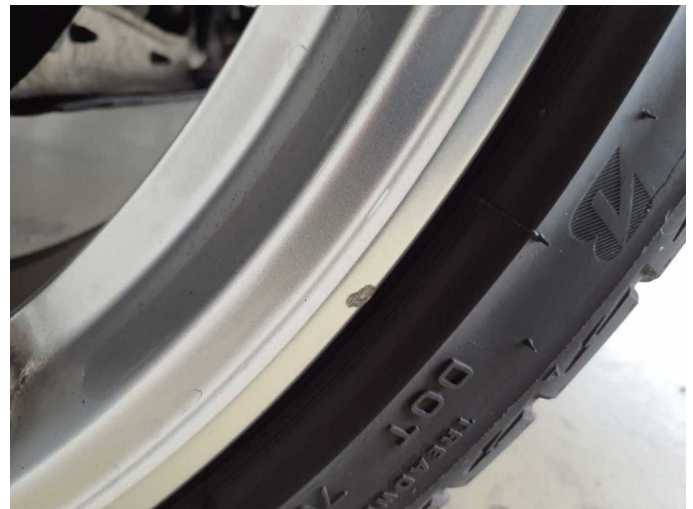
Damage 5: Wheel / tyres: Alloy rim - rear left side - Scratch(es) - Loss in value

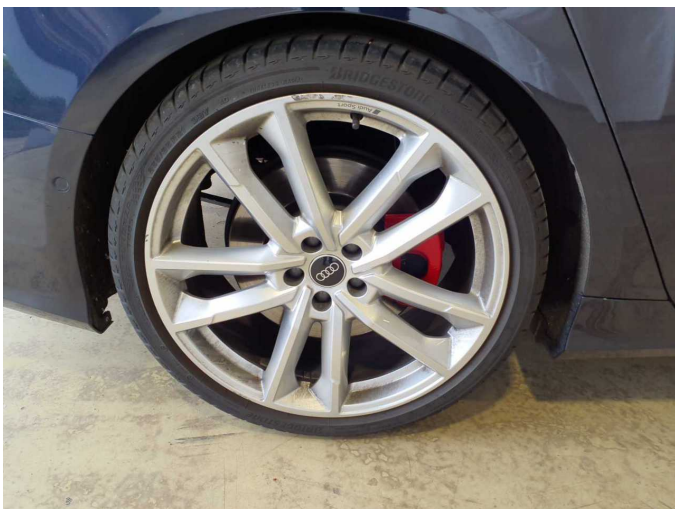
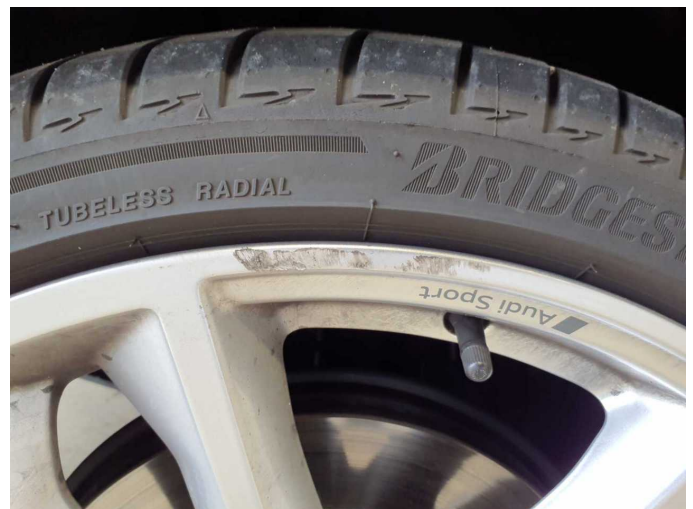
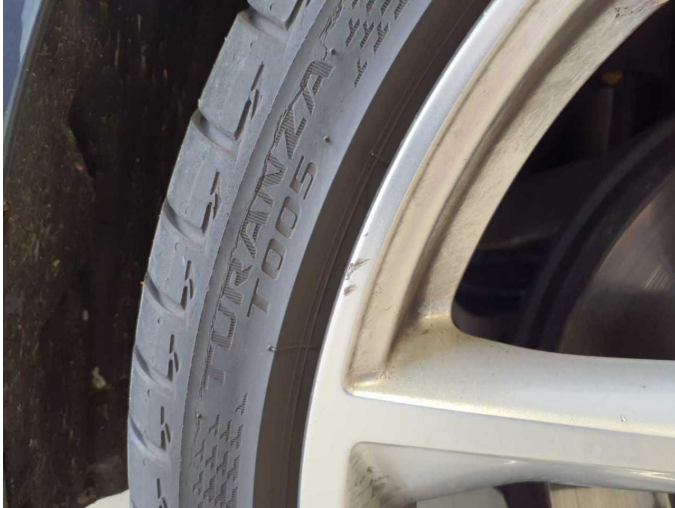
Damage 6: Wheel / tyres: Alloy rim - rear right side - Scratch(es) - Loss in value

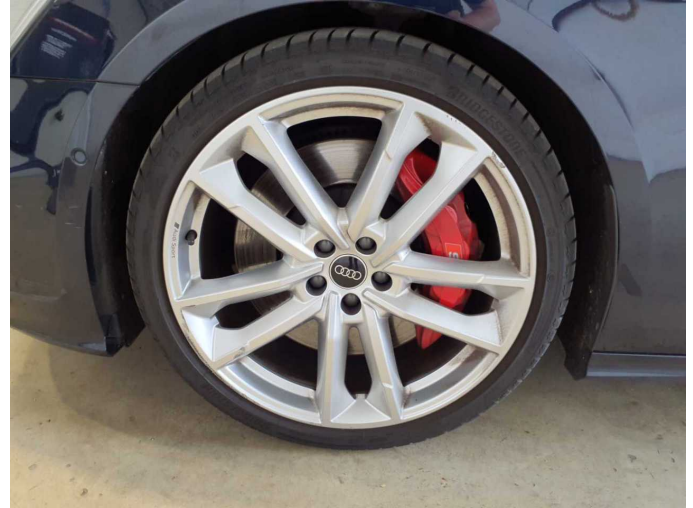
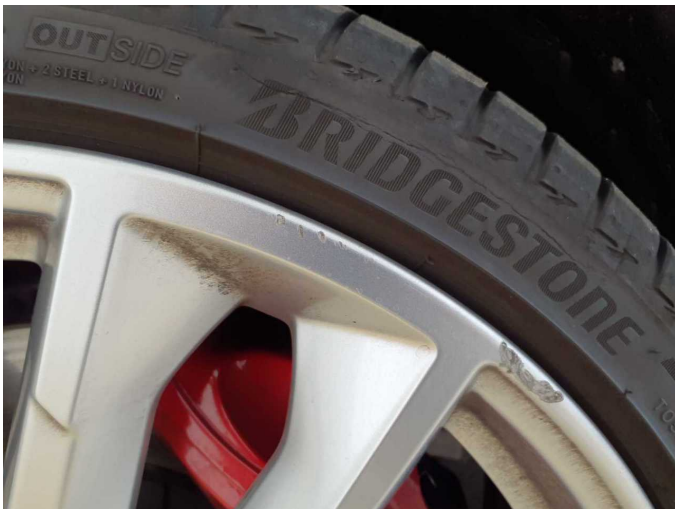
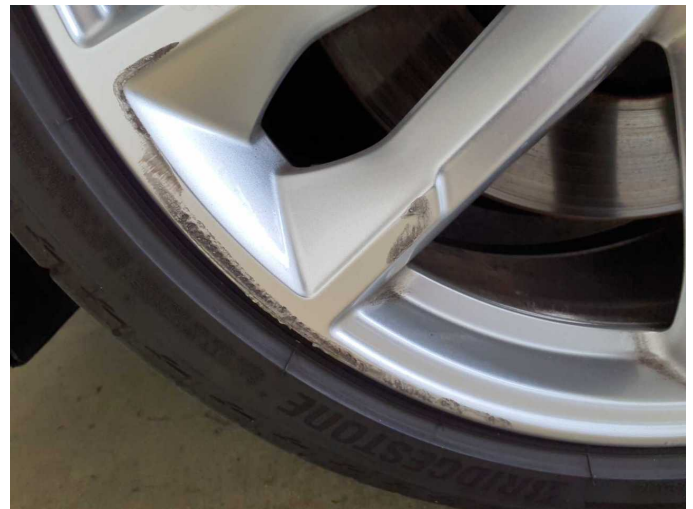
Damage 7: Wheel / tyres: Alloy rim - front left side - Scratch(es) - Loss in value

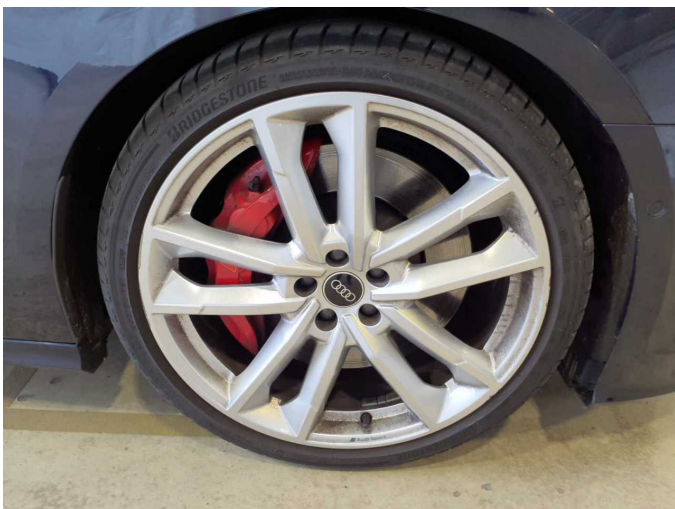
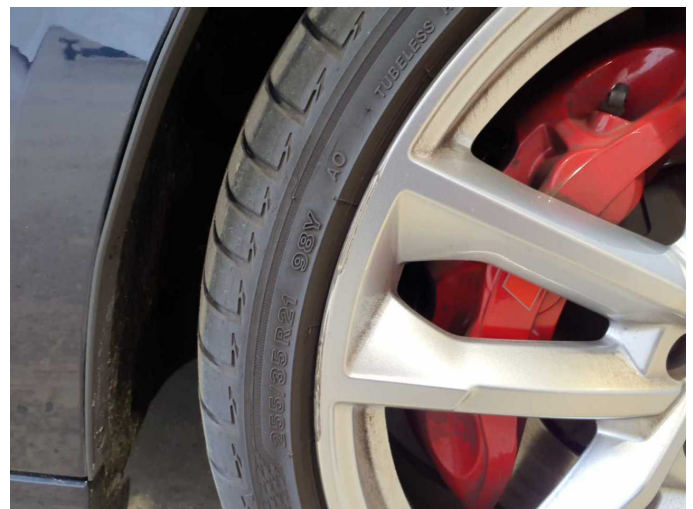
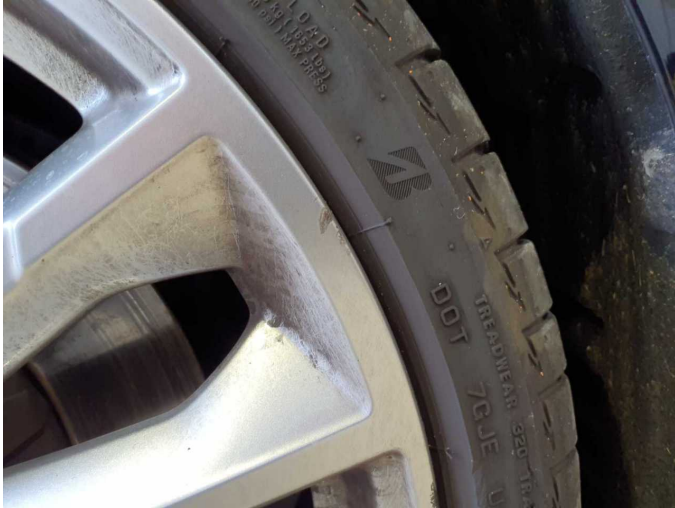
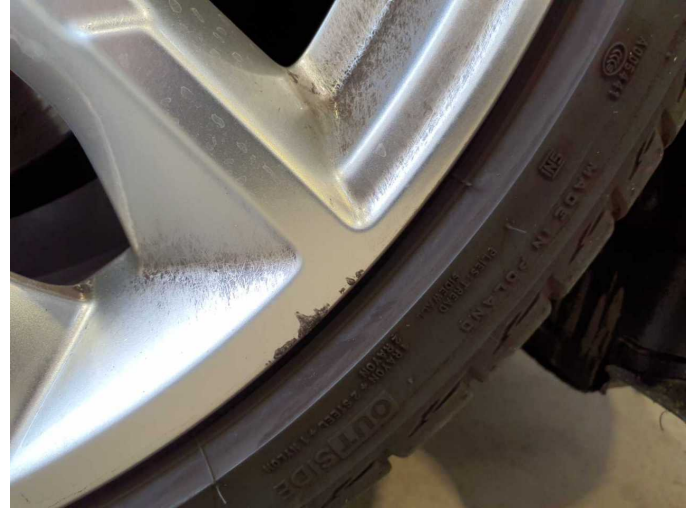
Damage 8: Wheel / tyres: Alloy rim - front right side - Scratch(es) - Loss in value

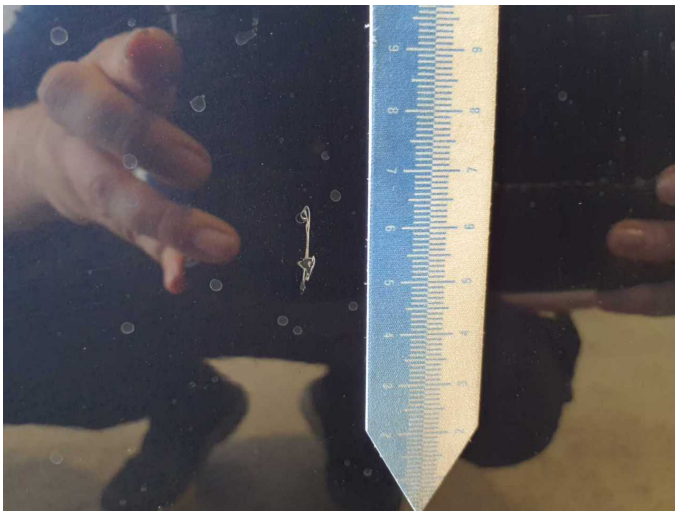
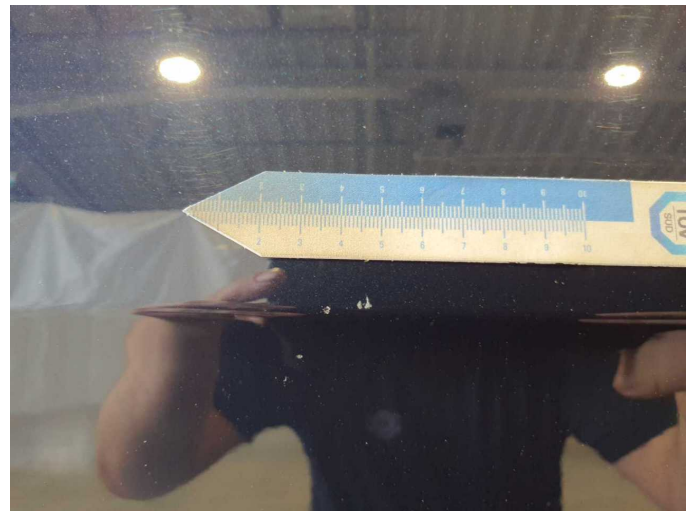
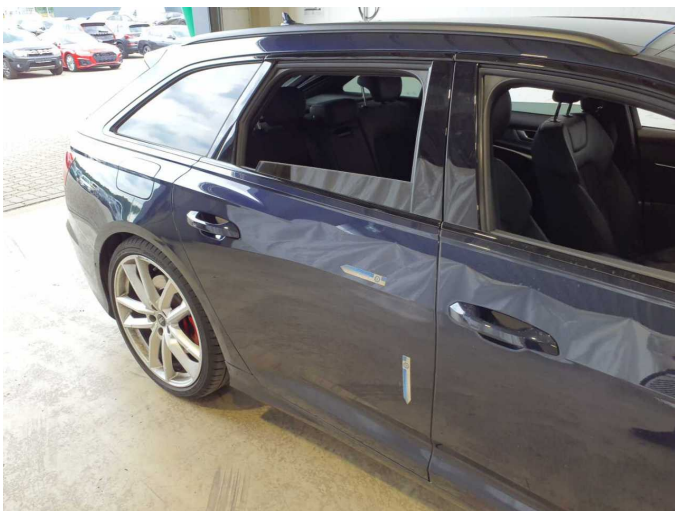
Damage 9: Door - rear right side: Door - Scratch(es) - Paint

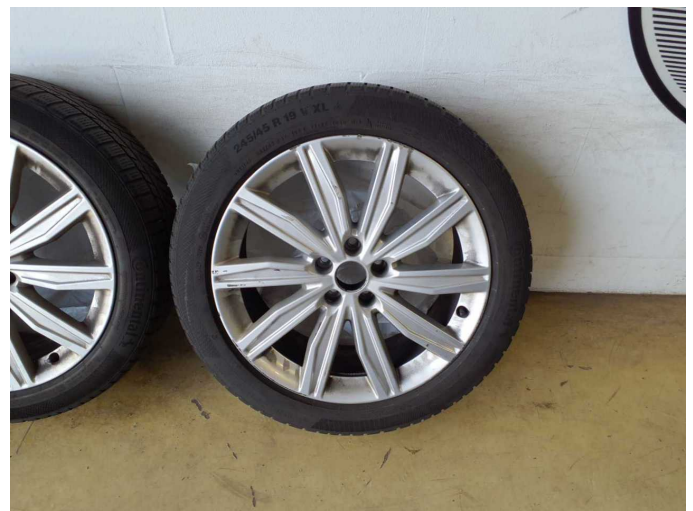
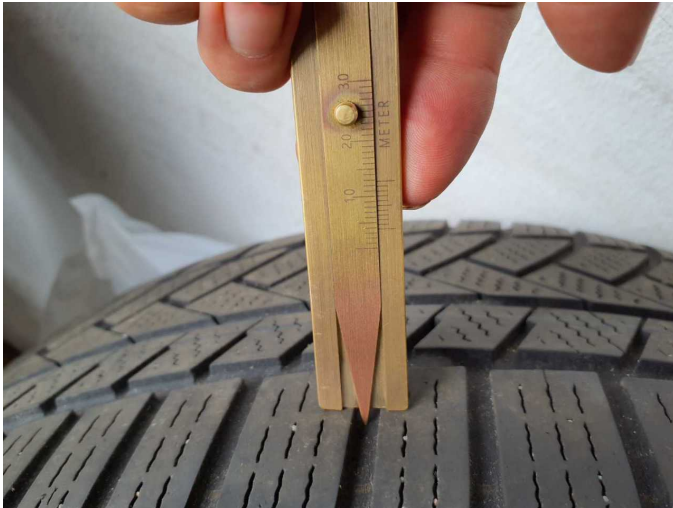
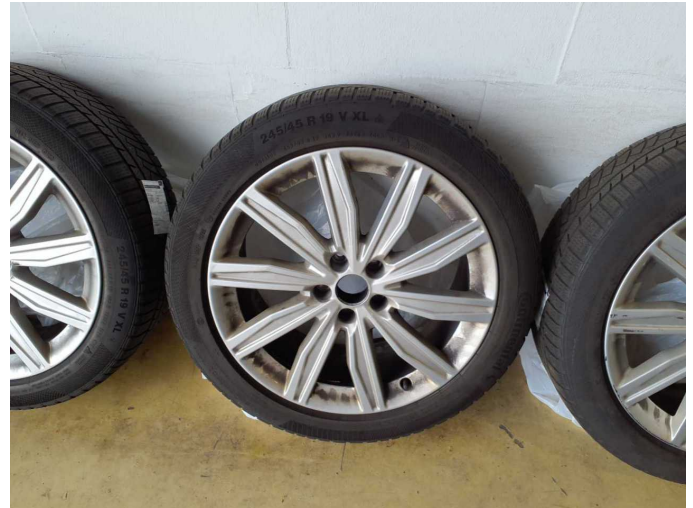
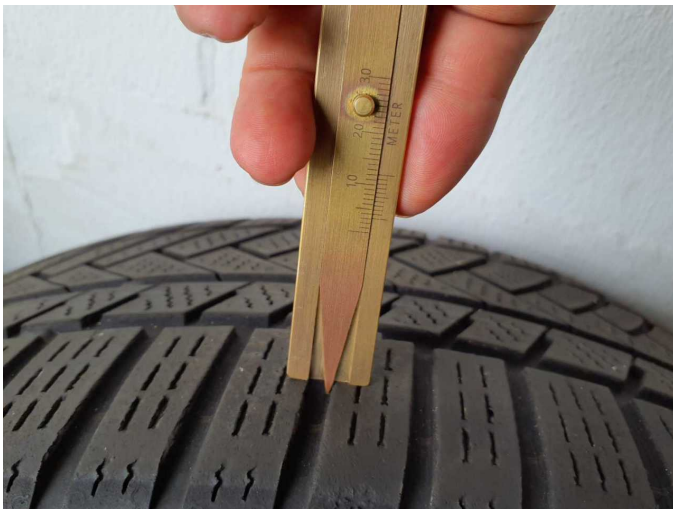
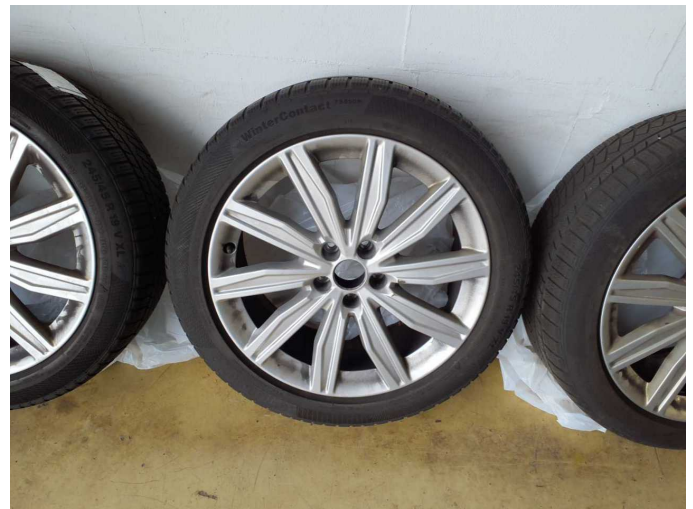
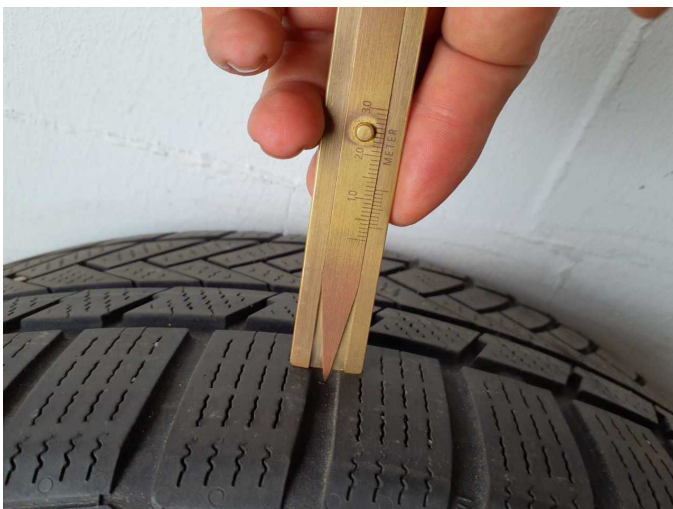
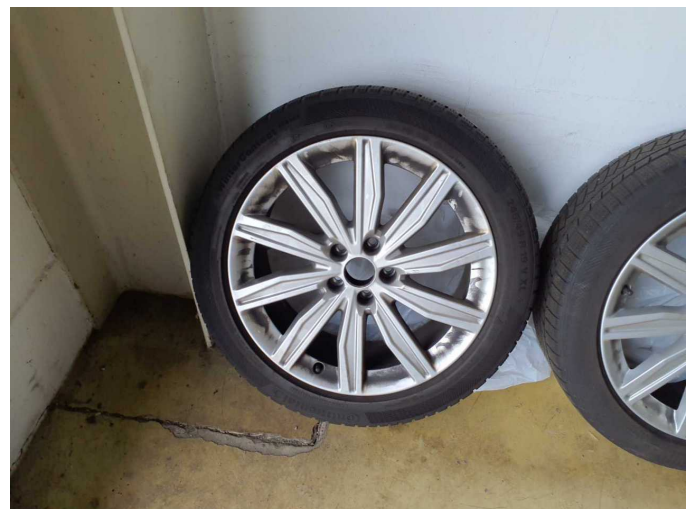
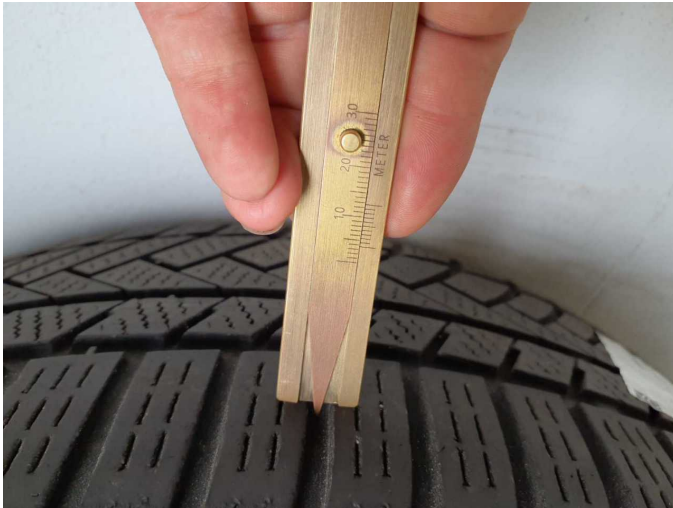
Damage 10: 2nd wheel set: Tyres - complete set - Worn - Replace

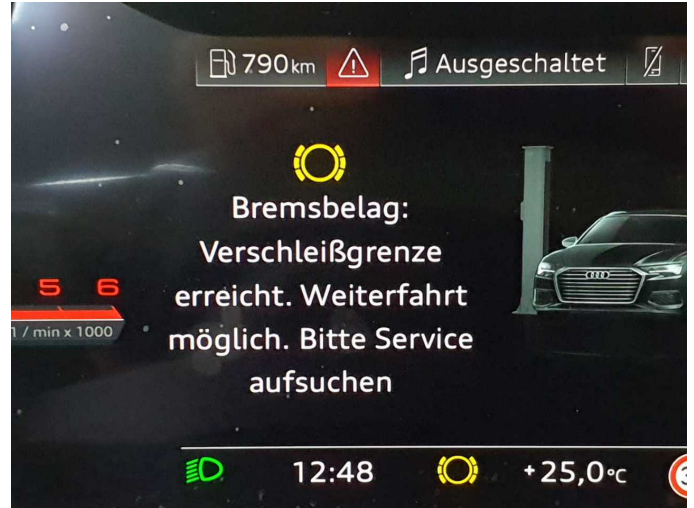
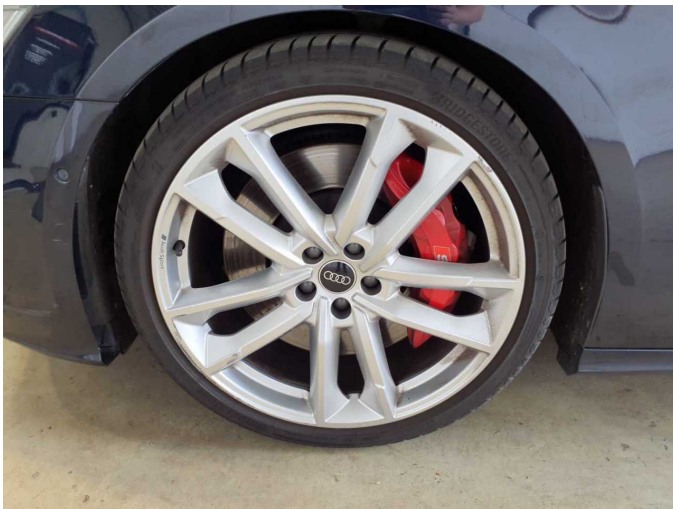
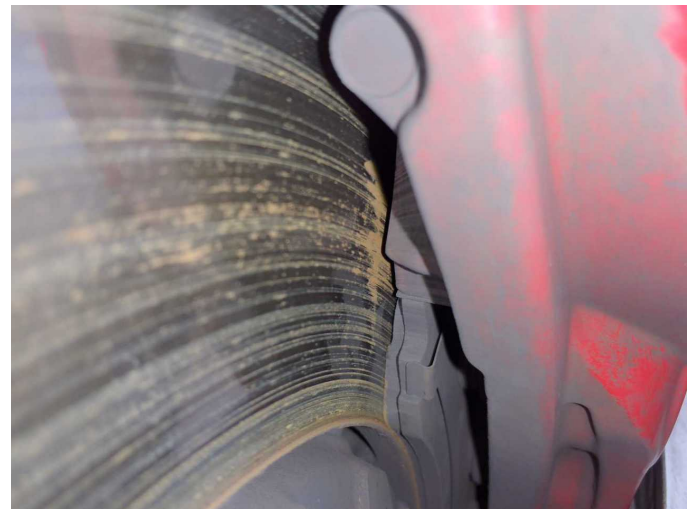
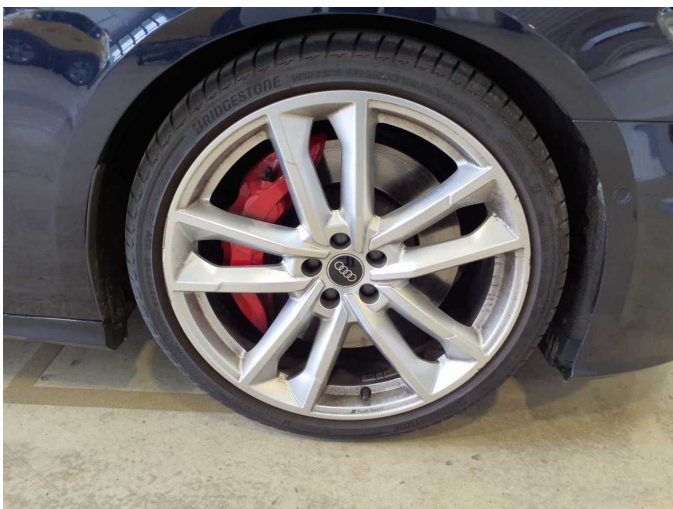
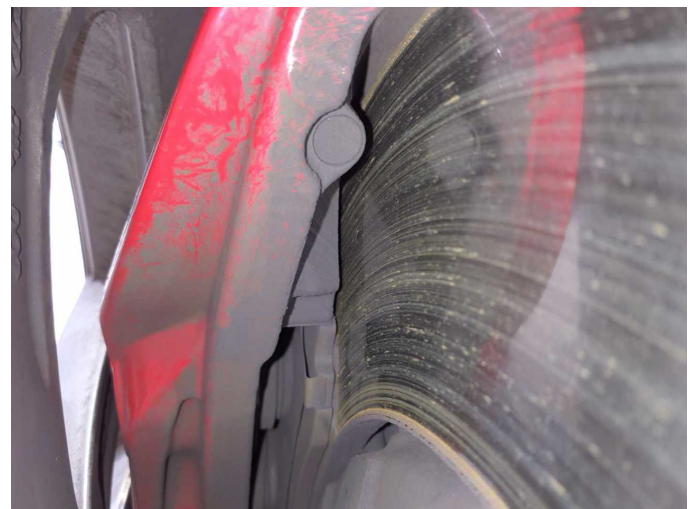
Damage 11: Braking system: Brake pads - front (Untermaß) - on - Replace

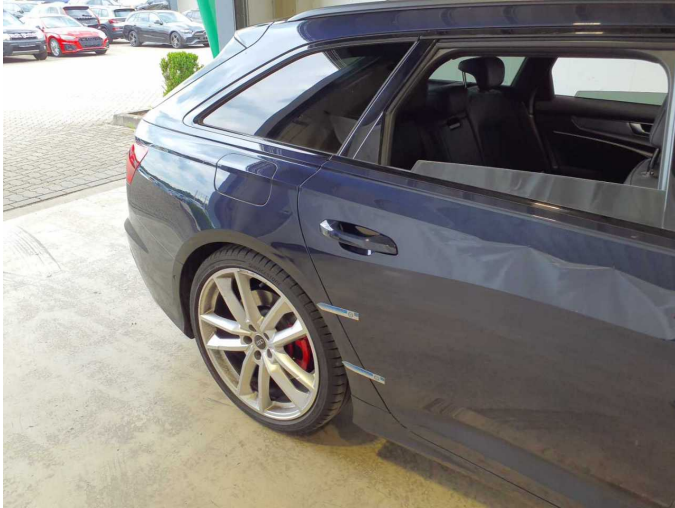
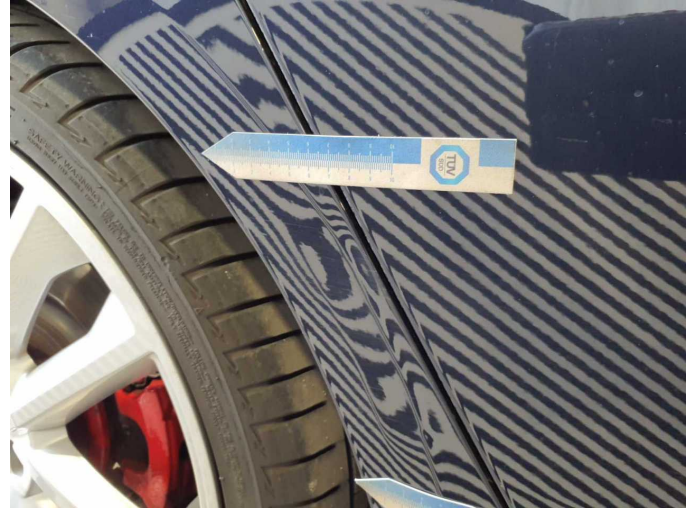
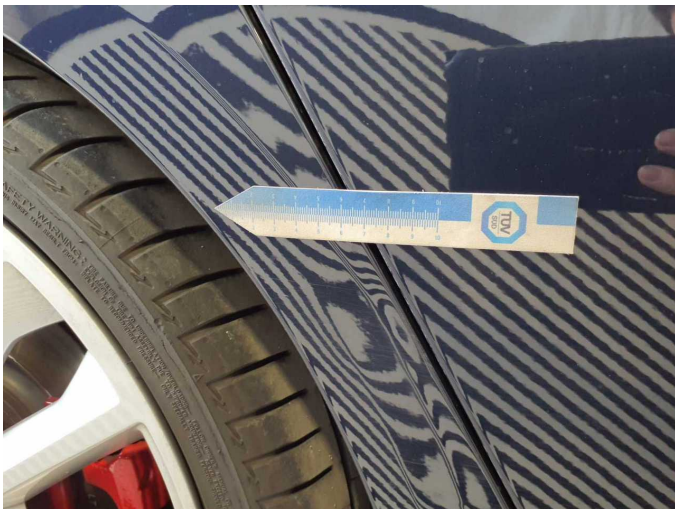
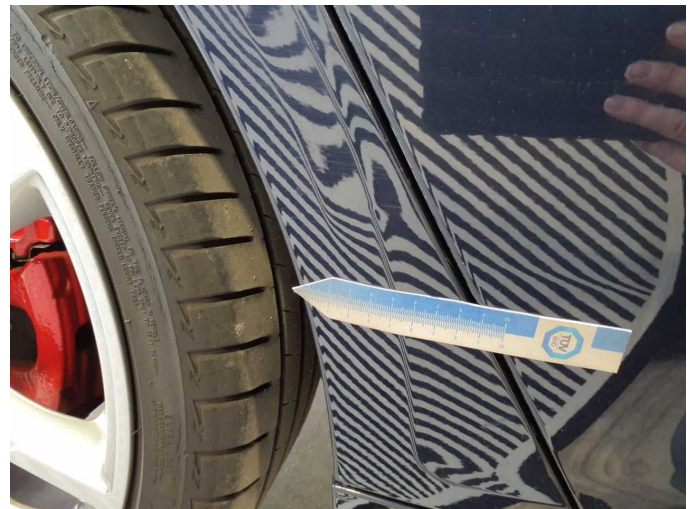
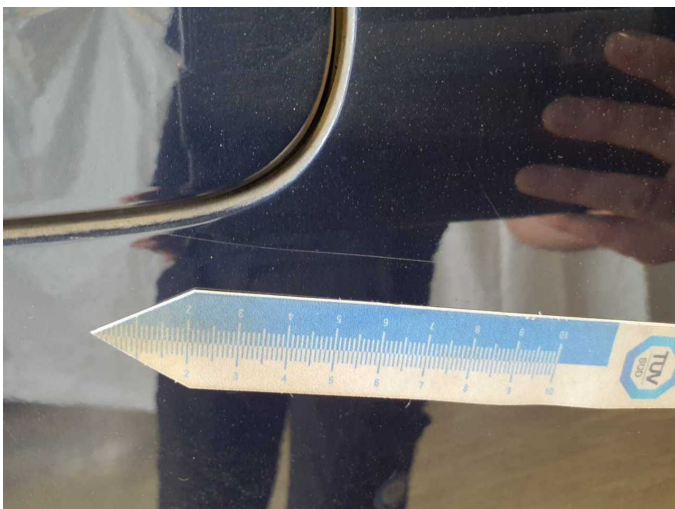
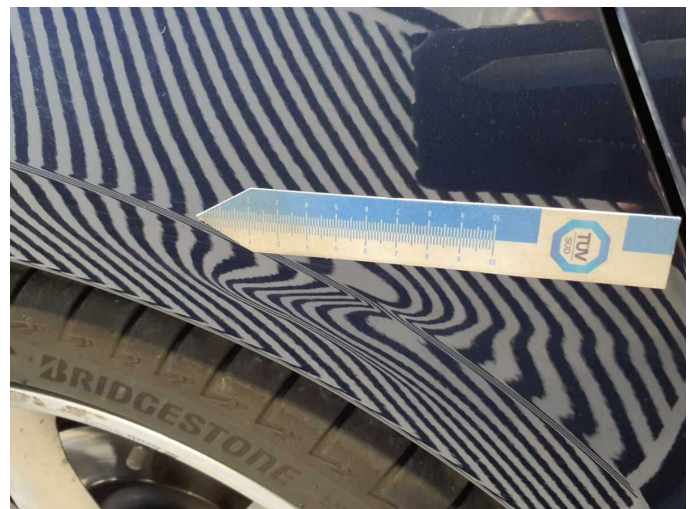
Damage 12: Side panel - rear right side: Side panel - Deformed - Repair and paint

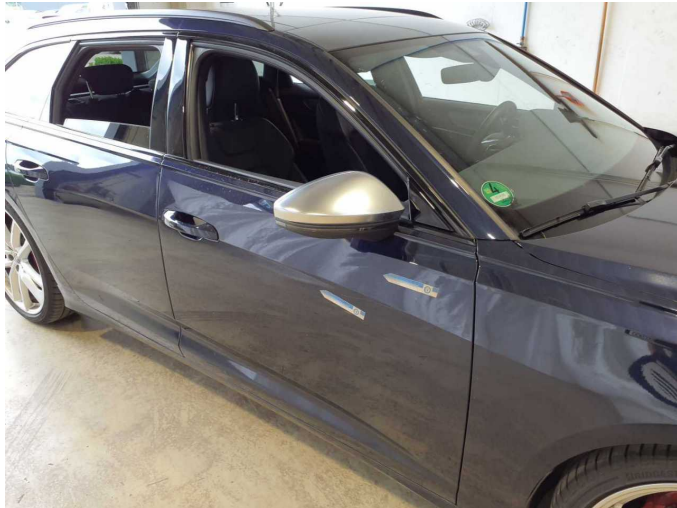
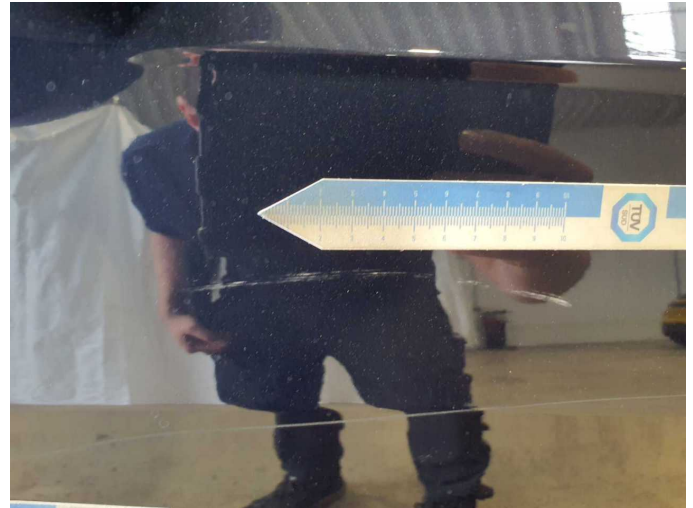
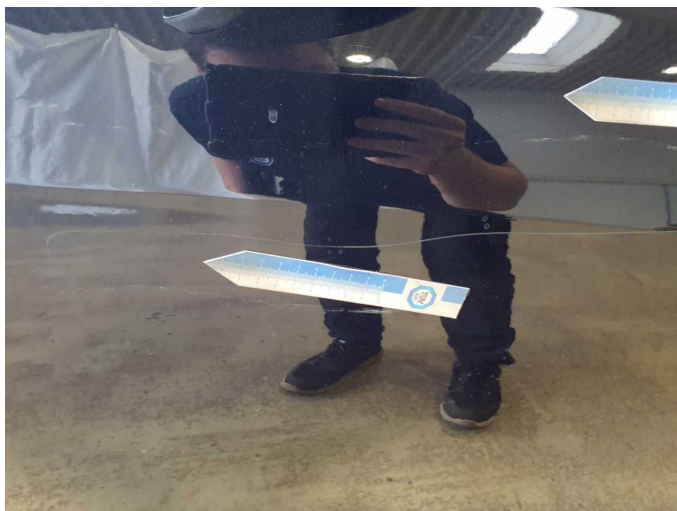
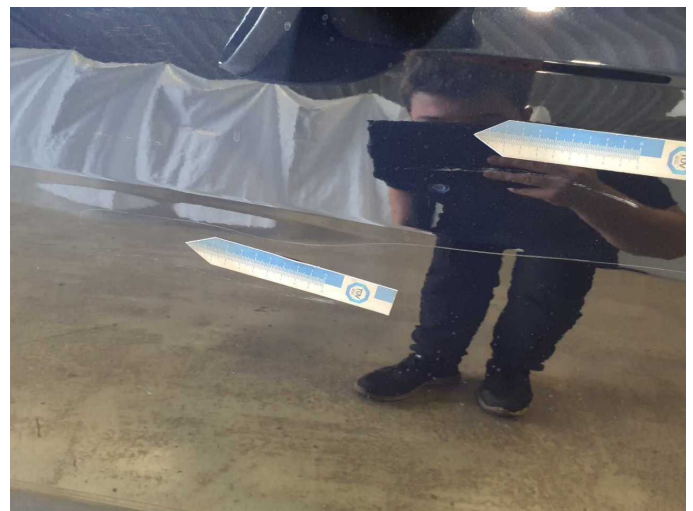
Damage 13: Door - front right side: Door - Scratch(es) - Paint

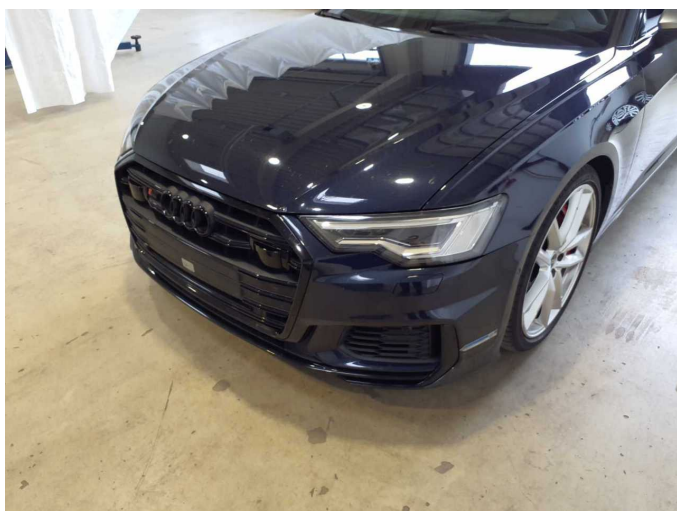
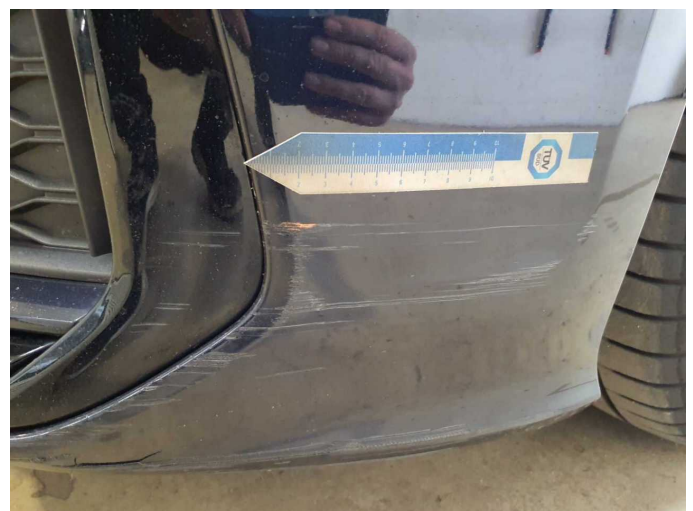
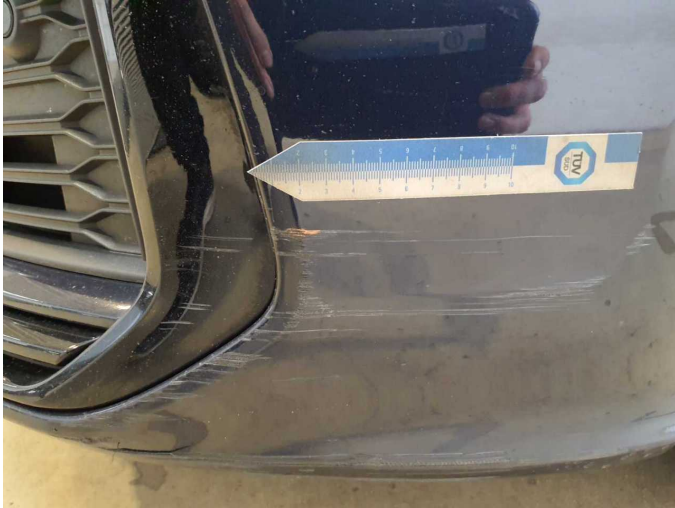
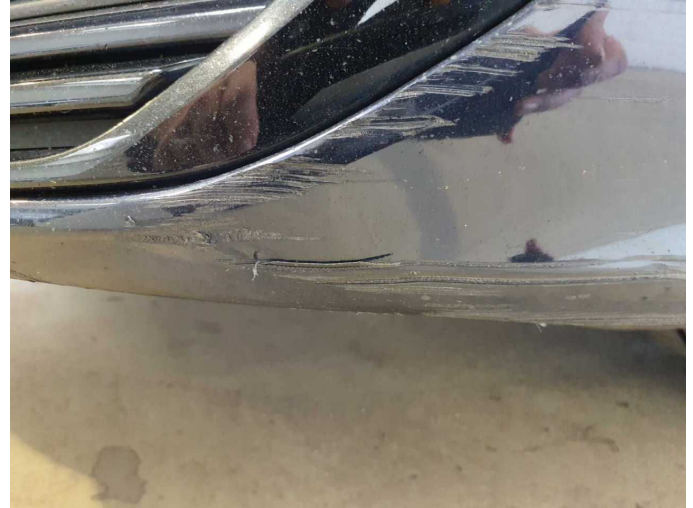
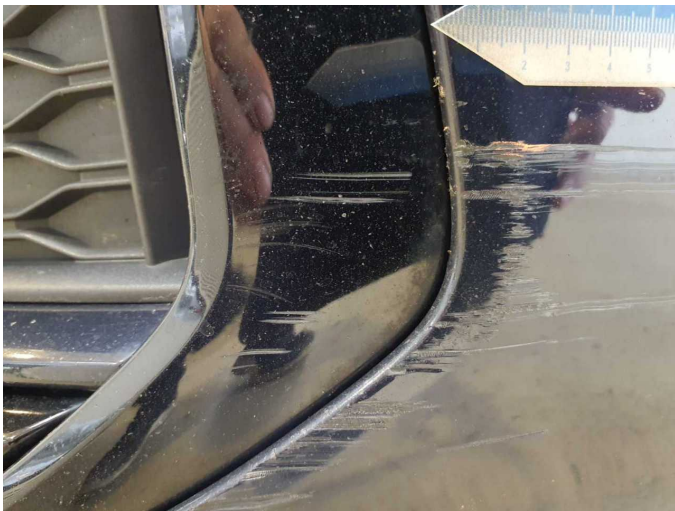
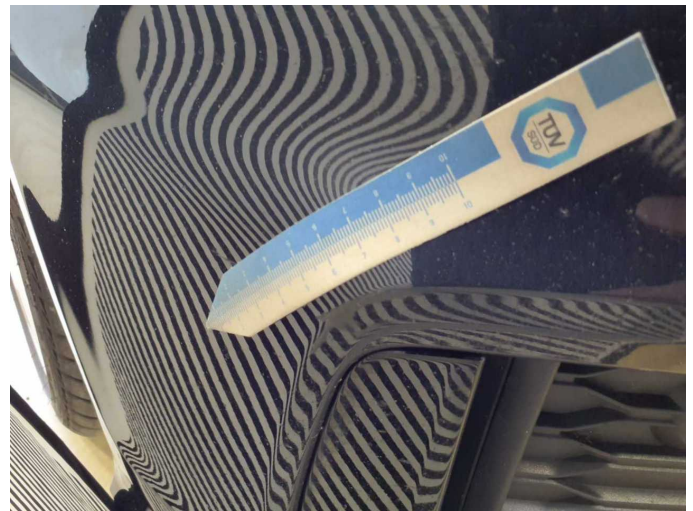
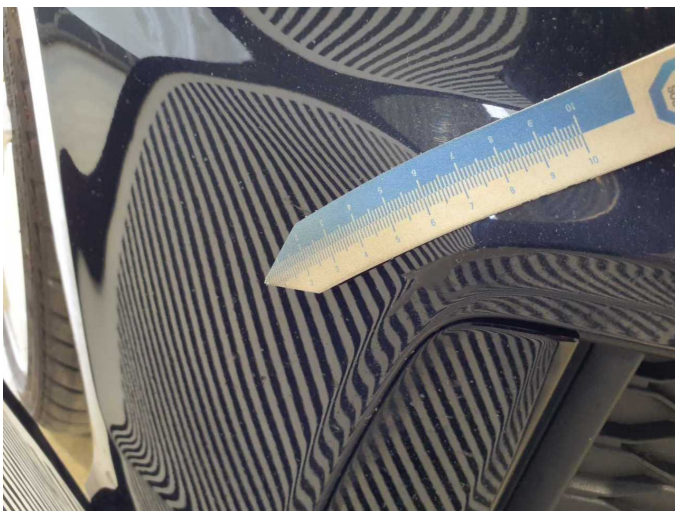
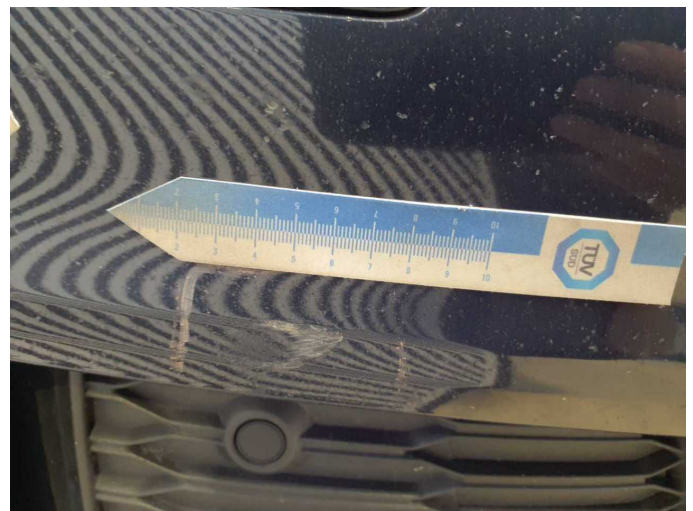
Damage 14: Front bumper: Front bumper (Zusätzlich Blende VL Kratzer) - Scratch(es) - repair according to calculation

Damage 14: Front bumper: Front bumper (Zusätzlich Blende VL Kratzer)
- Scratch(es) - repair according to calculation

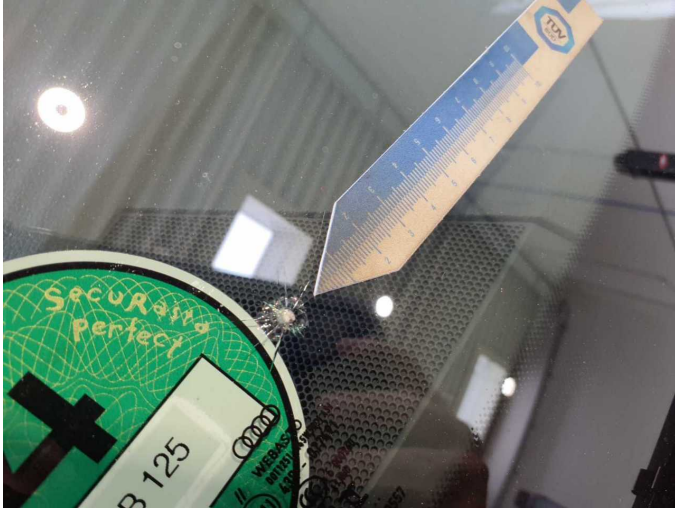
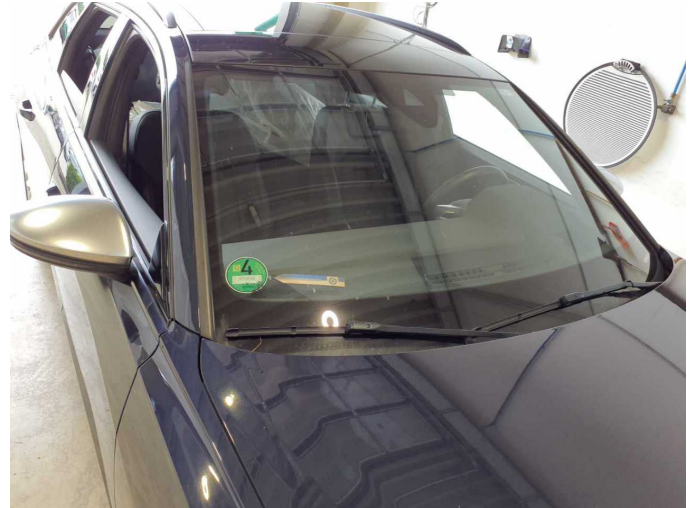
Damage 15: Vehicle glazing: Windscreen - Broken / torn - repair according to calculation

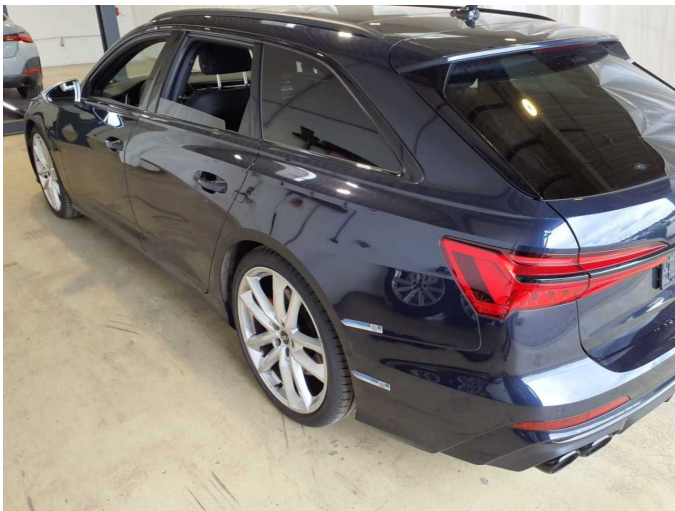
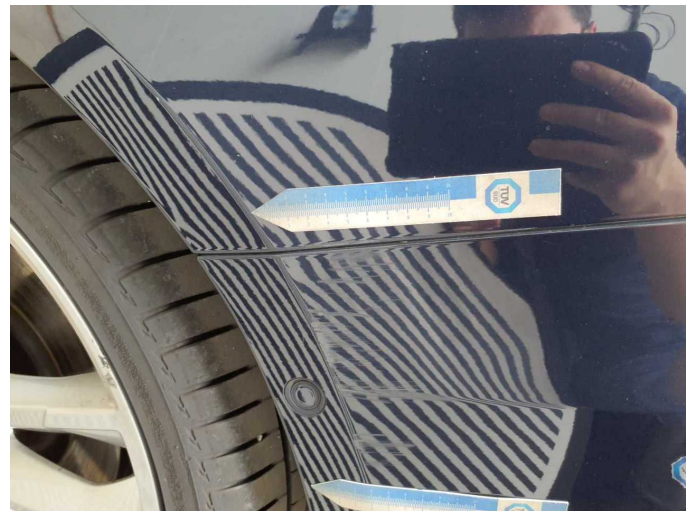
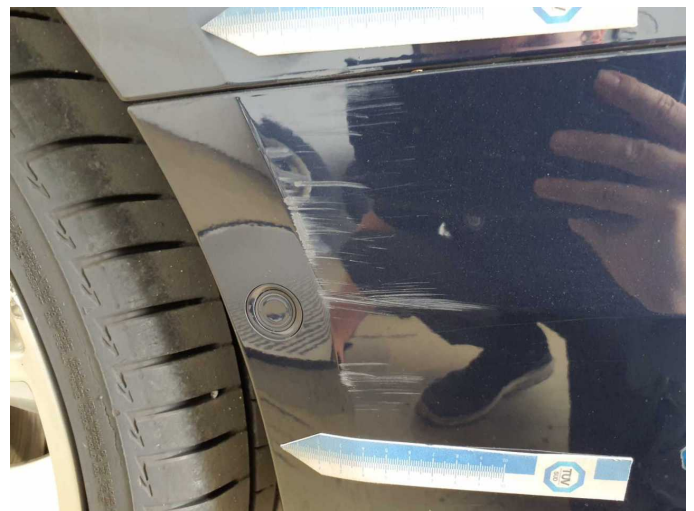
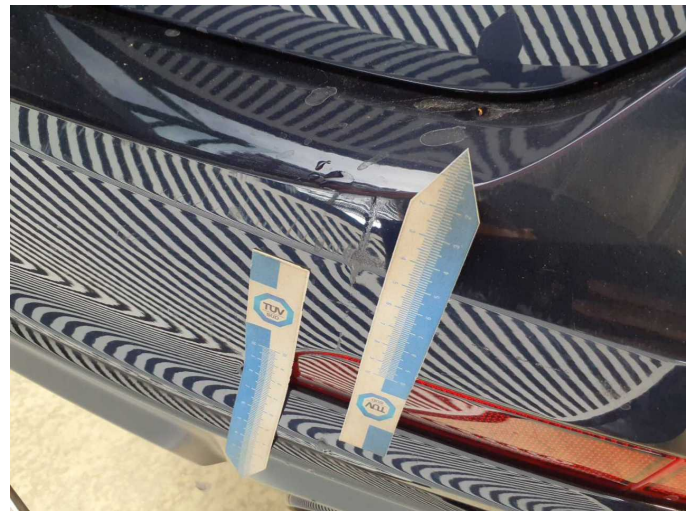
Accident 1: Rear, Side - left
