Expertise

Protocol number: 46211213
Order No. / Reference: 26573210
Inspection date: 25 Jun 2026

Manufacturer: Ford

Model: Transit Connect 230 L2 Trend

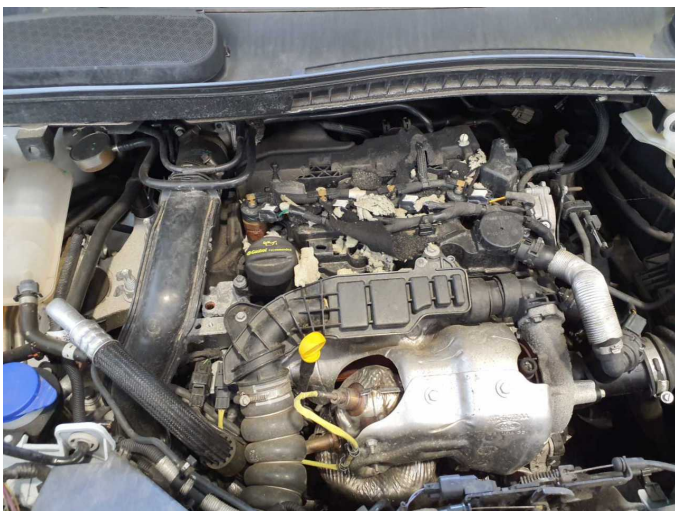
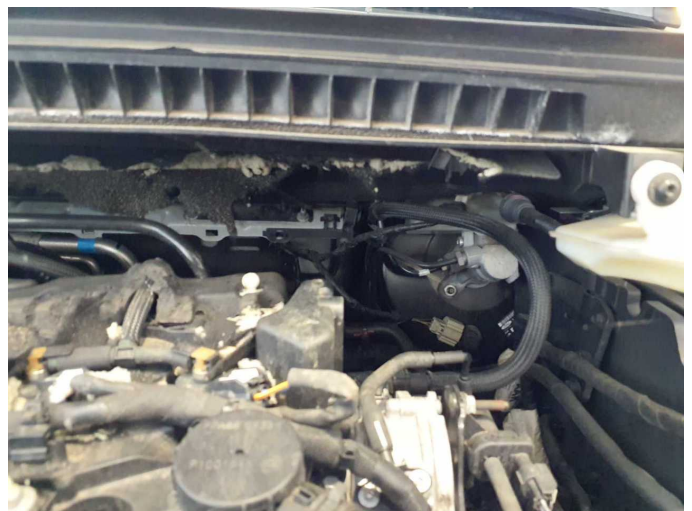
| No. | Component group | Description |
|---|---|---|
| 2 | Cab | Insulation lining (Marderschaden) - Damaged - Replace |

Damage 2: Cab: Insulation lining (Marderschaden) - Damaged - Replace

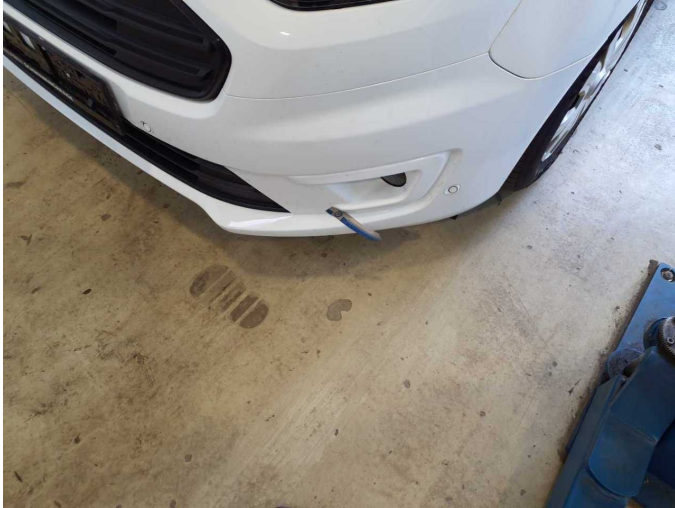
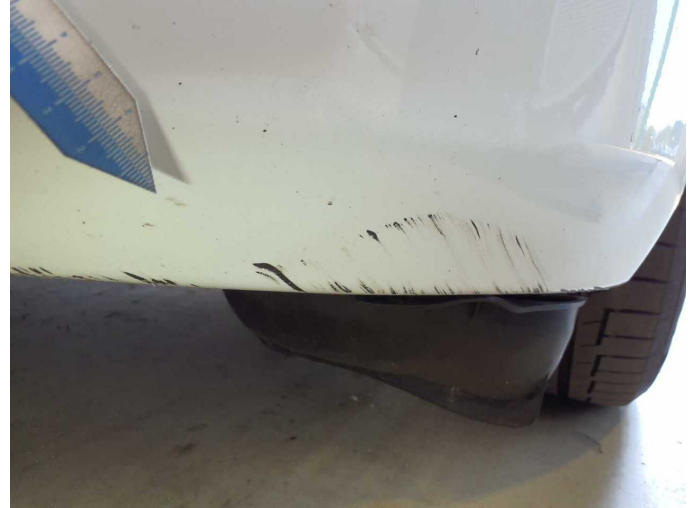
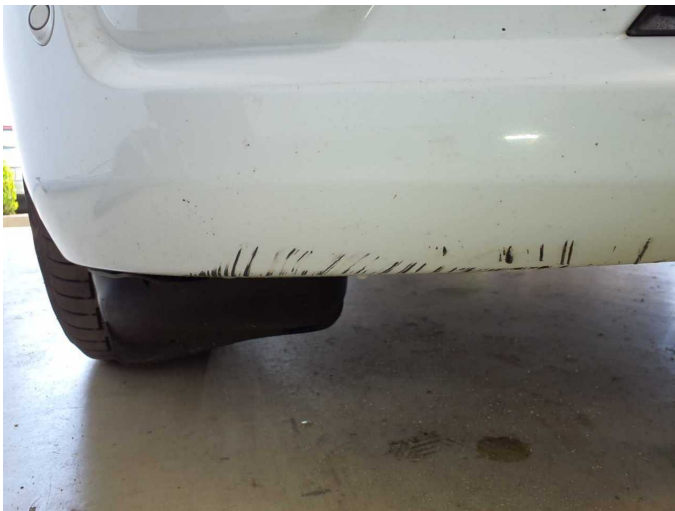
| No. | Component group | Description |
|---|---|---|
| 3 | Front bumper | Front bumper - Scratch(es) - Smart repair |

Damage 3: Front bumper: Front bumper - Scratch(es) - Smart repair

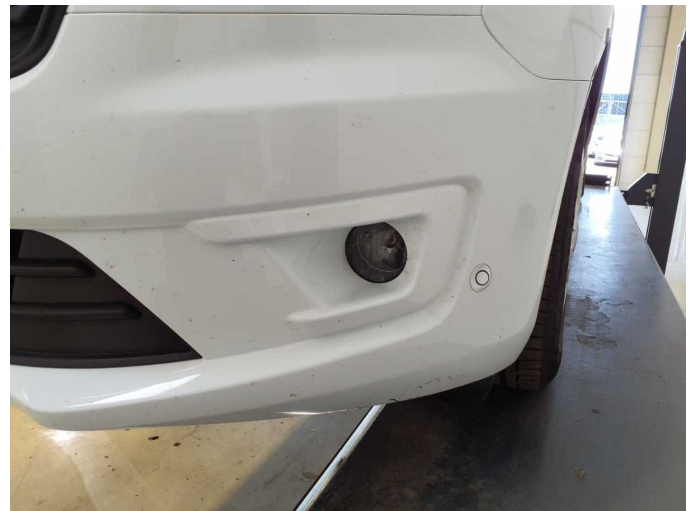
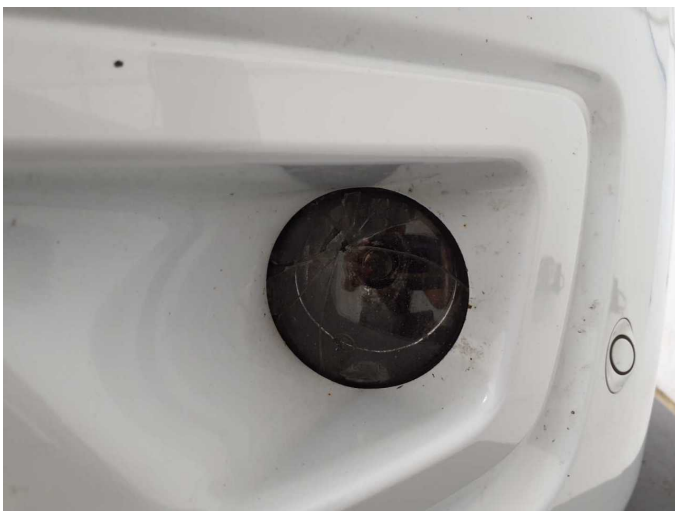
| No. | Component group | Description |
|---|---|---|
| 4 | Fog lamp | Fog lamp - front left side - Broken / torn - Replace |

Damage 4: Fog lamp: Fog lamp - front left side - Broken / torn - Replace

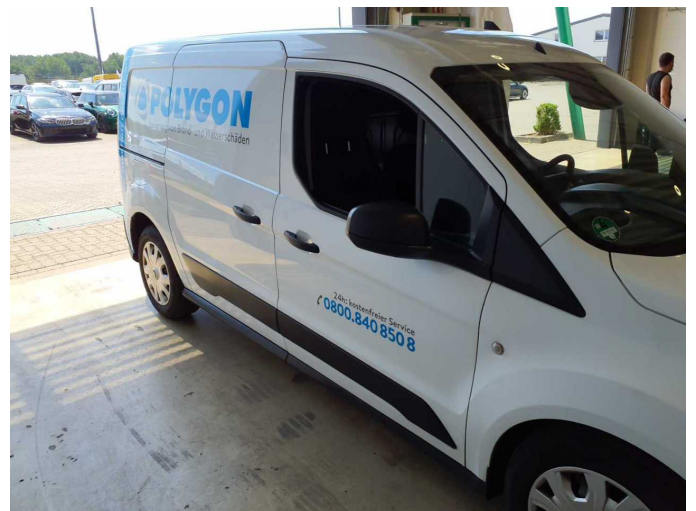
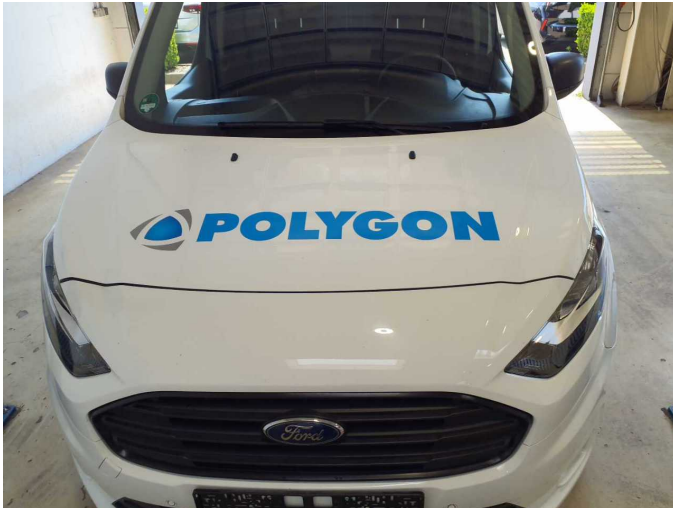
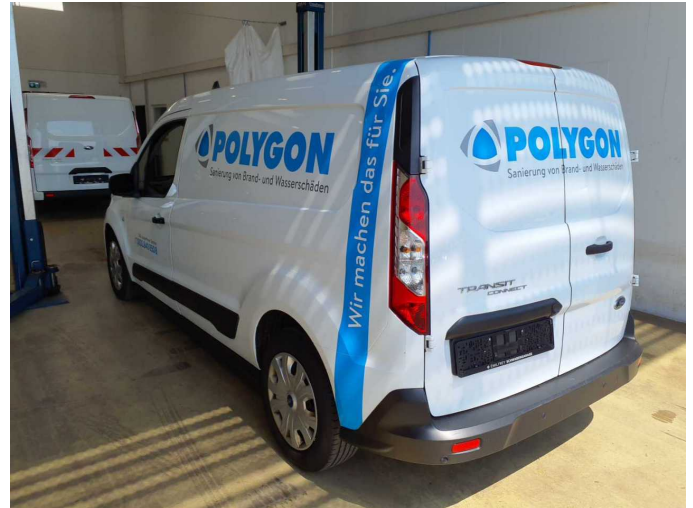
| No. | Component group | Description |
|---|---|---|
| 5 | Body | Body (Firmenlogo und Anschrift) - Glued / labelled - De-glue / neutralise |

Damage 5: Body: Body (Firmenlogo und Anschrift) - Glued / labelled - De-glue / neutralise

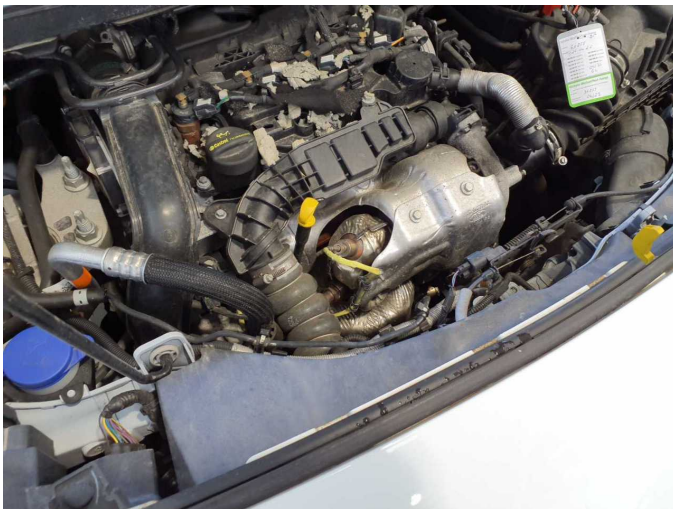
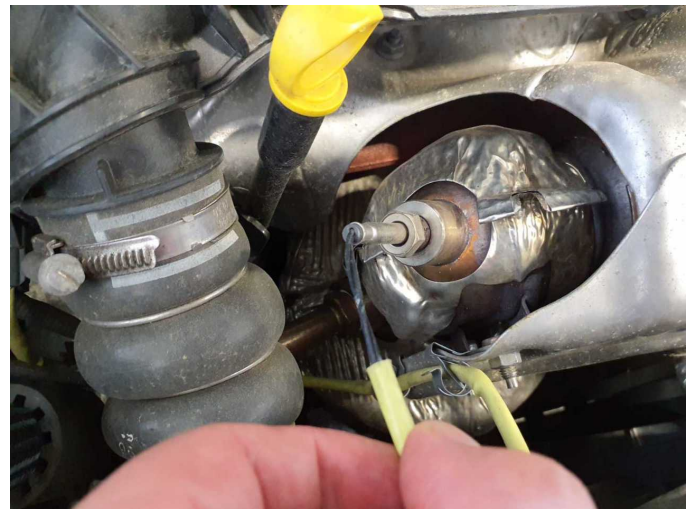
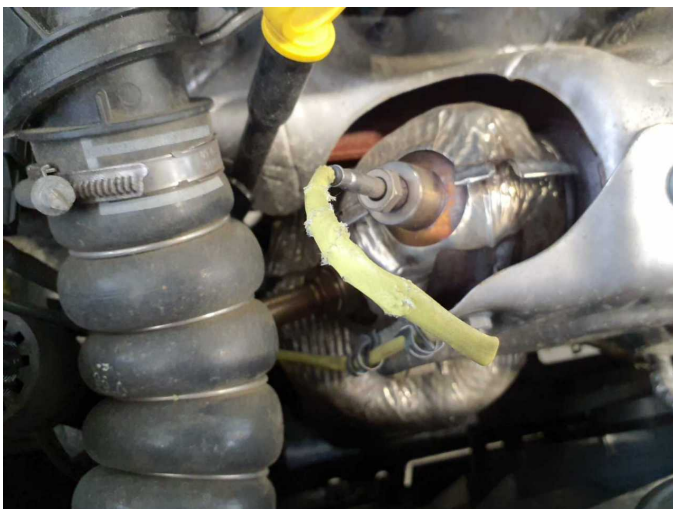
| No. | Component group | Description |
|---|---|---|
| 6 | Engine | Engine (Lampdasonde Kabel angefressen) - Damage caused by marten / rodent - Perform diagnosis |

Damage 6: Engine: Engine (Lampdasonde Kabel angefressen) - Damage caused by marten / rodent - Perform diagnosis

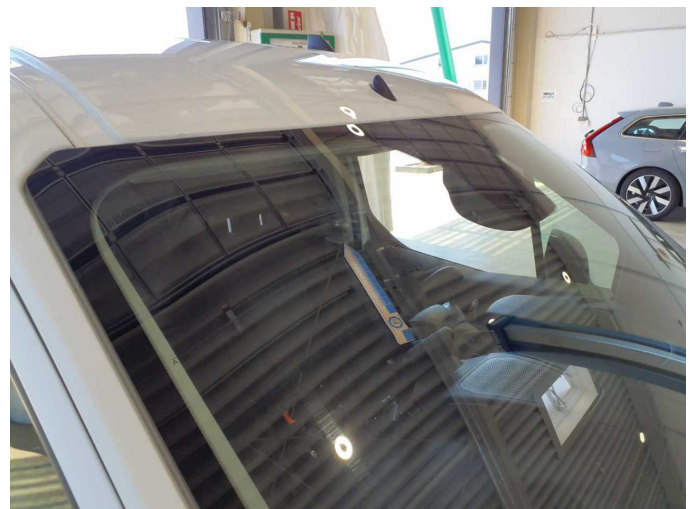
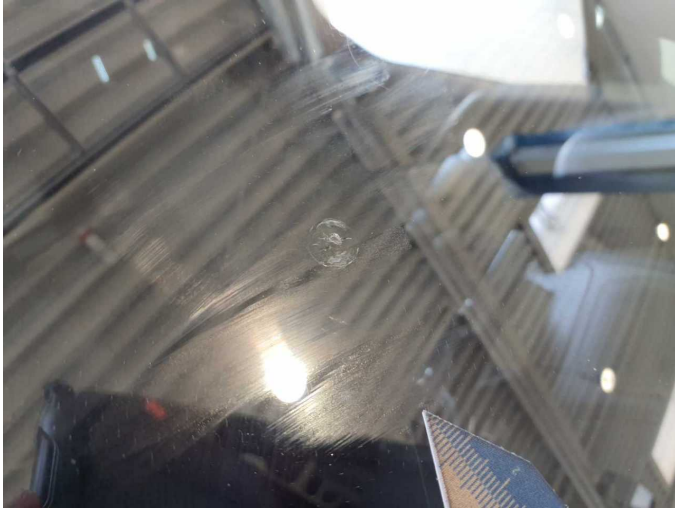
| No. | Component group | Description |
|---|---|---|
| 7 | Vehicle glazing | Windscreen - Stone chips - repair according to calculation |

Damage 7: Vehicle glazing: Windscreen - Stone chips - repair according to calculation

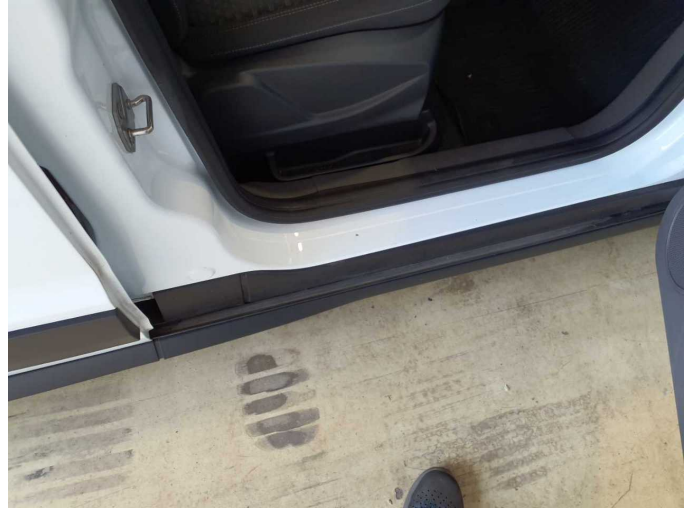
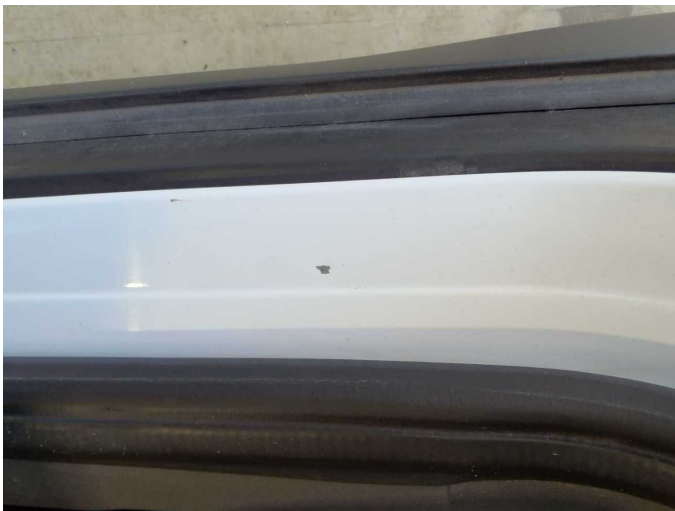
| No. | Component group | Description |
|---|---|--|
| 8 | Sill - right side | Sill - Scratch(es) - Cover / polish |

Wear and tear 8: Sill - right side: Sill - Scratch(es) - Cover / polish

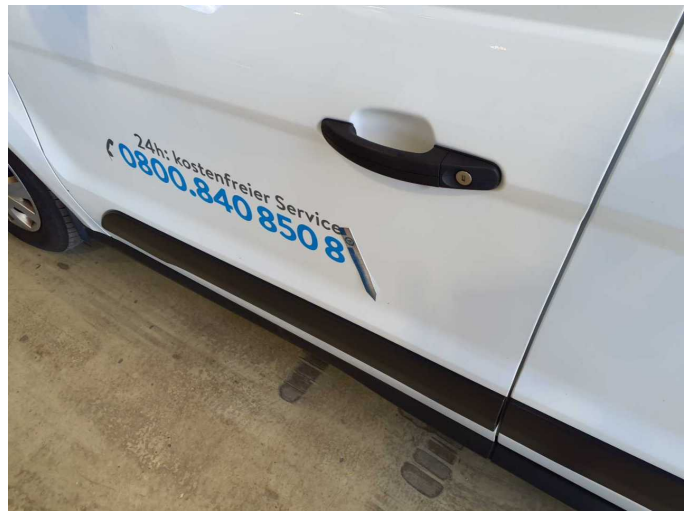
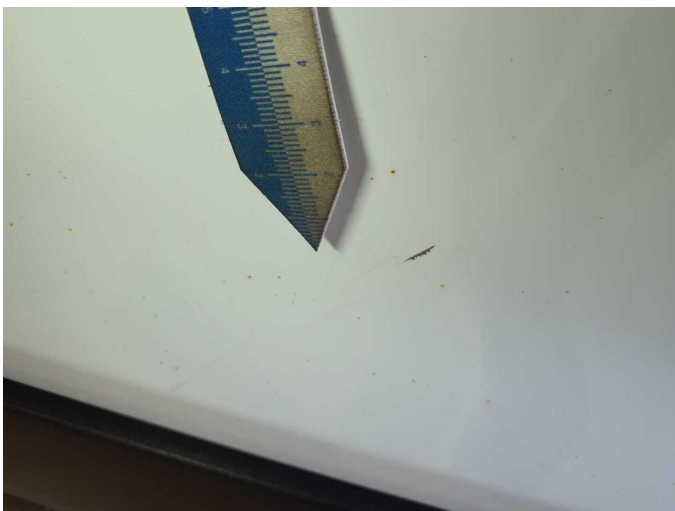
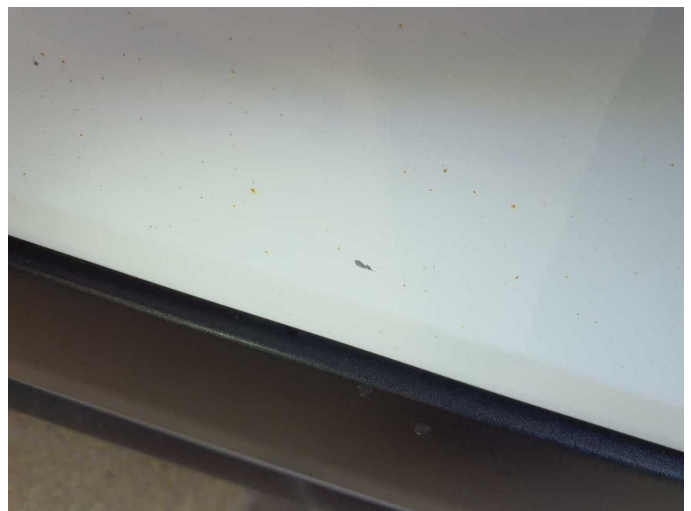
| No. | Component group | Description |
|---|---|--|
| 9 | Door - front left side | Door - Scratch(es) - No deduction |

Wear and tear 9: Door - front left side: Door - Scratch(es) - No deduction

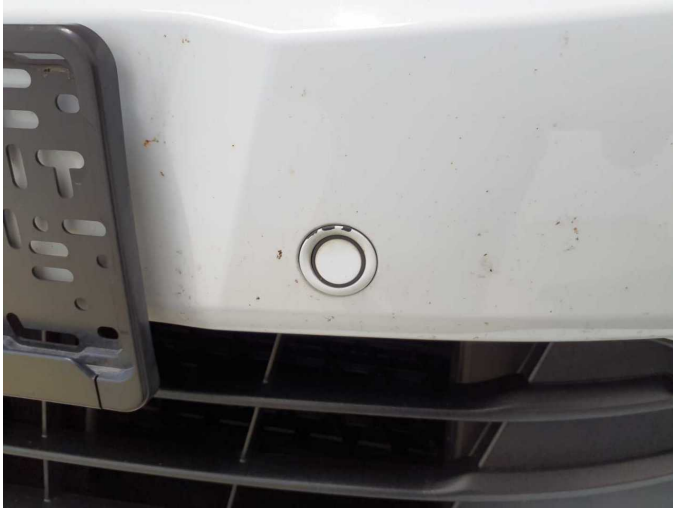
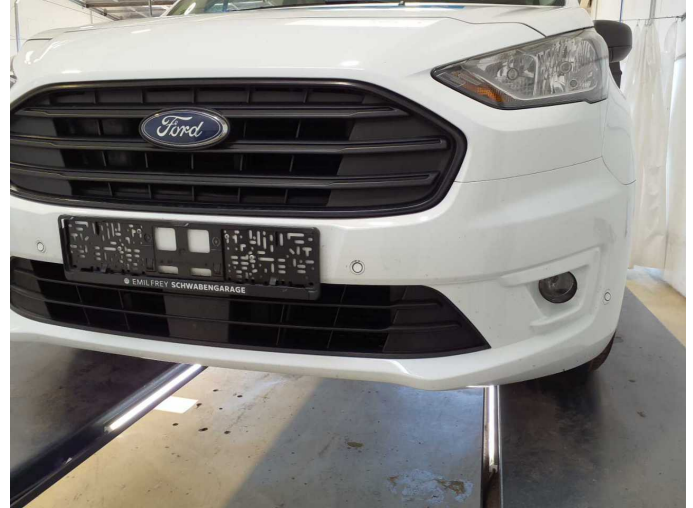
| No. | Component group | Description |
|---|---|--|
| 11 | Front bumper | Parking sensors - centre - Scratch(es) - Cover / polish |

Wear and tear 11: Front bumper: Parking sensors - centre - Scratch(es) - Cover / polish

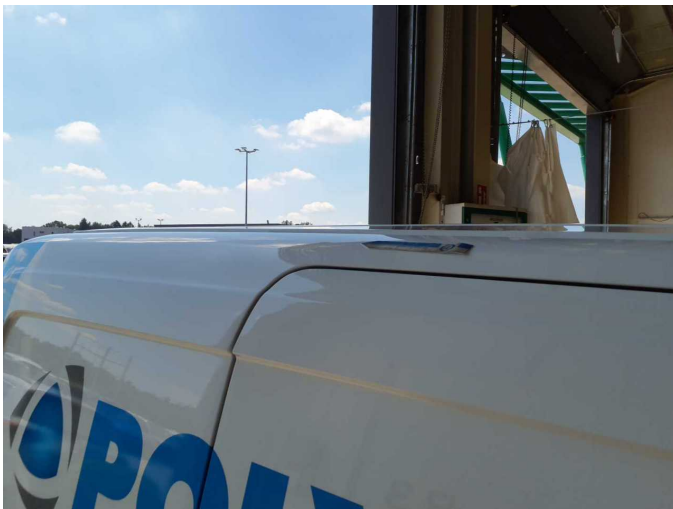
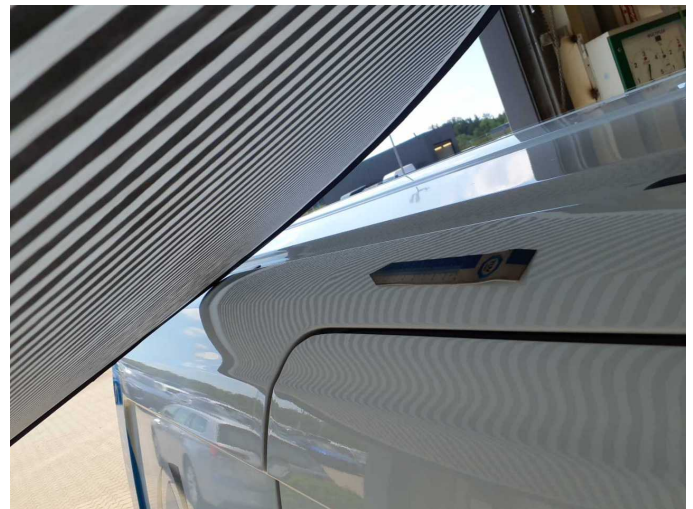
| No. | Component group | Description |
|---|---|--|
| 12 | Roof | Roof rail - right side - dent(s) - Smooth repair work |

Wear and tear 12: Roof: Roof rail - right side - dent(s) - Smooth repair work

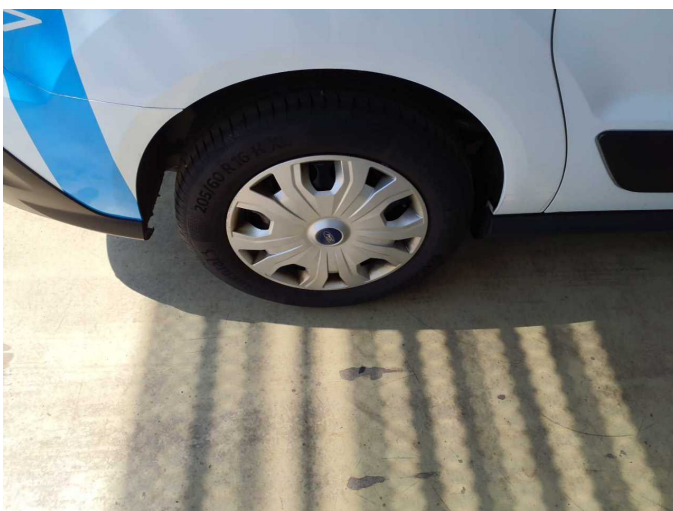
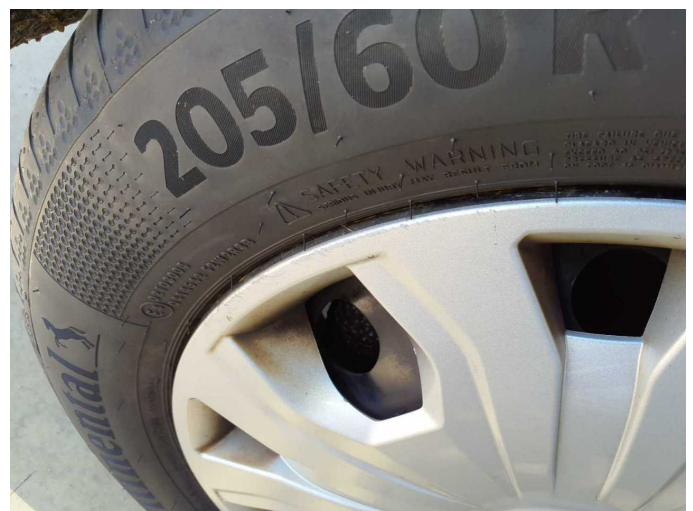
| No. | Component group | Description |
|---|---|--|
| 13 | Wheel / tyres | Wheel cover - rear right side - Scratch(es) - No deduction |

Wear and tear 13: Wheel / tyres: Wheel cover - rear right side - Scratch(es) - No deduction
