Expertise

Protocol number: 45449892
Order No. / Reference: 26368233
Inspection date: 8 May 2026

Model: Astra 1.5 D Automatik Business Elegance

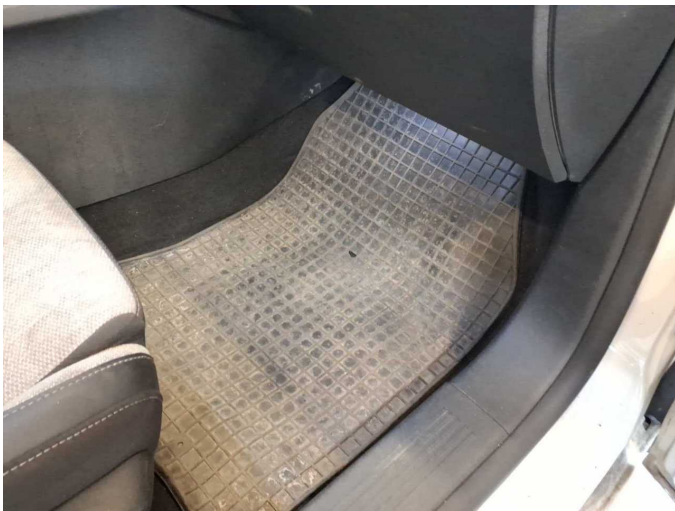
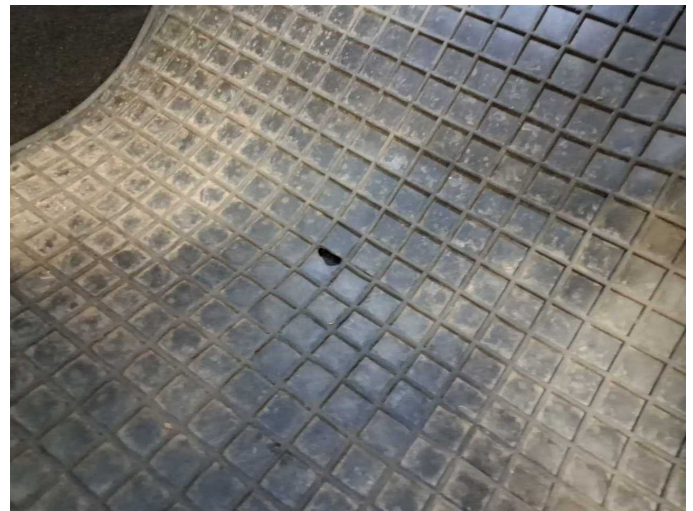
Damage 1: Trim / covers: Floor mats - Holes - Replace

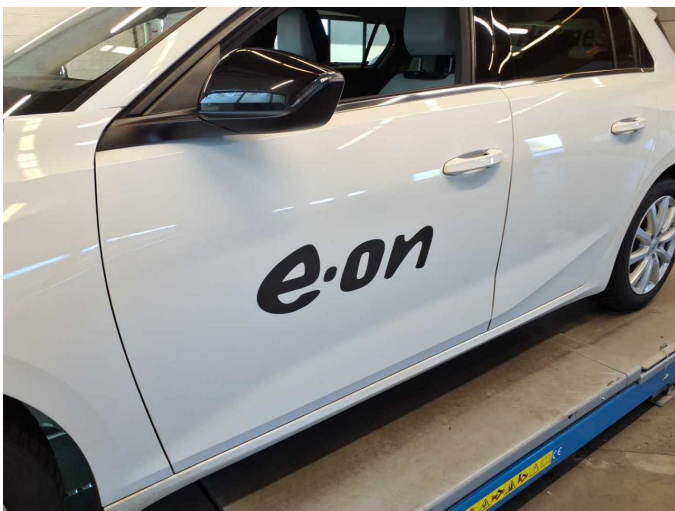
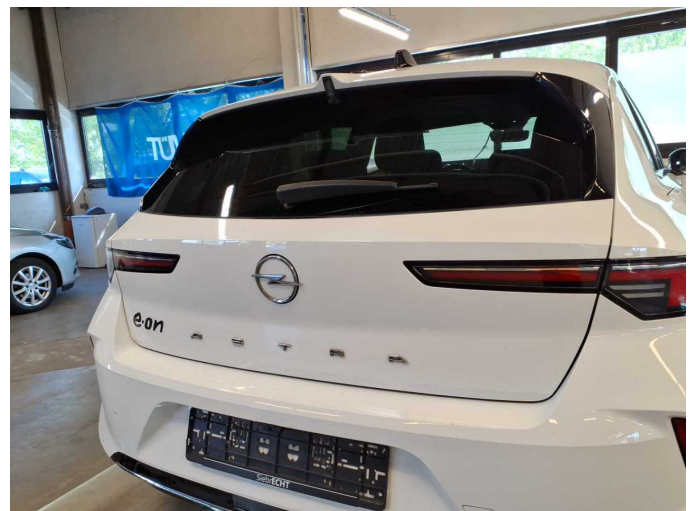
Damage 2: Body: Body - Glued / labelled - De-glug / neutralise

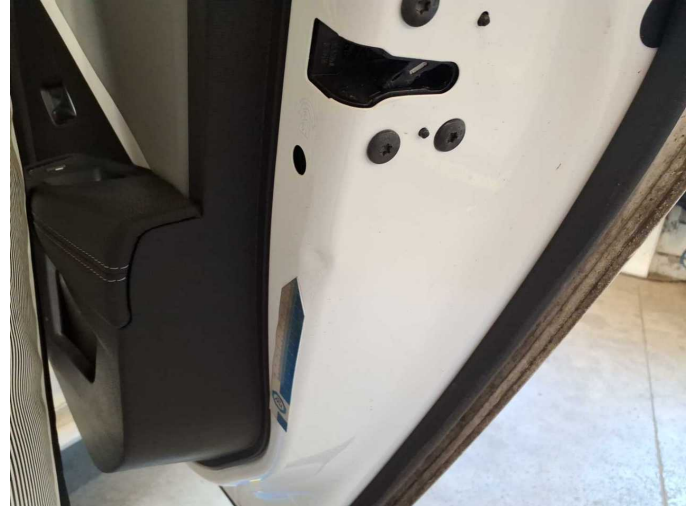
Damage 3: Door - rear right side: Door (Innen) - dent(s) - Smooth repair work

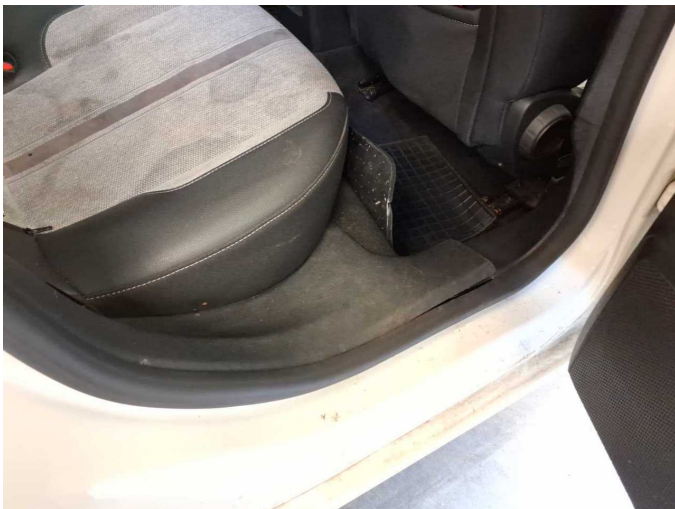
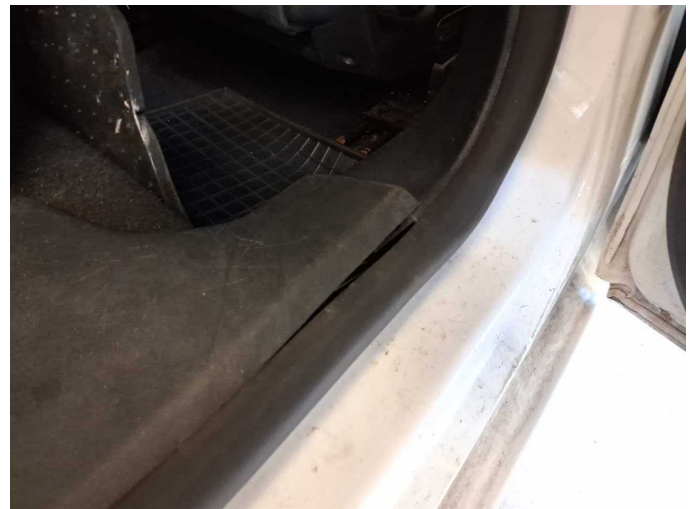
Damage 4: Trim / covers: C-pillar - trim - interior, right side - Loose - Un- / install

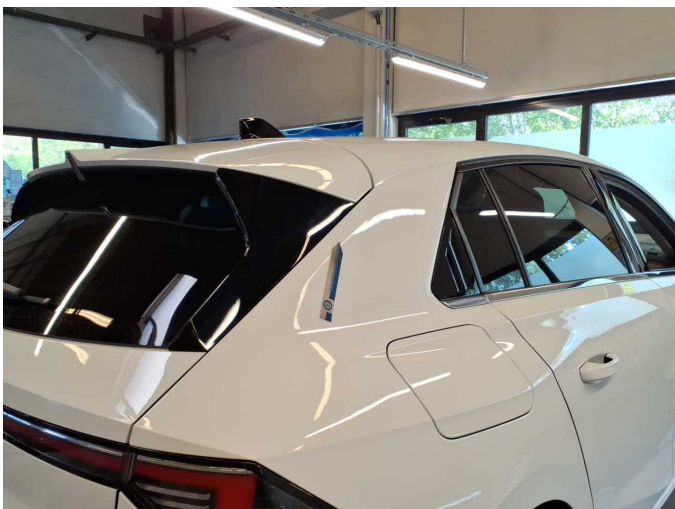
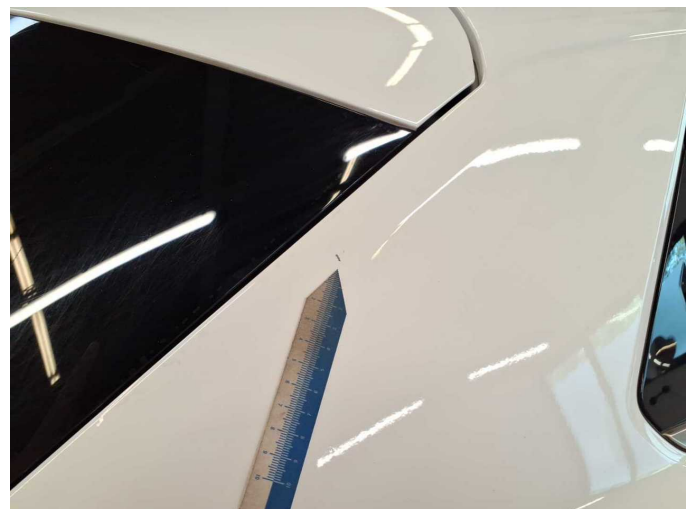
Damage 5: Side panel - rear right side: Side panel - Scratch(es) - Smart repair

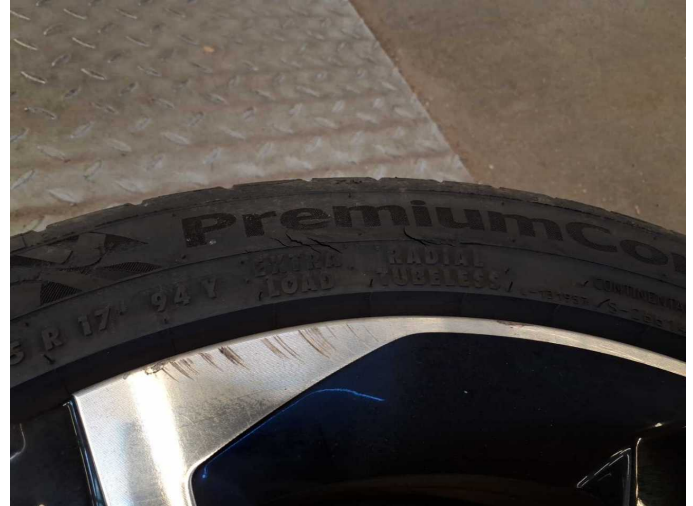
Damage 6: 2nd wheel set: 1 tyre - Damaged - Replace

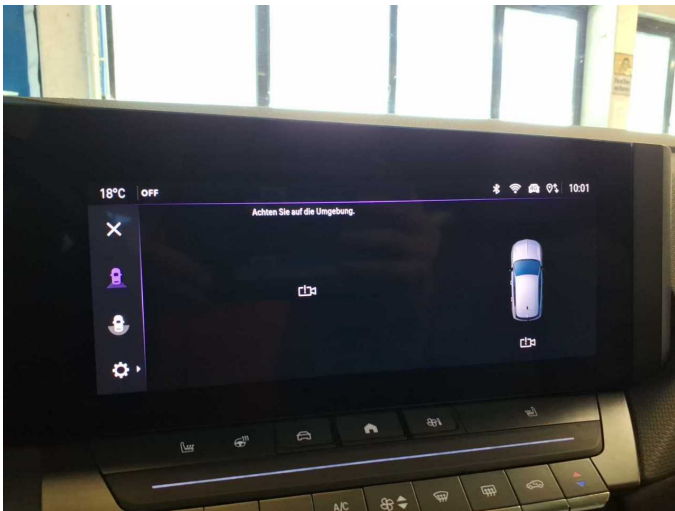
Damage 7: Electronic systems: Rear view camera - Non-operational - Perform diagnosis

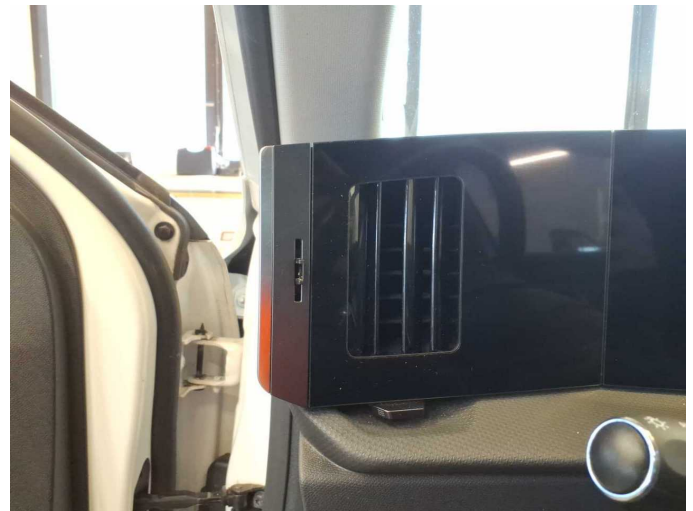
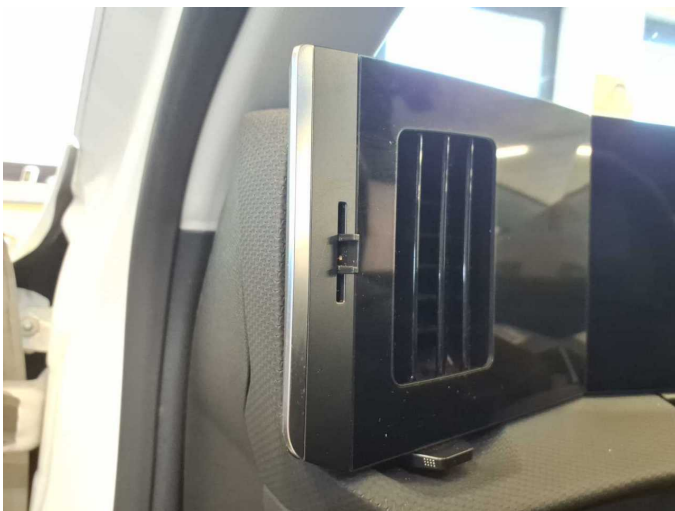
Damage 8: Trim / covers: Trim / covers (Lüftungsgitter verstellhebel) - Missing - Replace

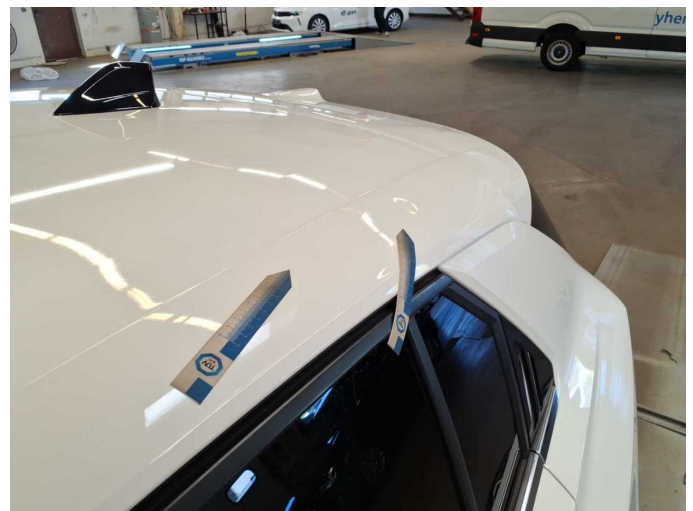
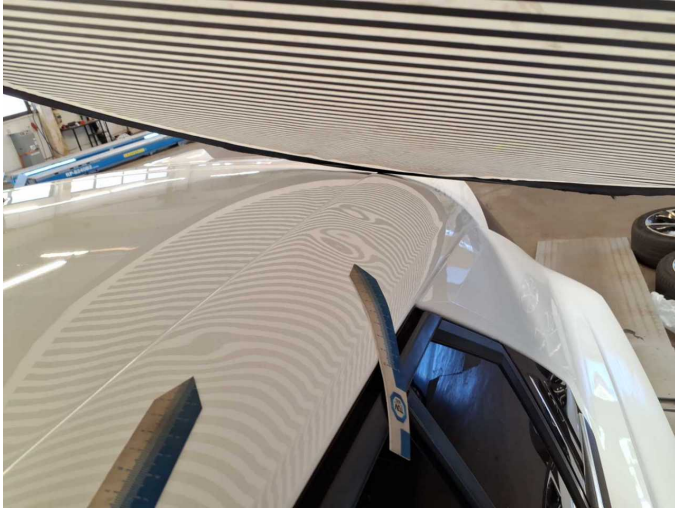
Damage 9: Roof: Roof rail - left side - dent(s) - Smooth repair work

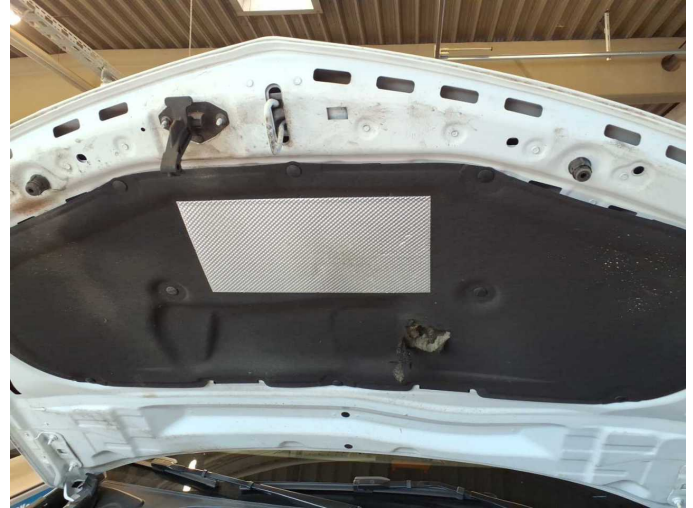
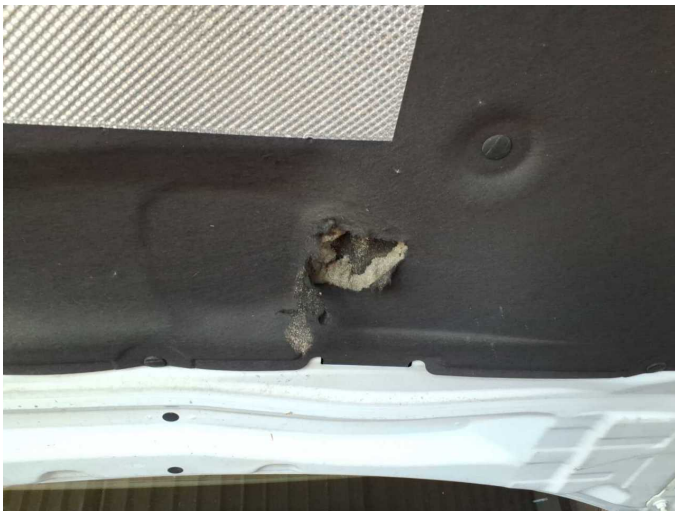
Damage 10: Bonnet: Insulation lining - Damage caused by marten / rodent - Replace

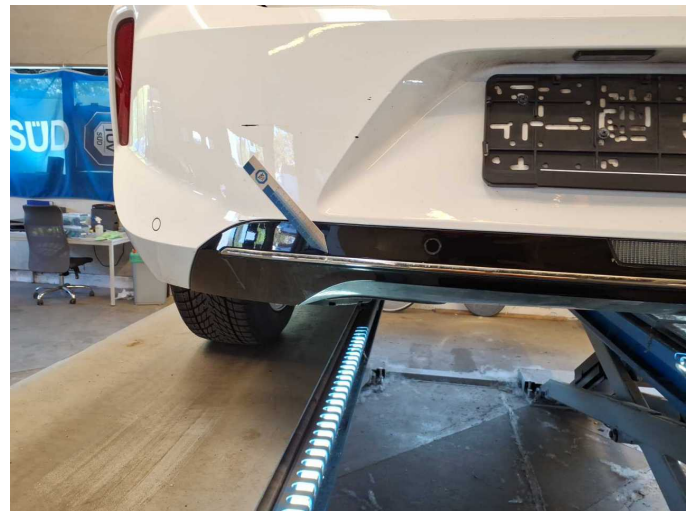
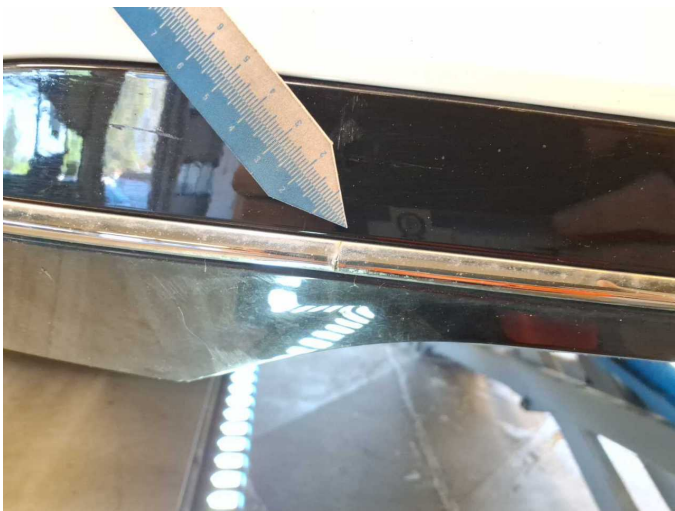
Damage 11: Rear bumper: Spoiler (Zierleiste) - Broken / torn - Replace

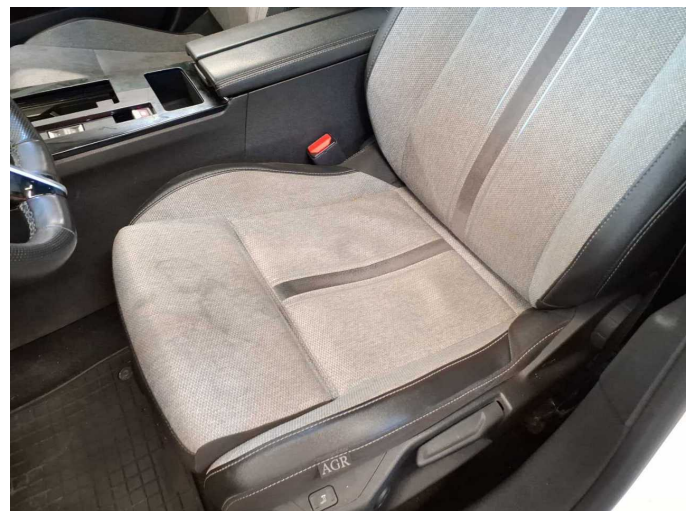
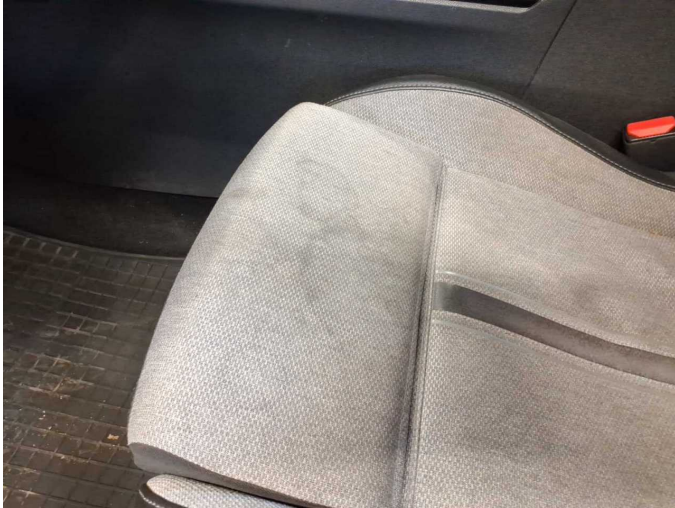
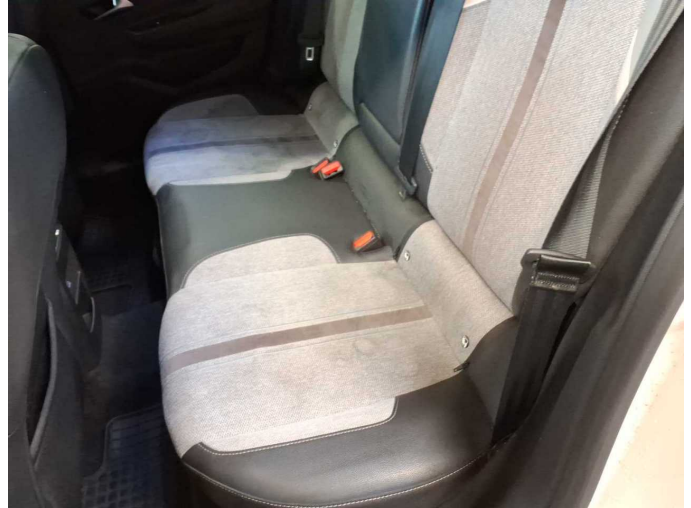
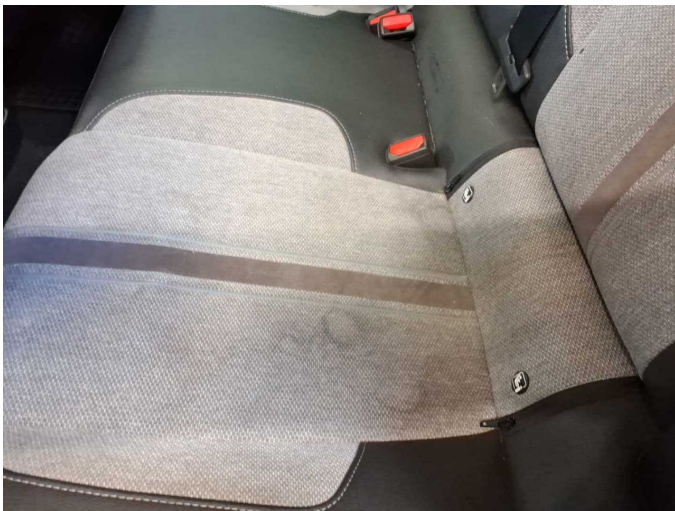
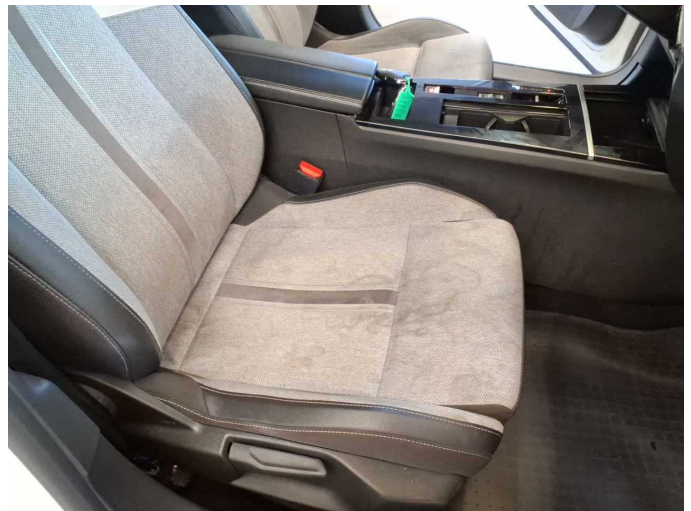
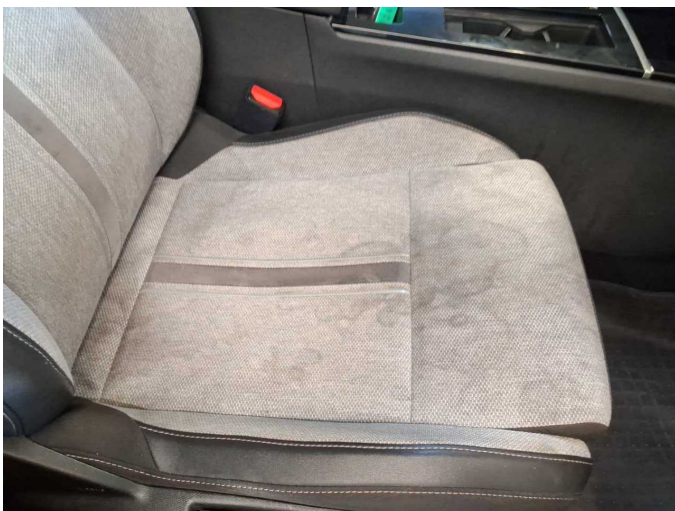
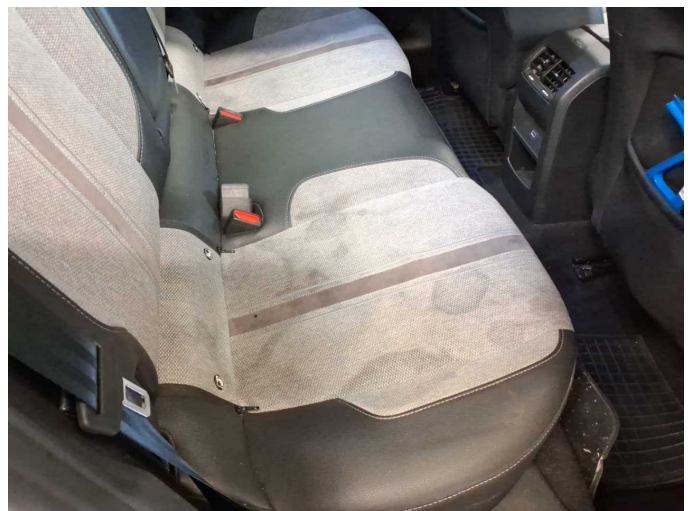
Damage 12: Interior: Interior (Sitze) - Soiled - Clean

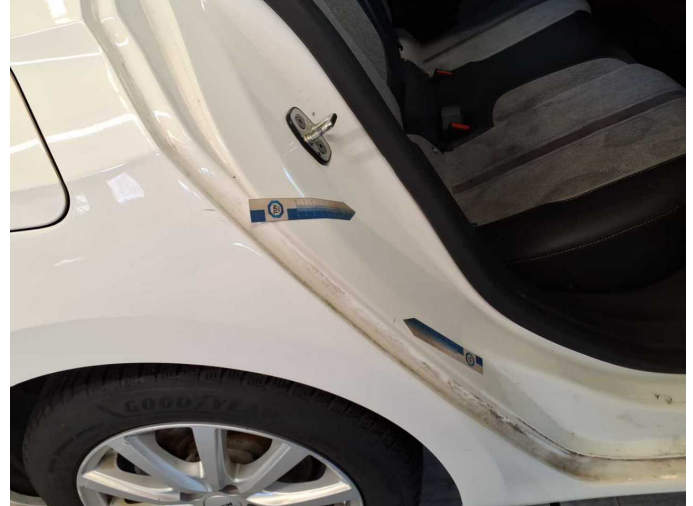
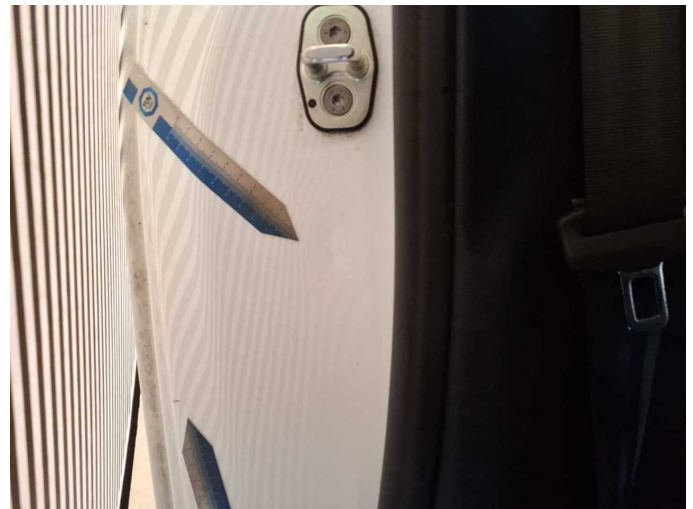
Damage 13: Side panel - rear right side: Sill - Dent / paintcoat damage - Smart repair

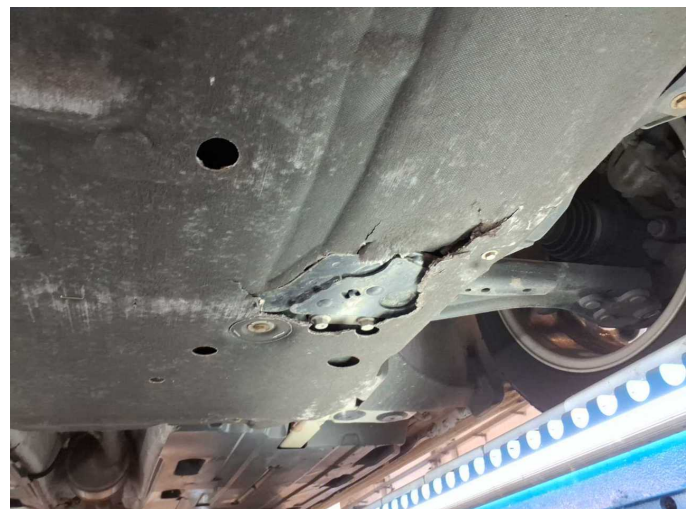
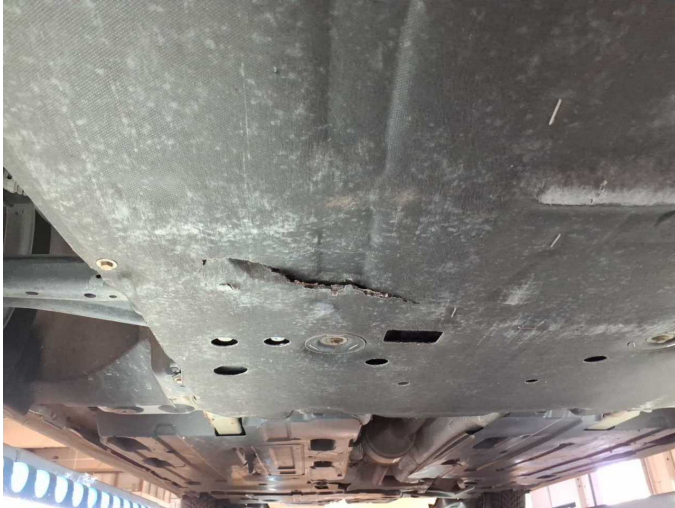
Damage 14: Engine: Engine cowling - lower - Broken / torn - Replace

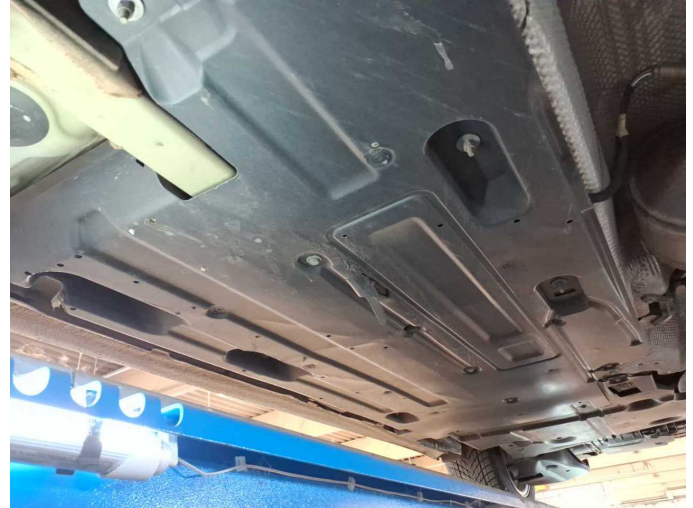
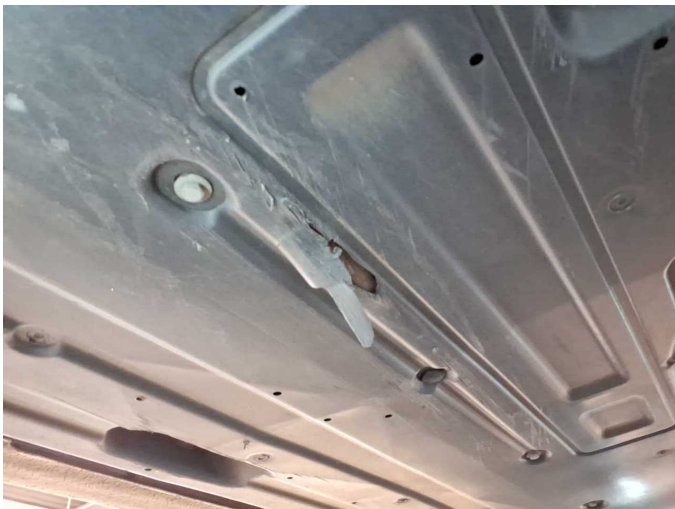
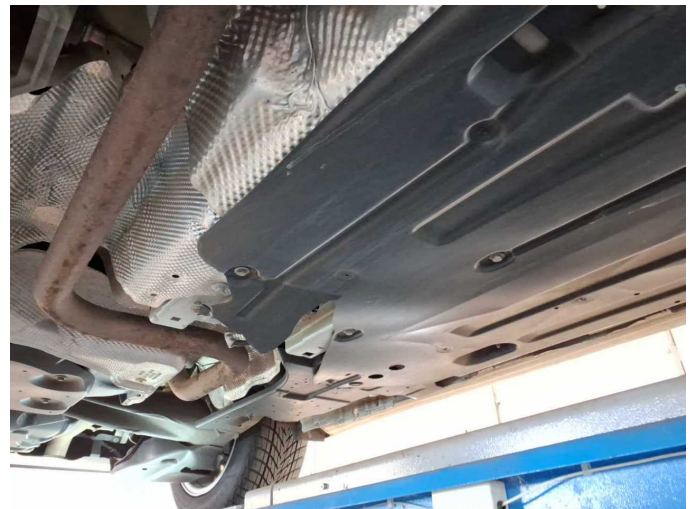
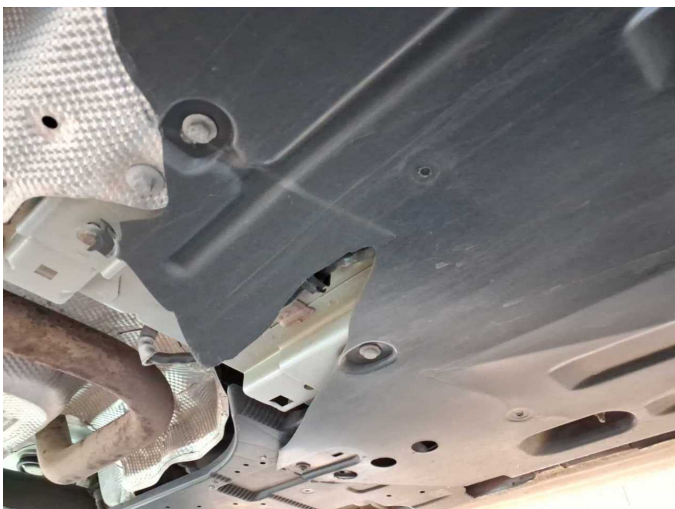
Damage 15: Body: Underbody panelling (Rechts und links) - Broken / torn - Replace

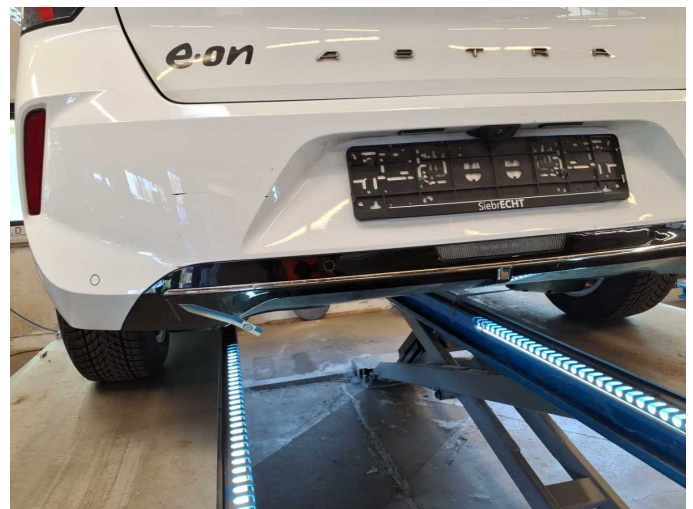
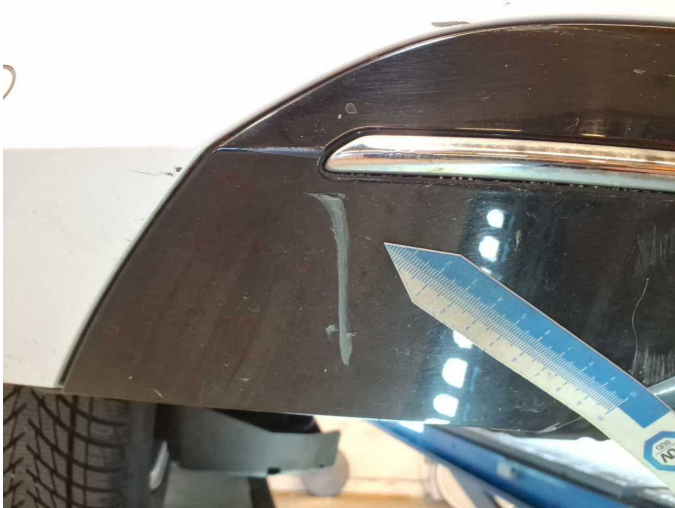
Damage 16: Rear bumper: Spoiler - Scratch(es) - Paint

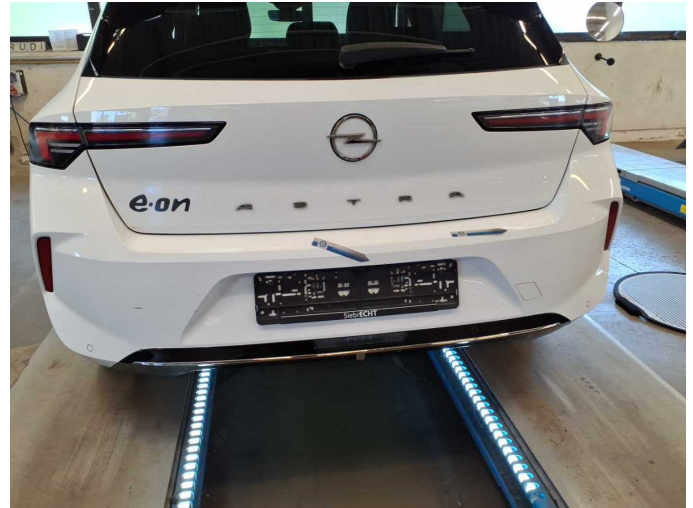
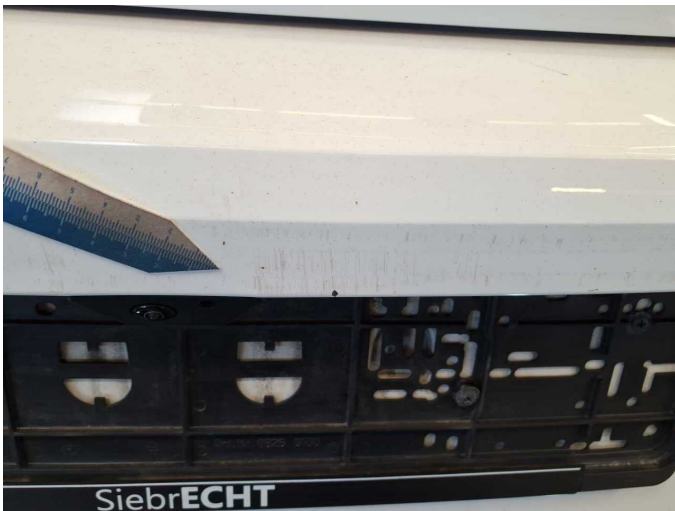
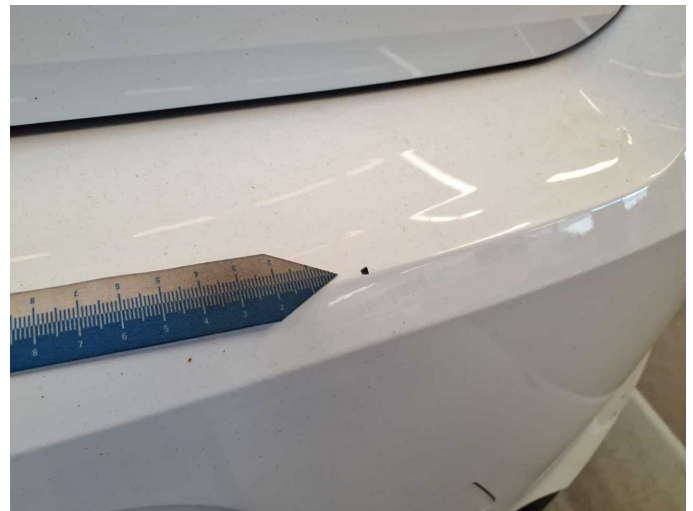
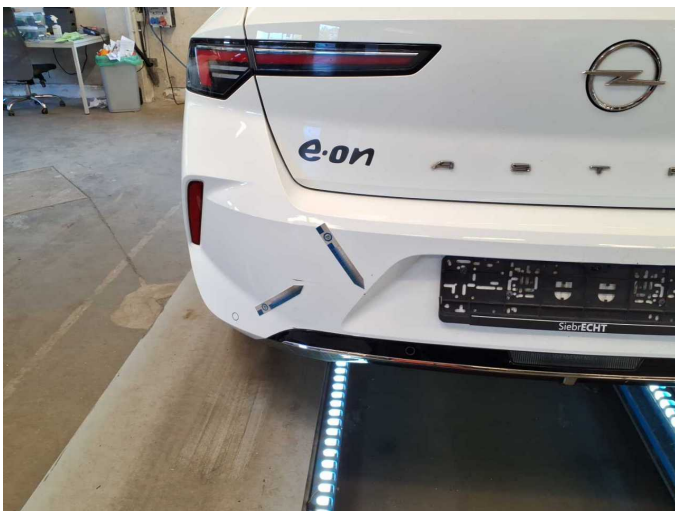
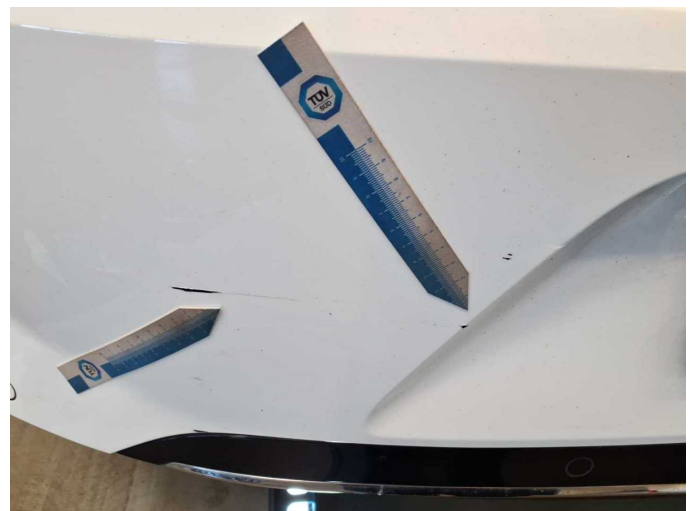
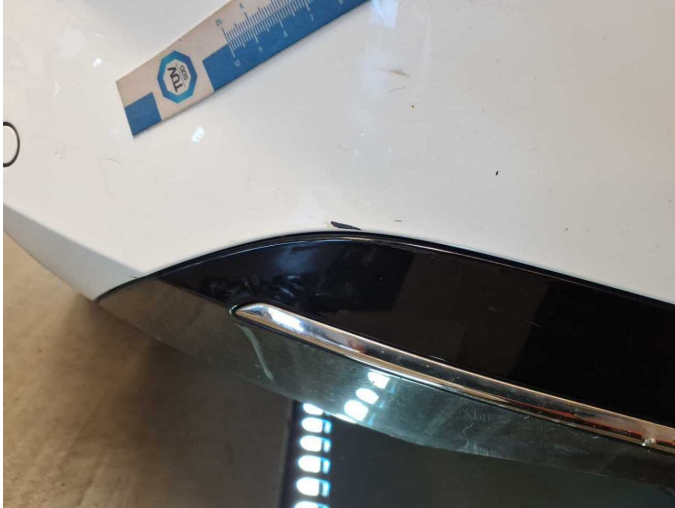
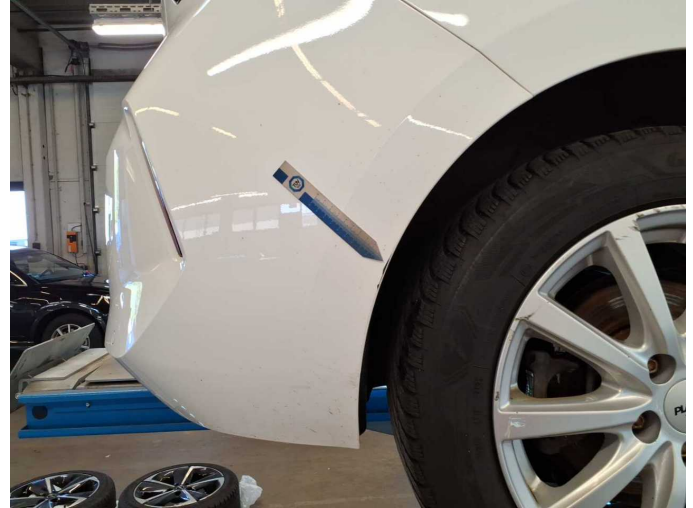
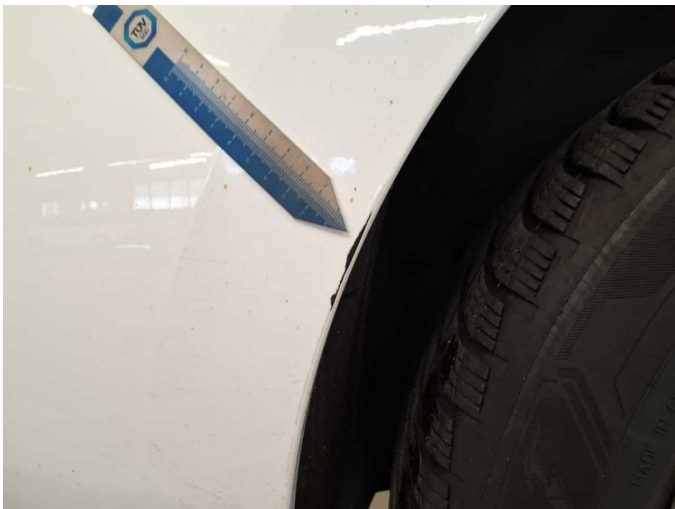
Damage 17: Rear bumper: Rear bumper - Scratch(es) - Paint

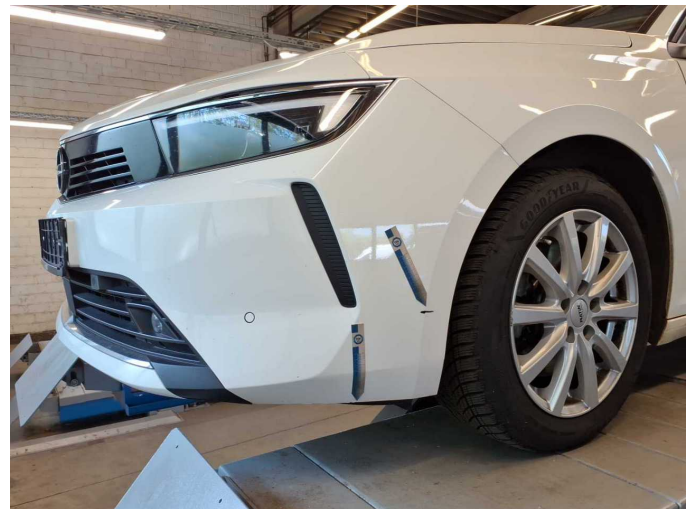
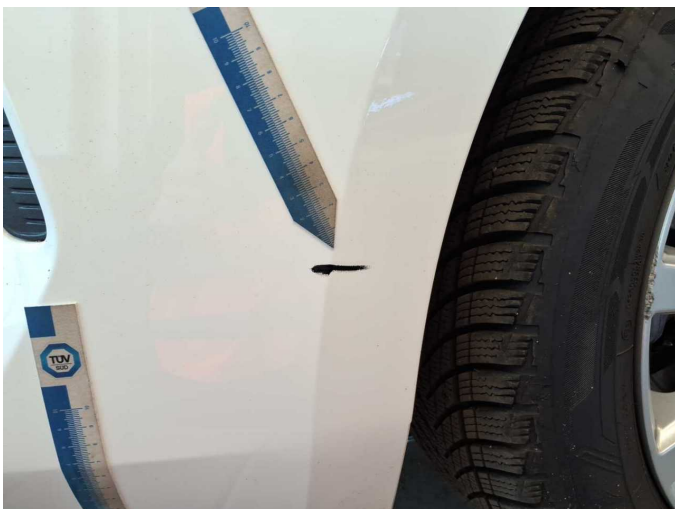
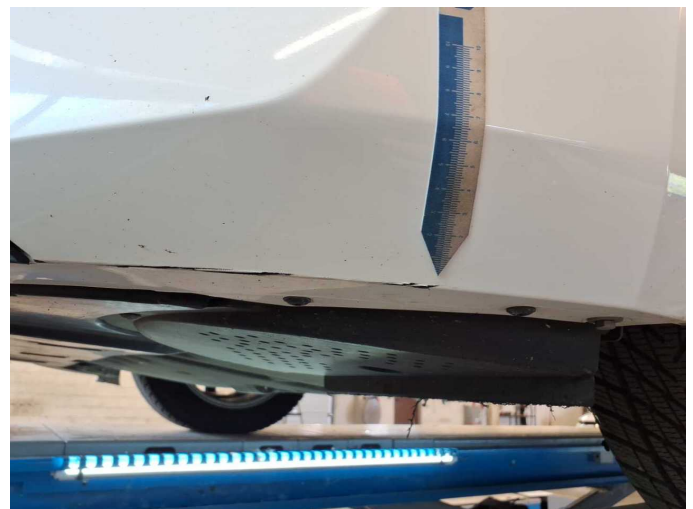
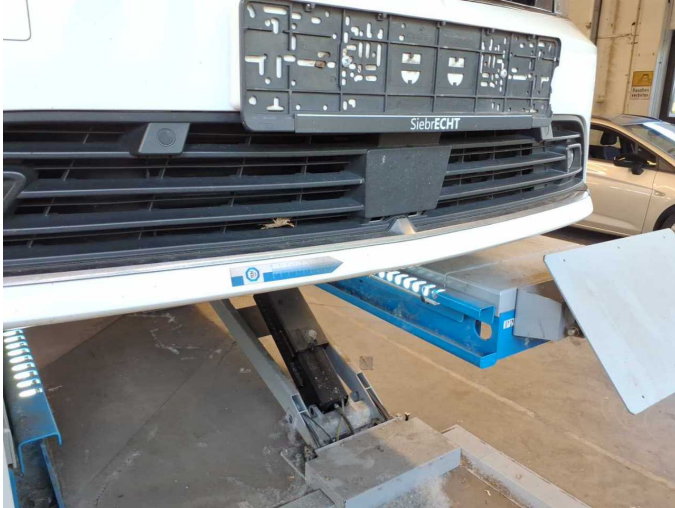
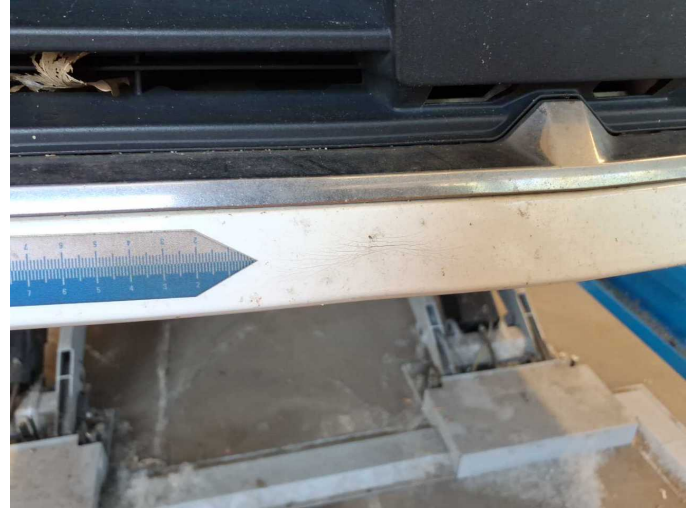
Damage 18: Front bumper: Front bumper - Scratch(es) - Paint

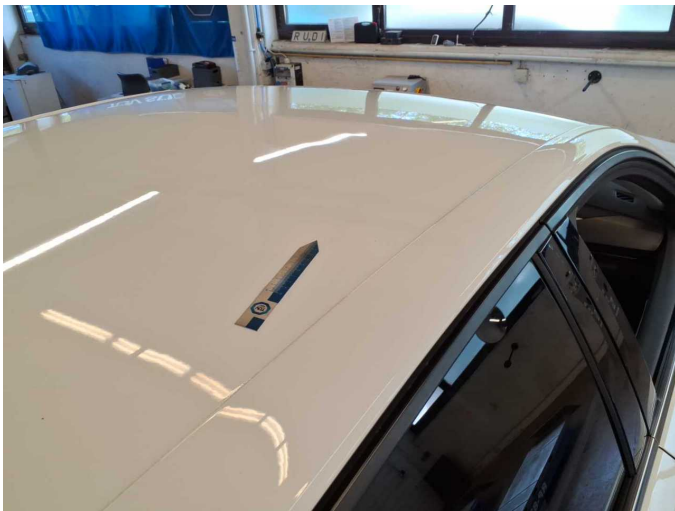
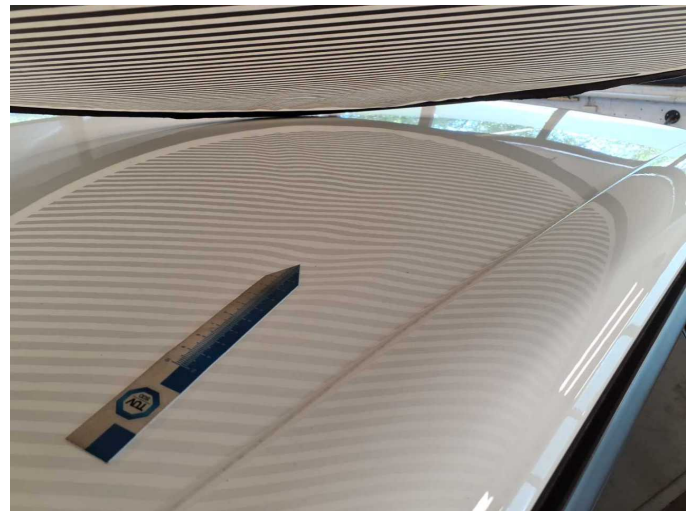
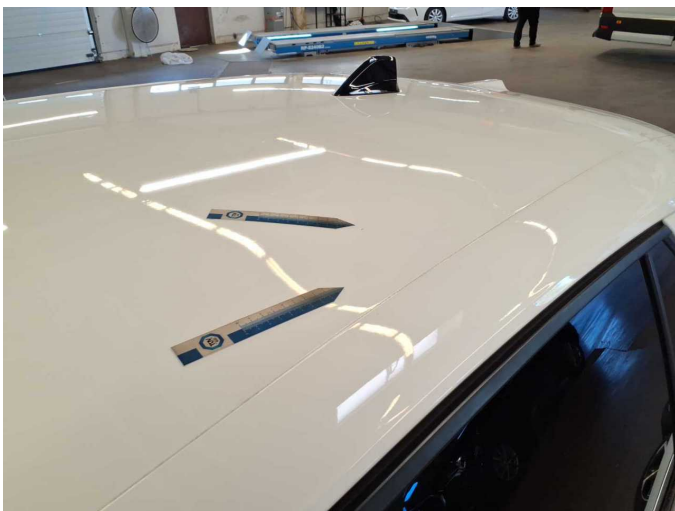
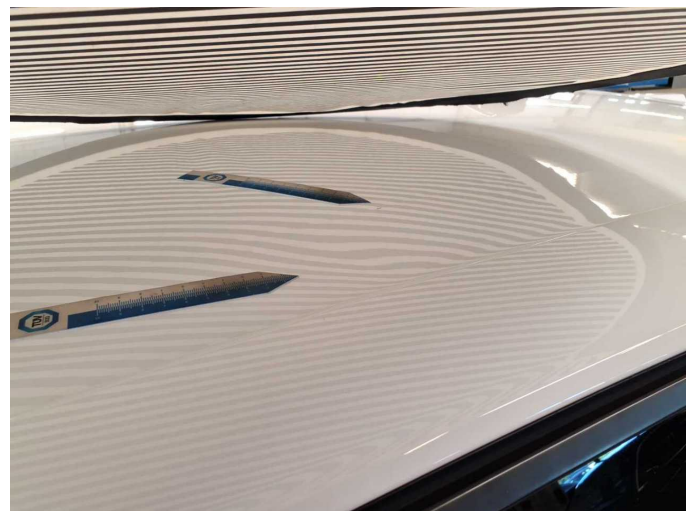
Damage 19: Roof: Roof - Dent / paintcoat damage - Repair and paint
