Expertise

Protocol number: 45449892
Order No. / Reference: 26368233
Inspection date: 8 May 2026

Model: Astra 1.5 D Automatik Business Elegance

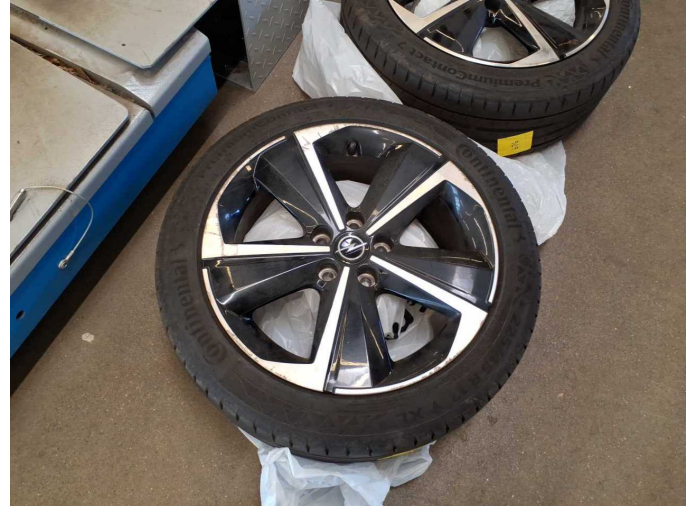
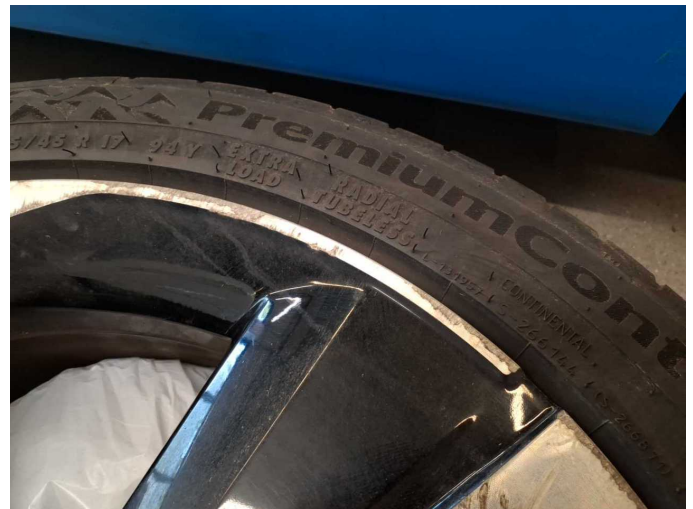
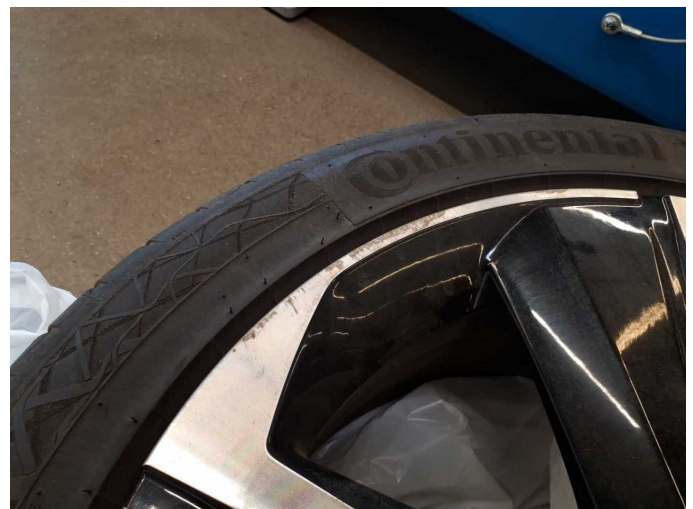
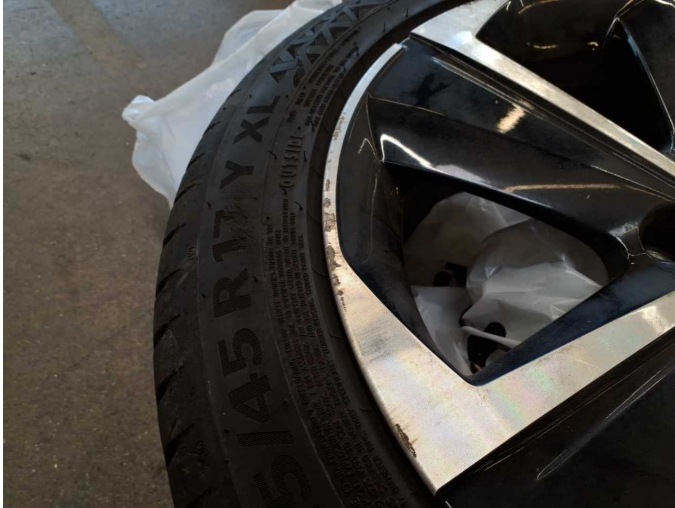
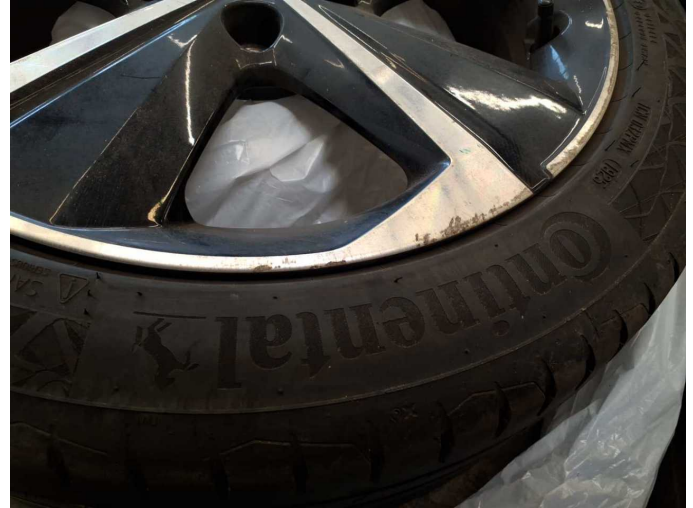
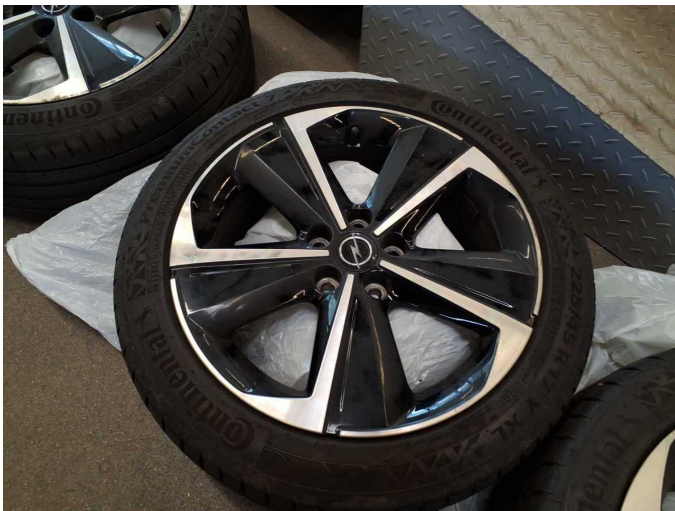
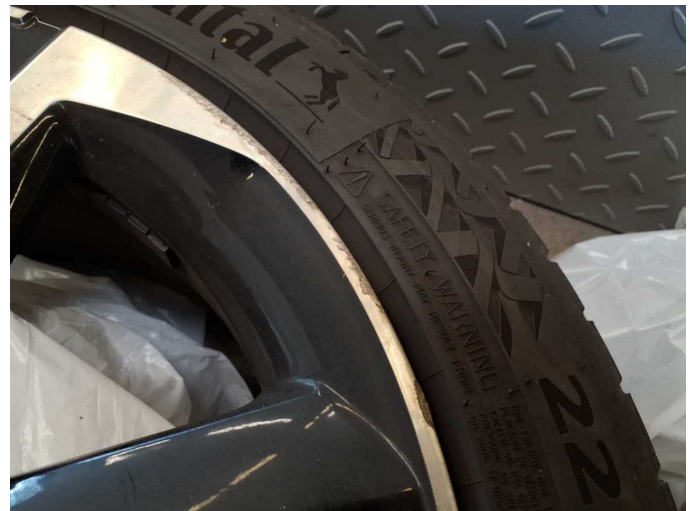
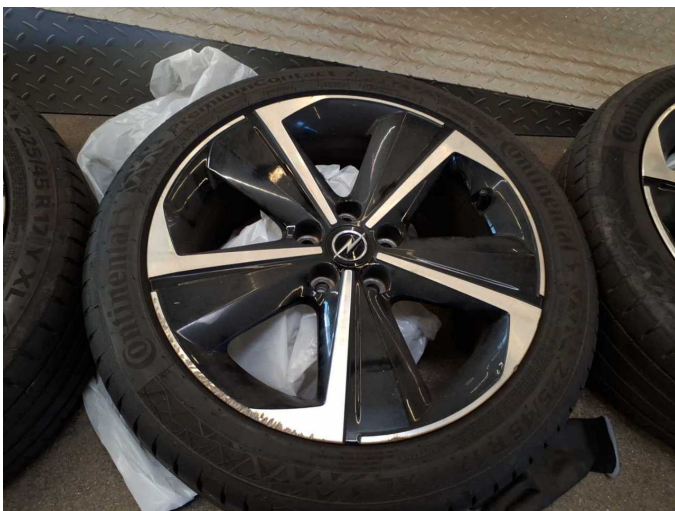
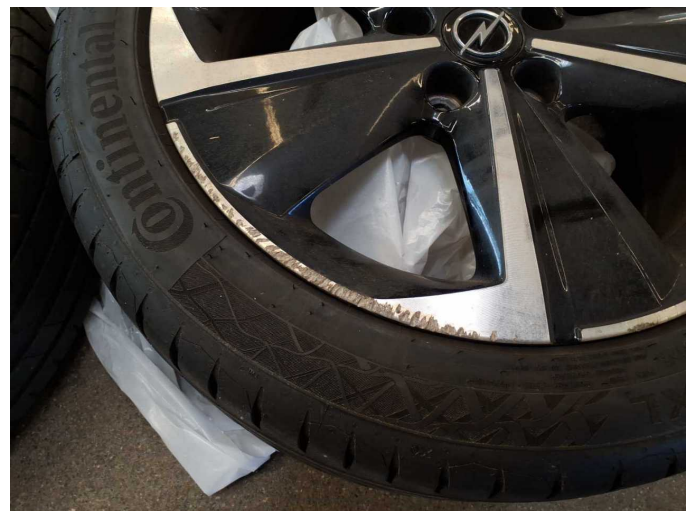
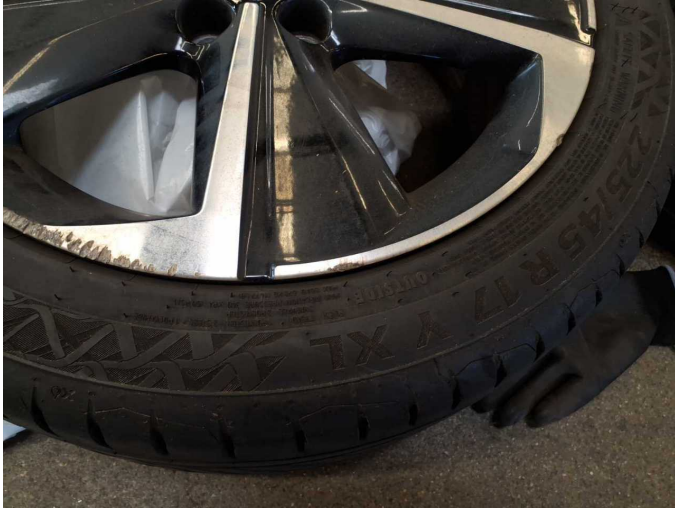
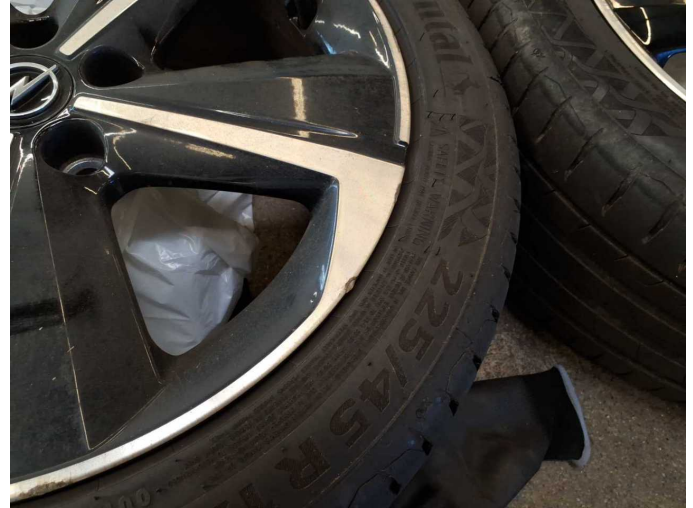
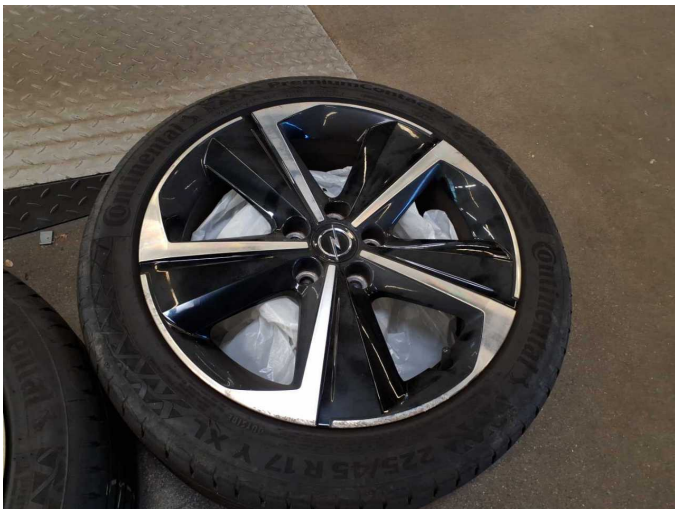
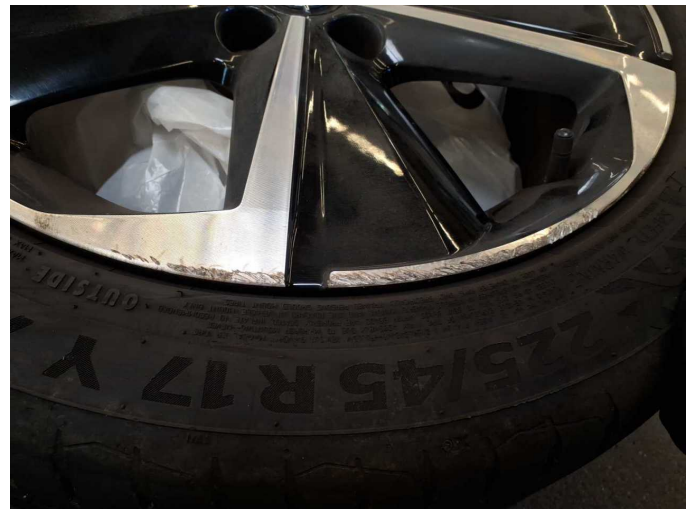
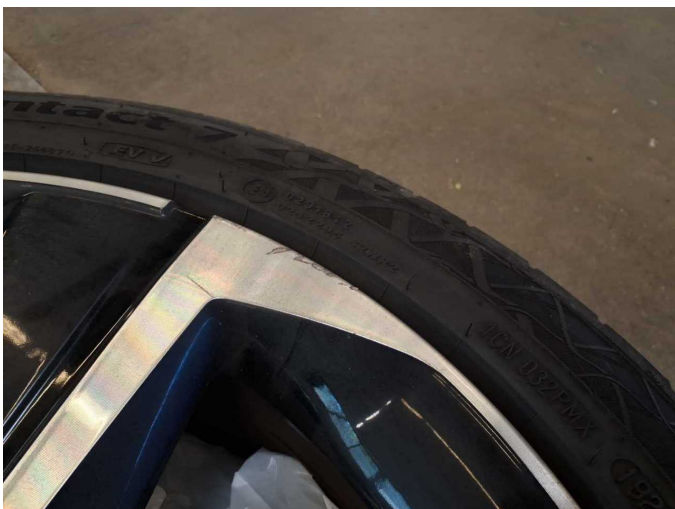
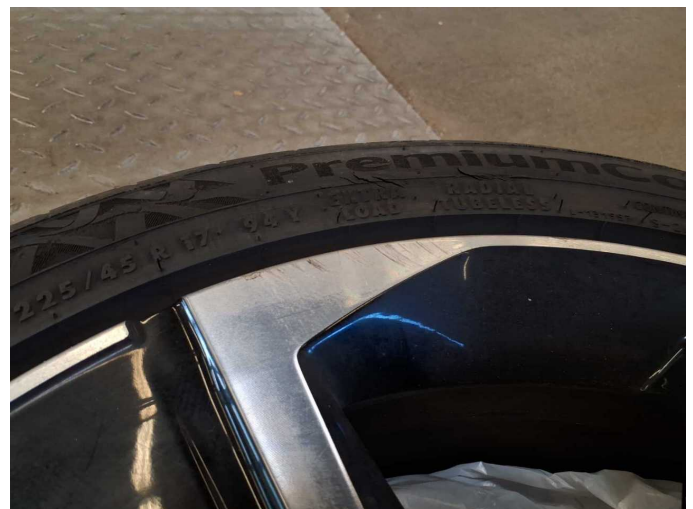
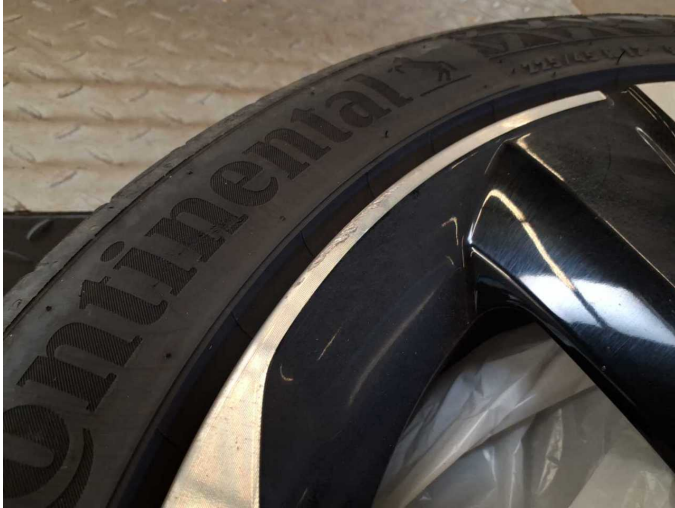
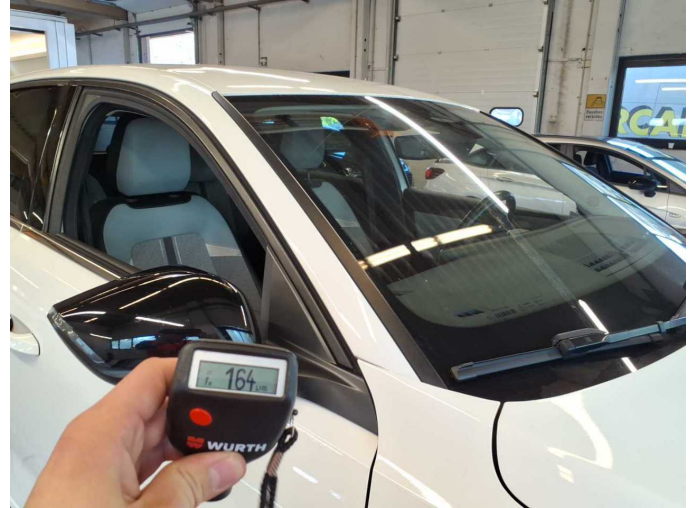
Damage 20: 2nd wheel set: Alloy rim set - complete - Scratch(es) - Replace
