## Expertise

Protocol number: 46010104  
Order No. / Reference: 26154546  
Inspection date: 17 Jun 2026

Manufacturer: Mercedes-Benz

Model: Vito 116 CDI Lang HA Aut. PRO

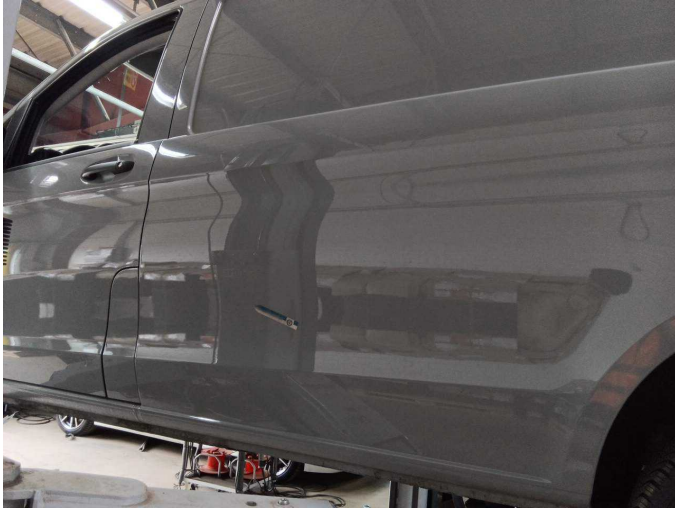
No.	Component group	Description
1	Misc.	Inspection / maintenance - No evidence - No deduction
2	Misc.	Main inspection - No evidence - No deduction
3	Side panel - rear left side	Side panel (1) - dent(s) - Smooth repair work
4	Bonnet	Bonnet (2) - dent(s) - Smooth repair work
5	Door - front right side	Door - Scratch(es) - Smart repair
6	Rear bumper	Rear bumper - Scratch(es) - Smart repair
7	Mudguard - left side	Mudguard - left side - Dent / paintcoat damage - Repair and paint

**Damage 3:** Side panel - rear left side: Side panel (1) - dent(s) - Smooth repair work

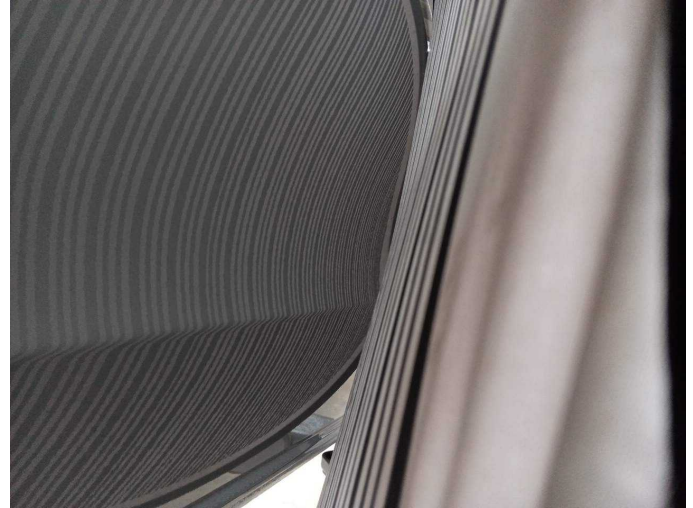
**Damage 3:** Side panel - rear left side: Side panel (1) - dent(s) - Smooth repair work

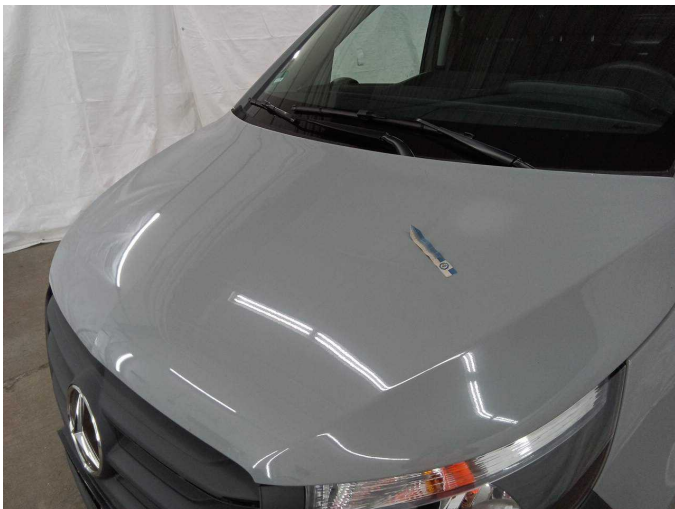
**Damage 4:** Bonnet: Bonnet (2) - dent(s) - Smooth repair work

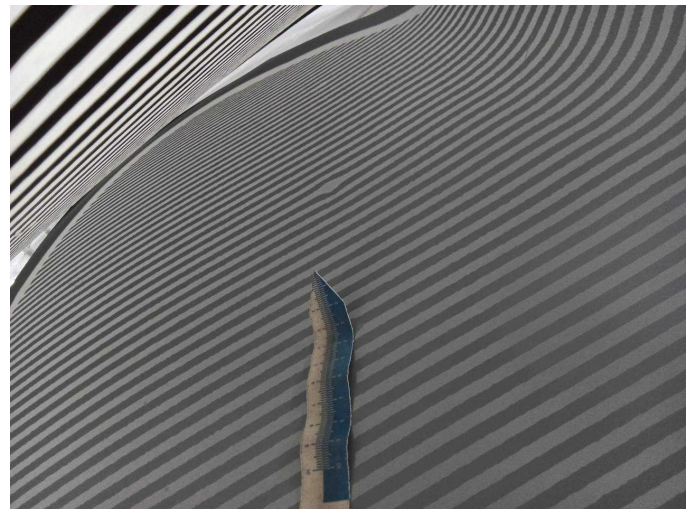
**Damage 4:** Bonnet: Bonnet (2) - dent(s) - Smooth repair work

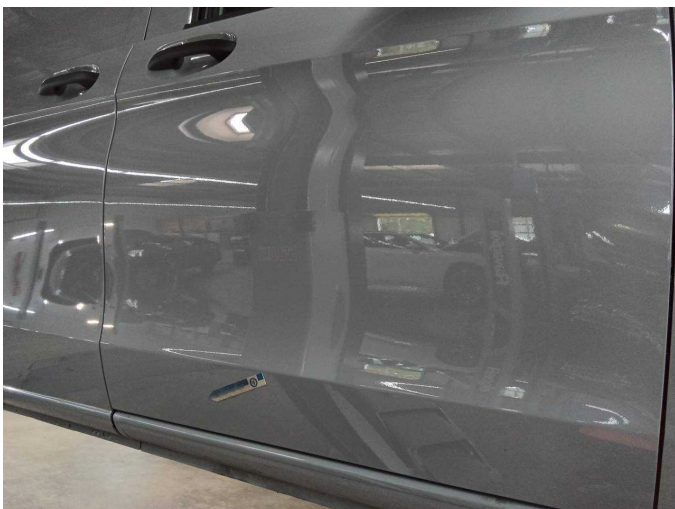
**Damage 5:** Door - front right side: Door - Scratch(es) - Smart repair

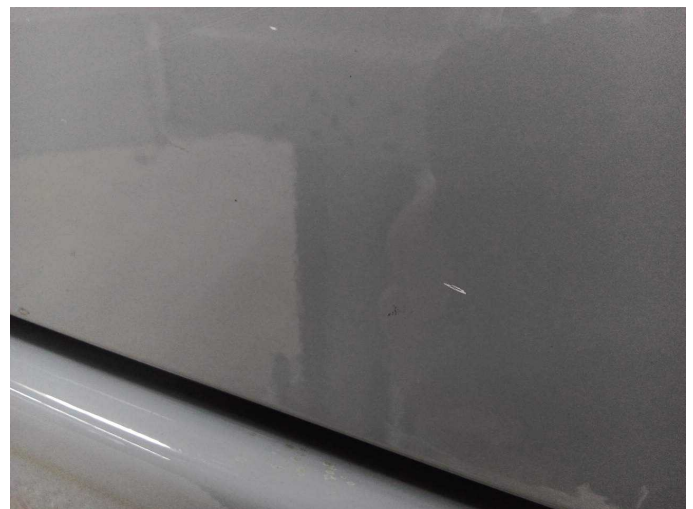
**Damage 5:** Door - front right side: Door - Scratch(es) - Smart repair

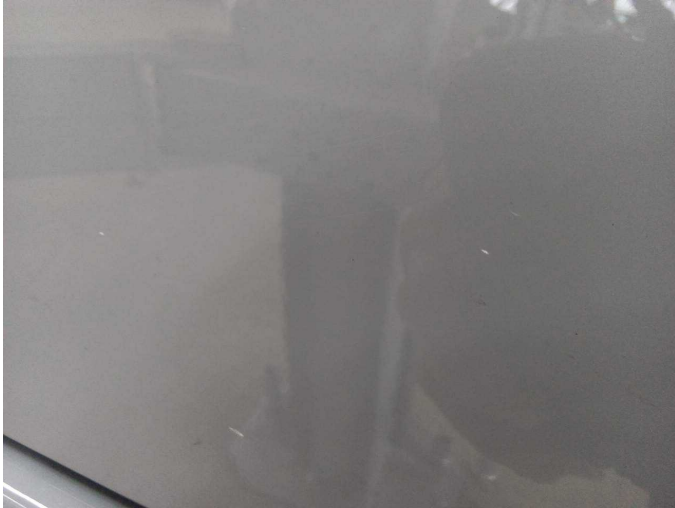
**Damage 5:** Door - front right side: Door - Scratch(es) - Smart repair

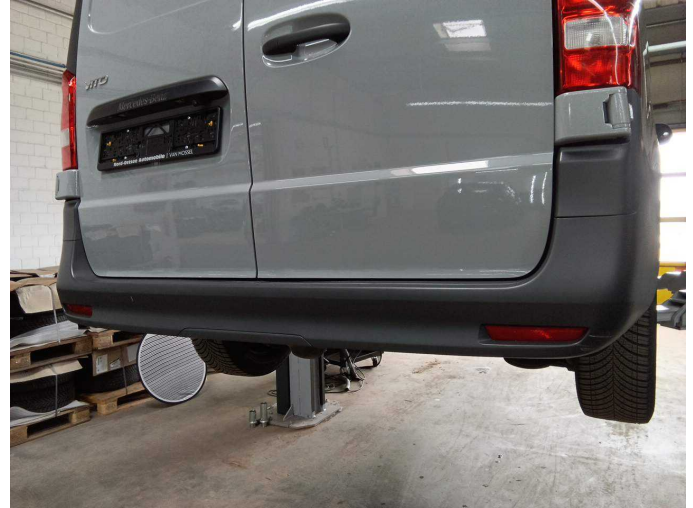
**Damage 6:** Rear bumper: Rear bumper - Scratch(es) - Smart repair

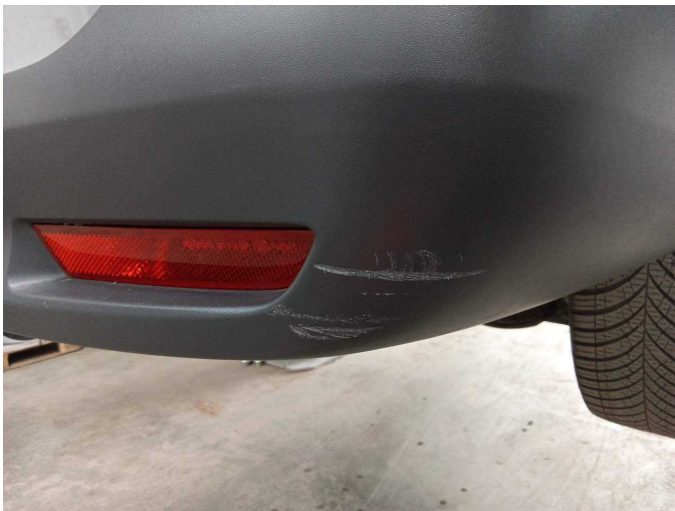
**Damage 6:** Rear bumper: Rear bumper - Scratch(es) - Smart repair

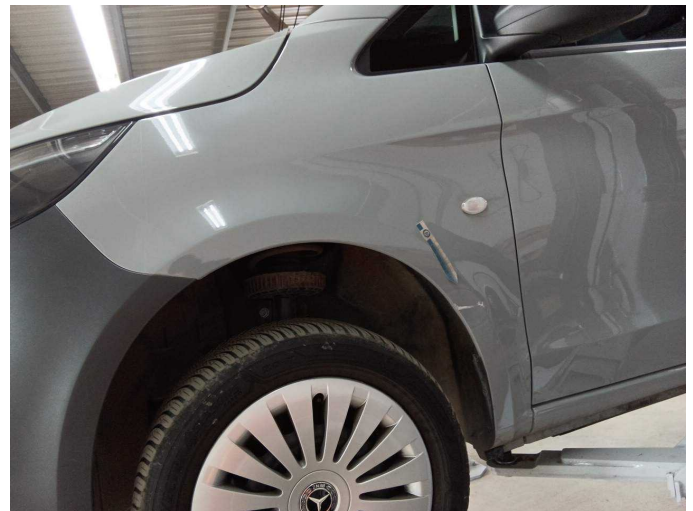
**Damage 7:** Mudguard - left side: Mudguard - left side - Dent / paintcoat damage - Repair and paint

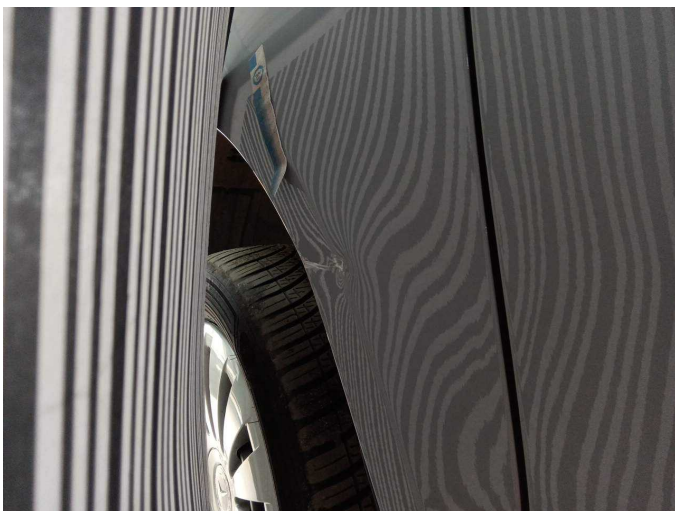
**Damage 7:** Mudguard - left side: Mudguard - left side - Dent / paintcoat damage - Repair and paint

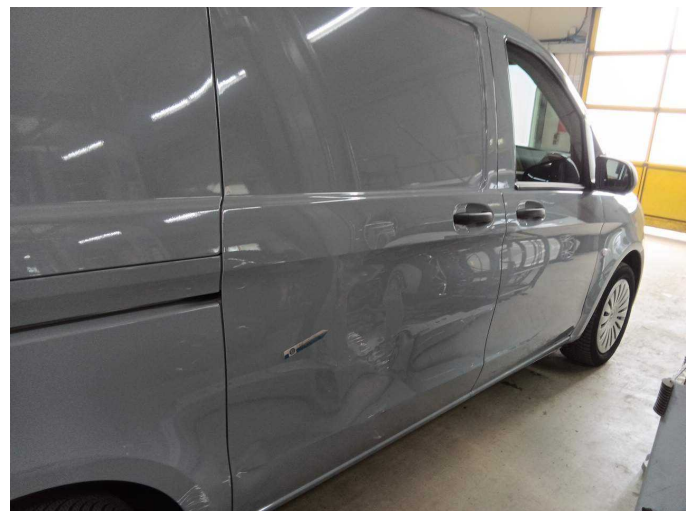
No.	Accident
1	Side right

**Accident 1:** Side right

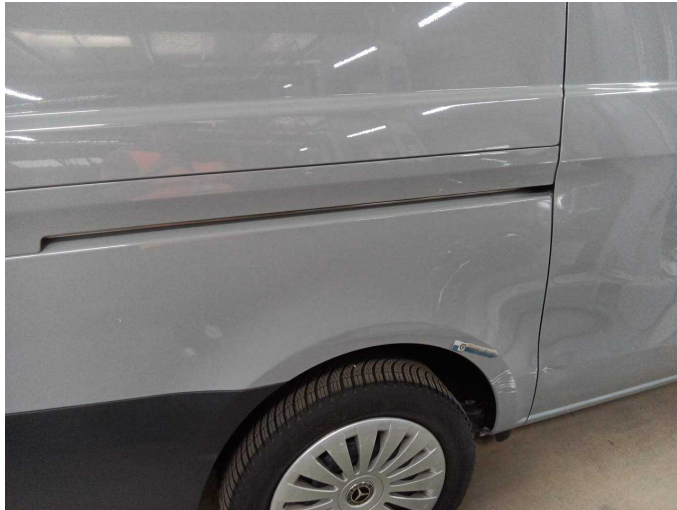
**Accident 1: Side right**

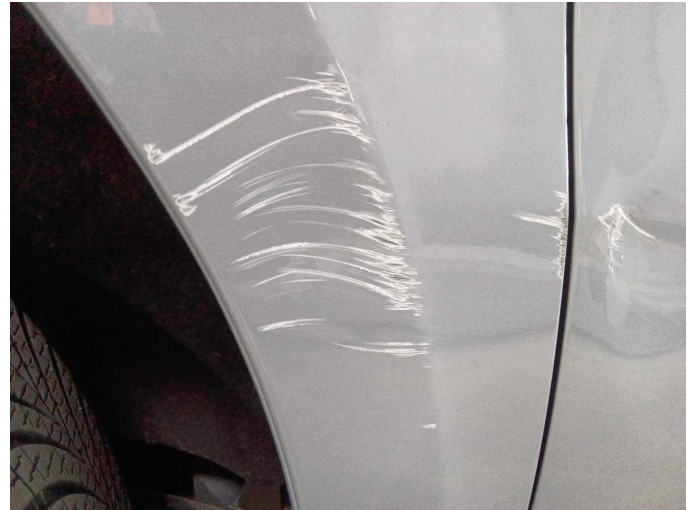
**Accident 1: Side right**
