## Expertise

Protocol number: 46347533  
Order No. / Reference: 26152043  
Inspection date: 29 Jun 2026

Model: Vito 116 CDI Tourer Extralang Aut. PRO

VIN: W1VVLGFZ1T4558800

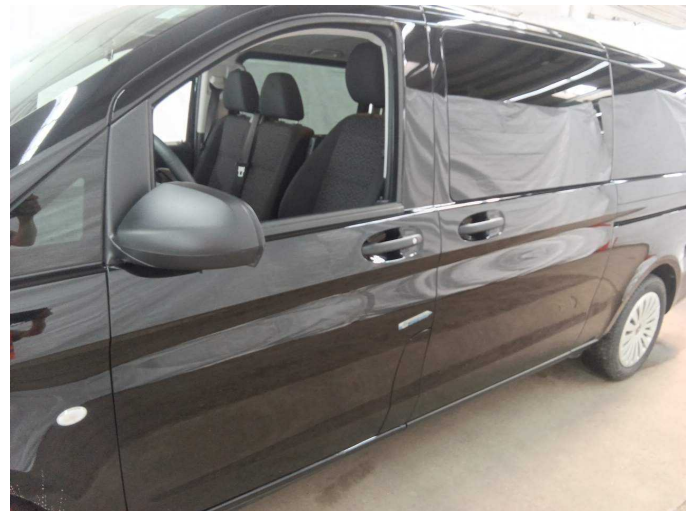
Damage 1: Door - front left side: Door edge - Scratch(es) - Smart repair

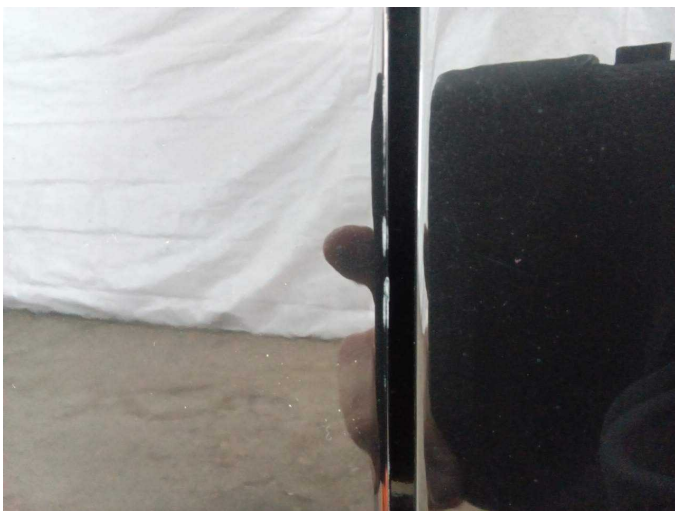
Damage 1: Door - front left side: Door edge - Scratch(es) - Smart repair

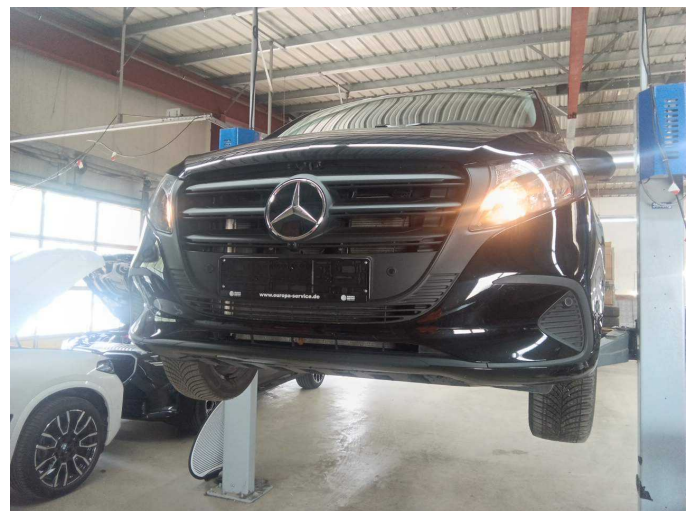
Damage 2: Front bumper: Front bumper - Scratch(es) - Smart repair

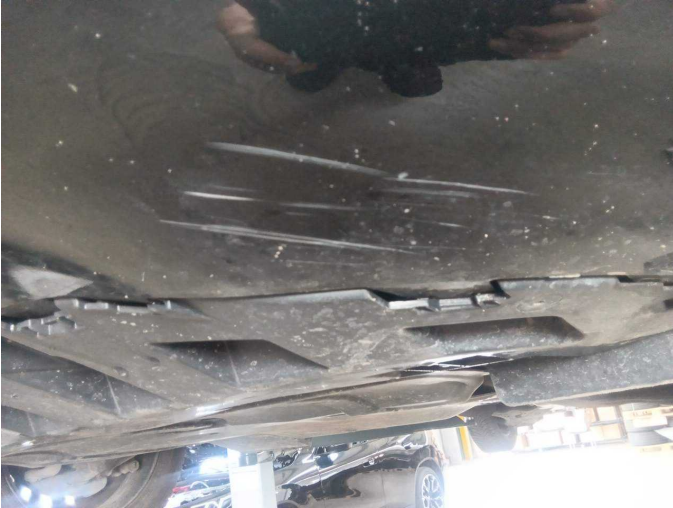
**Damage 2:** Front bumper: Front bumper - Scratch(es) - Smart repair

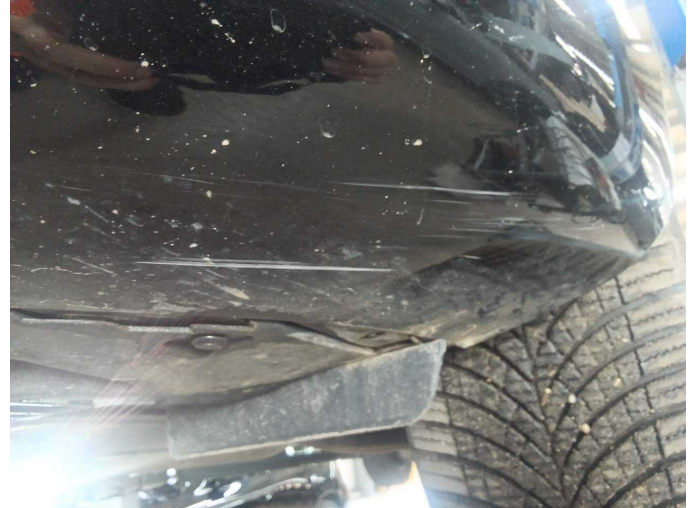
**Damage 2:** Front bumper: Front bumper - Scratch(es) - Smart repair

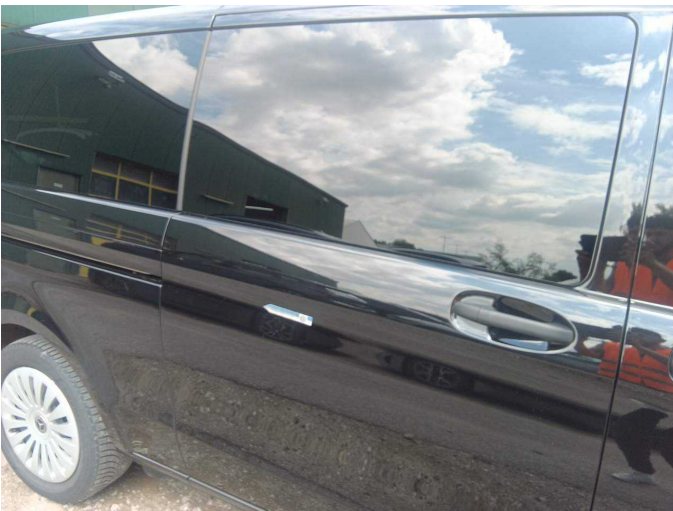
**Damage 3:** Sliding door, right: Sliding door - Scratch(es) - Paint

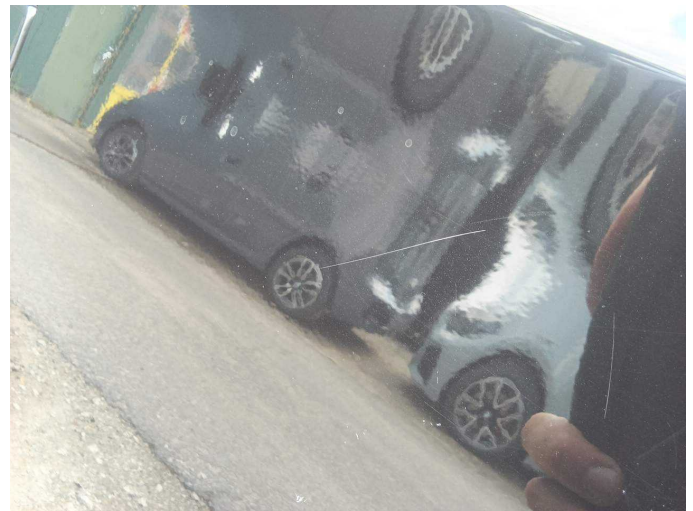
**Damage 3:** Sliding door, right: Sliding door - Scratch(es) - Paint

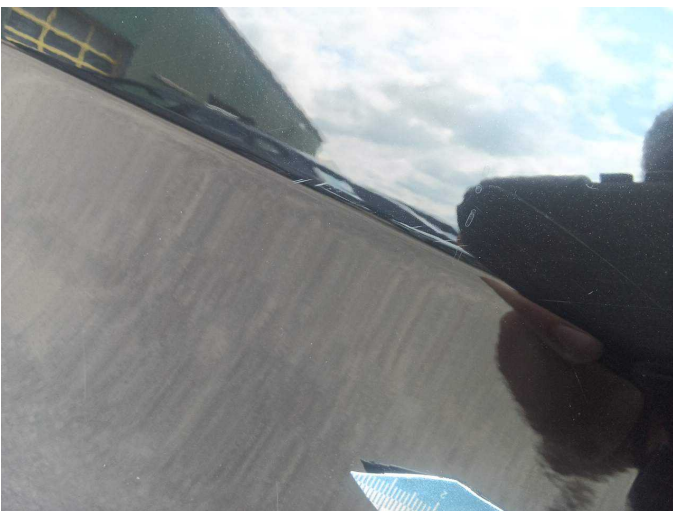
**Damage 3:** Sliding door, right: Sliding door - Scratch(es) - Paint

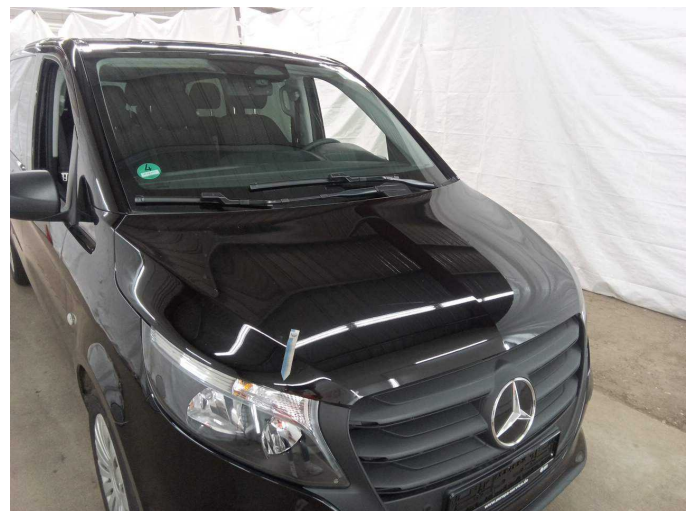
**Damage 4:** Bonnet: Bonnet - Stone chips - Paint

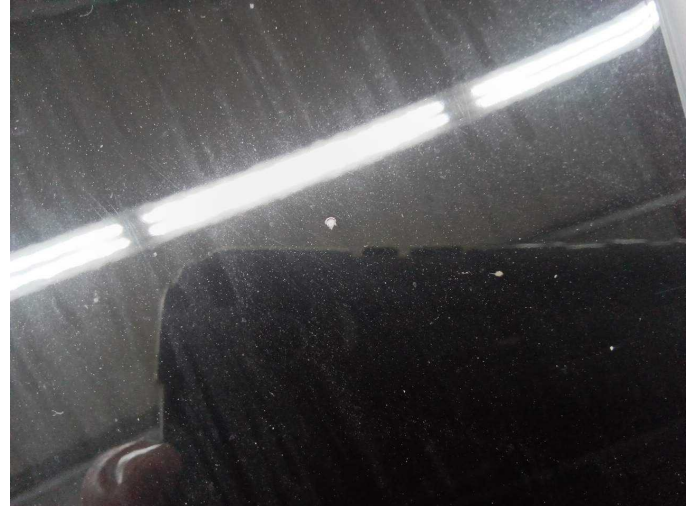
**Damage 4:** Bonnet: Bonnet - Stone chips - Paint

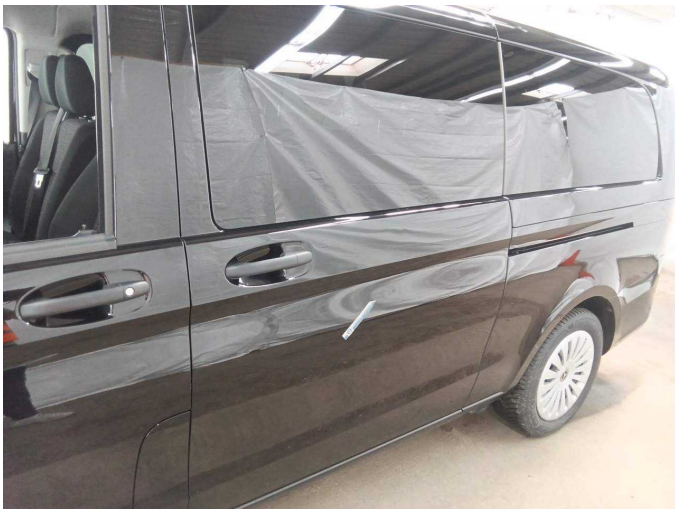
**Damage 5:** Sliding door - left side: Sliding door - Dent / paintcoat damage - Repair and paint

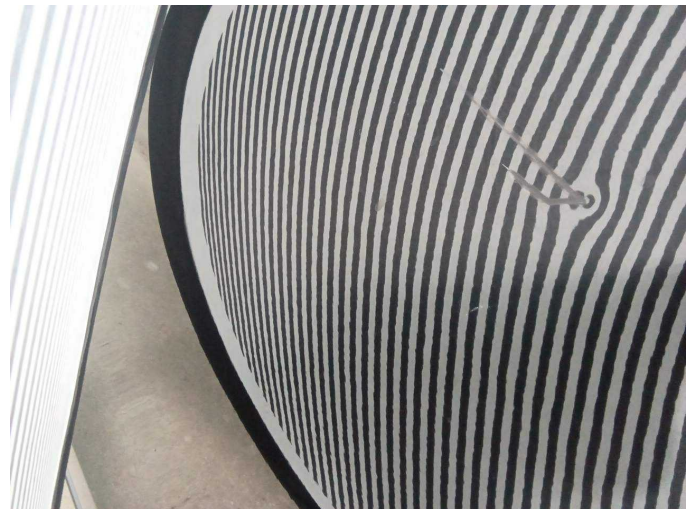
**Damage 5:** Sliding door - left side: Sliding door - Dent / paintcoat damage - Repair and paint

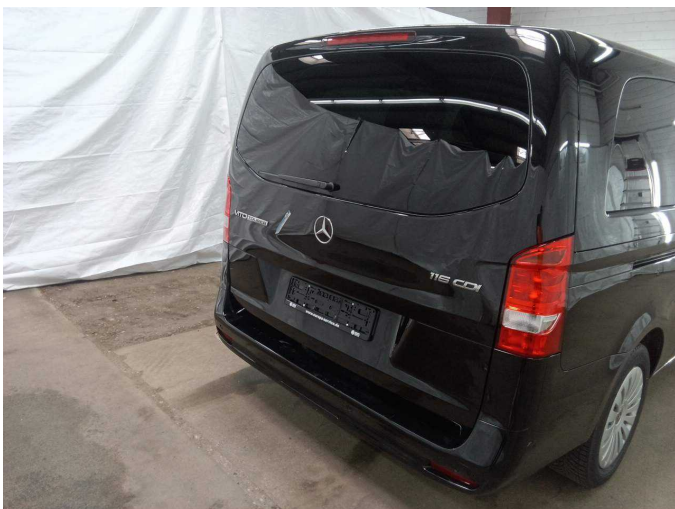
**Damage 6:** Boot lid / rear door: Boot lid - Dent / paintcoat damage - Repair and paint

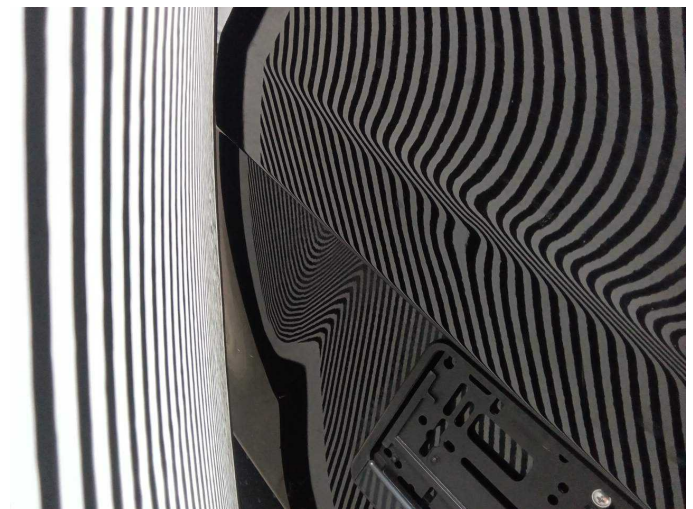
**Damage 6:** Boot lid / rear door: Boot lid - Dent / paintcoat damage - Repair and paint

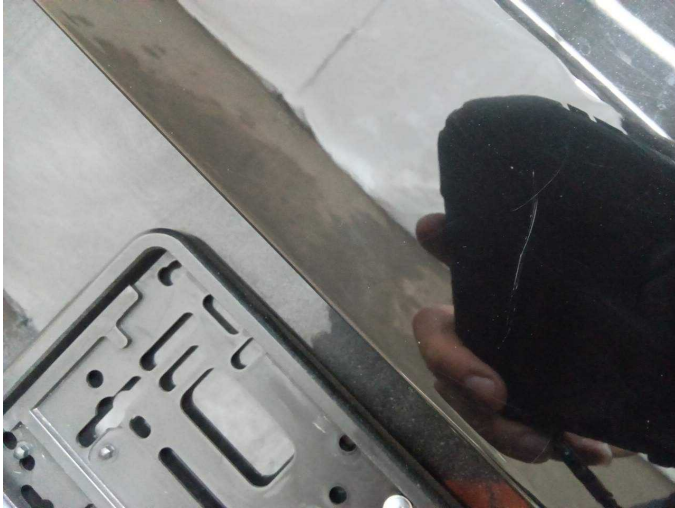
**Damage 6:** Boot lid / rear door: Boot lid - Dent / paintcoat damage - Repair and paint

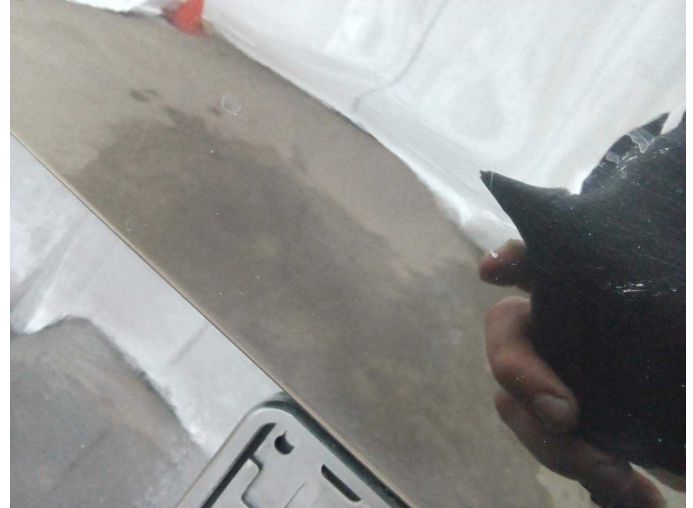
**Damage 6:** Boot lid / rear door: Boot lid - Dent / paintcoat damage - Repair and paint

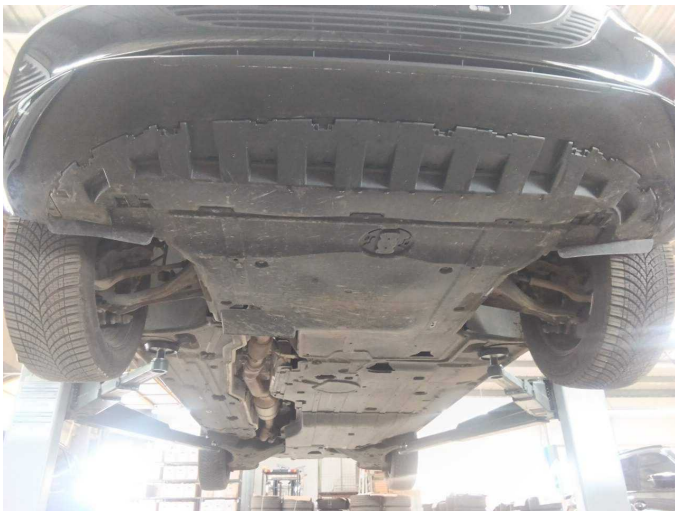
**Wear and tear 2:** Body: Underbody panelling - Scratch(es) - No deduction

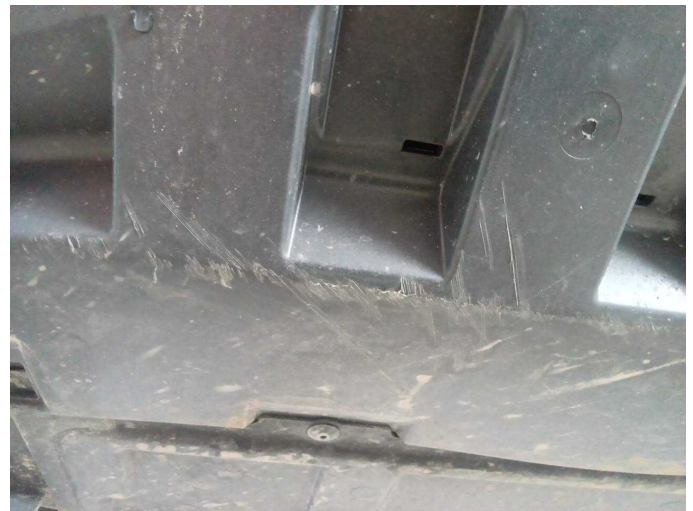
**Wear and tear 2:** Body: Underbody panelling - Scratch(es) - No deduction
