Expertise

Protocol number: 46149895
Order No. / Reference: 26489486
Inspection date: 25 Jun 2026

Model: Astra 1.2 Turbo Start/Stop Sports Tourer Business Edition

VIN: W0VBD8ESXL8035274

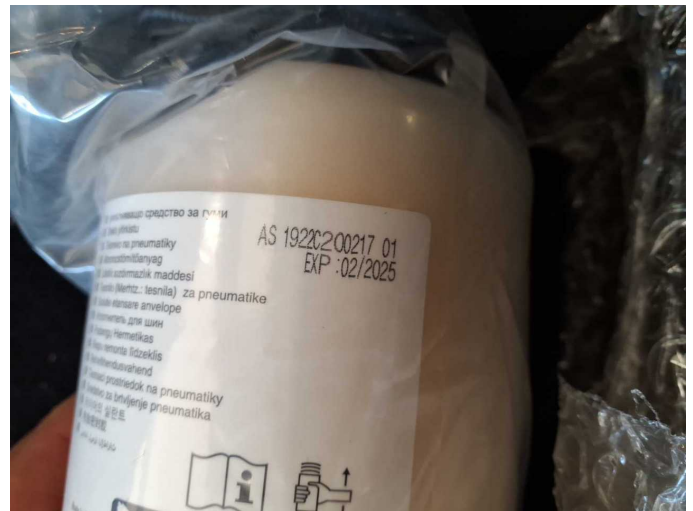
Damage 1: Equipment: Tirefit filler - Expired - Replace

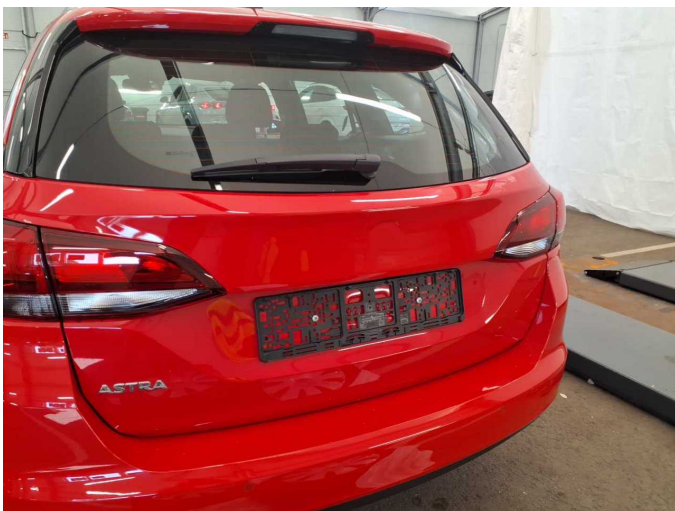
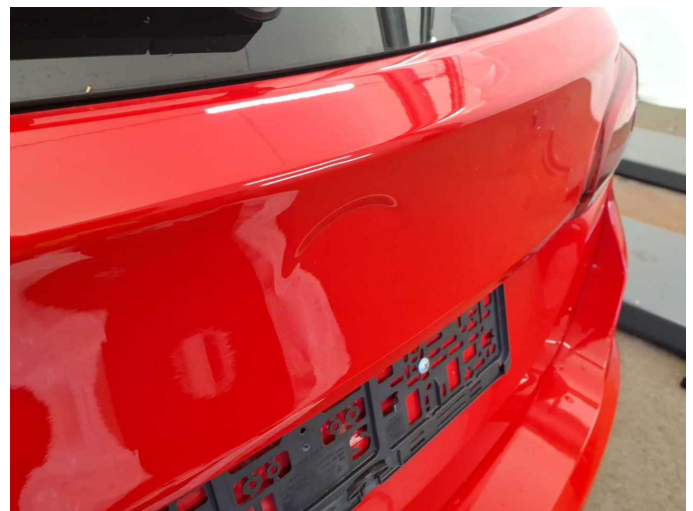
Damage 2: Boot lid / rear door: Emblem - Missing - Replace

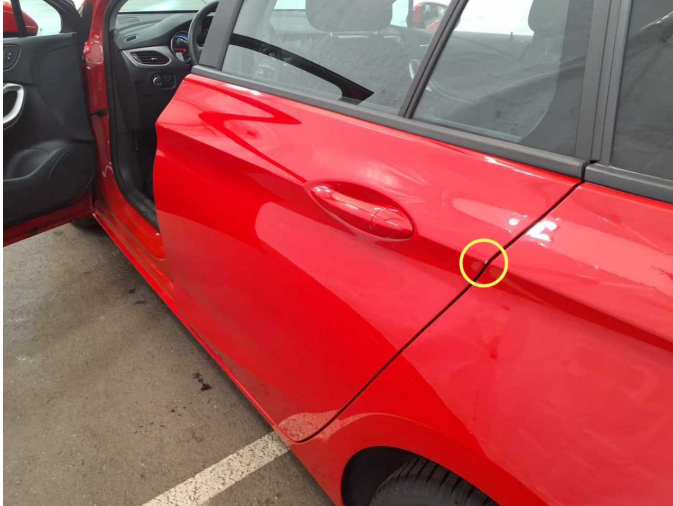
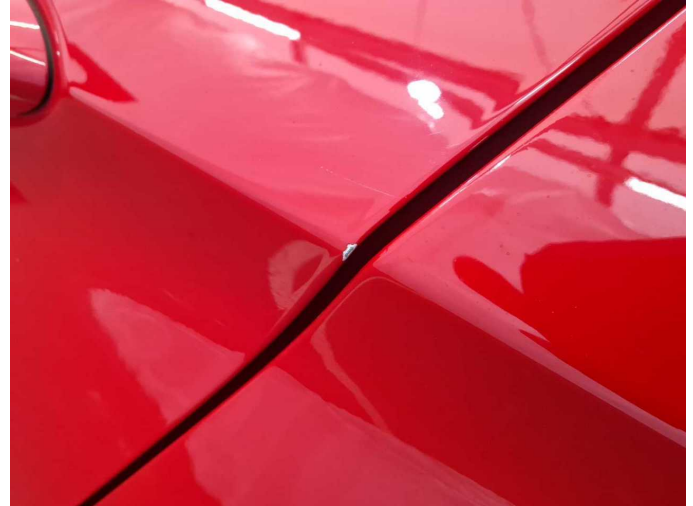
Damage 3: Door - rear left side: Door edge - Scratch(es) - Smart repair

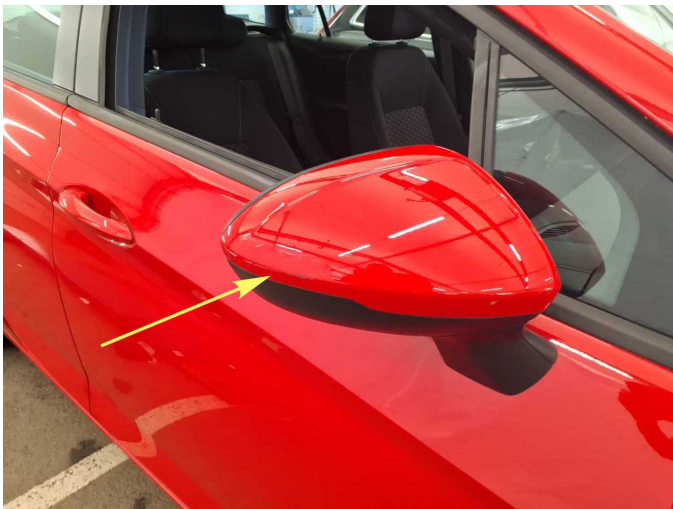
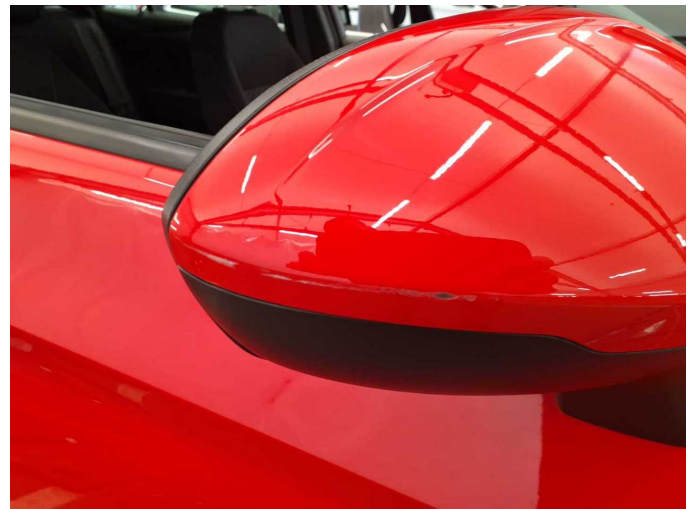
Damage 4: Wing mirror - right side: Cap - Scratch(es) - Paint

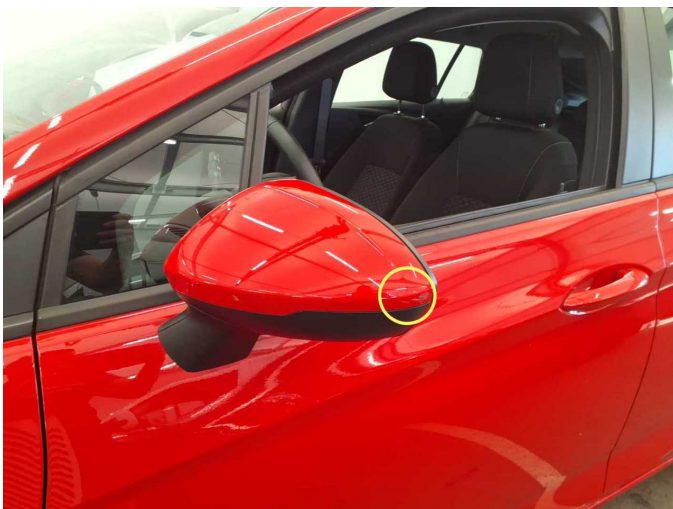
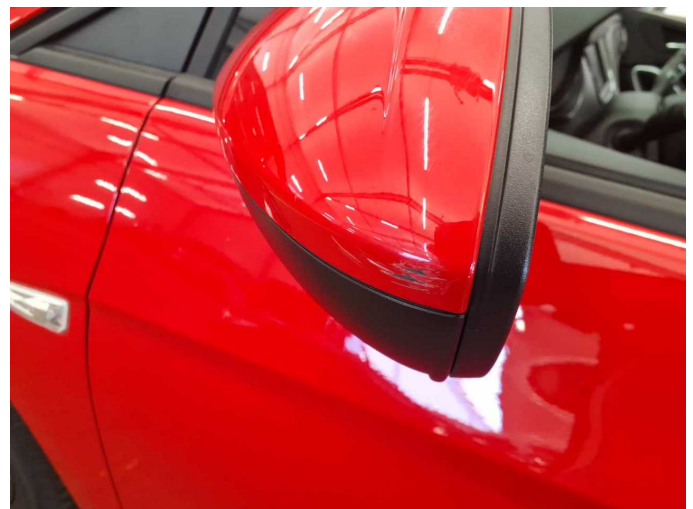
Damage 5: Wing mirror - left side: Cap - Scratch(es) - Paint

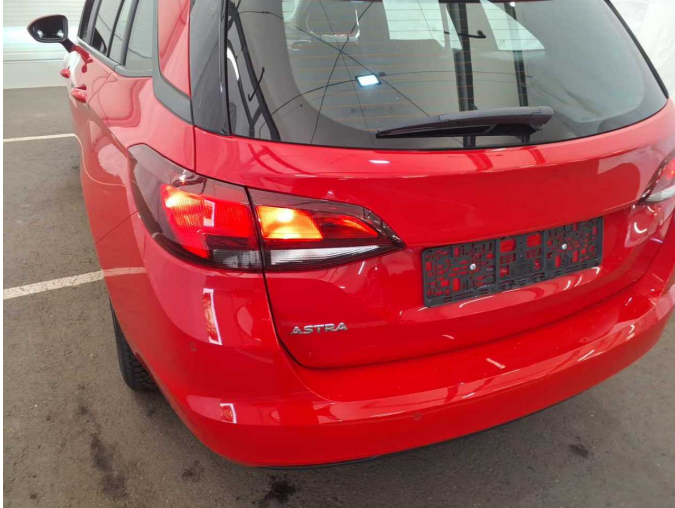
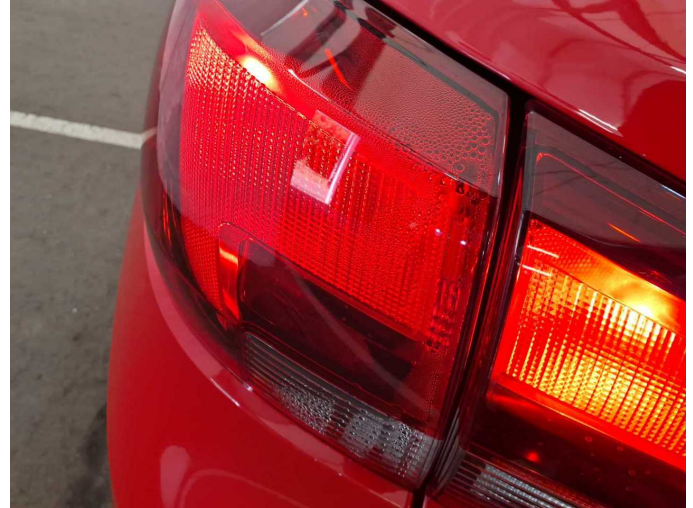
Damage 6: Tail light: Tail lamp - left side - Leaking - Replace

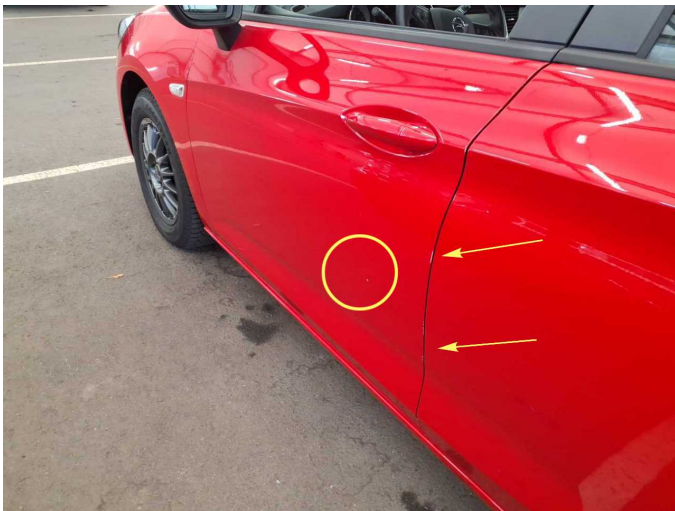
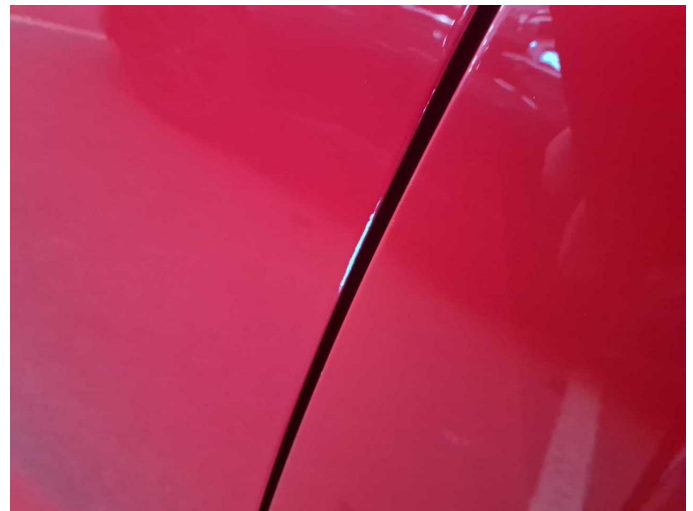
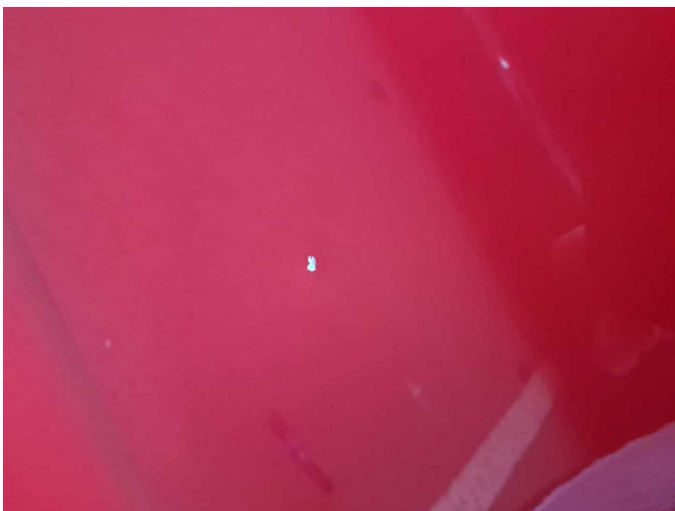
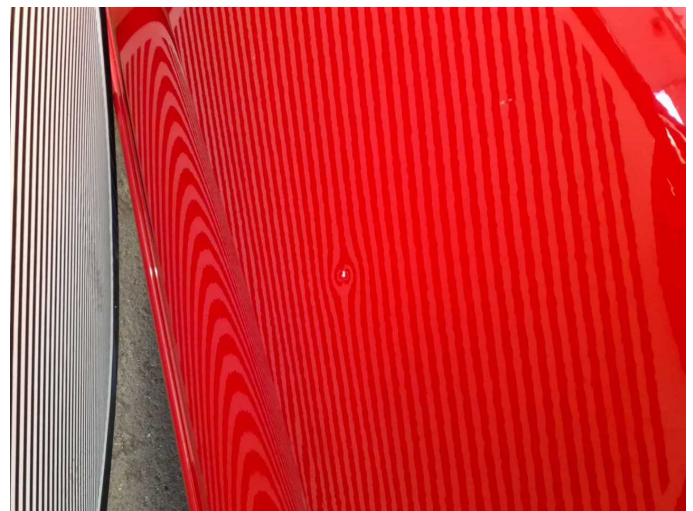
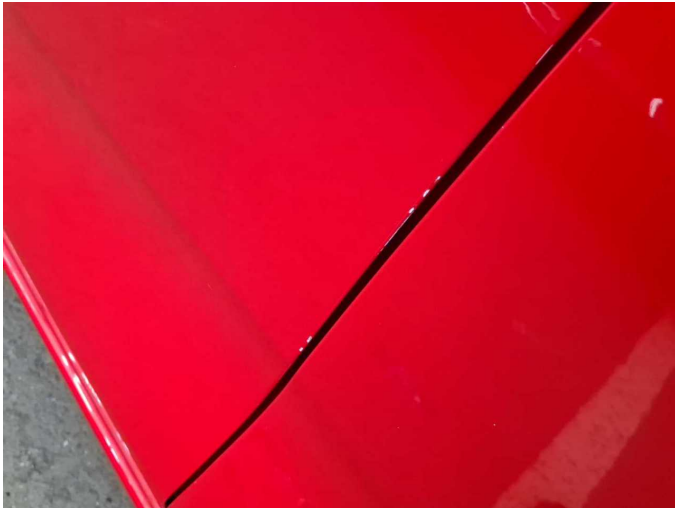
Damage 7: Door - front left side: Door - Dent / paintcoat damage - Repair and paint

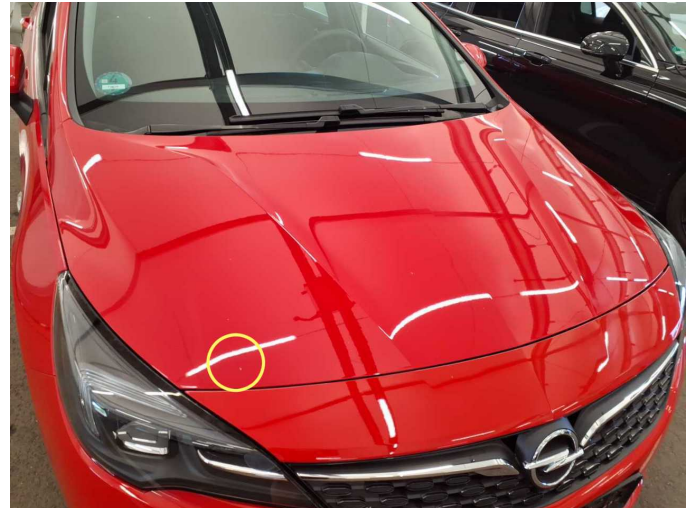
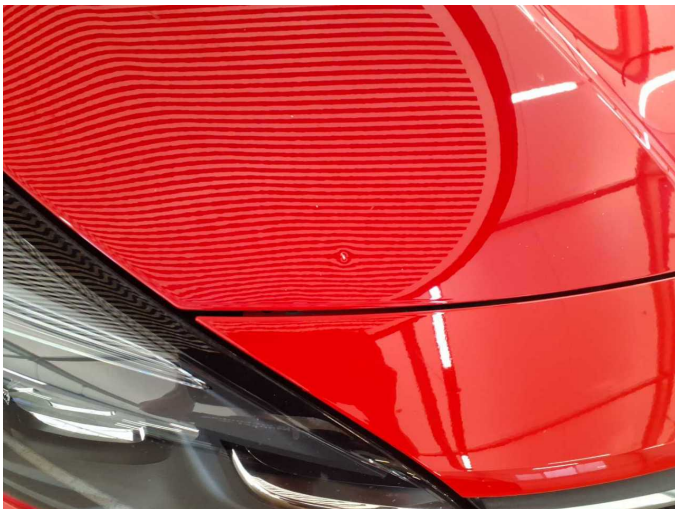
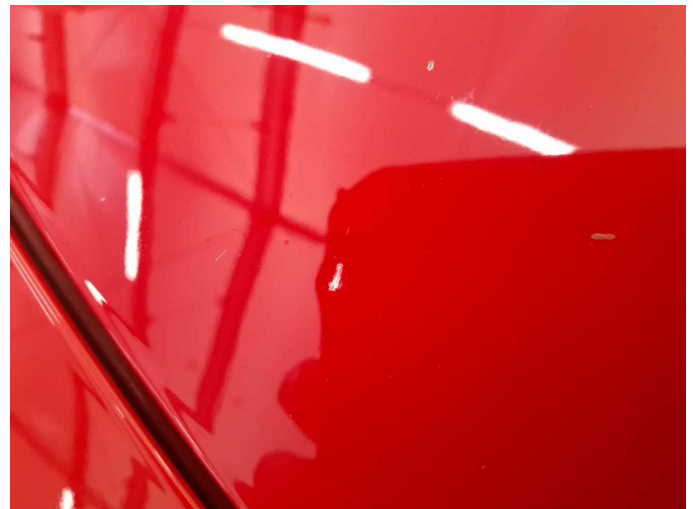
Damage 8: Bonnet: Bonnet - Dent / paintcoat damage - Repair and paint

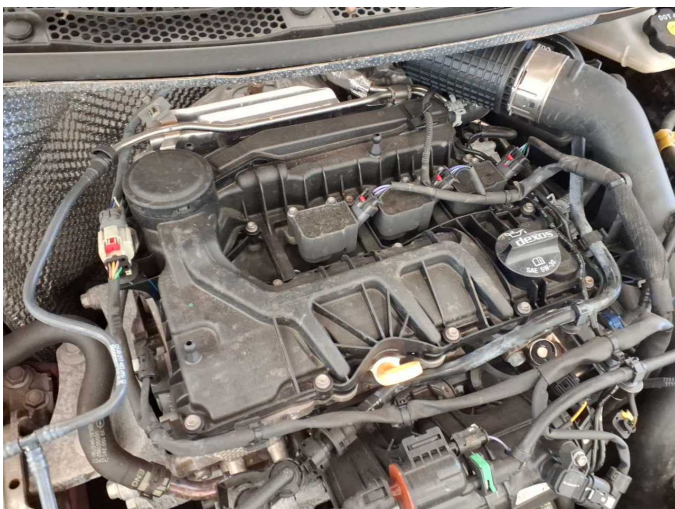
Missing part 1: Engine: Engine cover - Missing - Replace

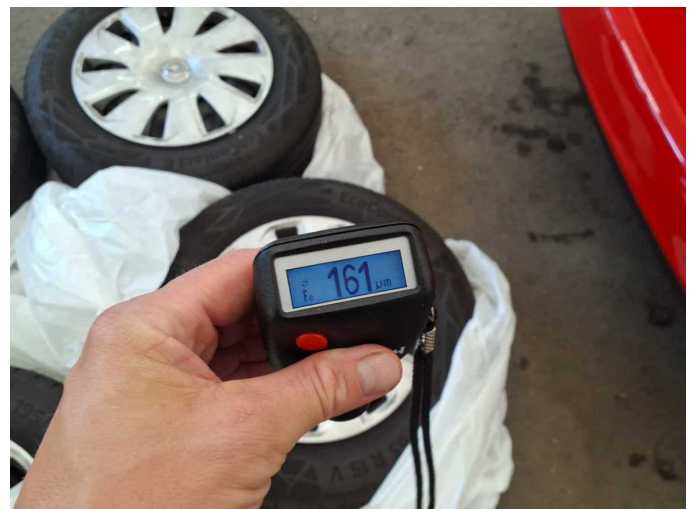
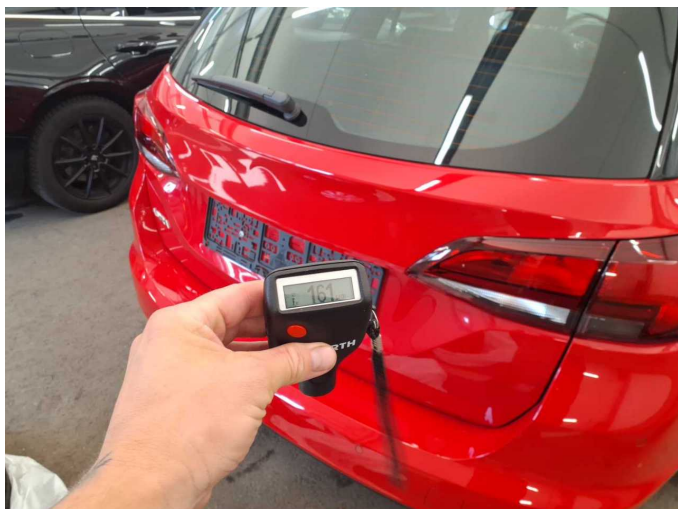
1 Boot lid / rear door, Professionally carried out, Invoice of repair done

Boot lid / rear door 161 µm |

Repainting 1: Boot lid / rear door
