Expertise

Protocol number: 46500609  
Order No. / Reference: 26576673  
Inspection date: 10 Jul 2026

Manufacturer: Citroën

Model: Berlingo M BlueHDi 130 FEEL PACK

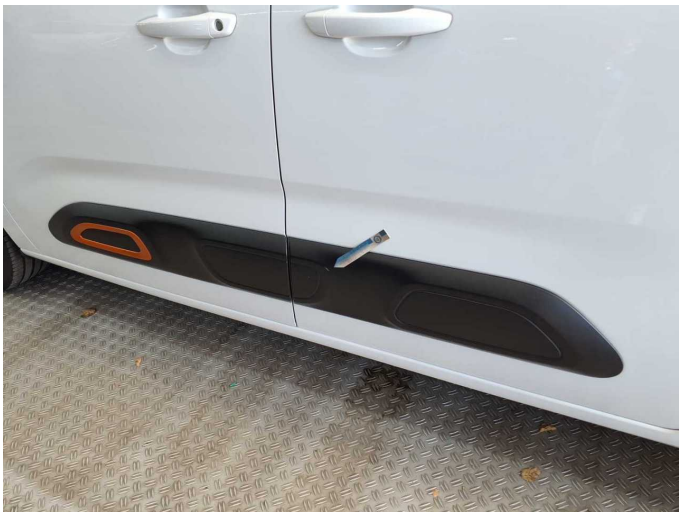
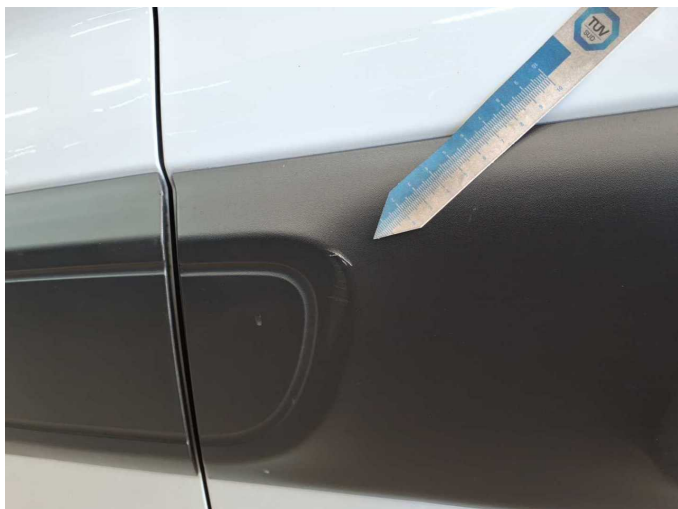
| No. | Component group | Description |
|---|---|---|
| 1 | Door - rear left side | Brightware - lower - Scratch(es) - Loss in value |

**Damage 1:** Door - rear left side: Brightware - lower - Scratch(es) - Loss in value

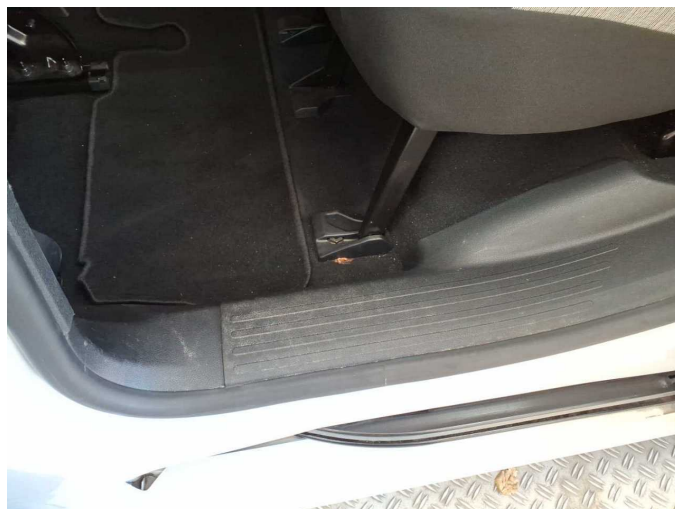
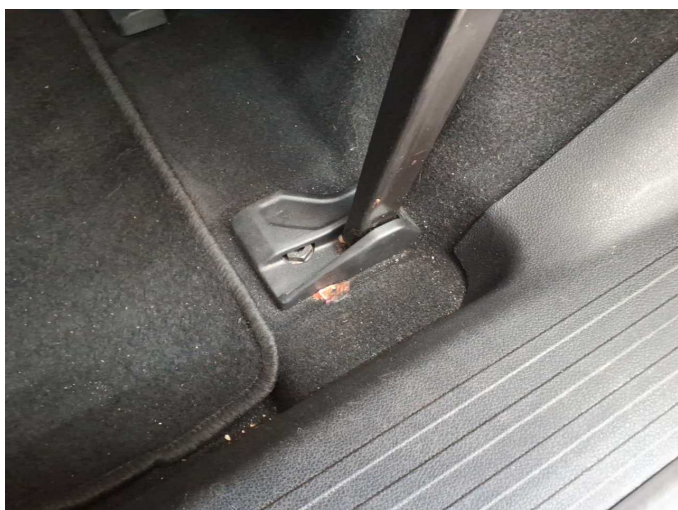
| No. | Component group | Description |
|---|---|---|
| 2 | Trim / covers | Carpet - rear left side (Kaugummi) - Soiled - Clean |

**Damage 2:** Trim / covers: Carpet - rear left side (Kaugummi) - Soiled - Clean

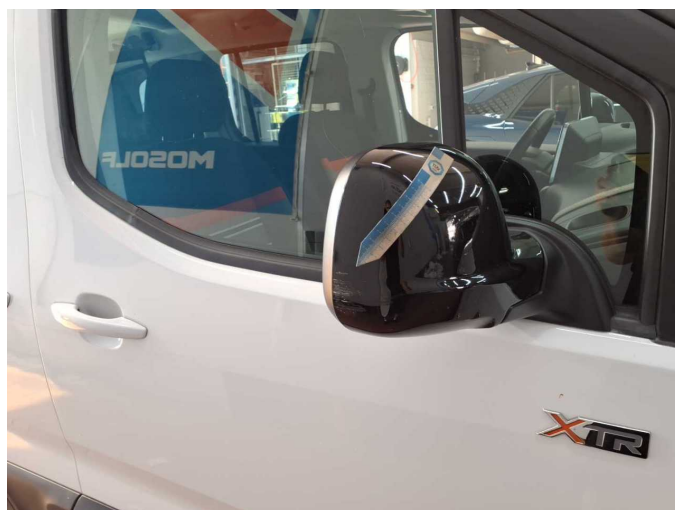
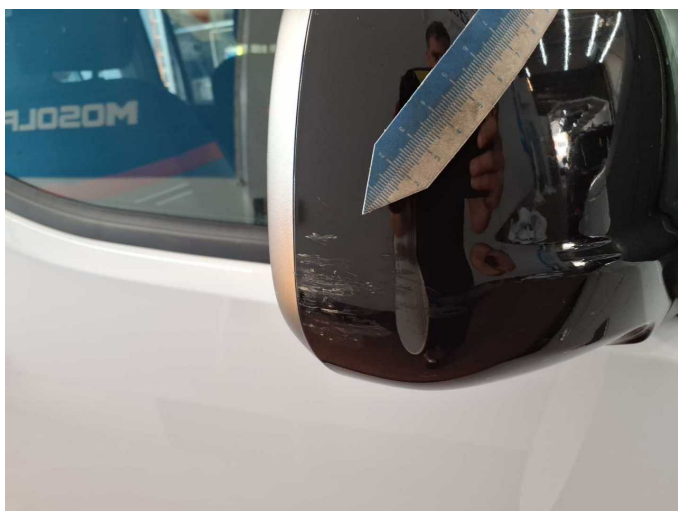
| No. | Component group | Description |
|---|---|---|
| 3 | Wing mirror - right side | Cap - Scratch(es) - Smart repair |

**Damage 3:** Wing mirror - right side: Cap - Scratch(es) - Smart repair

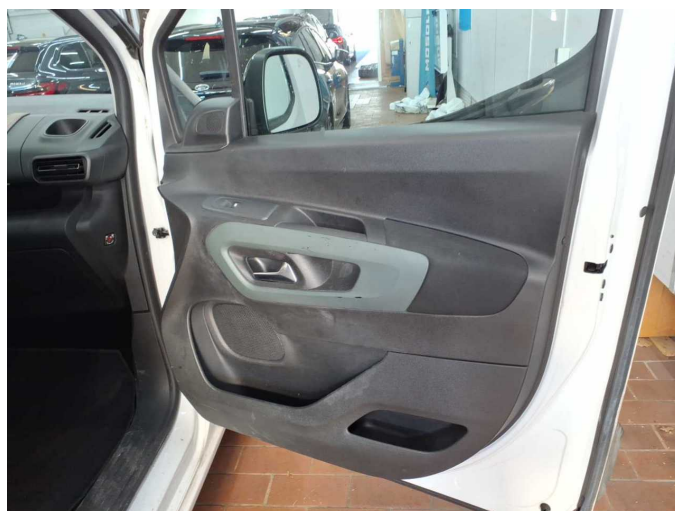
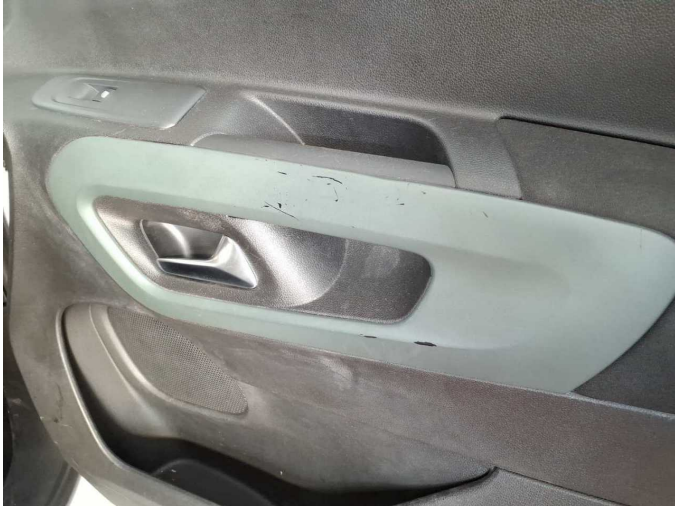
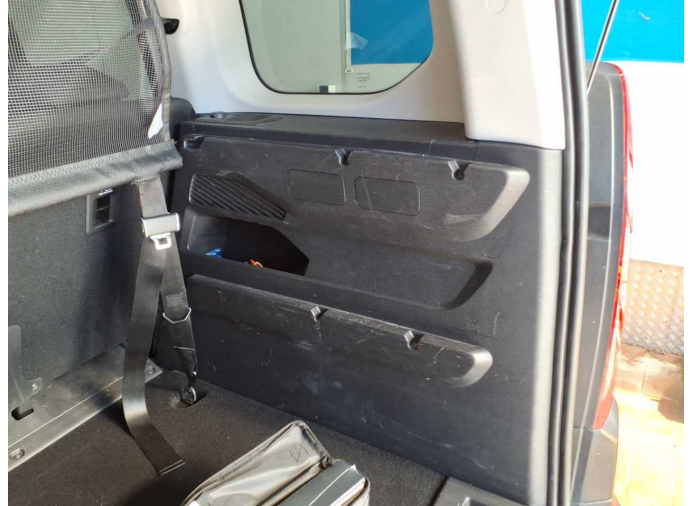
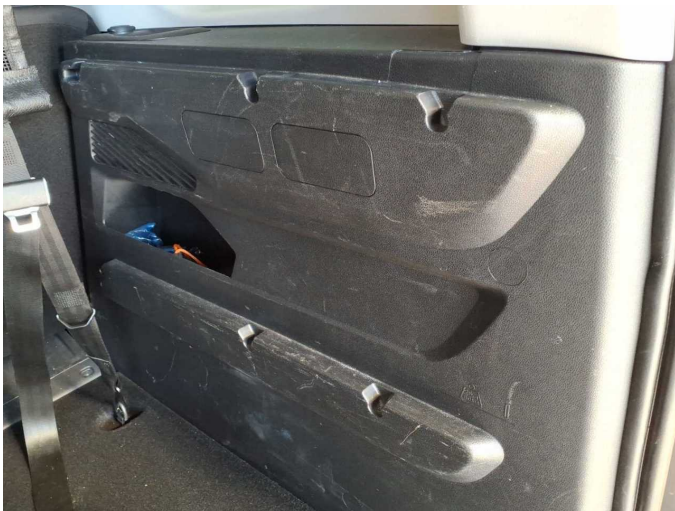
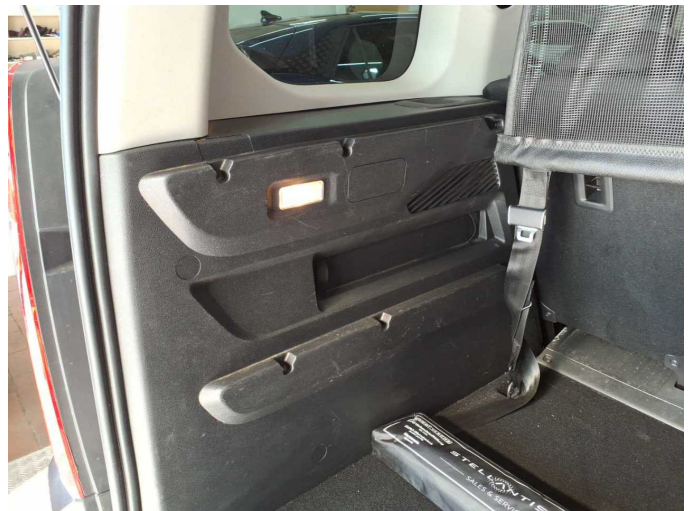
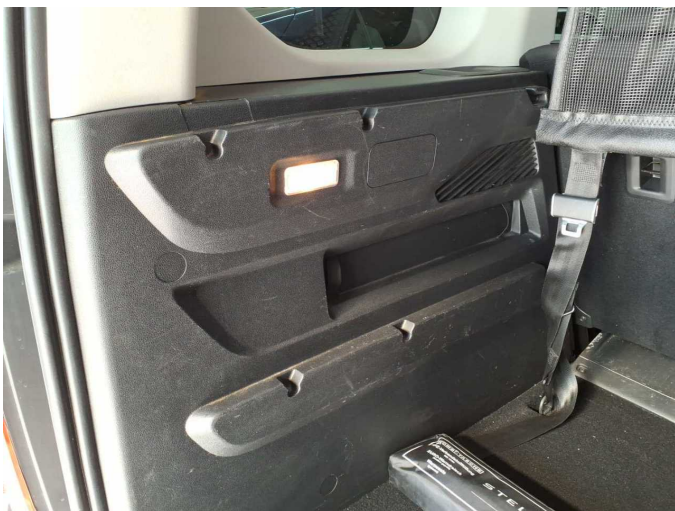
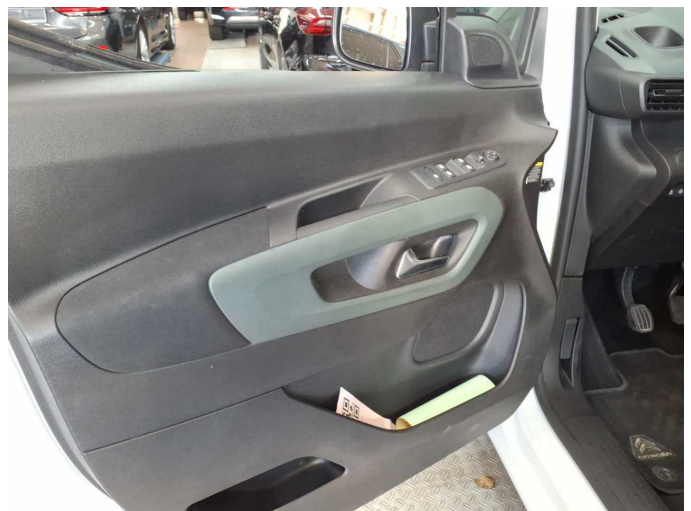
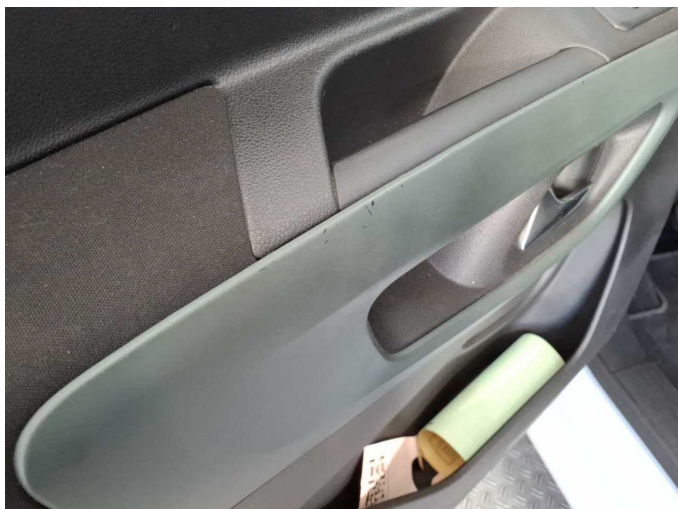
| No. | Component group | Description |
|---|---|---|
| 4 | Interior | Interior - Scratch(es) - Loss in value |

**Damage 4:** Interior: Interior - Scratch(es) - Loss in value

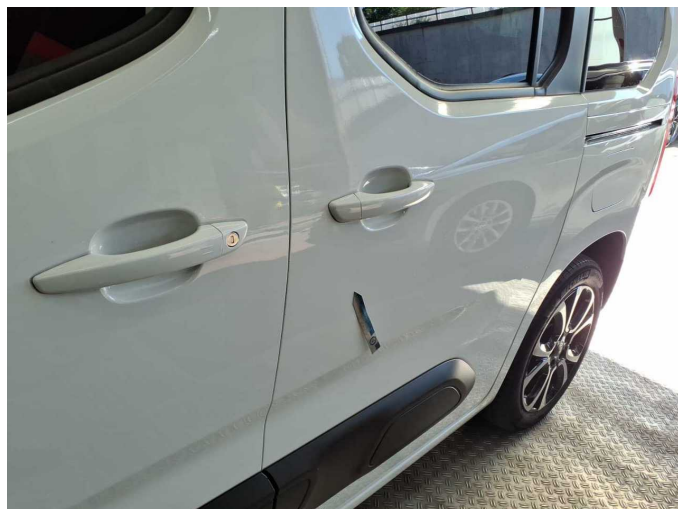
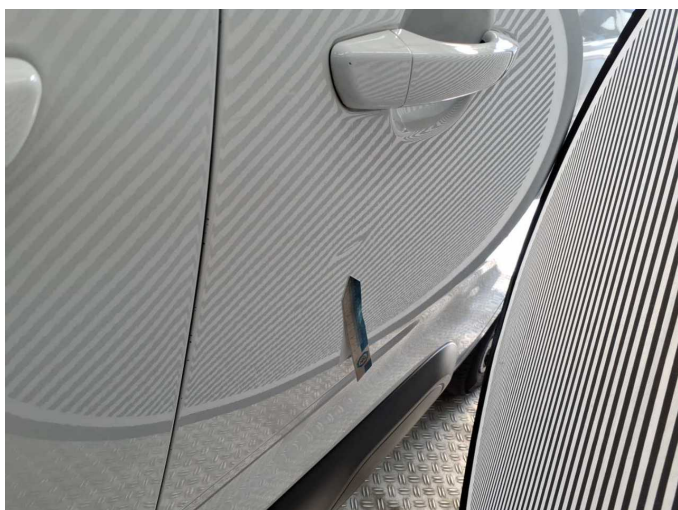
| No. | Component group | Description |
|---|---|---|
| 5 | Sliding door - left side | Sliding door with glass panel - dent(s) - Smart repair |

**Damage 5:** Sliding door - left side: Sliding door with glass panel - dent(s) - Smart repair

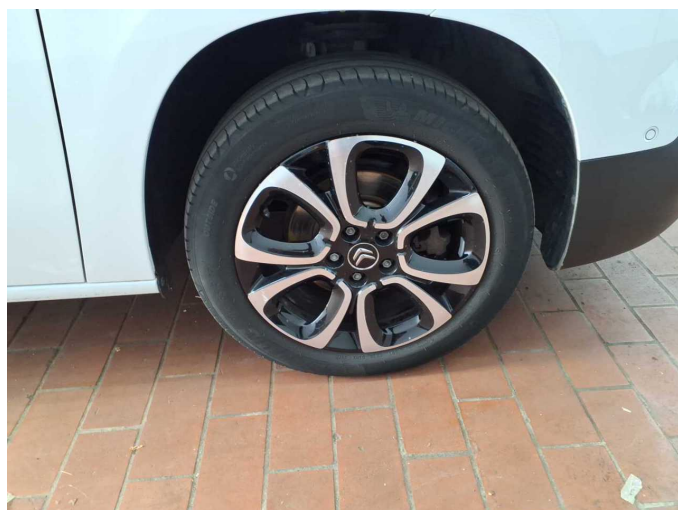
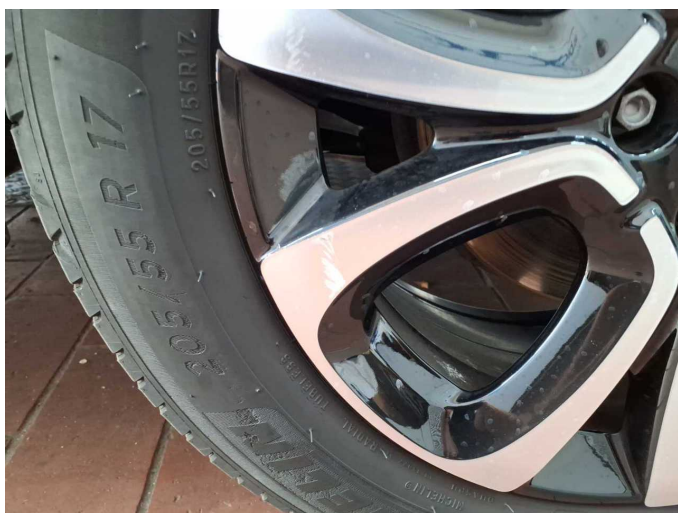
| No. | Component group | Description |
|---|---|---|
| 6 | Wheel / tyres | Alloy rim - front right side - Scratch(es) - Loss in value |

**Damage 6:** Wheel / tyres: Alloy rim - front right side - Scratch(es) - Loss in value

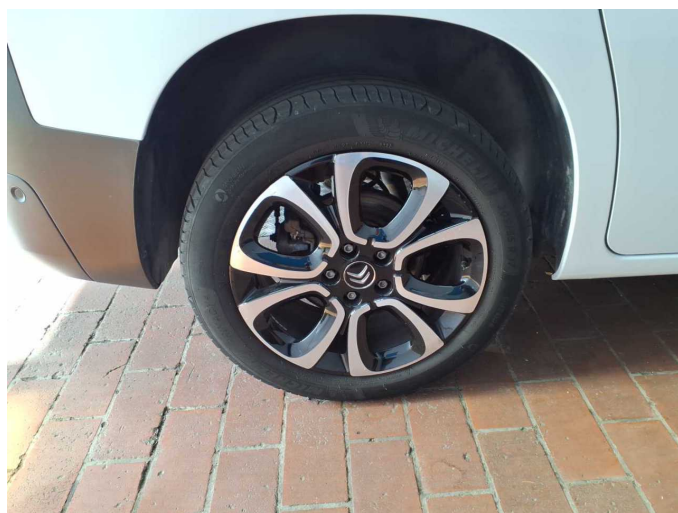
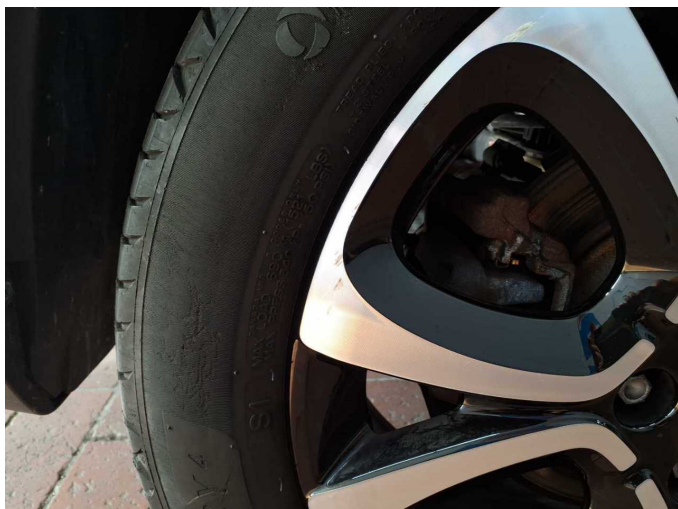
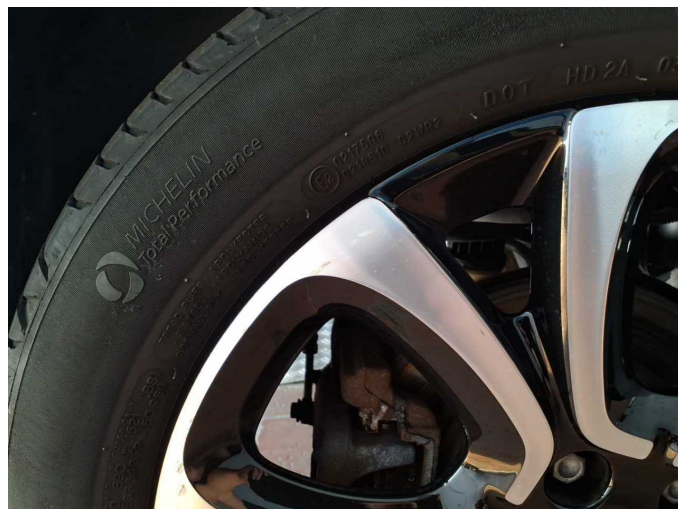
| No. | Component group | Description |
|---|---|---|
| 7 | Wheel / tyres | Alloy rim - rear right side - Scratch(es) - Loss in value |

**Damage 7:** Wheel / tyres: Alloy rim - rear right side - Scratch(es) - Loss in value

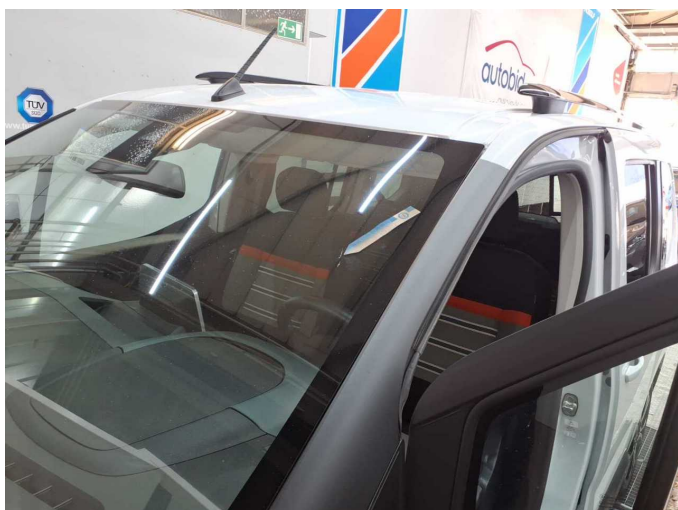
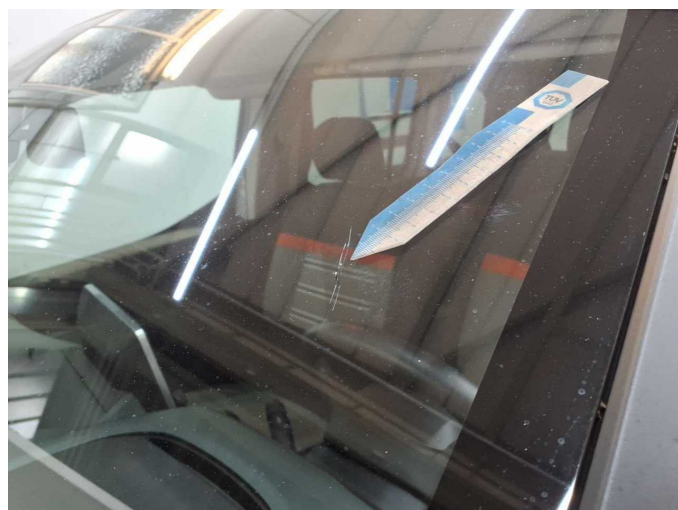
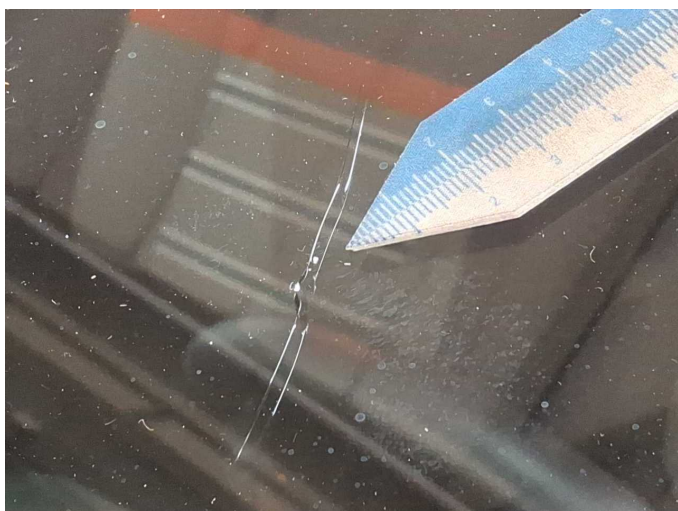
| No. | Component group | Description |
|---|---|---|
| 8 | Vehicle glazing | Windscreen - Stone chips - Replace |

**Damage 8:** Vehicle glazing: Windscreen - Stone chips - Replace

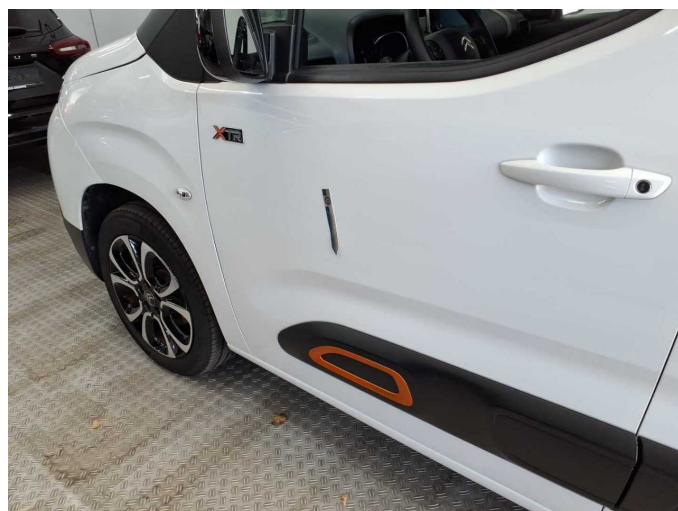
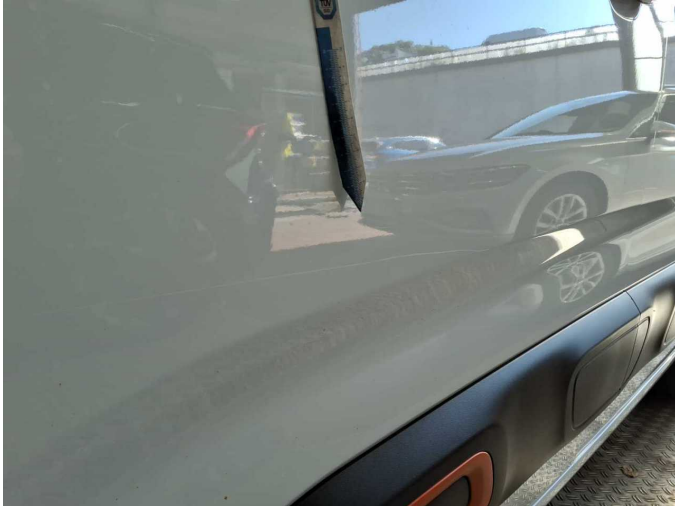
| No. | Component group | Description |
|---|---|---|
| 4 | Door - front left side | Door (Polieren) - Scratch(es) - No deduction |

**Wear and tear 4:** Door - front left side: Door (Polieren) - Scratch(es) - No deduction

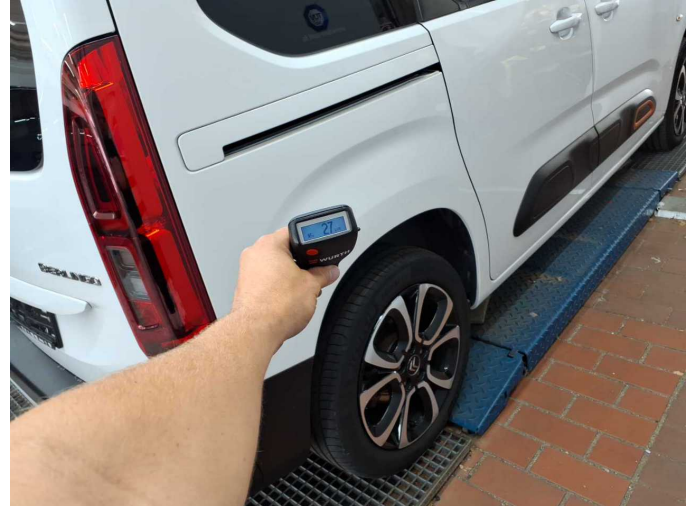
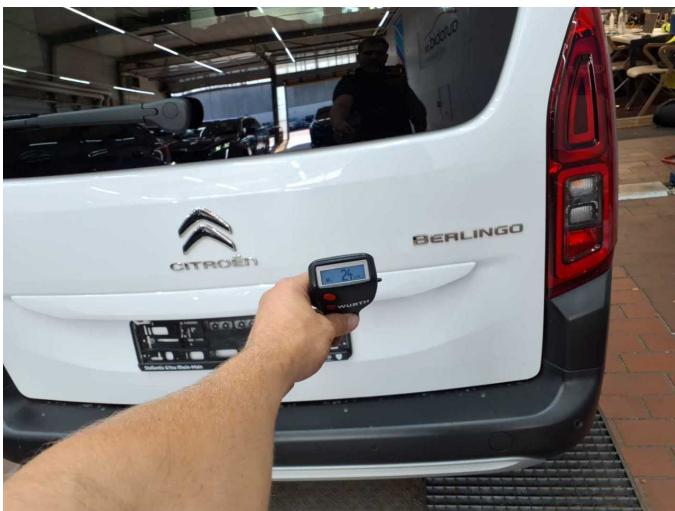
| No. | Previous damage | Extent of damage (Net) |
|---|---|---|
| 1 | Rear, Side right, Provided by user / customer, from 17 Oct 2025 | 1.433,63 € |

According to available information previous damages were repaired at the vehicle. Traces of repairs, which allow conclusions about the area of repair, were not recognizable during the inspection.

**Previous damage 1:** Rear, Side right
