Expertise

Protocol number: 45790581
Order No. / Reference: 26382093
Inspection date: 1 Jun 2026

Manufacturer: Volvo

Model: XC90 T8 AWD Recharge Core

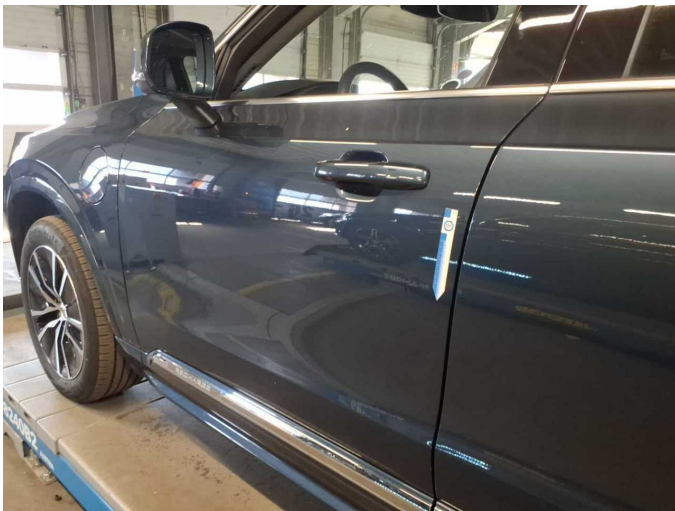
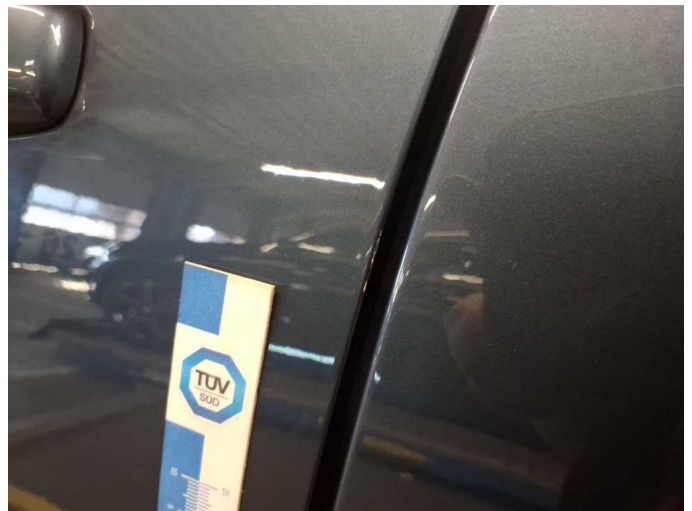
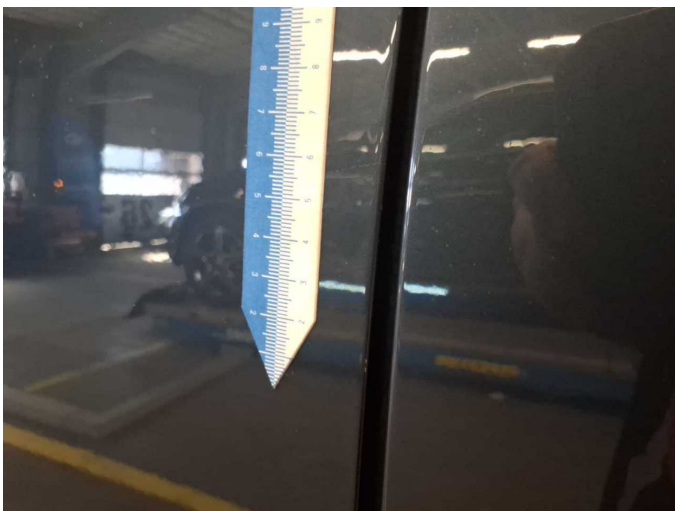
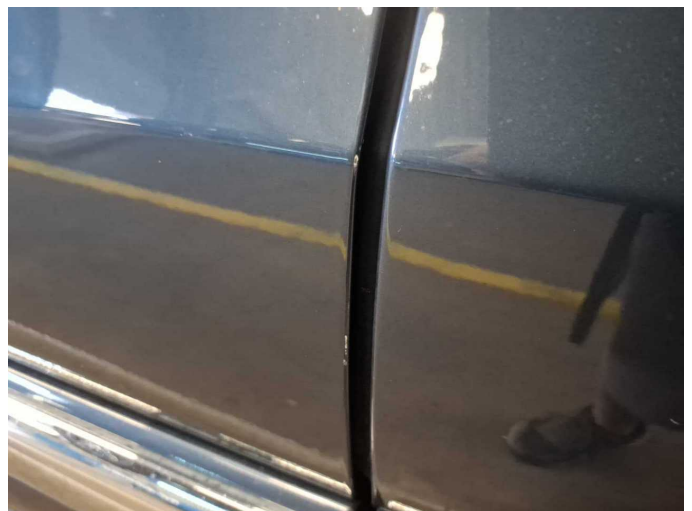
| No. | Component group | Description |
|---|---|--|
| 1 | Door - front left side | Door edge - Scratch(es) - Smart repair |

Damage 1: Door - front left side: Door edge - Scratch(es) - Smart repair

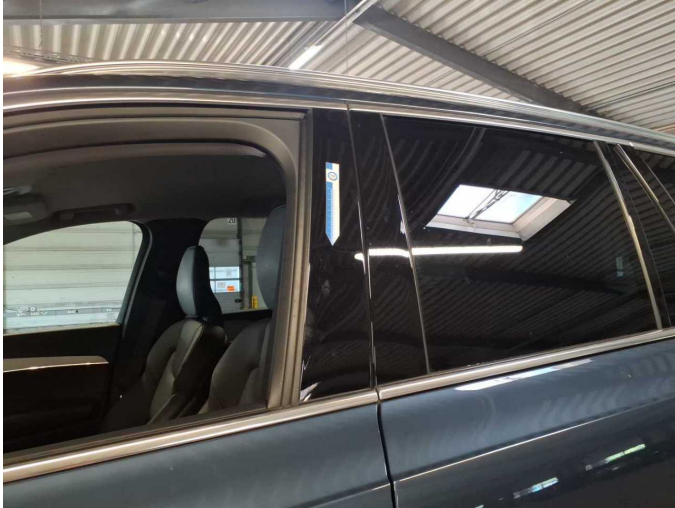
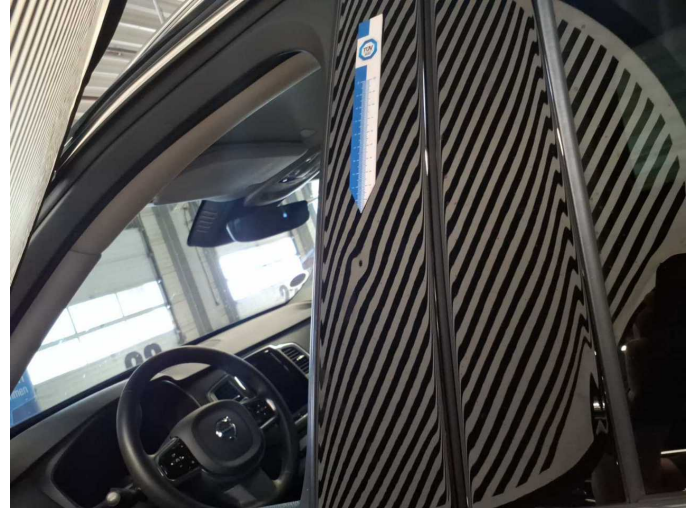
| No. | Component group | Description |
|---|---|--|
| 2 | Door - front left side | Door (Rahmen Leiste) - dent(s) - Replace |

Damage 2: Door - front left side: Door (Rahmen Leiste) - dent(s) - Replace

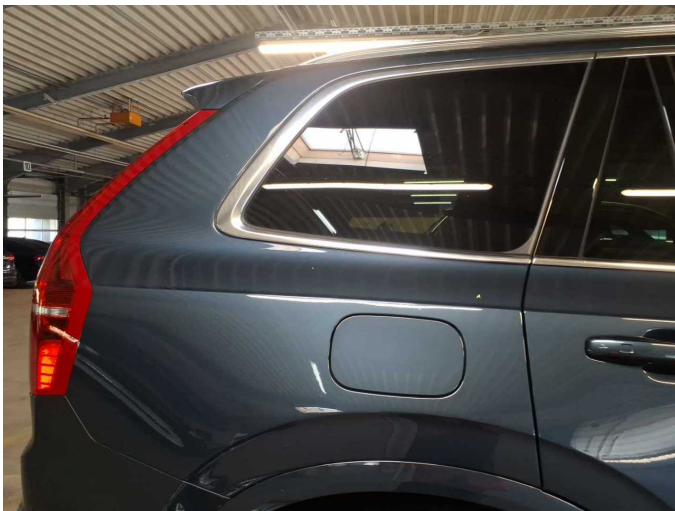
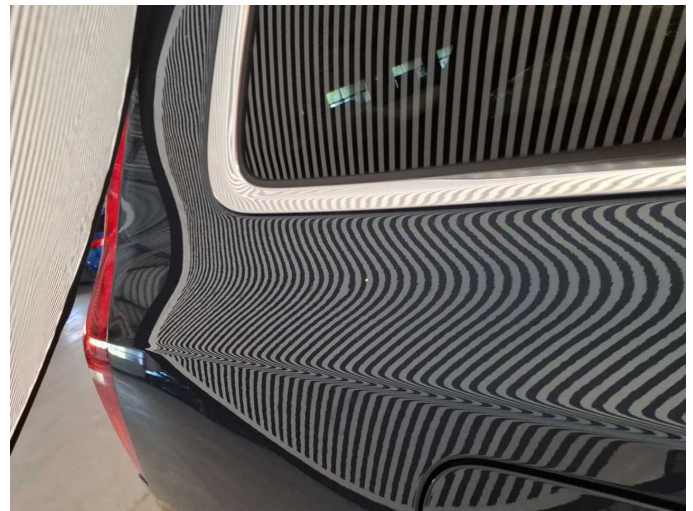
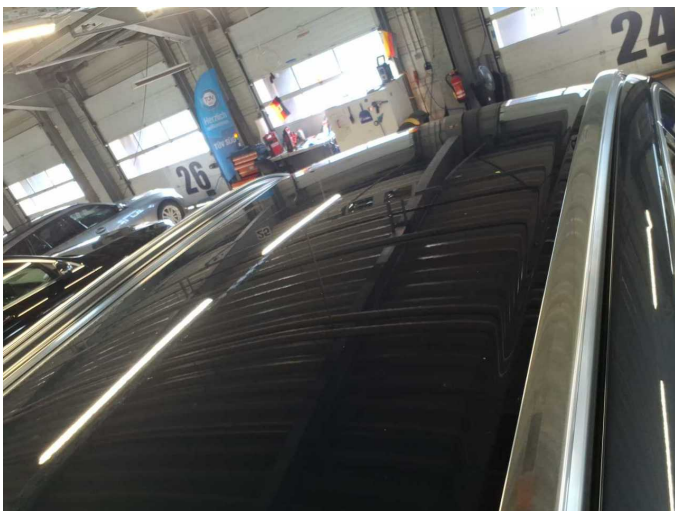
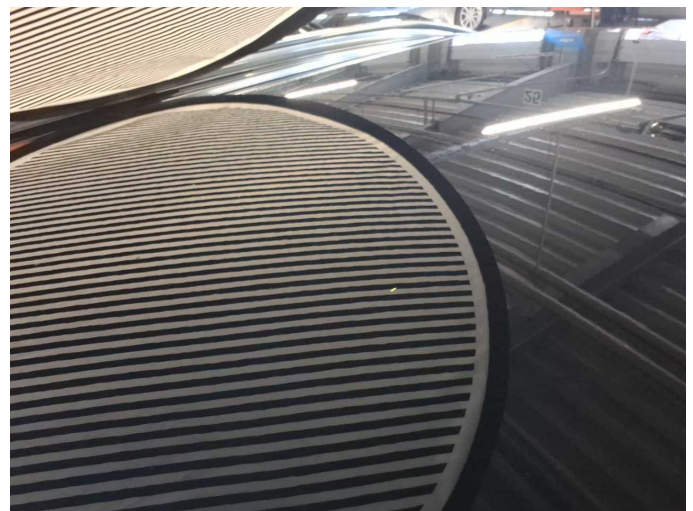
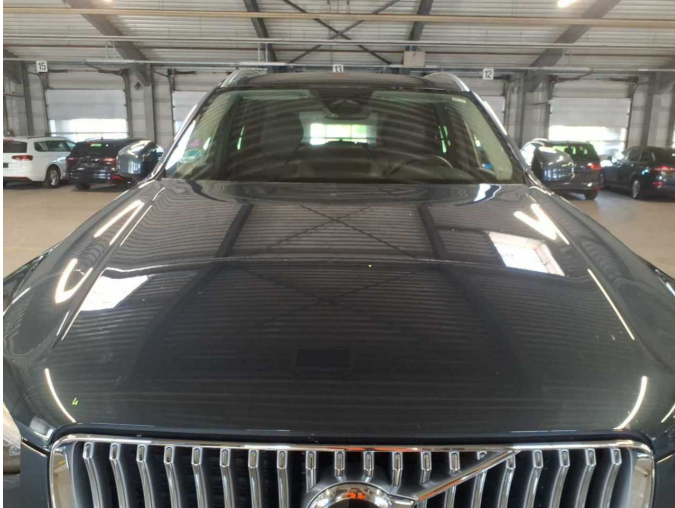
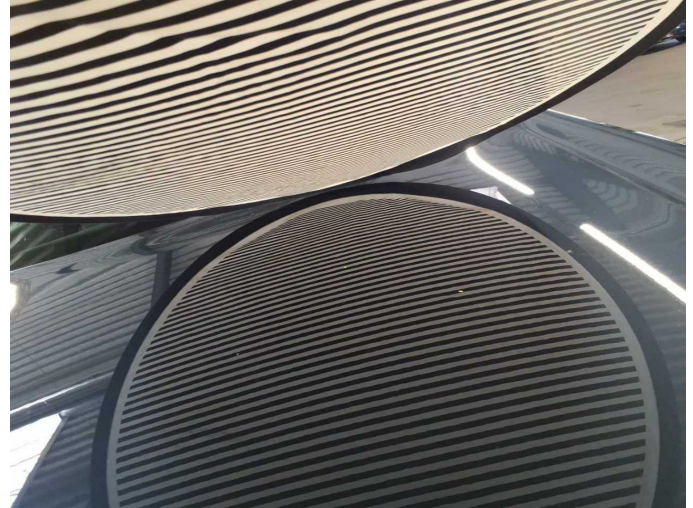
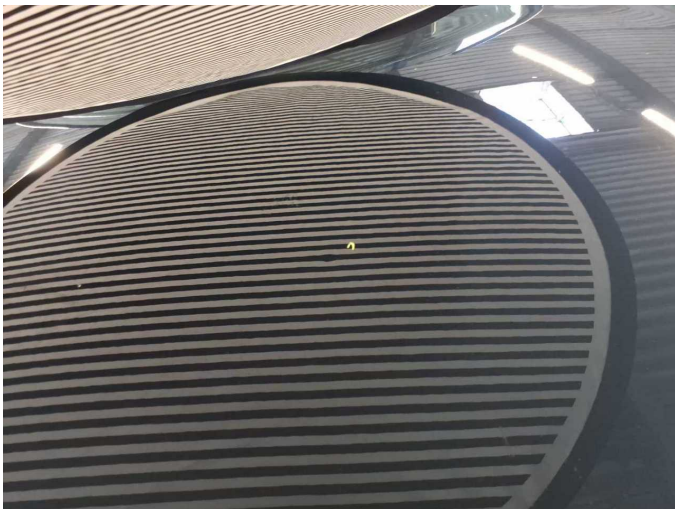
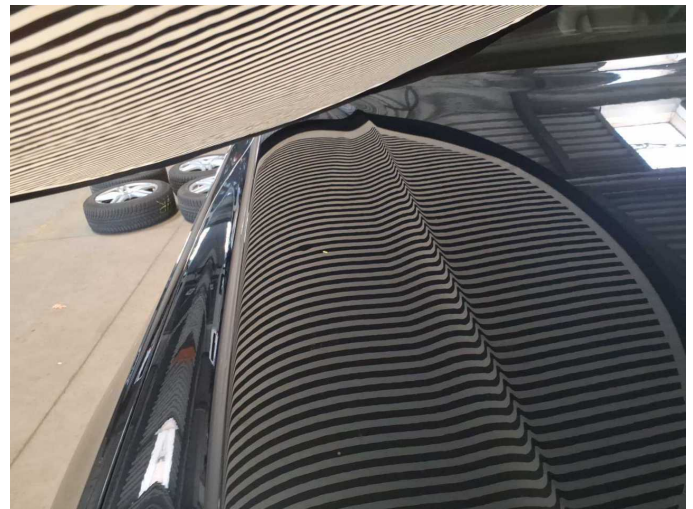
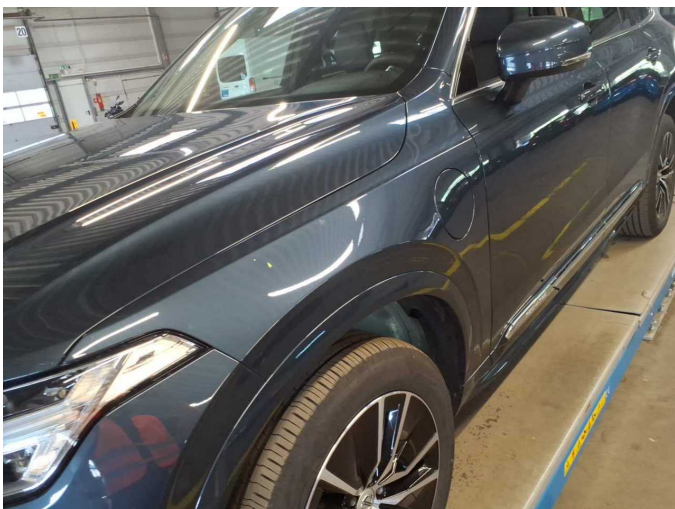
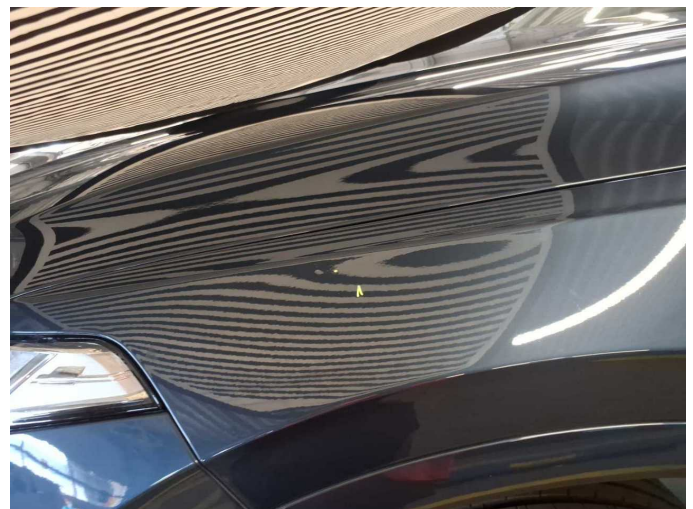
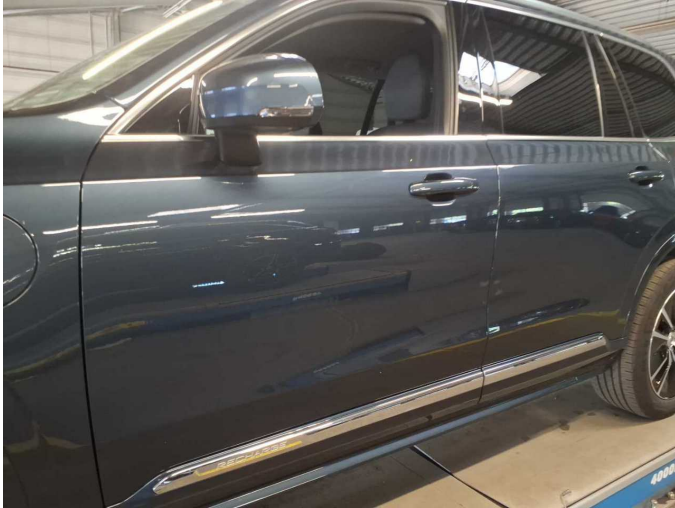
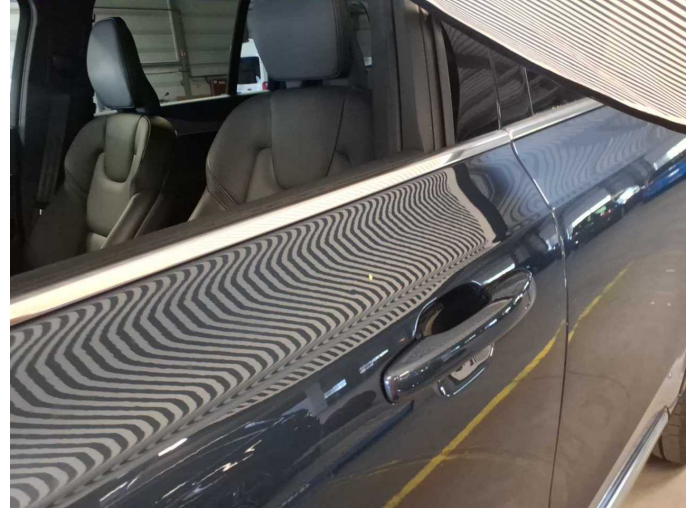
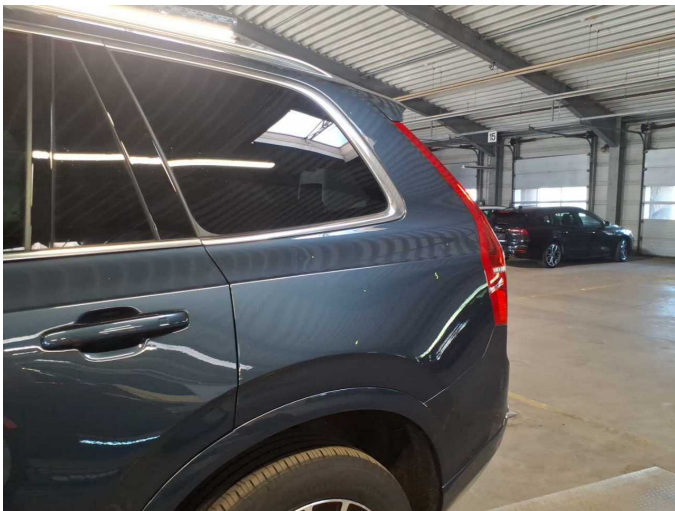
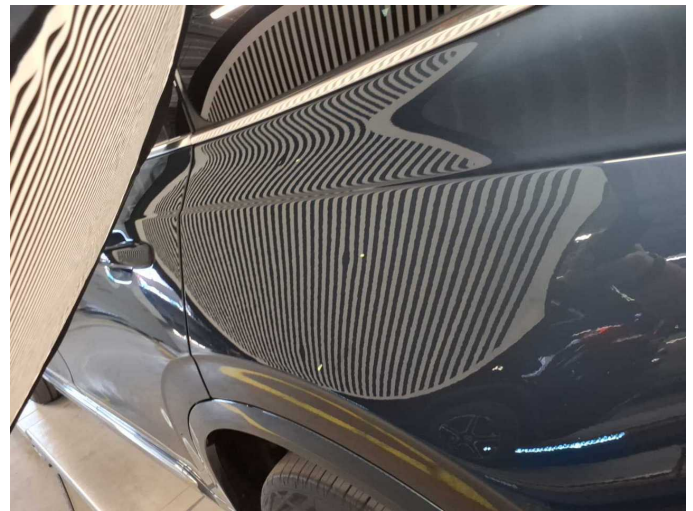
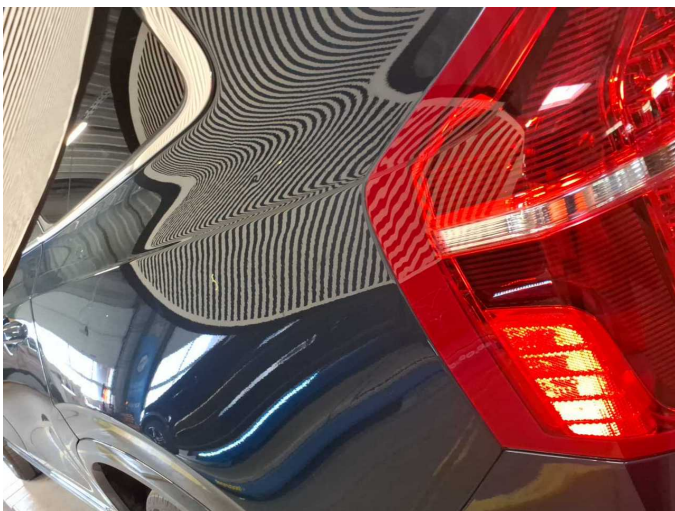
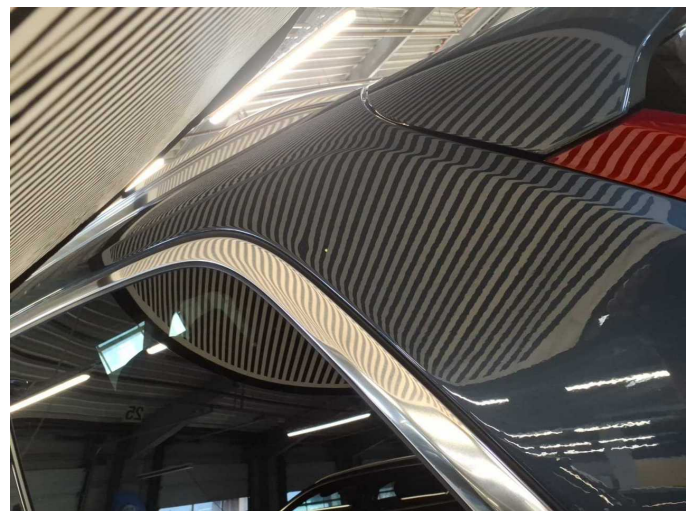
| No. | Component group | Description |
|---|---|--|
| 3 | Body | Body - Damage by hail - Smooth repair work |

Damage 3: Body: Body - Damage by hail - Smooth repair work

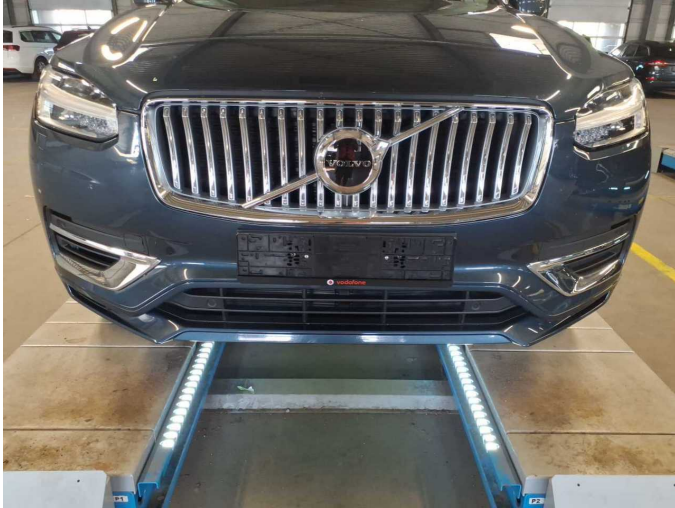
| No. | Component group | Description |
|---|---|---|
| 1 | Front bumper | Front bumper - Stone chips - No deduction |

Wear and tear 1: Front bumper: Front bumper - Stone chips - No deduction

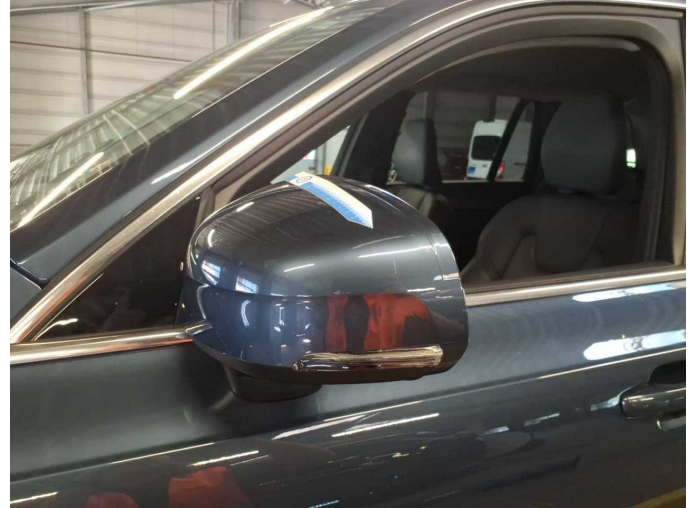
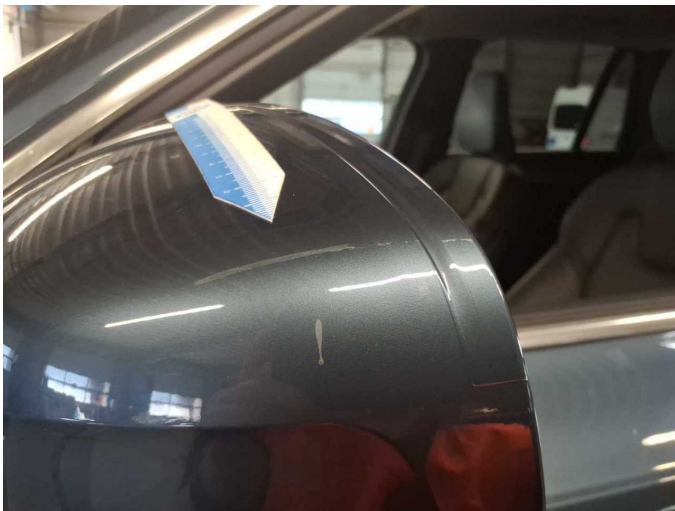
| No. | Component group | Description |
|---|---|---|
| 2 | Wing mirror - left side | Cap - Soiled - No deduction |

Wear and tear 2: Wing mirror - left side: Cap - Soiled - No deduction
