Expertise

Protocol number: 46094838
Order No. / Reference: 26512161
Inspection date: 18 Jun 2026

Manufacturer: Opel

Model: Astra Sports Tourer 1.5 D Automatik Business Elegance

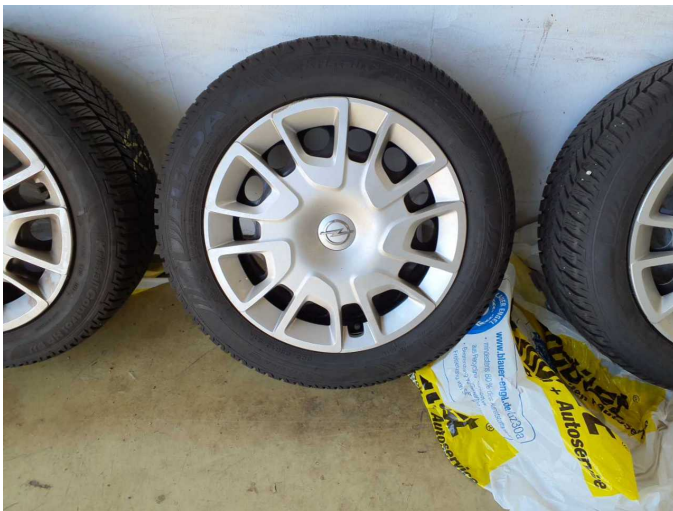
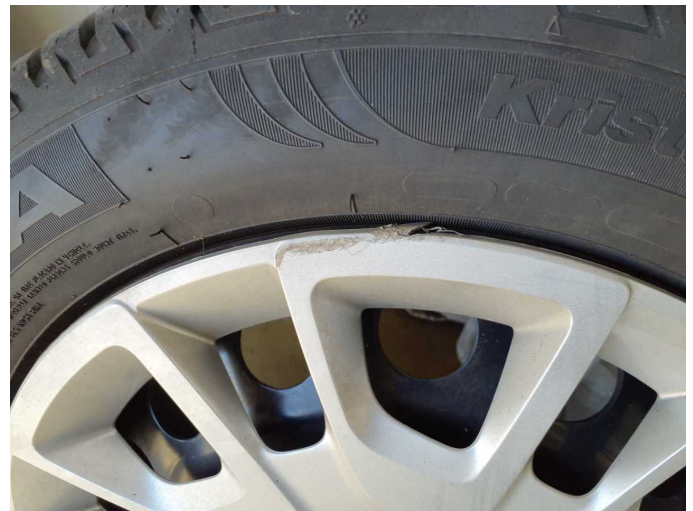
Damage 3: 2nd wheel set: 1 wheel cover - Broken / torn - Replace

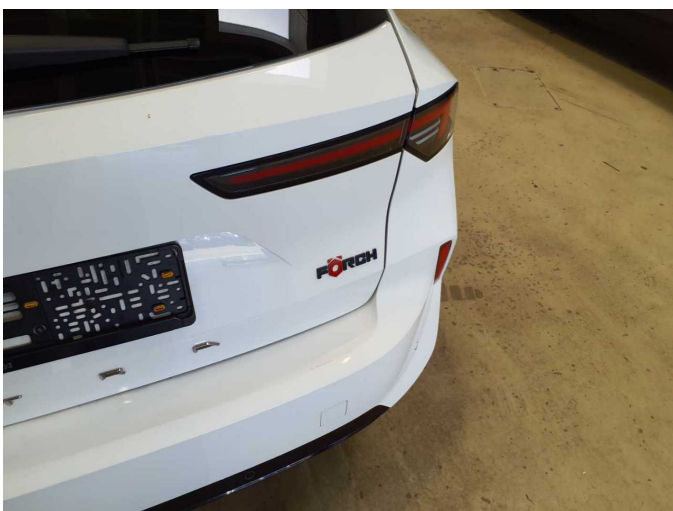
Damage 4: Boot lid / rear door: Boot lid - Glued / labelled - De-glue / neutralise

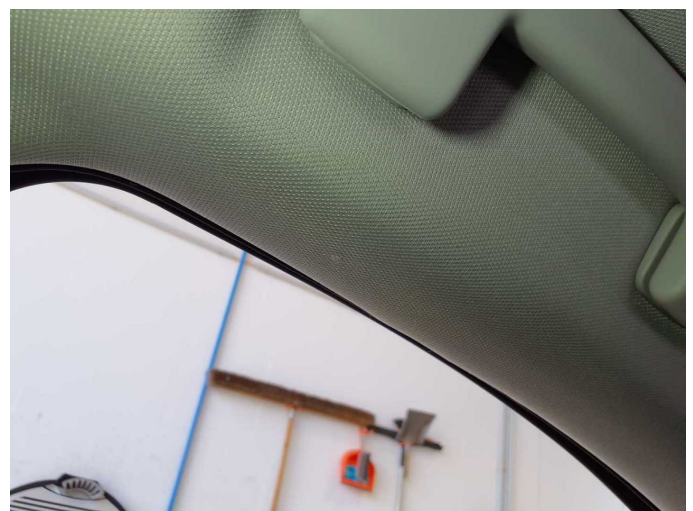
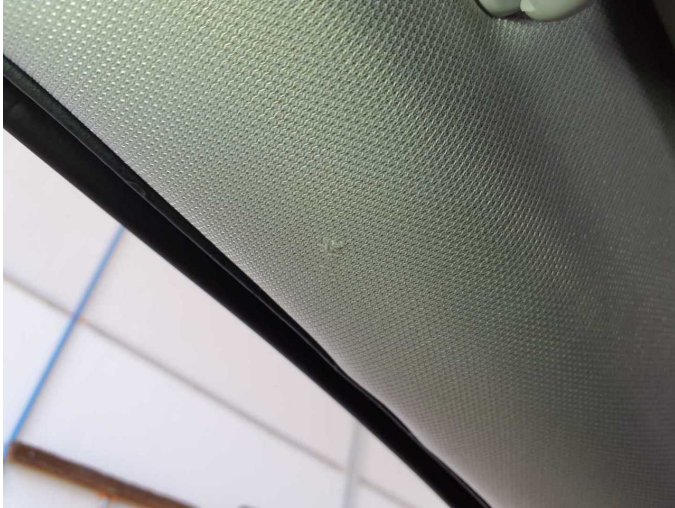
Damage 5: Trim / covers: Roof lining - Scratch(es) - Smart repair

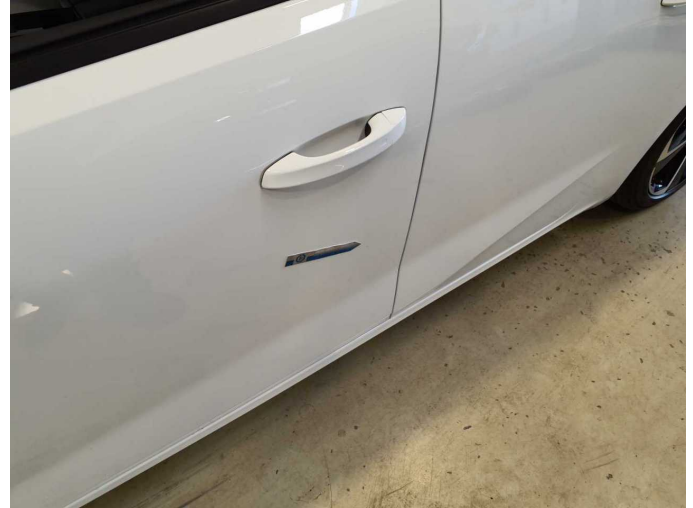
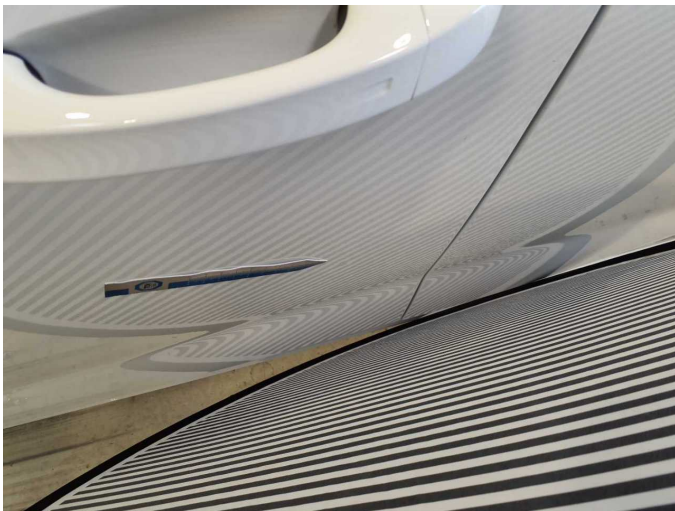
Damage 6: Door - front left side: Door - Dent / paintcoat damage - Smart repair

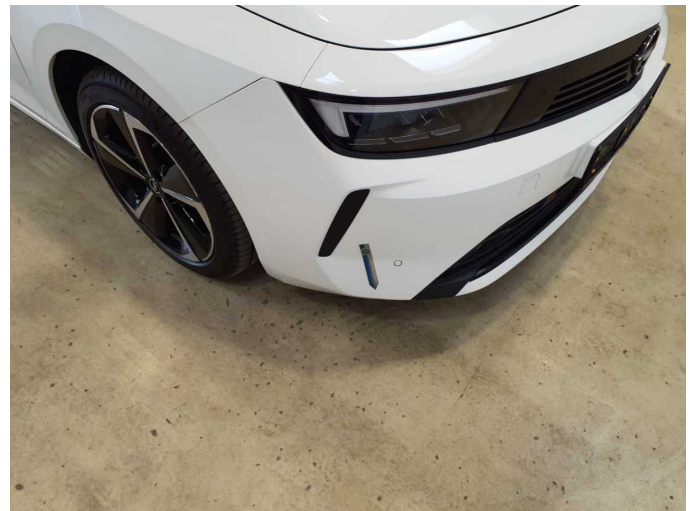
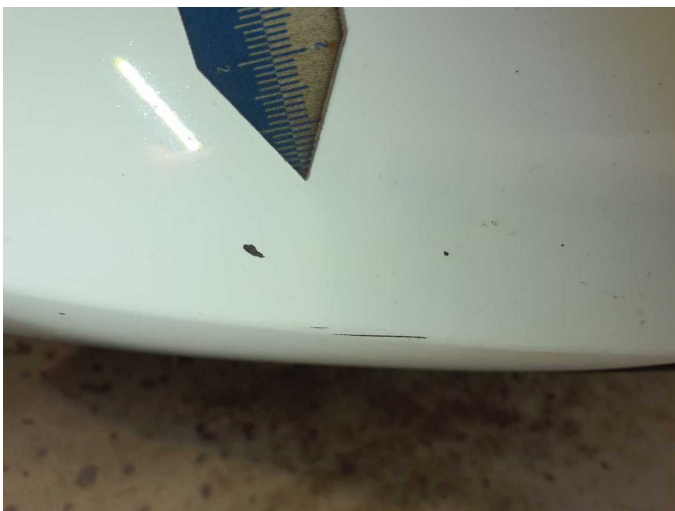
Damage 7: Front bumper: Front bumper - Scratch(es) - Smart repair

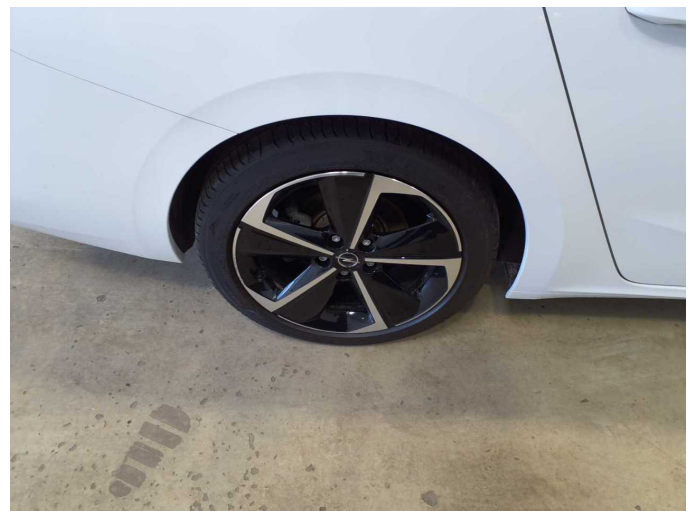
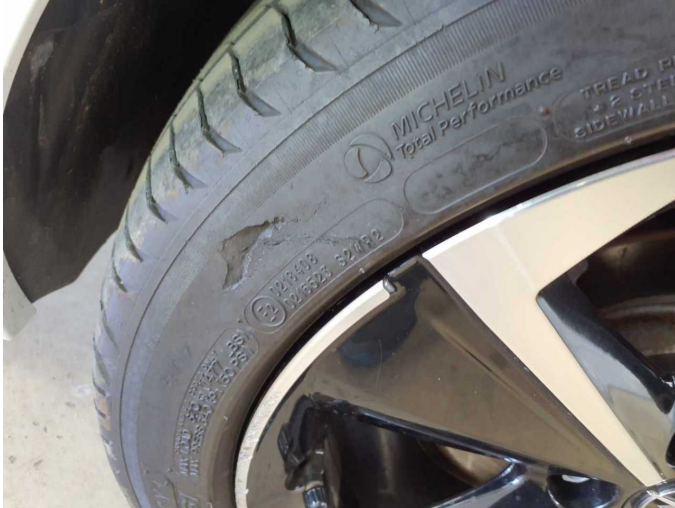
Damage 8: Wheel / tyres: Tyre - rear right side (nicht fahrbereit) - Broken / torn - Replace

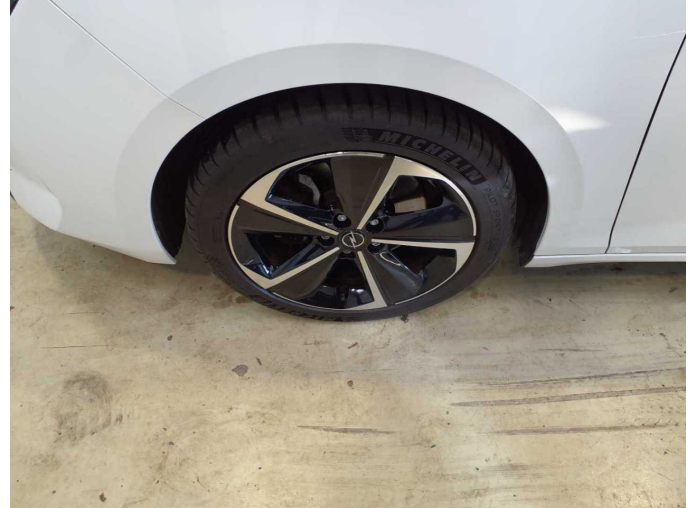
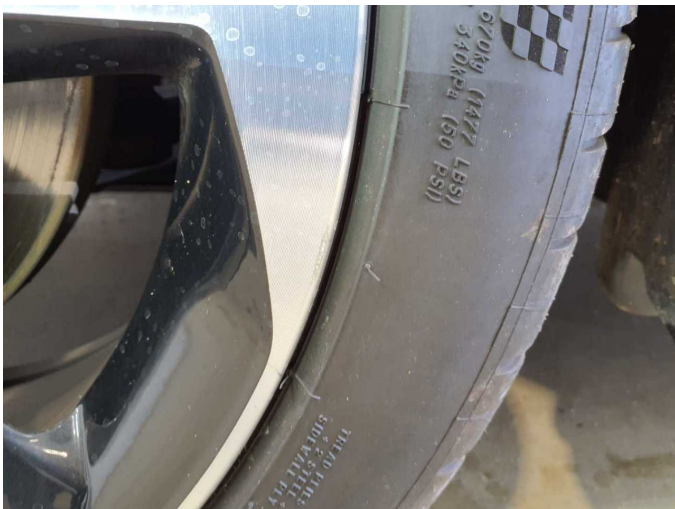
Damage 9: Wheel / tyres: Alloy rim - front left side - Scratch(es) - Loss in value

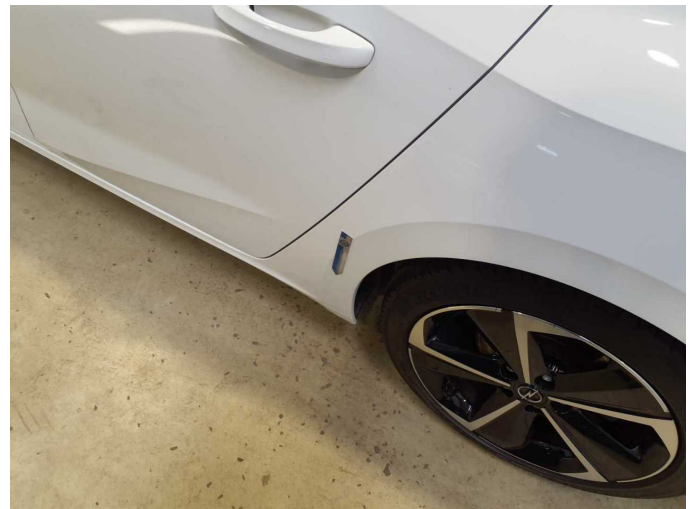
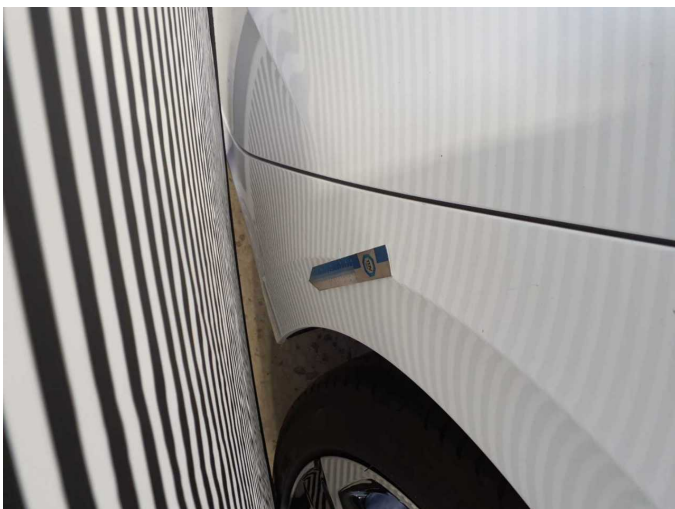
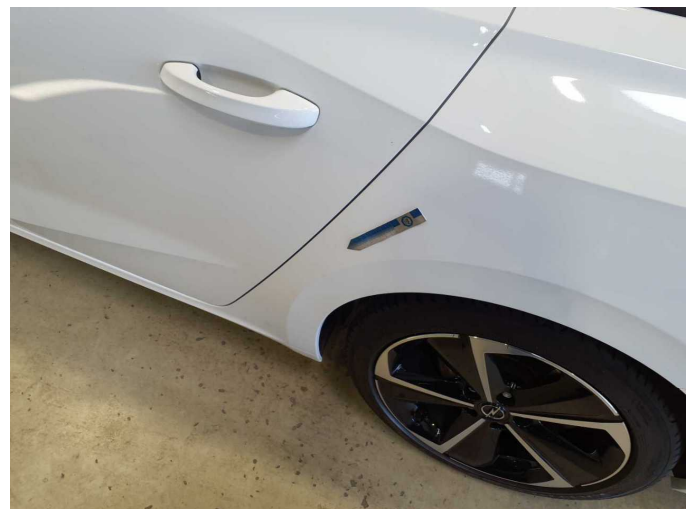
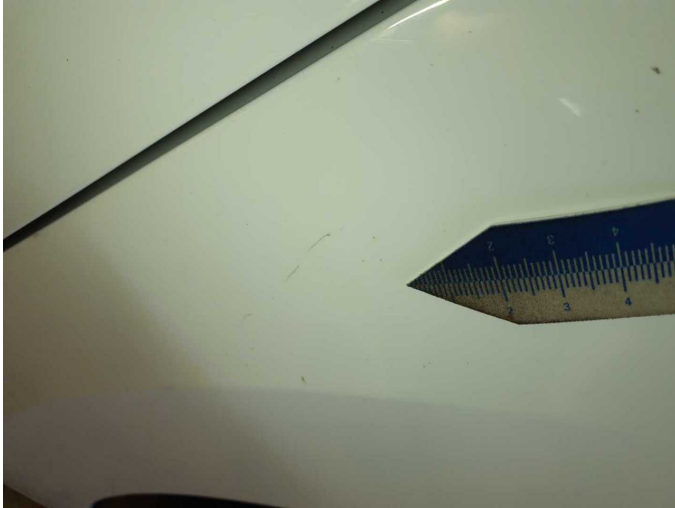
Damage 10: Side panel - rear left side: Side panel - Dent / paintcoat damage - Smooth repair work

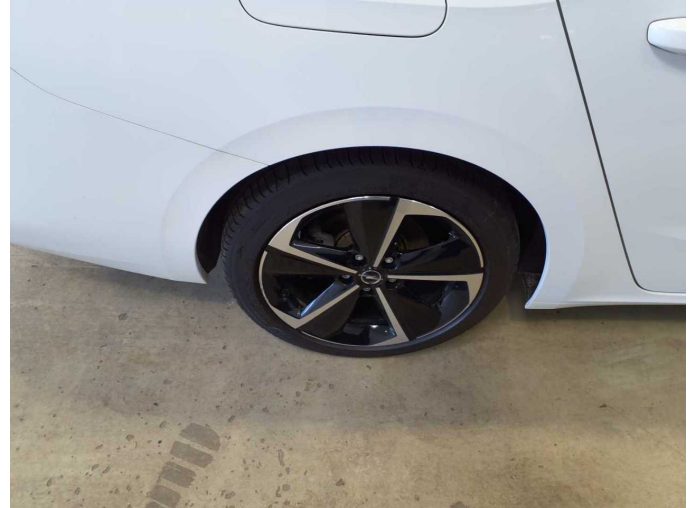
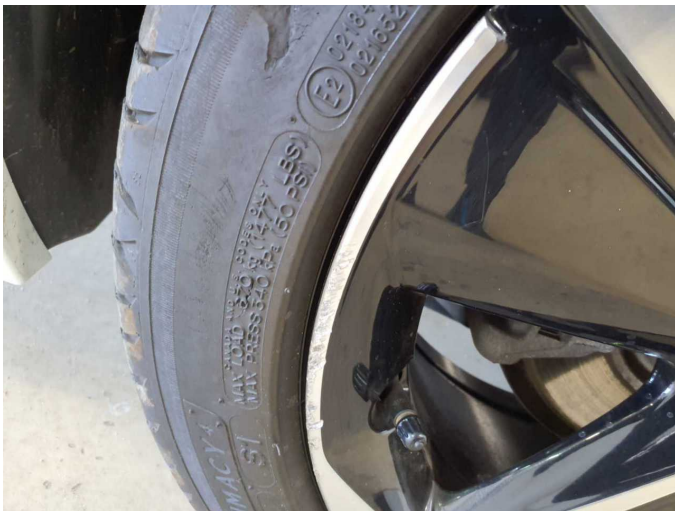
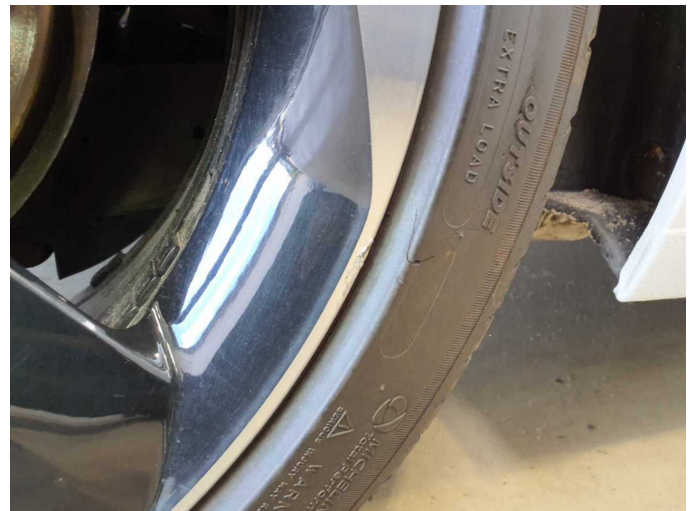
Damage 11: Wheel / tyres: Alloy rim - rear right side - Scratch(es) - Replace

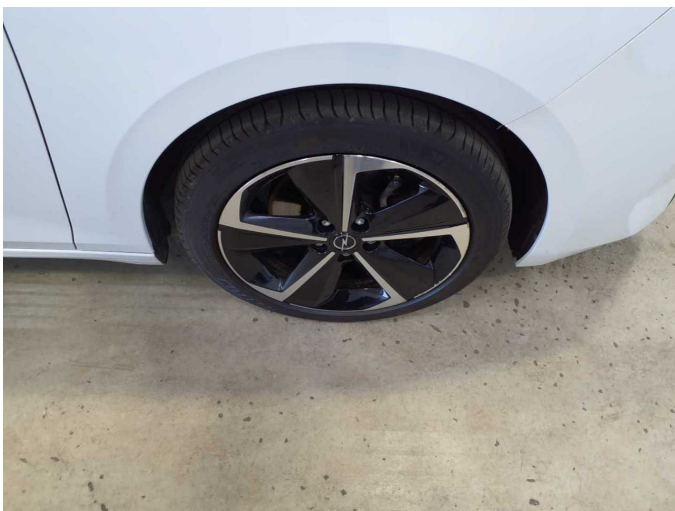
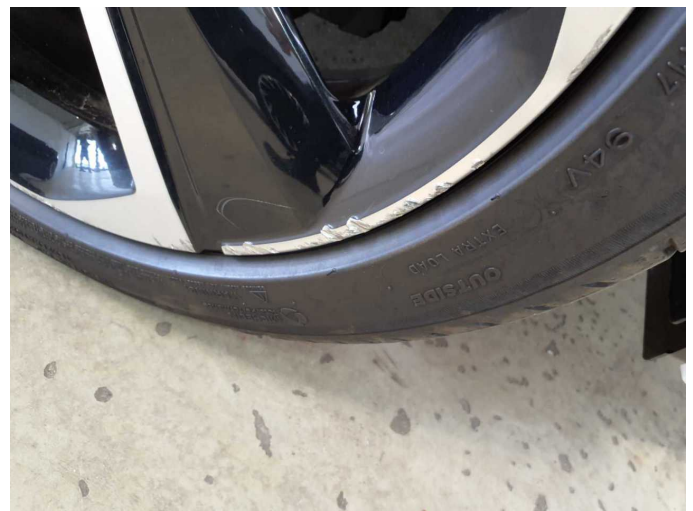
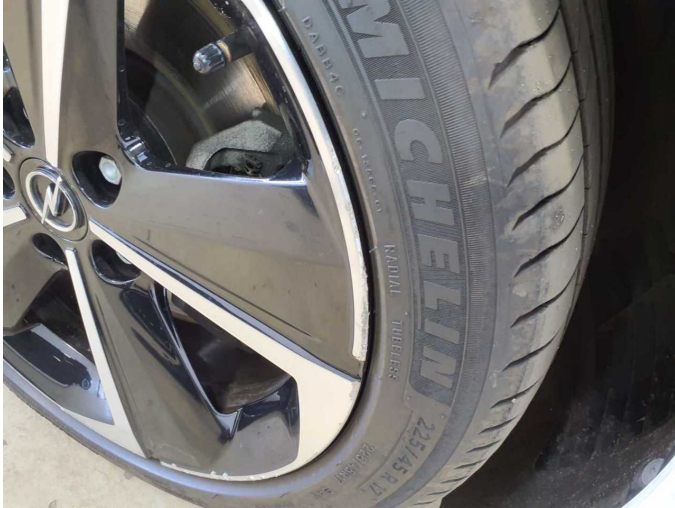
Damage 12: Wheel / tyres: Alloy rim - front right side - Scratch(es) - Replace

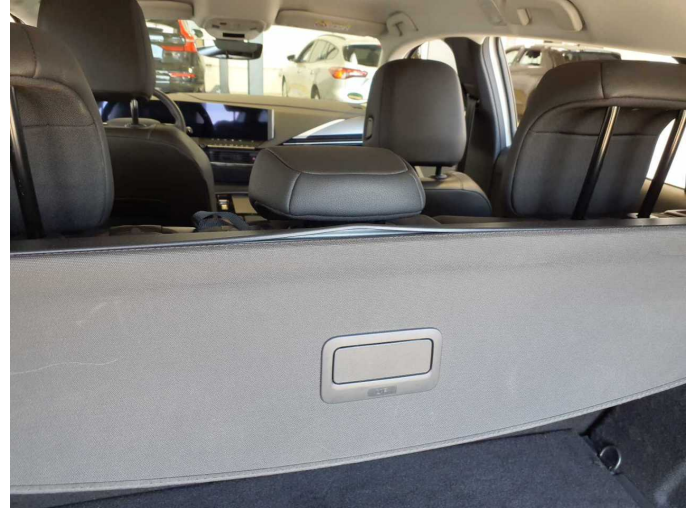
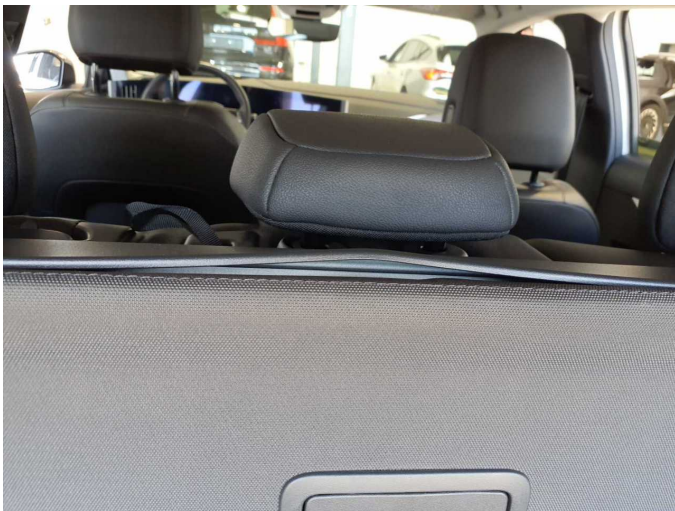
Damage 13: Interior: Boot cover / roller cover - dent(s) - Replace

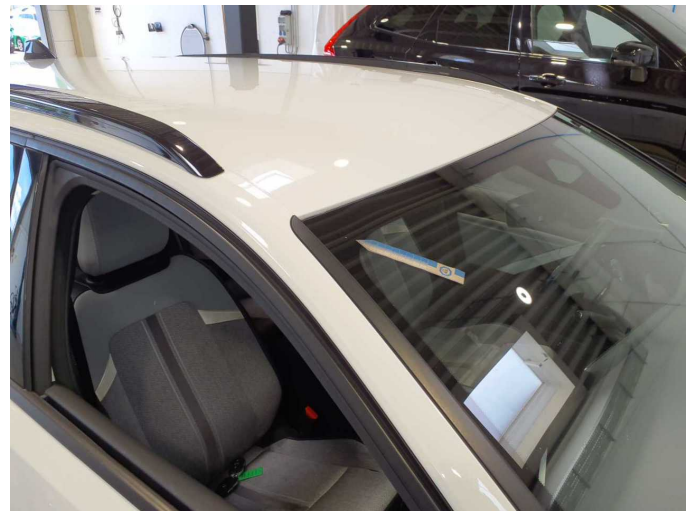
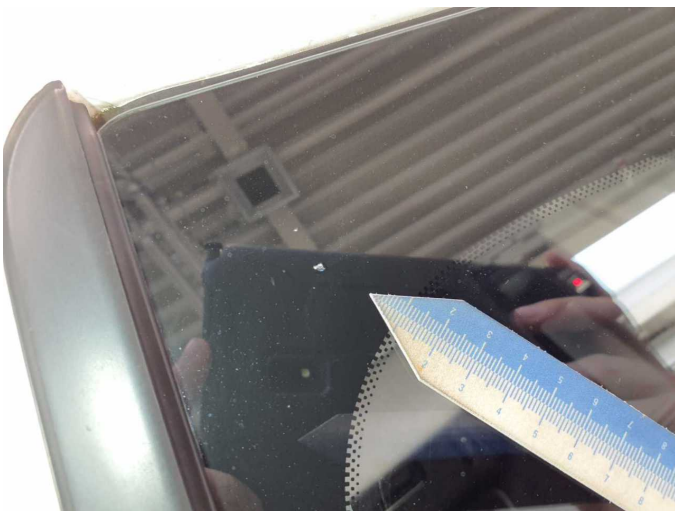
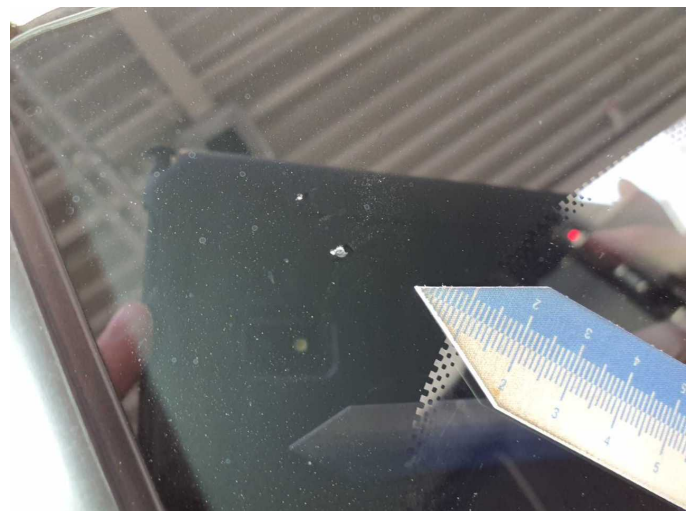
Damage 14: Vehicle glazing: Windscreen - Stone chips - Replace

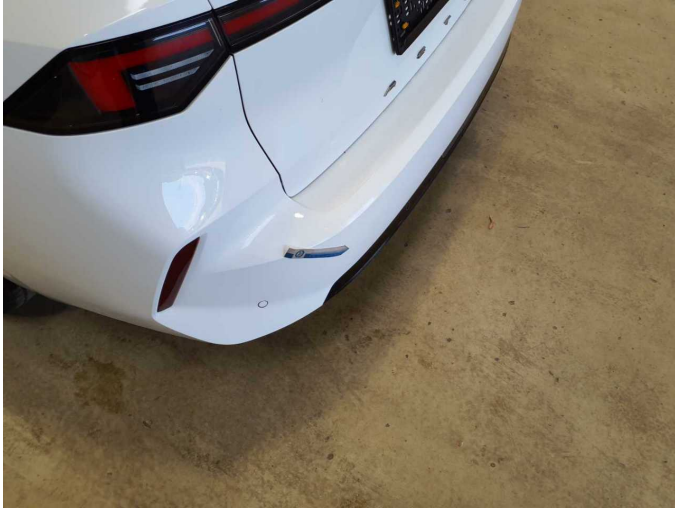
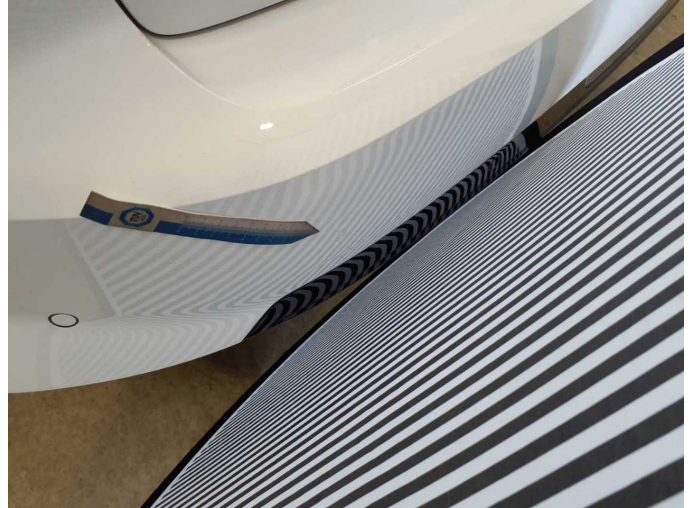
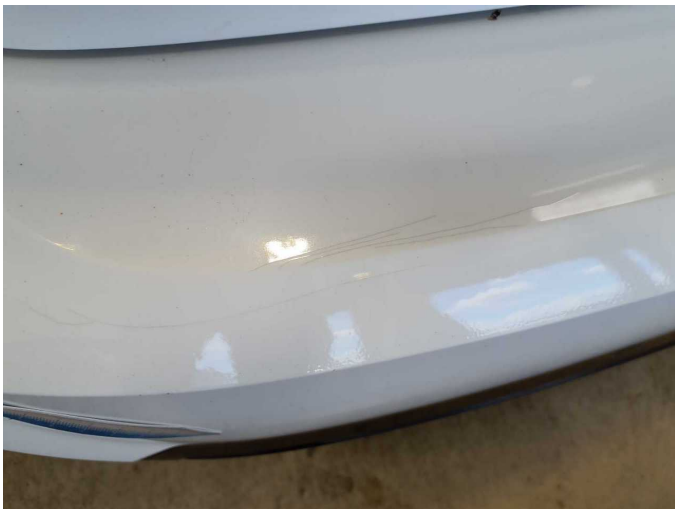
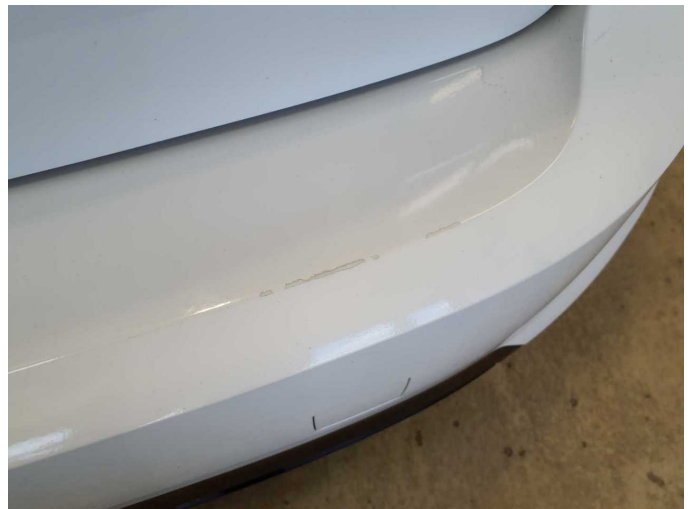
15	Rear bumper	Rear bumper (gestaucht) - Dent / paintcoat damage - Repair and paint
16	Roof	Roof - Dent / paintcoat damage - Repair and paint

Damage 15: Rear bumper: Rear bumper (gestaucht) - Dent / paintcoat damage - Repair and paint

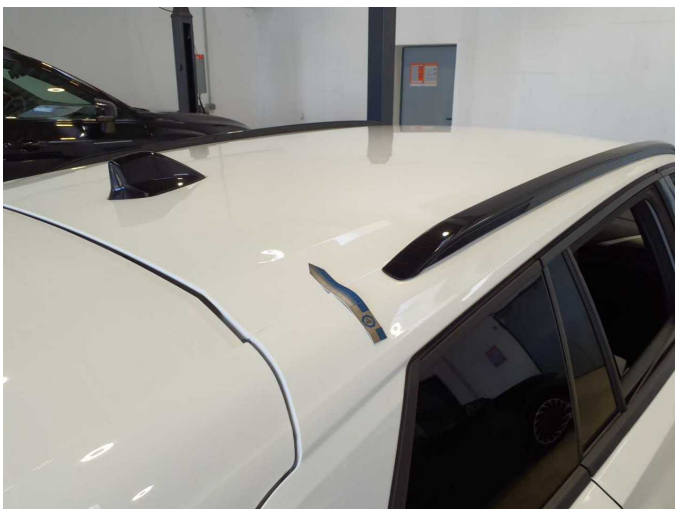
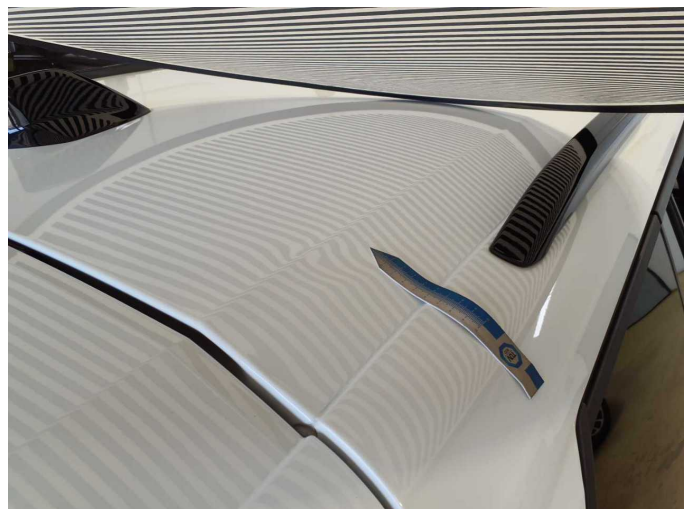
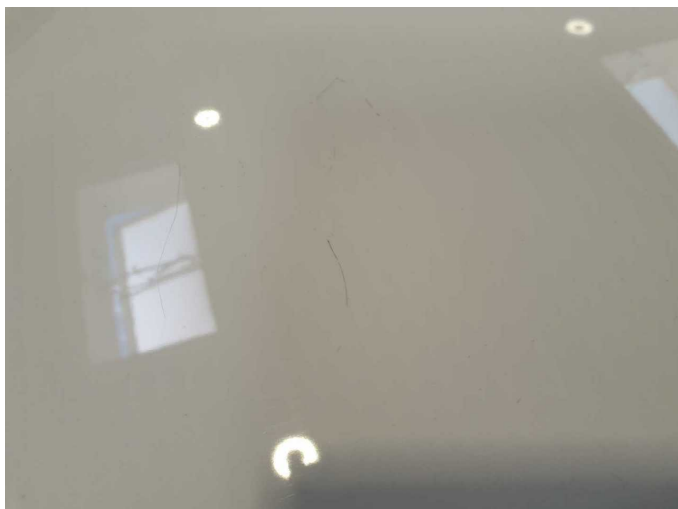
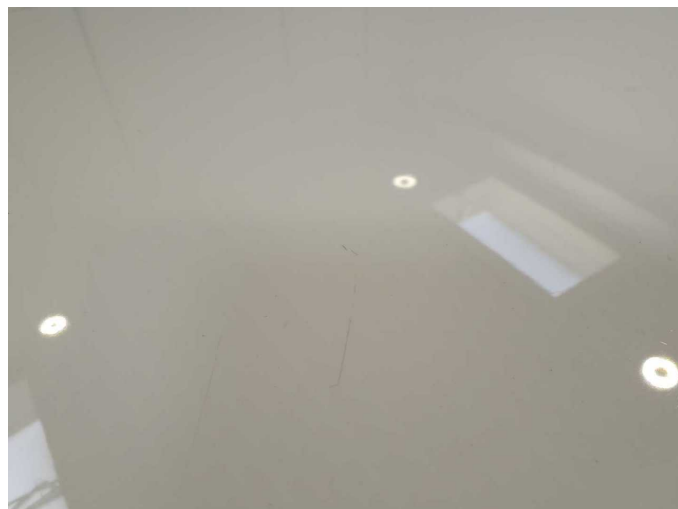
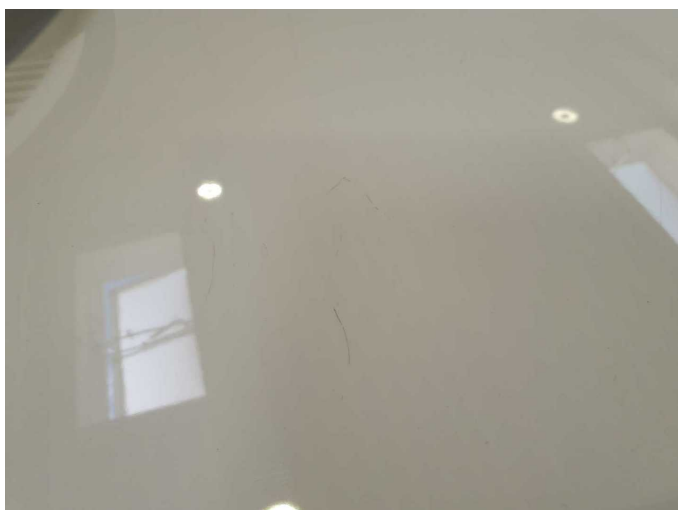
Damage 16: Roof: Roof - Dent / paintcoat damage - Repair and paint
