Expertise

Protocol number: 45791402
Order No. / Reference: 26264416
Inspection date: 26 May 2026

Manufacturer: Opel

Model: Astra Sports Tourer 1.5 D Automatik Business Elegance

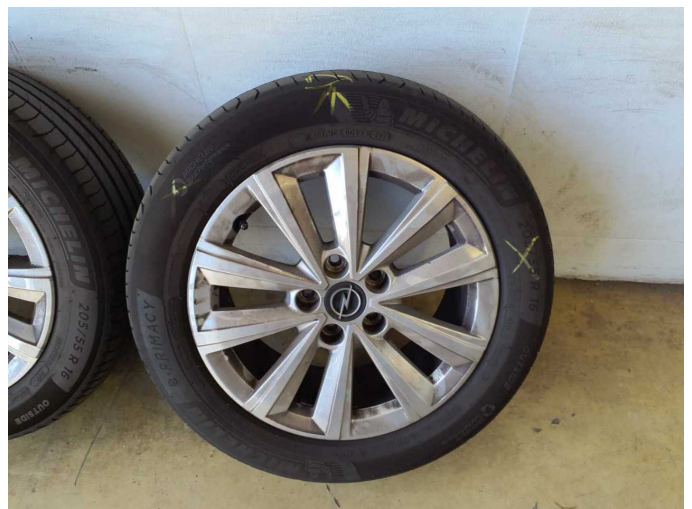
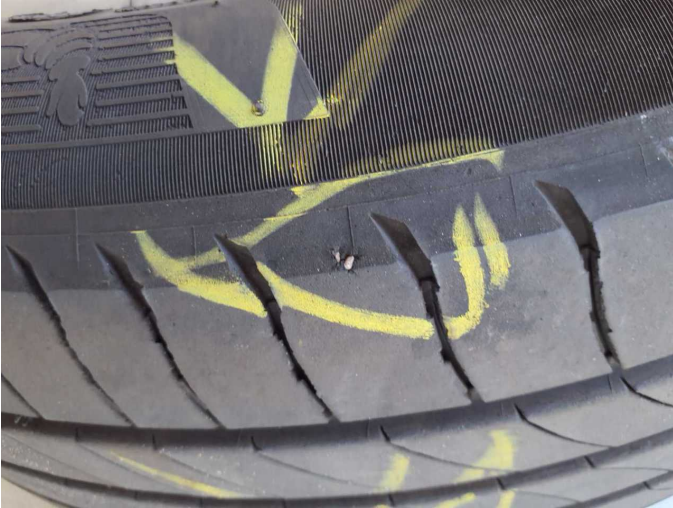
Damage 1: 2nd wheel set: 1 tyre - Damaged - Replace

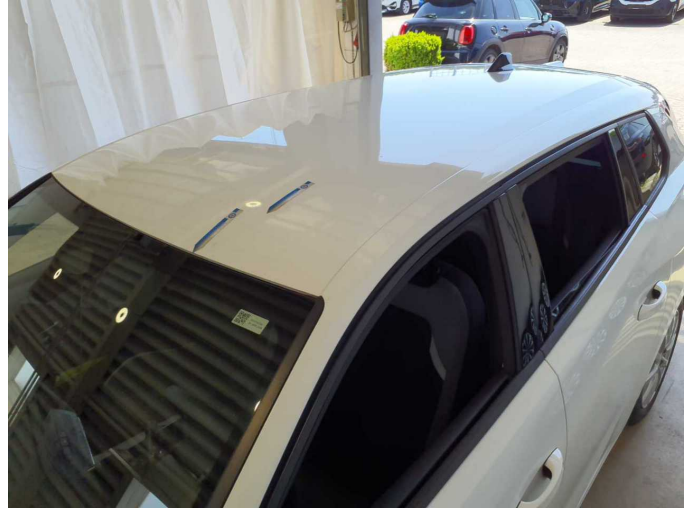
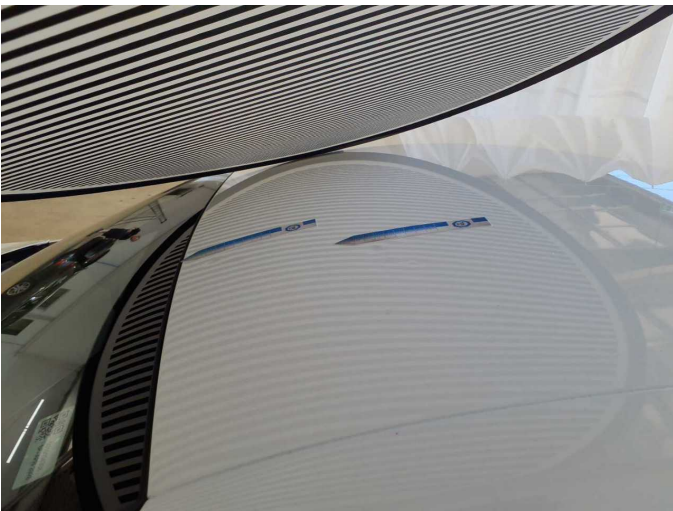
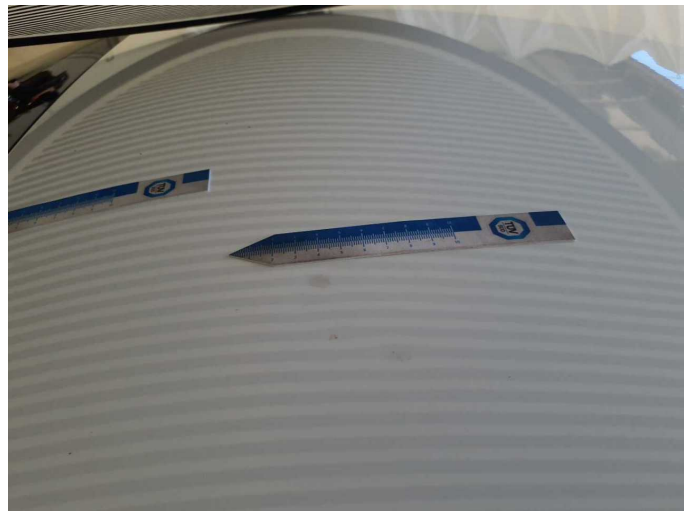
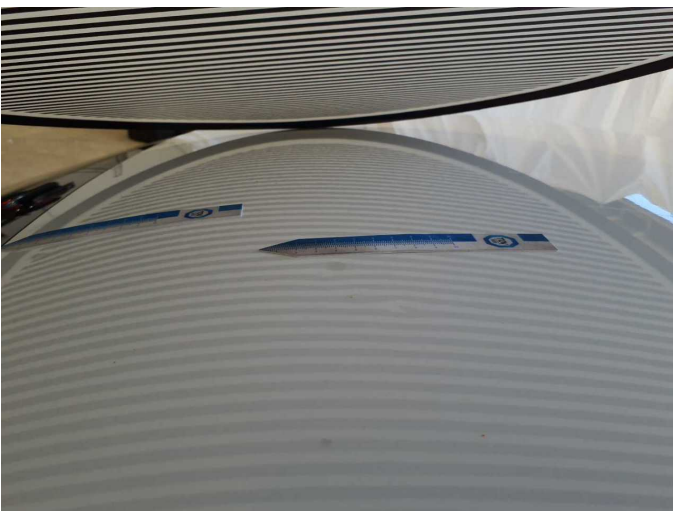
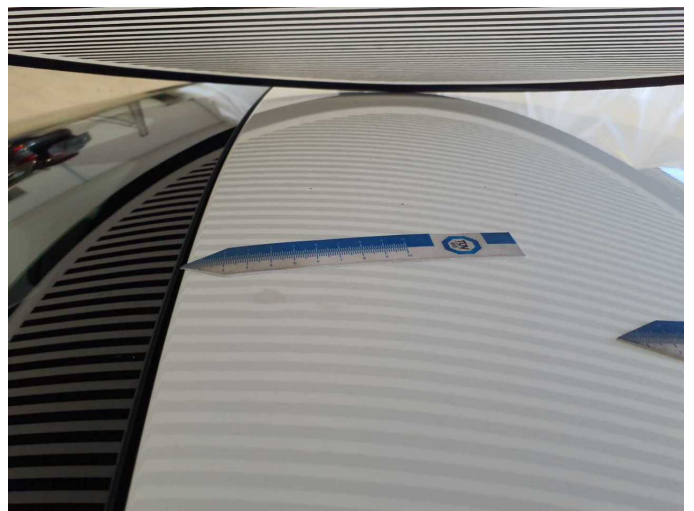
Damage 2: Roof: Roof (6 Dellen) - dent(s) - Smooth repair work

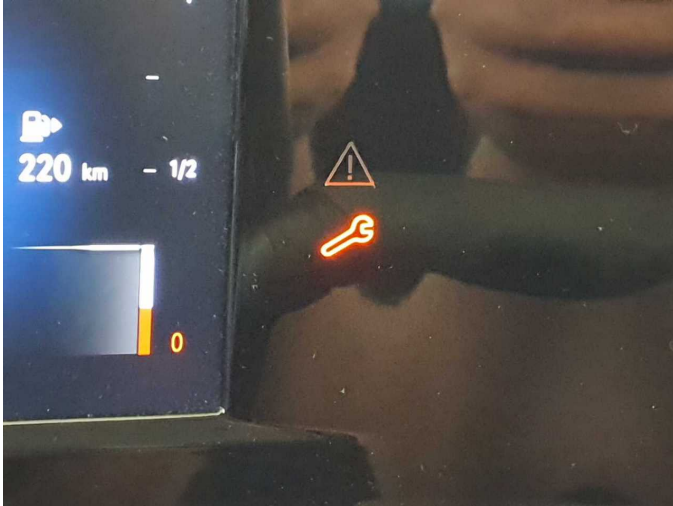
Restlauf Service nicht ablesbar.

Damage 3: Misc.: Inspection / maintenance - Due - Perform

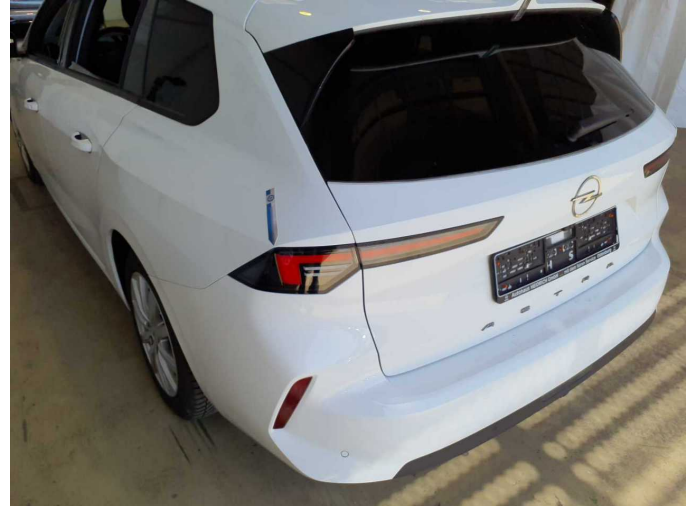
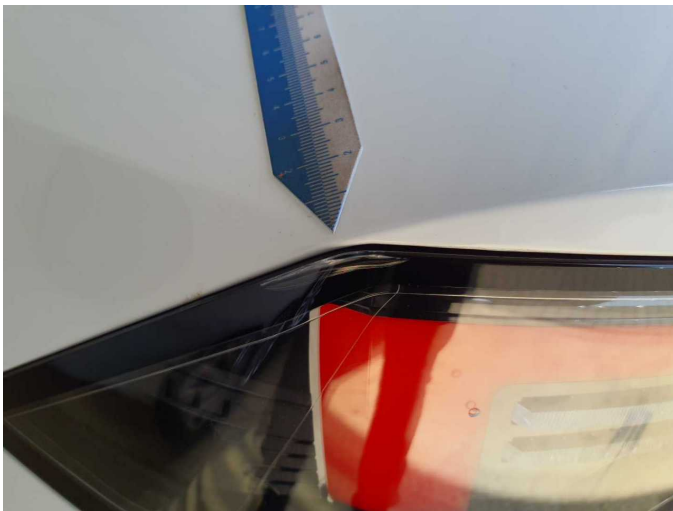
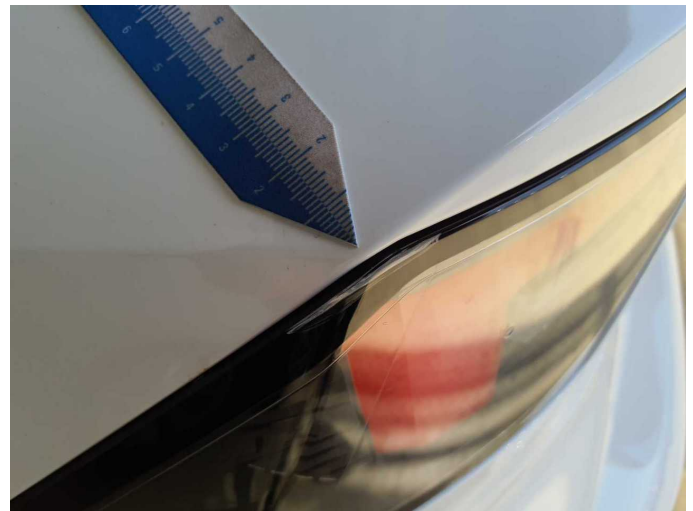
Damage 4: Tail light: Tail lamp - left side - Broken / torn - Replace
