Expertise

Protocol number: 46008837
Order No. / Reference: 26154584
Inspection date: 17 Jun 2026

Model: Vito 116 CDI Tourer Extralang Aut. PRO

VIN: W1VVLGFZ5T4543944

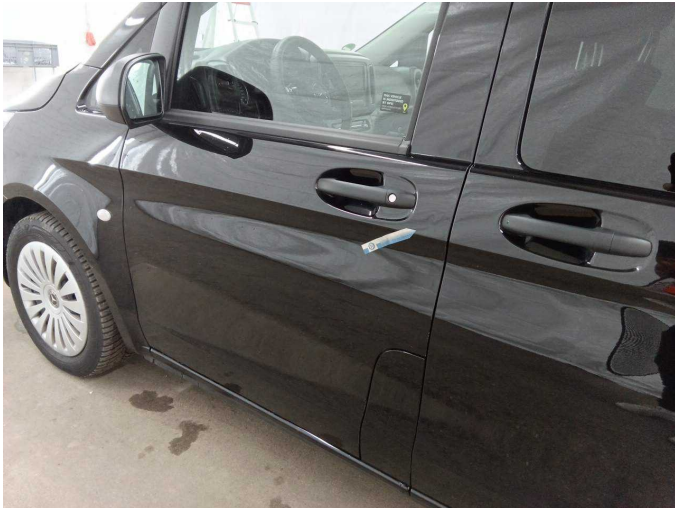
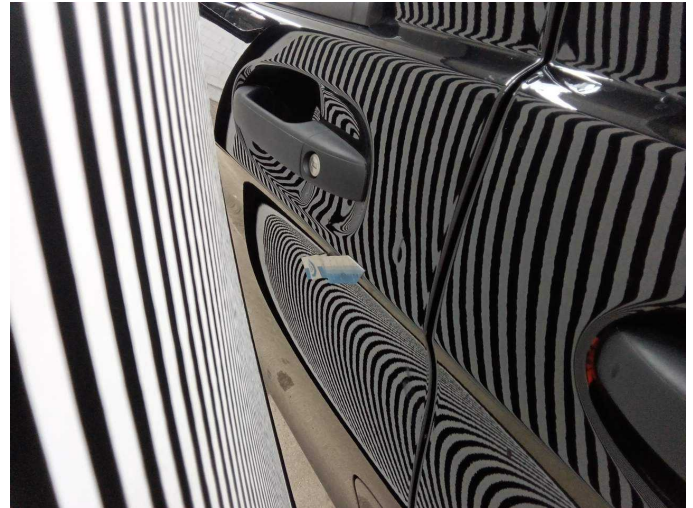
Damage 3: Door - front left side: Door - Dent / paintcoat damage - Smooth repair work

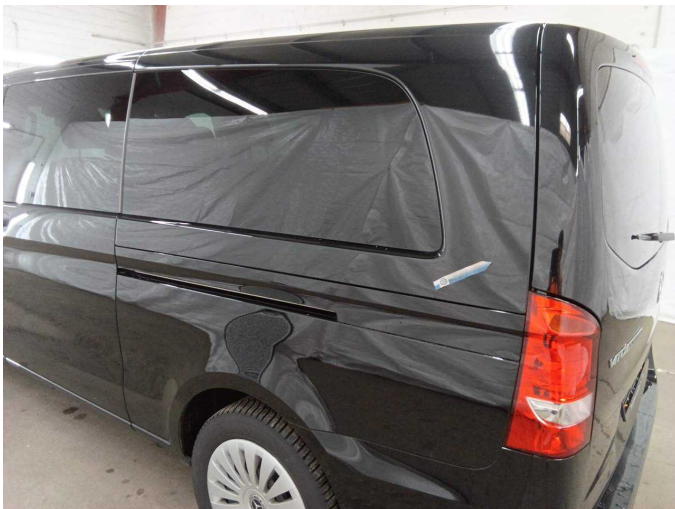
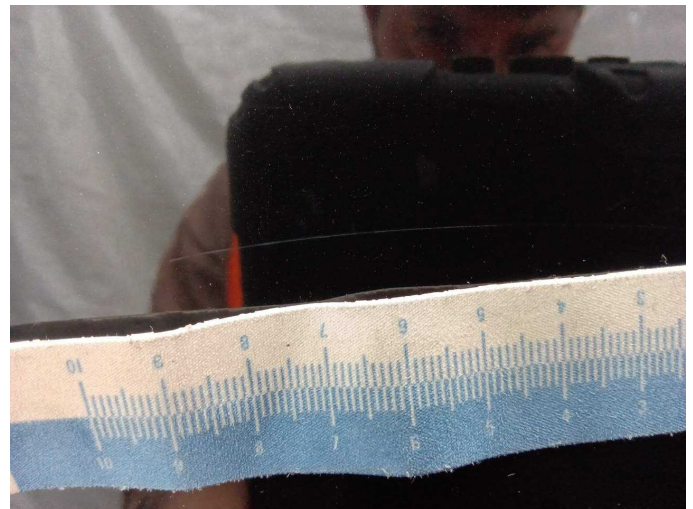
Damage 4: Side panel - rear left side: Side panel - Scratch(es) - Smart repair

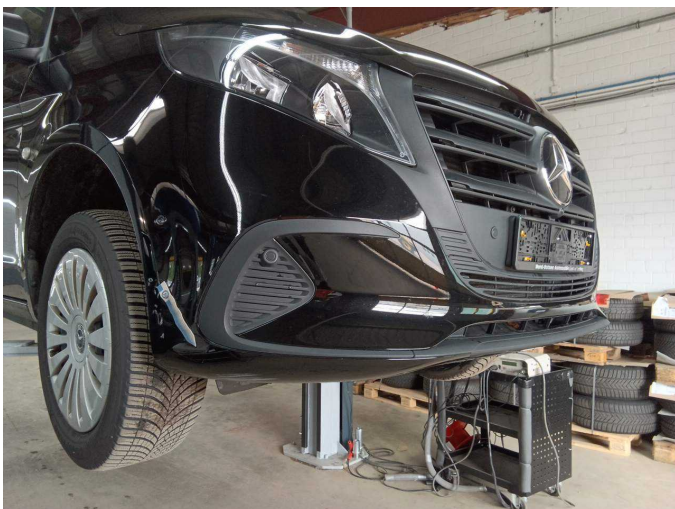
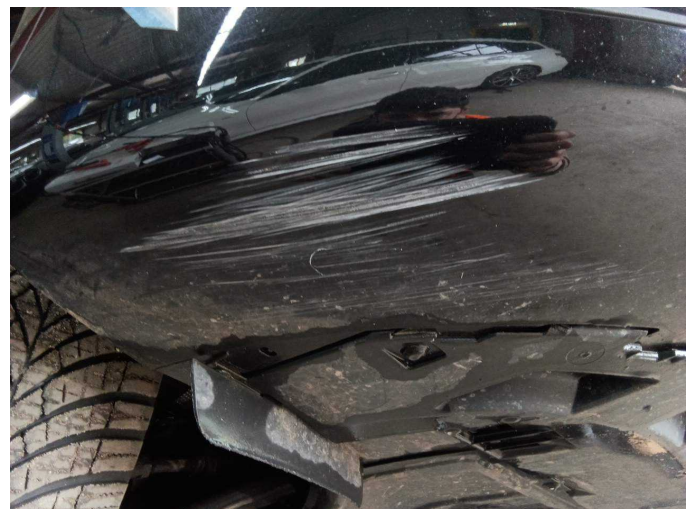
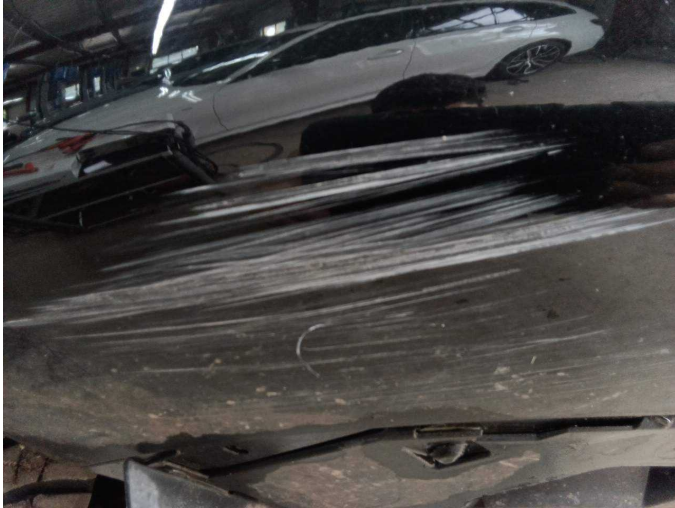
Damage 5: Front bumper: Front bumper - Scratch(es) - Smart repair

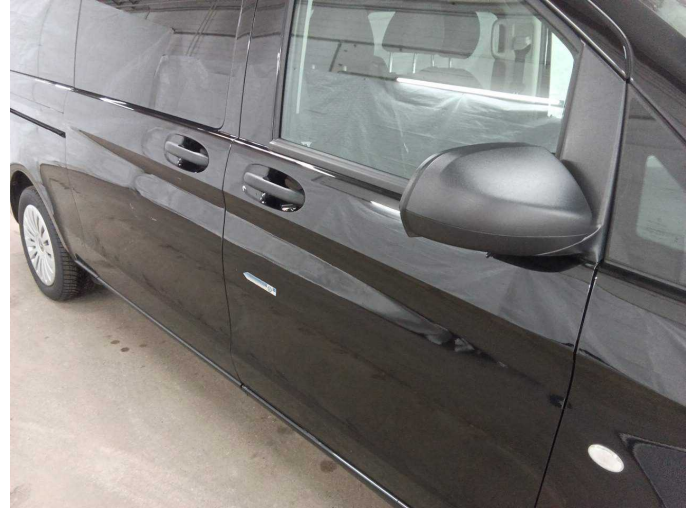
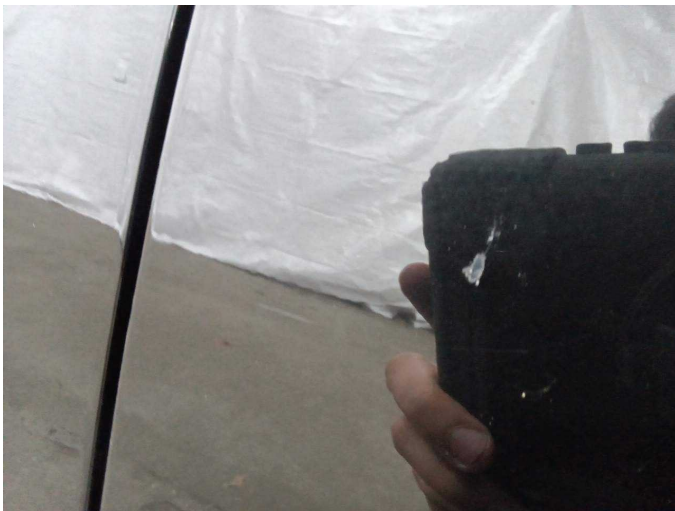
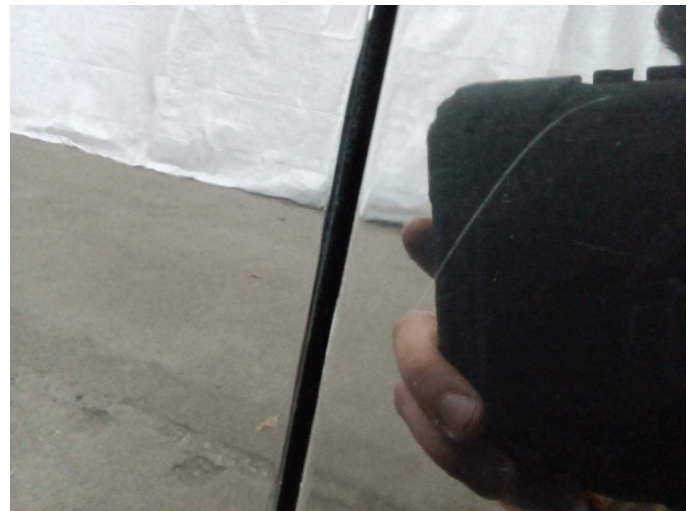
Damage 6: Door - front right side: Door - Dent / paintcoat damage - Smart repair

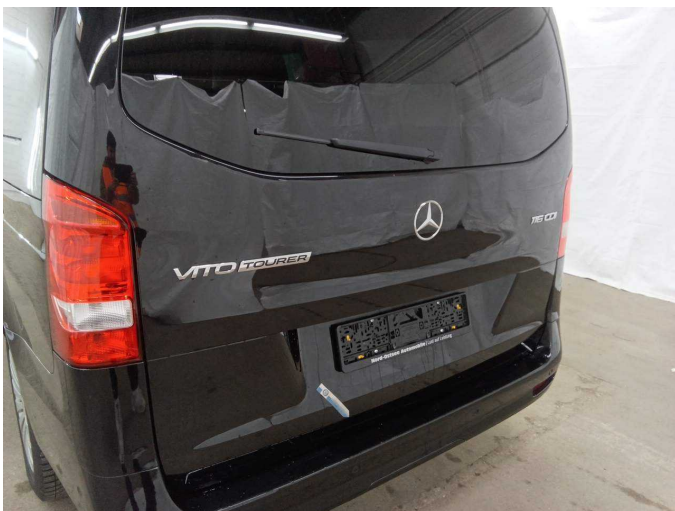
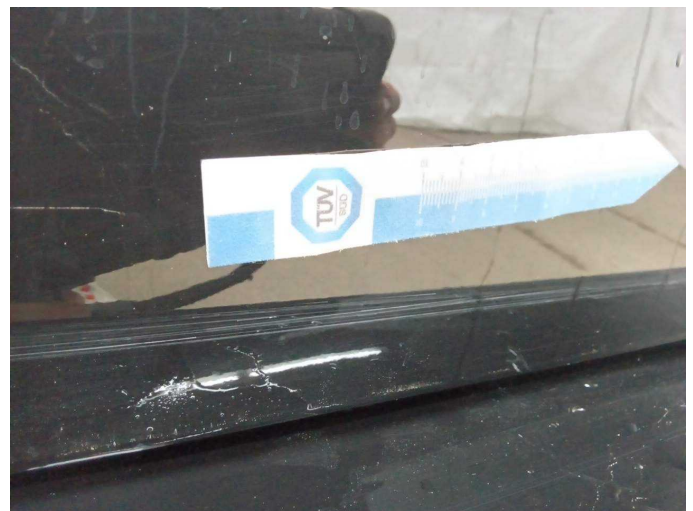
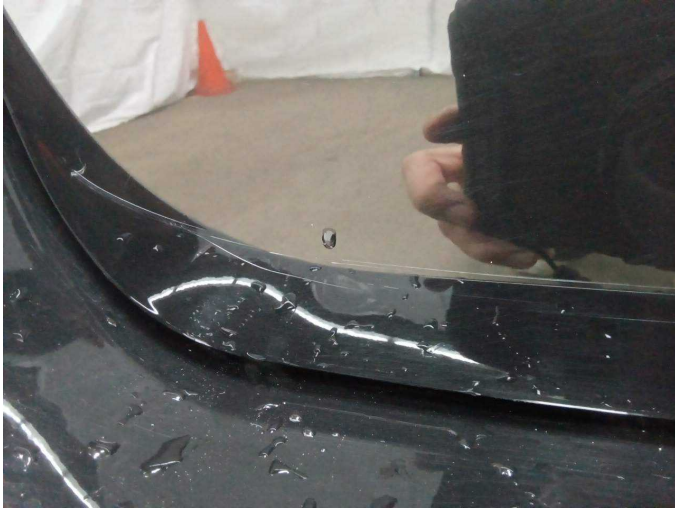
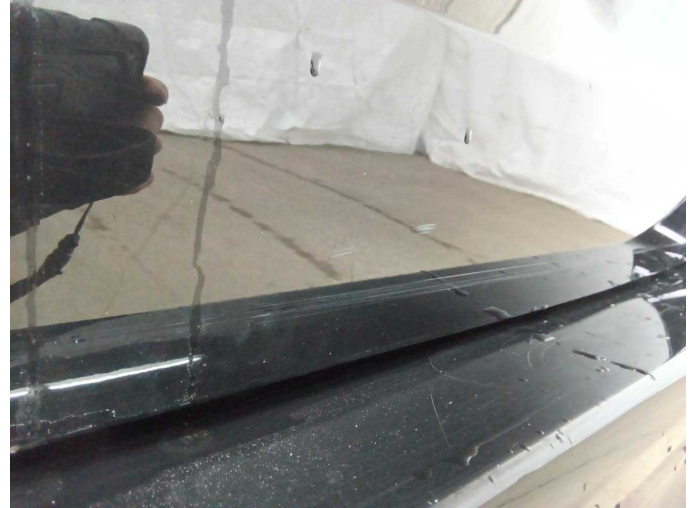
Damage 7: Boot lid / rear door: Boot lid - Scratch(es) - Smart repair

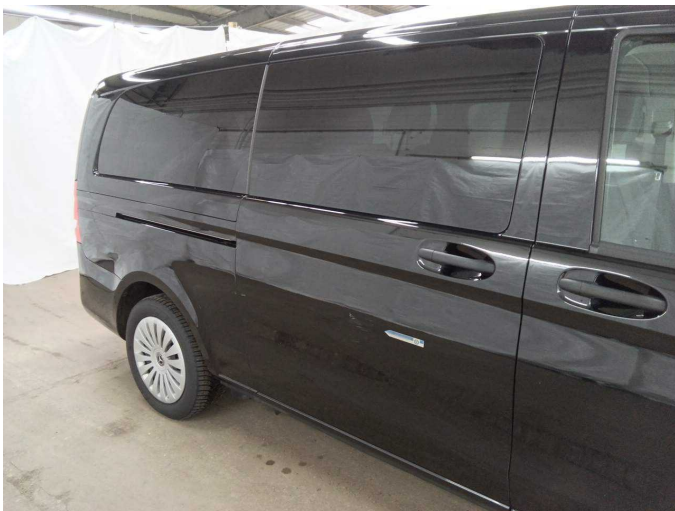
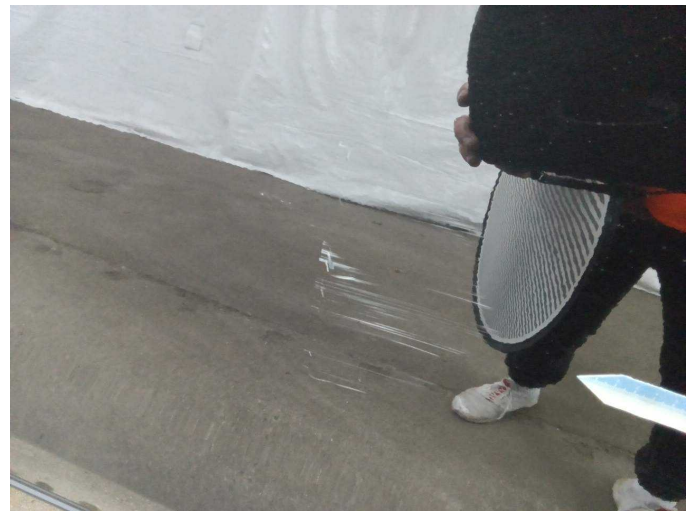
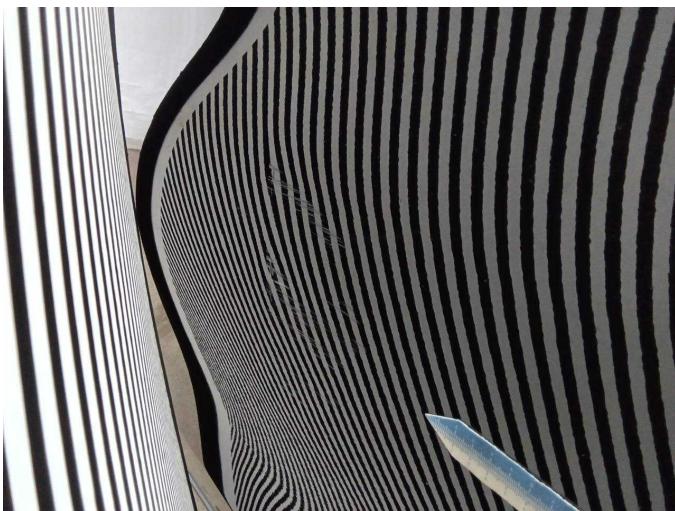
Damage 8: Sliding door, right: Sliding door - Dent / paintcoat damage - Smart repair

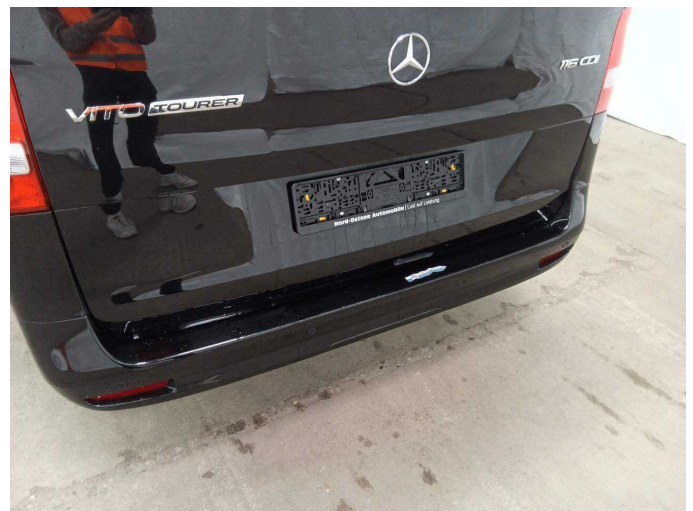
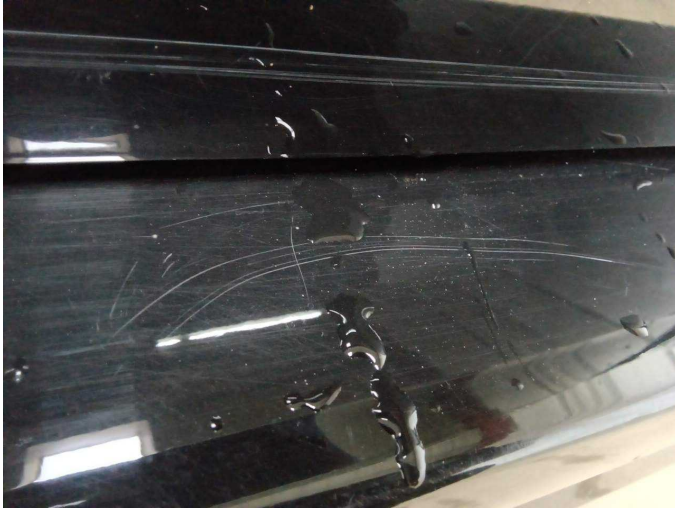
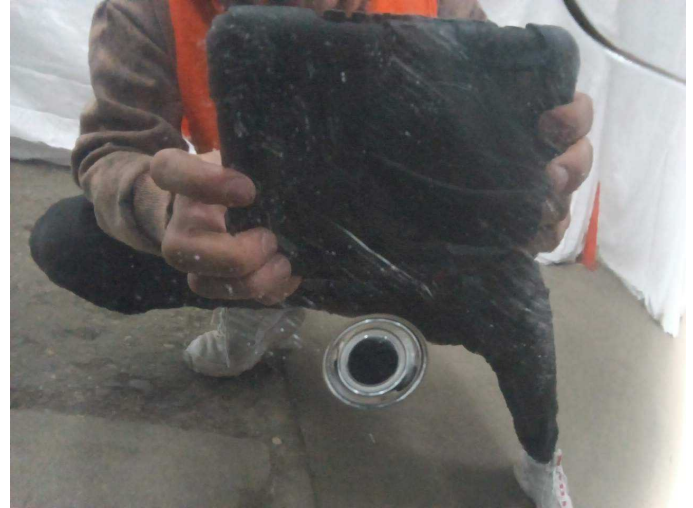
Damage 9: Rear bumper: Rear bumper - Scratch(es) - Paint

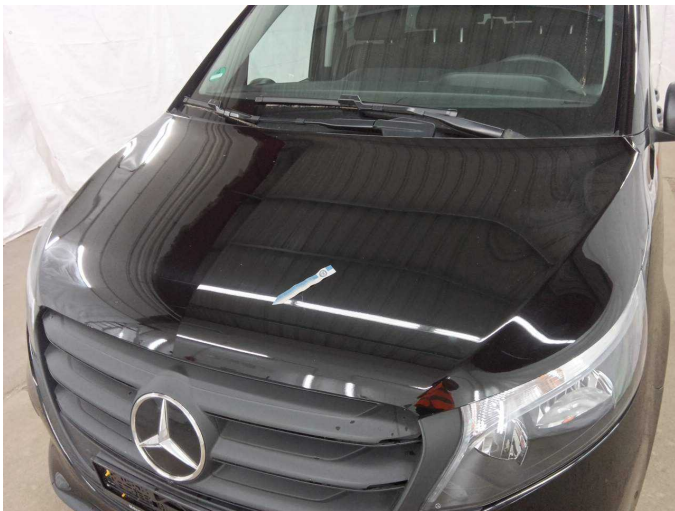
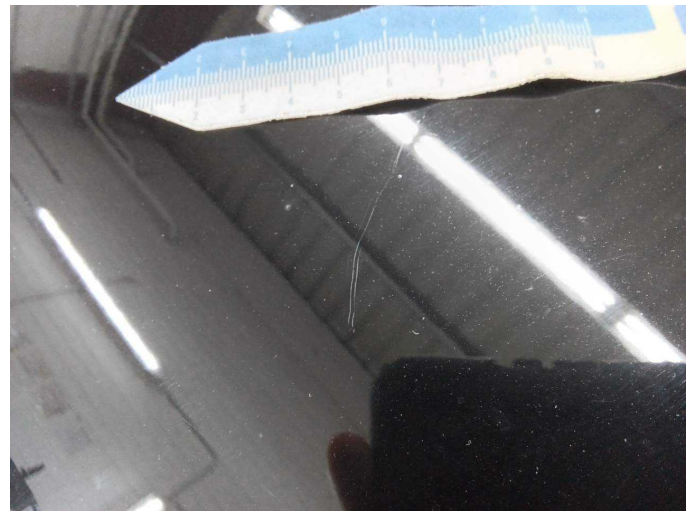
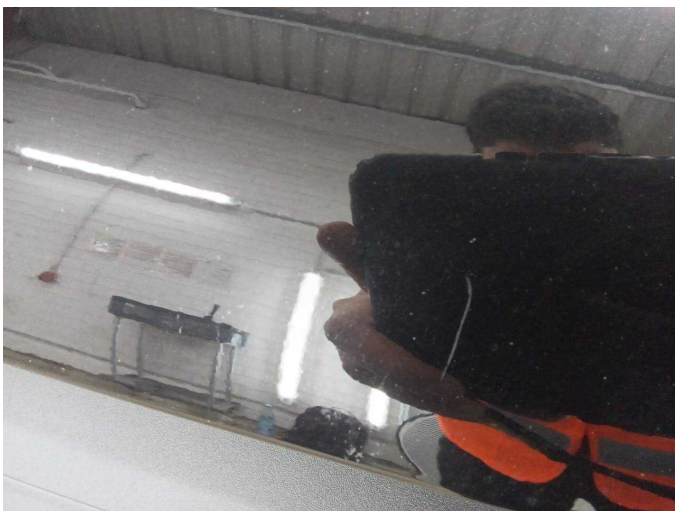
Damage 10: Bonnet: Bonnet - Scratch(es) - Paint

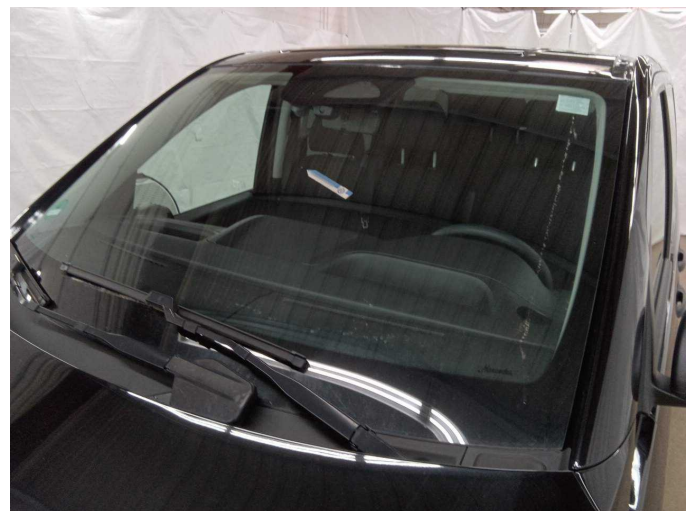
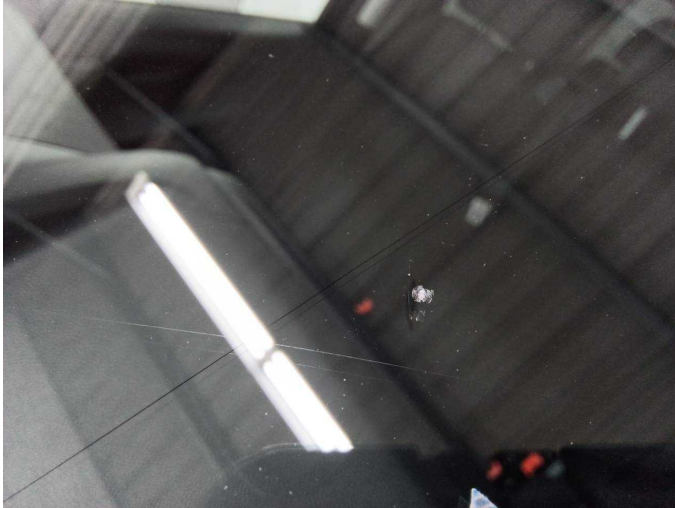
Damage 11: Vehicle glazing: Windscreen (kein Staubschutz) - Stone chips - repair according to calculation
