Expertise

Protocol number: 46189125
Order No. / Reference: 26042847
Inspection date: 22 Jun 2026

Model: Vito 116 CDI Extralang HA Aut. PRO

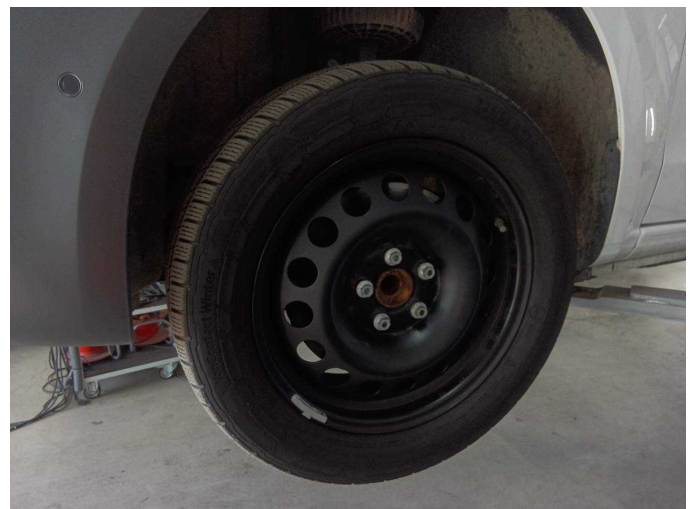
Damage 1: Wheel / tyres: Wheel cover - front left side - Missing - Replace

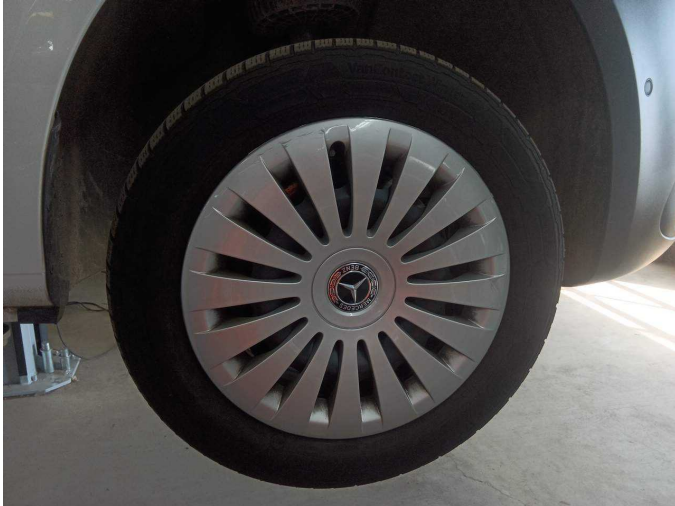
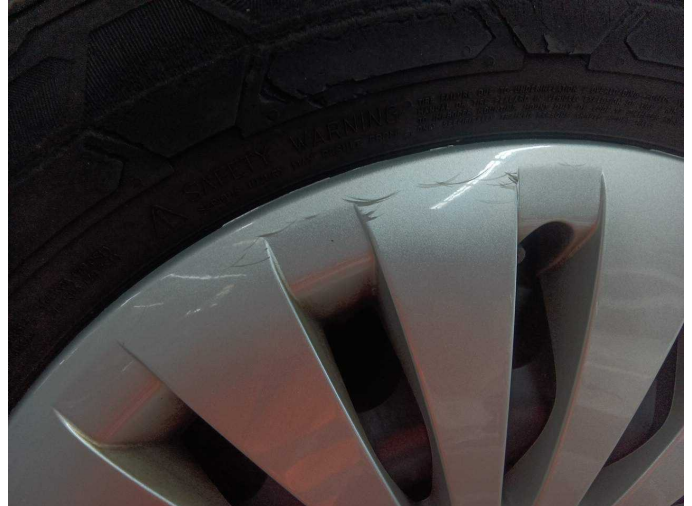
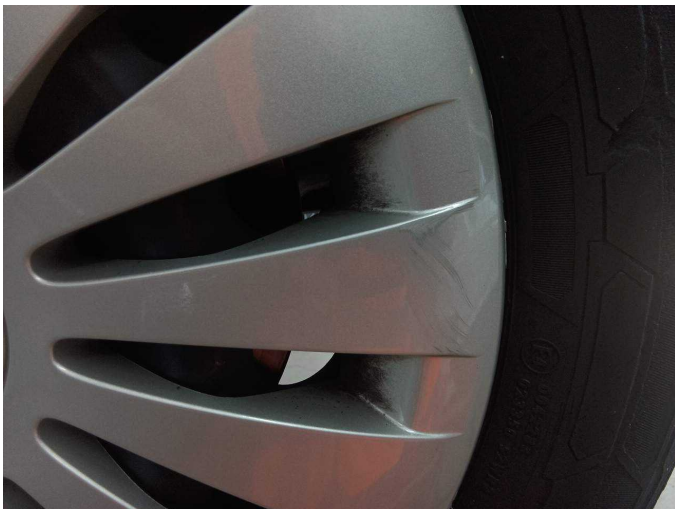
Damage 2: Wheel / tyres: Wheel cover - front right side - Scratch(es) - Replace

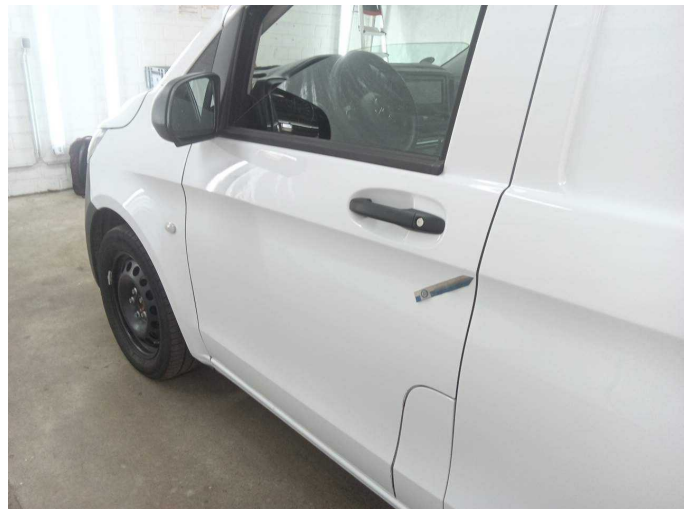
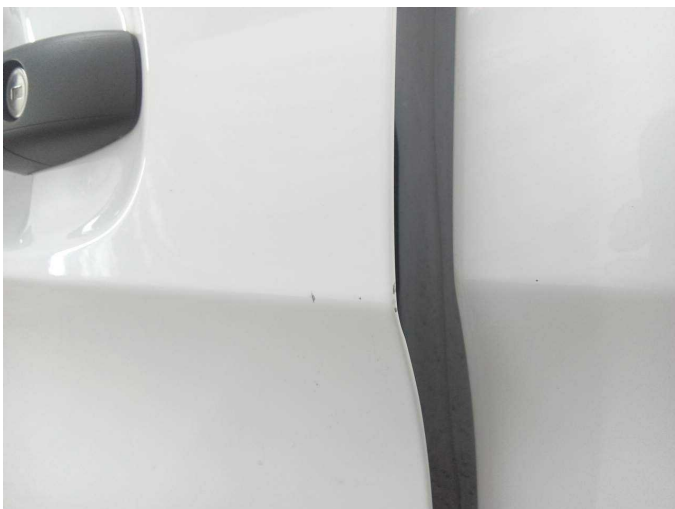
Damage 3: Door - front left side: Door edge - Scratch(es) - Smart repair

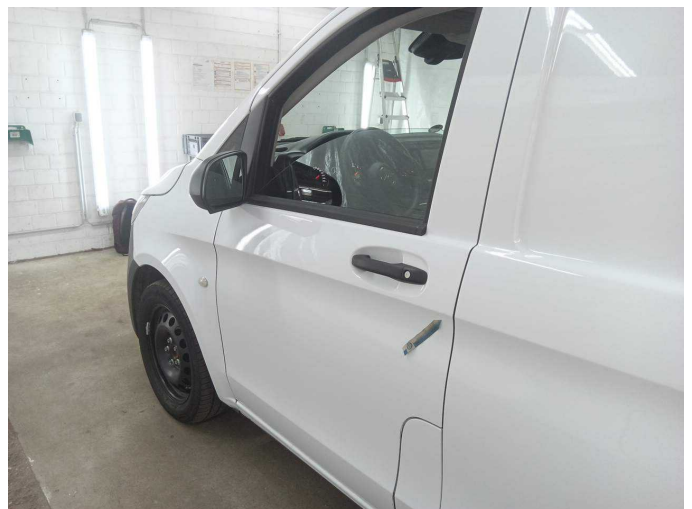
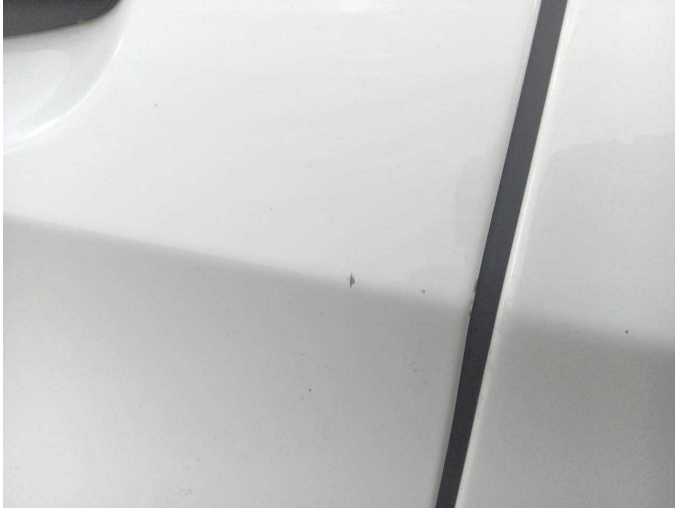
Damage 4: Door - front left side: Door - Scratch(es) - Smart repair

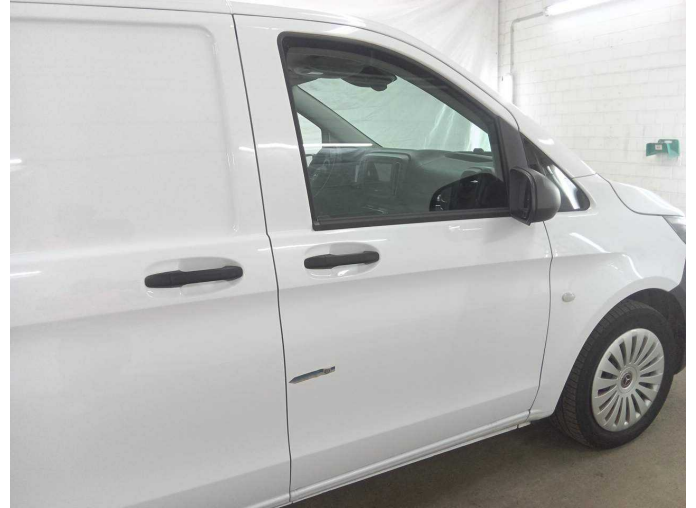
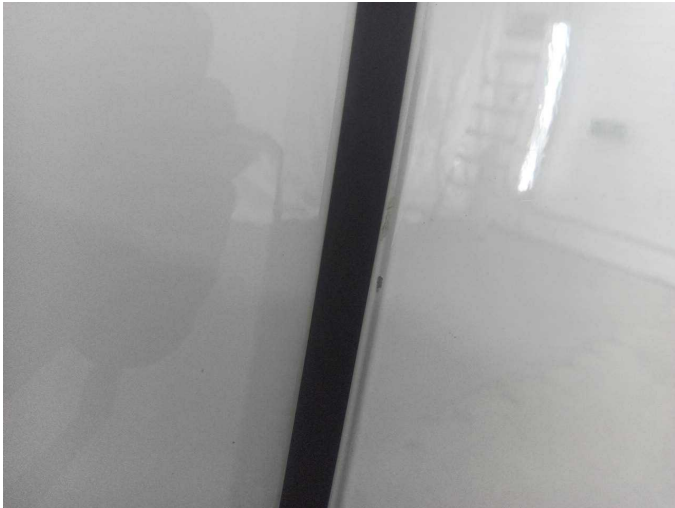
Damage 5: Door - front right side: Door edge - Scratch(es) - Smart repair

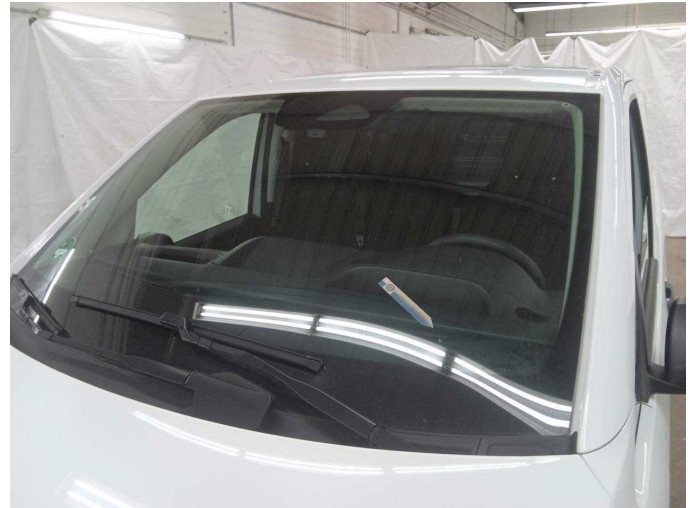
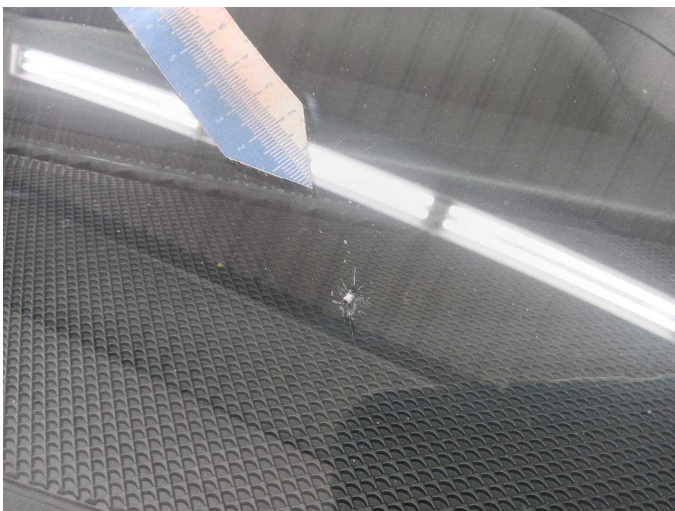
Damage 6: Vehicle glazing: Windscreen - Stone chips - Replace
