Expertise

Protocol number: 46630590  
Order No. / Reference: 26801840  
Inspection date: 20 Jul 2026

Manufacturer: Skoda  
VIN: TMBJH9NP6N7007508

Model: Superb Combi 2.0 TDI DSG Ambition

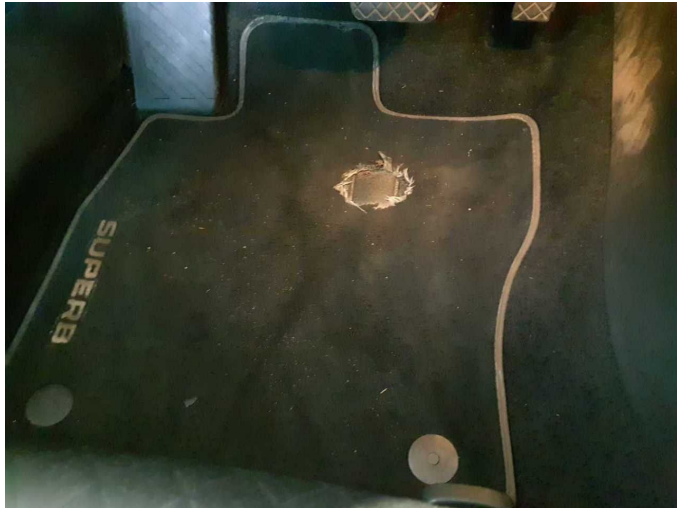
| No. | Component group | Description |
|---|---|---|
| 2 | Trim / covers | Floor mats (VL) - Holes - Replace |

**Damage 2:** Trim / covers: Floor mats (VL) - Holes - Replace

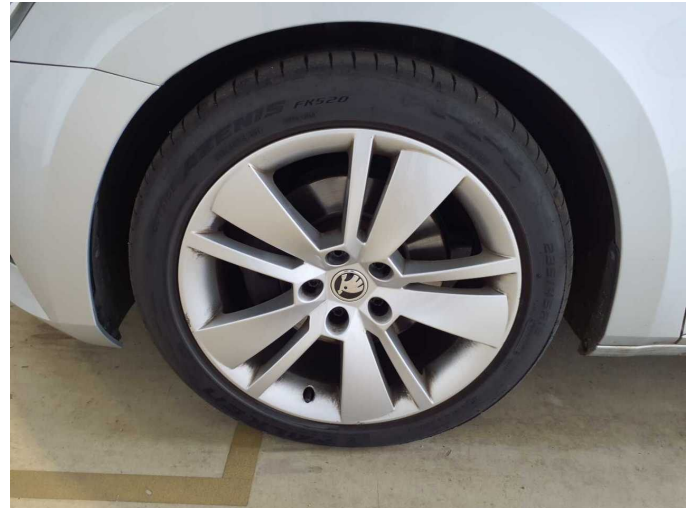
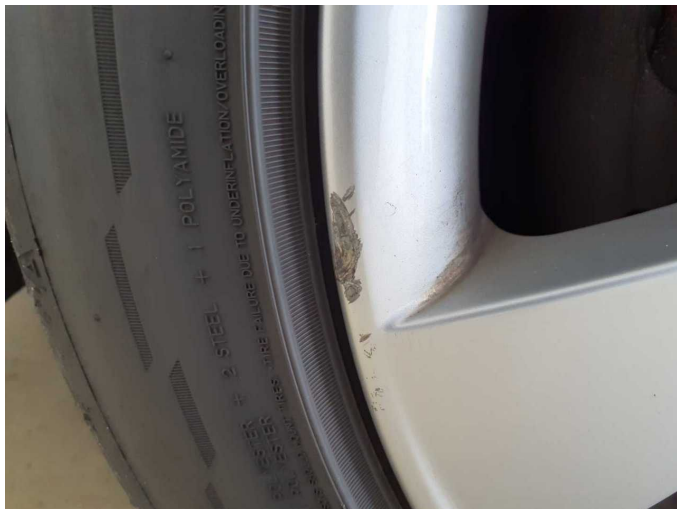
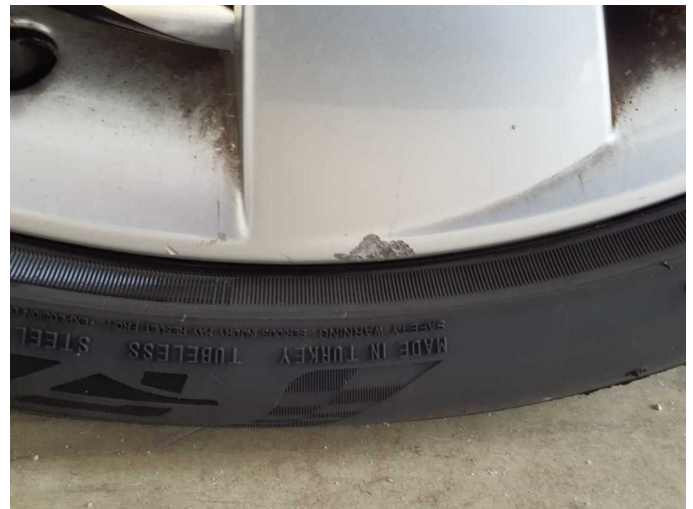
| No. | Component group | Description |
|---|---|---|
| 3 | Wheel / tyres | Alloy rim - front left side - Scratch(es) - Loss in value |

**Damage 3:** Wheel / tyres: Alloy rim - front left side - Scratch(es) - Loss in value

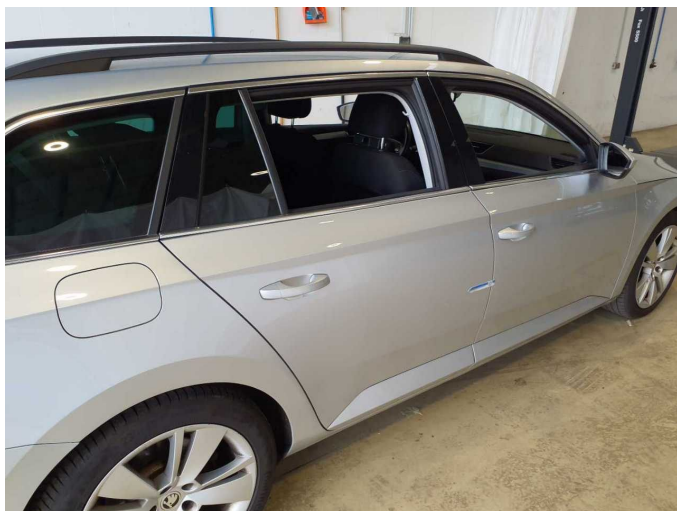
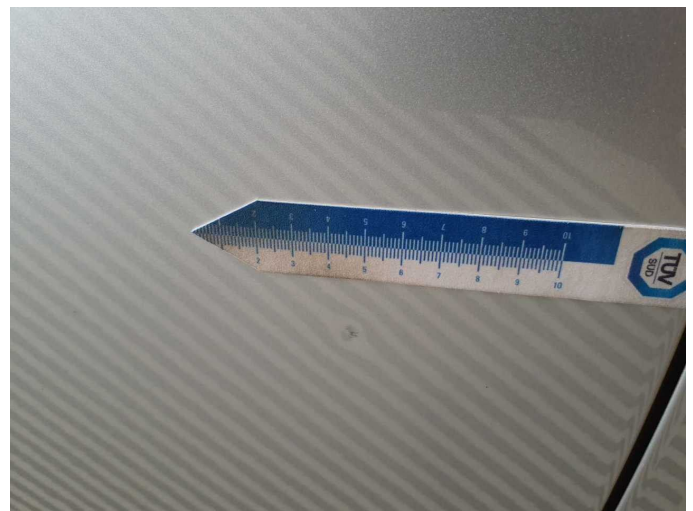
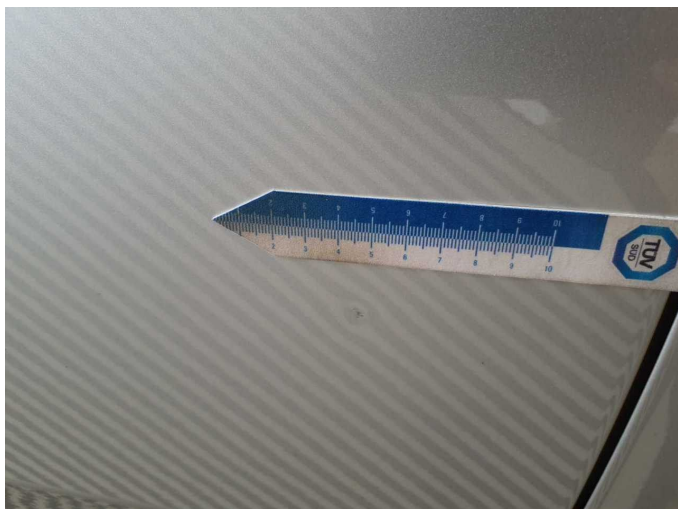
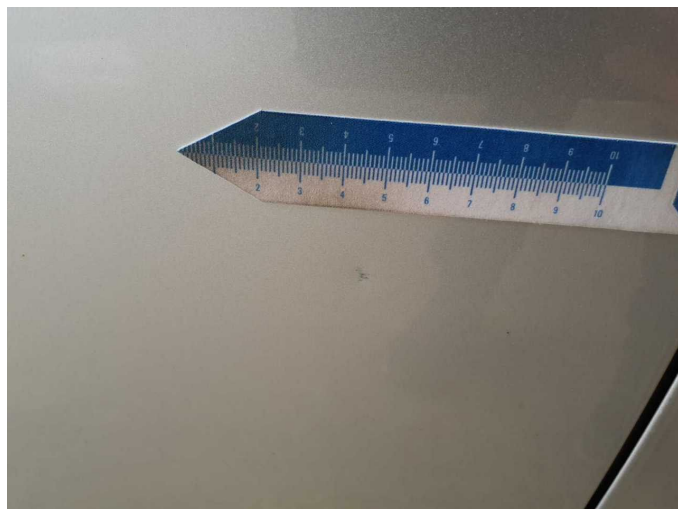
| No. | Component group | Description |
|---|---|---|
| 4 | Door - rear right side | Door - Dent / paintcoat damage - Smart repair |

**Damage 4:** Door - rear right side: Door - Dent / paintcoat damage - Smart repair

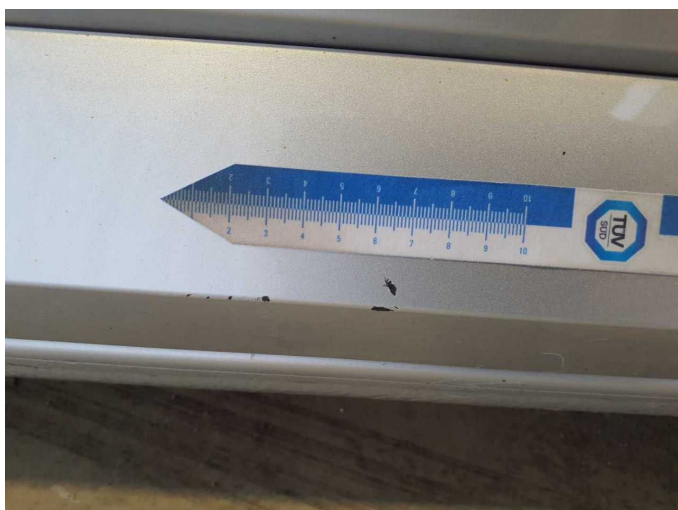
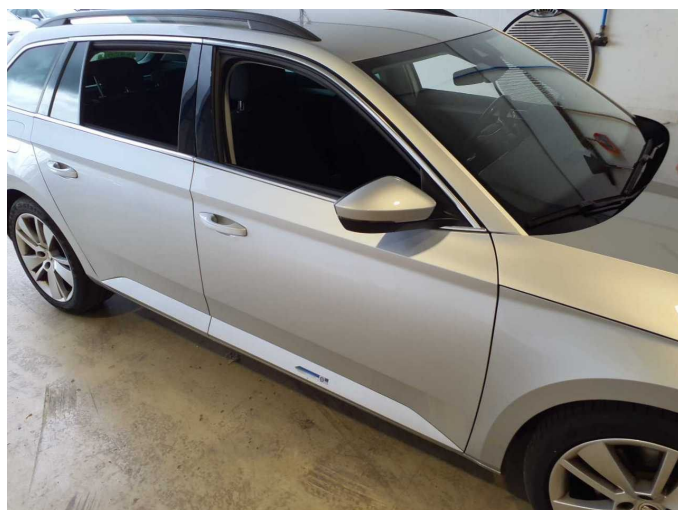
| No. | Component group | Description |
|---|---|---|
| 5 | Door - front right side | Door (Blende unten) - Scratch(es) - Smart repair |

**Damage 5:** Door - front right side: Door (Blende unten) - Scratch(es) - Smart repair

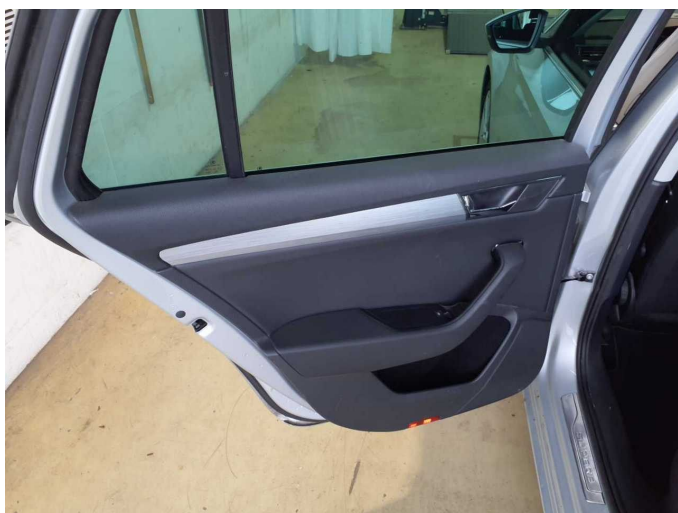
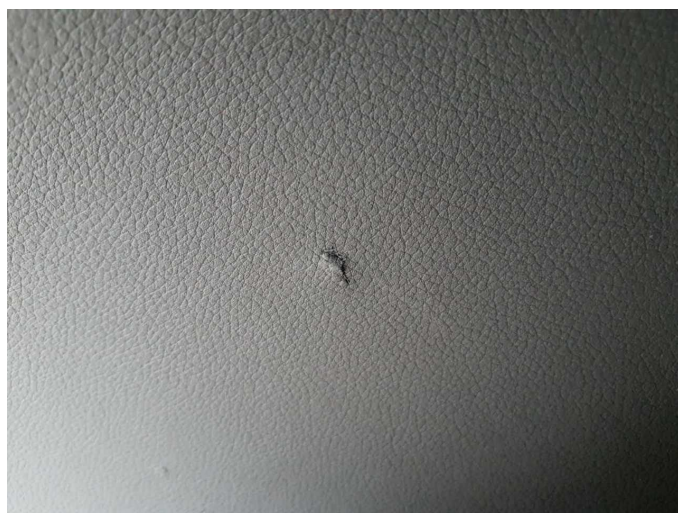
| No. | Component group | Description |
|---|---|---|
| 6 | Trim / covers | Door trim - rear left side - Scratch(es) - Smart repair |

**Damage 6:** Trim / covers: Door trim - rear left side - Scratch(es) - Smart repair

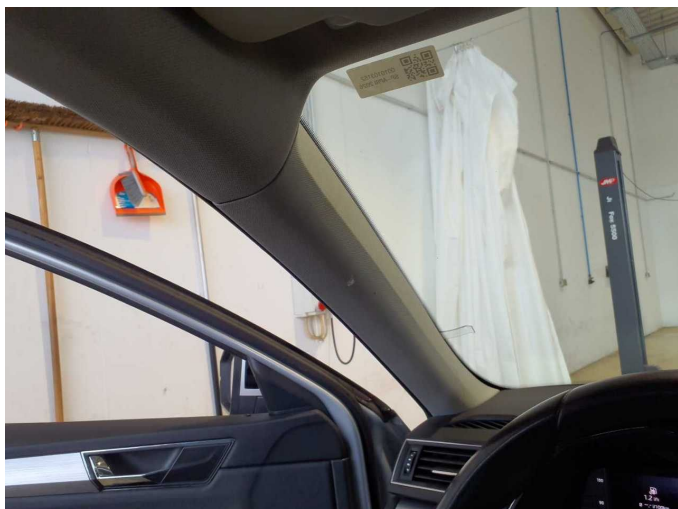
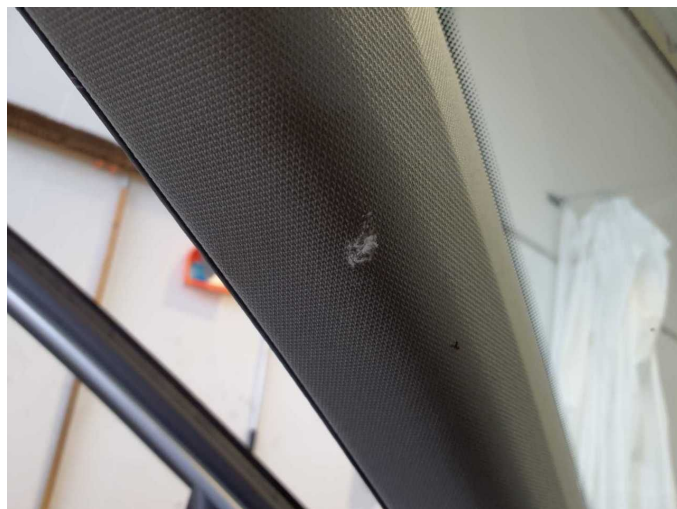
| No. | Component group | Description |
|---|---|---|
| 7 | Trim / covers | A-pillar - trim - interior, left side - Scratch(es) - Replace |

**Damage 7:** Trim / covers: A-pillar - trim - interior, left side - Scratch(es) - Replace

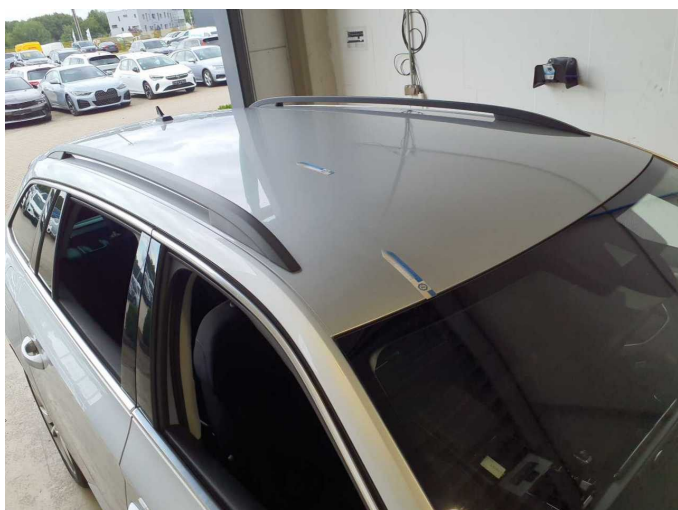
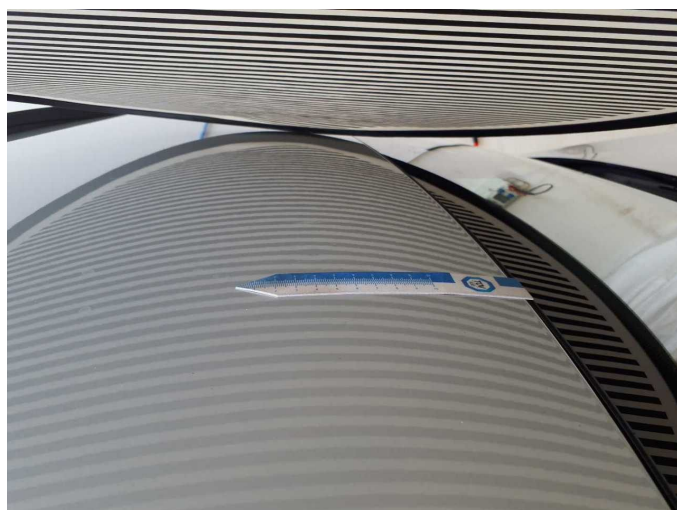
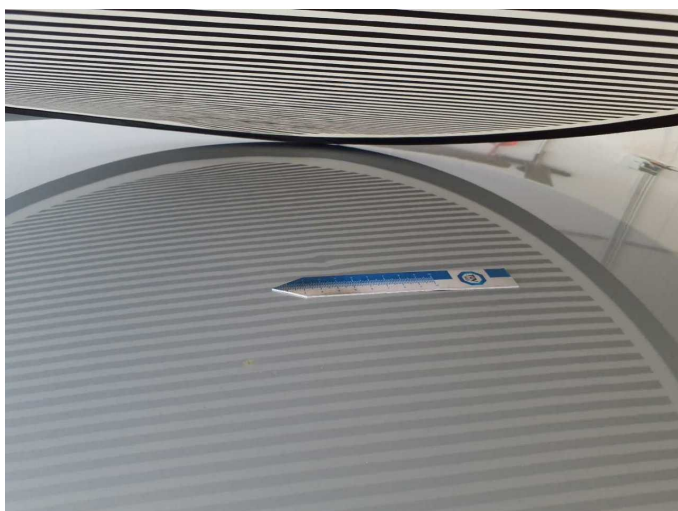
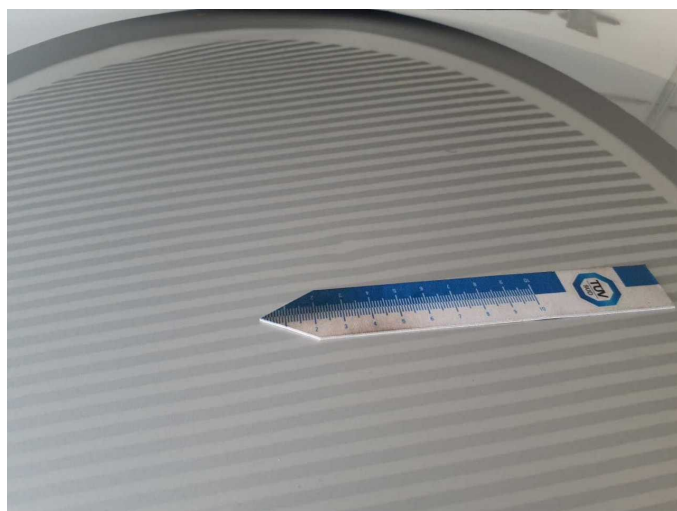
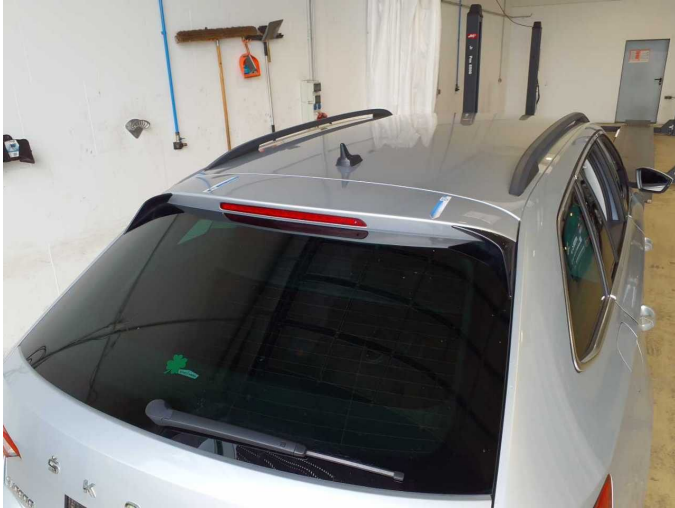
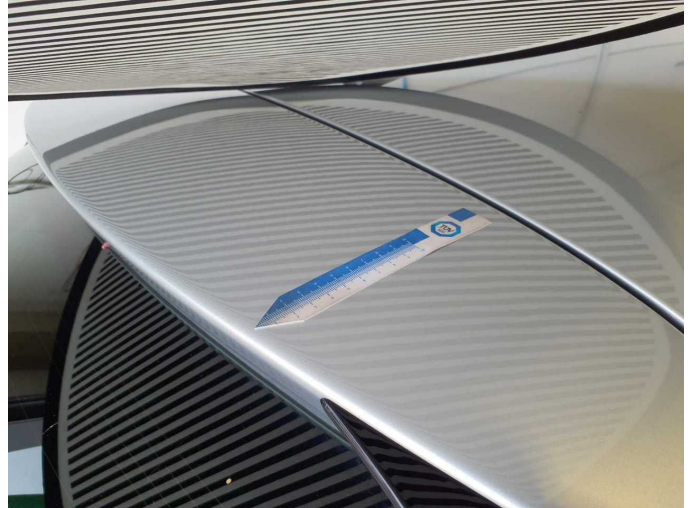
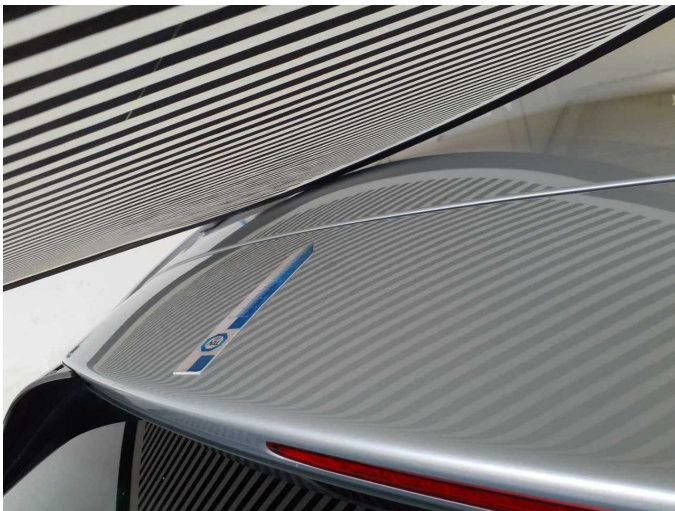
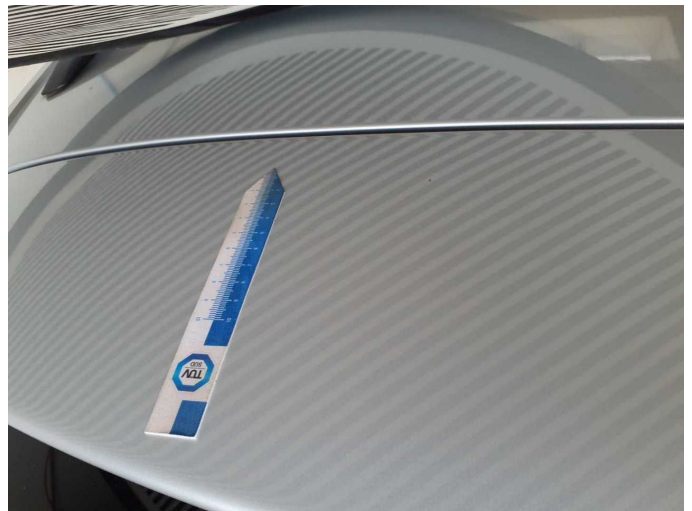
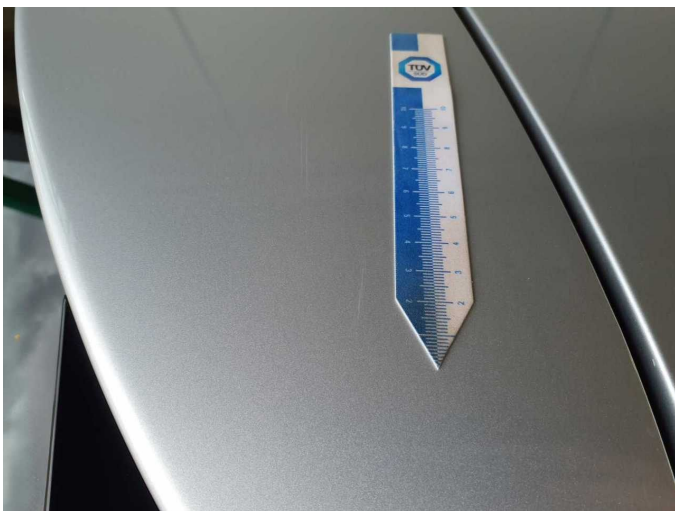
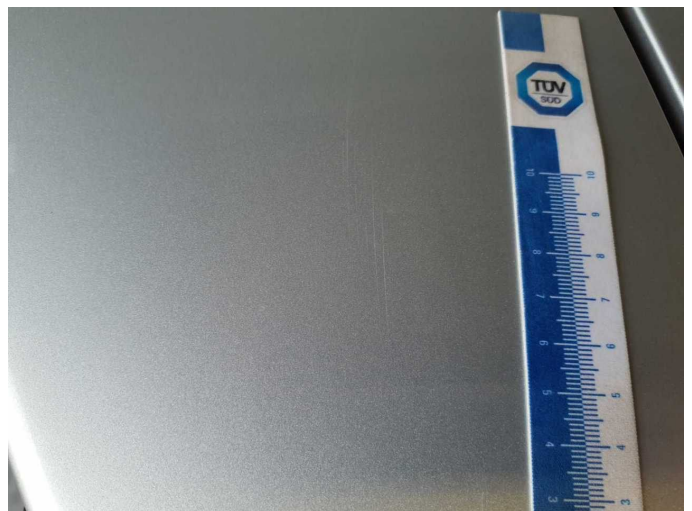
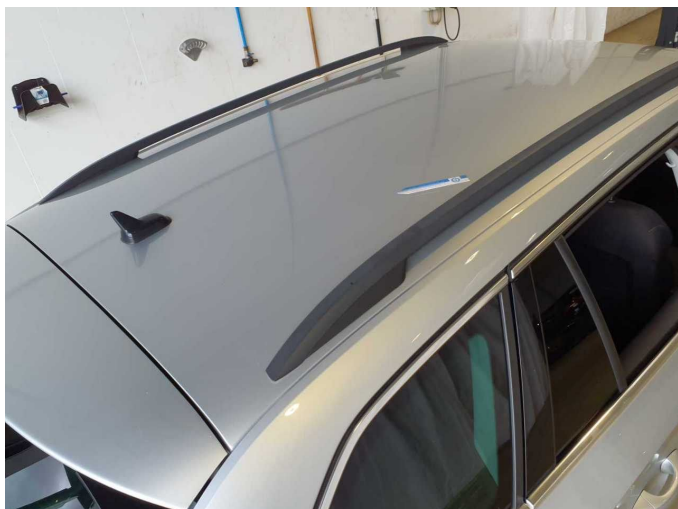
| No. | Component group | Description |
|---|---|---|
| 9 | Body | Body - Damage by hail - Repair |

**Damage 9:** Body: Body - Damage by hail - Repair

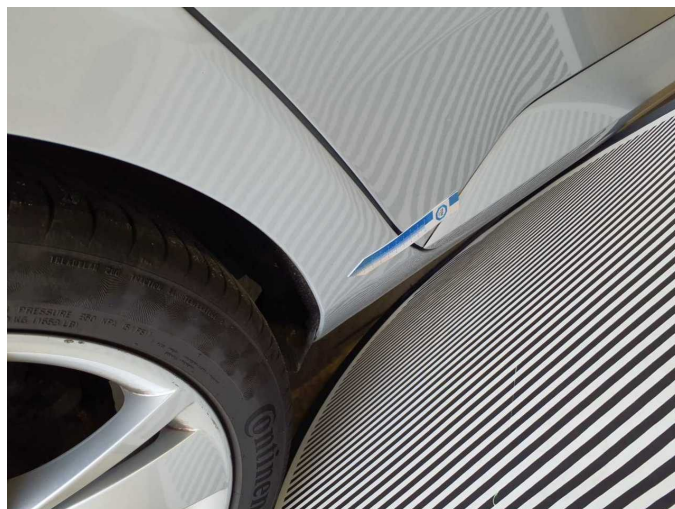
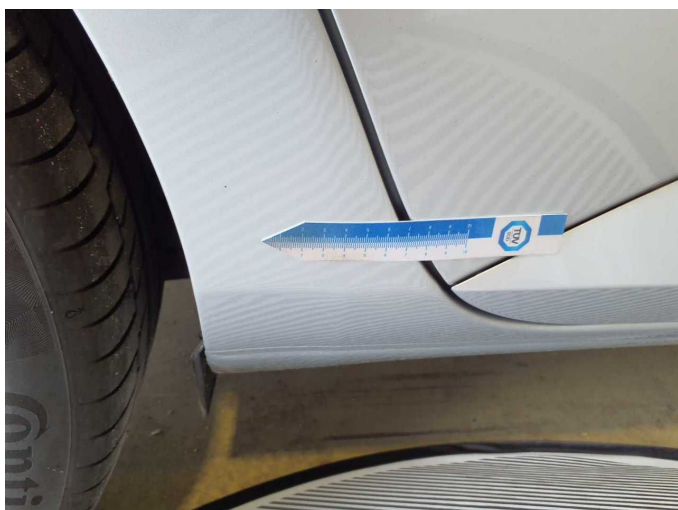
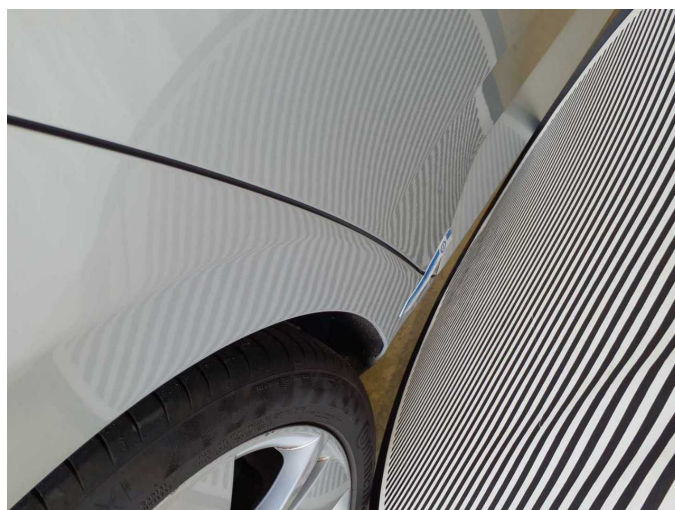
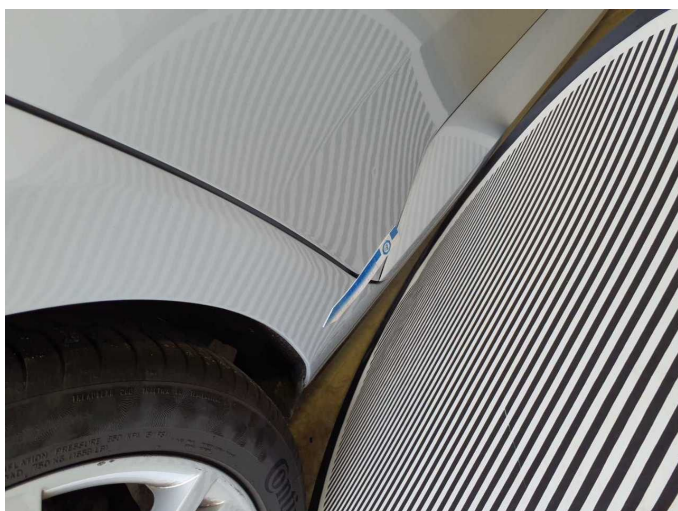
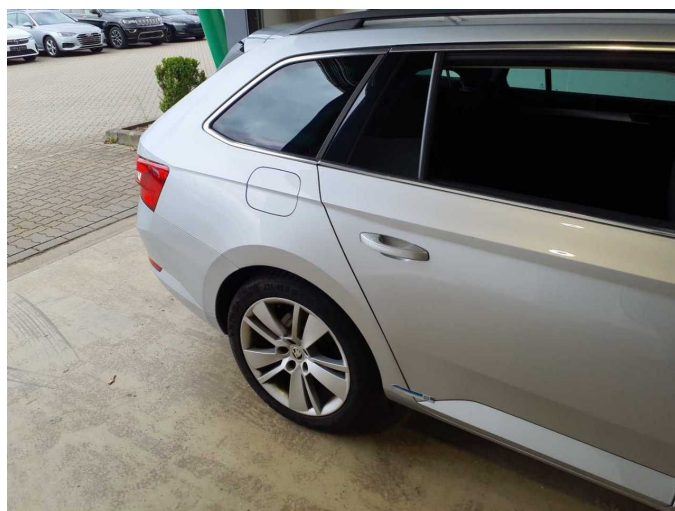
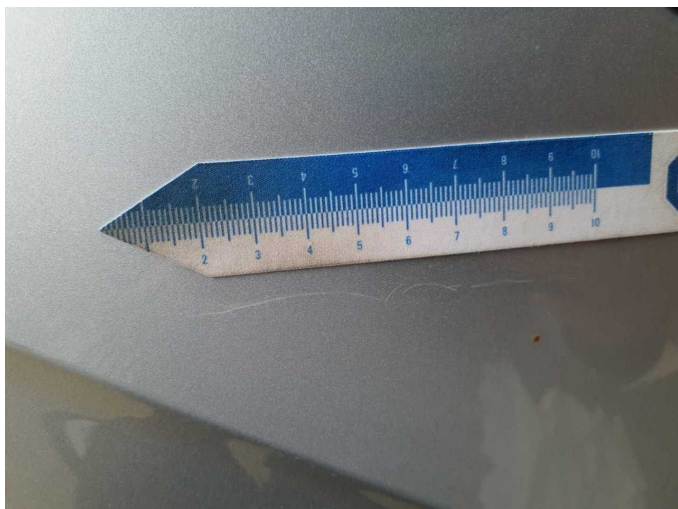
| No. | Component group | Description |
|---|---|---|
| 10 | Side panel - rear right side | Side panel (Spachtelmasse eingefallen) - Unprofessionally repaired - Repair and paint |

| Side panel - rear right side | 1,500 µm | Door - rear right side | 280 µm |

**Damage 10:** Side panel - rear right side: Side panel (Spachtelmasse eingefallen) - Unprofessionally repaired - Repair and paint

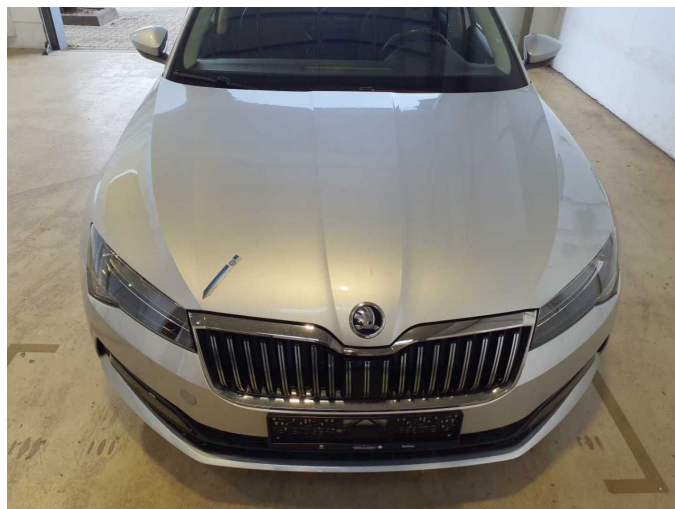
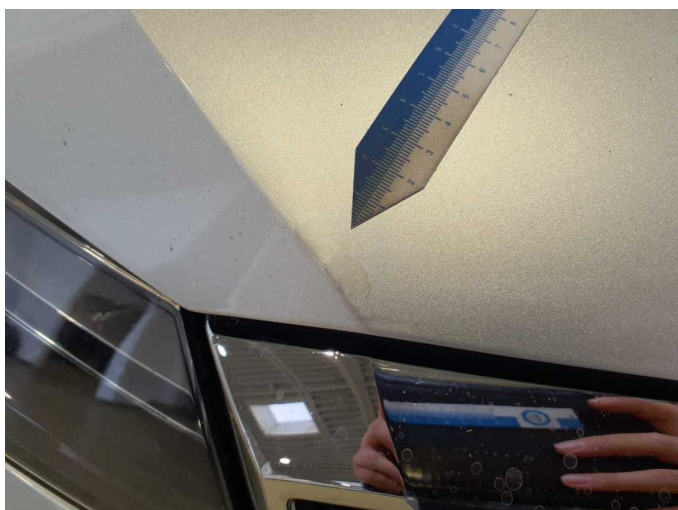
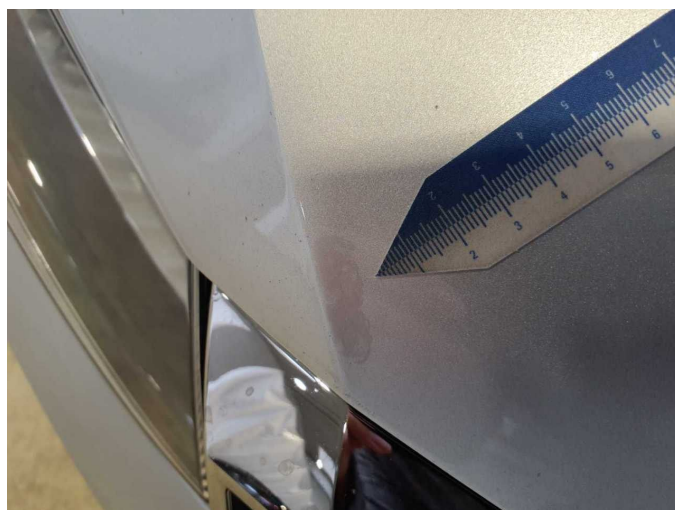
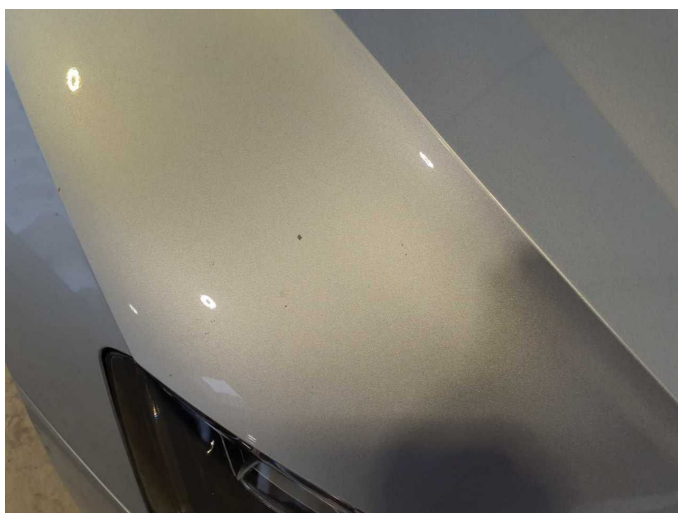
| No. | Component group | Description |
|---|---|---|
| 11 | Bonnet | Bonnet (Lackstift) - Paint defect - Paint |

**Damage 11:** Bonnet: Bonnet (Lackstift) - Paint defect - Paint

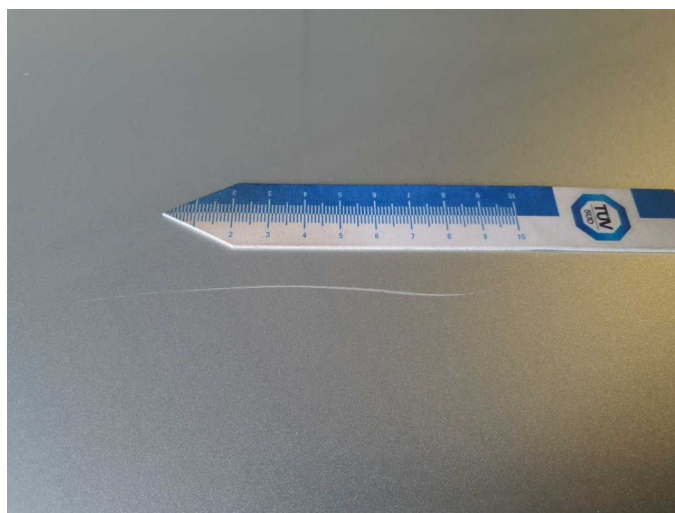
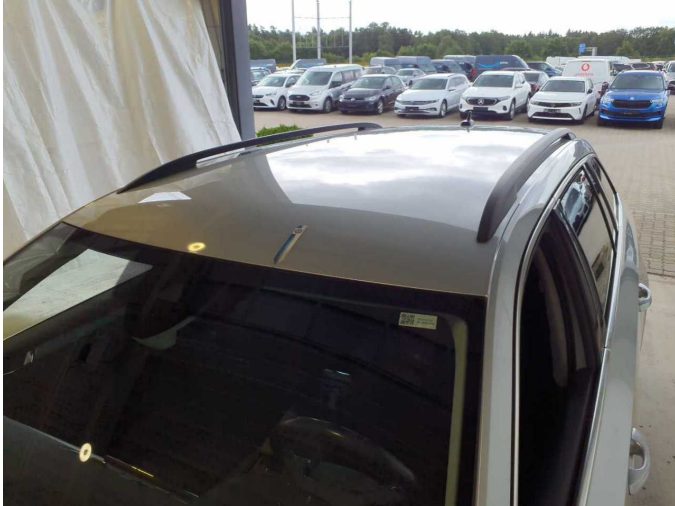
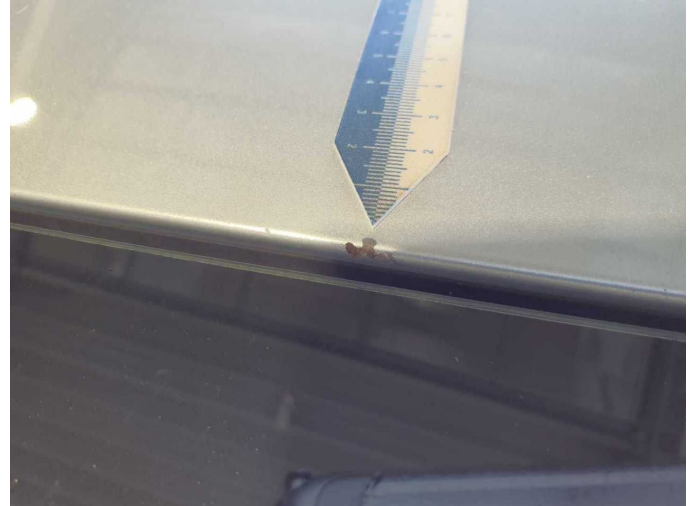
| No. | Component group | Description |
|---|---|---|
| 12 | Roof | Roof (+ Kratzer) - Corrosion - Paint |

**Damage 12:** Roof: Roof (+ Kratzer) - Corrosion - Paint

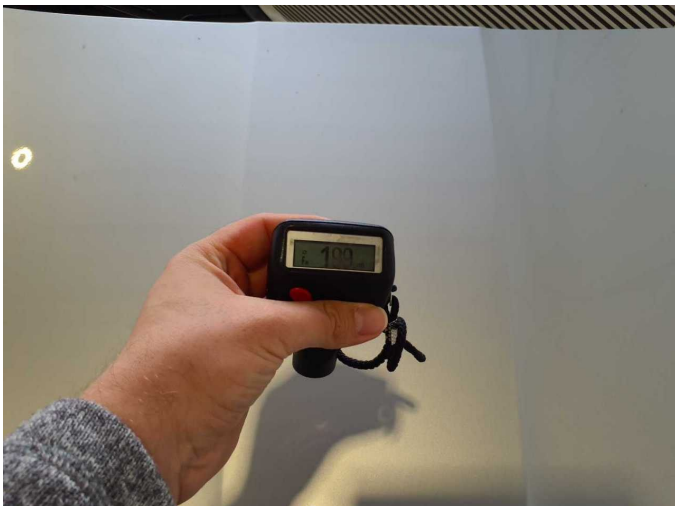
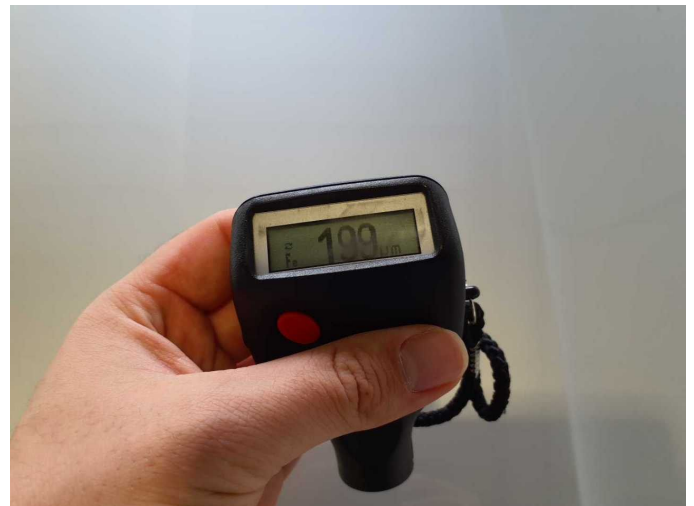
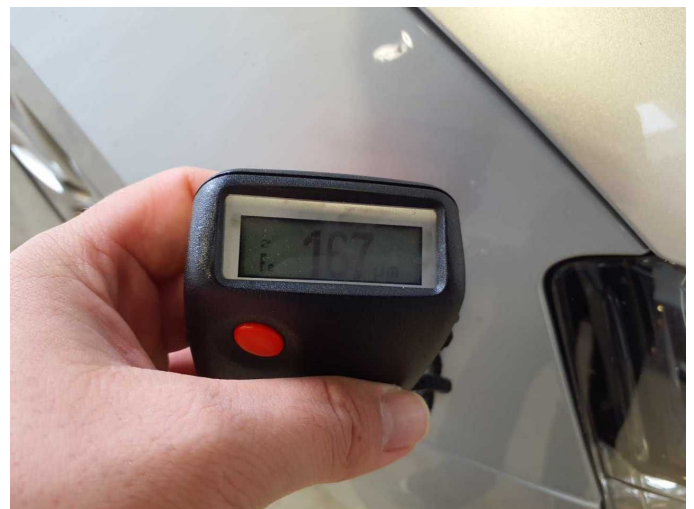
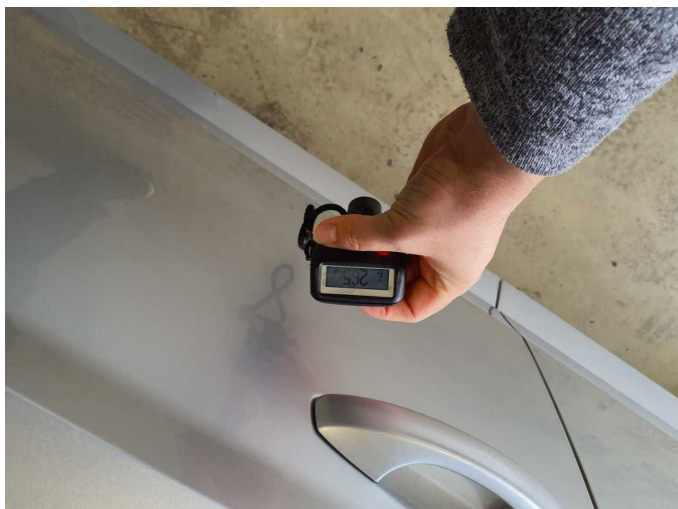
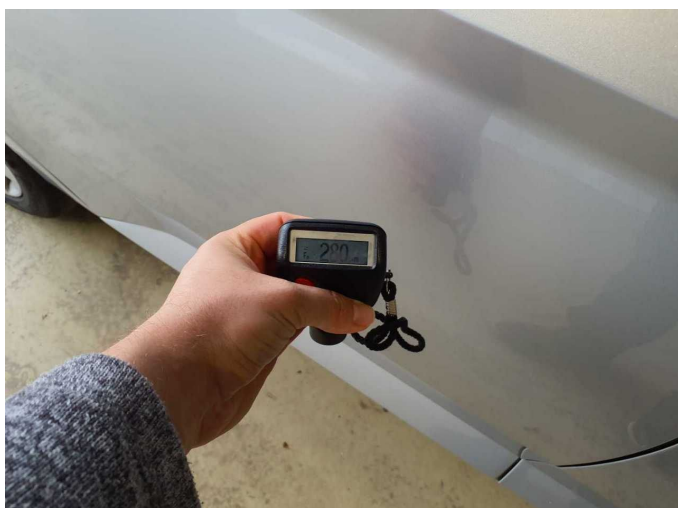
- Mudguard - right side, Bonnet, Door - rear right side, Door - front right side, Professionally carried out, Invoice of repair done Non-existent
- Side panel - rear right side, Unprofessionally carried out, Invoice of repair done Non-existent

| Mudguard - right side | 167 µm | Bonnet | 199 µm |

**Repainting 1:** Mudguard - right side, Bonnet, Door - rear right side, Door - front right side

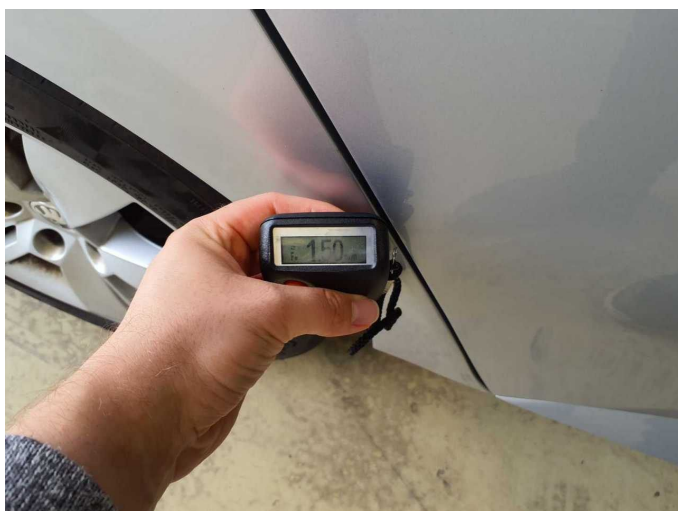
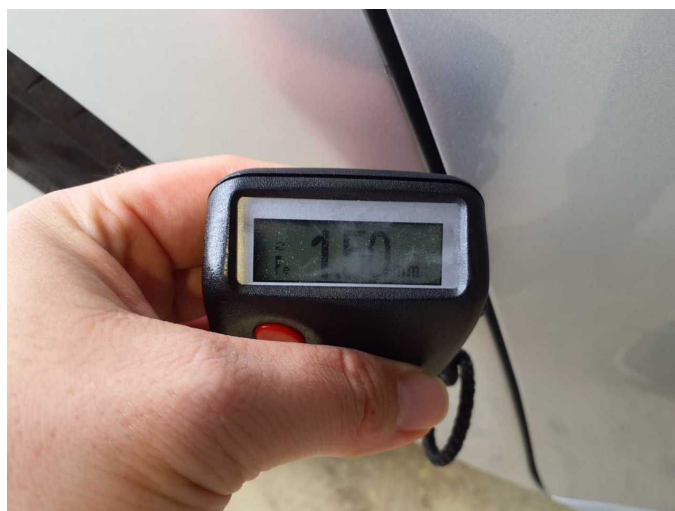
**Repainting 2:** Side panel - rear right side
