Expertise

Protocol number: 45503306
Order No. / Reference: 26351925
Inspection date: 11 May 2026

Manufacturer: Ford

Model: Focus Turnier 2.0 EcoBlue Start-Stopp-System Aut.
COOL&CONNECT

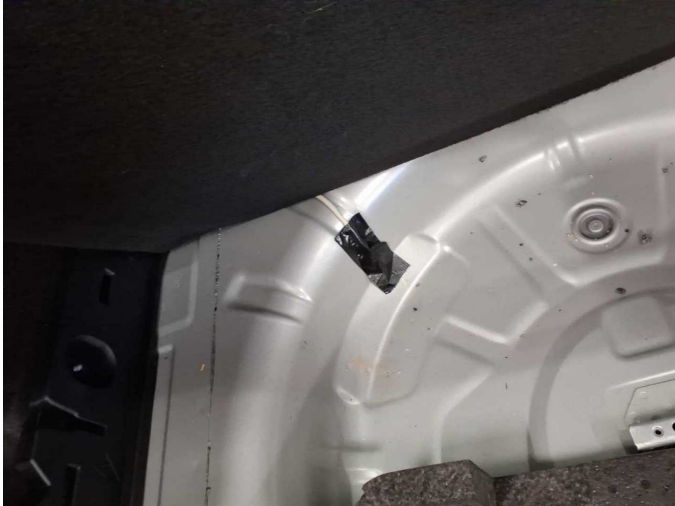
Damage 2: Electrical system: Cable strand (Kabelführung von Frontbereich in Laderaum) - Differs from the original configuration - Un-/install

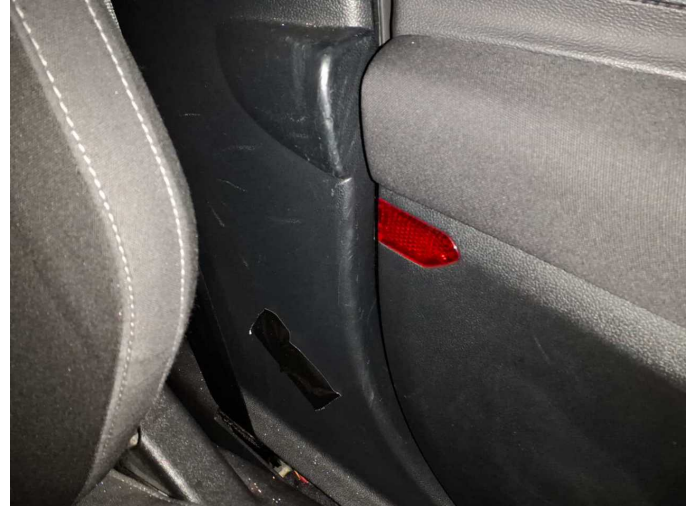
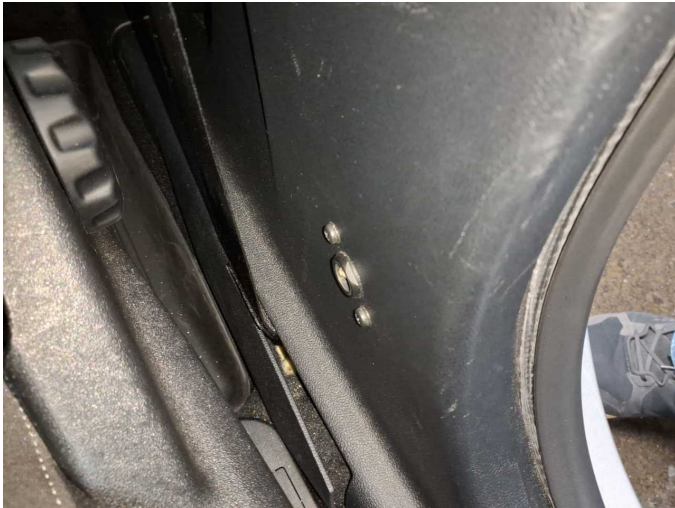
Damage 3: Trim / covers: B-pillar - trim - interior, left side (Fehlbohrungen) - Damaged - Replace

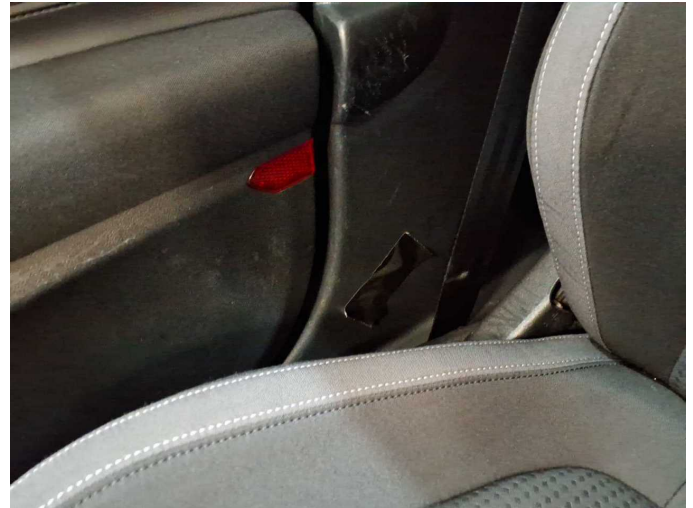
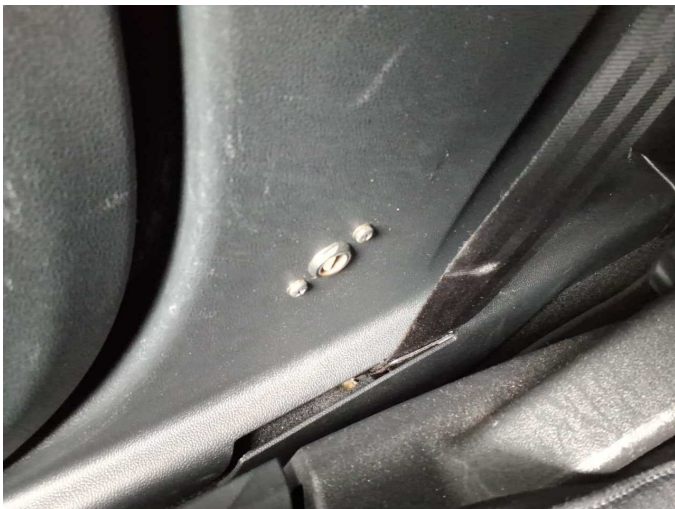
Damage 4: Trim / covers: B-pillar - trim - interior, right side (Fehlbohrungen) - Damaged - Replace

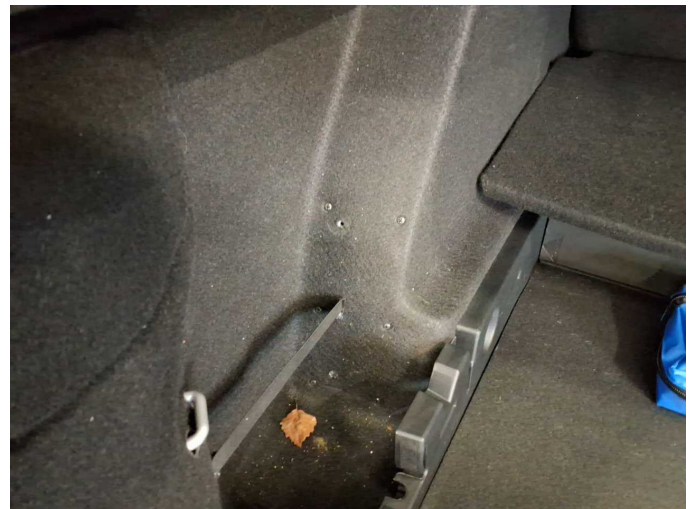
Damage 5: Trim / covers: Cargo area - lining -left side (Fehlbohrungen) - Damaged - Replace

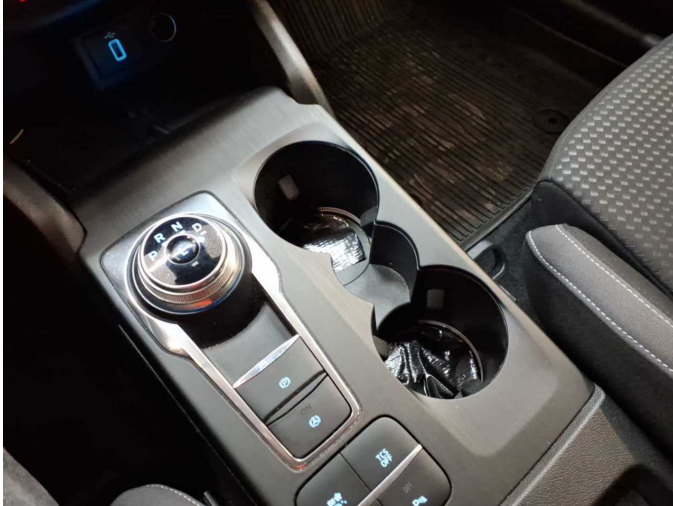
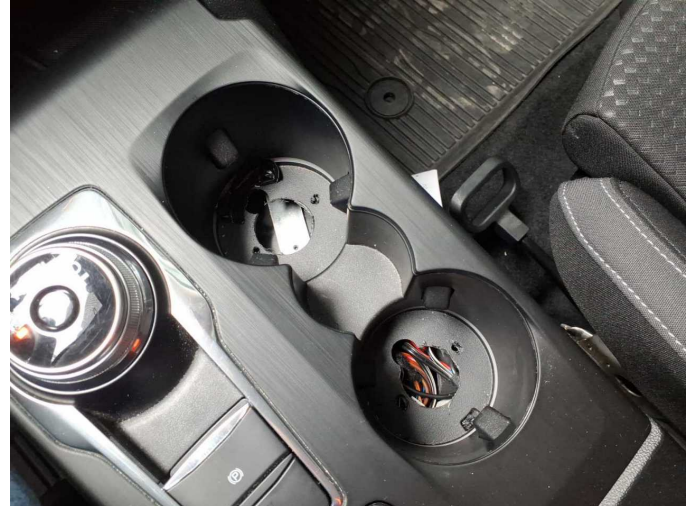
Damage 6: Instrument panel: Centre console - front (Getränkhalter, Fehlbohrungen) - Damaged - Replace

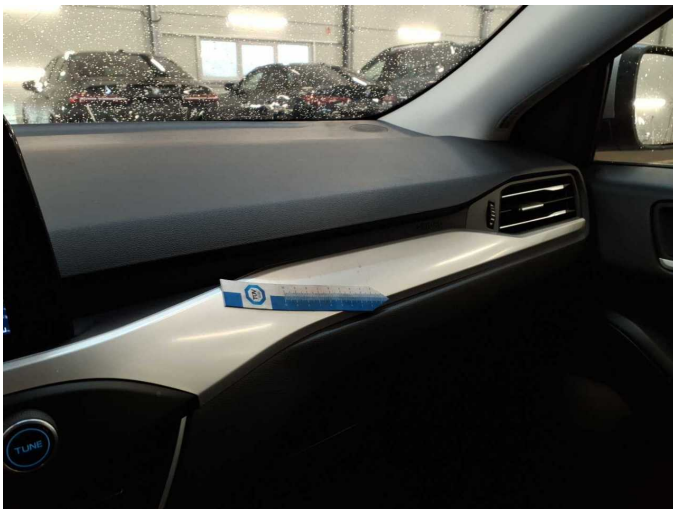
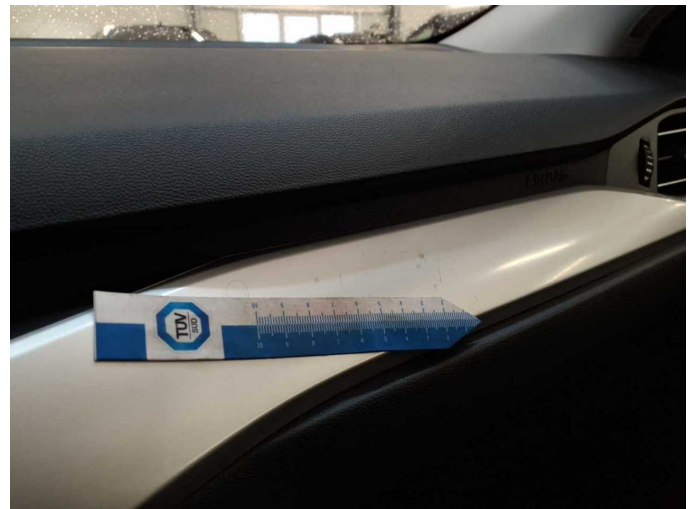
Wear and tear 1: Trim / covers: Brightware / decorative strip - Scratch(es) - No deduction

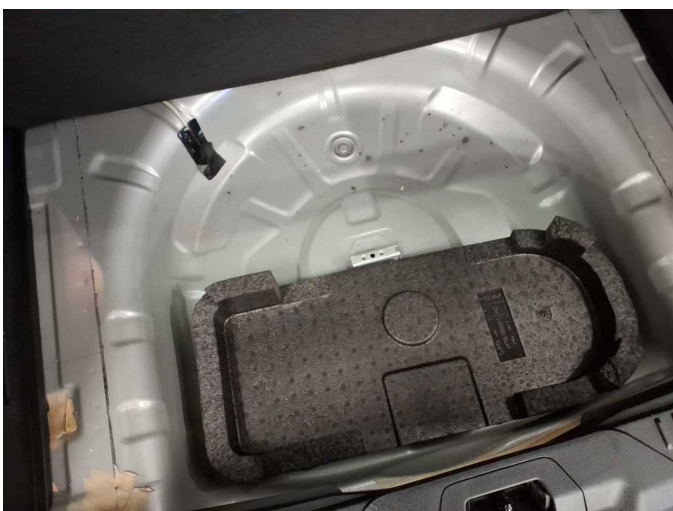
Missing part 1: Equipment: Tirefit complete - Missing - Replace

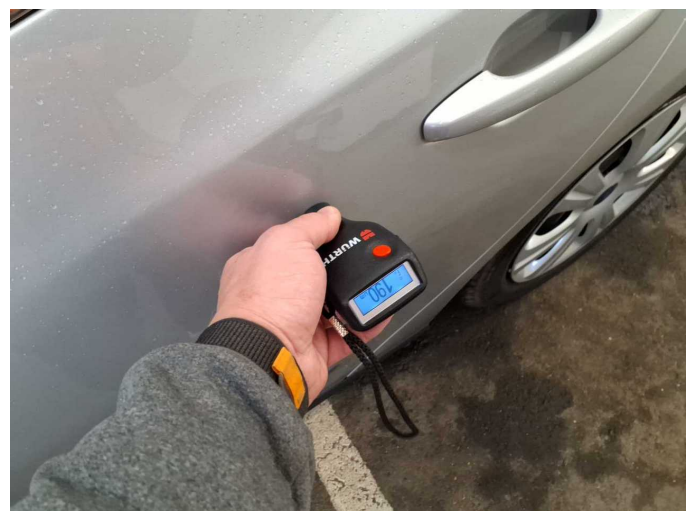
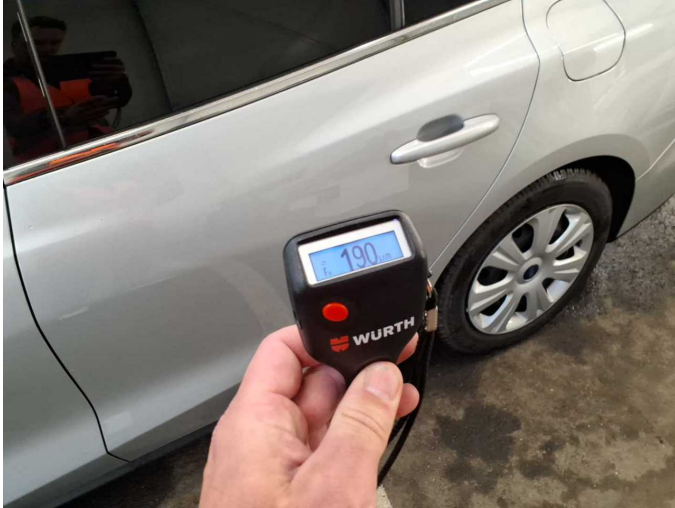
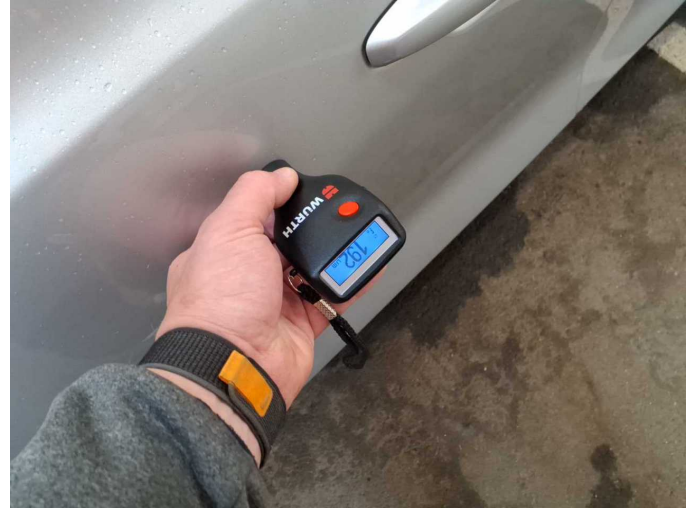
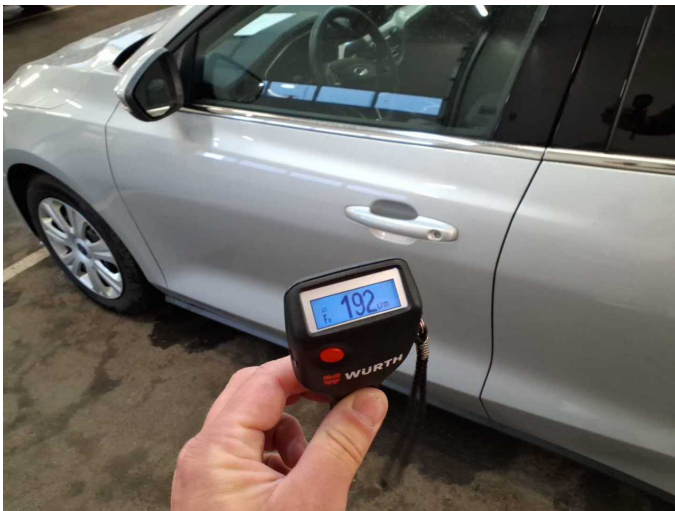
1 Door - rear left side, Door - front left side, Professionally carried out

Door - rear left side	190 µm	Door - front left side	192 µm
-----------------------	--------	------------------------	--------

Repainting 1: Door - rear left side, Door - front left side
