Expertise

Protocol number: 46517006  
Order No. / Reference: 26535403  
Inspection date: 8 Jul 2026

Manufacturer: Mercedes-Benz

Model: E 220 d T 9G-TRONIC Avantgarde

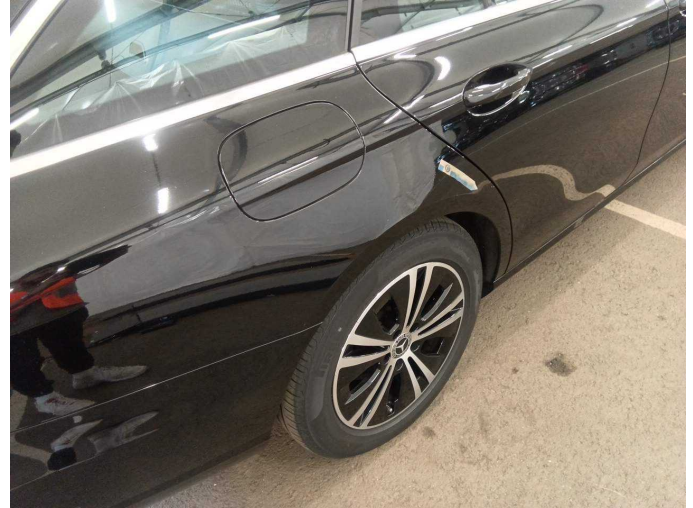
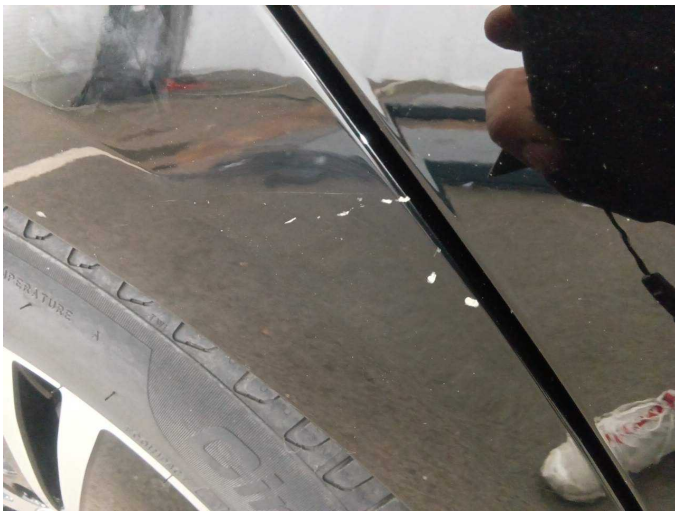
| No. | Component group | Description |
|---|---|---|
| 1 | Side panel - rear right side | Mudguard - rear right side - Scratch(es) - Smart repair |

**Damage 1:** Side panel - rear right side: Mudguard - rear right side - Scratch(es) - Smart repair

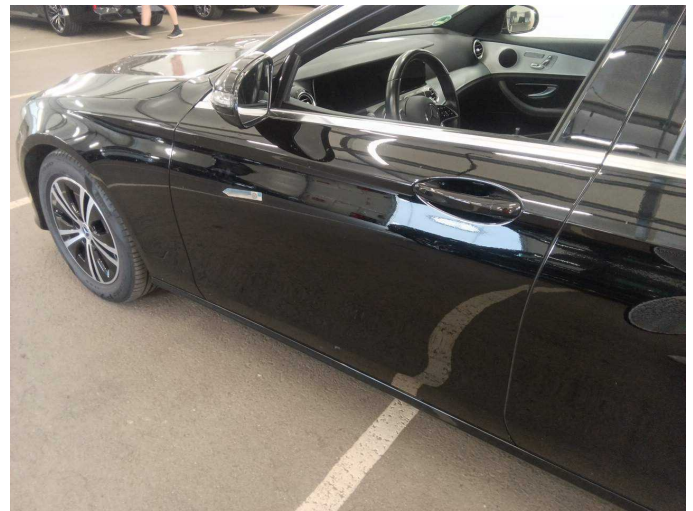
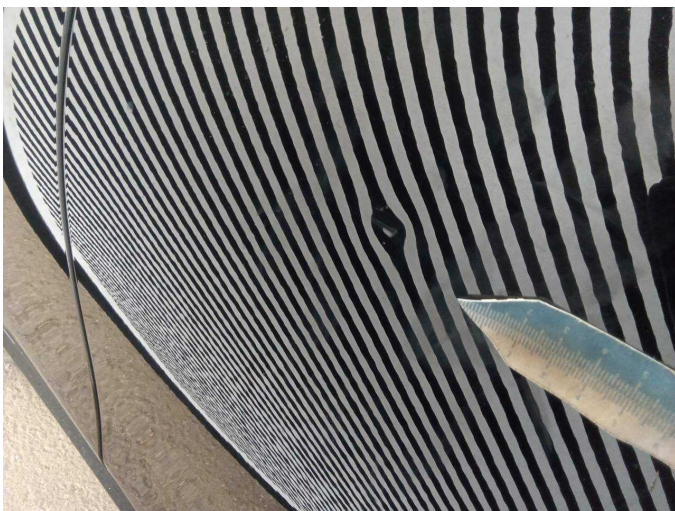
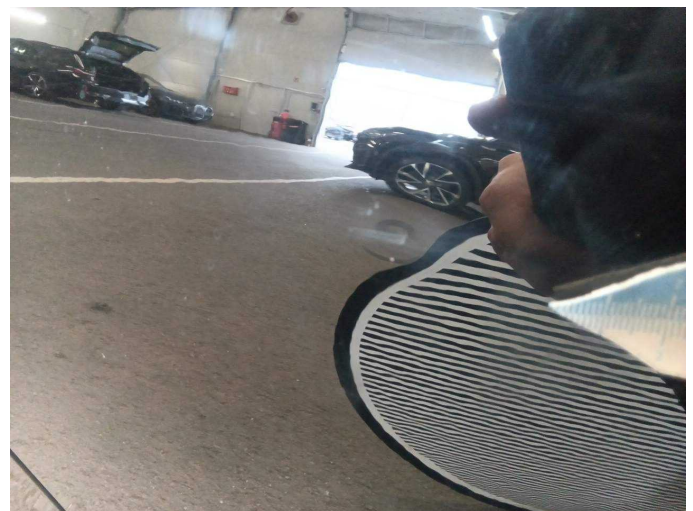
| No. | Component group | Description |
|---|---|---|
| 2 | Door - front left side | Door - Dent / paintcoat damage - Repair and paint |

**Damage 2:** Door - front left side: Door - Dent / paintcoat damage - Repair and paint

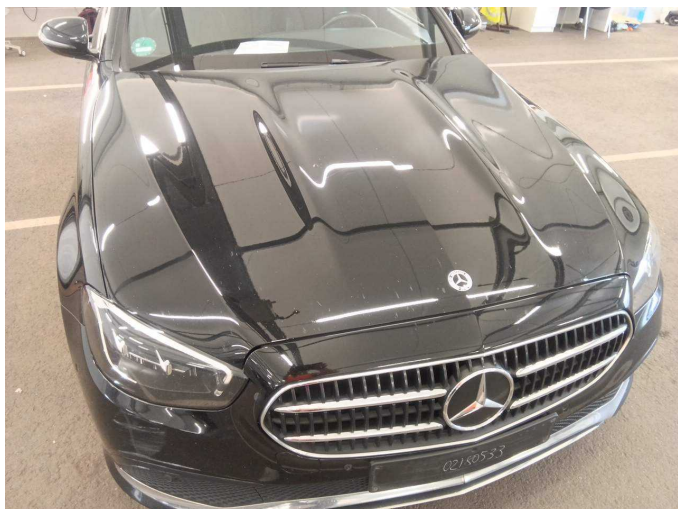
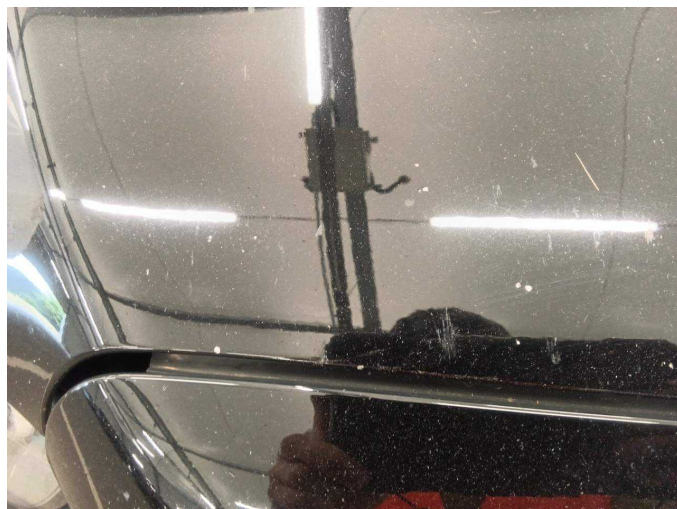
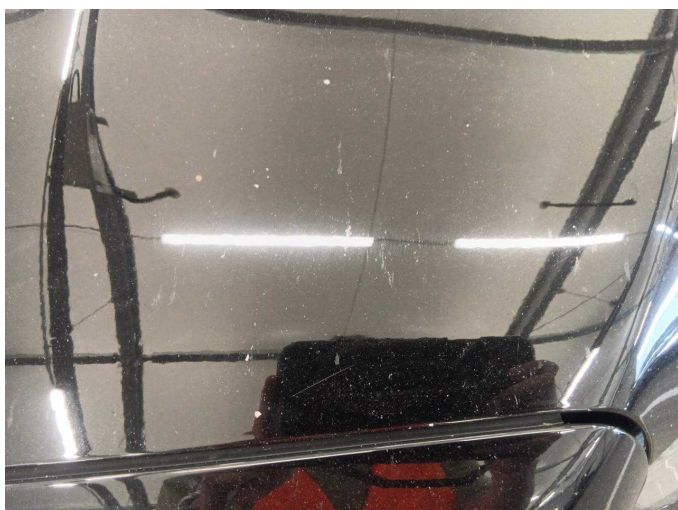
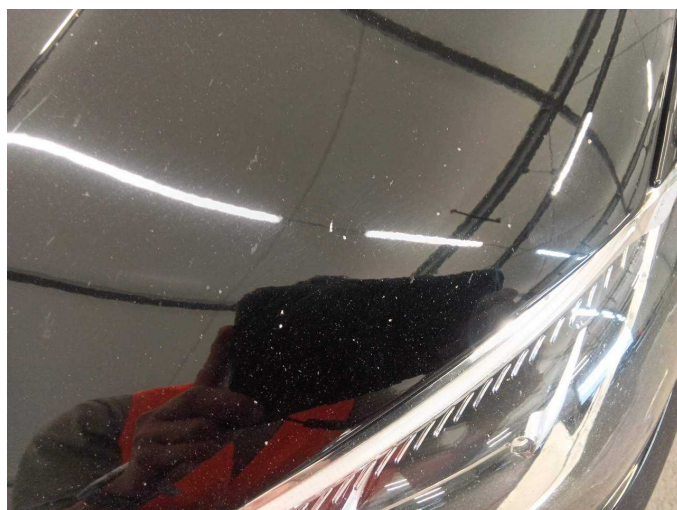
| No. | Component group | Description |
|---|---|---|
| 3 | Bonnet | Bonnet (Übermäßige Steinschläge) - Stone chips - Paint |

**Damage 3:** Bonnet: Bonnet (Übermäßige Steinschläge) - Stone chips - Paint

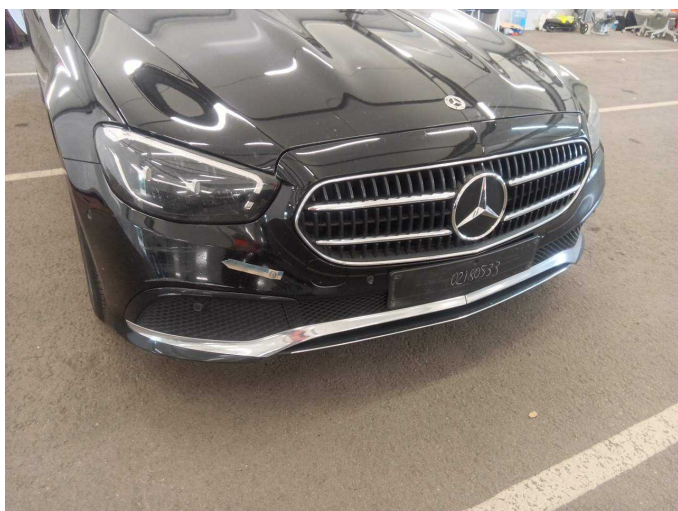
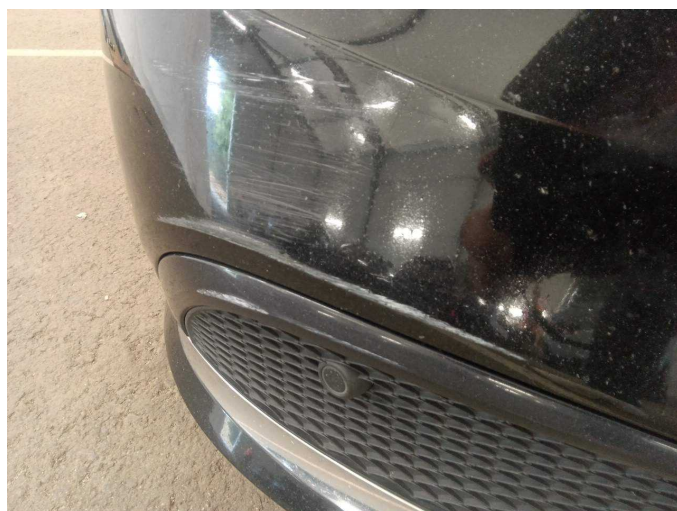
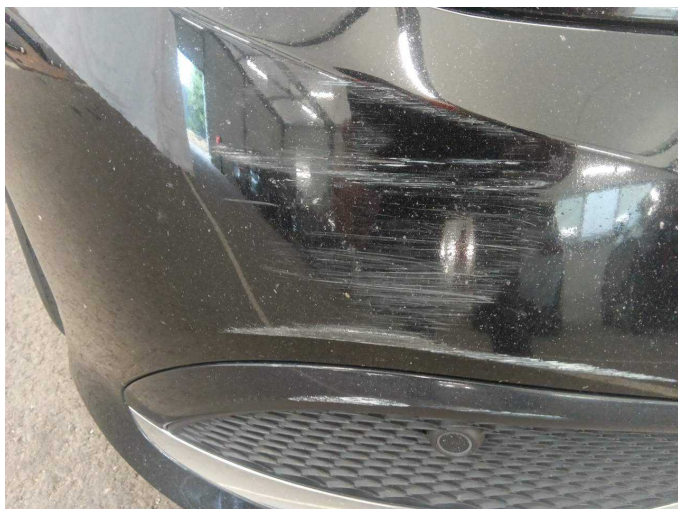
| No. | Component group | Description |
|---|---|---|
| 4 | Front bumper | Front bumper - Scratch(es) - Paint |

**Damage 4:** Front bumper: Front bumper - Scratch(es) - Paint

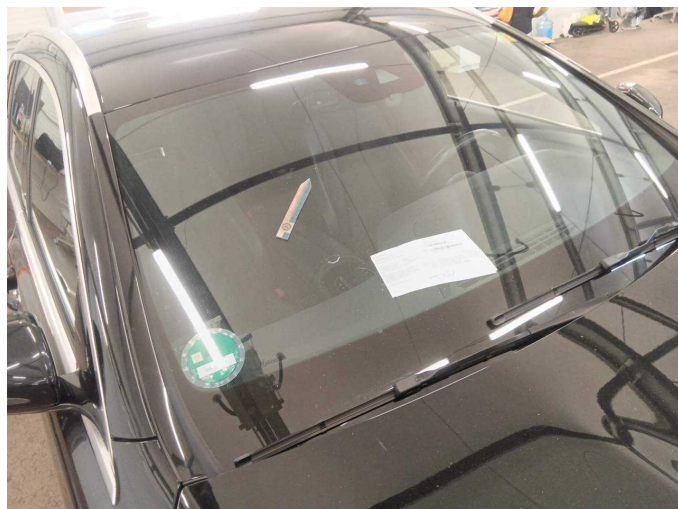
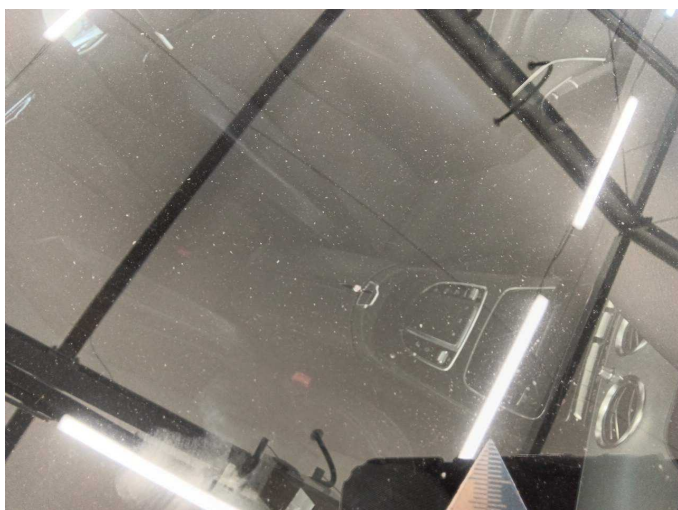
| No. | Component group | Description |
|---|---|---|
| 5 | Vehicle glazing | Windscreen (Mit Rissbildung) - Stone chips - repair according to calculation |

**Damage 5:** Vehicle glazing: Windscreen (Mit Rissbildung) - Stone chips - repair according to calculation

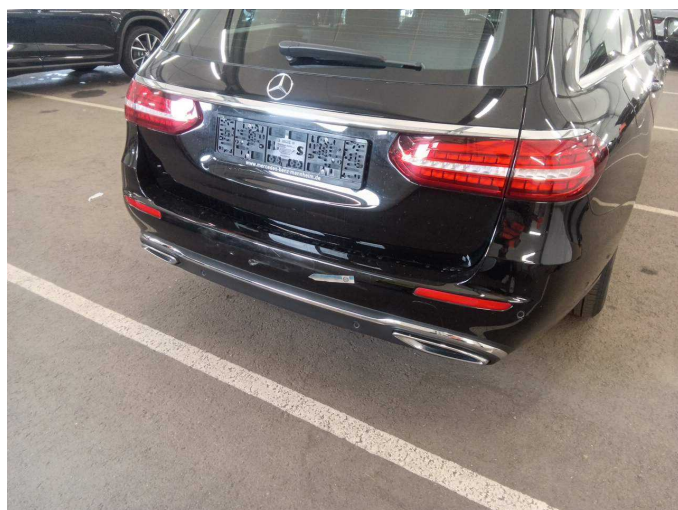
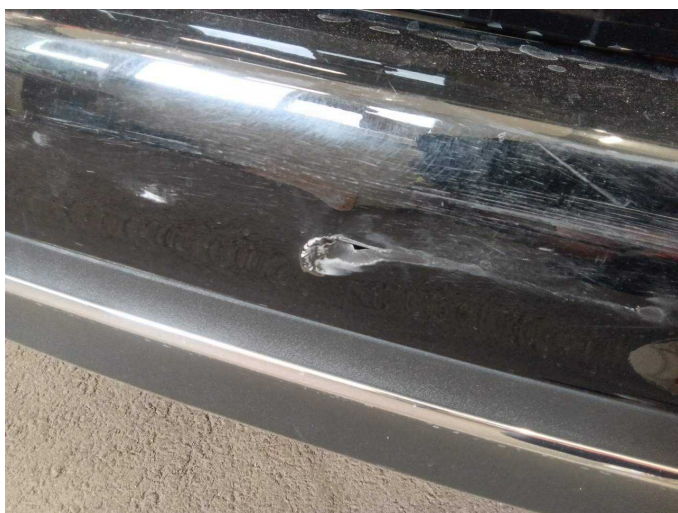
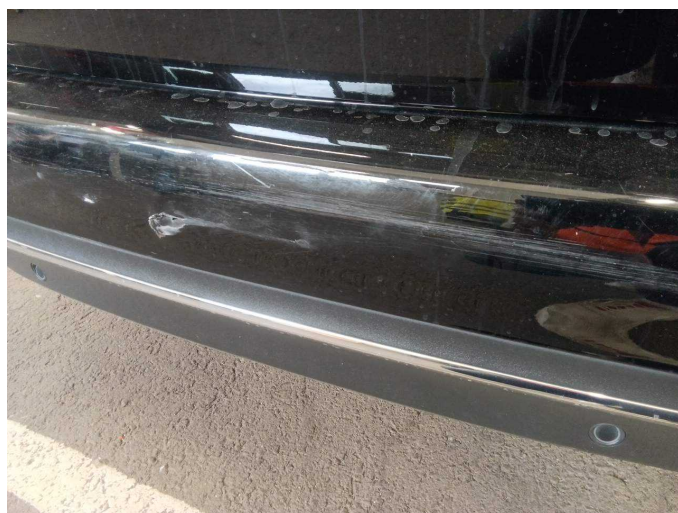
| No. | Component group | Description |
|---|---|---|
| 6 | Rear bumper | Rear bumper - Broken / torn - repair according to calculation |

Die beigefügte Reparaturkostenkalkulation wurde nach bestem Wissen und Gewissen unter eingeschränkten Besichtigungsbedingung im demontagefreien Zustand erstellt. Es können aufgrund verdeckter Beschädigung, Mehrkosten und somit Abweichung der für die Stoßstange ausgewiesenen Reparaturkosten nicht ausgeschlossen werden.

**Damage 6:** Rear bumper: Rear bumper - Broken / torn - repair according to calculation

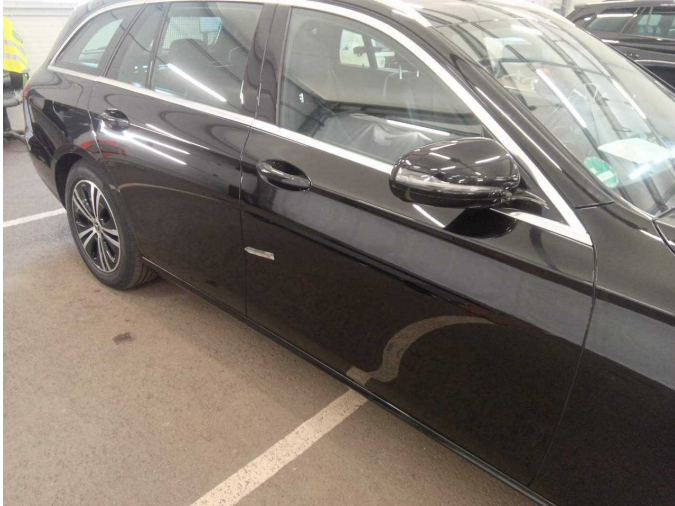
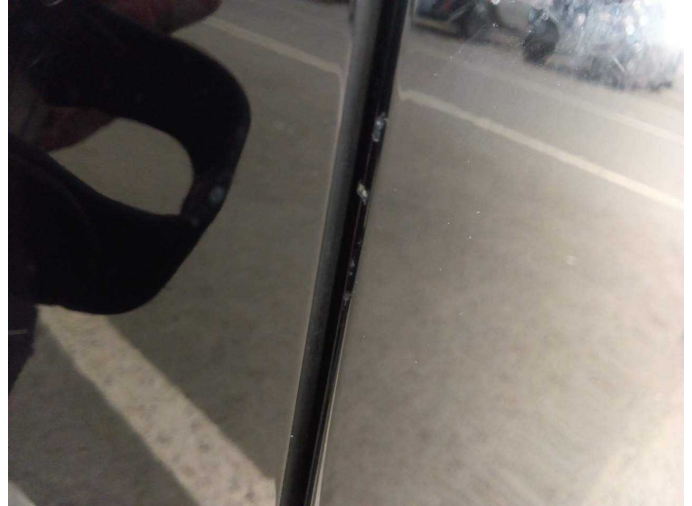
| No. | Component group | Description |
|---|---|---|
| 1 | Door - front right side | Door edge - Scratch(es) - No deduction |

**Wear and tear 1:** Door - front right side: Door edge - Scratch(es) - No deduction

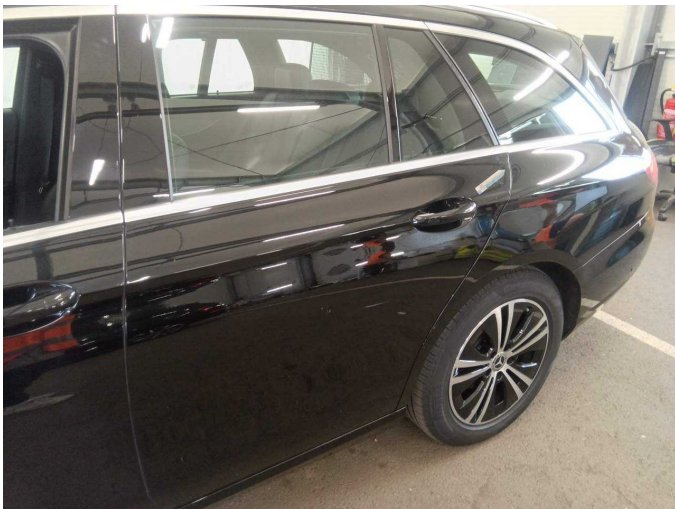
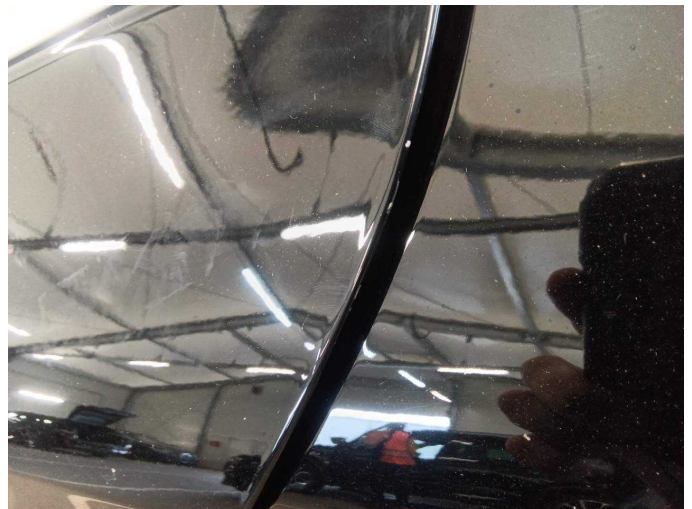
| No. | Component group | Description |
|---|---|---|
| 2 | Door - rear left side | Door edge - Scratch(es) - No deduction |

**Wear and tear 2:** Door - rear left side: Door edge - Scratch(es) - No deduction
