Expertise

Protocol number: 46339164
Order No. / Reference: 26653169
Inspection date: 2 Jul 2026

Model: Astra 1.2 Turbo Hybrid 48 V GS

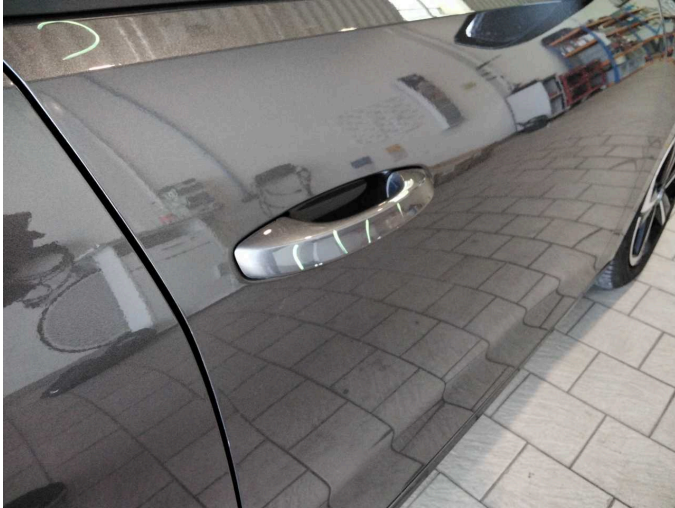
Damage 1: Door - front right side: Door handle - outside - Scratch(es) - Smart repair

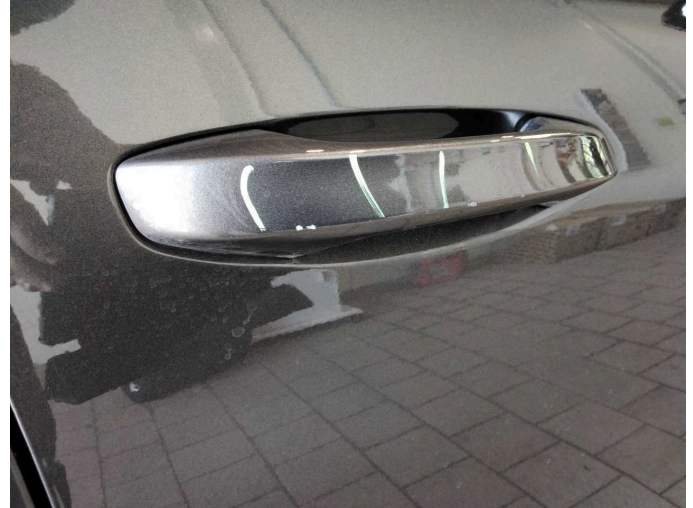
Damage 1: Door - front right side: Door handle - outside - Scratch(es) - Smart repair

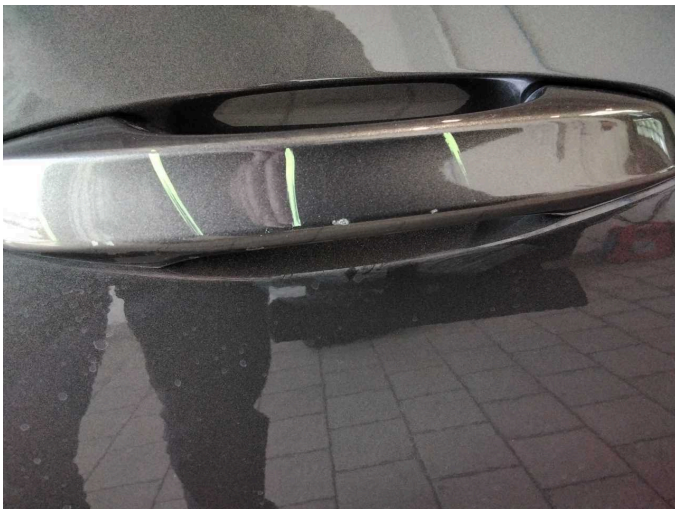
Damage 1: Door - front right side: Door handle - outside - Scratch(es) - Smart repair

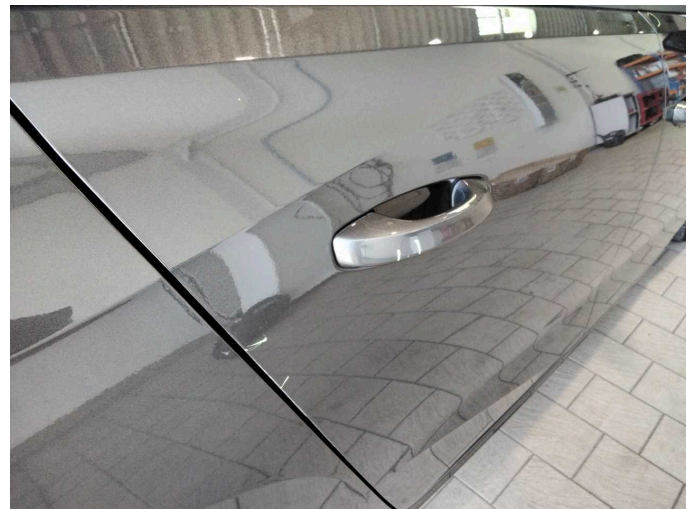
Damage 2: Door - rear right side: Door handle - outside - Scratch(es) - Smart repair

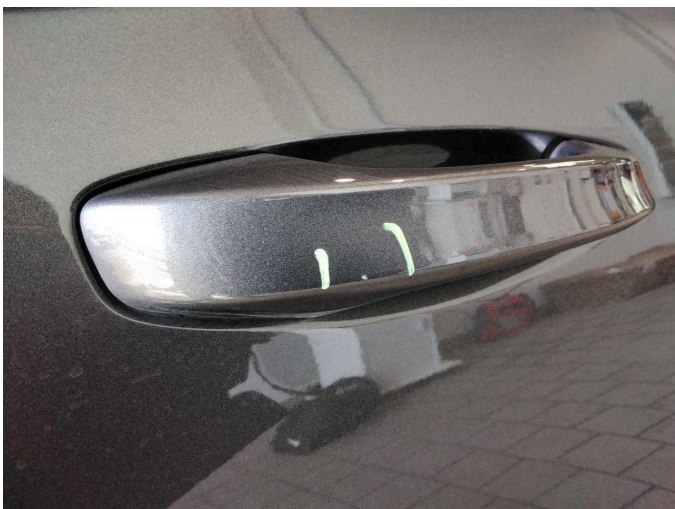
Damage 2: Door - rear right side: Door handle - outside - Scratch(es) - Smart repair

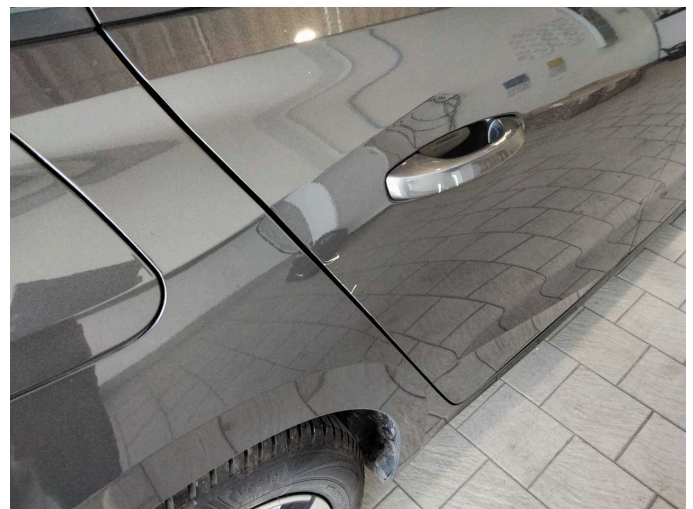
Damage 3: Door - rear right side: Door - Scratch(es) - Smart repair

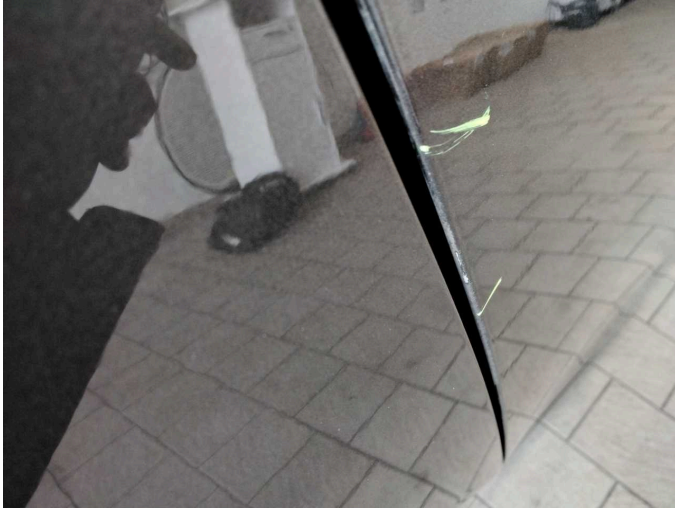
Damage 3: Door - rear right side: Door - Scratch(es) - Smart repair

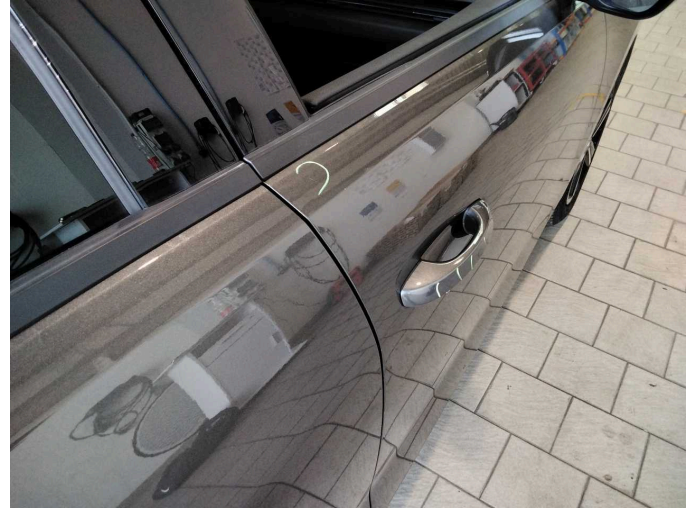
Damage 4: Door - front right side: Door - Scratch(es) - Smart repair

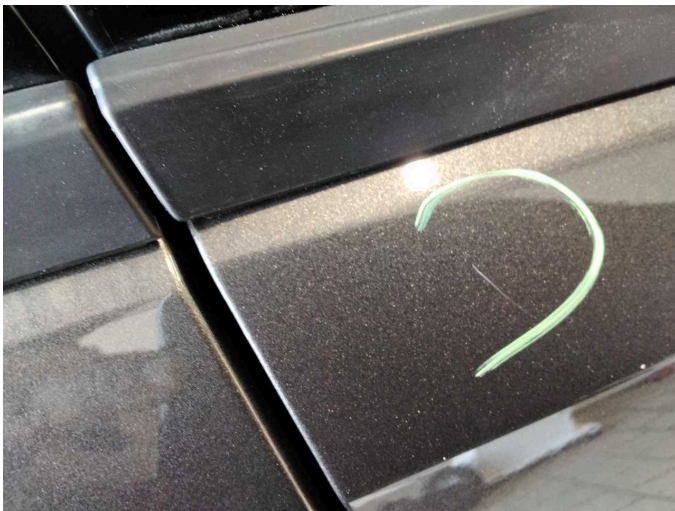
Damage 4: Door - front right side: Door - Scratch(es) - Smart repair

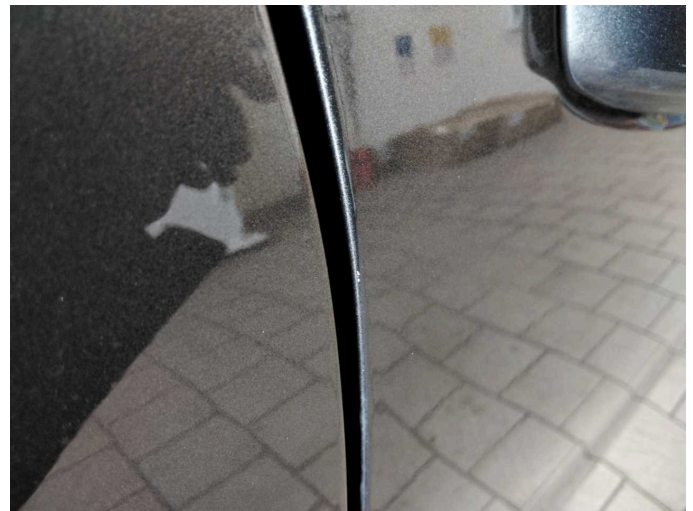
Damage 4: Door - front right side: Door - Scratch(es) - Smart repair

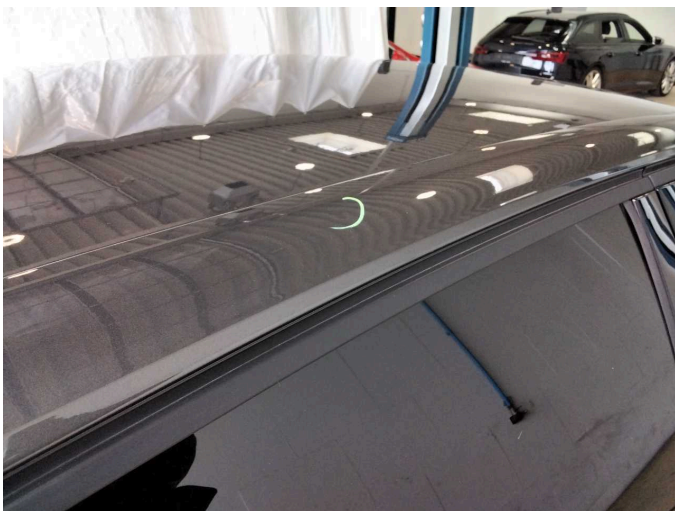
Damage 5: Roof: Roof rail - right side - dent(s) - Smooth repair work

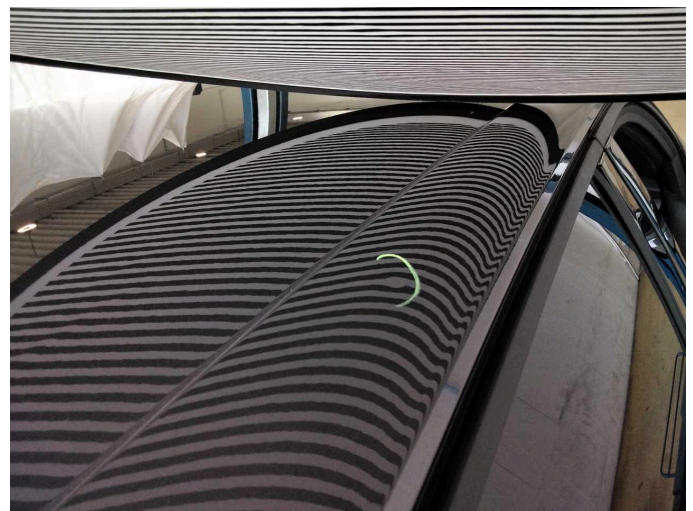
Damage 5: Roof: Roof rail - right side - dent(s) - Smooth repair work

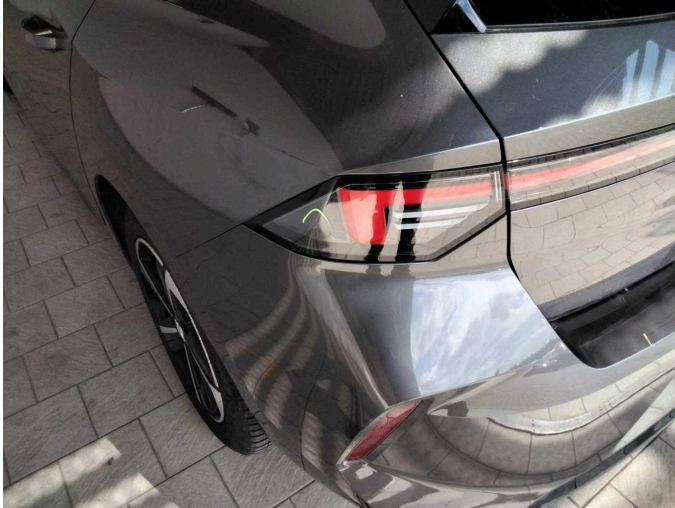
Damage 6: Tail light: Tail lamp - left side - Scratch(es) - Loss in value

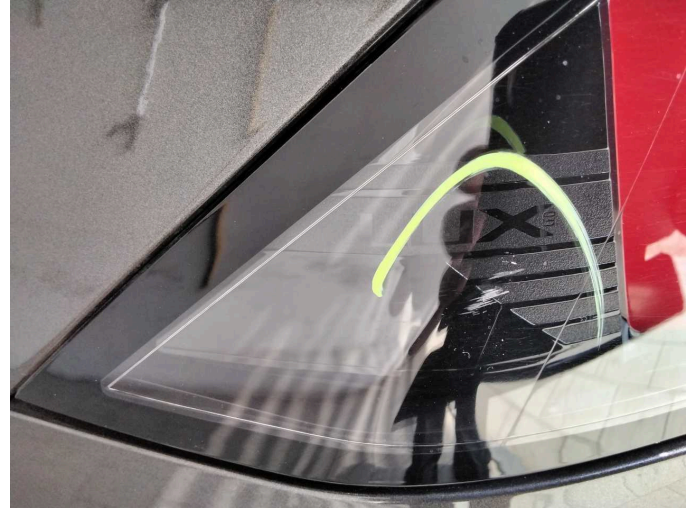
Damage 6: Tail light: Tail lamp - left side - Scratch(es) - Loss in value

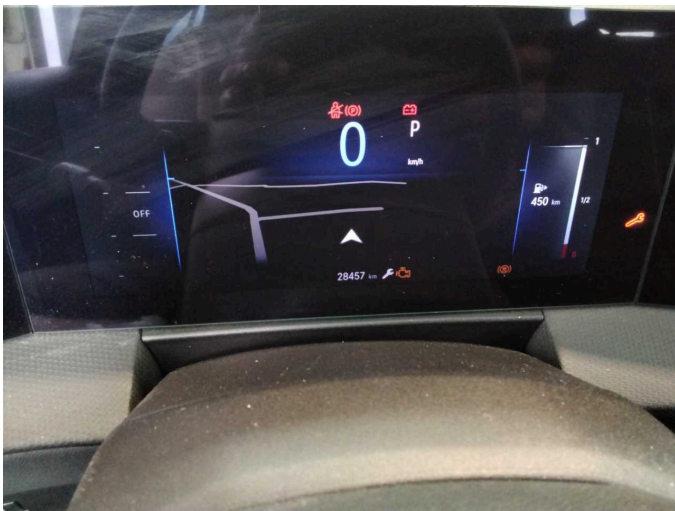
Documents submitted	At the time of the inspection, the vehicle registration certificate Part 2 (title) was available, but the vehicle registration certificate Part 1 (document) was not. (Copy)
VIN comparison	The vehicle identification number (VIN) was read from the vehicle and its conformity with the submitted documents was confirmed by the undersigned during the inspection.
Inspection	The inspection conditions were sufficient for the assessment of the vehicle. No lifting equipment or pit was available for inspecting the vehicle. Therefore, inspection of the vehicle's underside was only possible to a limited extent.
Test drive	No test drive/shunting maneuver was carried out during the inspection of the vehicle.
Engine function test	An engine test run was performed, problem has been detected This is due to the following reason.: Motorkontrolle leuchtet

Damage 7: Instrument panel: Indicator light (Motorkontrolle, nicht fahrbereit) - on - Perform diagnosis

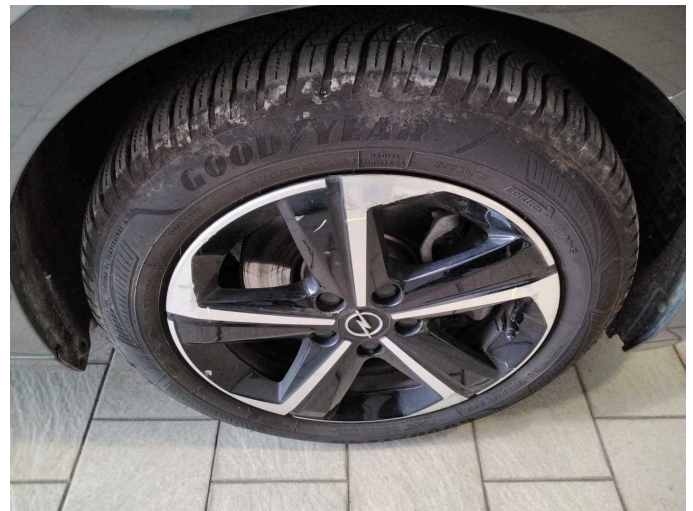
Damage 8: Wheel / tyres: Alloy rim - front right side - Scratch(es) - Replace

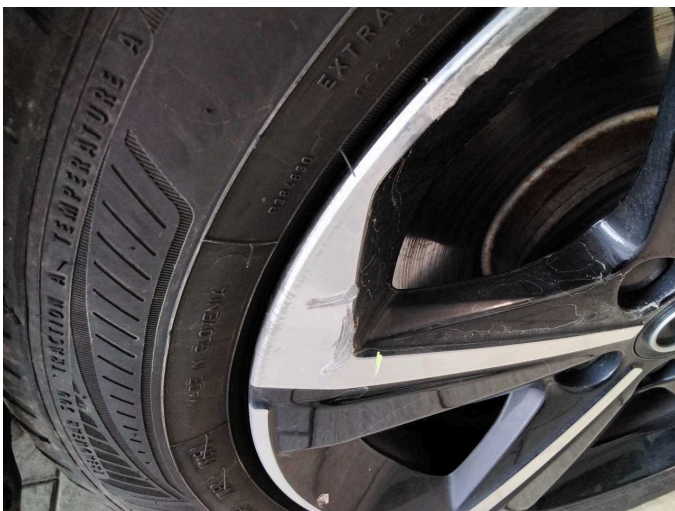
Damage 8: Wheel / tyres: Alloy rim - front right side - Scratch(es) - Replace

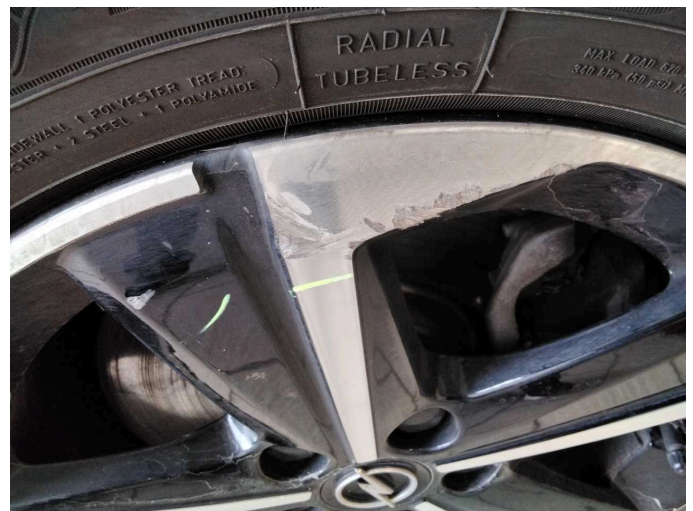
Damage 8: Wheel / tyres: Alloy rim - front right side - Scratch(es) - Replace

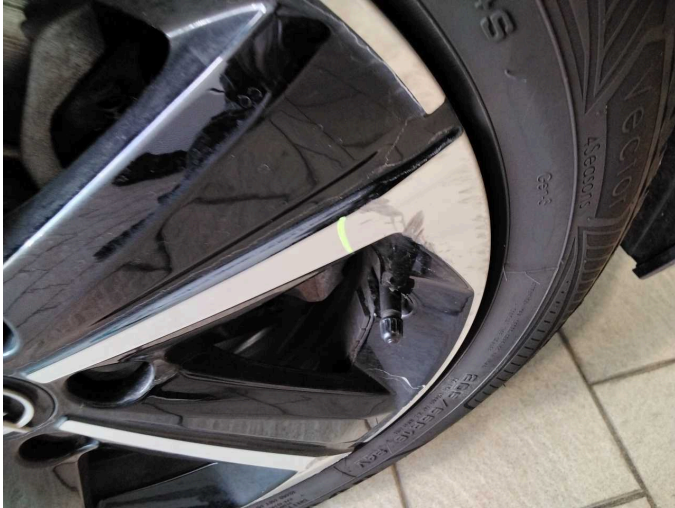
Damage 8: Wheel / tyres: Alloy rim - front right side - Scratch(es) - Replace

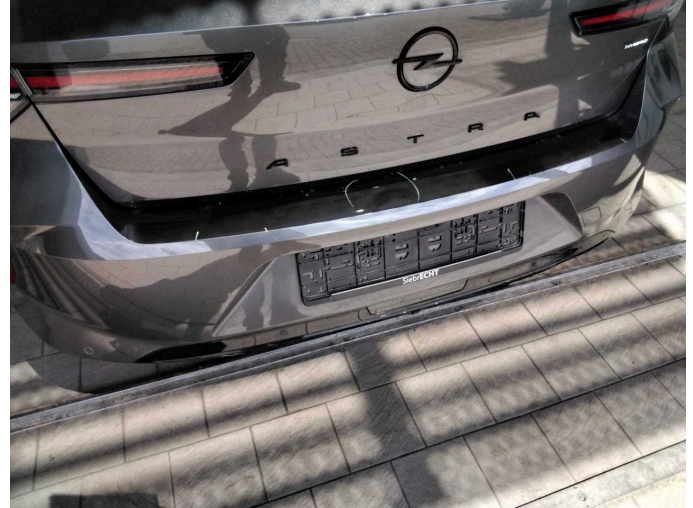
Damage 9: Rear bumper: Rear bumper - Dent / paintcoat damage - Repair and paint

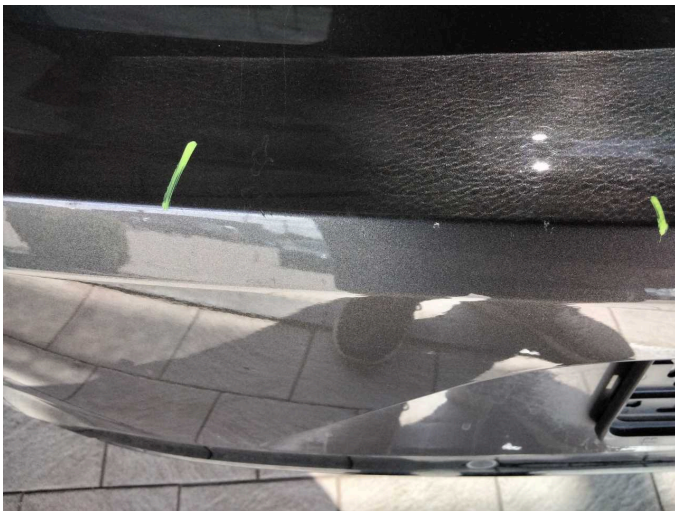
Damage 9: Rear bumper: Rear bumper - Dent / paintcoat damage - Repair and paint

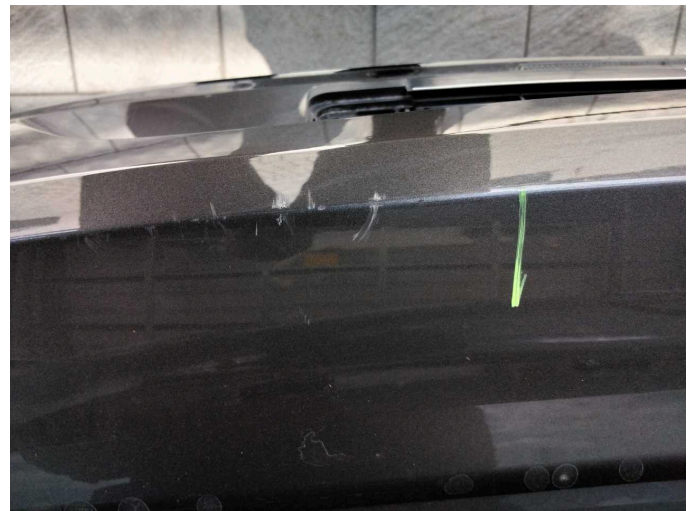
Damage 9: Rear bumper: Rear bumper - Dent / paintcoat damage - Repair and paint

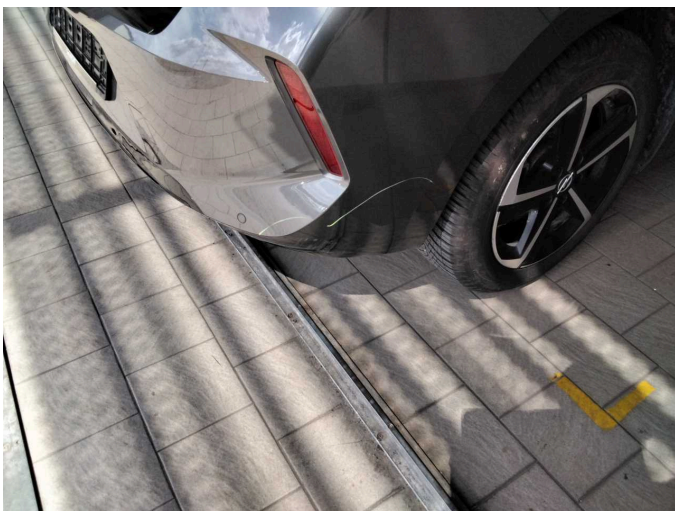
Damage 9: Rear bumper: Rear bumper - Dent / paintcoat damage - Repair and paint

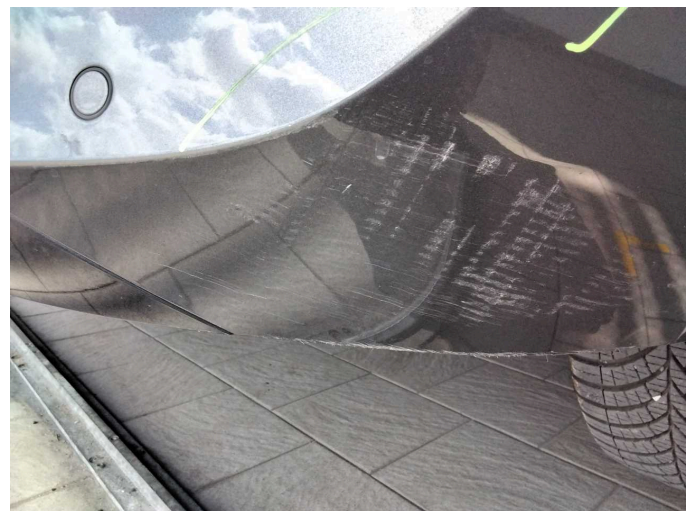
Damage 9: Rear bumper: Rear bumper - Dent / paintcoat damage - Repair and paint

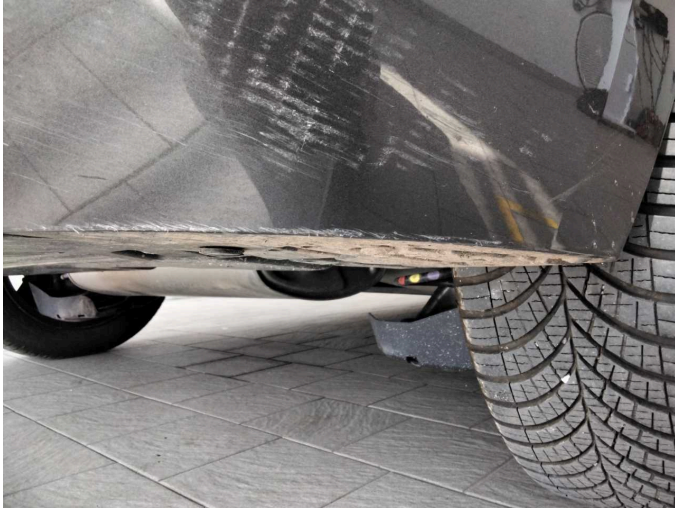
Damage 9: Rear bumper: Rear bumper - Dent / paintcoat damage - Repair and paint

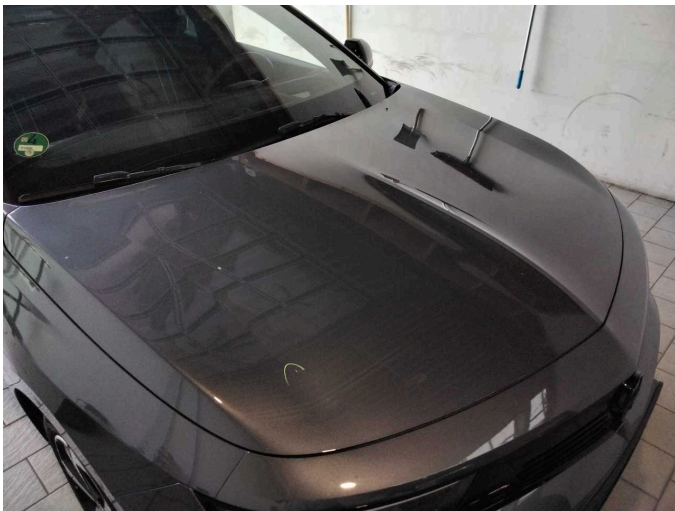
Damage 10: Bonnet: Bonnet - Scratch(es) - Paint

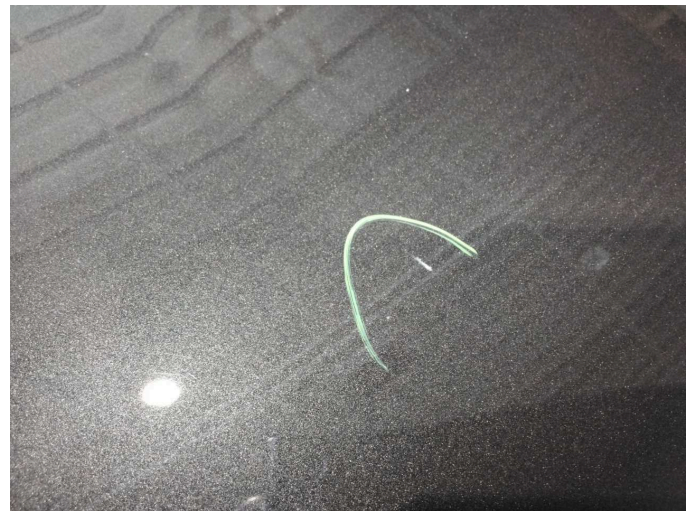
Damage 10: Bonnet: Bonnet - Scratch(es) - Paint

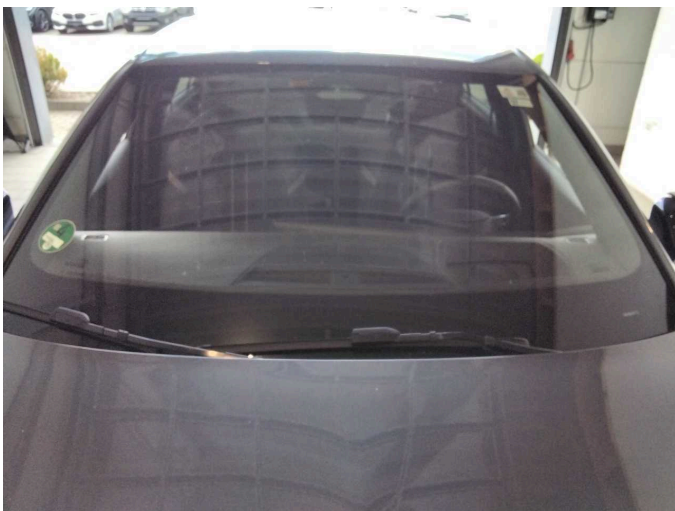
Wear and tear 1: Vehicle glazing: Windscreen - Stone chips - No deduction
