Expertise

Protocol number: 46844895  
Order No. / Reference: 26816532  
Inspection date: 3 Aug 2026

Manufacturer: Mercedes-Benz  
VIN: W1VVKFZ1P4281925

Model: EQV 300 lang

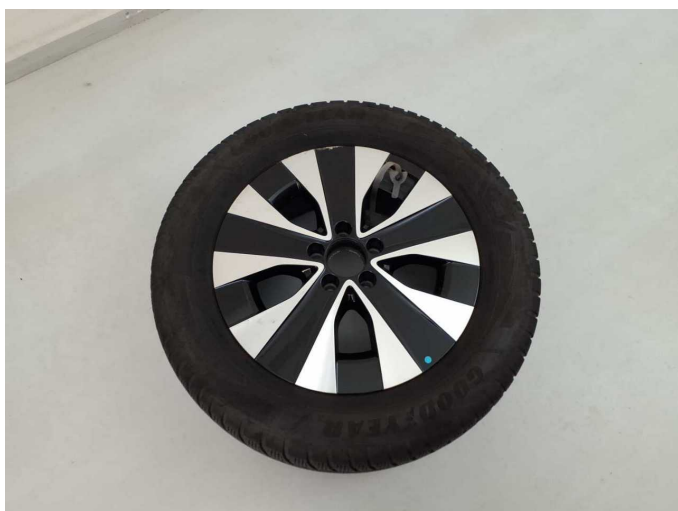
| No. | Component group | Description |
|---|---|---|
| 1 | 2nd wheel set | 1 alloy rim - Scratched - No deduction |

Damage 1: 2nd wheel set: 1 alloy rim - Scratched - No deduction

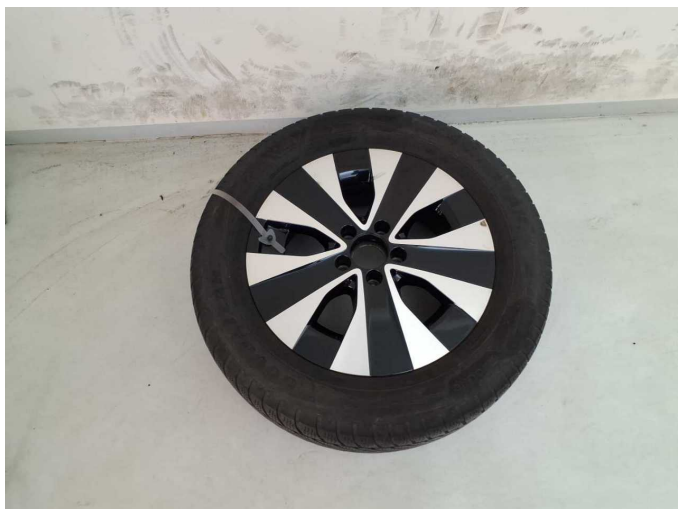
| No. | Component group | Description |
|---|---|---|
| 2 | 2nd wheel set | 1 alloy rim - Scratch(es) - No deduction |

**Damage 2:** 2nd wheel set: 1 alloy rim - Scratch(es) - No deduction

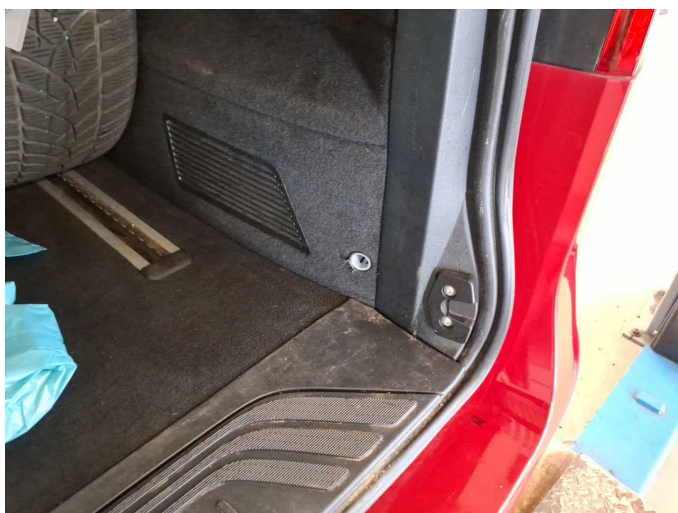
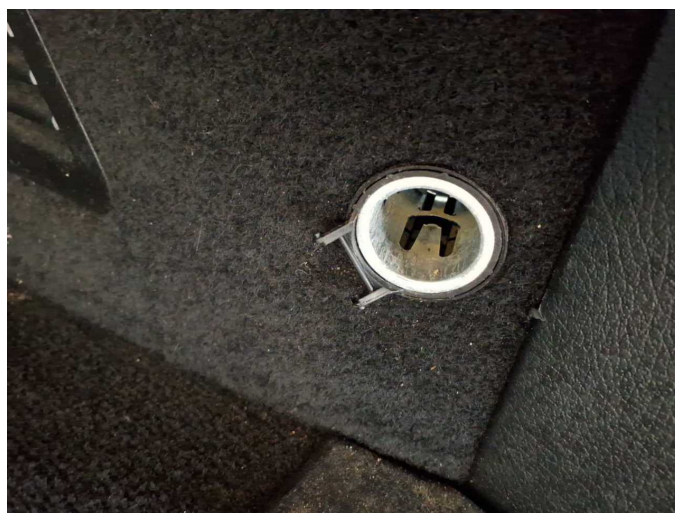
| No. | Component group | Description |
|---|---|---|
| 3 | Electrical system | Power socket (Laderaum - Deckel fehlt) - Broken / torn - Replace |

**Damage 3:** Electrical system: Power socket (Laderaum - Deckel fehlt) - Broken / torn - Replace

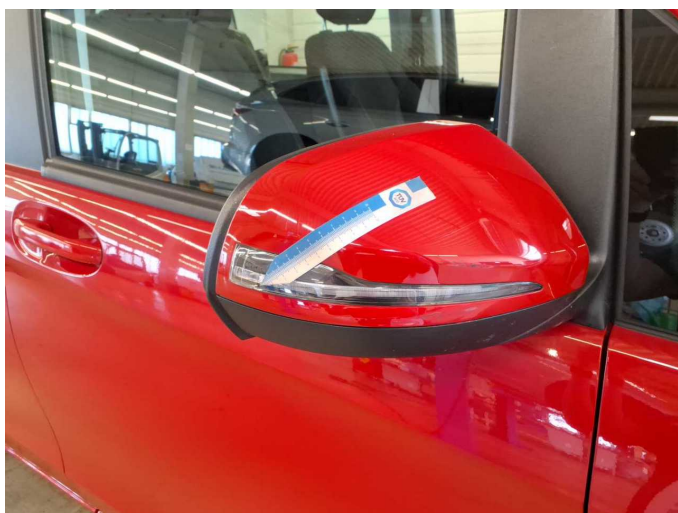
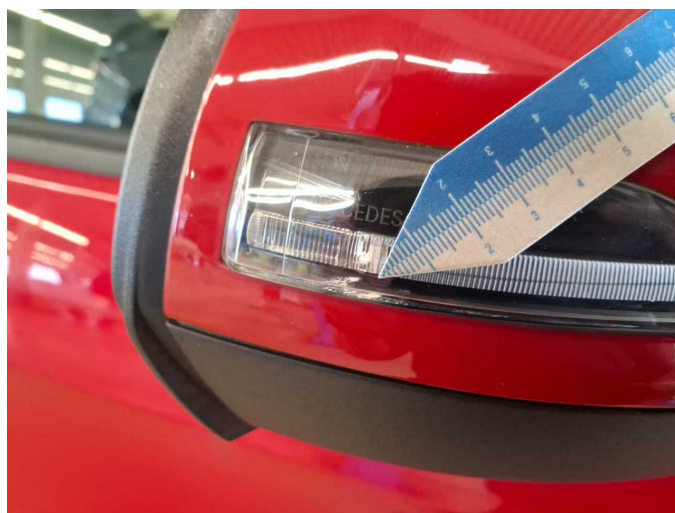
| No. | Component group | Description |
|---|---|---|
| 4 | Indicator - front | Mirror - right side - Scratched - Replace |

**Damage 4:** Indicator - front: Mirror - right side - Scratched - Replace

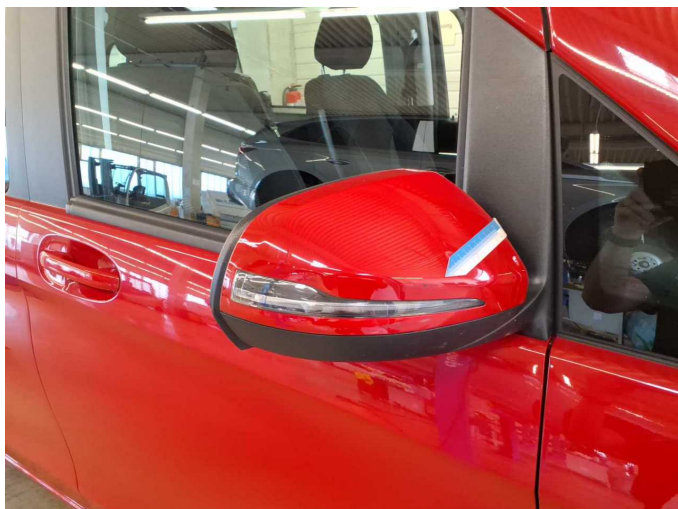
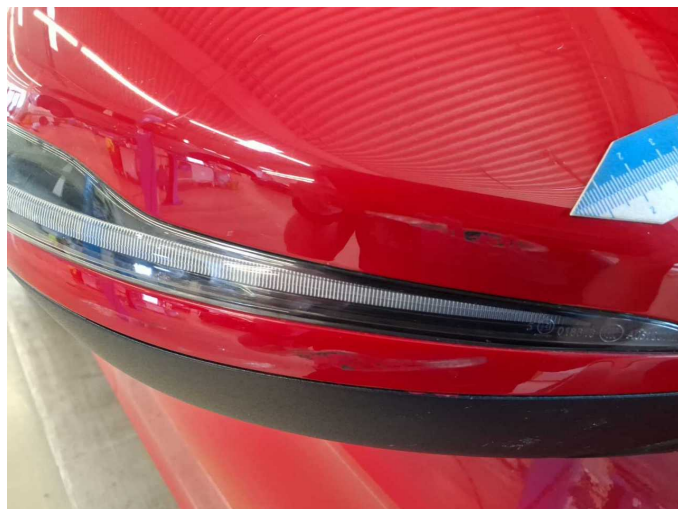
| No. | Component group | Description |
|---|---|---|
| 5 | Wing mirror - right side | Cap - Scratched - Paint |

**Damage 5:** Wing mirror - right side: Cap - Scratched - Paint

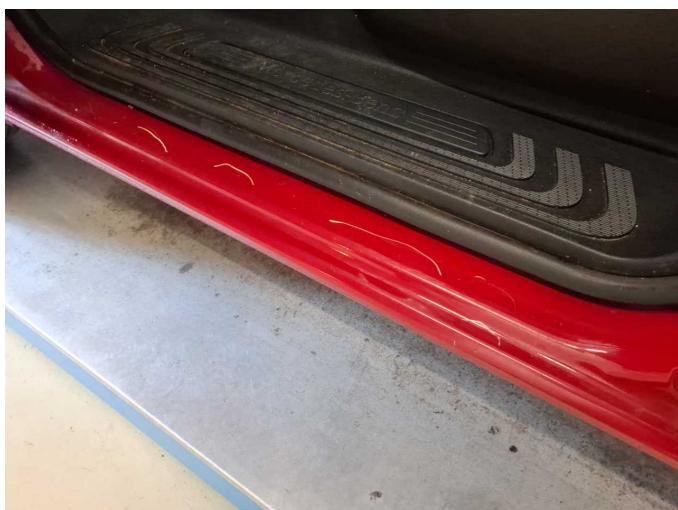
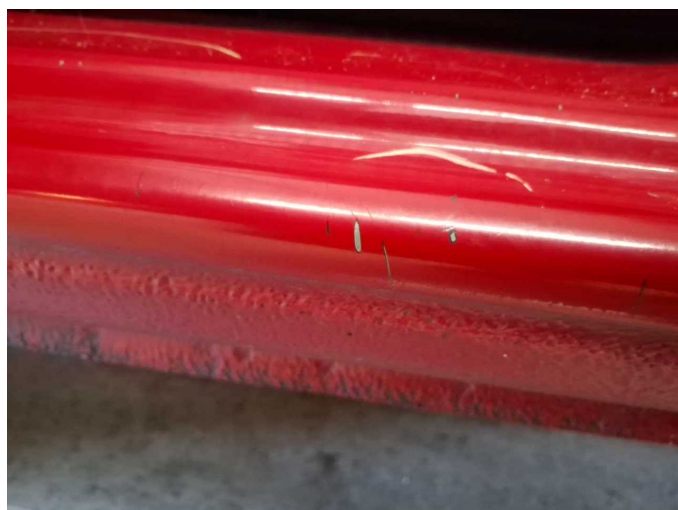
| No. | Component group | Description |
|---|---|---|
| 6 | Sill - left side | Sill - Scratch(es) - Smart repair |

**Damage 6:** Sill - left side: Sill - Scratch(es) - Smart repair

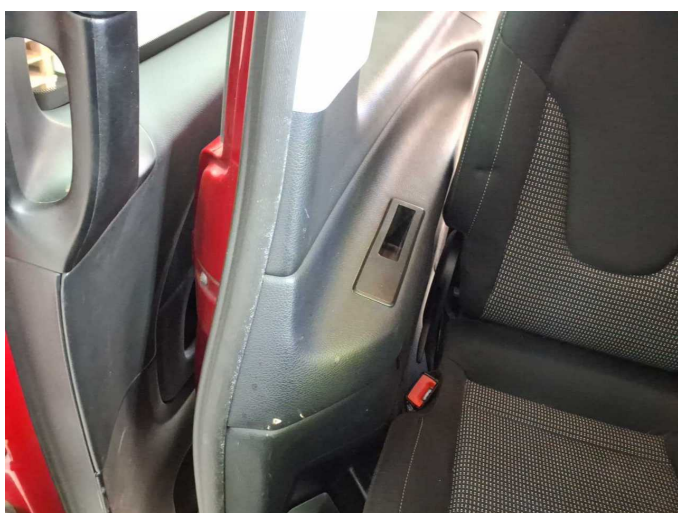
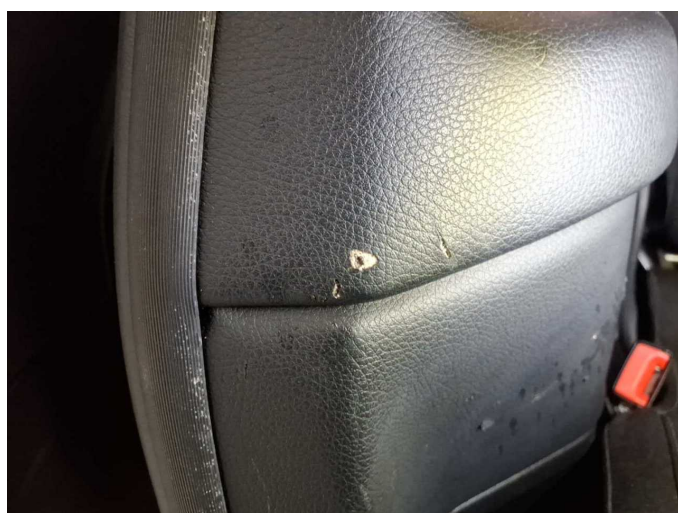
| No. | Component group | Description |
|---|---|---|
| 7 | Side panel - rear right side | Interior trim - Damaged - Smart repair |

**Damage 7:** Side panel - rear right side: Interior trim - Damaged - Smart repair

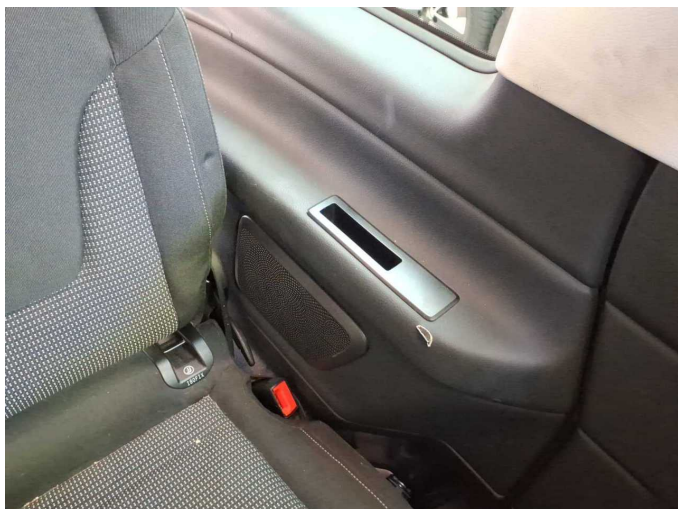
| No. | Component group | Description |
|---|---|---|
| 8 | Side panel - rear left side | Interior trim - Damaged - Smart repair |

**Damage 8:** Side panel - rear left side: Interior trim - Damaged - Smart repair

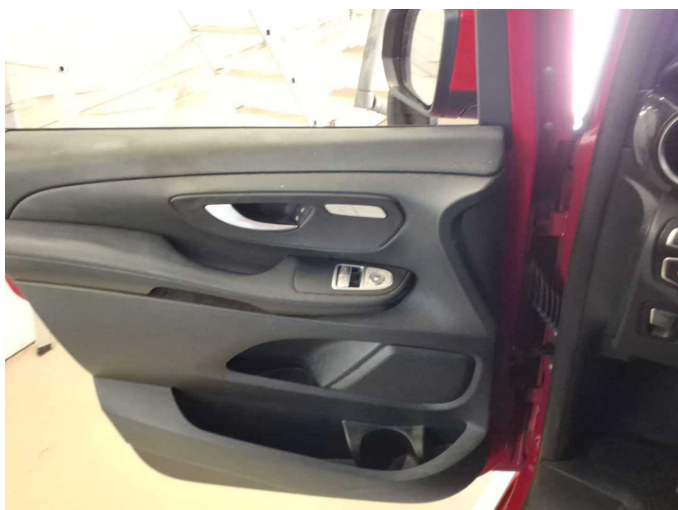
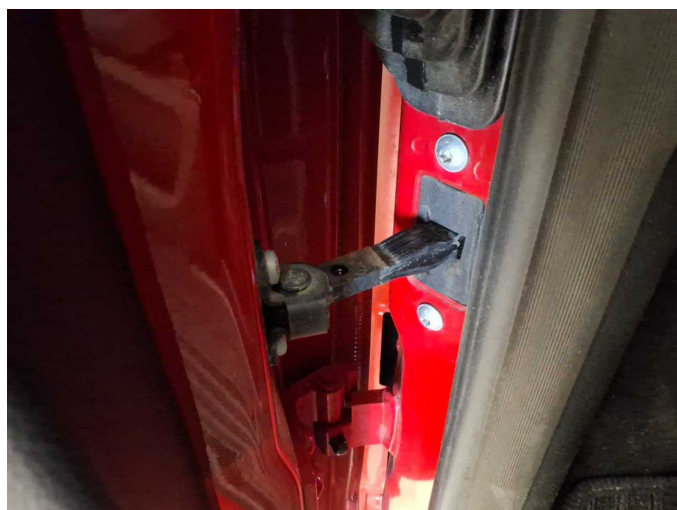
| No. | Component group | Description |
|---|---|---|
| 9 | Door - front left side | Door check strap / arrestor - Noise - Replace |

**Damage 9:** Door - front left side: Door check strap / arrestor - Noise - Replace

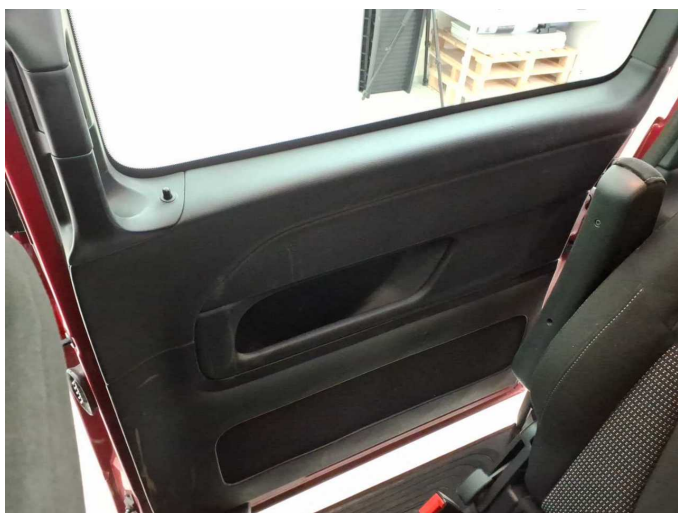
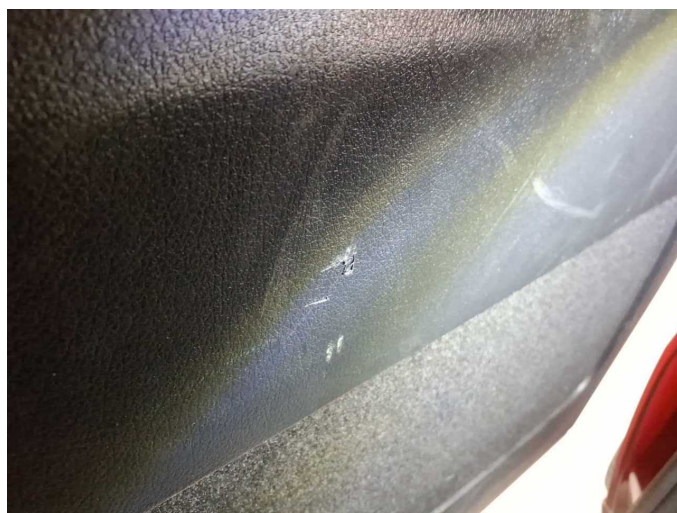
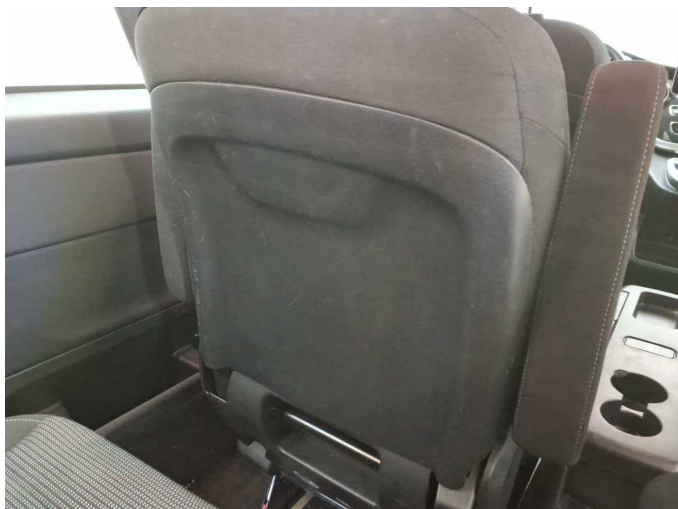
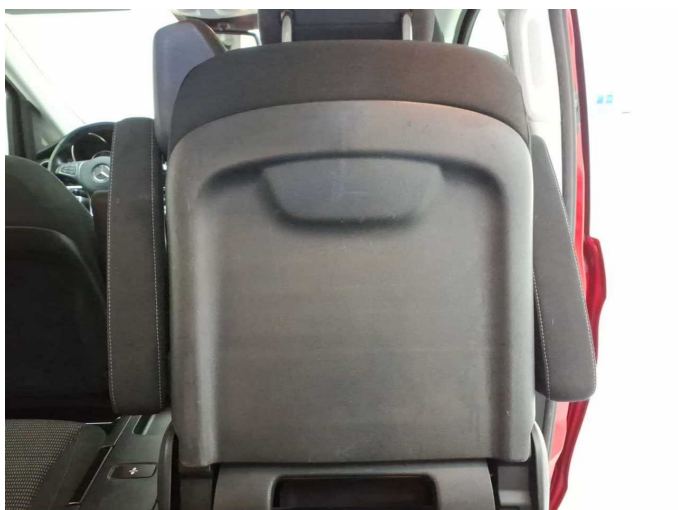
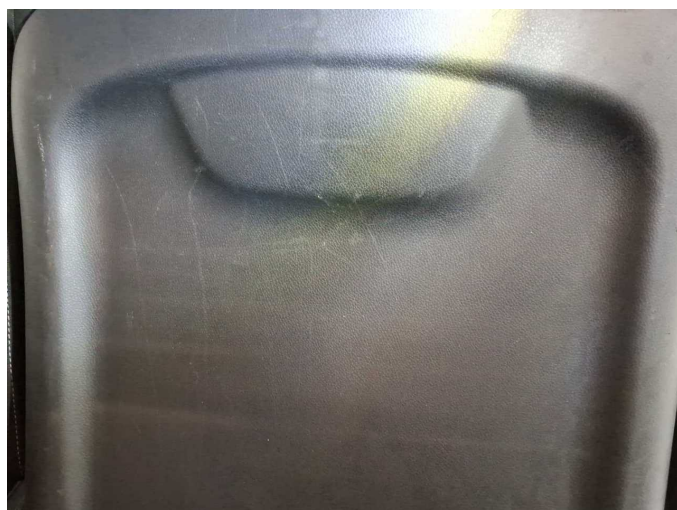
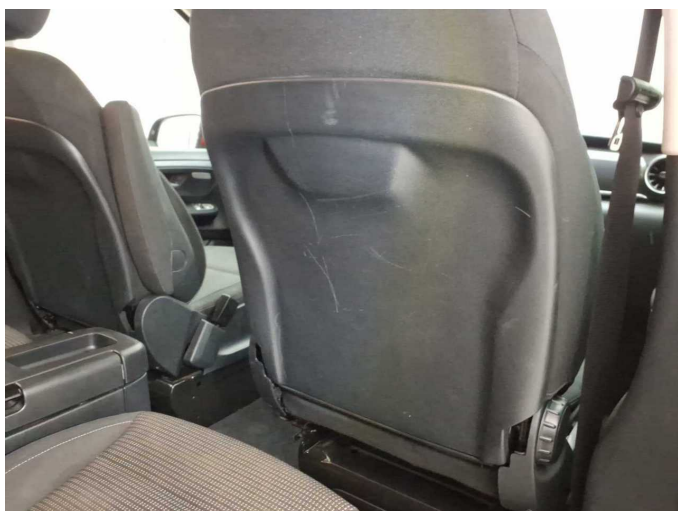
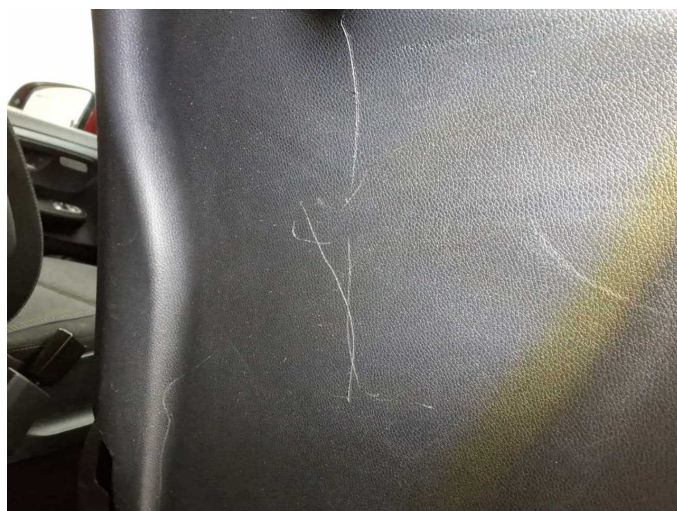
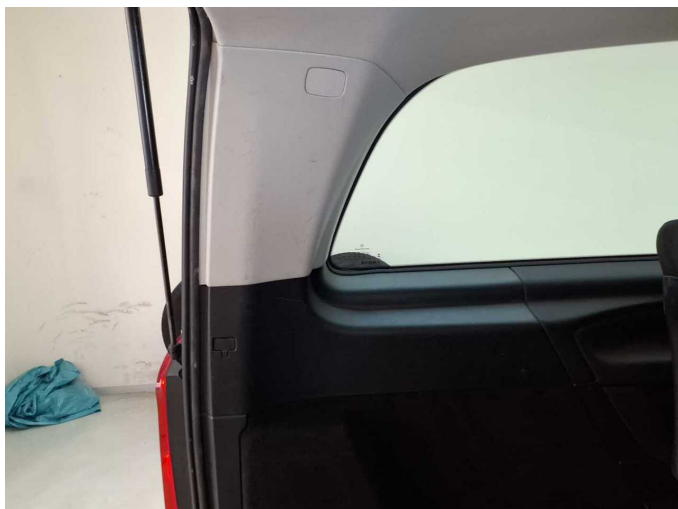
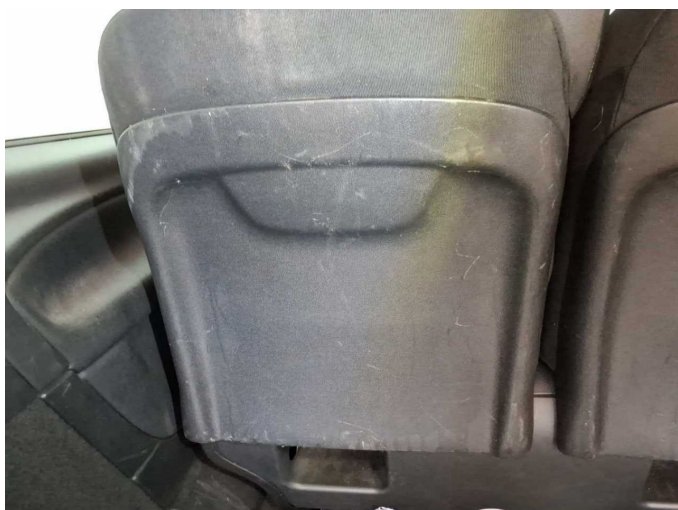
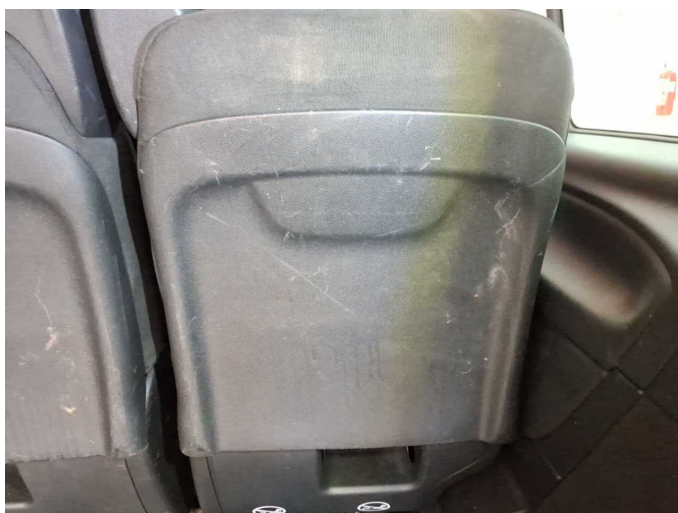
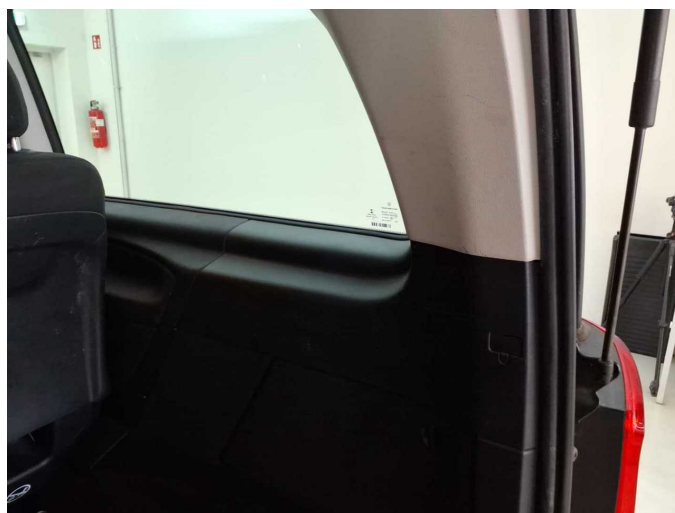
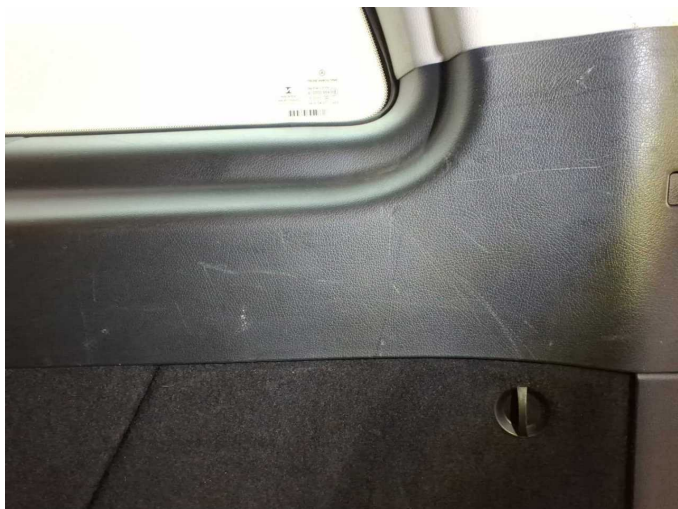
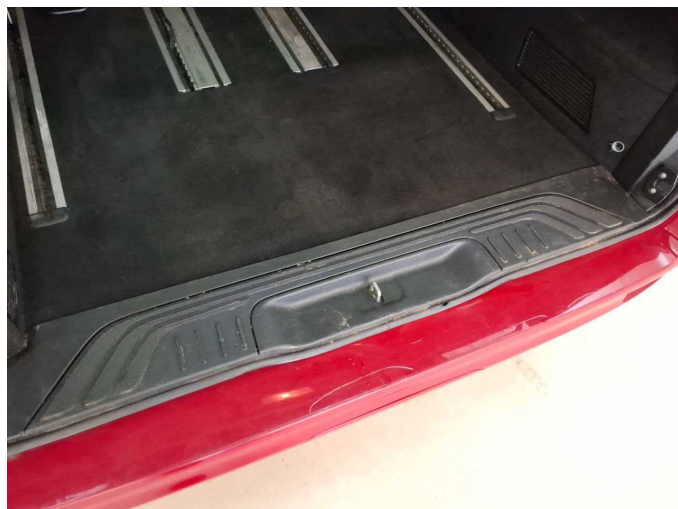
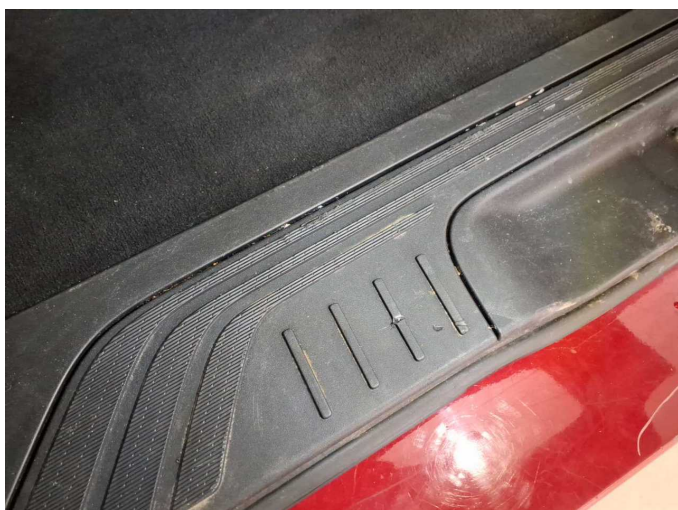
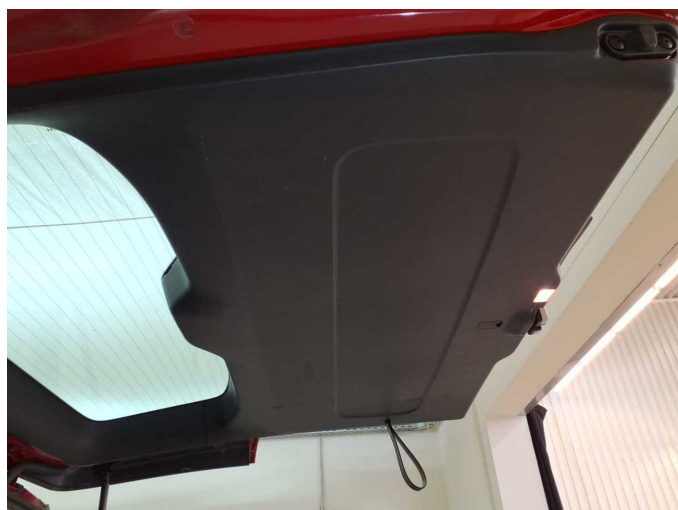
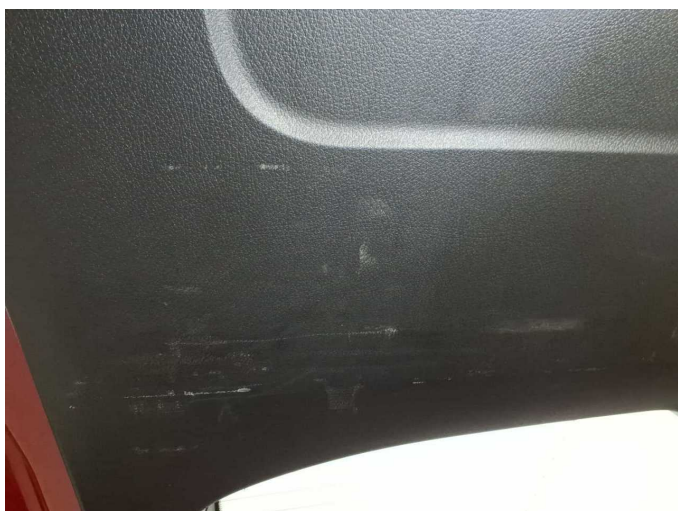
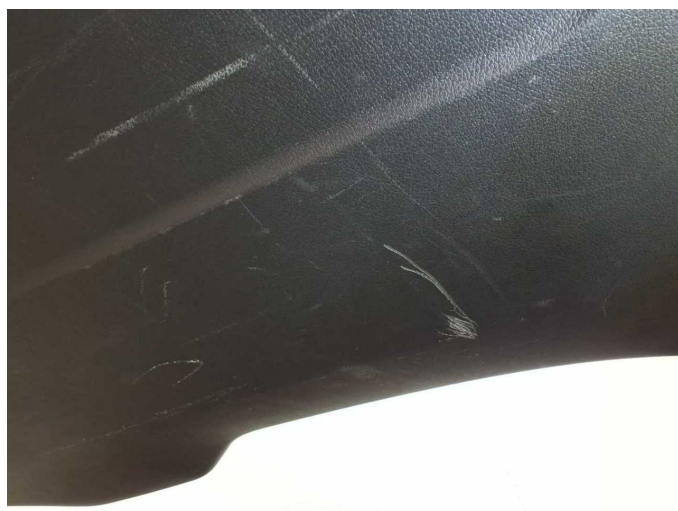
| No. | Component group | Description |
|---|---|---|
| 10 | Trim / covers | Trim / covers (Innenraum) - Scratched - Loss in value |

**Damage 10:** Trim / covers: Trim / covers (Innenraum) - Scratched - Loss in value

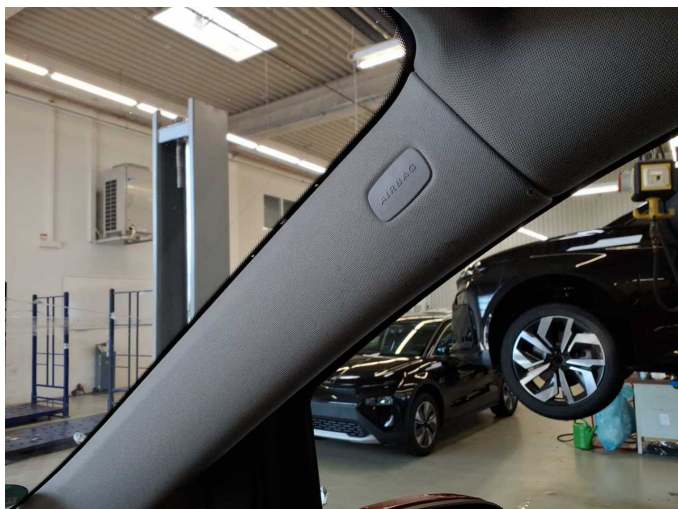
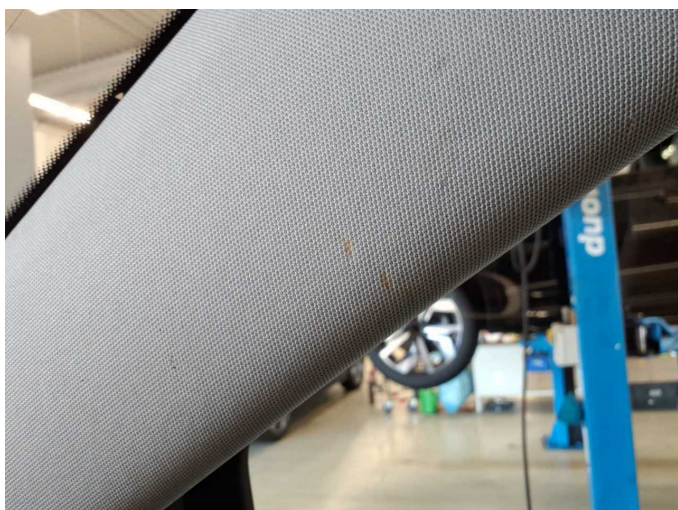
| No. | Component group | Description |
|---|---|---|
| 11 | Trim / covers | A-pillar - interior trim - right side - Damaged - Replace |

**Damage 11:** Trim / covers: A-pillar - interior trim - right side - Damaged - Replace

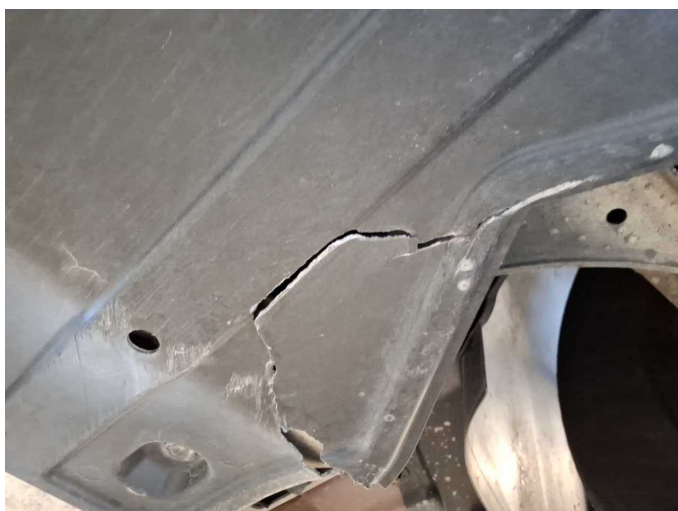
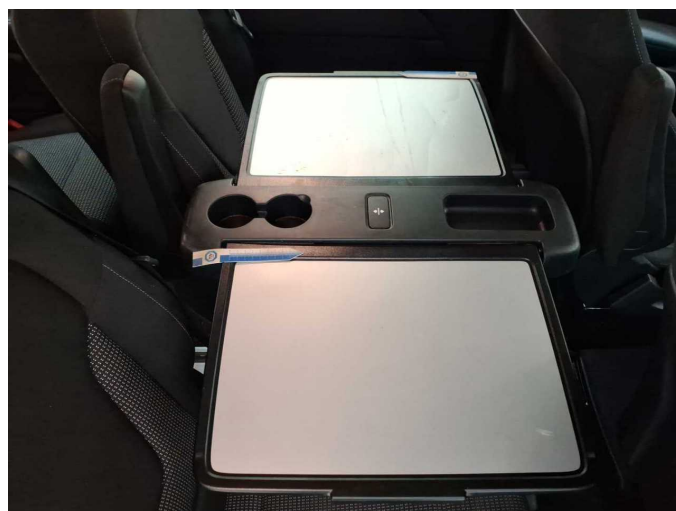
| No. | Component group | Description |
|---|---|---|
| 12 | Engine | Engine cowling lower front - Broken / torn - Replace |

**Damage 12:** Engine: Engine cowling lower front - Broken / torn - Replace

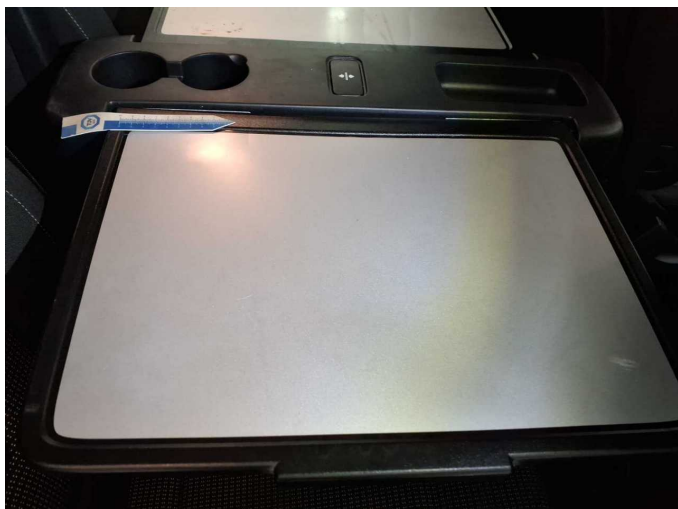
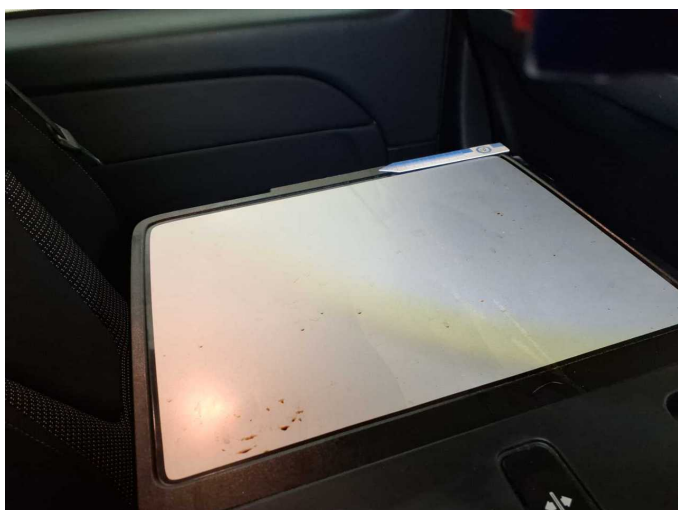
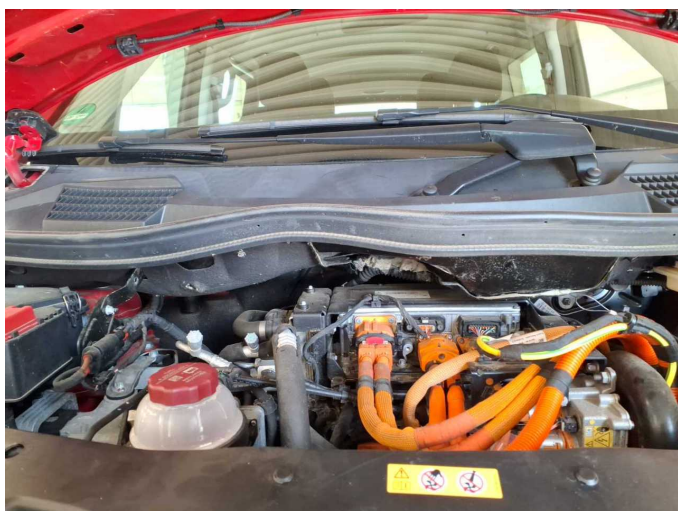
| No. | Component group | Description |
|---|---|---|
| 13 | Equipment | tabletop (+ verschmutzt) - Scratched - Replace |

**Damage 13:** Equipment: tabletop (+ verschmutzt) - Scratched - Replace

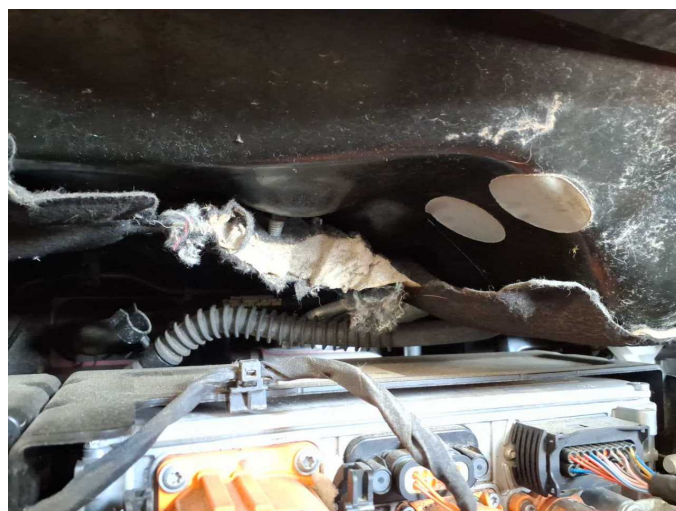
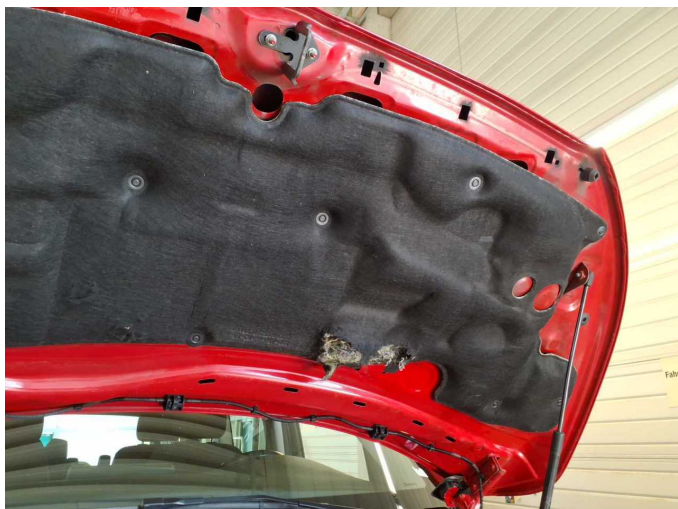
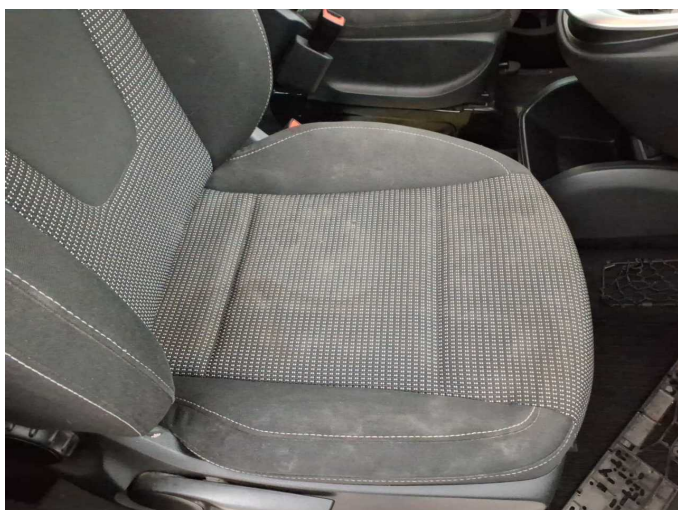
| No. | Component group | Description |
|---|---|---|
| 14 | Cab | Insulation lining (+ Motorhaube) - Damage caused by marten / rodent - Replace |

**Damage 14:** Cab: Insulation lining (+ Motorhaube) - Damage caused by marten / rodent - Replace

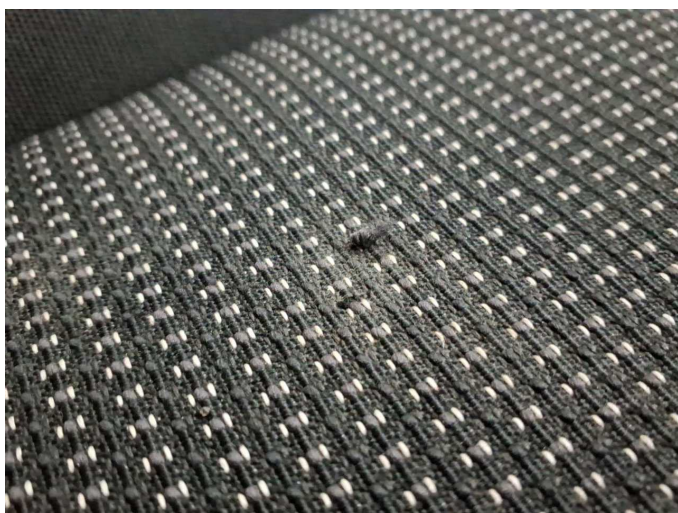
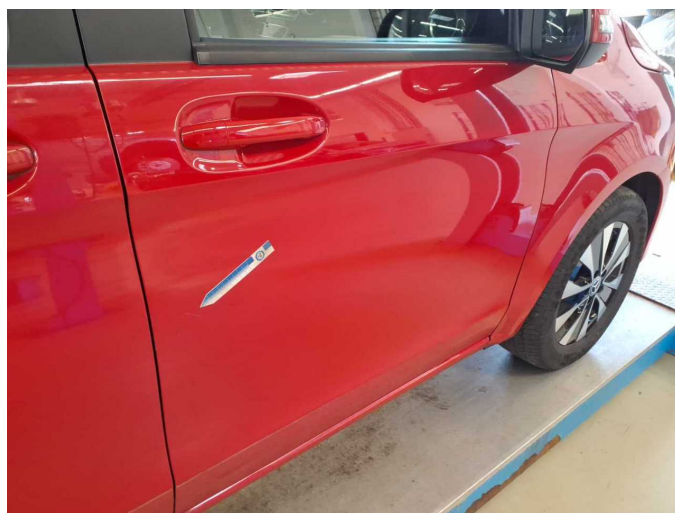
| No. | Component group | Description |
|---|---|---|
| 15 | Seat - front | Seat cover - right side (+ verschmutzt) - Damaged - Replace |

**Damage 15:** Seat - front: Seat cover - right side (+ verschmutzt) - Damaged - Replace

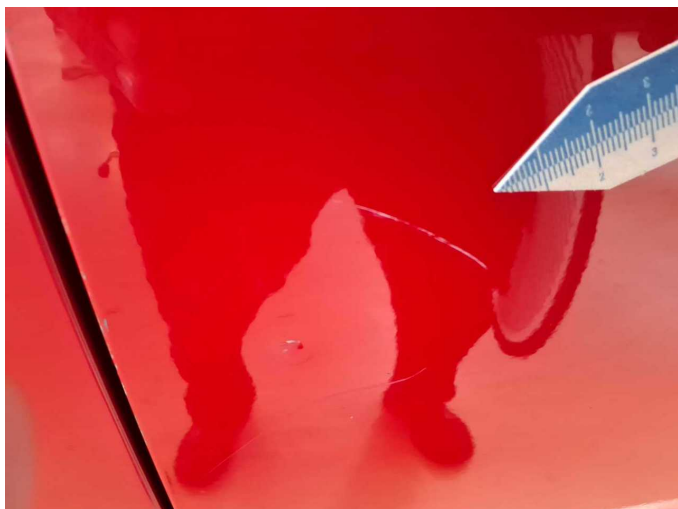
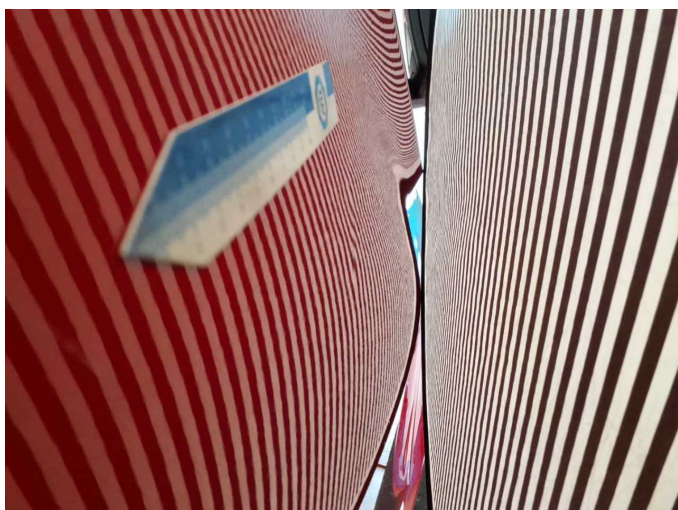
| No. | Component group | Description |
|---|---|---|
| 16 | Door - front right side | Door - Dent / paintcoat damage - Repair and paint |

**Damage 16:** Door - front right side: Door - Dent / paintcoat damage - Repair and paint

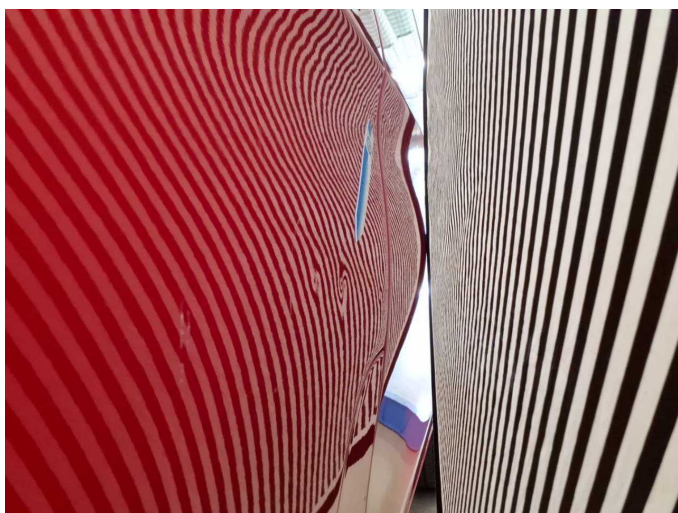
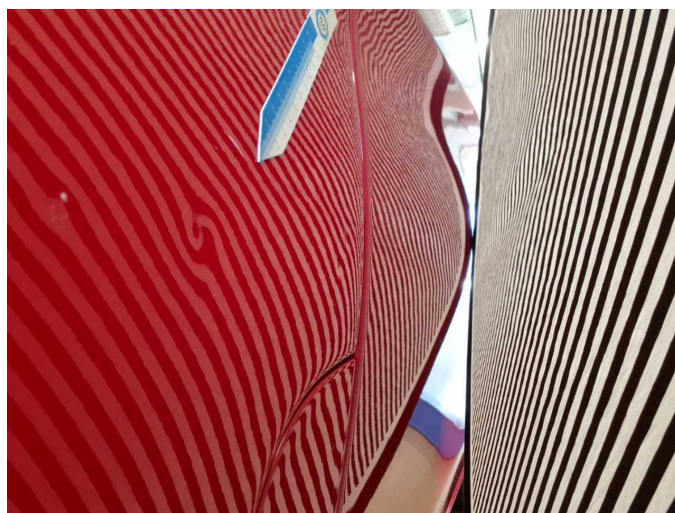
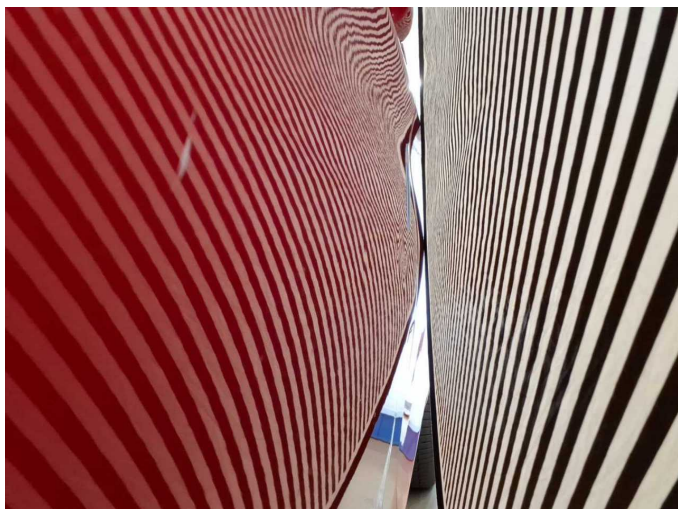
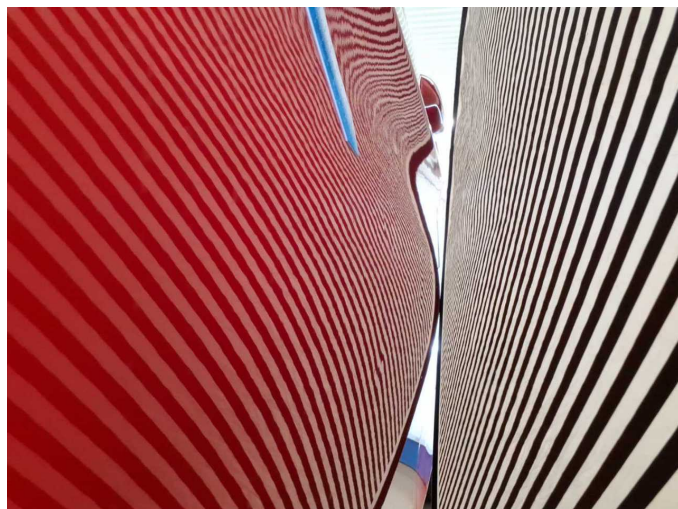
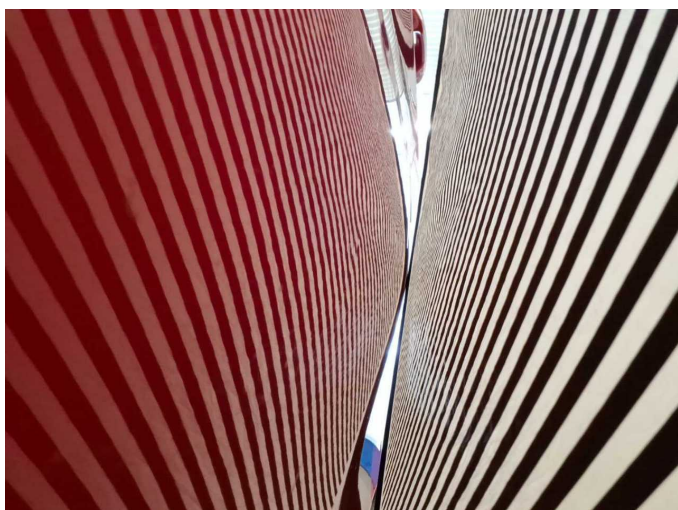
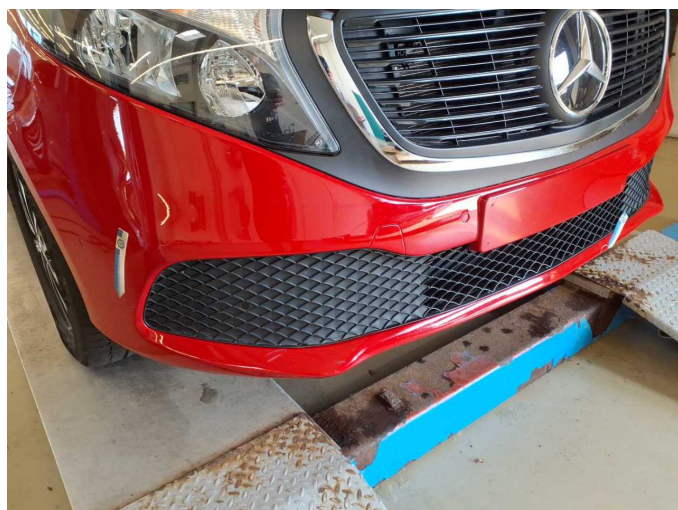
| No. | Component group | Description |
|---|---|---|
| 17 | Door - front left side | Door (wellig + Folgeschaden) - Unprofessionally repaired - Repair and paint |

| No. | Repainting |
|---|---|
| 1 | Side panel - rear left side, Door - front left side, Unprofessionally carried out |

| Side panel - rear left side | 1,290<br>µm | Door - front left side | 284 µm |

**Damage 17:** Door - front left side: Door (wellig + Folgeschaden) - Unprofessionally repaired - Repair and paint

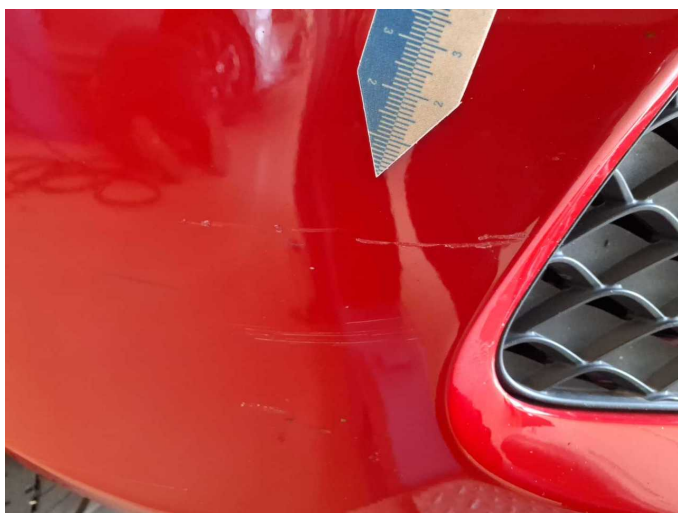
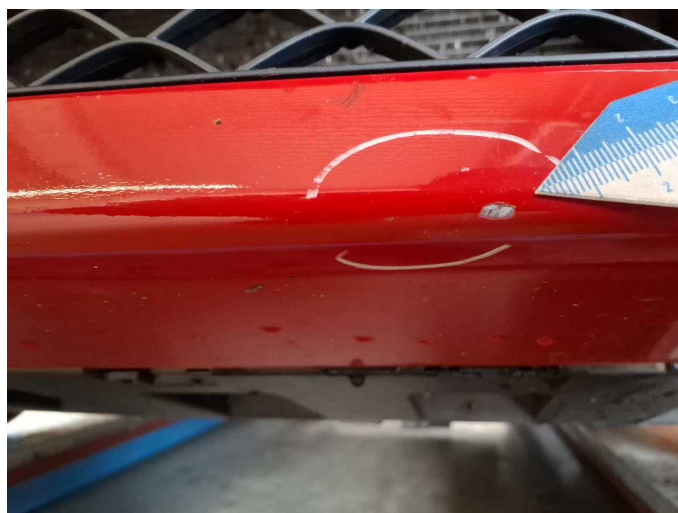
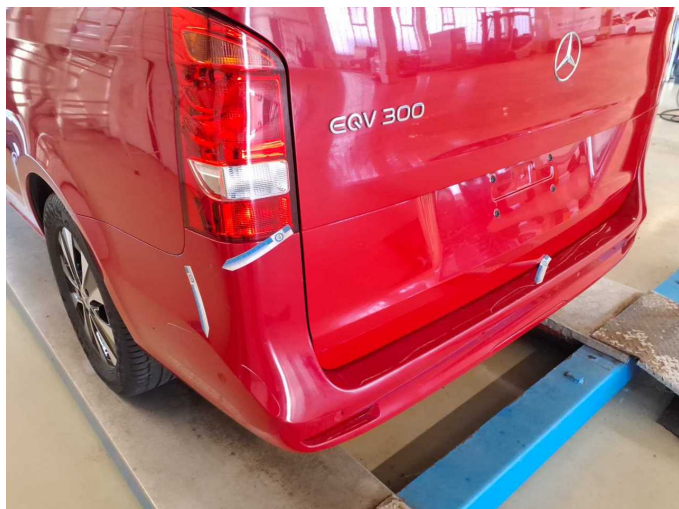
| No. | Component group | Description |
|---|---|---|
| 18 | Front bumper | Bumper with Parktronic - Scratch(es) - Paint |

**Damage 18:** Front bumper: Bumper with Parktronic - Scratch(es) - Paint

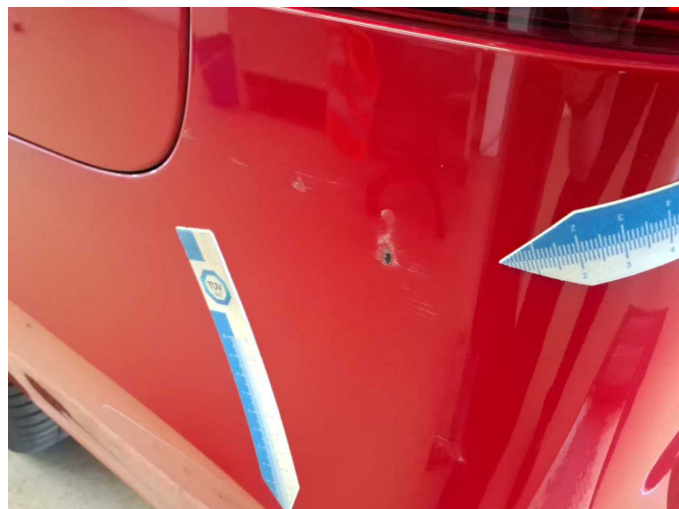
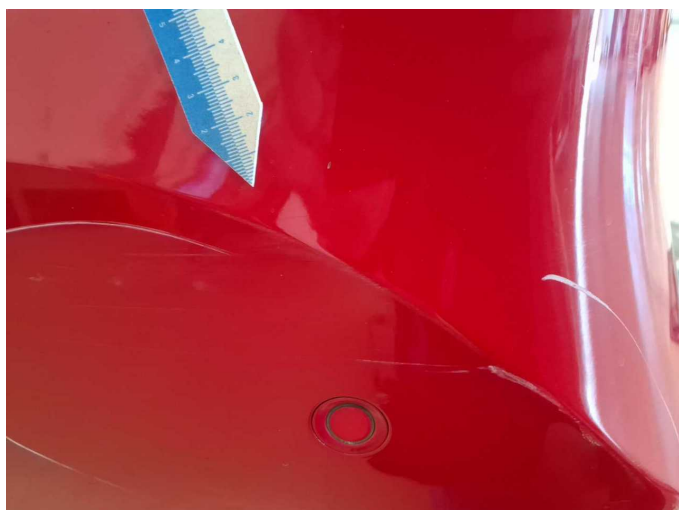
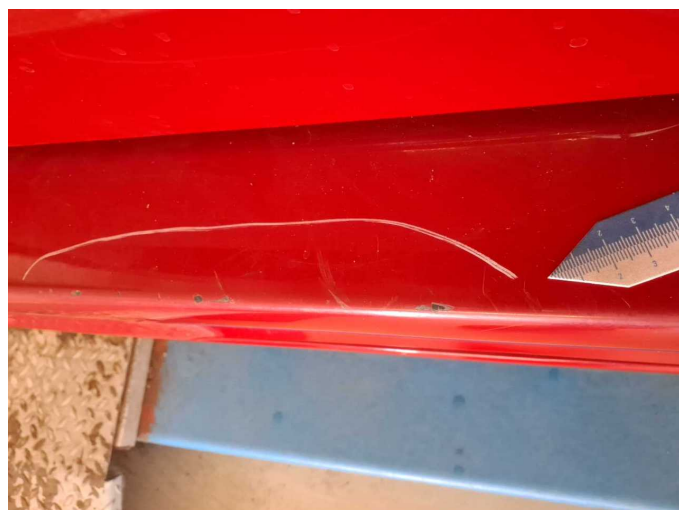
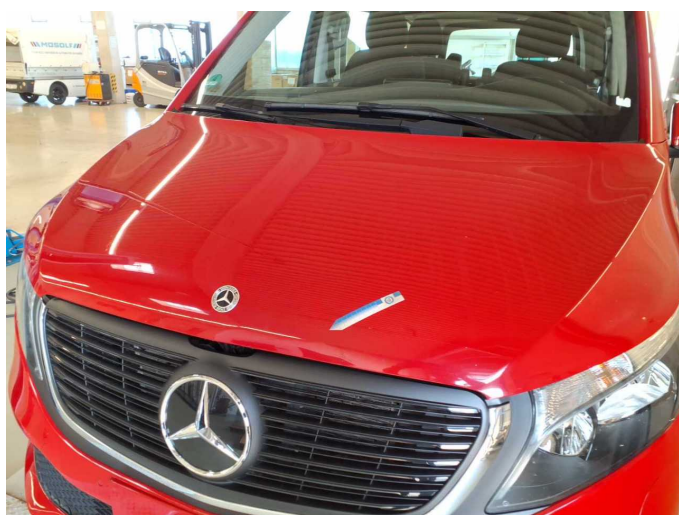
| No. | Component group | Description |
|---|---|---|
| 19 | Rear bumper | Bumper with Parktronic - Scratched - Paint |

**Damage 19:** Rear bumper: Bumper with Parktronic - Scratched - Paint

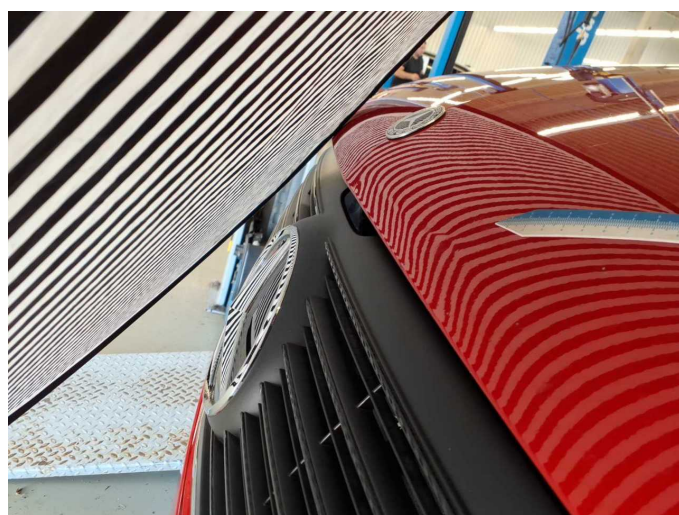
| No. | Component group | Description |
|---|---|---|
| 20 | Bonnet | Bonnet - Deformed - Repair and paint |

**Damage 20:** Bonnet: Bonnet - Deformed - Repair and paint

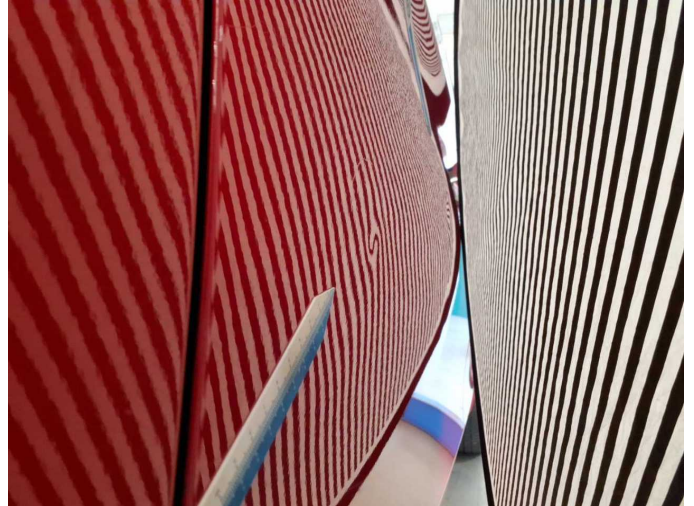
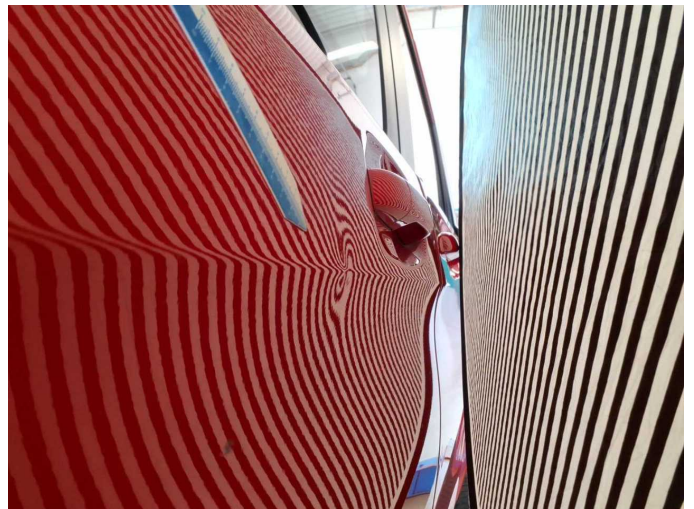
| No. | Component group | Description |
|---|---|---|
| 21 | Sliding door, right | Sliding door with glass panel - dent(s) - Repair and paint |

**Damage 21:** Sliding door, right: Sliding door with glass panel - dent(s) - Repair and paint
