Expertise

Protocol number: 46844895  
Order No. / Reference: 26816532  
Inspection date: 3 Aug 2026

Manufacturer: Mercedes-Benz  
VIN: W1VVKFZ1P4281925

Model: EQV 300 lang

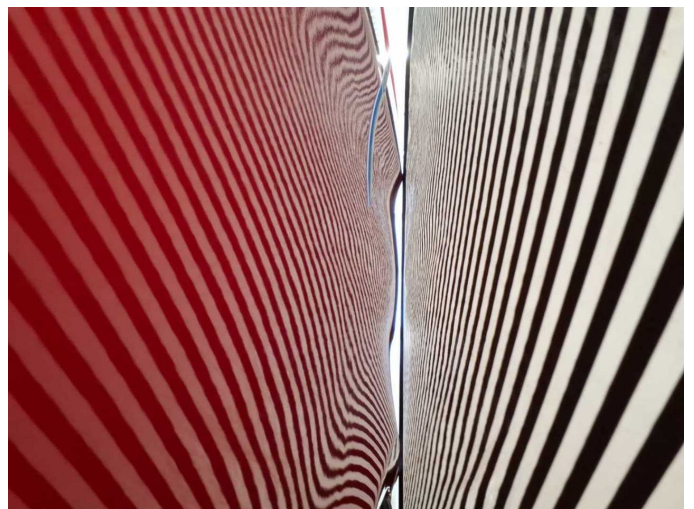
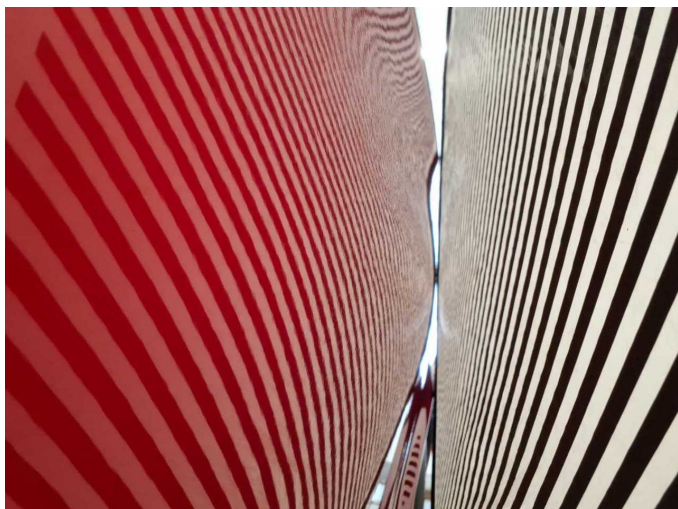
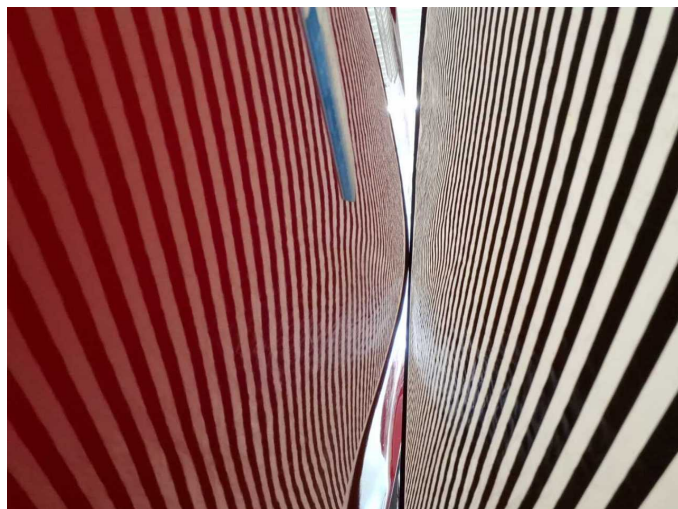
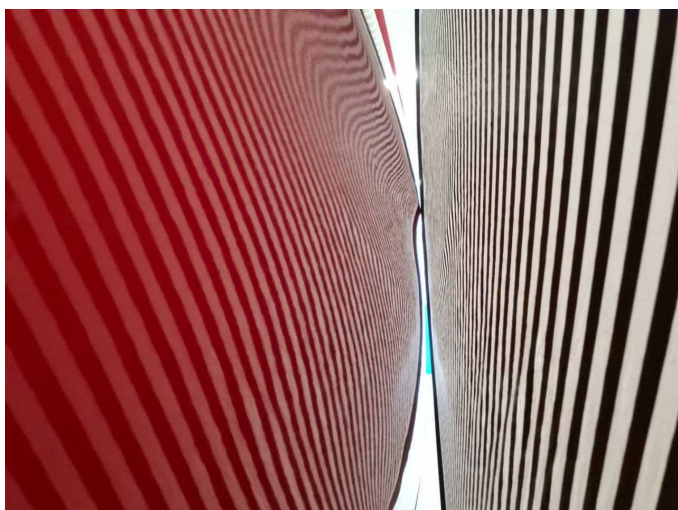
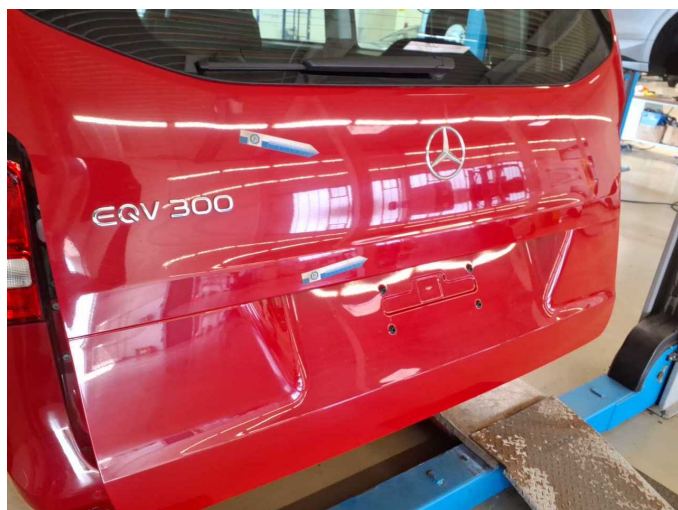
| No. | Component group | Description |
|---|---|---|
| 22 | Side panel - rear left side | Side panel (wellig) - Unprofessionally repaired - Repair and paint |

| No. | Repainting |
|---|---|
| 1 | Side panel - rear left side, Door - front left side, Unprofessionally carried out |

| Side panel - rear left side | 1,290<br>µm | Door - front left side | 284 µm |

**Damage 22:** Side panel - rear left side: Side panel (wellig) - Unprofessionally repaired - Repair and paint

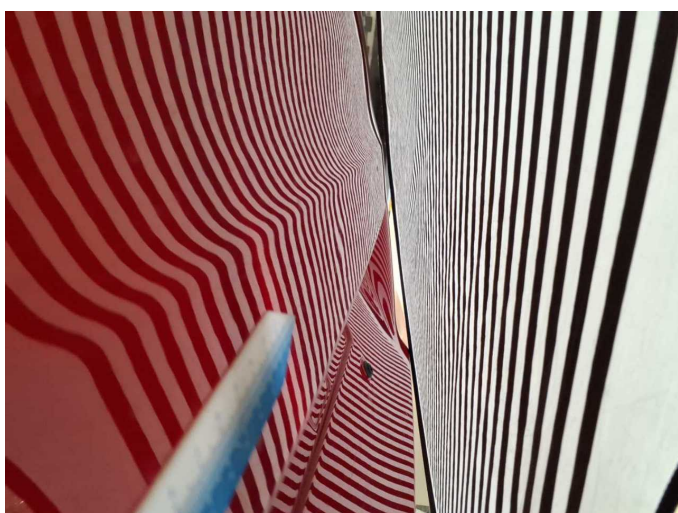
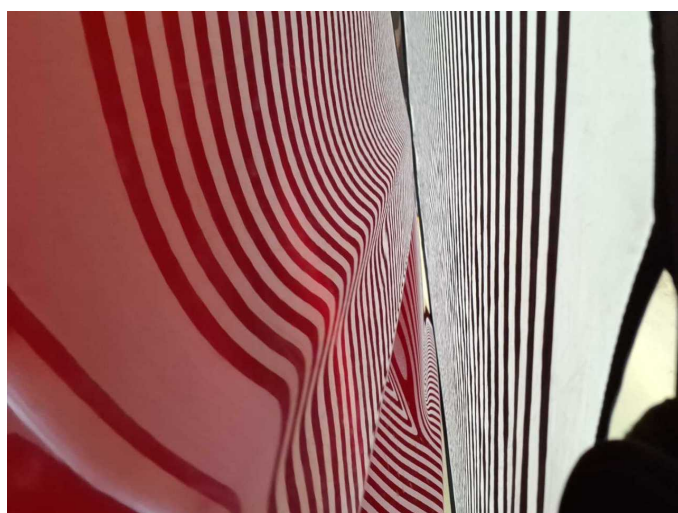
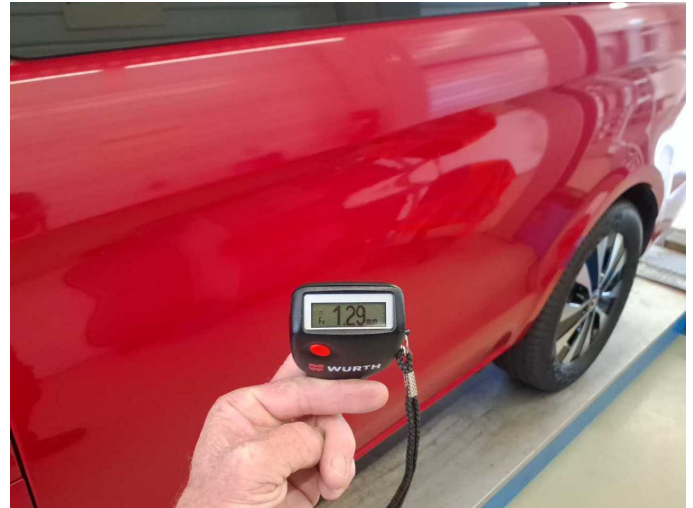
| No. | Component group | Description |
|---|---|---|
| 3 | Boot lid / rear door | Boot lid glazed - dent(s) - No deduction |

**Wear and tear 3:** Boot lid / rear door: Boot lid glazed - dent(s) - No deduction
