## Expertise

Protocol number: 46243427  
Order No. / Reference: 26454023  
Inspection date: 30 Jun 2026

Model: Octavia Combi 2.0 TDI DSG 4x4 RS Plus

VIN: TMBLK0NX2PY006164

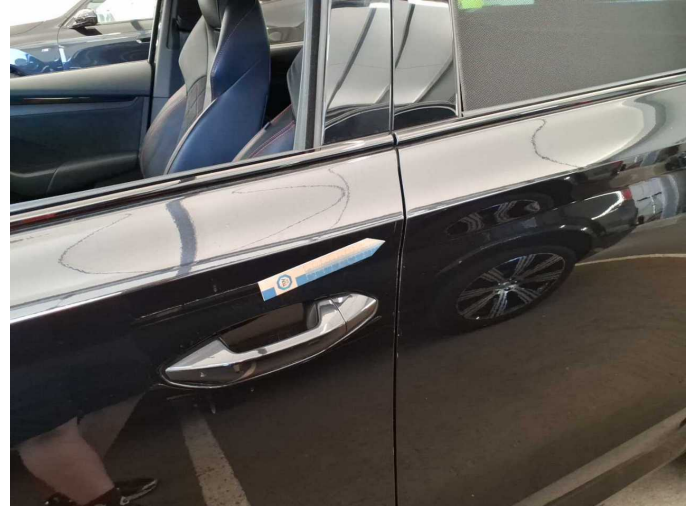
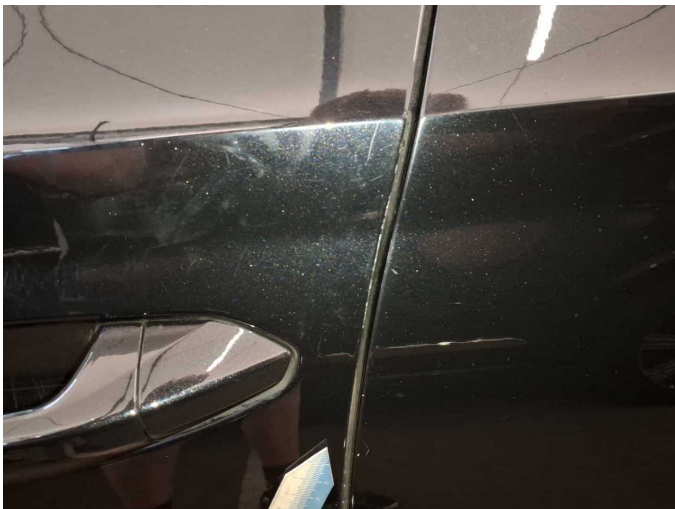
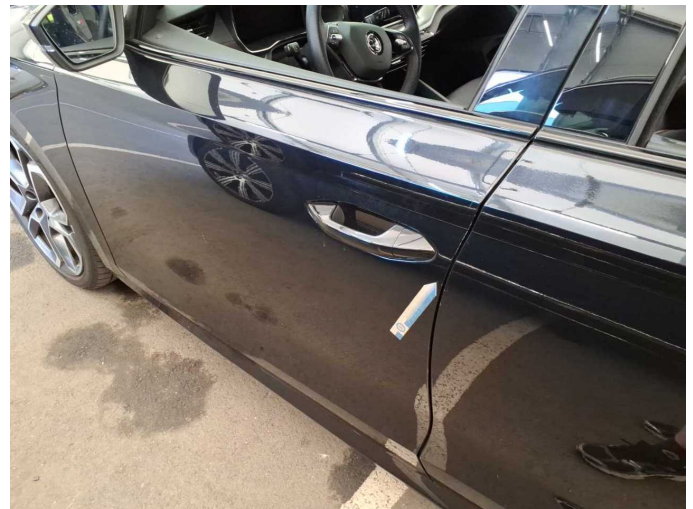
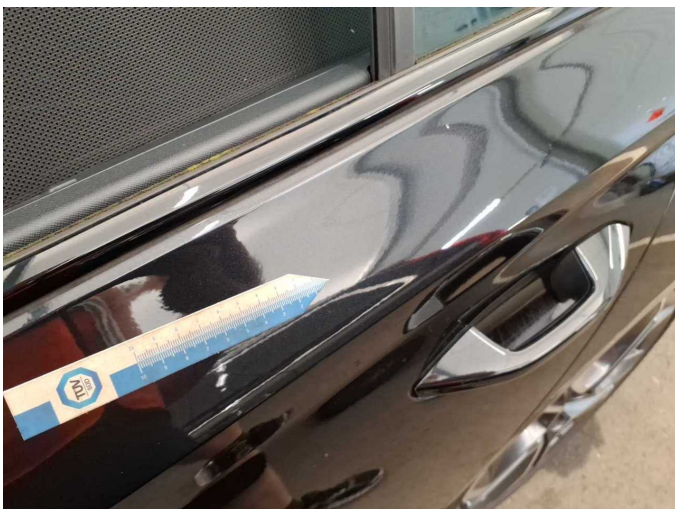
**Damage 2:** Door - front left side: Door - Scratch(es) - Smart repair

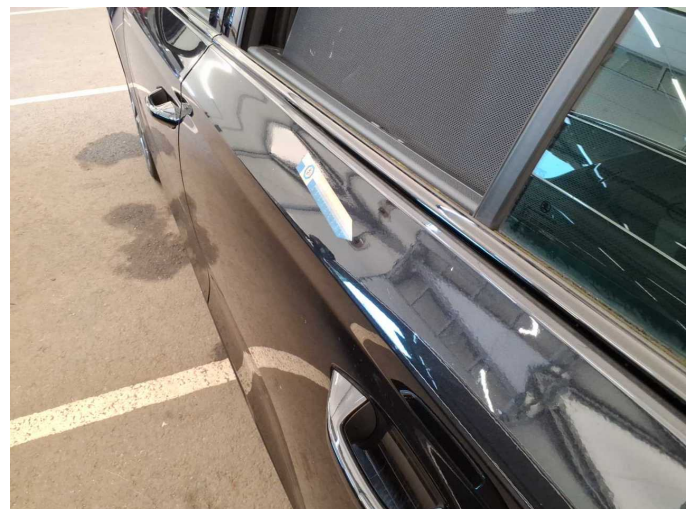
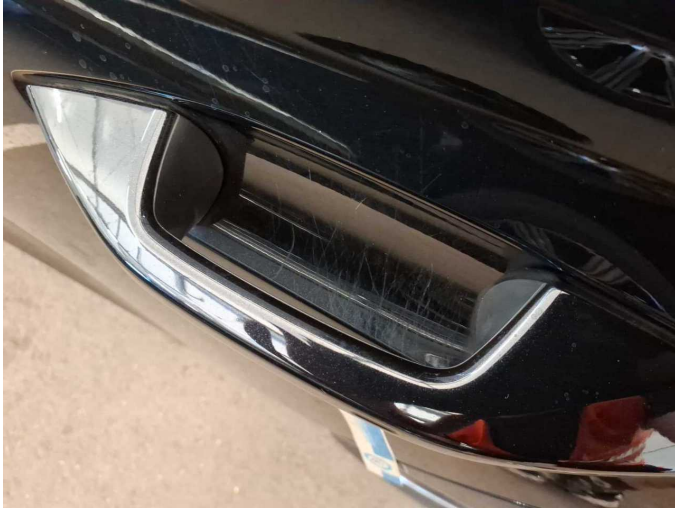
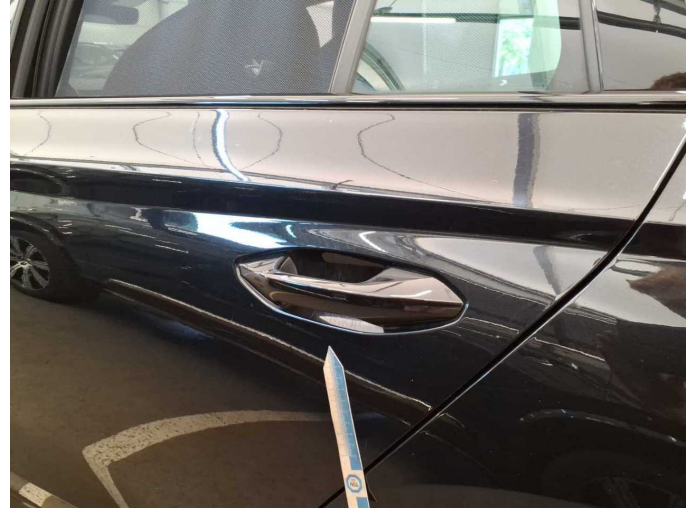
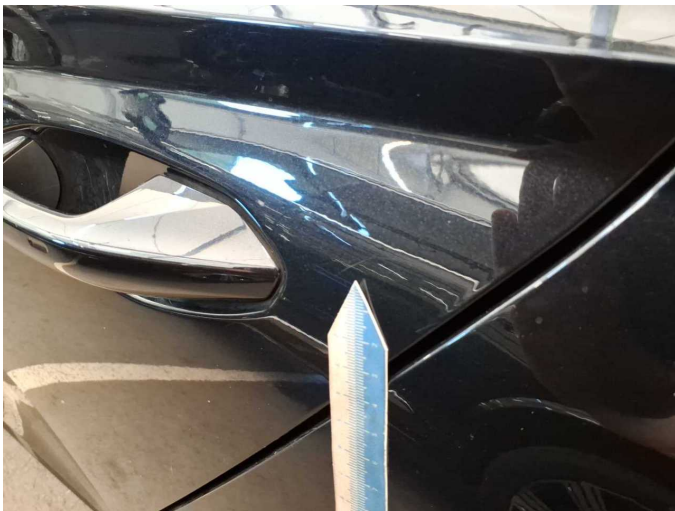
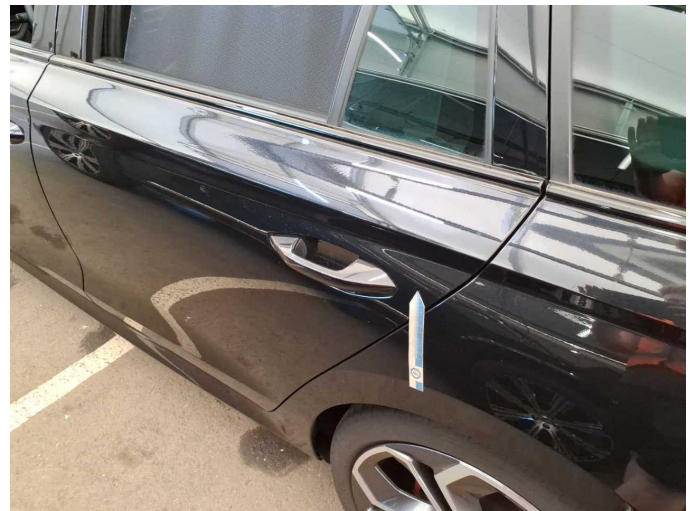
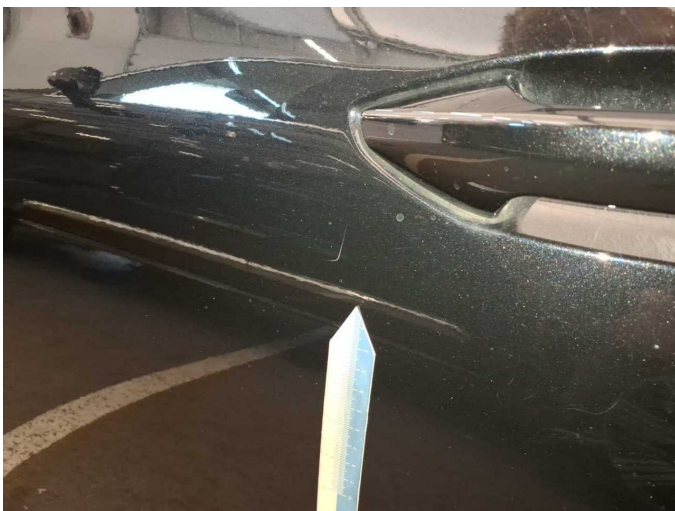
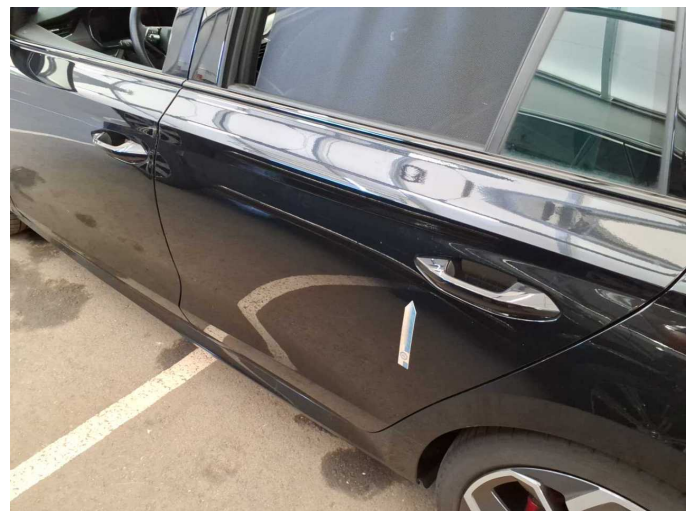
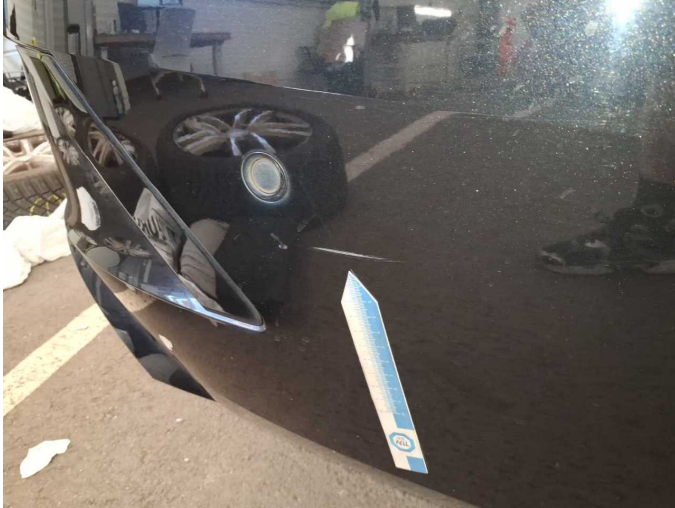
**Damage 3:** Door - rear left side: Door - Scratch(es) - Paint

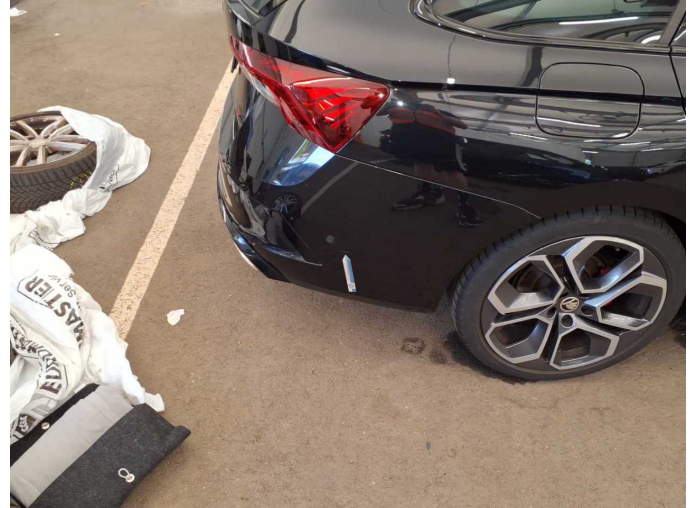
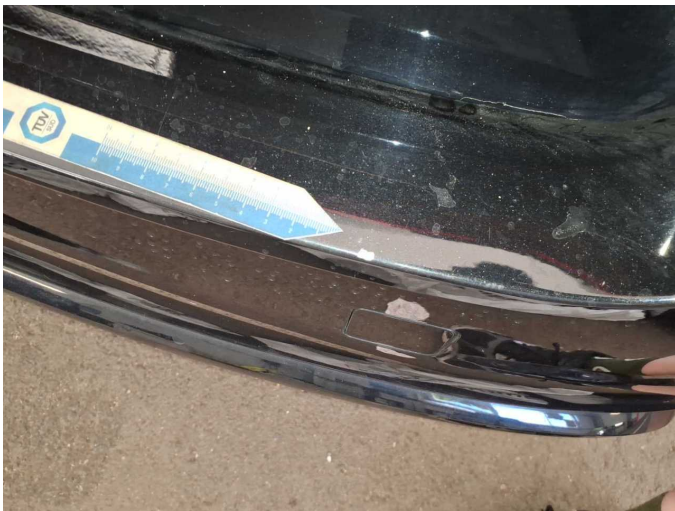
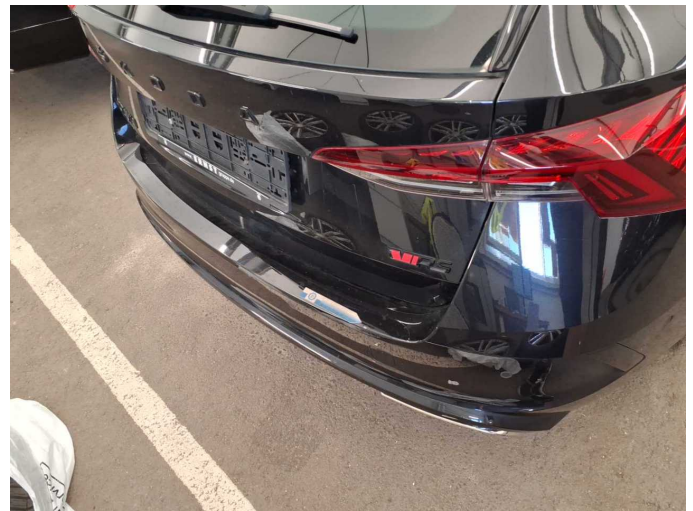
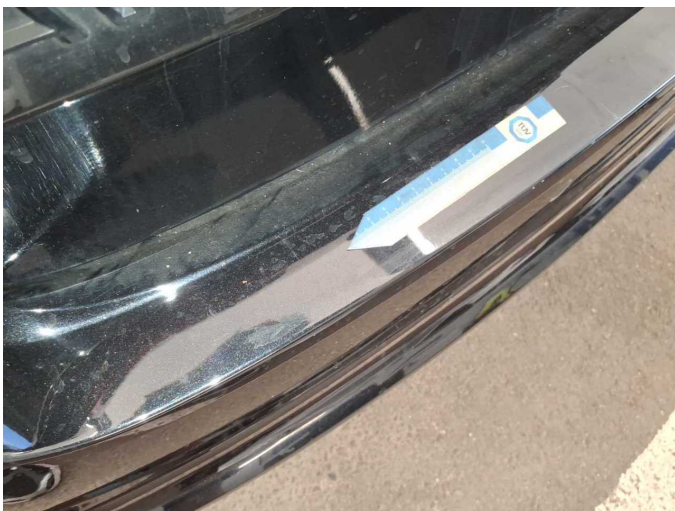
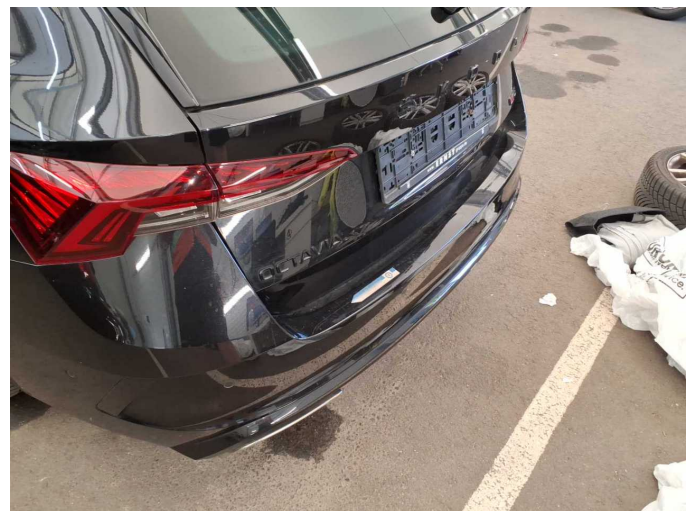
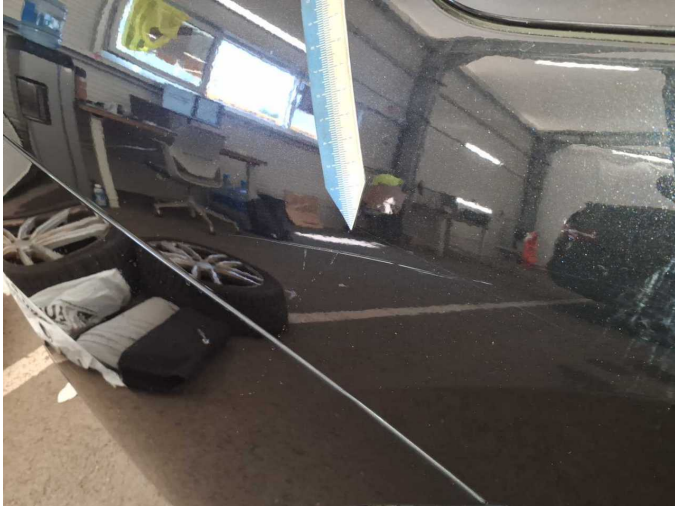
**Damage 4:** Rear bumper: Rear bumper - Scratch(es) - Paint

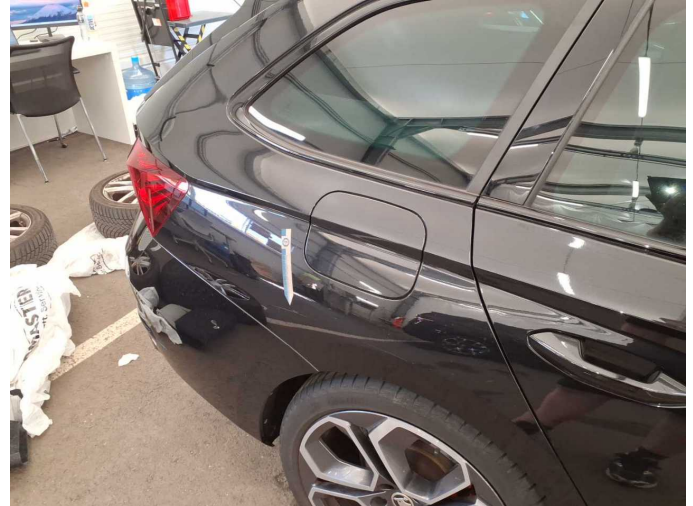
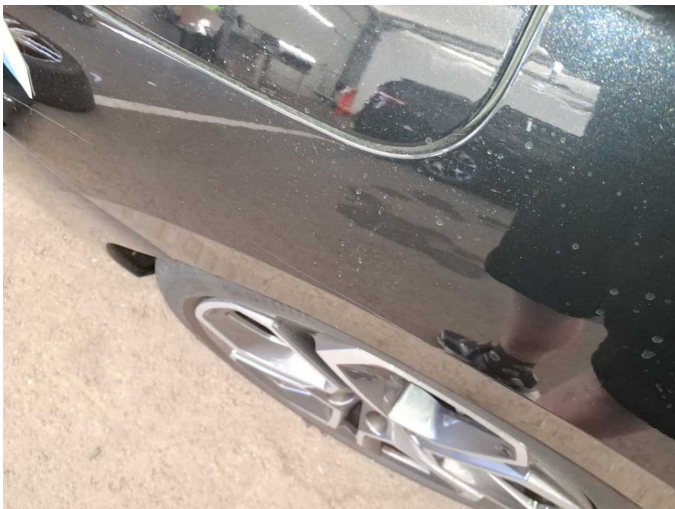
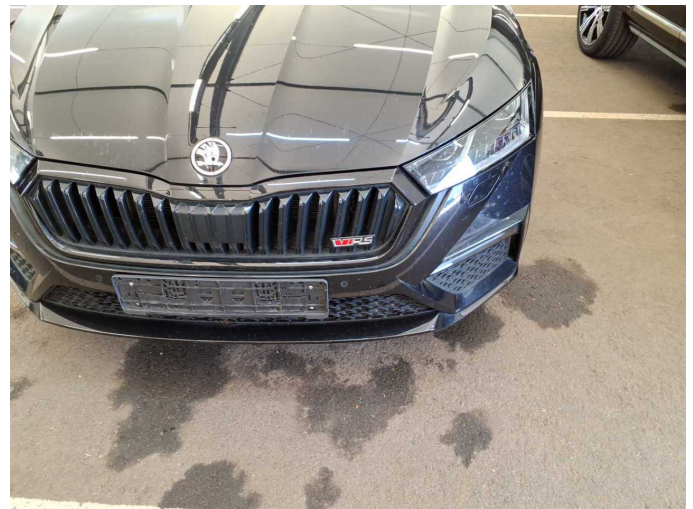
**Damage 5:** Side panel - rear right side: Side panel - Scratch(es) - Paint

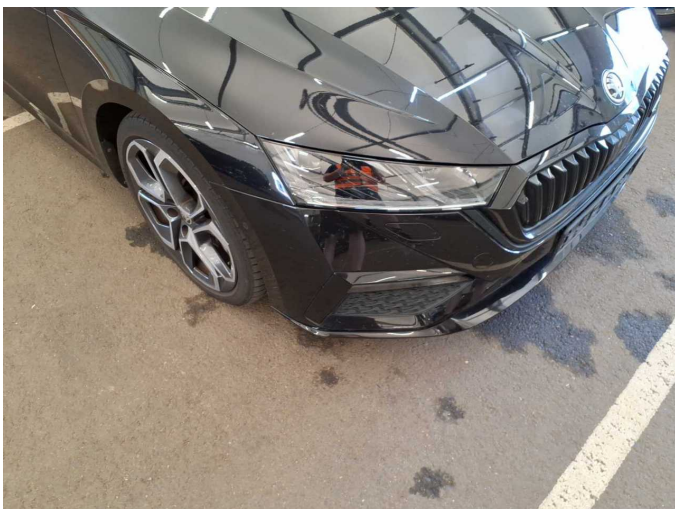
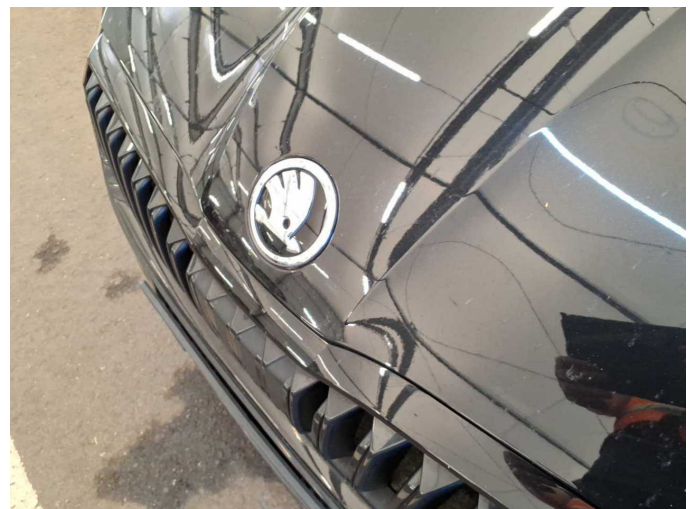
**Wear and tear 1:** Front bumper: Front bumper - Stone chips - No deduction

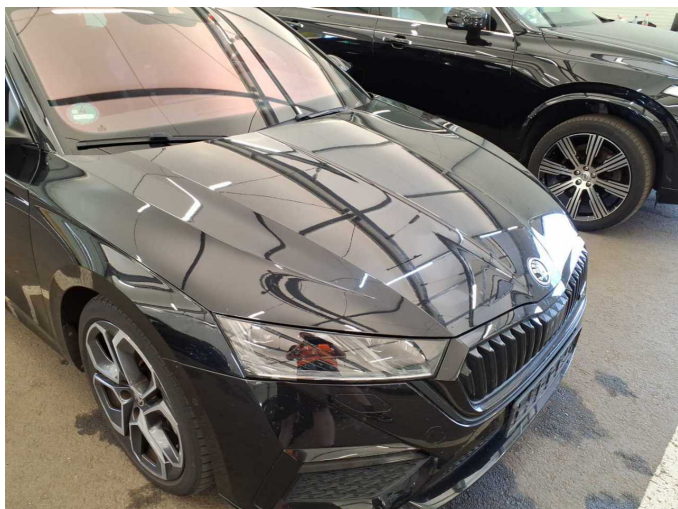
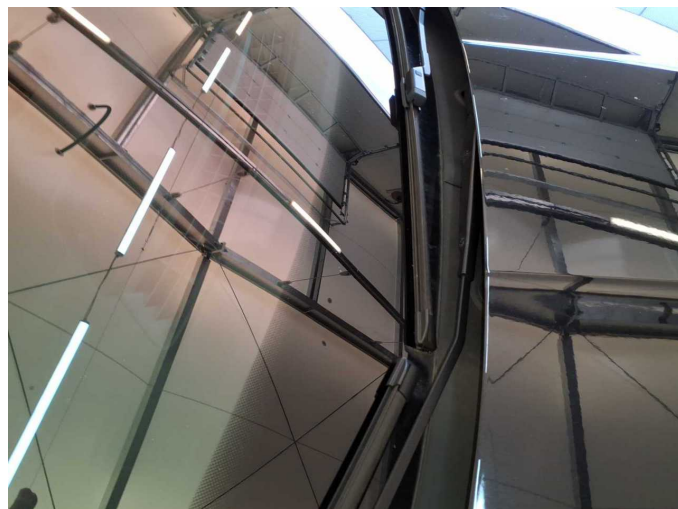
**Wear and tear 2:** Bonnet: Bonnet - Stone chips - No deduction

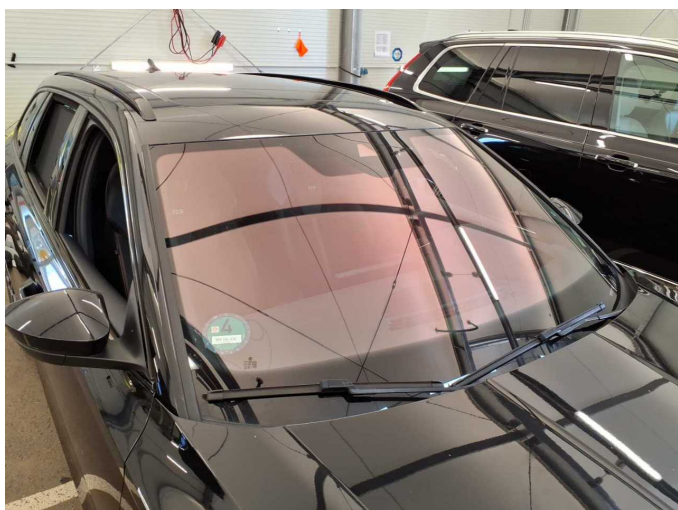
**Wear and tear 3:** Vehicle glazing: Windscreen - Stone chips - No deduction
