Expertise

Protocol number: 46809117  
Order No. / Reference: 26661602  
Inspection date: 29 Jul 2026

Manufacturer: Peugeot

Model: 5008 BlueHDi 180 EAT8 GT

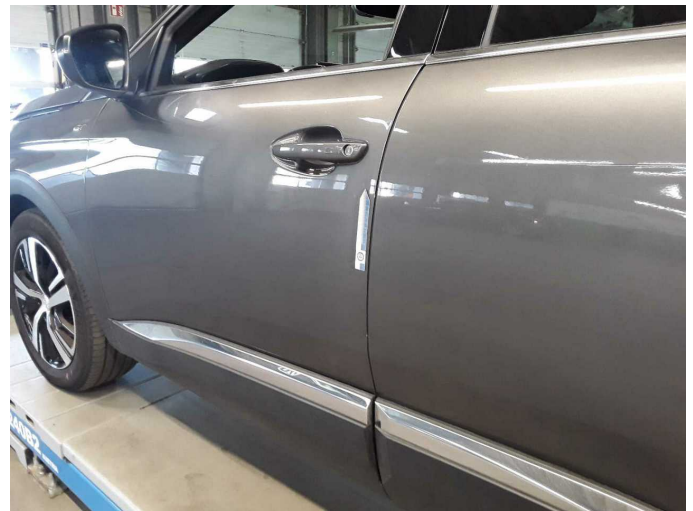
| No. | Component group | Description |
|---|---|---|
| 2 | Door - front left side | Door edge - Scratch(es) - Smart repair |

**Damage 2:** Door - front left side: Door edge - Scratch(es) - Smart repair

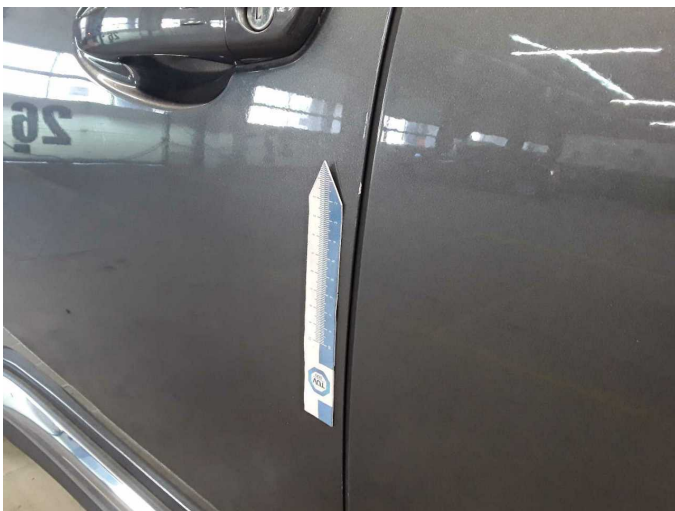
**Damage 2:** Door - front left side: Door edge - Scratch(es) - Smart repair

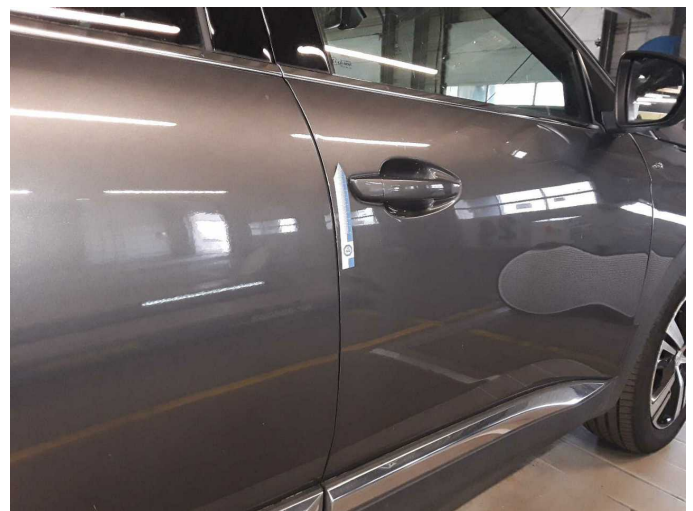
| No. | Component group | Description |
|---|---|---|
| 3 | Door - front right side | Door edge - Scratch(es) - Smart repair |

**Damage 3:** Door - front right side: Door edge - Scratch(es) - Smart repair

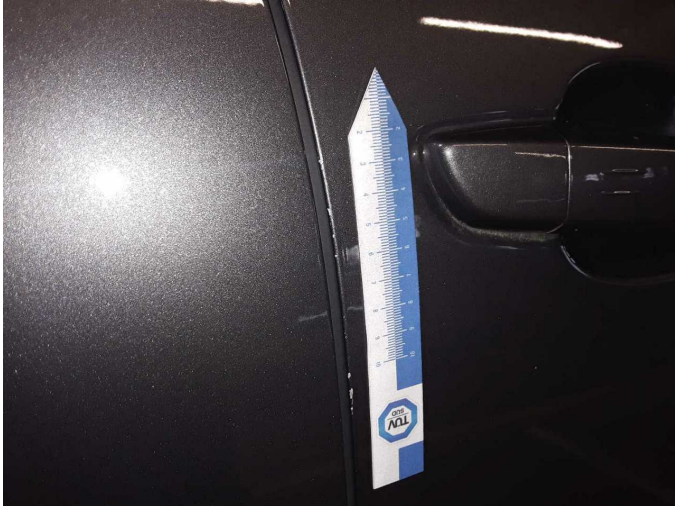
**Damage 3:** Door - front right side: Door edge - Scratch(es) - Smart repair

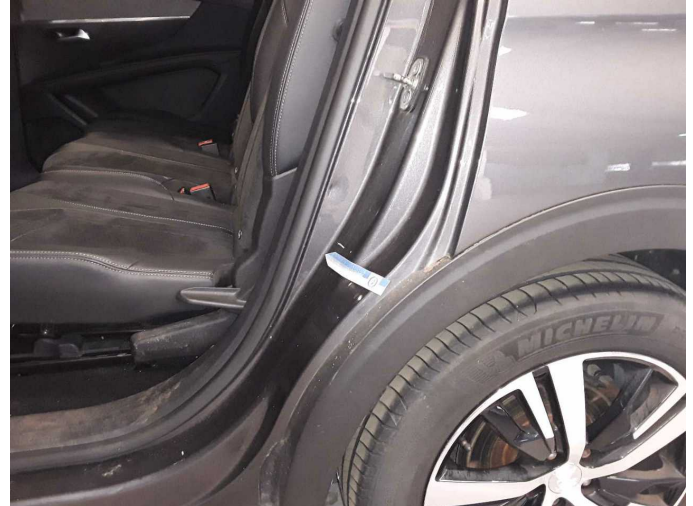
| No. | Component group | Description |
|---|---|---|
| 4 | Body | C-pillar - left side - Dent / paintcoat damage - Smart repair |

**Damage 4:** Body: C-pillar - left side - Dent / paintcoat damage - Smart repair

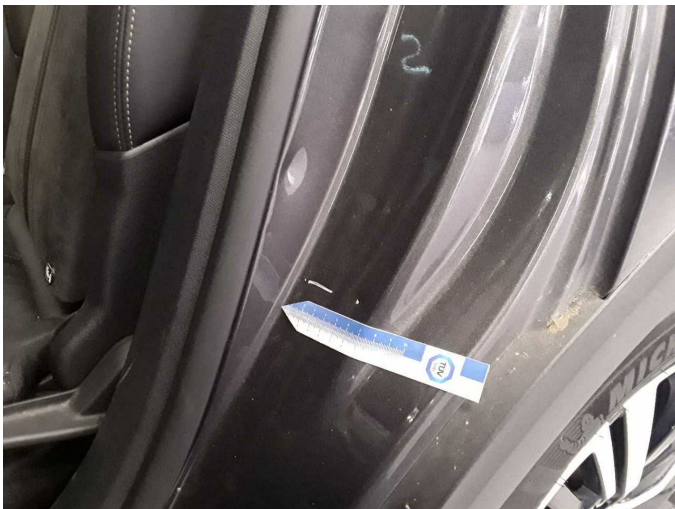
**Damage 4:** Body: C-pillar - left side - Dent / paintcoat damage - Smart repair

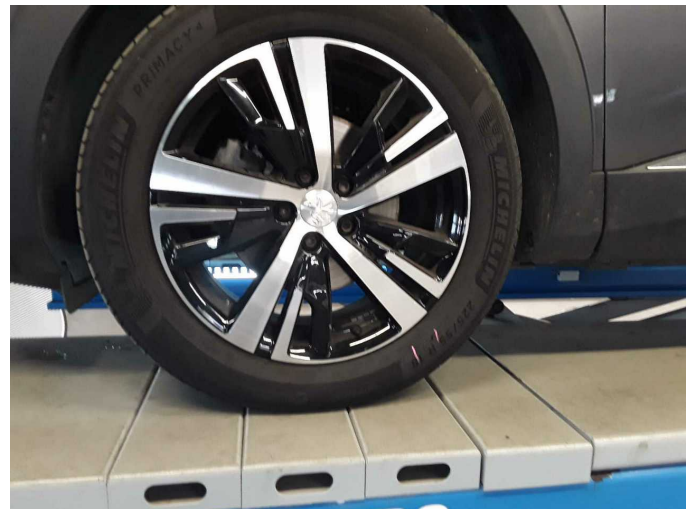
| No. | Component group | Description |
|---|---|---|
| 5 | Wheel / tyres | Tyre - front left side (nicht fahrbereit) - Damaged - Replace |

**Damage 5:** Wheel / tyres: Tyre - front left side (nicht fahrbereit) - Damaged - Replace

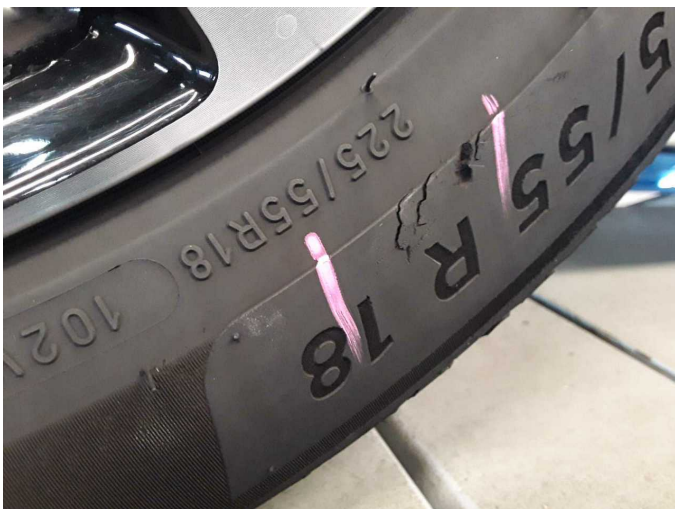
**Damage 5:** Wheel / tyres: Tyre - front left side (nicht fahrbereit) - Damaged - Replace

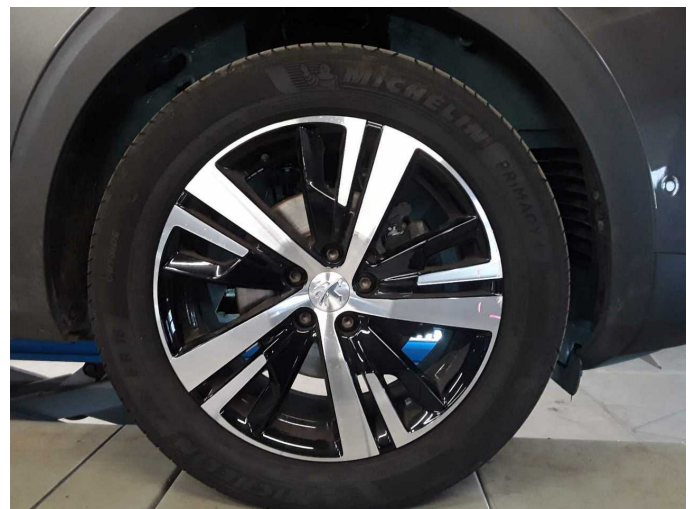
| No. | Component group | Description |
|---|---|---|
| 6 | Wheel / tyres | Alloy rim - front right side - Scratch(es) - Loss in value |

**Damage 6:** Wheel / tyres: Alloy rim - front right side - Scratch(es) - Loss in value

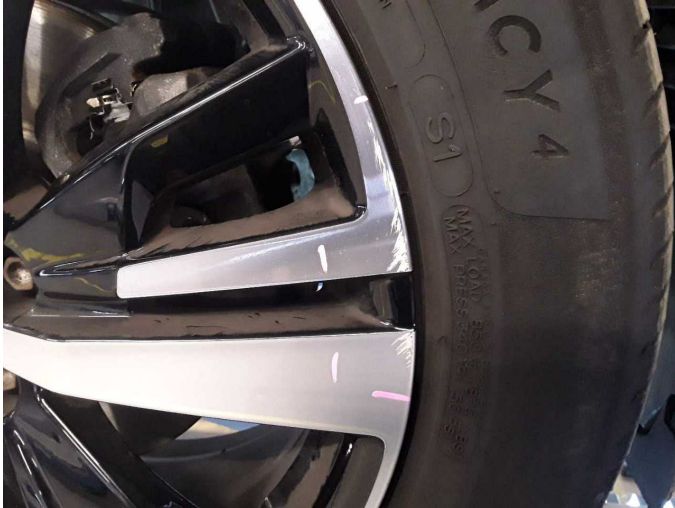
**Damage 6:** Wheel / tyres: Alloy rim - front right side - Scratch(es) - Loss in value

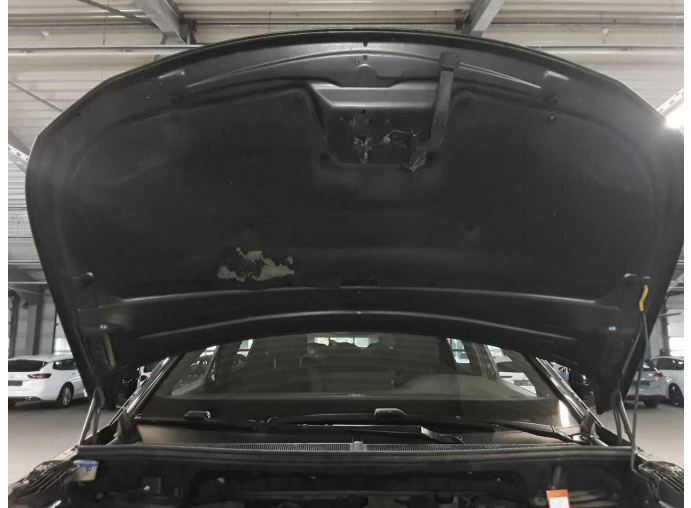
| No. | Component group | Description |
|---|---|---|
| 7 | Bonnet | Insulation lining - Damage caused by marten / rodent - Replace |

**Damage 7:** Bonnet: Insulation lining - Damage caused by marten / rodent - Replace

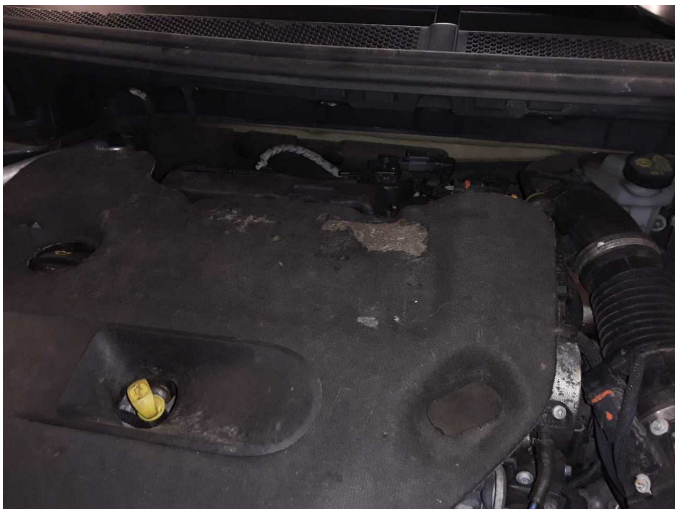
**Damage 7:** Bonnet: Insulation lining - Damage caused by marten / rodent - Replace

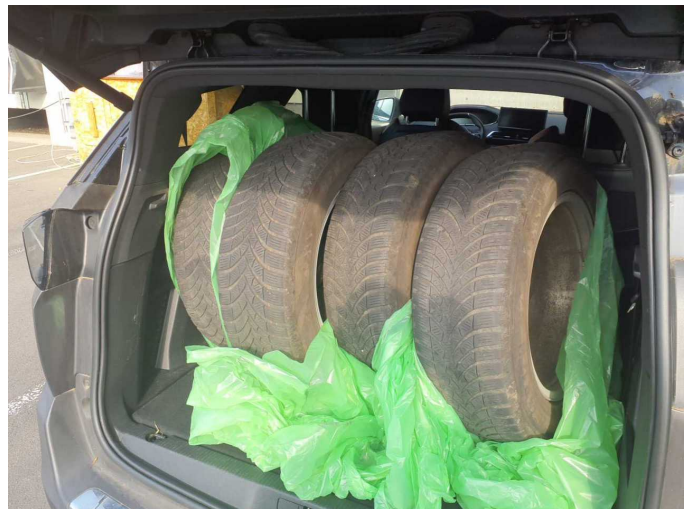
| No. | Component group | Description |
|---|---|---|
| 8 | 2nd wheel set | 2 tyres - Does not meet the leasing specifications - Replace |

**Damage 8:** 2nd wheel set: 2 tyres - Does not meet the leasing specifications - Replace

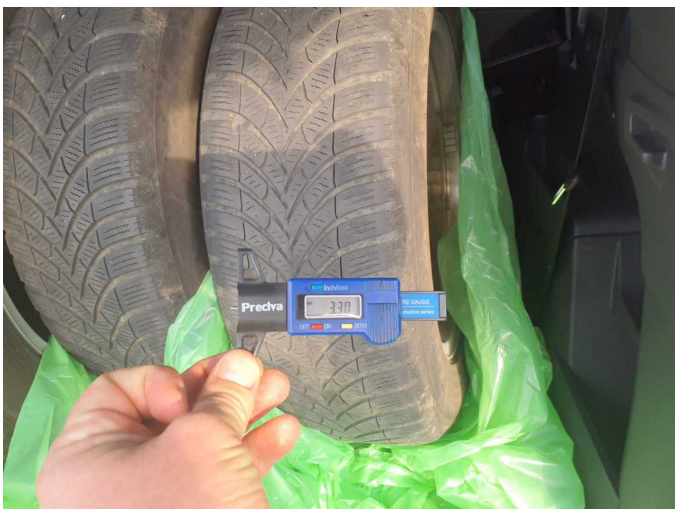
**Damage 8:** 2nd wheel set: 2 tyres - Does not meet the leasing specifications - Replace

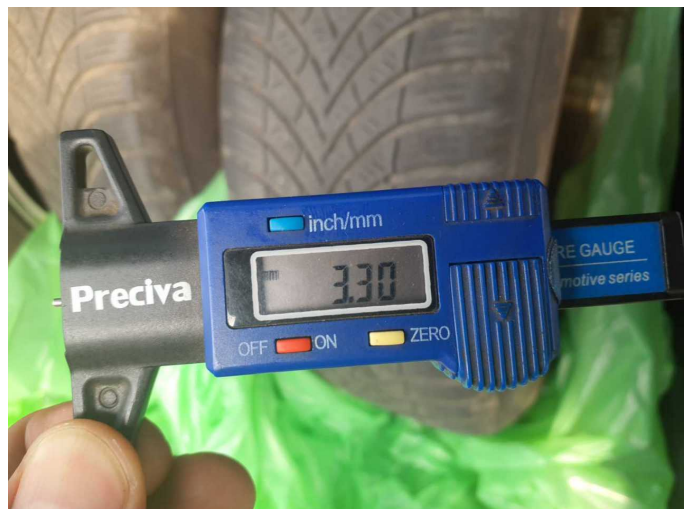
**Damage 8:** 2nd wheel set: 2 tyres - Does not meet the leasing specifications - Replace

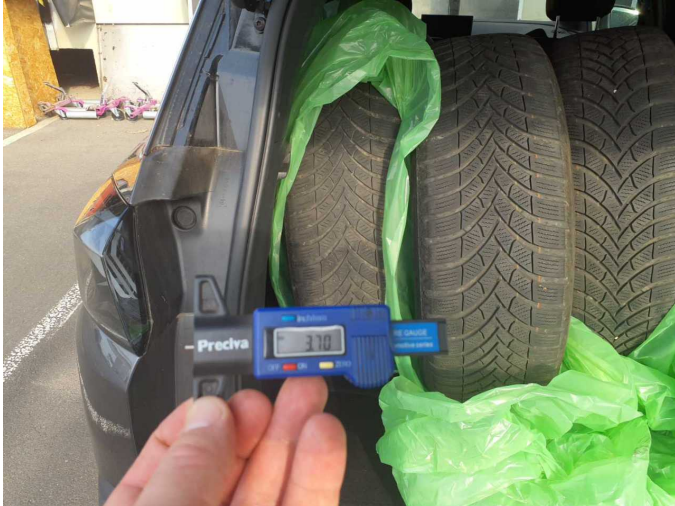
**Damage 8:** 2nd wheel set: 2 tyres - Does not meet the leasing specifications - Replace

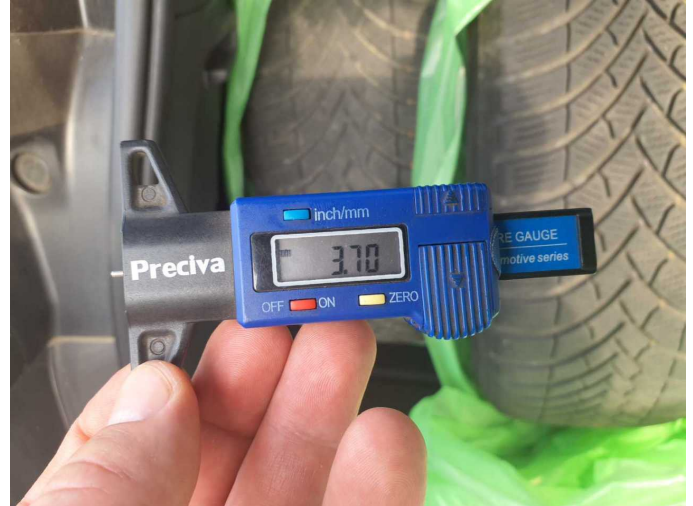
**Damage 8:** 2nd wheel set: 2 tyres - Does not meet the leasing specifications - Replace

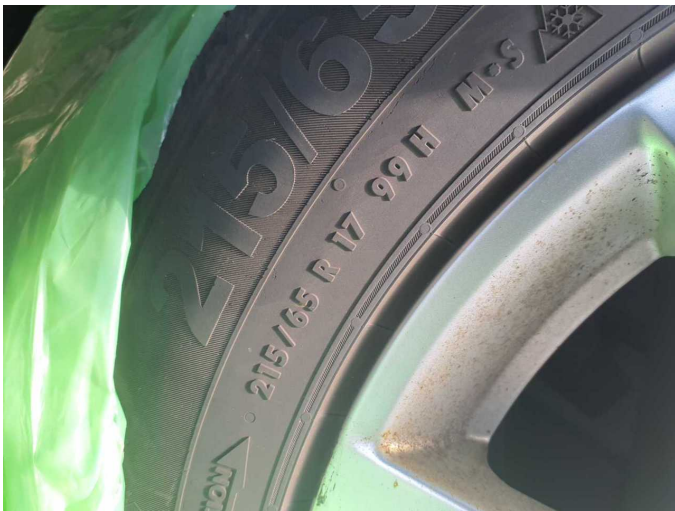
**Damage 8:** 2nd wheel set: 2 tyres - Does not meet the leasing specifications - Replace

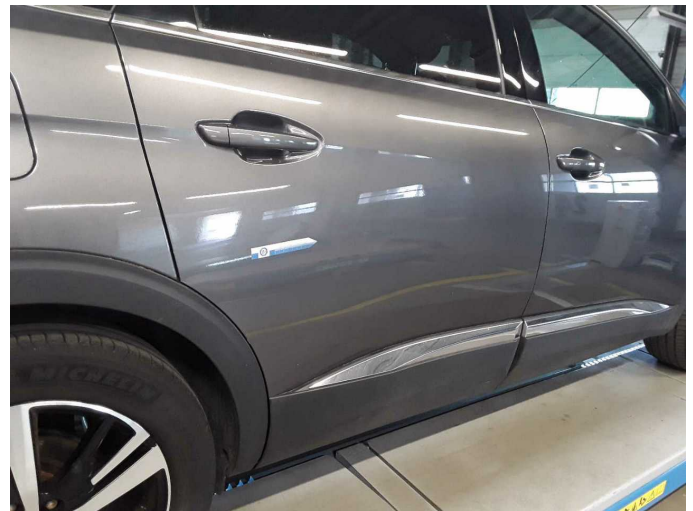
| No. | Component group | Description |
|---|---|---|
| 9 | Door - rear right side | Door - Scratch(es) - Paint |

**Damage 9:** Door - rear right side: Door - Scratch(es) - Paint

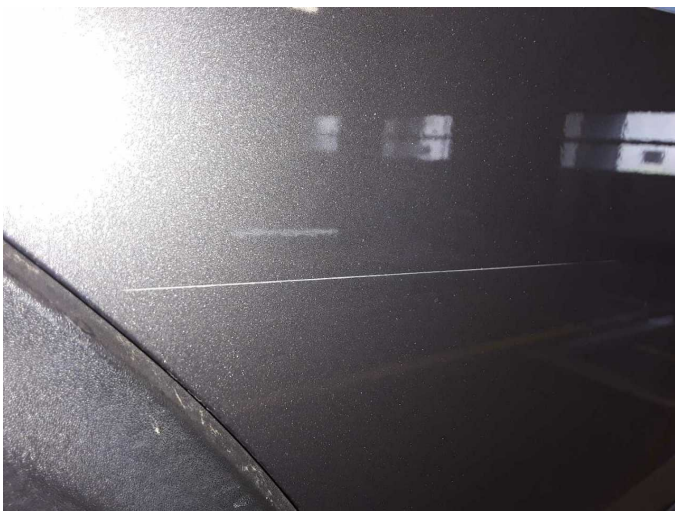
**Damage 9:** Door - rear right side: Door - Scratch(es) - Paint

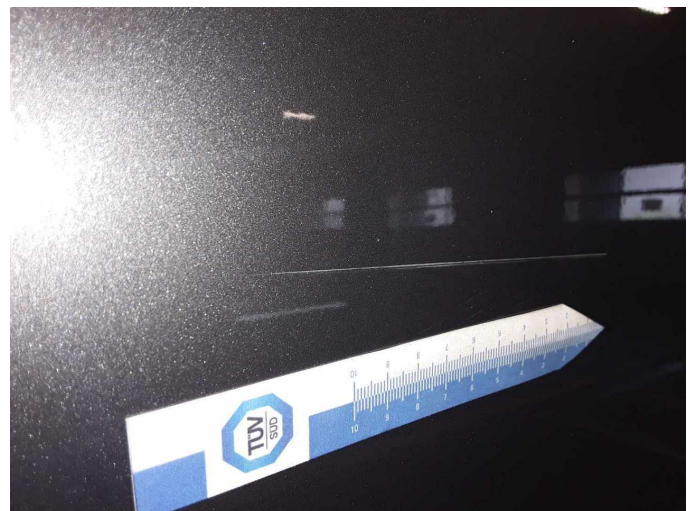
**Damage 9:** Door - rear right side: Door - Scratch(es) - Paint

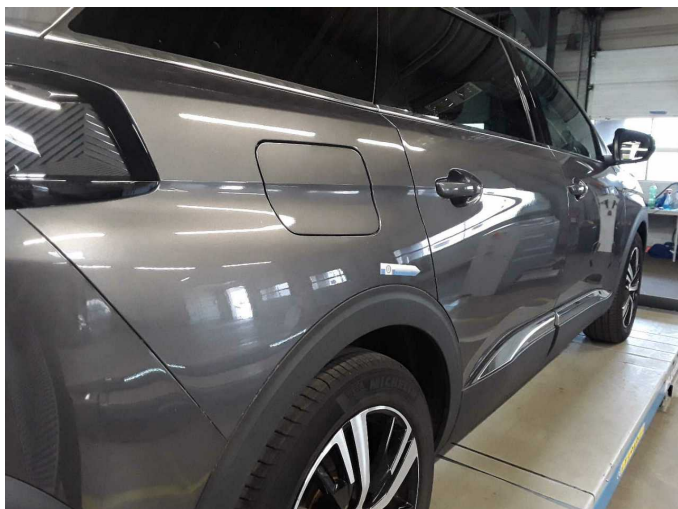
| No. | Component group | Description |
|---|---|---|
| 1 | Side panel - rear right side | Side panel - dent(s) - No deduction |

**Wear and tear 1:** Side panel - rear right side: Side panel - dent(s) - No deduction

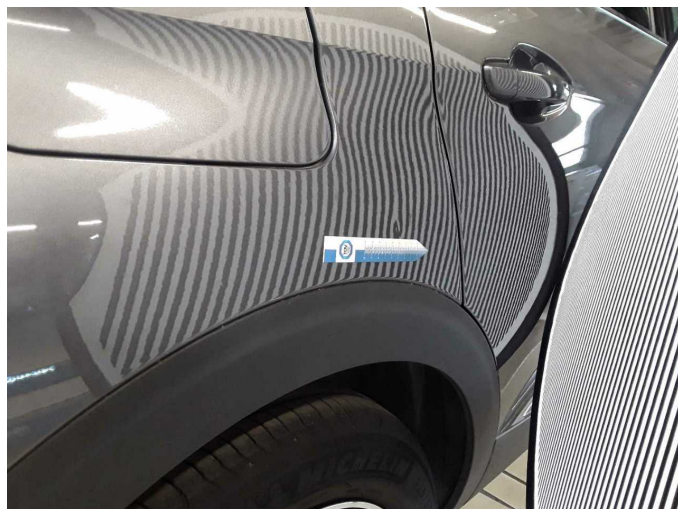
**Wear and tear 1:** Side panel - rear right side: Side panel - dent(s) - No deduction

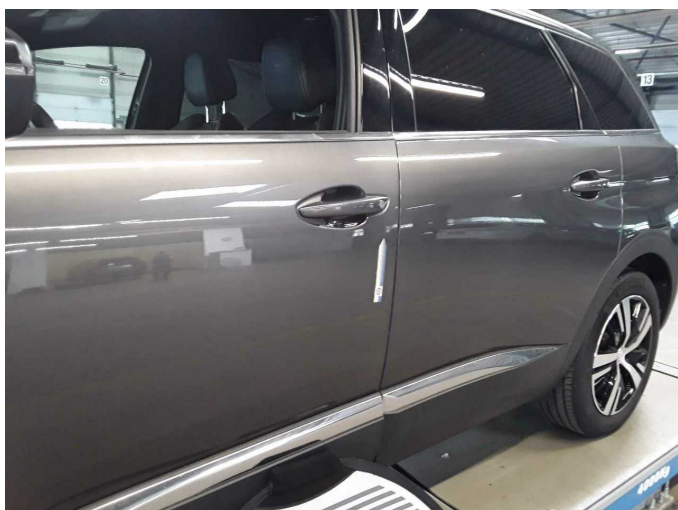
| No. | Component group | Description |
|---|---|---|
| 2 | Door - front left side | Door - dent(s) - No deduction |

**Wear and tear 2:** Door - front left side: Door - dent(s) - No deduction

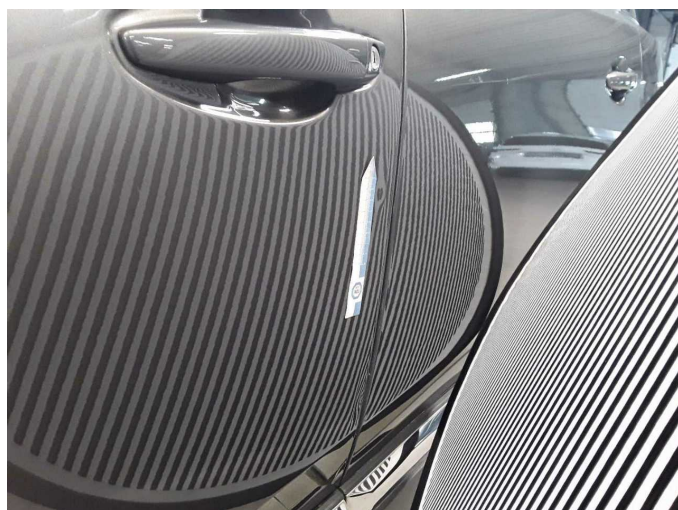
**Wear and tear 2:** Door - front left side: Door - dent(s) - No deduction
