## Expertise

Protocol number: 45977723  
Order No. / Reference: 26430895  
Inspection date: 16 Jun 2026

Manufacturer: Volkswagen

Model: Tiguan 2.0 TDI SCR ACTIVE

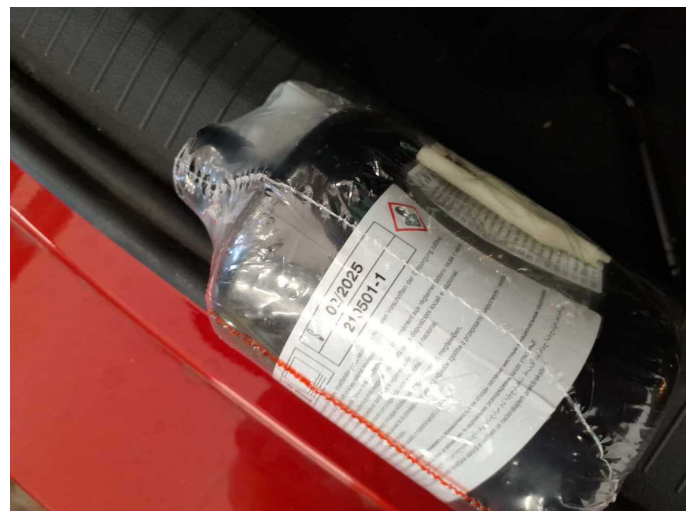
Damage 1: Equipment: Tirefit filler - Expired - Perform

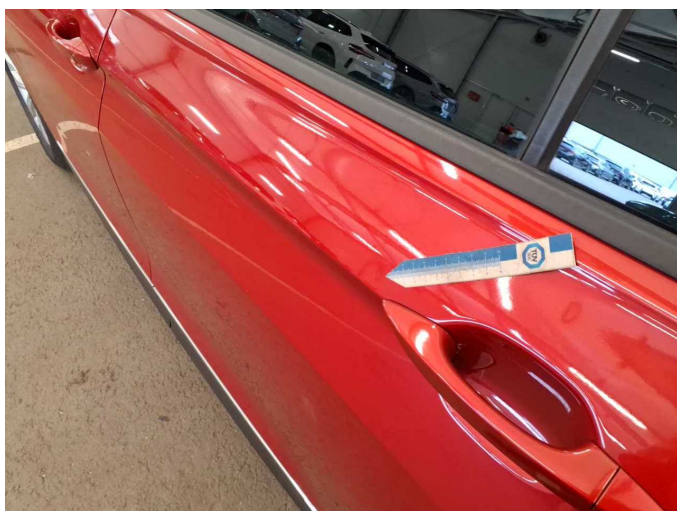
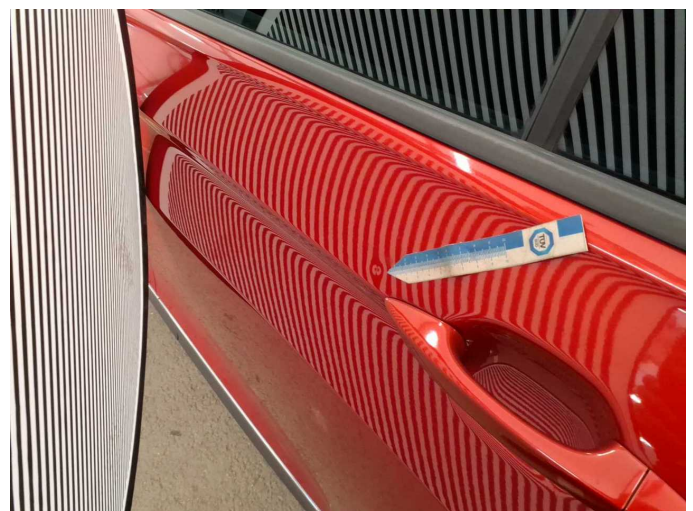
Damage 2: Door - rear left side: Door - dent(s) - Smooth repair work

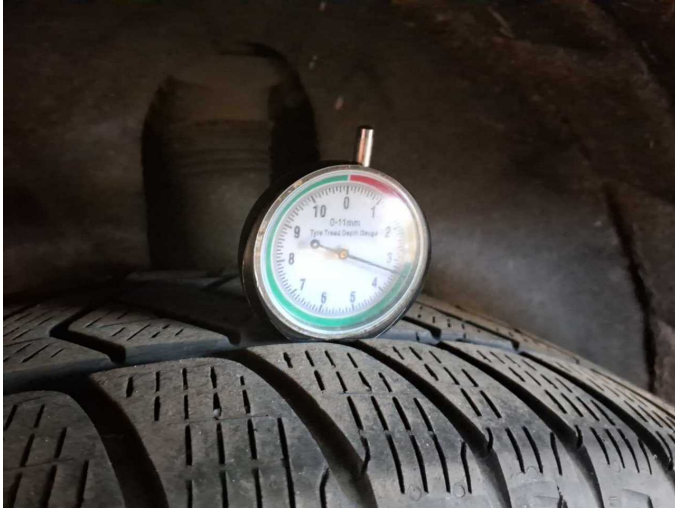
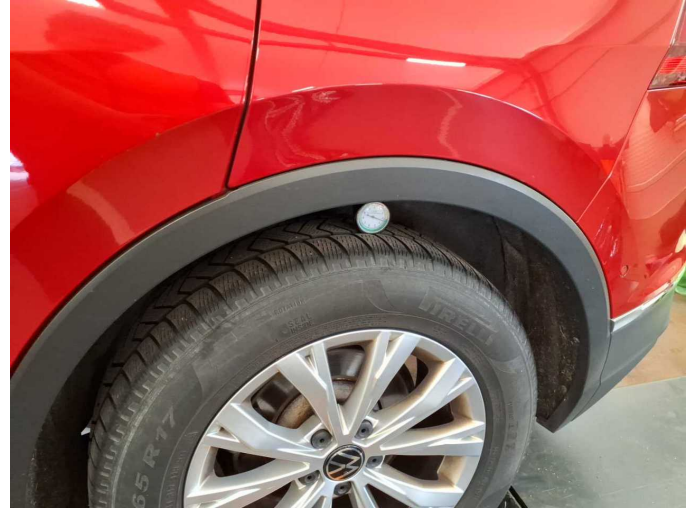
#	Tyre size	Type of tyre	Manufacturer	Tread depth
1)	215/65 R17 99H	Winter tires (with run-flat tires) on Light alloy	Pirelli	2mm / 2mm
2)	215/65 R17 99H	Winter tires (with run-flat tires) on Light alloy	Pirelli	3mm / 4mm

**Damage 3:** Wheel / tyres: Tyre - rear left side - Does not meet the leasing specifications - Replace

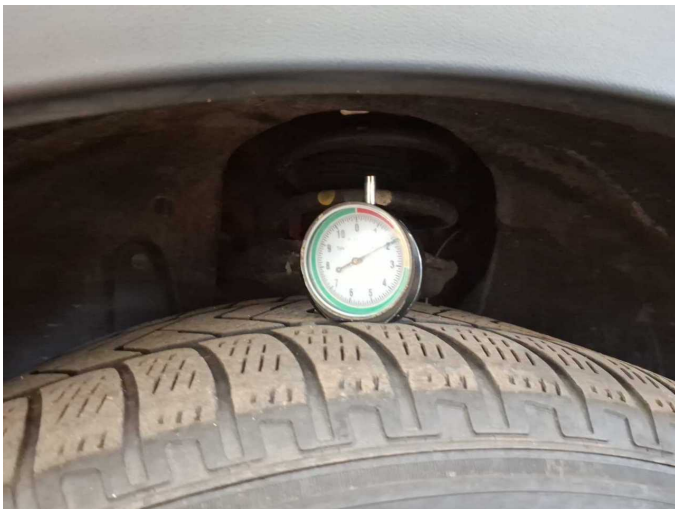
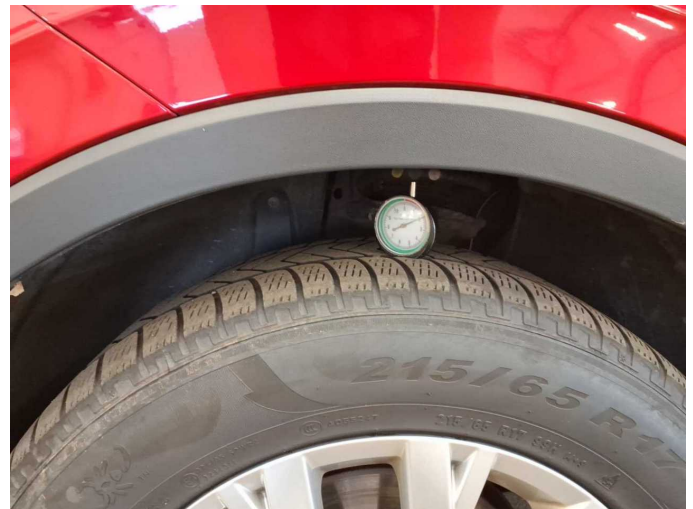
**Damage 4:** Wheel / tyres: Tyre - front left side - Does not meet the leasing specifications - Replace

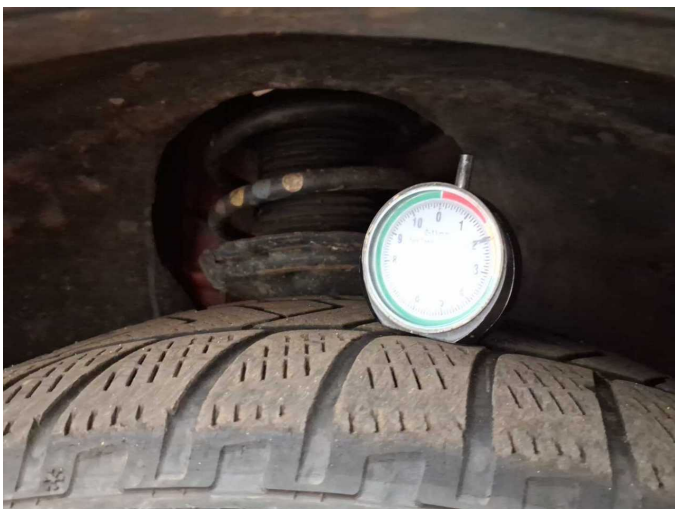
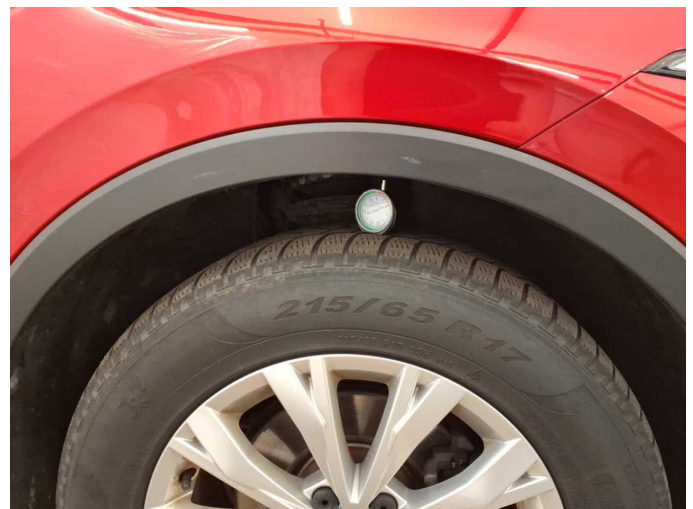
**Damage 5:** Wheel / tyres: Tyre - front right side - Does not meet the leasing specifications - Replace

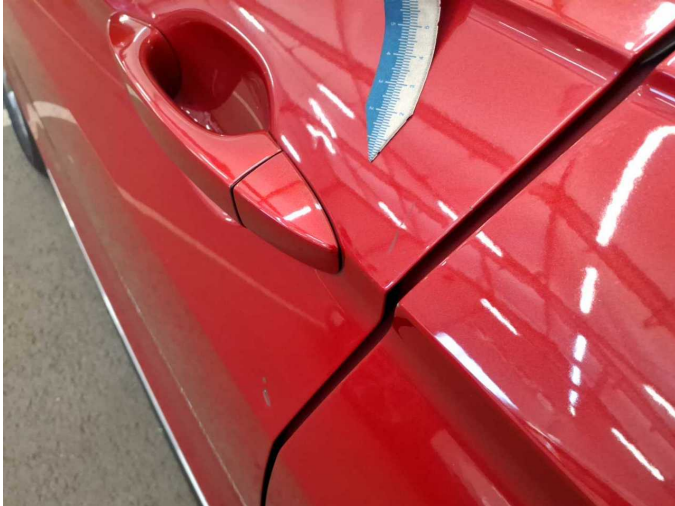
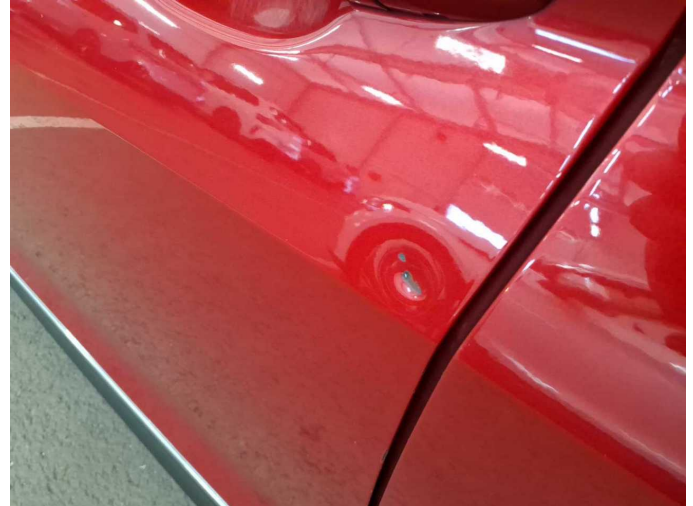
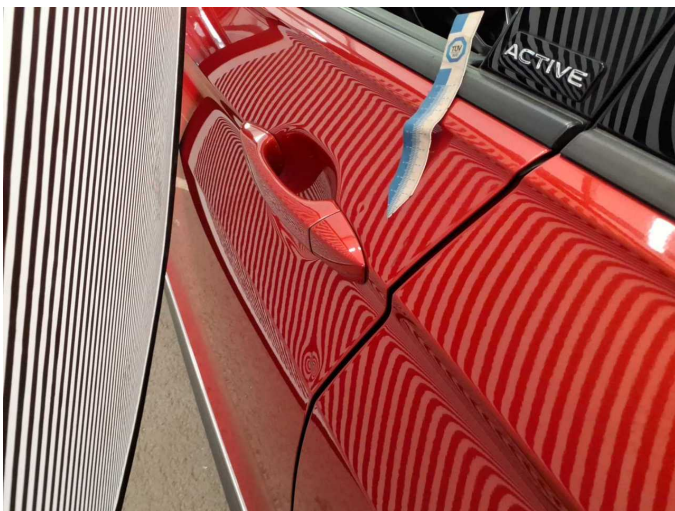
**Damage 6:** Door - front left side: Door - Dent / paintcoat damage - Repair and paint

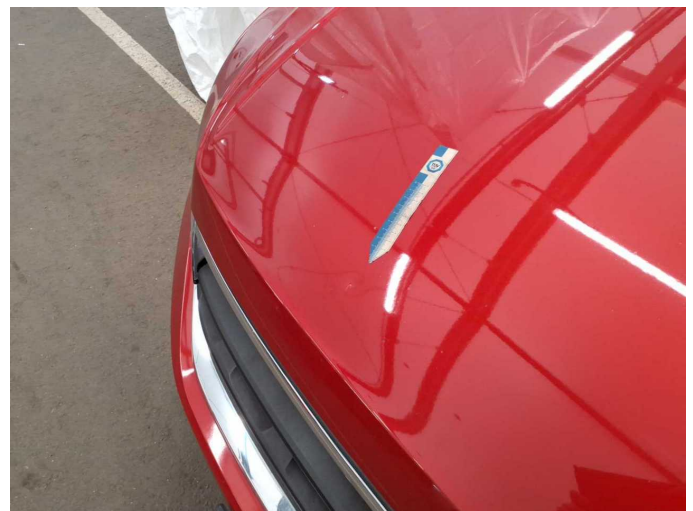
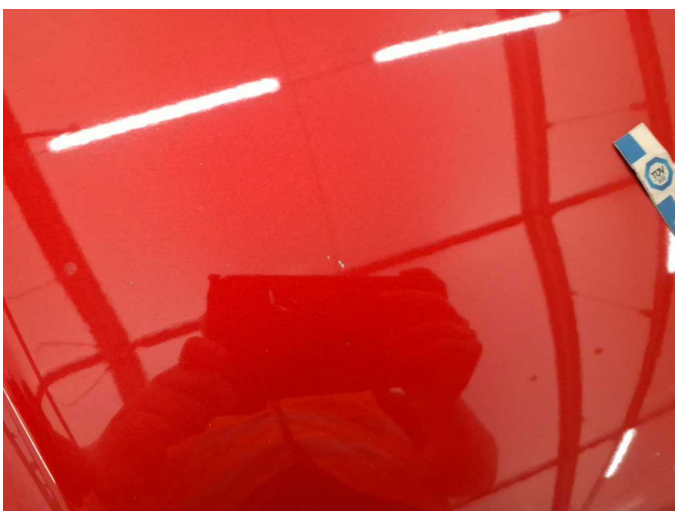
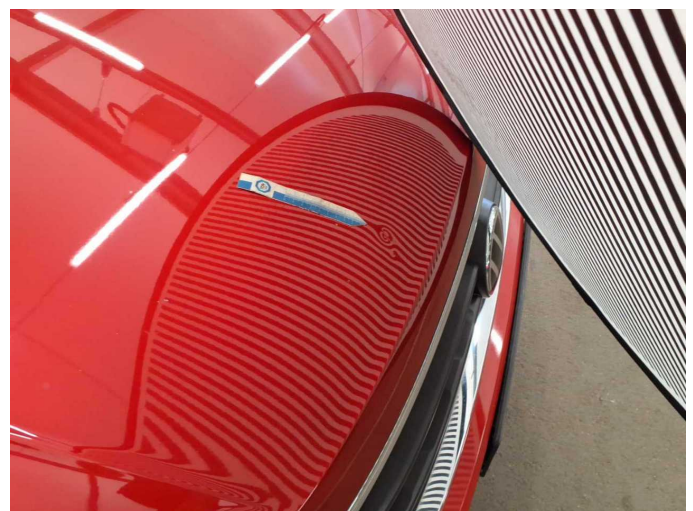
**Damage 7:** Bonnet: Bonnet - Deformed - Repair and paint

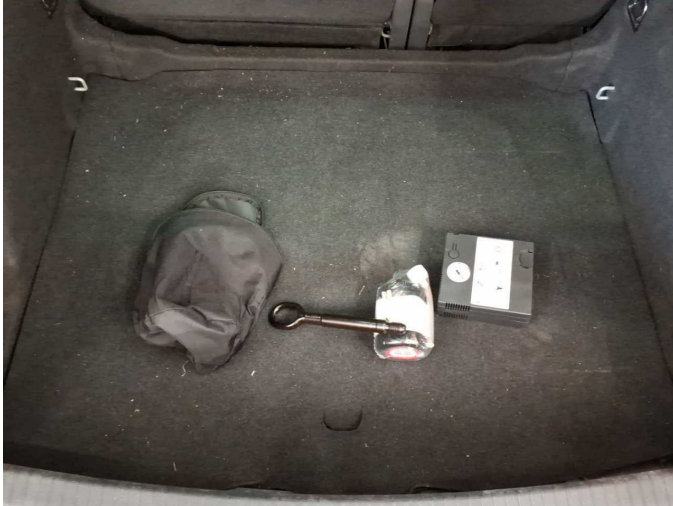
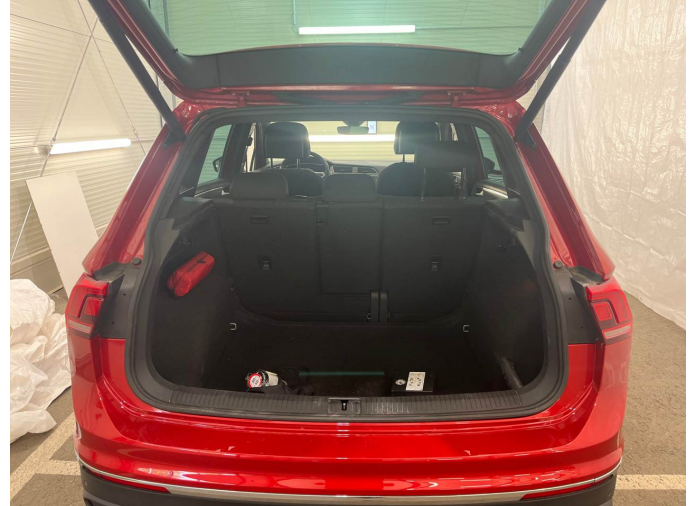
Interior - Boot cover / roller cover (Netztrennwand)

**Missing part 1:** Interior: Boot cover / roller cover (Netztrennwand) - Missing - Replace

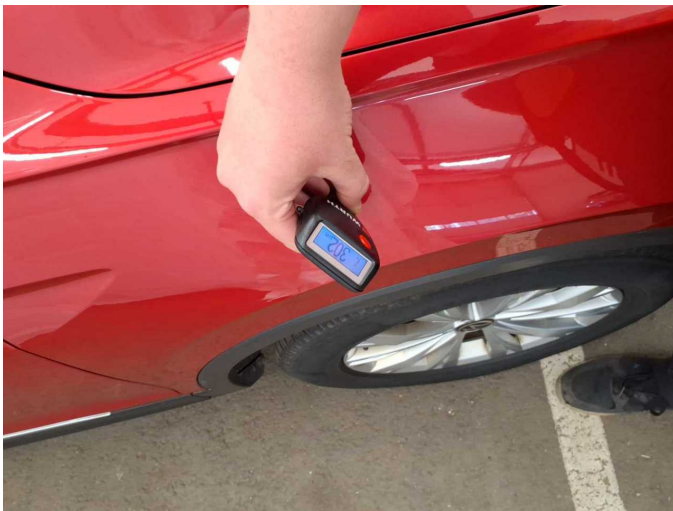
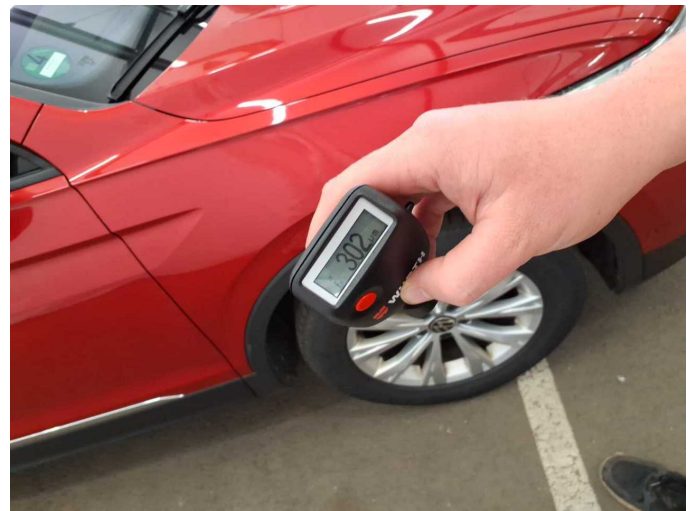
**Repainting 1:** Mudguard - right side

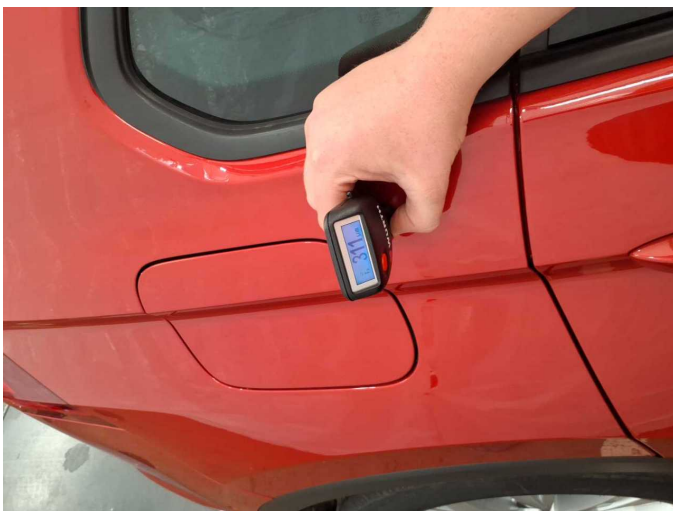
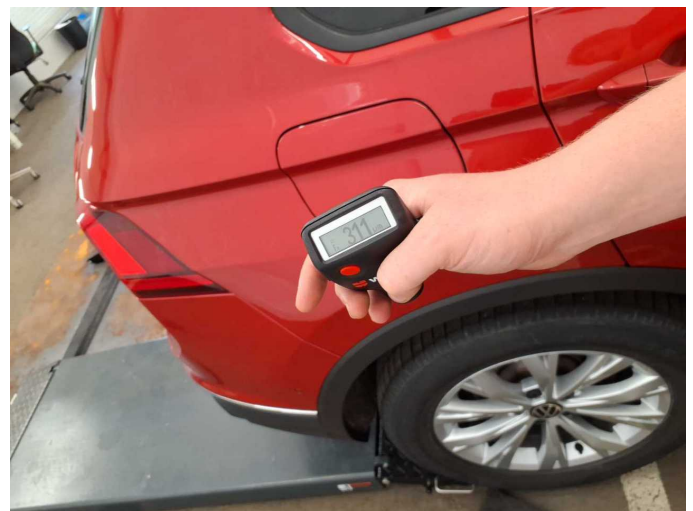
**Repainting 2:** Side panel - rear right side

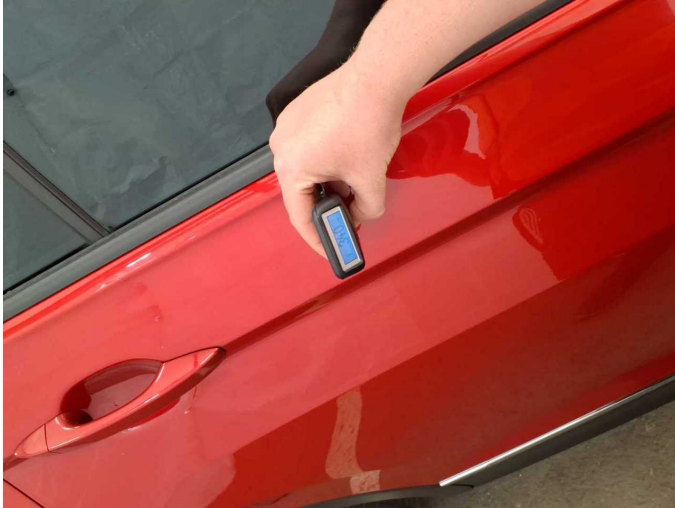
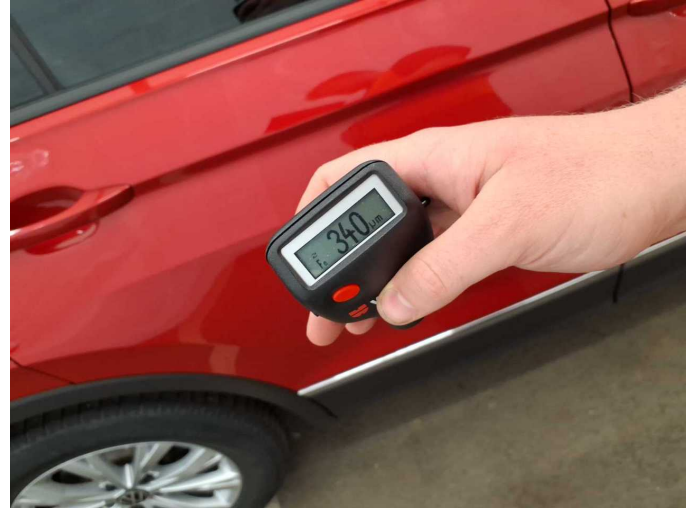
**Repainting 3:** Door - rear right side

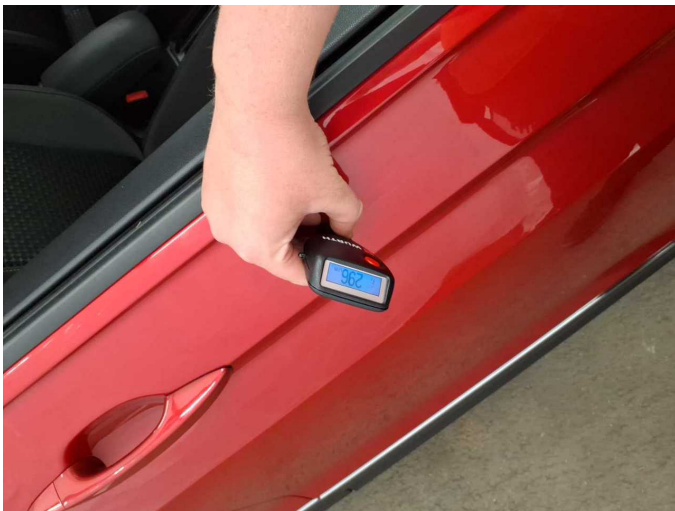
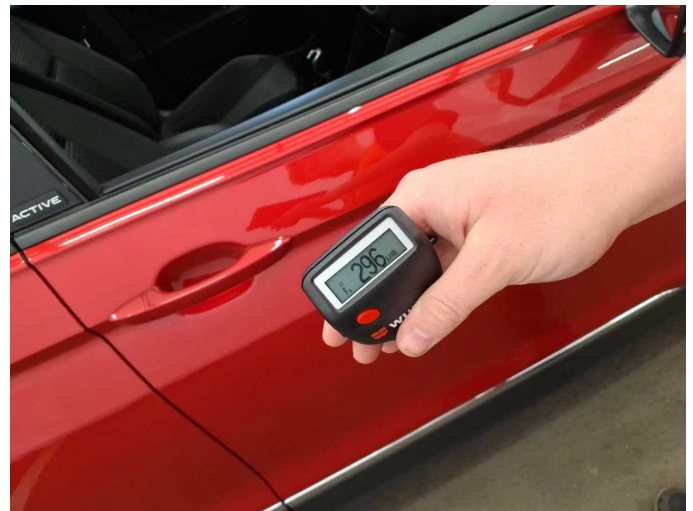
**Repainting 4:** Door - front right side
