## Expertise

Protocol number: 46198055  
Order No. / Reference: 26535466  
Inspection date: 22 Jun 2026

Manufacturer: Peugeot

Model: 208 BlueHDi 100 GT

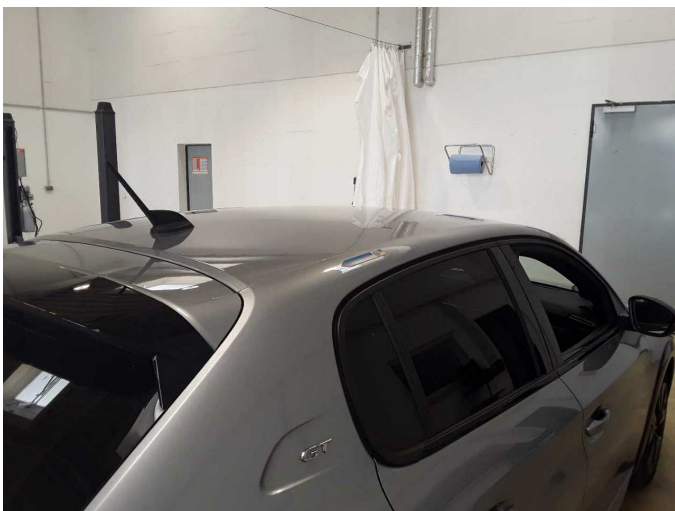
Damage 3: Roof: Roof rail - right side - dent(s) - Smooth repair work

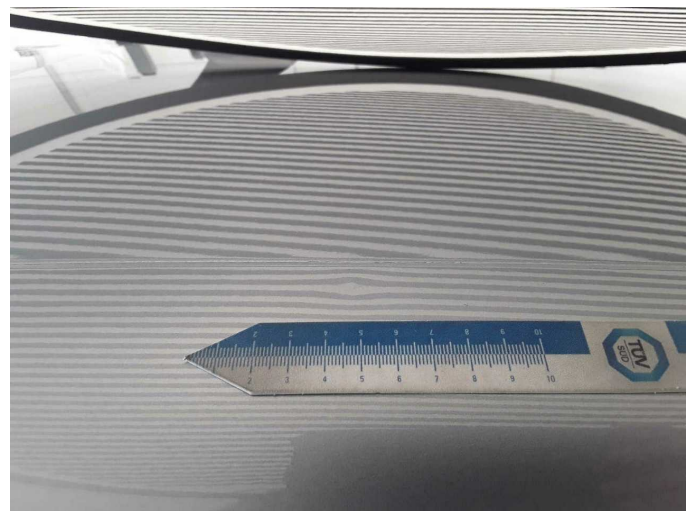
Damage 3: Roof: Roof rail - right side - dent(s) - Smooth repair work

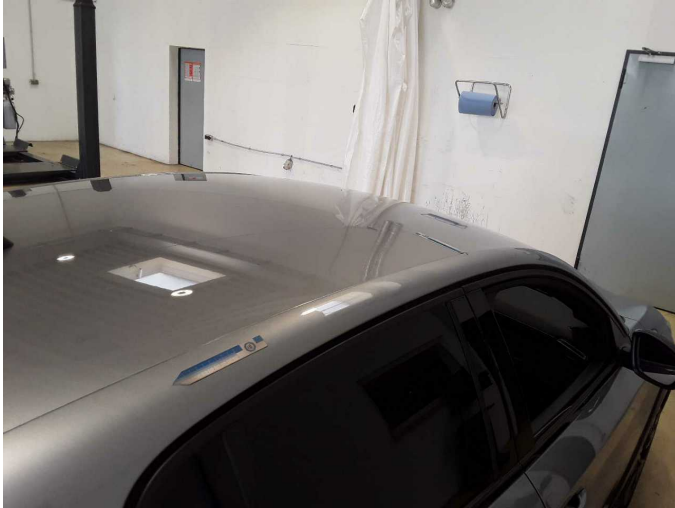
**Damage 4:** Roof: Roof - dent(s) - Smooth repair work

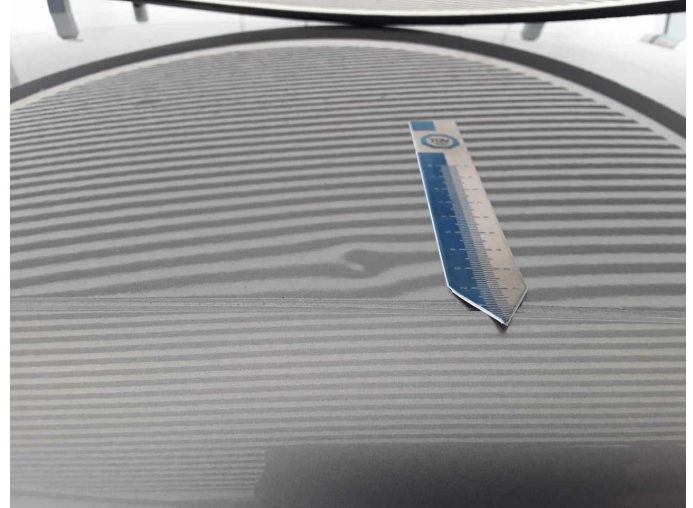
**Damage 4:** Roof: Roof - dent(s) - Smooth repair work

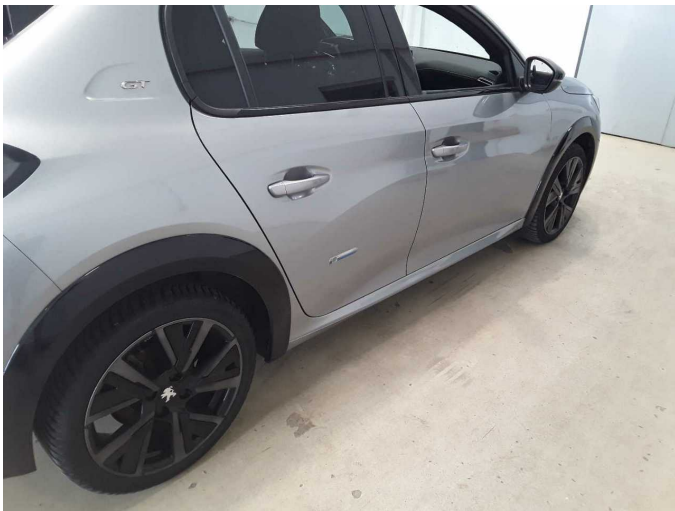
**Damage 5:** Door - rear right side: Door - dent(s) - Smart repair

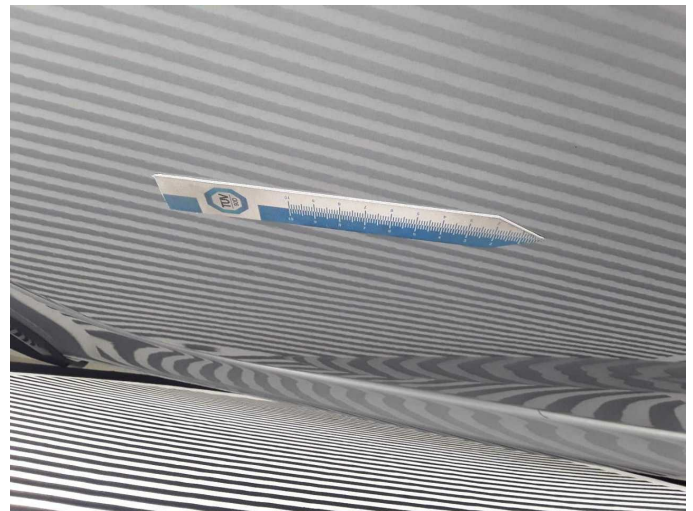
**Damage 5:** Door - rear right side: Door - dent(s) - Smart repair

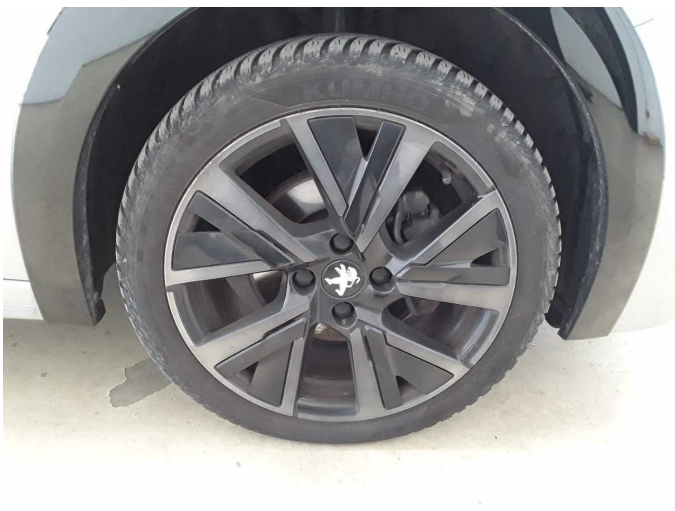
**Damage 6:** Wheel / tyres: Alloy rim - front right side - Scratch(es) - Loss in value

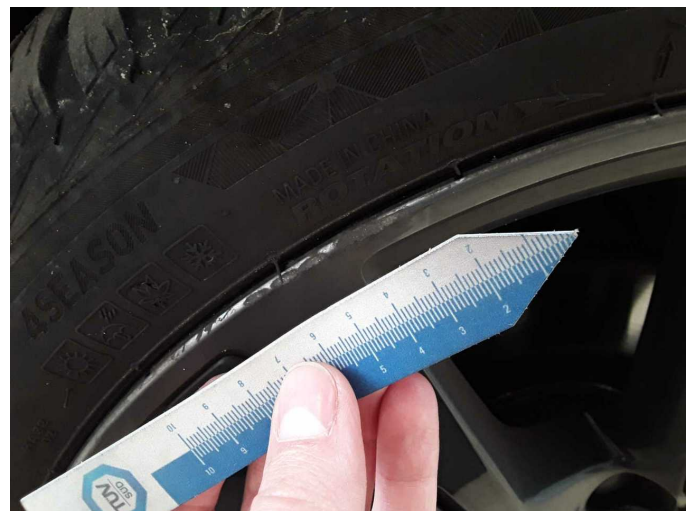
**Damage 6:** Wheel / tyres: Alloy rim - front right side - Scratch(es) - Loss in value

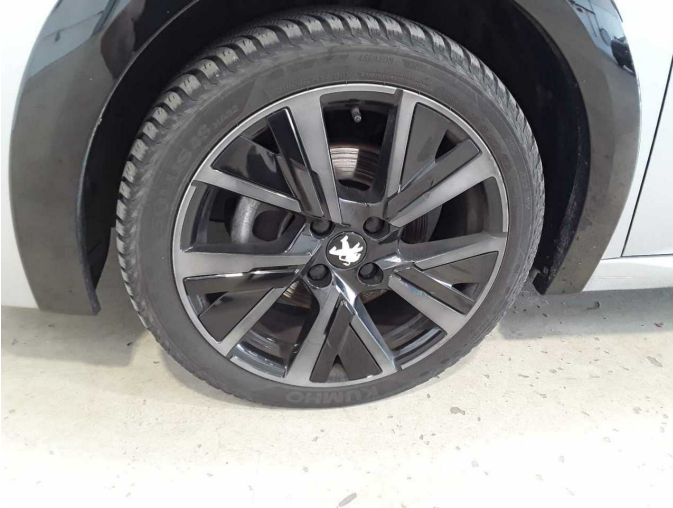
**Damage 7:** Wheel / tyres: Alloy rim - front left side - Scratch(es) - Replace

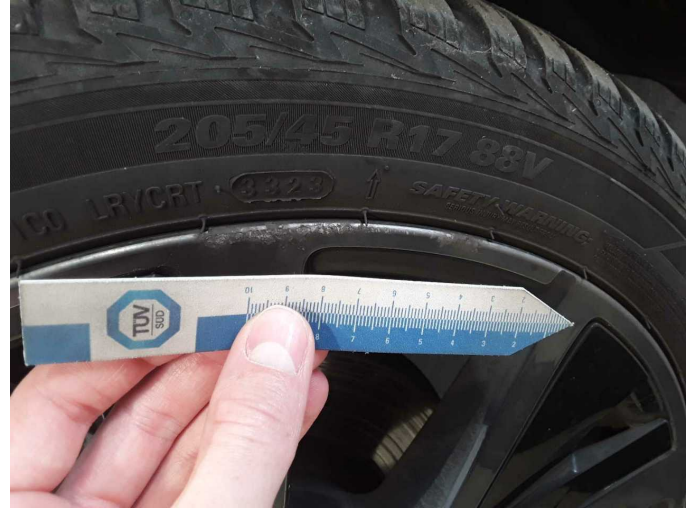
**Damage 7:** Wheel / tyres: Alloy rim - front left side - Scratch(es) - Replace

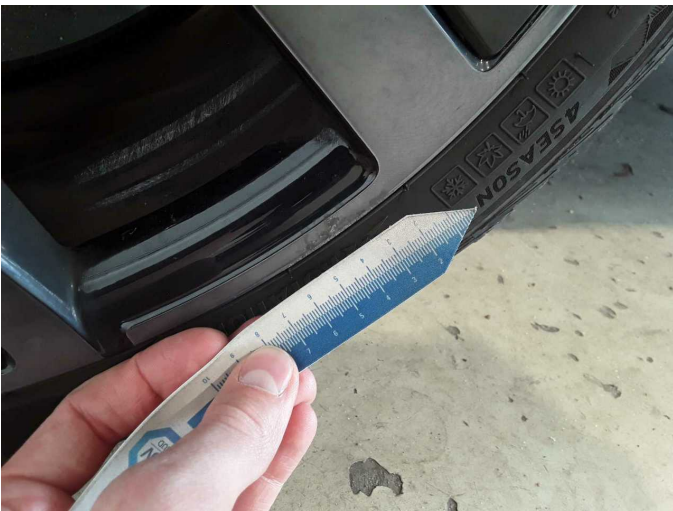
**Damage 7:** Wheel / tyres: Alloy rim - front left side - Scratch(es) - Replace
