Expertise

Protocol number: 46277296  
Order No. / Reference: 26509910  
Inspection date: 1 Jul 2026

Manufacturer: Nissan

Model: Leaf 62 kWh e+ N-Connecta

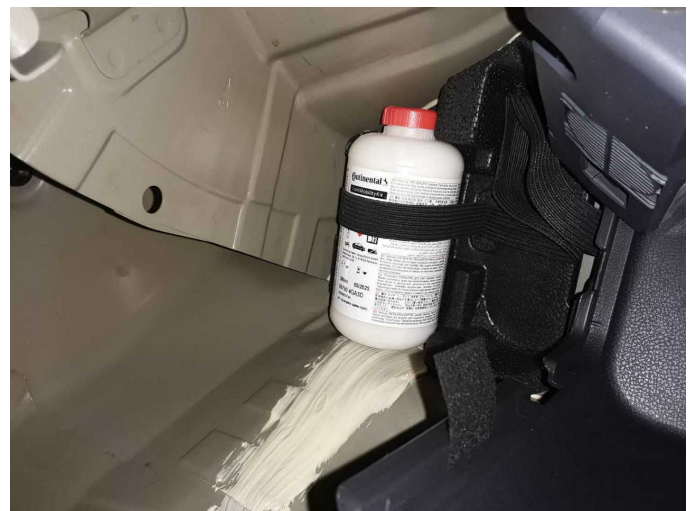
| Typ | Tyre size | Type of tyre | Manufacturer | Tread depth |
|---|---|---|---|---|
| | Tirefit | Expiration date 05/2025 | | |

| No. | Component group | Description |
|---|---|---|
| 3 | Equipment | Tirefit filler - Expired - Replace |

Damage 3: Equipment: Tirefit filler - Expired - Replace

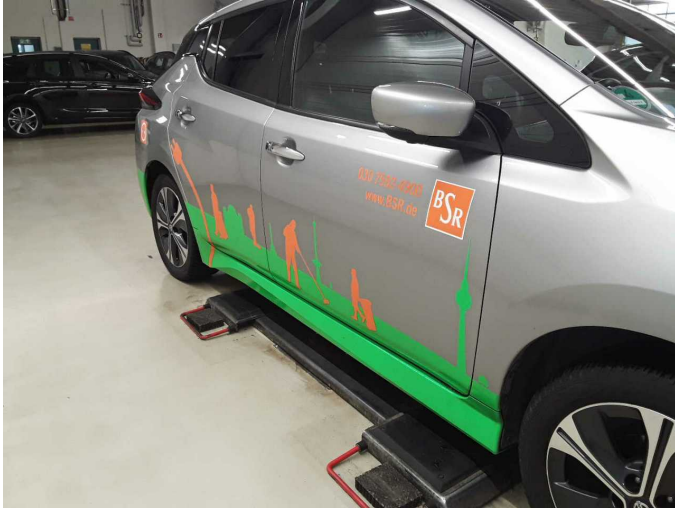
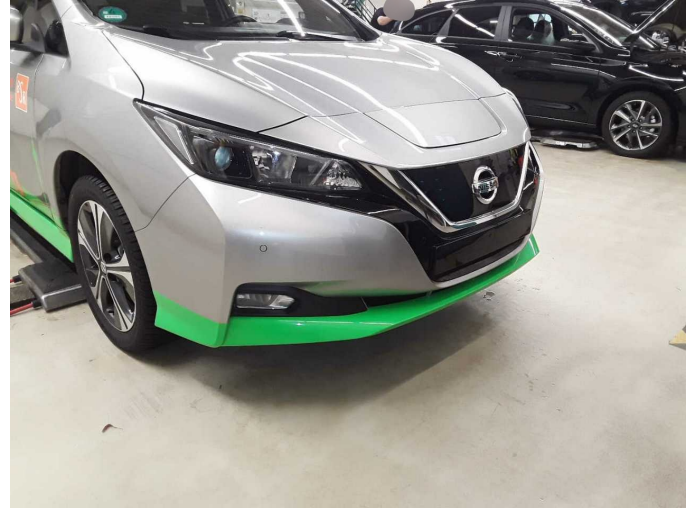
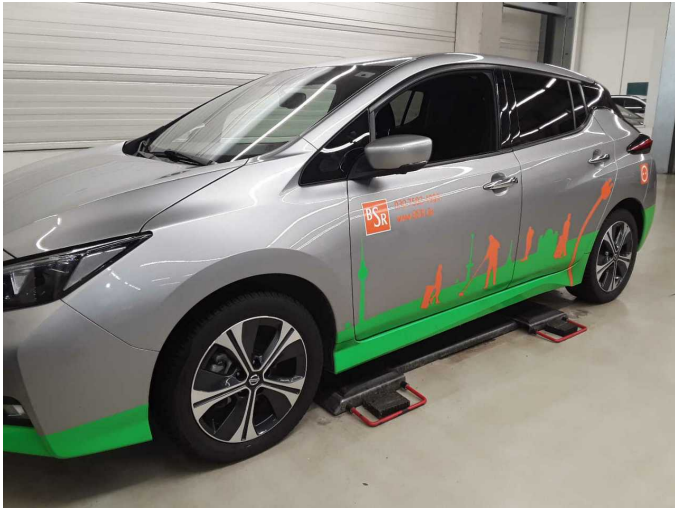
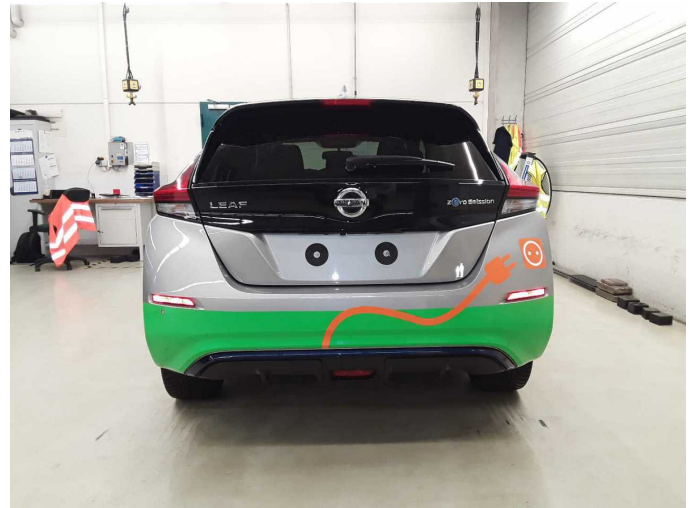
| No. | Component group | Description |
|---|---|---|
| 4 | Body | Body - Glued / labelled - De-glue / neutralise |

**Damage 4:** Body: Body - Glued / labelled - De-glue / neutralise
