## Expertise

Protocol number: 46318147  
Order No. / Reference: 26311440  
Inspection date: 3 Jul 2026

Manufacturer: Opel

Model: Astra Sports Tourer 1.2 Turbo Automatik GS

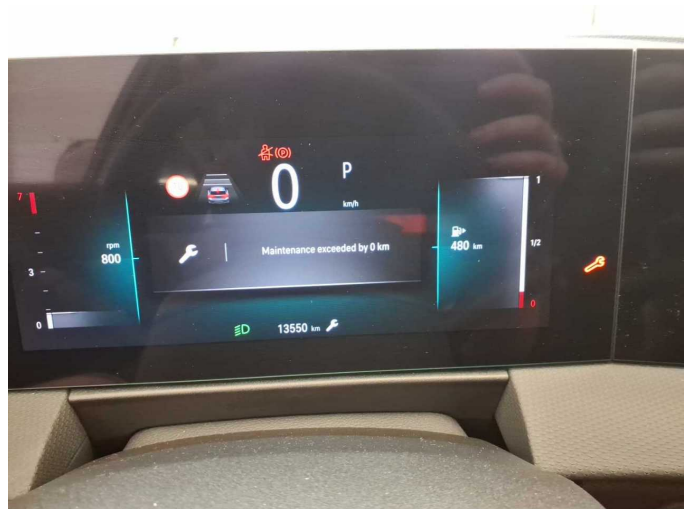
Damage 1: Misc.: Inspection / maintenance - Expired - Perform

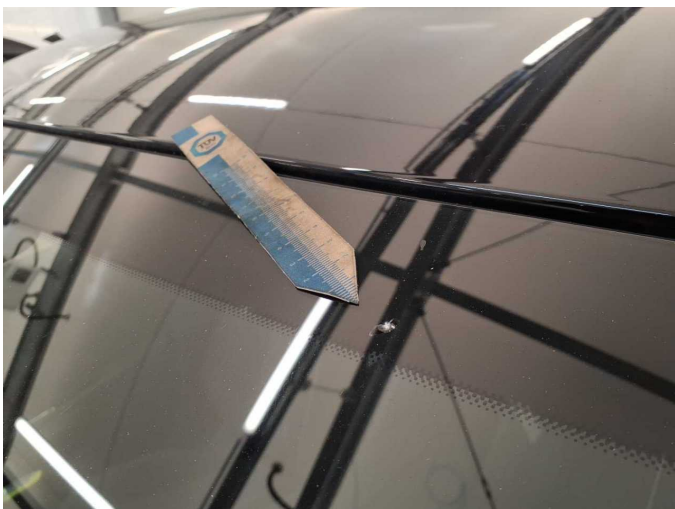
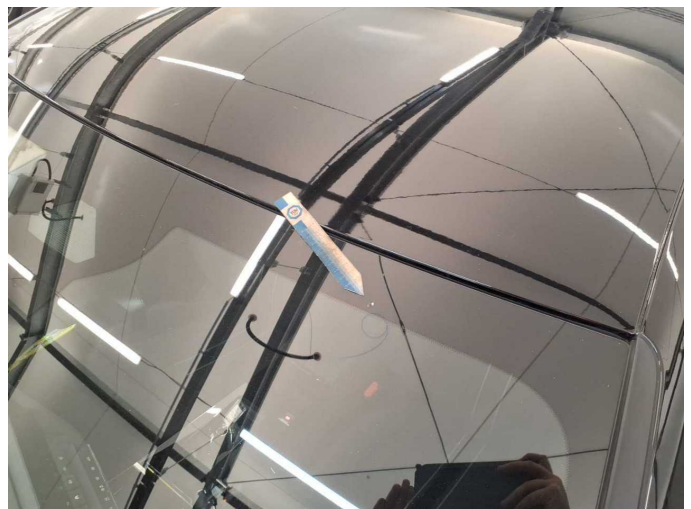
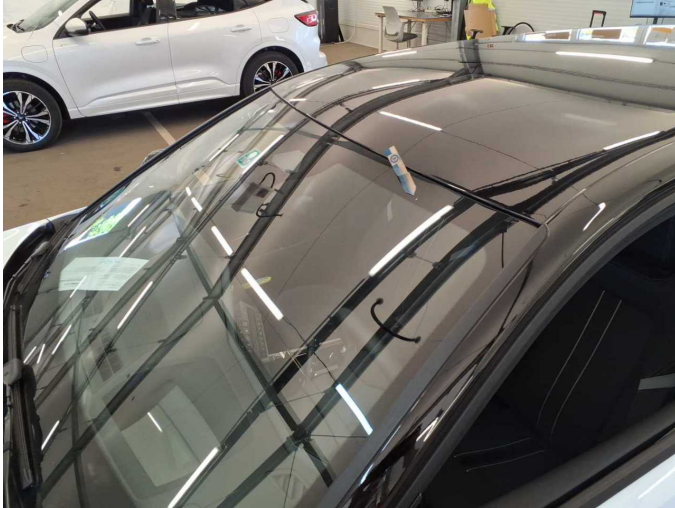
Damage 2: Vehicle glazing: Windscreen - Broken / torn - Replace

**Damage 2:** Vehicle glazing: Windscreen - Broken / torn - Replace

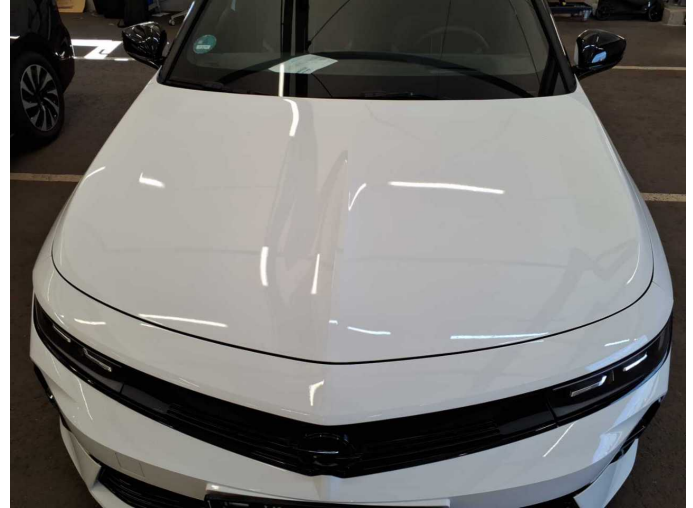
**Wear and tear 1:** Bonnet: Bonnet - Stone chips - No deduction

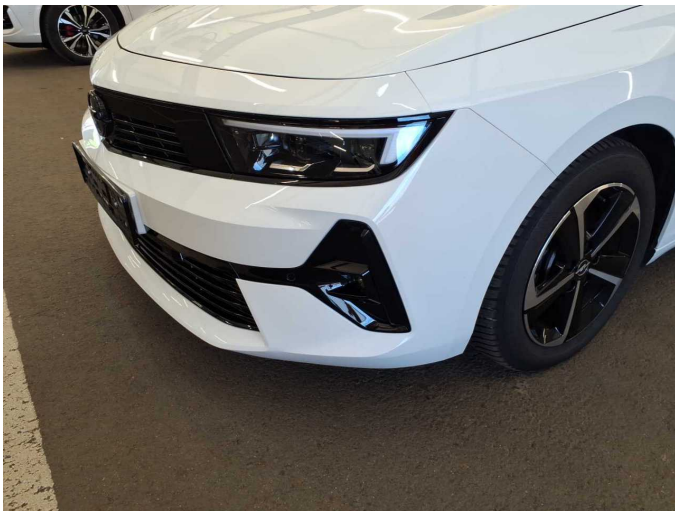
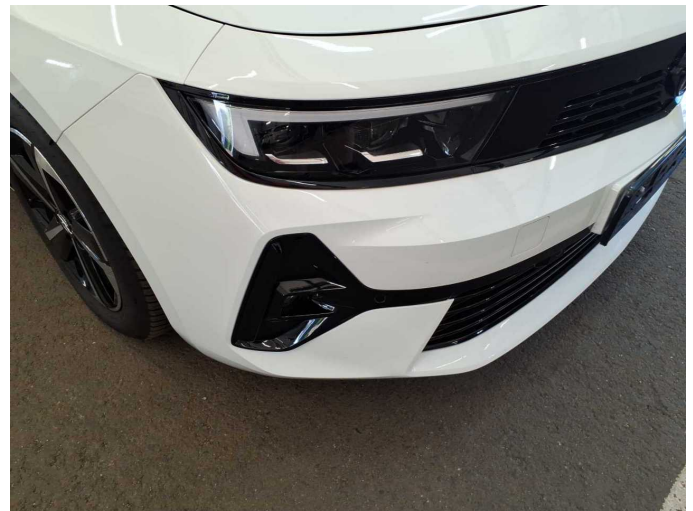
**Wear and tear 2:** Front bumper: Front bumper - Stone chips - No deduction

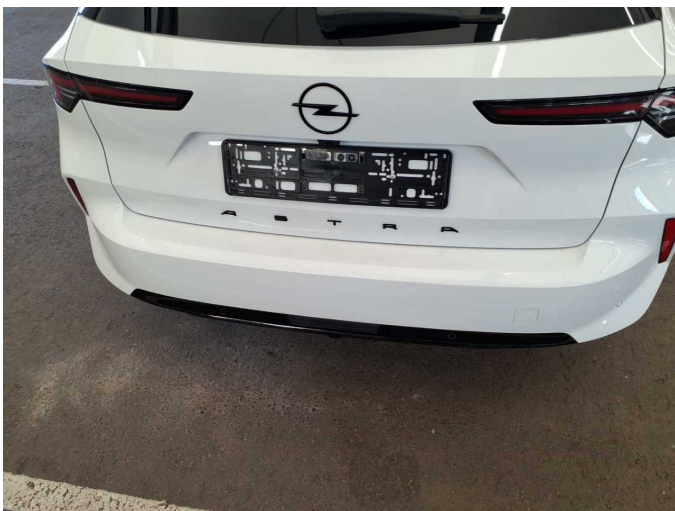
**Wear and tear 4:** Rear bumper: Rear bumper - Scratch(es) - No deduction
