Expertise

Protocol number: 46331617
Order No. / Reference: 26581874
Inspection date: 6 Jul 2026

Manufacturer: Ford

Model: Transit Custom 320 L1H1 LKW VA Trend

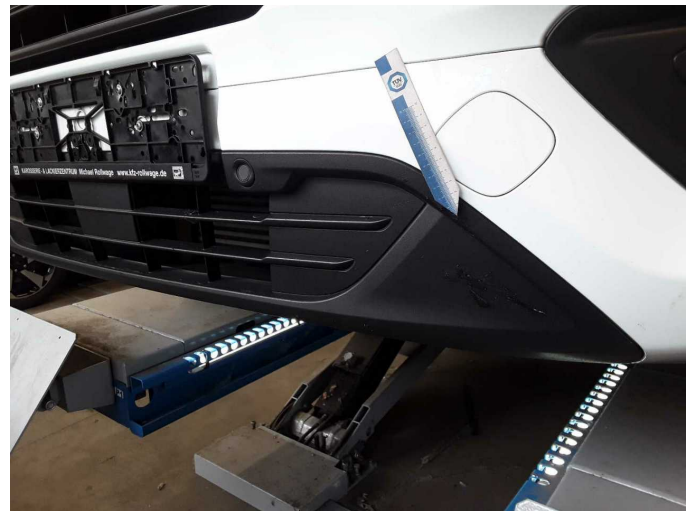
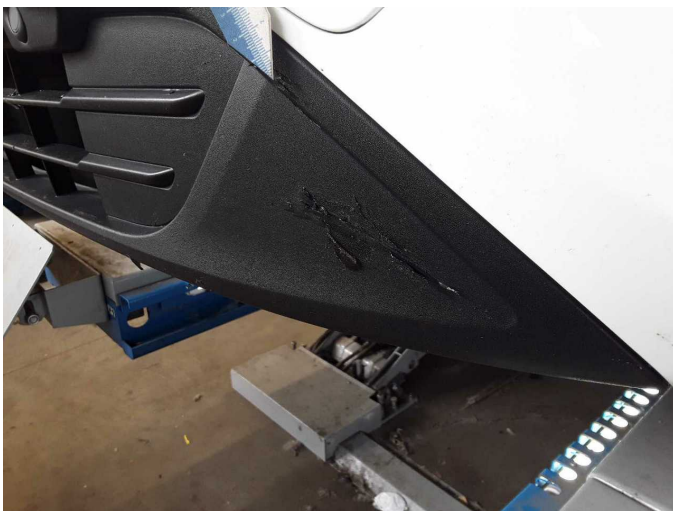
Damage 3: Front bumper: Front bumper (unpainted) - Scratched - Smart repair

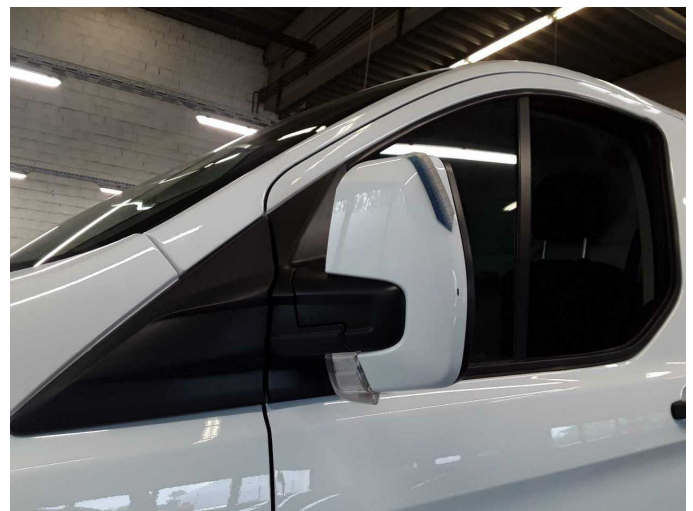
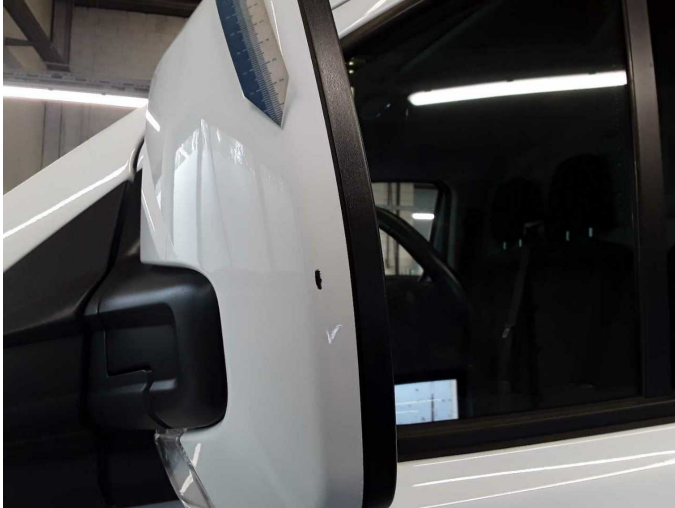
Damage 4: Wing mirror - left side: Cap - Scratch(es) - Smart repair

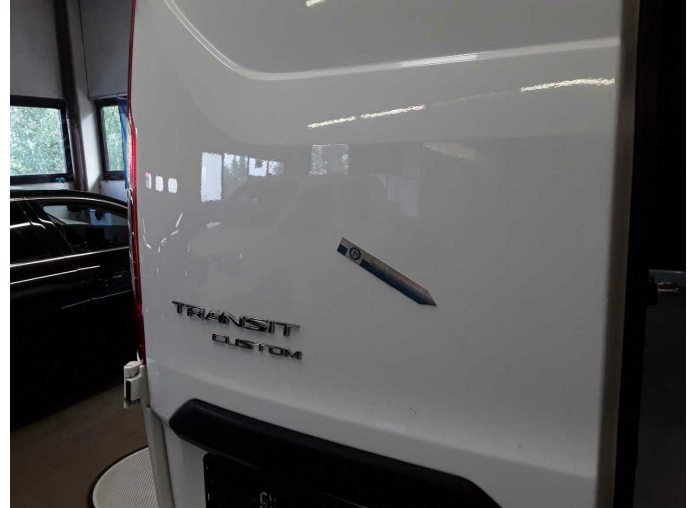
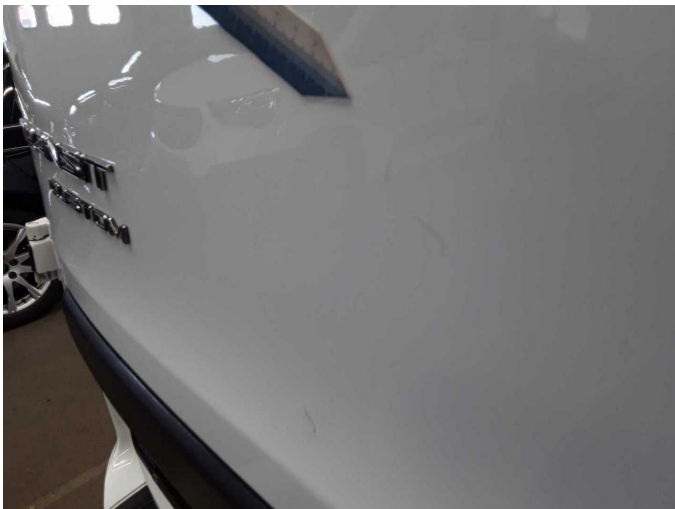
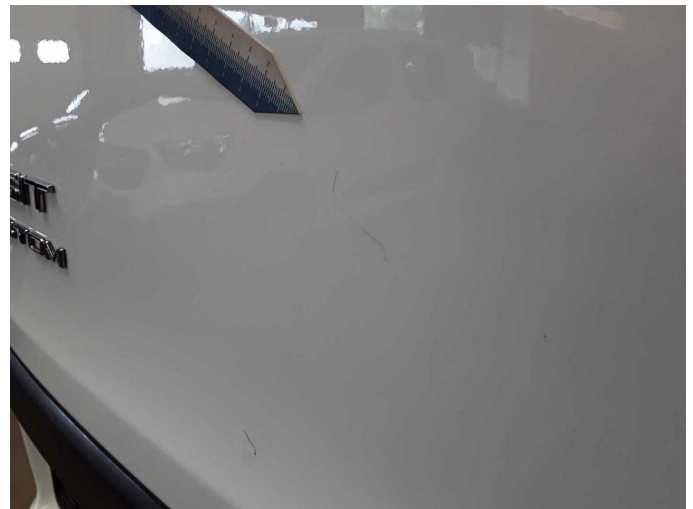
Damage 5: Boot lid / rear door: Rear door - left side - Scratch(es) - Smart repair

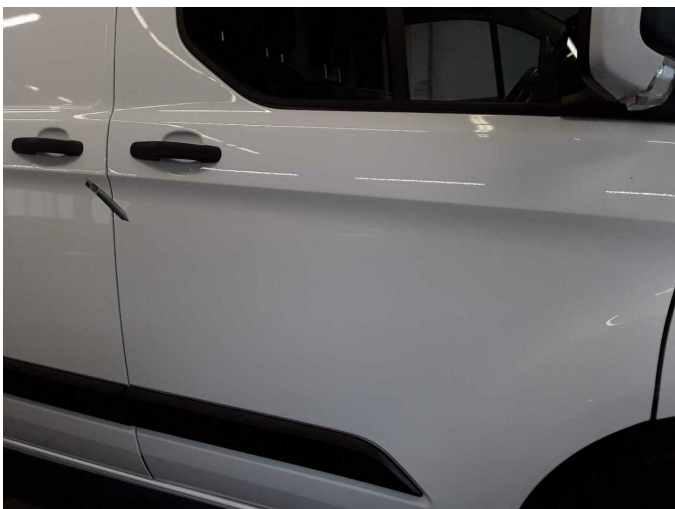
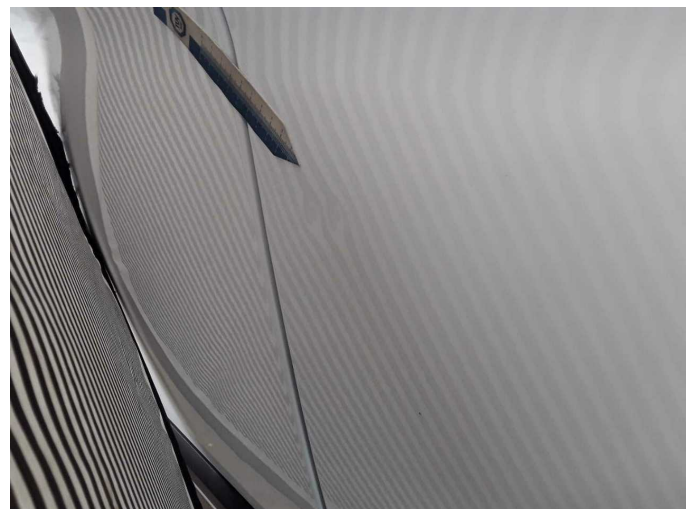
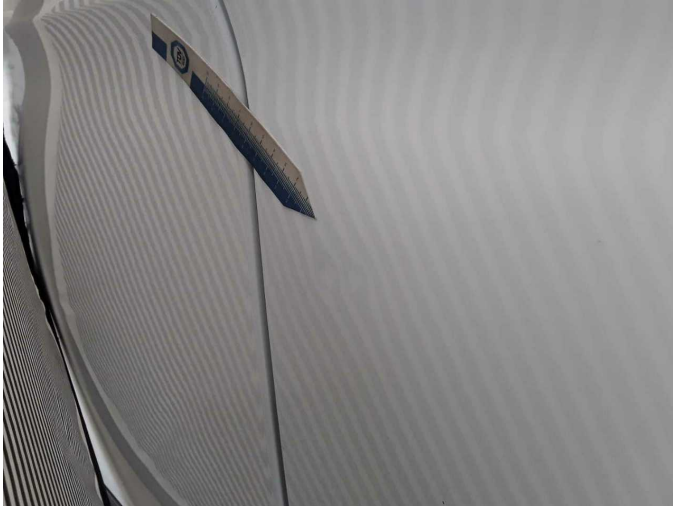
Damage 6: Door - front right side: Door - Dent / paintcoat damage - Smart repair

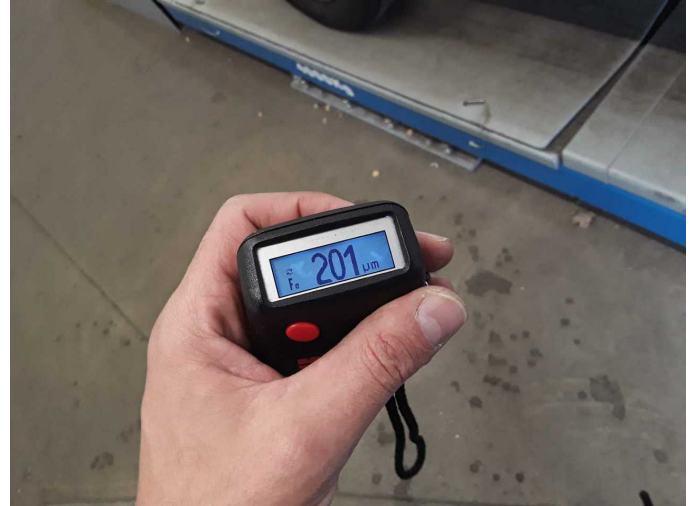
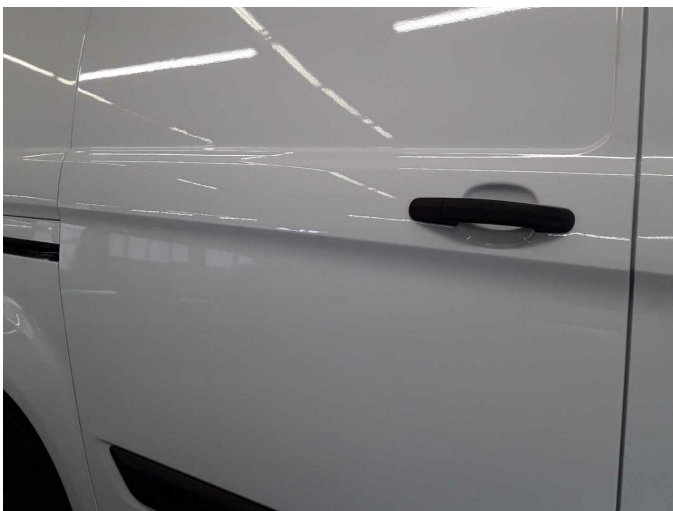
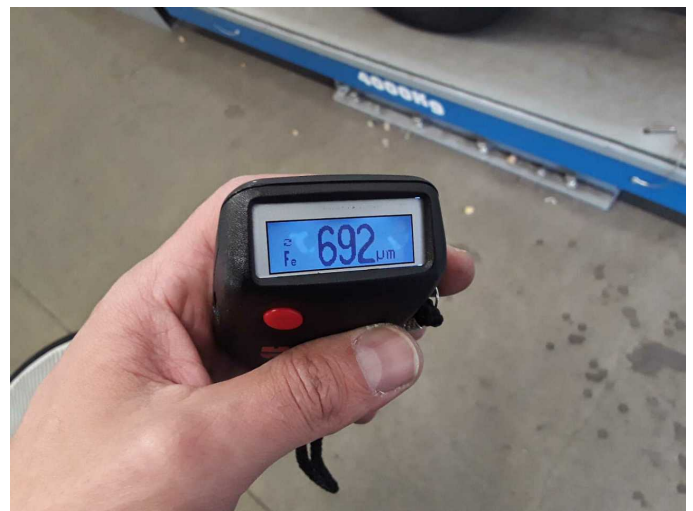
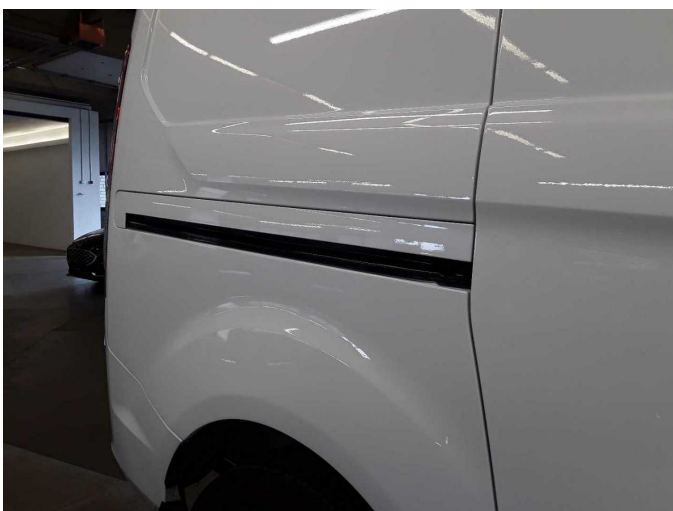
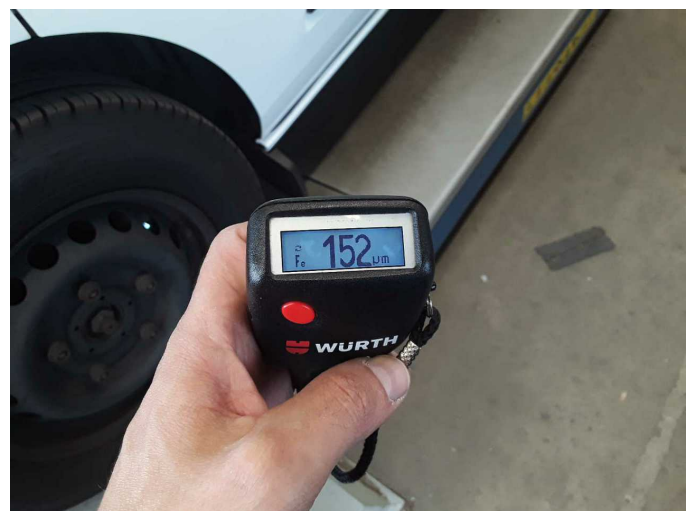
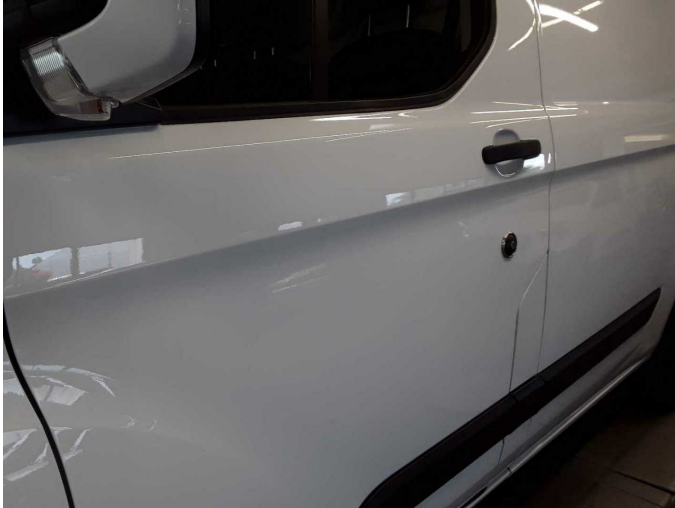
No.	Repainting
1	Side panel - rear right side, Door - rear right side, Door - front left side, Professionally carried out, Invoice of repair done Non-existent

Repainting 1: Side panel - rear right side, Door - rear right side, Door - front left side
