Expertise

Protocol number: 46373716  
Order No. / Reference: 26300764  
Inspection date: 6 Jul 2026

Manufacturer: Ford

Model: Transit Connect 230 L2 Trend

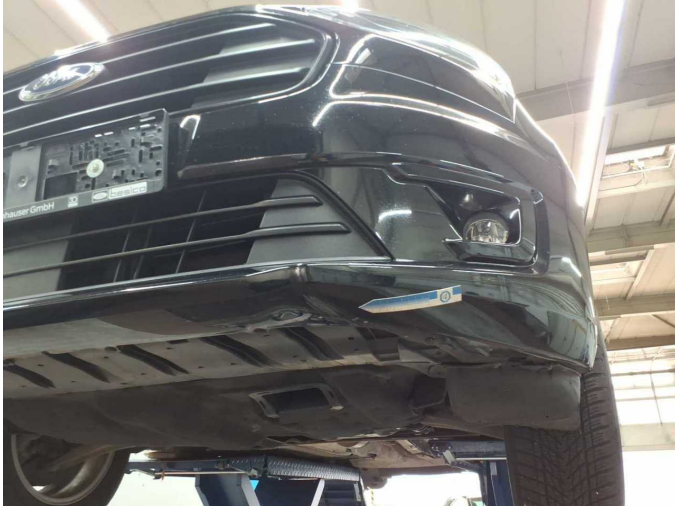
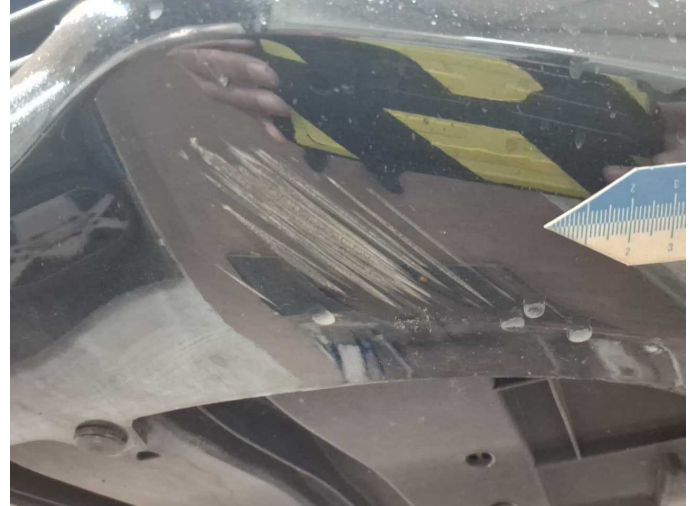
| No. | Component group | Description |
|---|---|---|
| 1 | Front bumper | Front bumper - Scratched - Smart repair |

**Damage 1:** Front bumper: Front bumper - Scratched - Smart repair

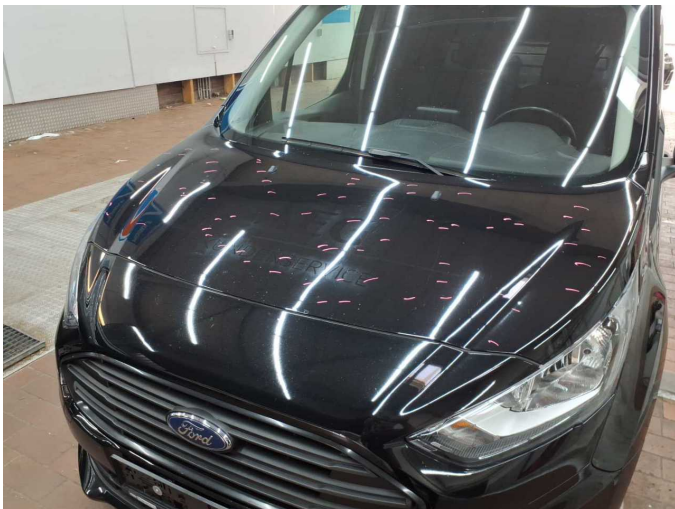
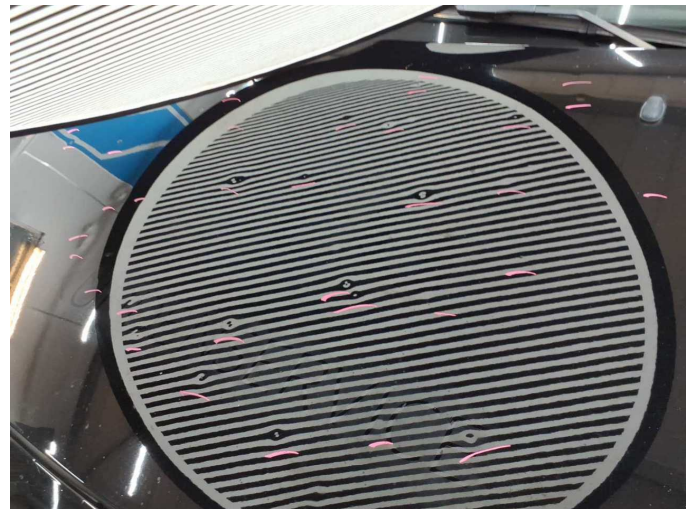
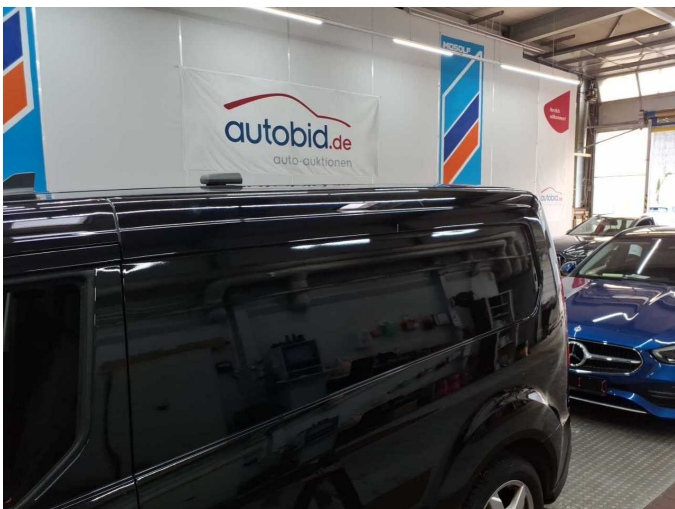
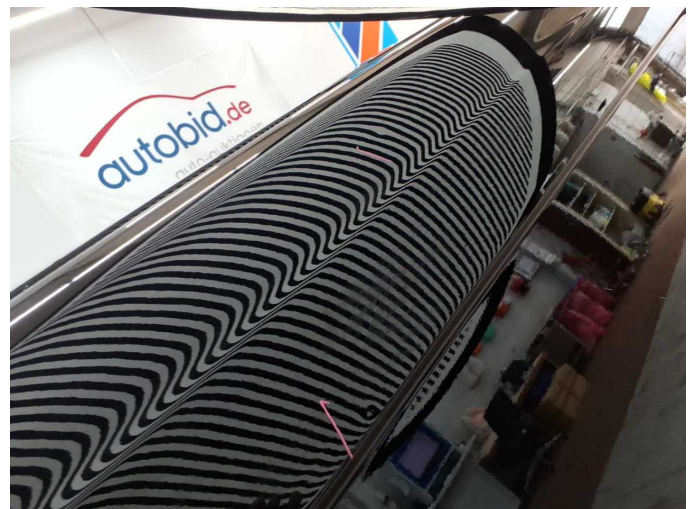
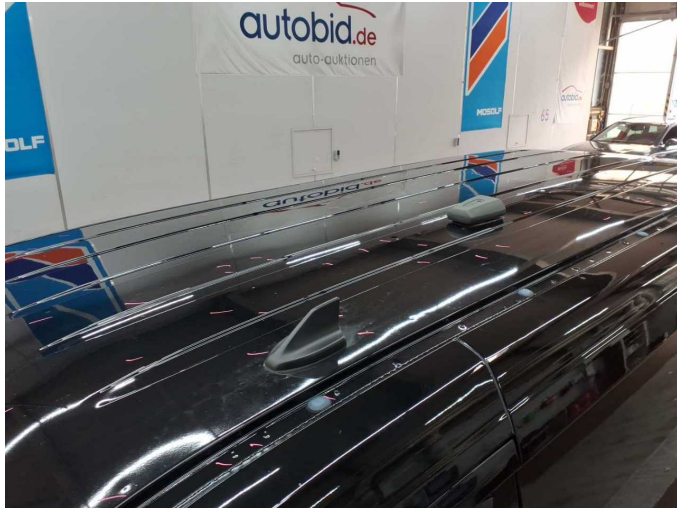
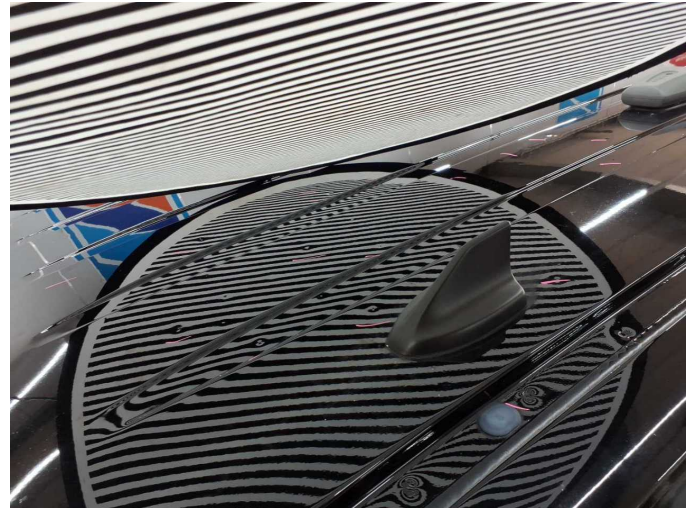
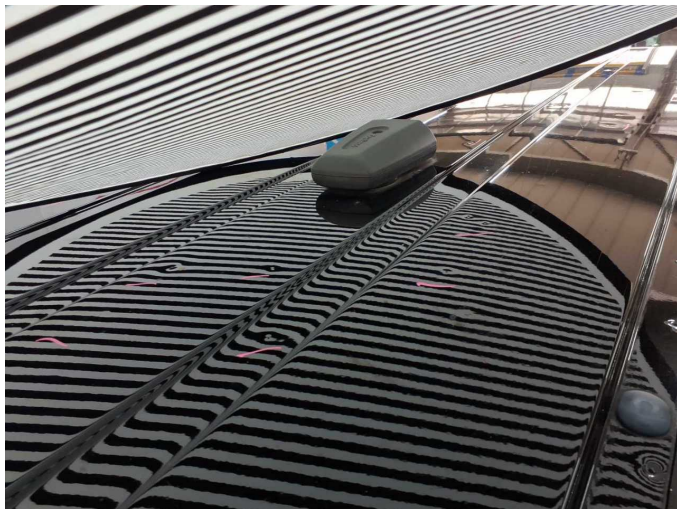
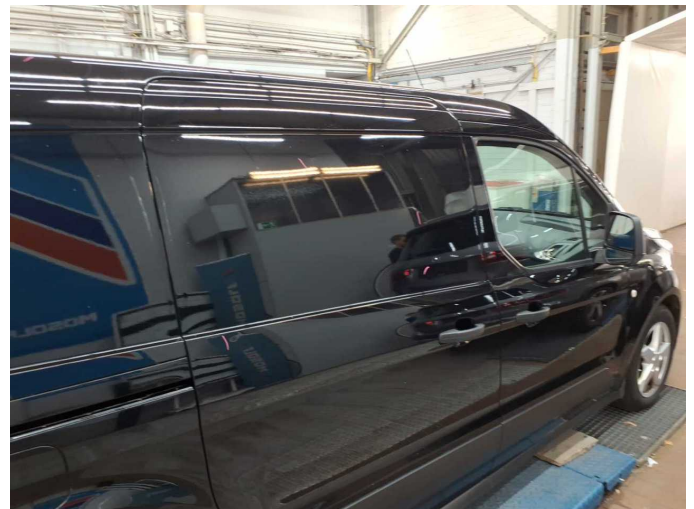
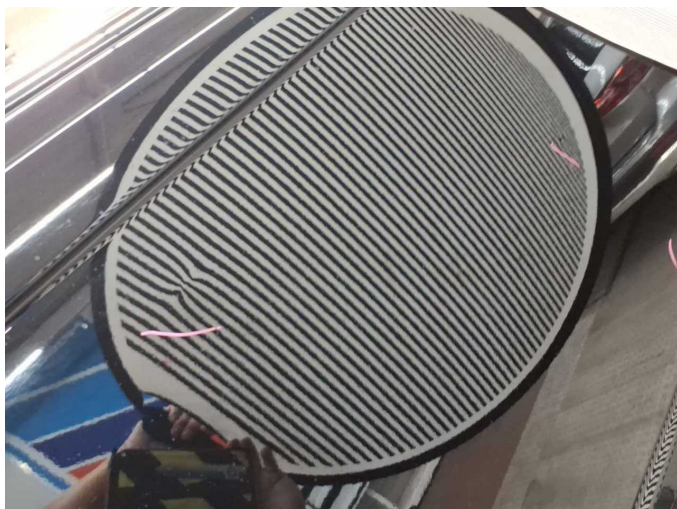
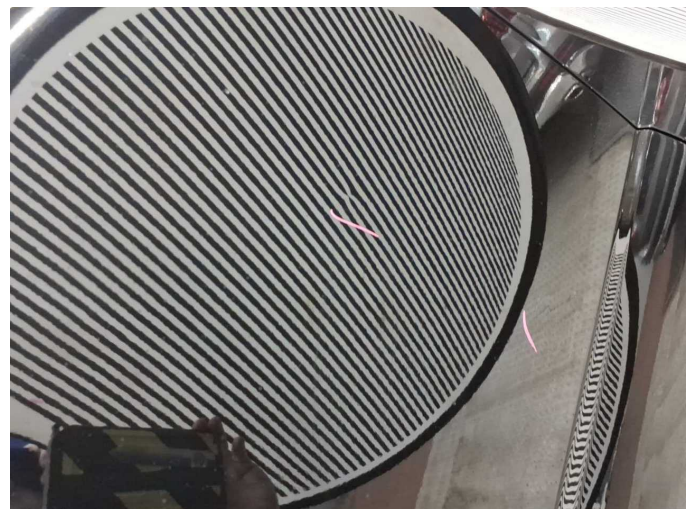
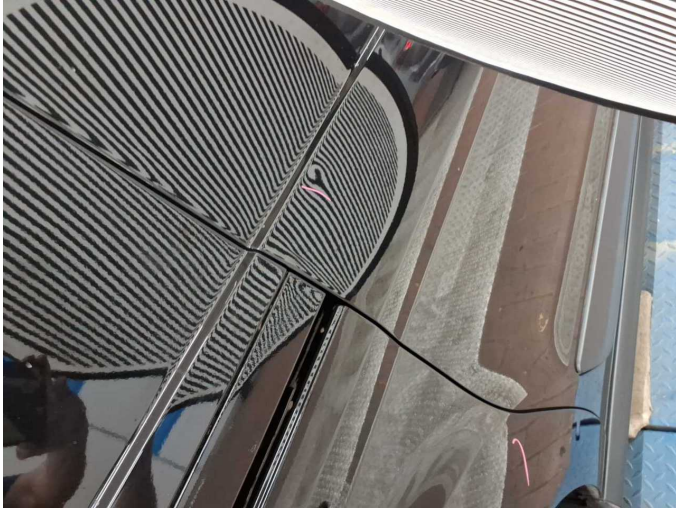
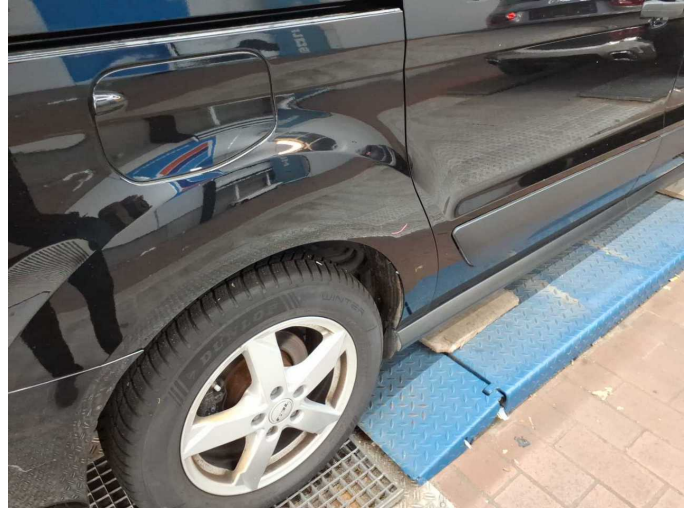
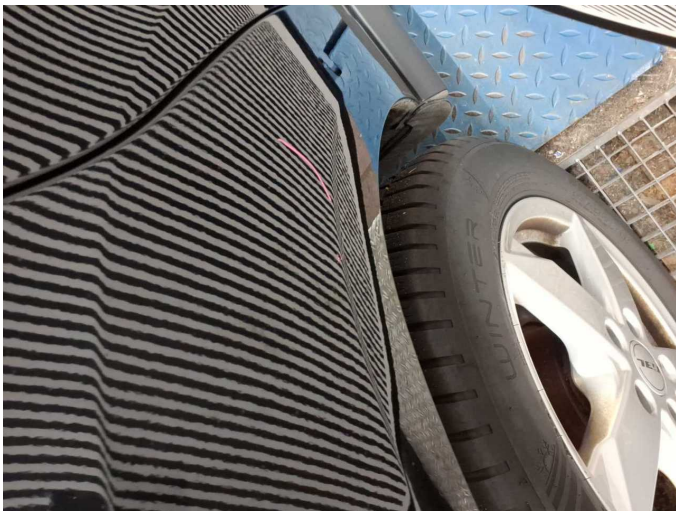
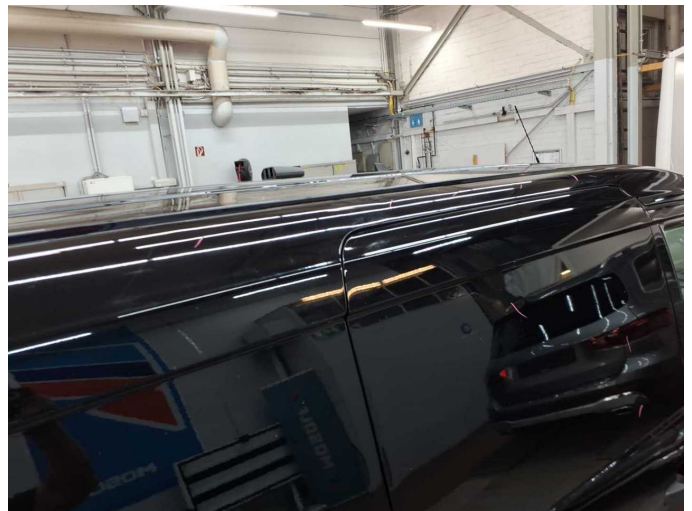
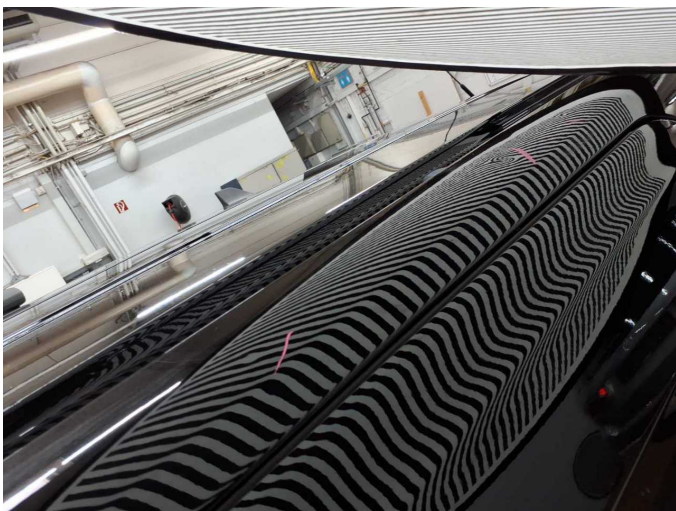
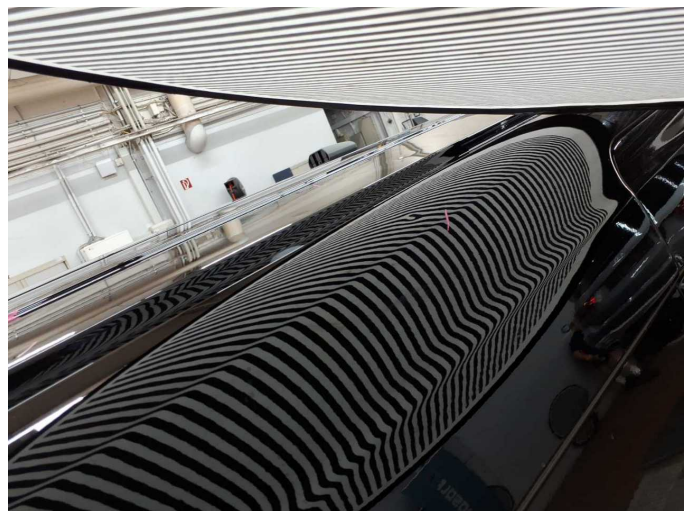
| No. | Component group | Description |
|---|---|---|
| 2 | Body | Body - Damage by hail - repair according to calculation |

**Damage 2:** Body: Body - Damage by hail - repair according to calculation

Die beigefügte Reparaturkostenkalkulation wurde nach bestem Wissen und Gewissen im demontagefreien Zustand erstellt. Es können Mehrkosten und somit Abweichung der für den Hagelschaden ausgewiesener Reparaturkosten nicht ausgeschlossen werden.

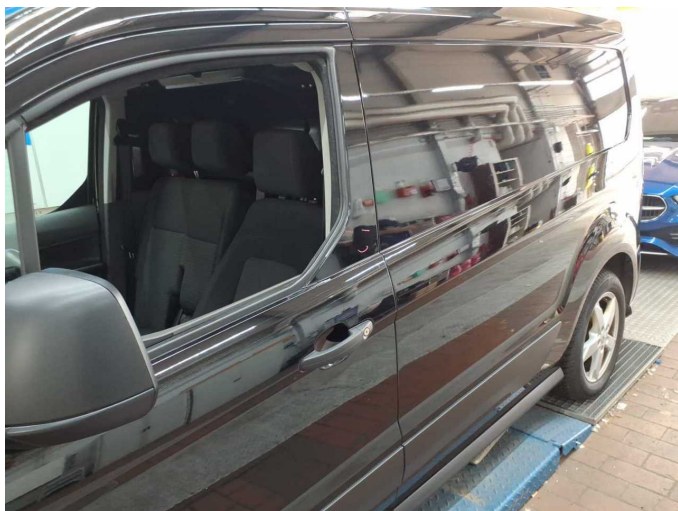
**Damage 2:** Body: Body - Damage by hail - repair according to calculation

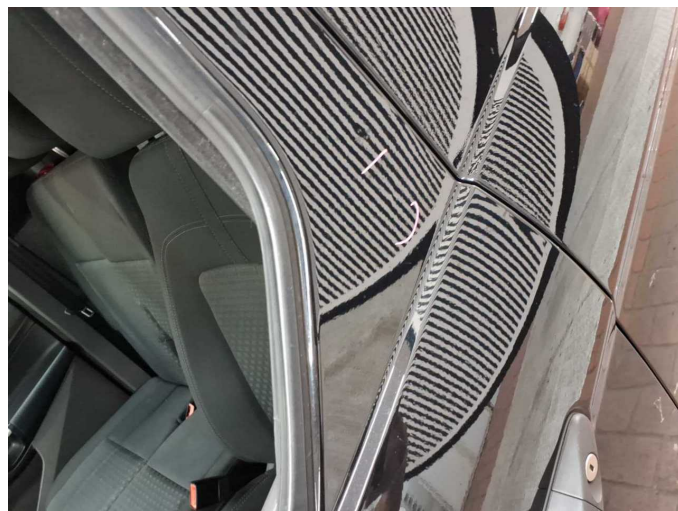
**Damage 2:** Body: Body - Damage by hail - repair according to calculation
