Expertise

Protocol number: 45769336  
Order No. / Reference: 26445520  
Inspection date: 3 Jun 2026

Manufacturer: Volkswagen

Model: Touareg 3.0 V6 TDI 4Motion DPF Aut. Elegance

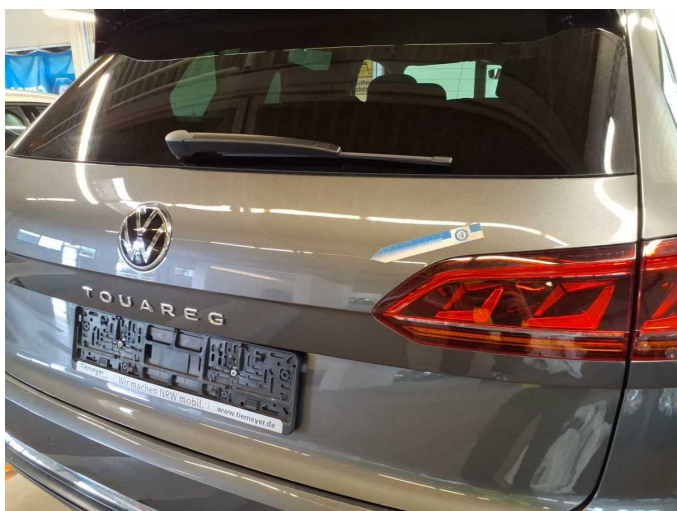
| No. | Component group | Description |
|---|---|---|
| 1 | Boot lid / rear door | Boot lid - dent(s) - Smooth repair work |

Damage 1: Boot lid / rear door: Boot lid - dent(s) - Smooth repair work

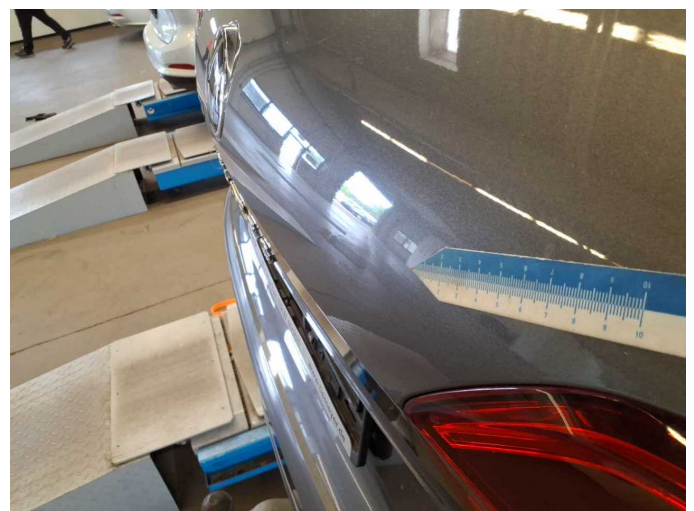
Damage 1: Boot lid / rear door: Boot lid - dent(s) - Smooth repair work

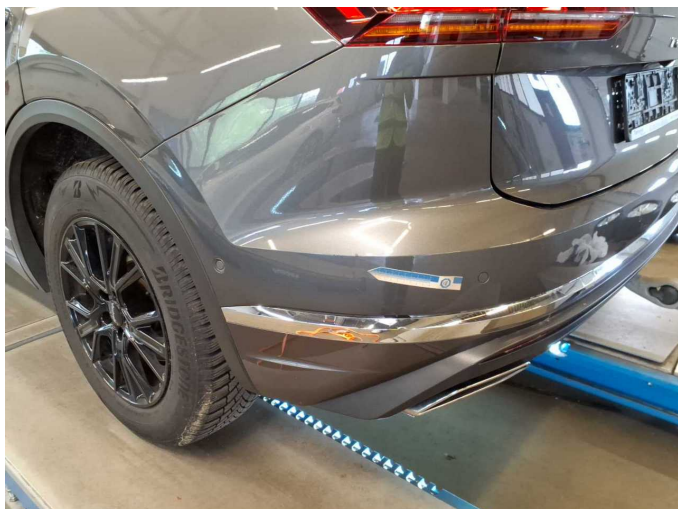
| No. | Component group | Description |
|---|---|---|
| 2 | Rear bumper | Rear bumper - Scratch(es) - Paint |

**Damage 2:** Rear bumper: Rear bumper - Scratch(es) - Paint

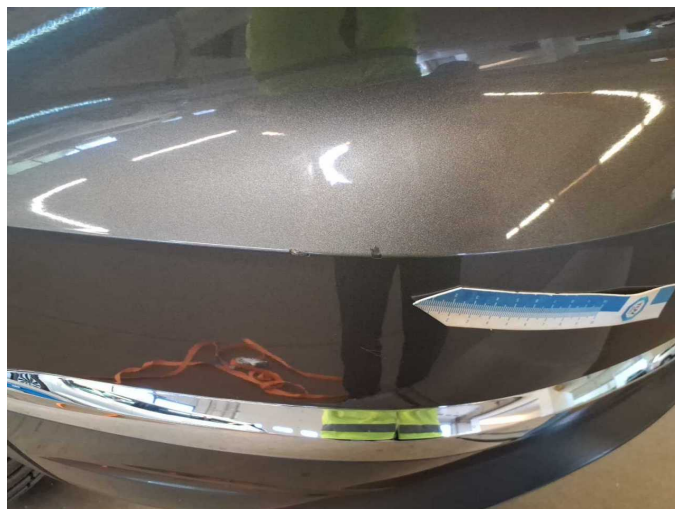
**Damage 2:** Rear bumper: Rear bumper - Scratch(es) - Paint

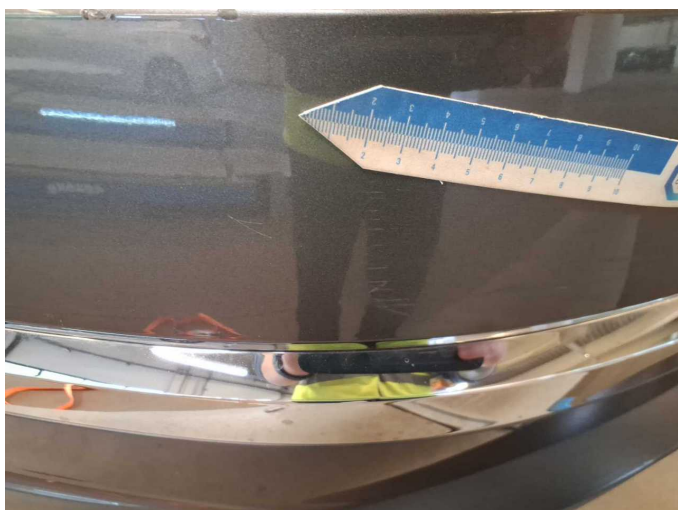
**Damage 2:** Rear bumper: Rear bumper - Scratch(es) - Paint
