Expertise

Protocol number: 45863769
Order No. / Reference: 26466385
Inspection date: 10 Jun 2026

Manufacturer: Skoda

Model: Kodiaq 2.0 TDI 4x4 DSG Sportline

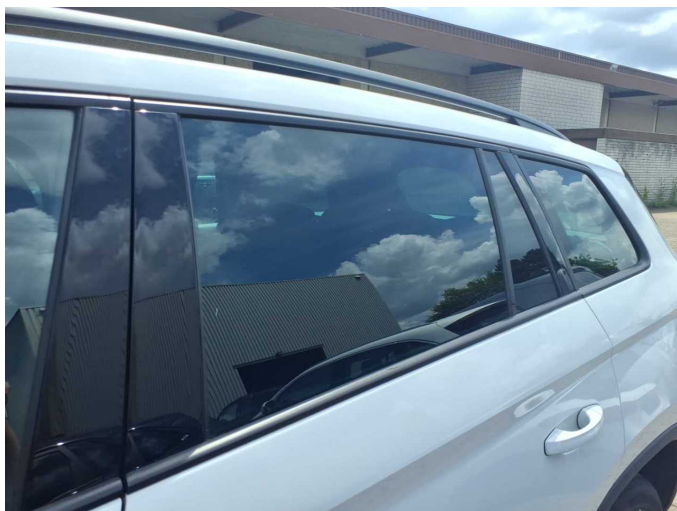
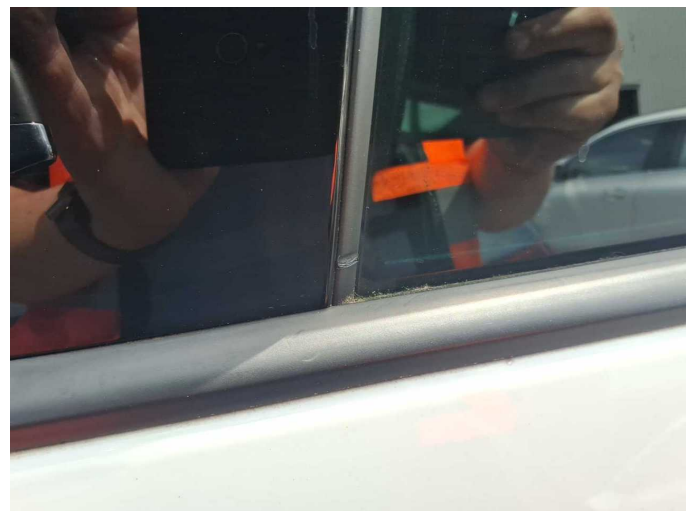
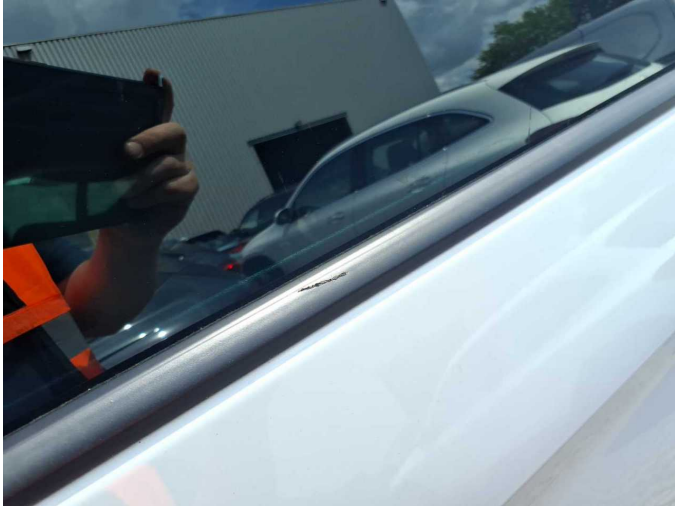
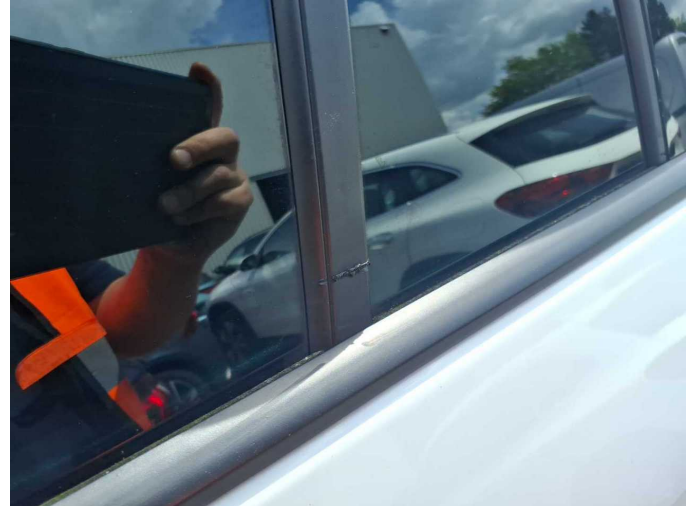
| No. | Component group | Description |
|---|---|---|
| 1 | Door - rear left side | Brightware - upper (Leiste) - Scratched - Loss in value |

Damage 1: Door - rear left side: Brightware - upper (Leiste) - Scratched - Loss in value

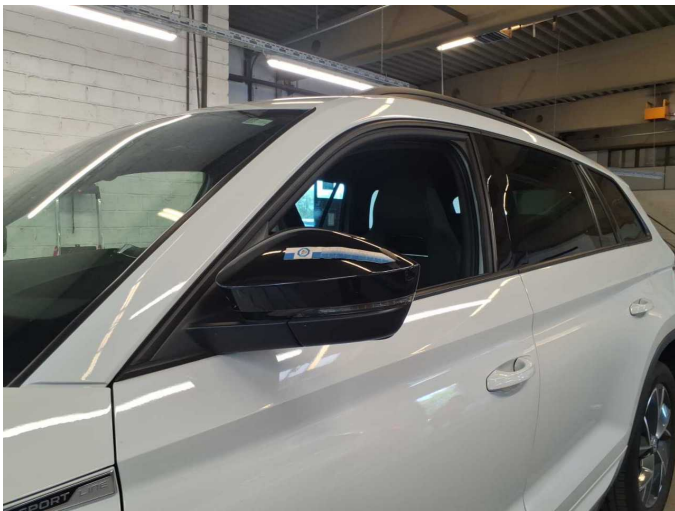
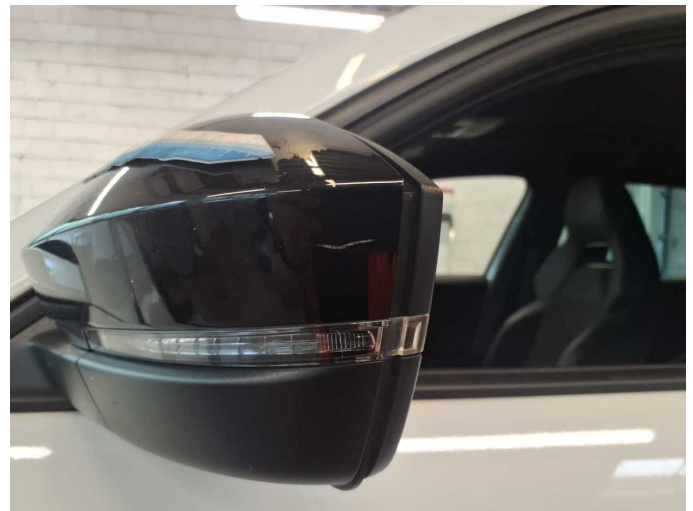
| No. | Component group | Description |
|---|---|---|
| 2 | Wing mirror - left side | Cap - Scratched - Smart repair |

Damage 2: Wing mirror - left side: Cap - Scratched - Smart repair

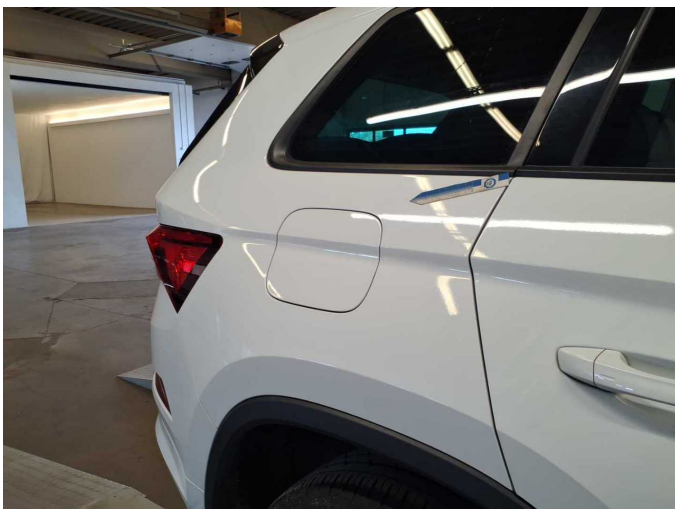
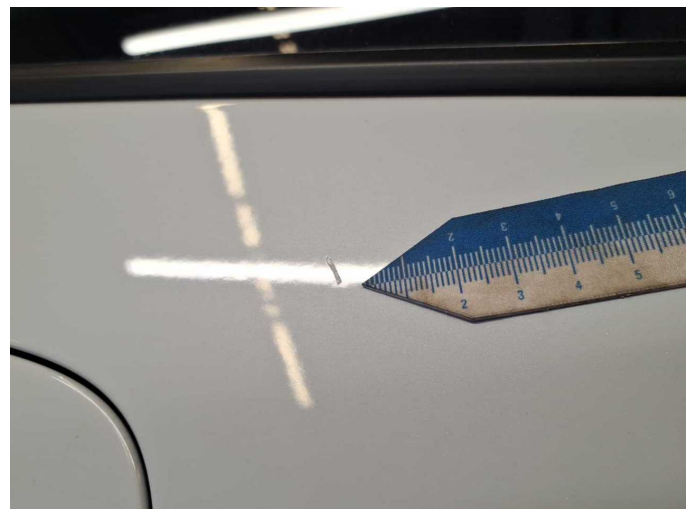
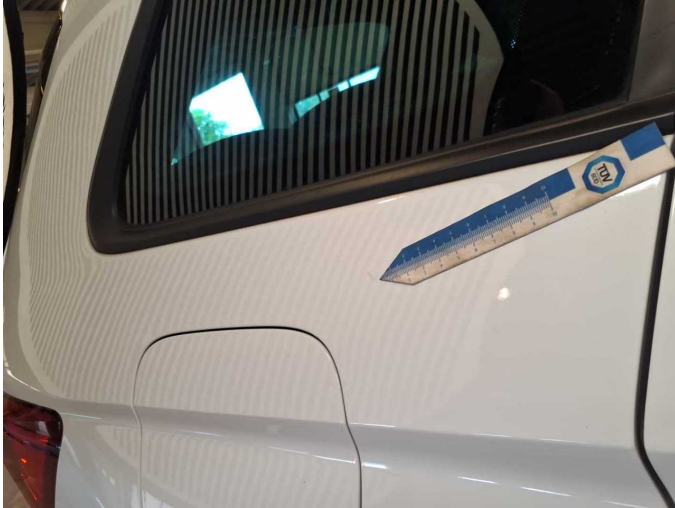
| No. | Component group | Description |
|---|---|---|
| 3 | Side panel - rear right side | Side panel - Dent / paintcoat damage - Smart repair |

Damage 3: Side panel - rear right side: Side panel - Dent / paintcoat damage - Smart repair

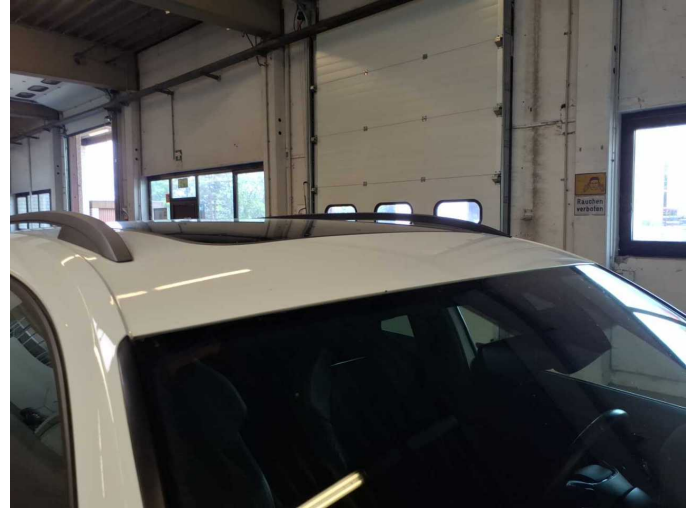
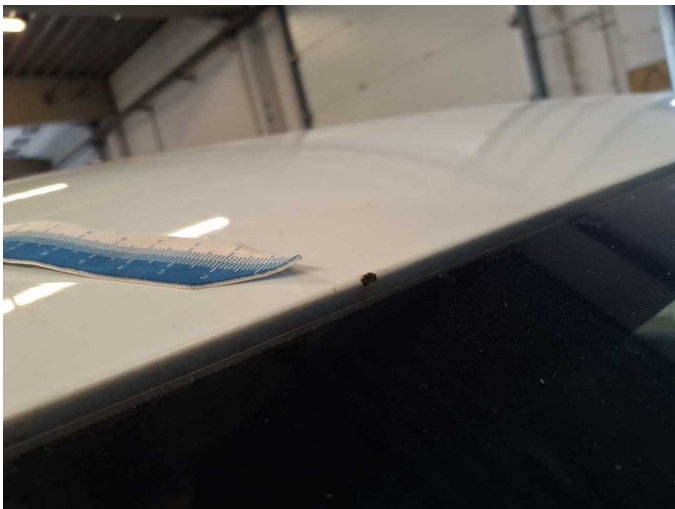
| No. | Component group | Description |
|---|---|---|
| 4 | Roof | Roof - Stone chips - Paint |

Damage 4: Roof: Roof - Stone chips - Paint

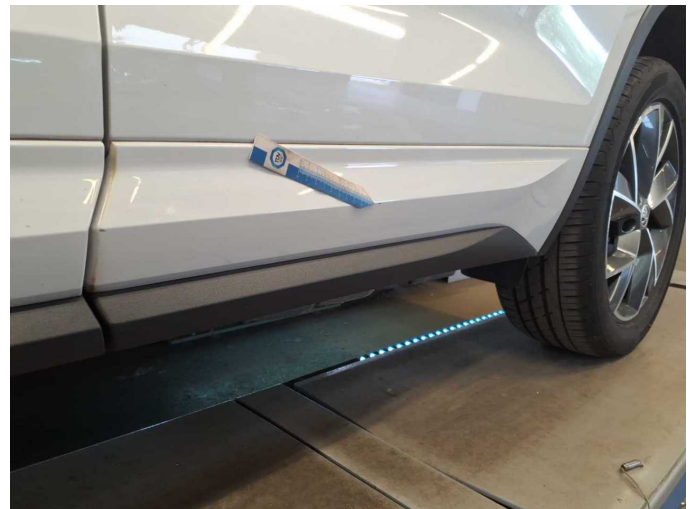
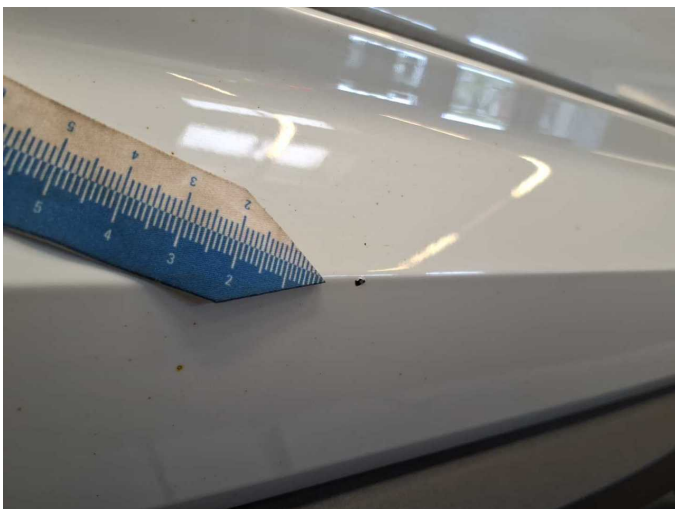
| No. | Component group | Description |
|---|---|---|
| 1 | Door - rear left side | Brightware - lower - Stone chips - No deduction |

Wear and tear 1: Door - rear left side: Brightware - lower - Stone chips - No deduction

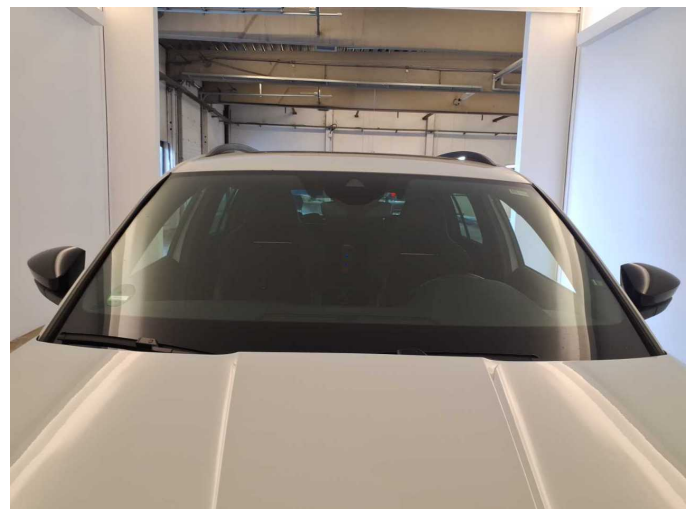
| No. | Component group | Description |
|---|---|---|
| 2 | Vehicle glazing | Windscreen - Stone chips - No deduction |

Wear and tear 2: Vehicle glazing: Windscreen - Stone chips - No deduction

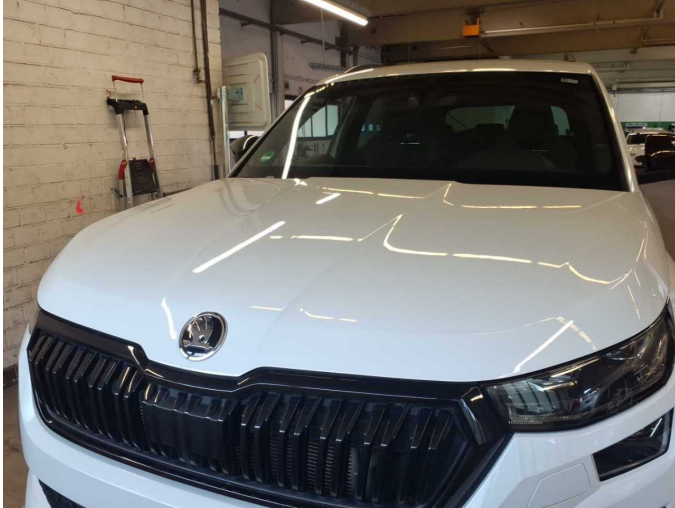
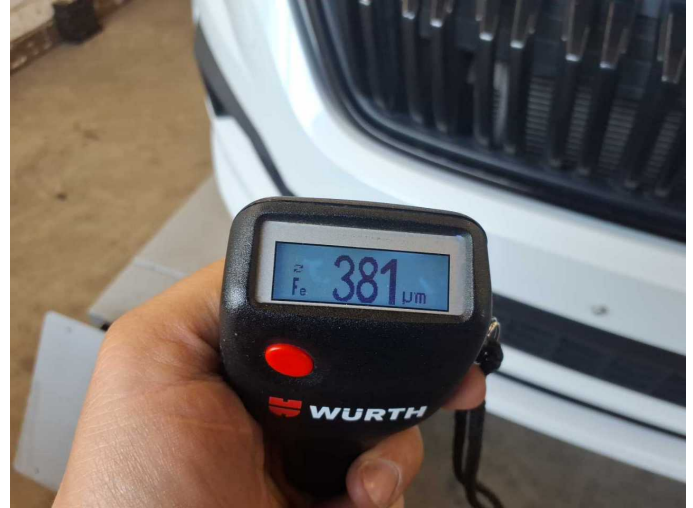
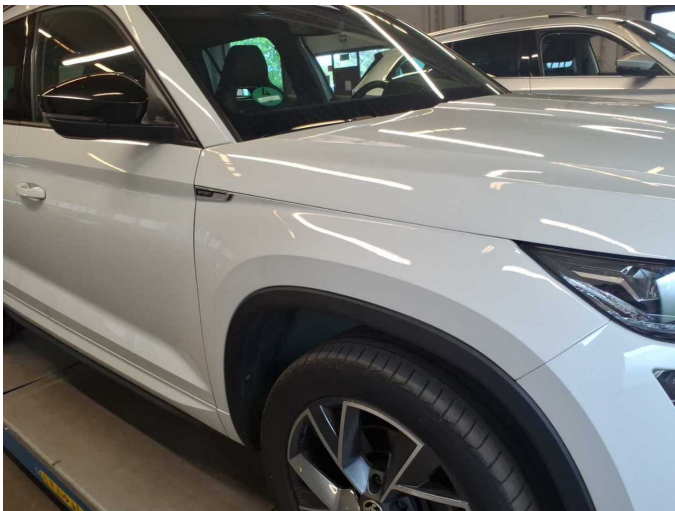
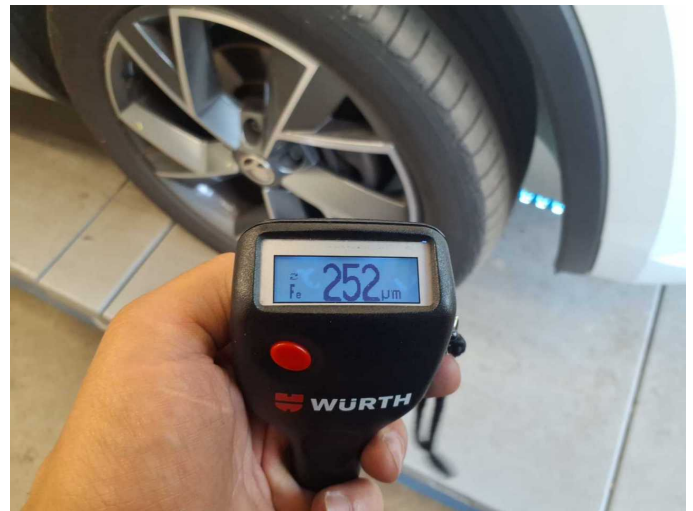
| No. | Repainting |
|---|---|
| 1 | Mudguard - right side, Bonnet |

| Mudguard - right side | 230 µm | Bonnet | 374 µm |

Repainting 1: Mudguard - right side, Bonnet
