# Skoda Enyaq '21 BEV

## Vehicle information

## Damage summary

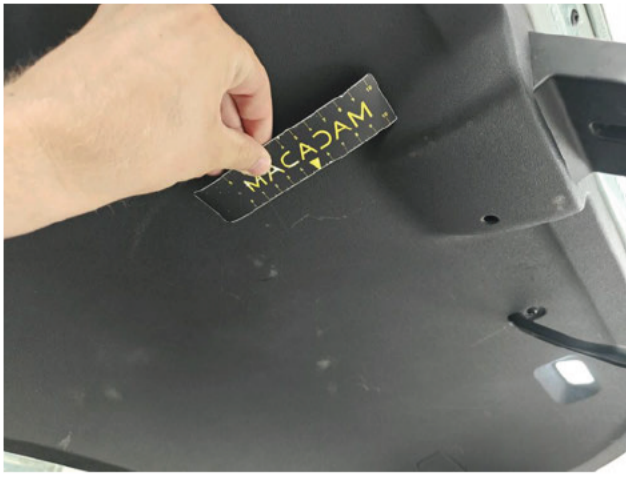
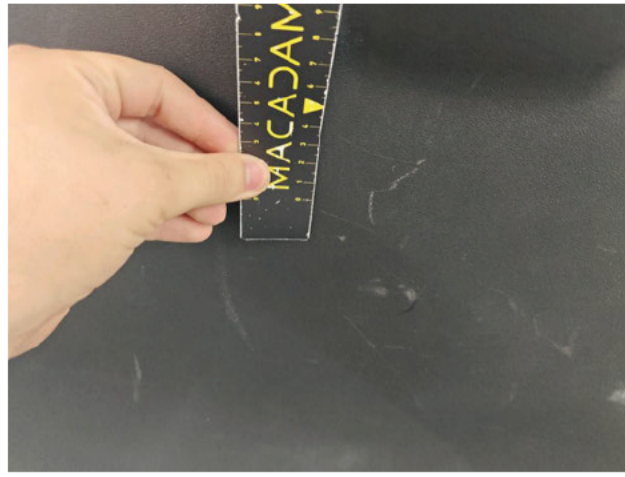
**Boot lid covering R**

Scratch(es)  
Smart repair  
Rear

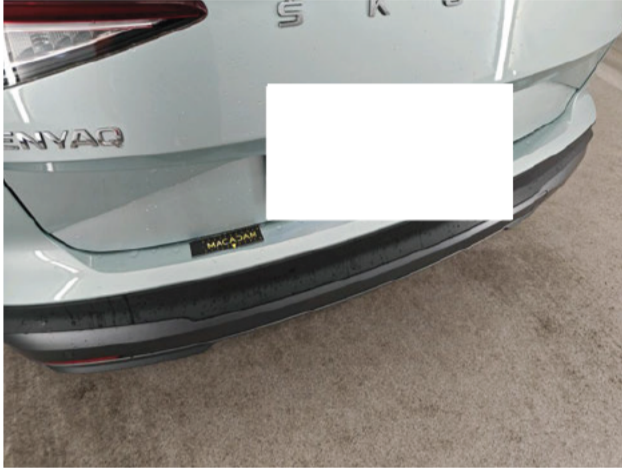
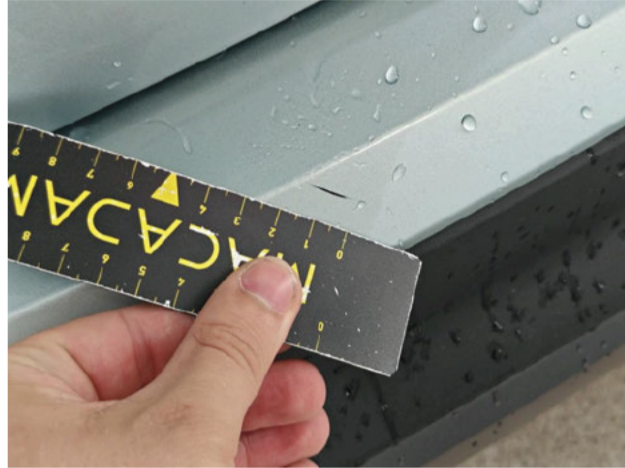
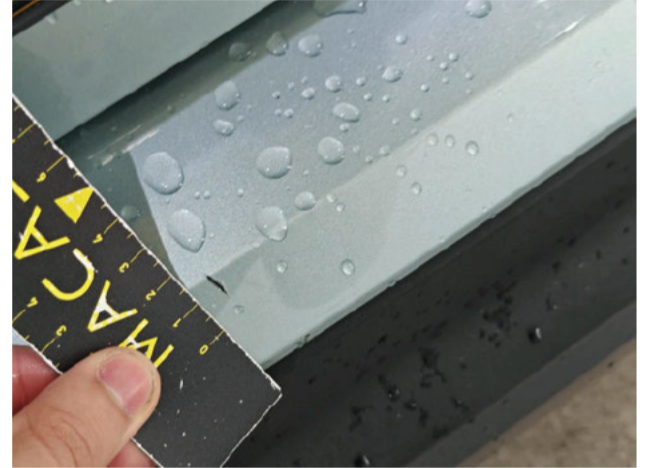
**Bumper R**

Scratch(es)  
Repair and paint (complete)  
Rear

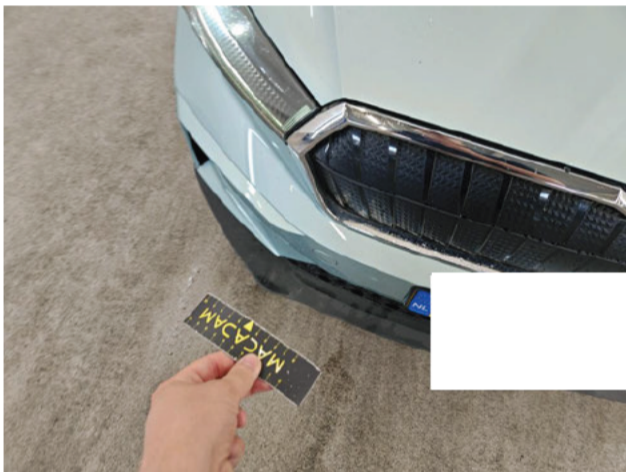
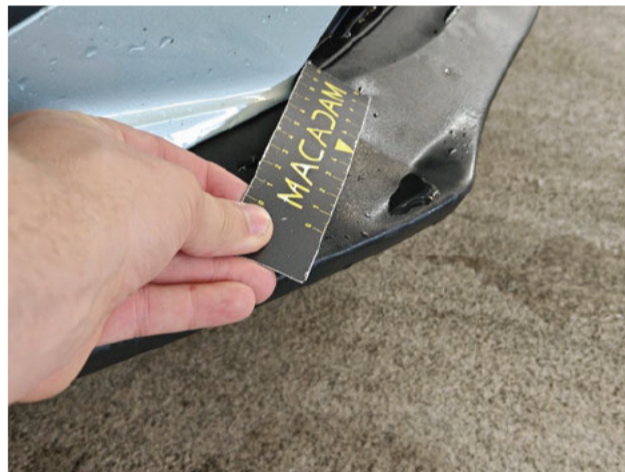
**Bumper trim F**

Deformed / Strained  
Replace  
Front

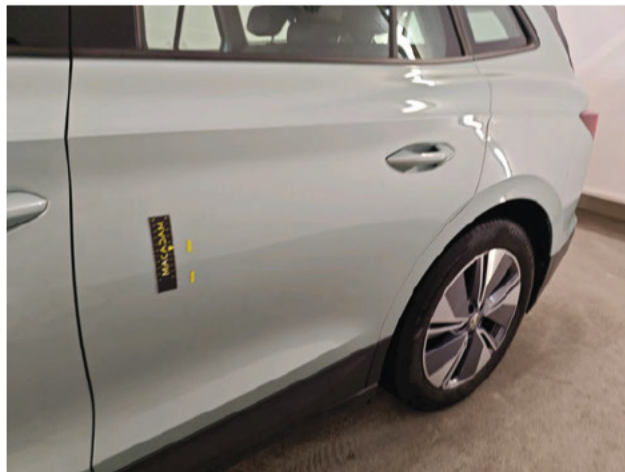
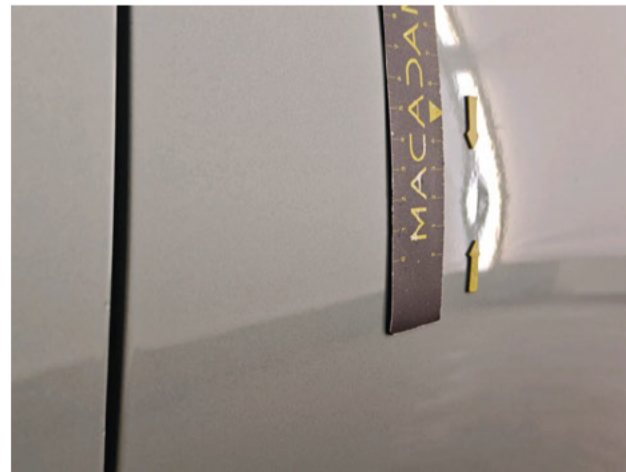
**Door RL**

Dent(s) and scratch(es)  
Repair and paint (complete)  
Left

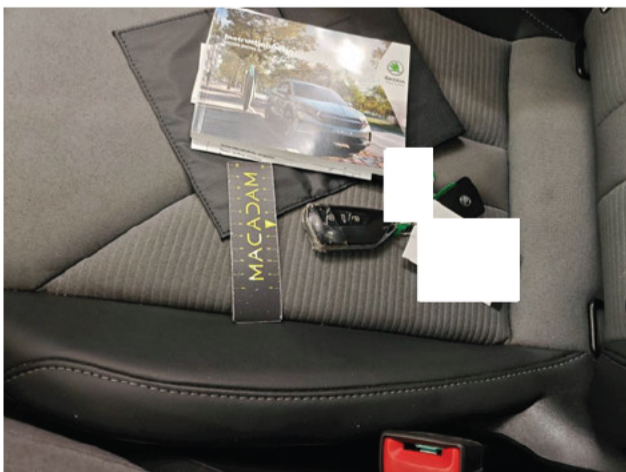
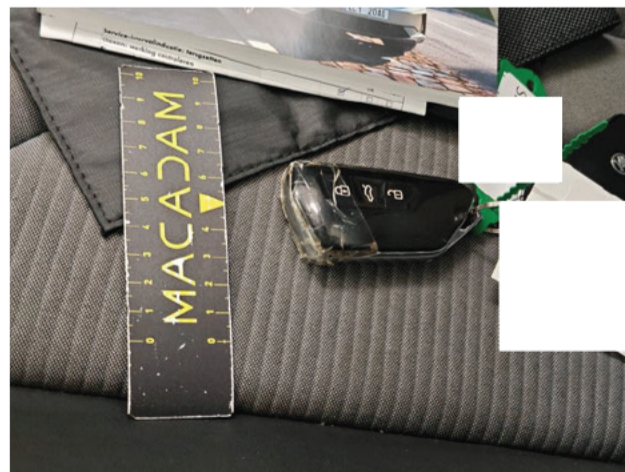
**Ignition key**

Worn  
Replace  
Interior

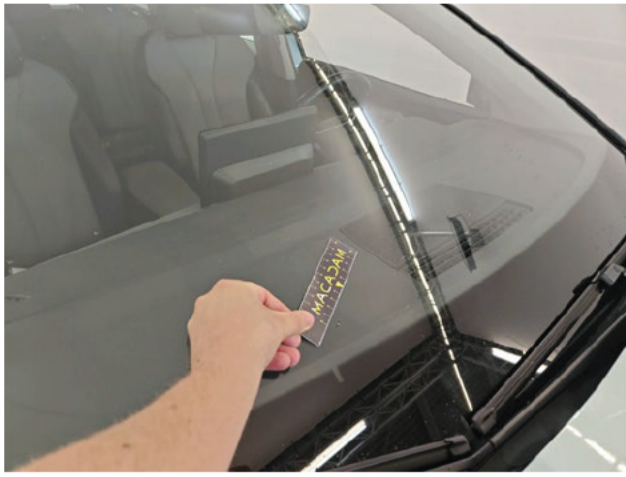
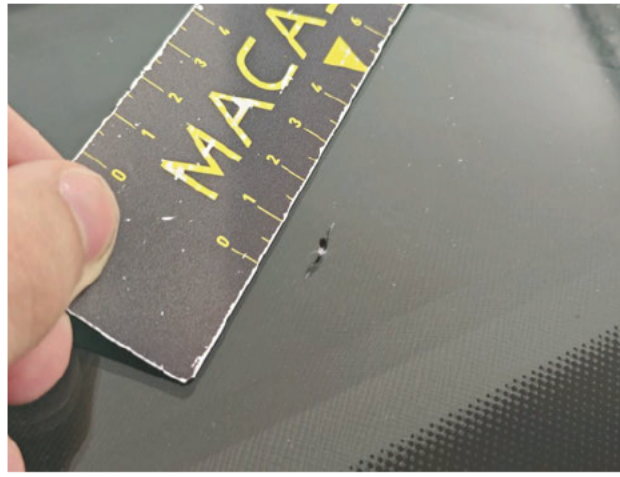
**Windscreen**  
Stone chip(s)  
Replace  
Front
