# MACDAM

## Ford Mustang '19 BEV

Make:	<b>Ford</b>	License:	
Gearbox:	<b>Automatic</b>	Body color:	
Model:	<b>Mustang '19 BEV</b>	VIN:	<b>WF0TK1E70MMA15051</b>
Fuel type:	<b>Electric</b>	Power:	<b>210 kW</b>
Version:	<b>Mustang EV 99kWh RWD Ext.R.</b>	First registration	<b>24/06/2021</b>
Mileage:	<b>130637 km</b>	N° of doors:

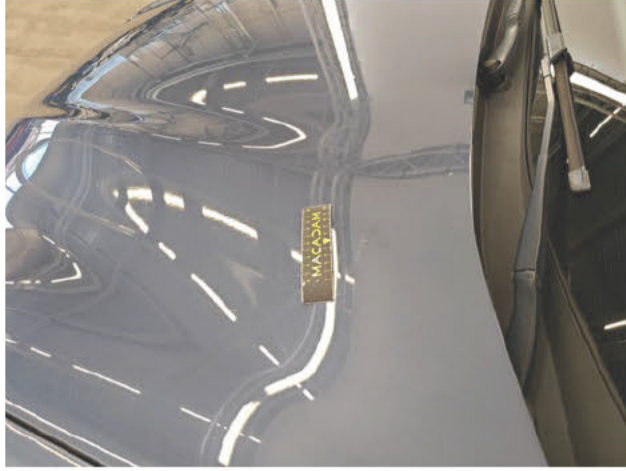
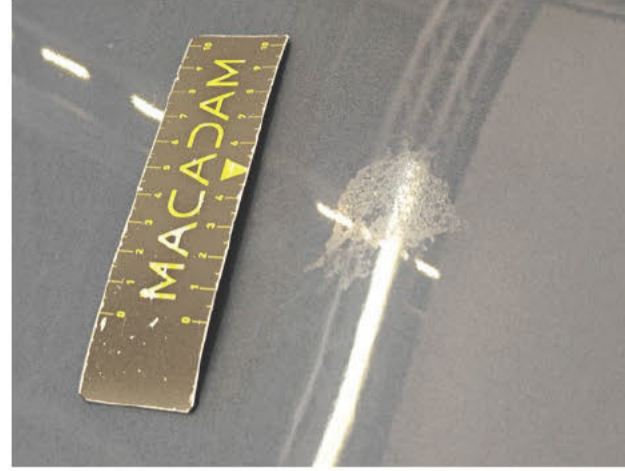
### Bonnet

Chemical polution  
Repair and paint (complete)  
Front

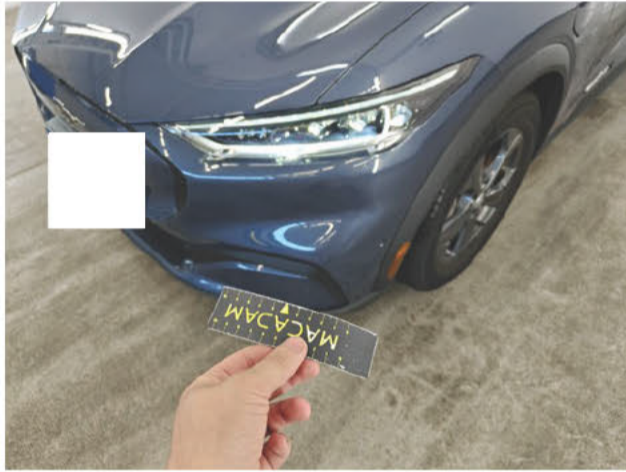
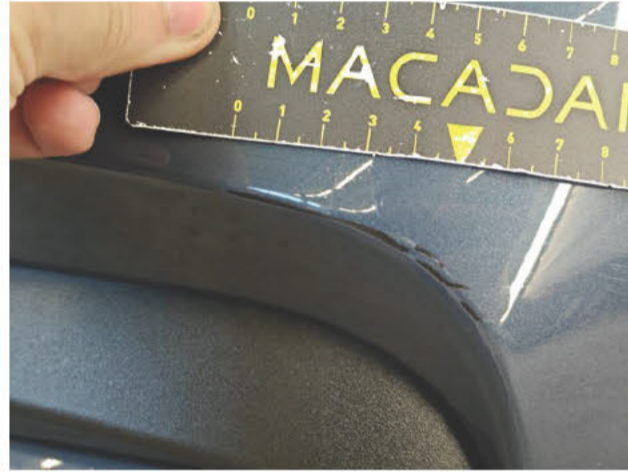
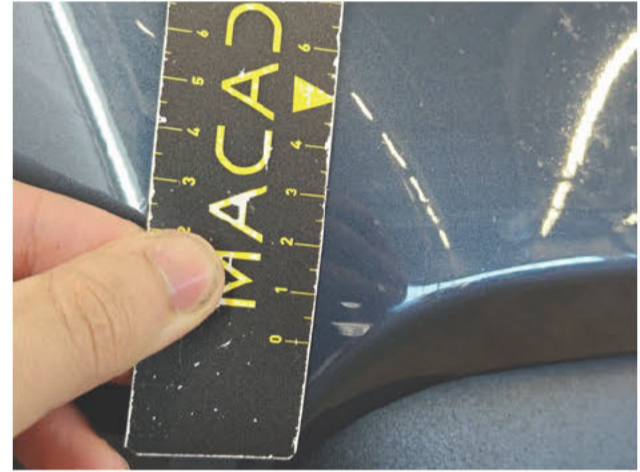
### Bumper F

Scratch(es)  
Repair and paint (complete)  
Front

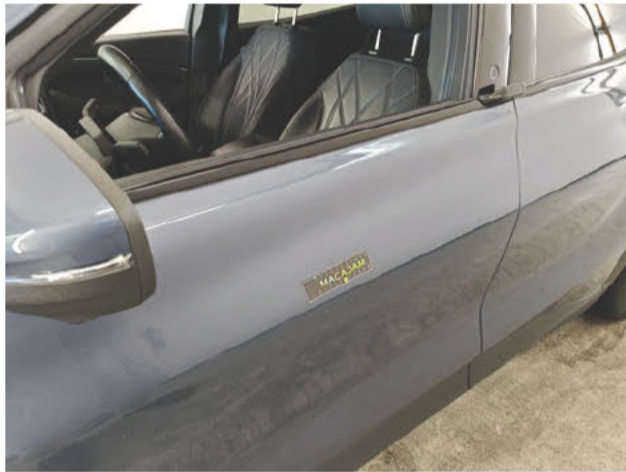
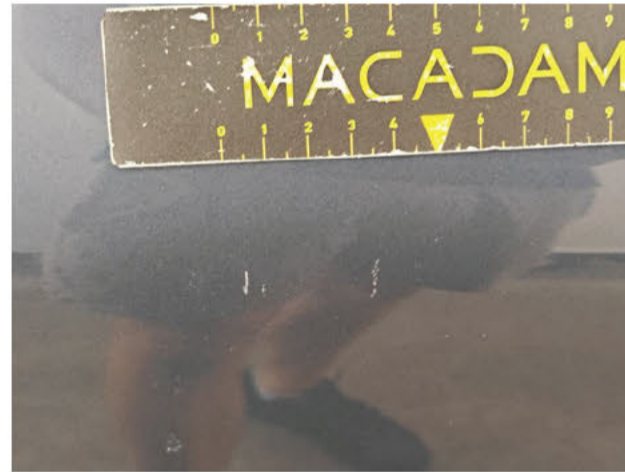
### Door FL

Scratch(es)  
Repair and paint (complete)  
Left

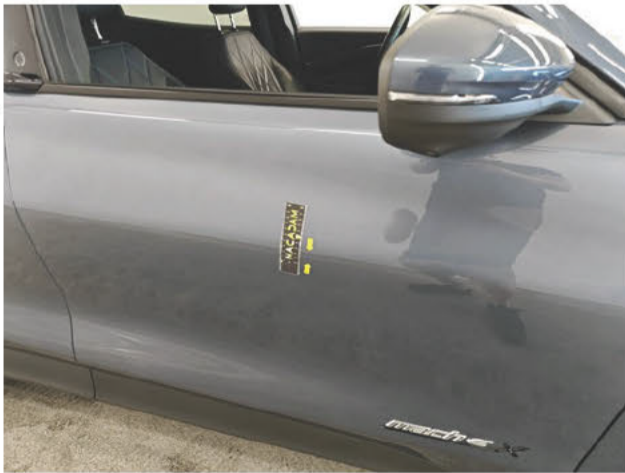
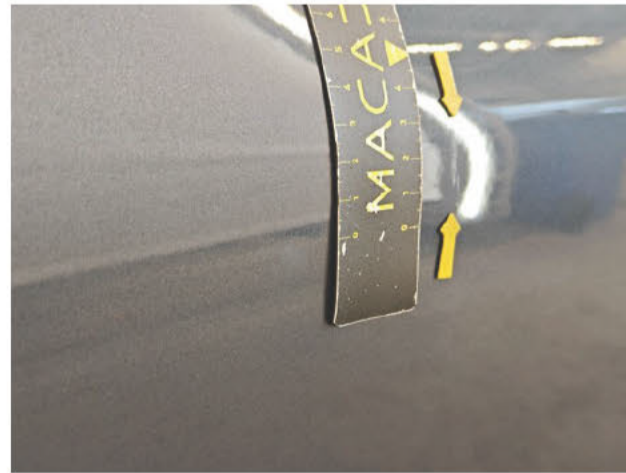
### Door FR

Dent(s)  
Paintless dent repair  
Right

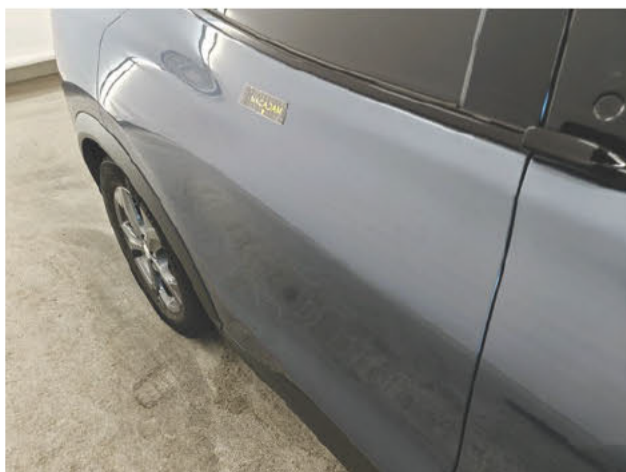
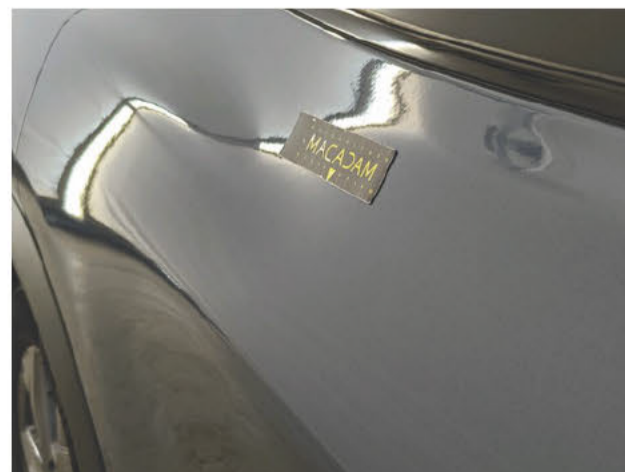
### Door RR

Bad repair  
Repair and paint (complete)  
Right

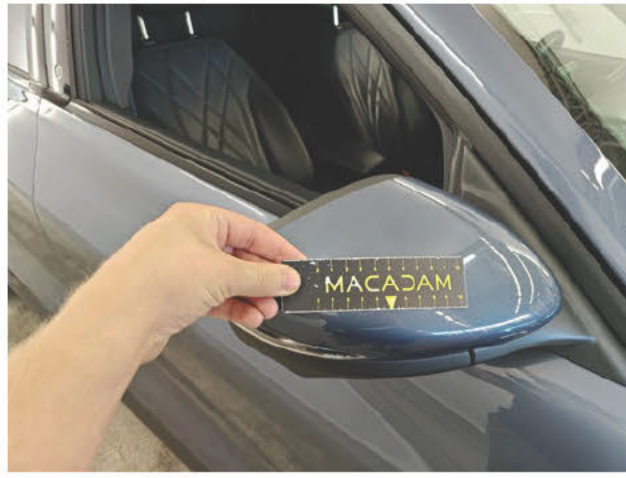
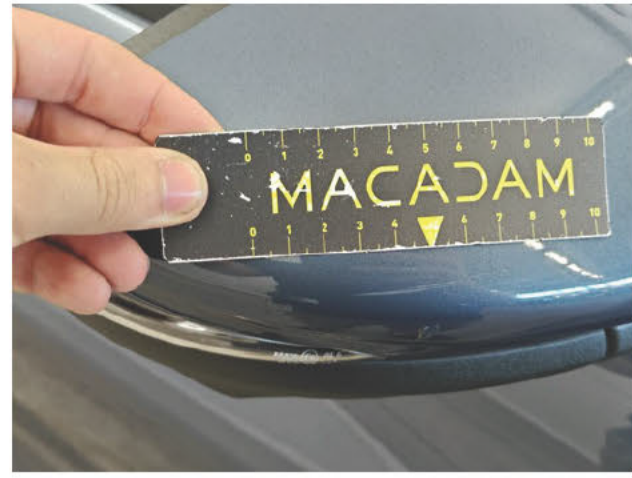
**Outside rear-view mirror housing R**

Scratch(es)  
Replace and paint  
Right

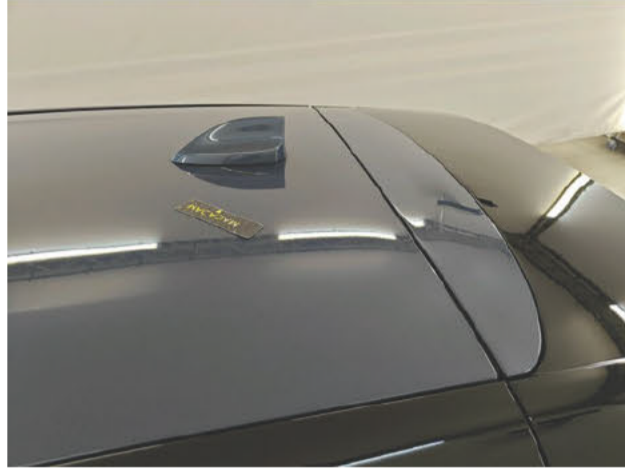
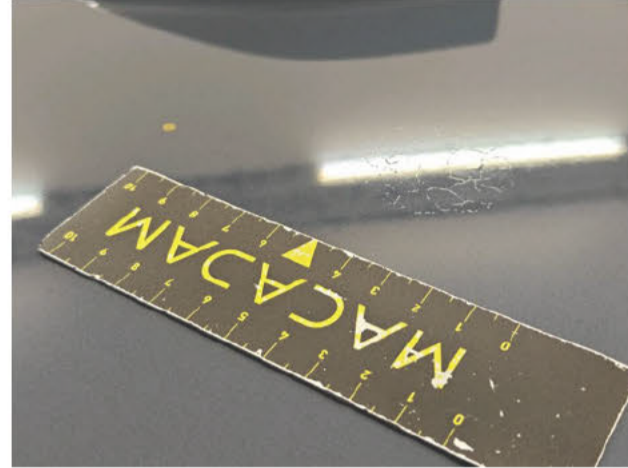
**Roof**

Chemical polution  
Repair and paint (complete)  
Roof & others

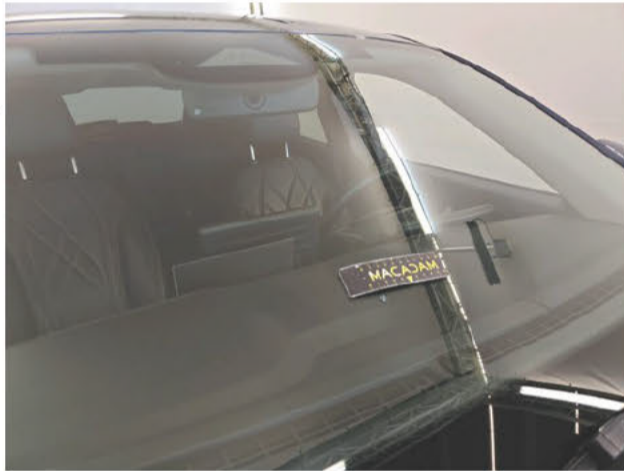
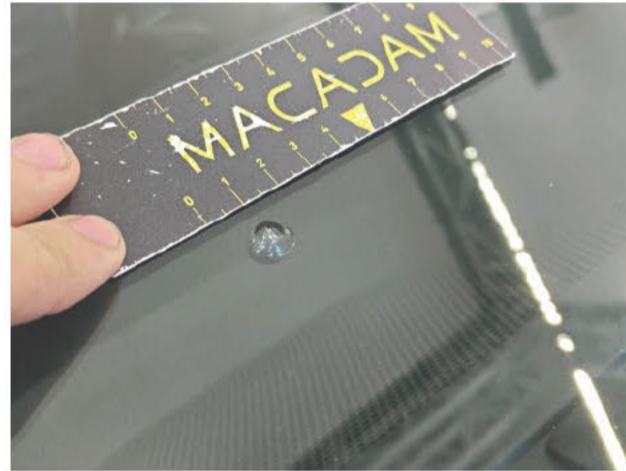
**Windscreen**

Stone chip(s)  
Windscreen repair  
Front

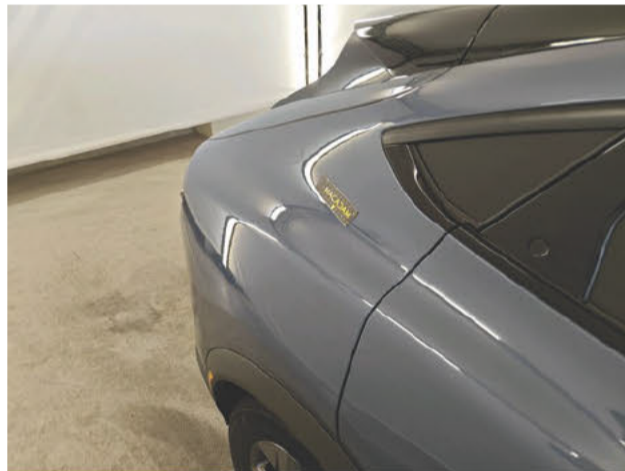
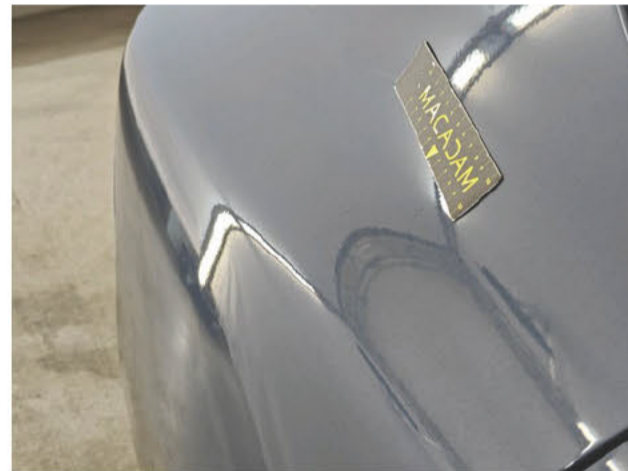
**Wing RR**

Bad repair  
Repair and paint (complete)  
Right
