Expertise

Protocol number: 46060785
Order No. / Reference: 26518872-1
Inspection date: 18 Jun 2026

Manufacturer: Volkswagen

Model: Caddy Cargo 2.0 TDI BMT DSG

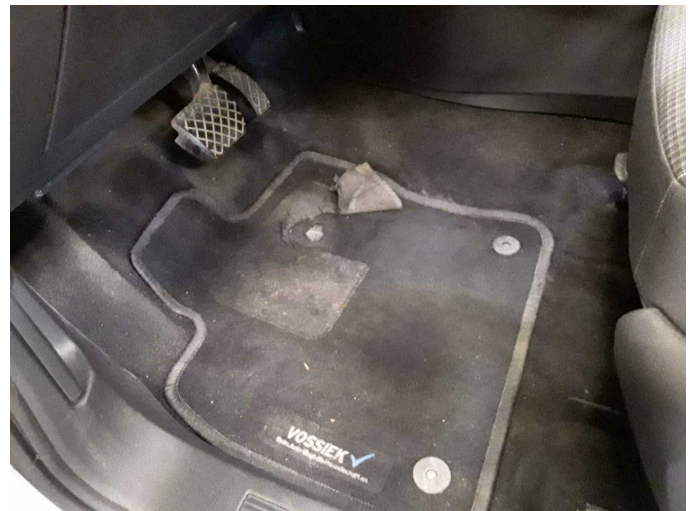
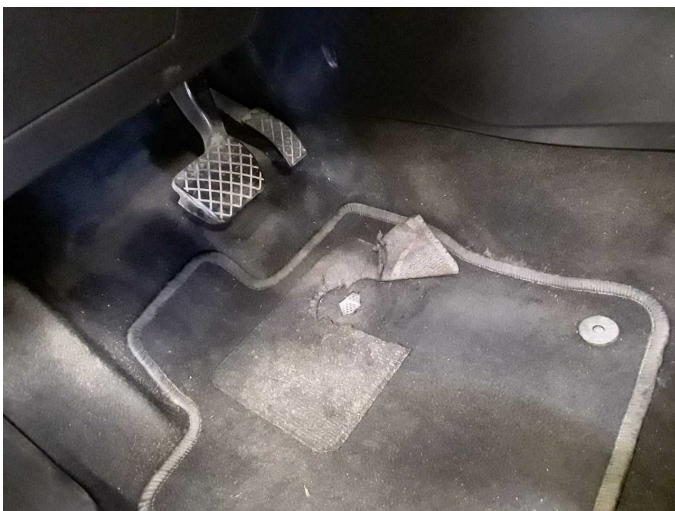
Damage 1: Trim / covers: Floor mats - Damaged - Replace

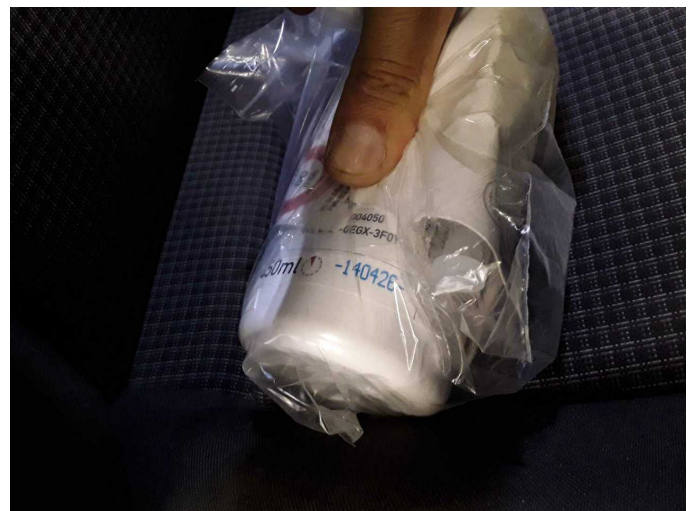
Typ	Tyre size	Type of tyre	Manufacturer	Tread depth
	Tirefit	Expiration date 04/2026

Damage 2: Equipment: Tirefit filler - Expired - Replace

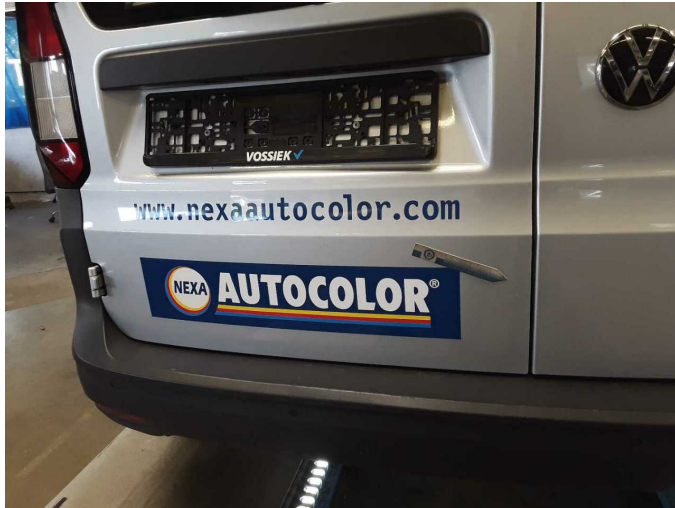
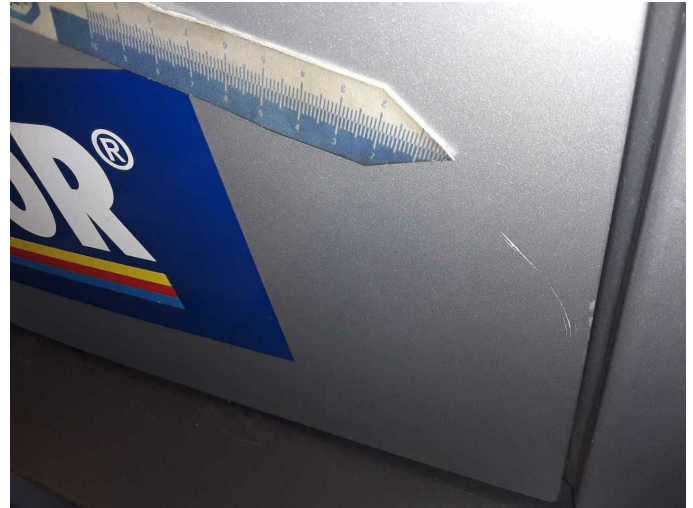
Damage 3: Boot lid / rear door: Rear door - left side - Scratch(es) - Smart repair

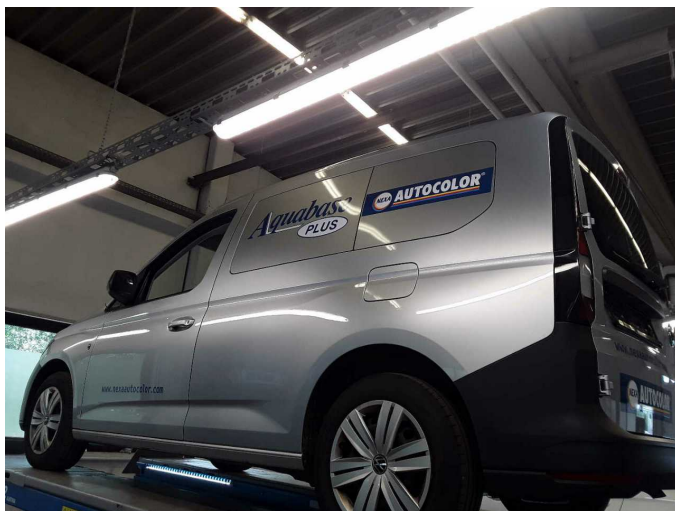
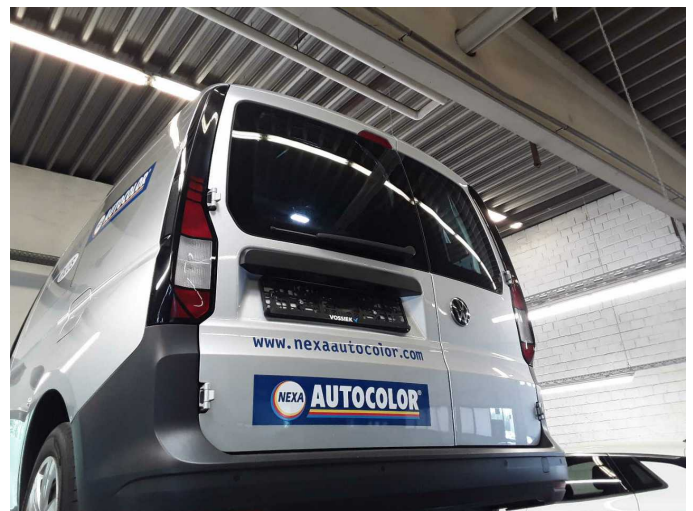
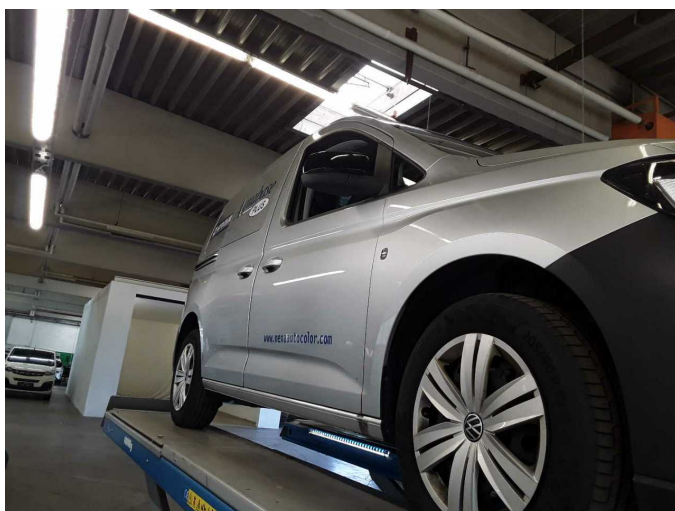
Damage 4: Body: Body - Glued / labelled - De-glug / neutralise

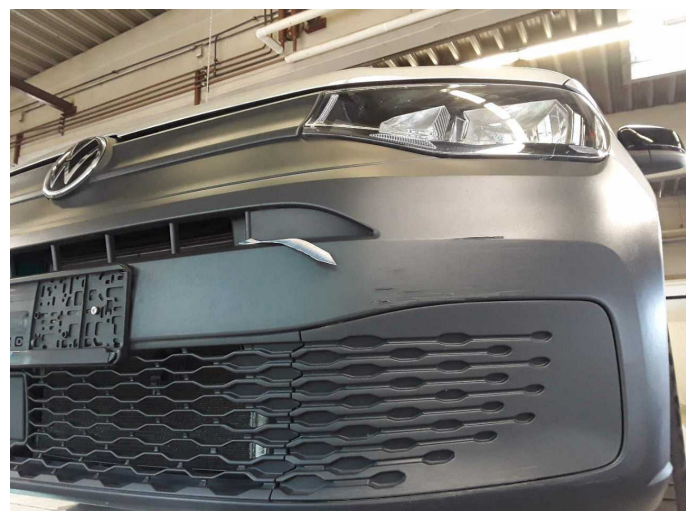
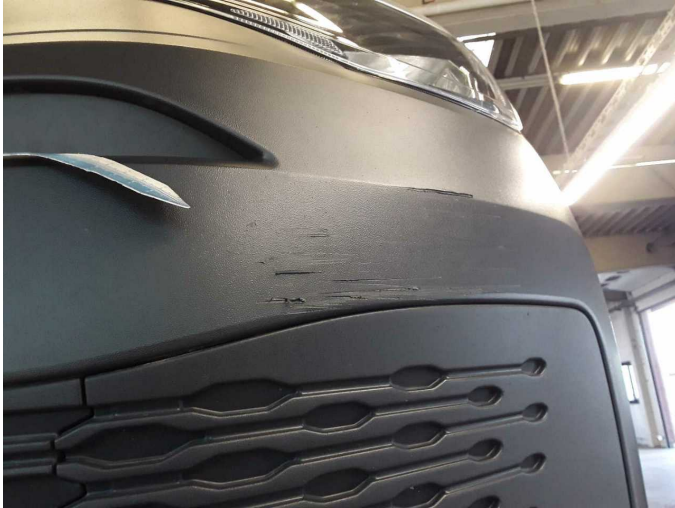
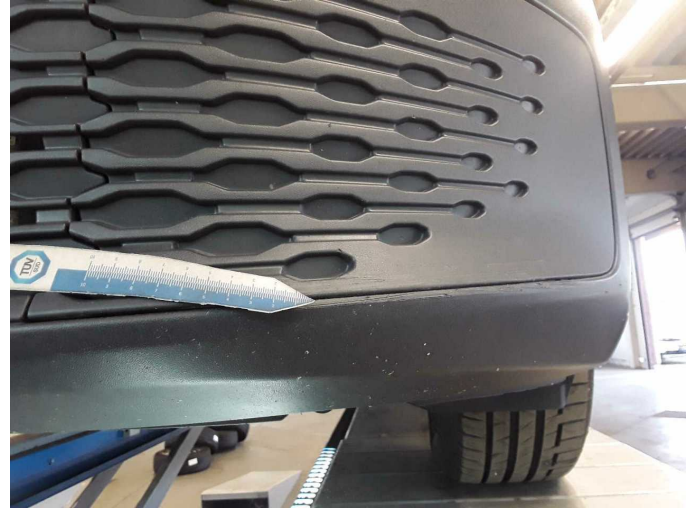
Wear and tear 1: Front bumper: Front bumper (unpainted) - Scratched - No deduction

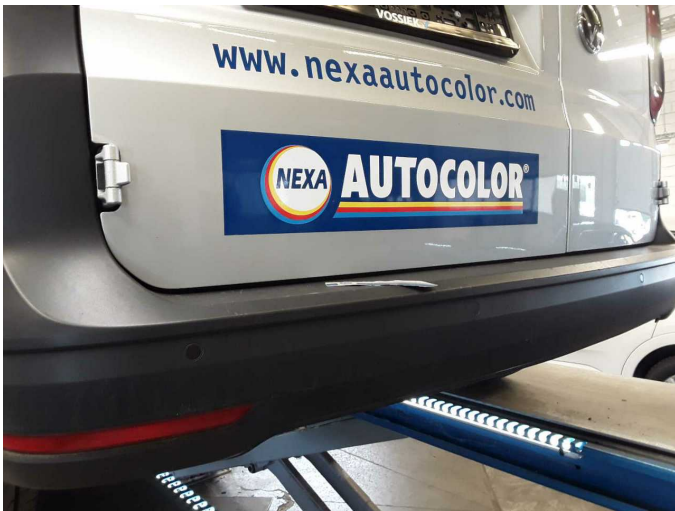
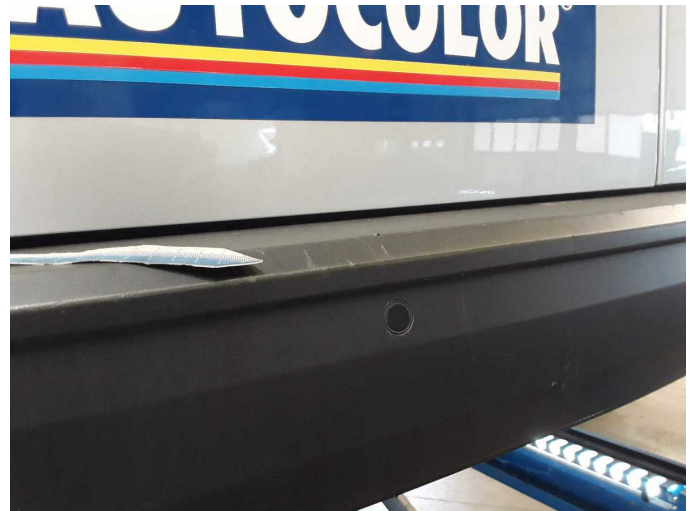
Wear and tear 2: Rear bumper: Rear bumper (unpainted) - Scratch(es) - No deduction

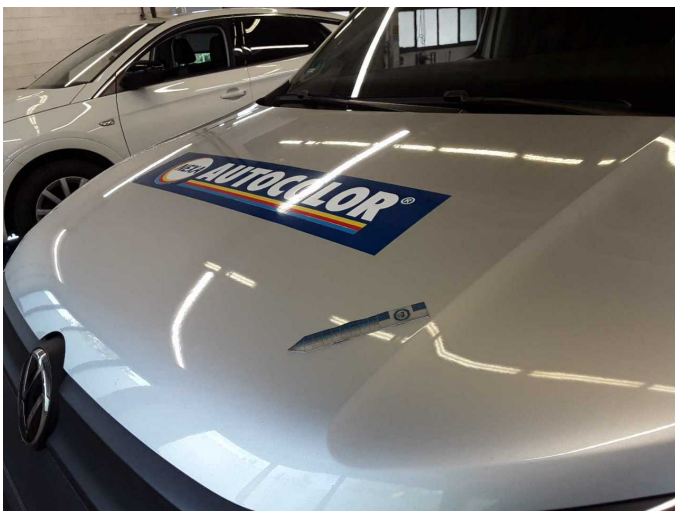
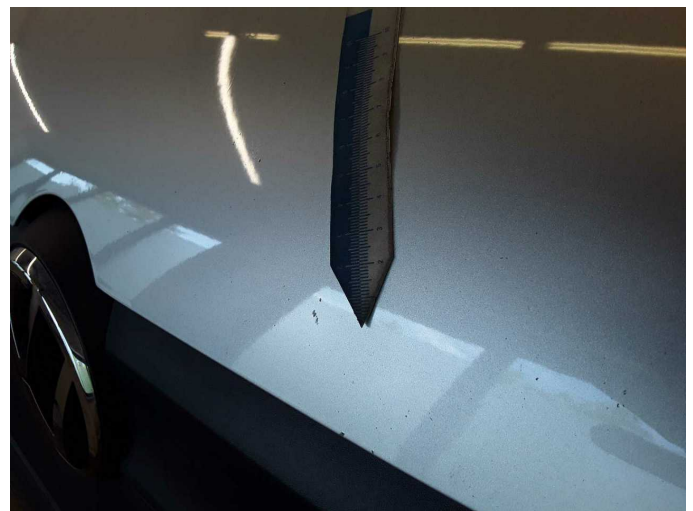
Wear and tear 3: Bonnet: Bonnet - Stone chips - No deduction

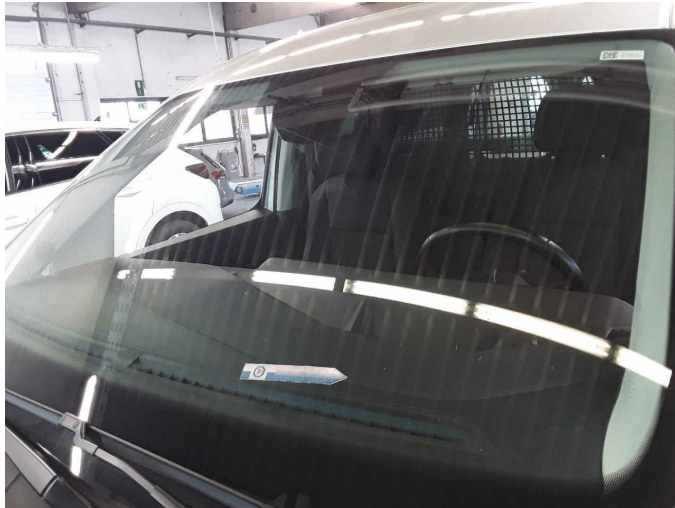
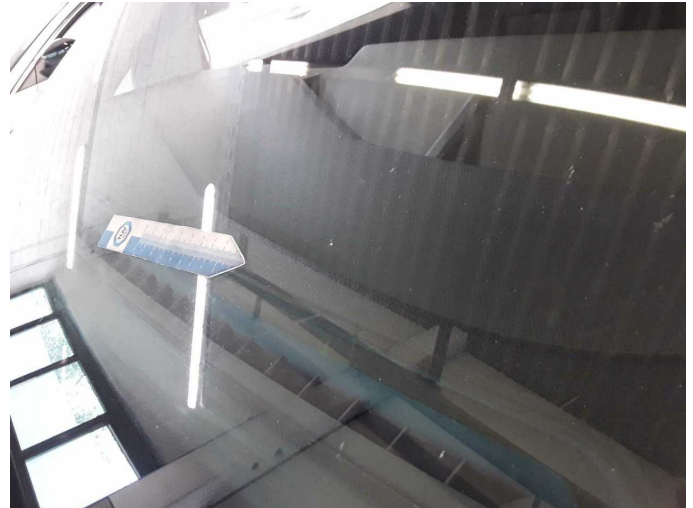
Wear and tear 4: Vehicle glazing: Windscreen - Stone chips - No deduction

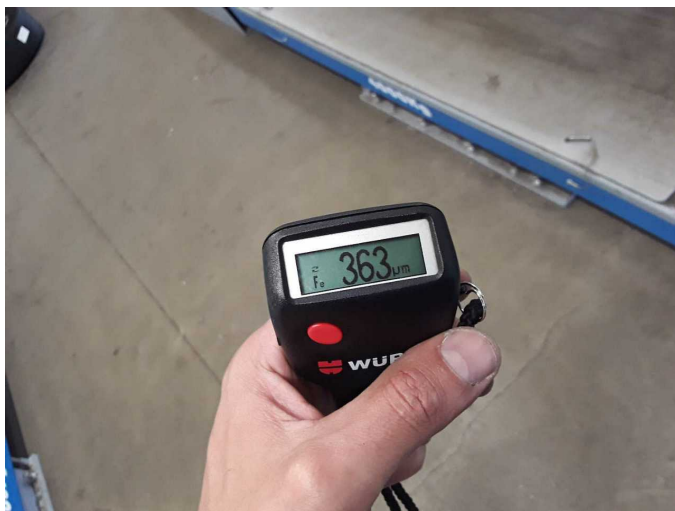
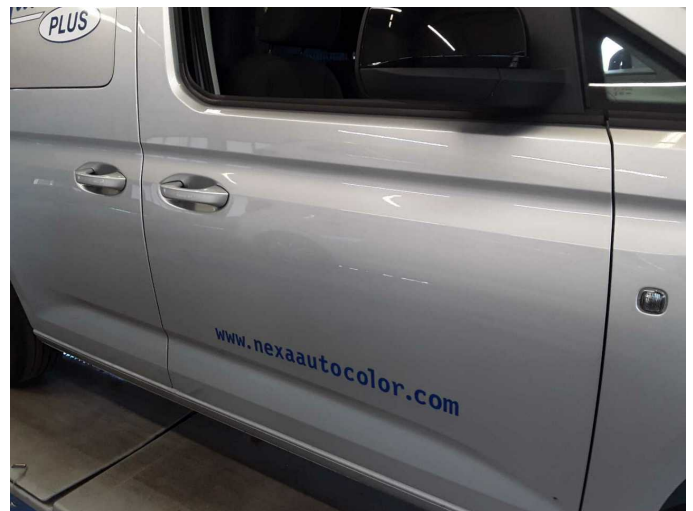
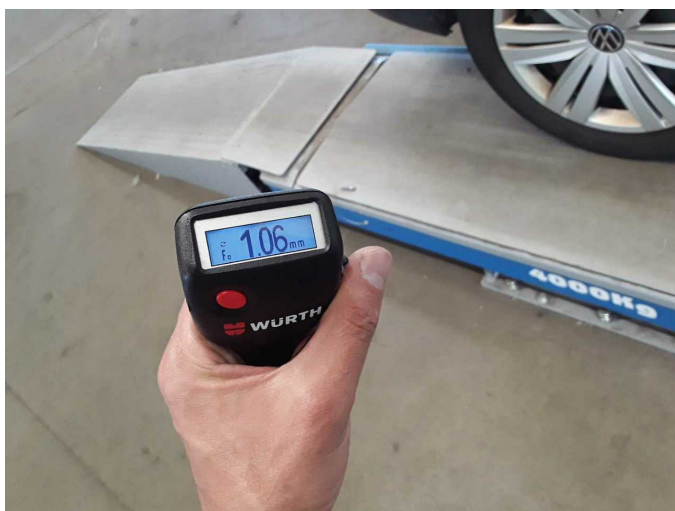
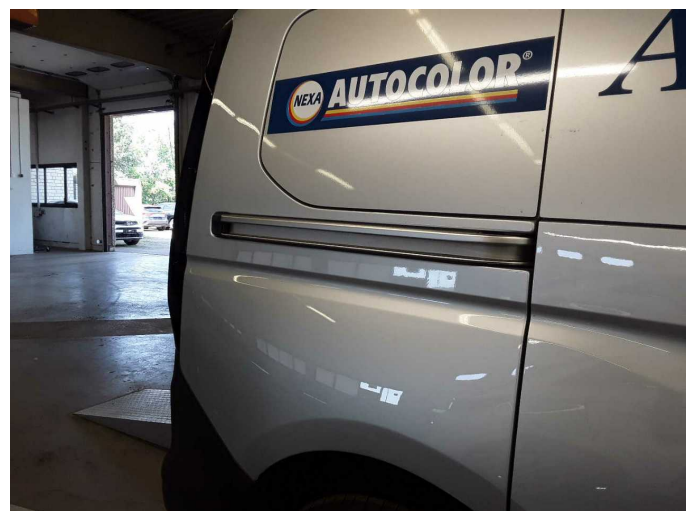
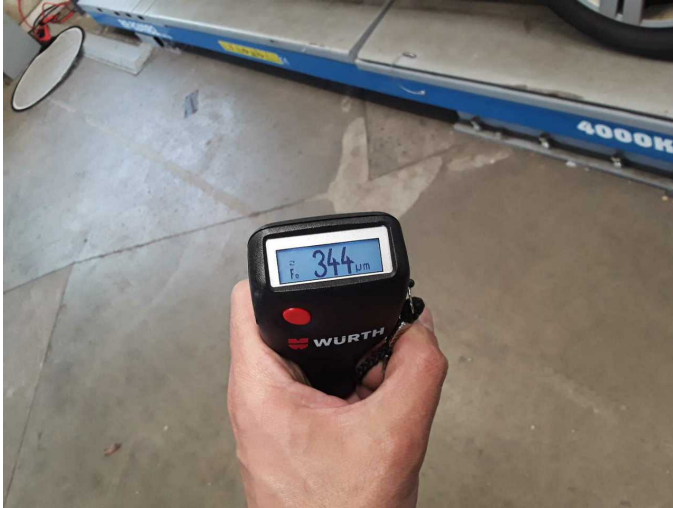
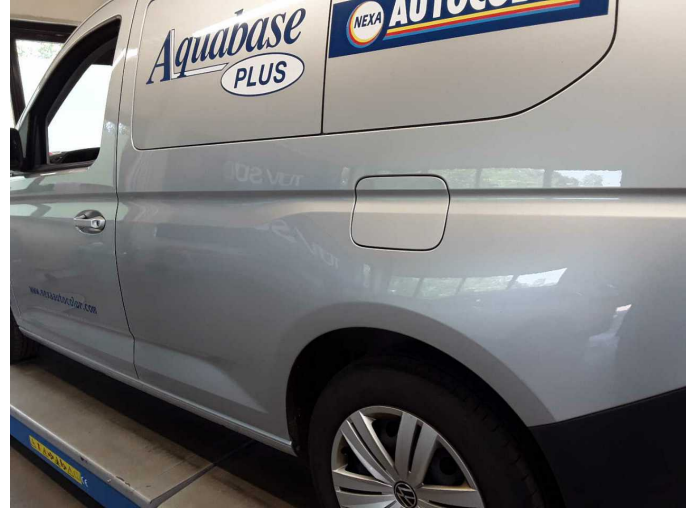
No.	Repainting
1	Side panel - rear left side, Side panel - rear right side, Door - front right side, Professionally carried out, Invoice of repair done Non-existent

Side panel - rear left side	344 µm	Side panel - rear right side	1,006 µm
Door - front right side	363 µm

Repainting 1: Side panel - rear left side, Side panel - rear right side, Door - front right side

Repainting 1: Side panel - rear left side, Side panel - rear right side,
Door - front right side
