Expertise

Protocol number: 46054141
Order No. / Reference: 26482494
Inspection date: 18 Jun 2026

Model: Cupra Born 150kW/58kWh

VIN: VSSZZK14RP024621

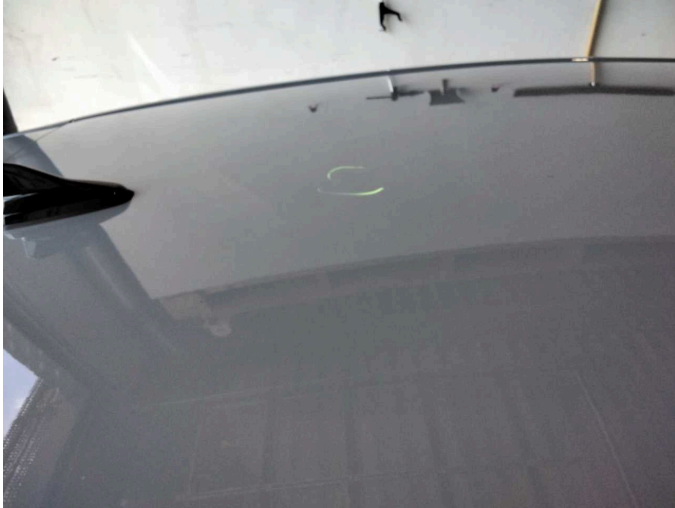
Damage 3: Roof: Roof - dent(s) - Smooth repair work

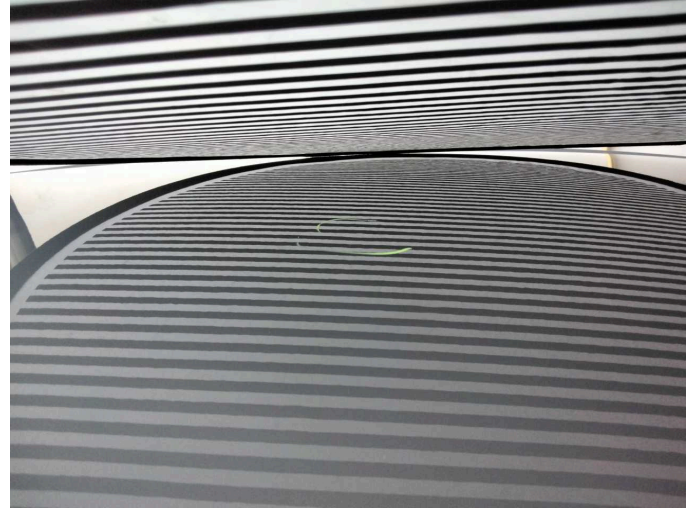
Damage 3: Roof: Roof - dent(s) - Smooth repair work

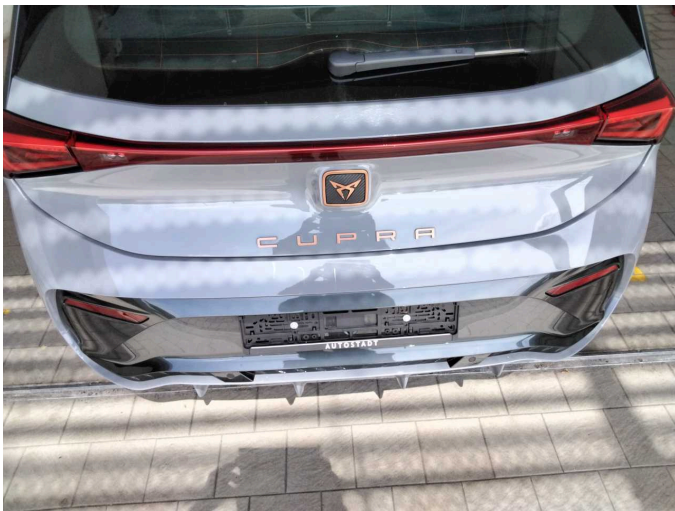
Damage 4: Rear bumper: Rear bumper - Scratch(es) - Smart repair

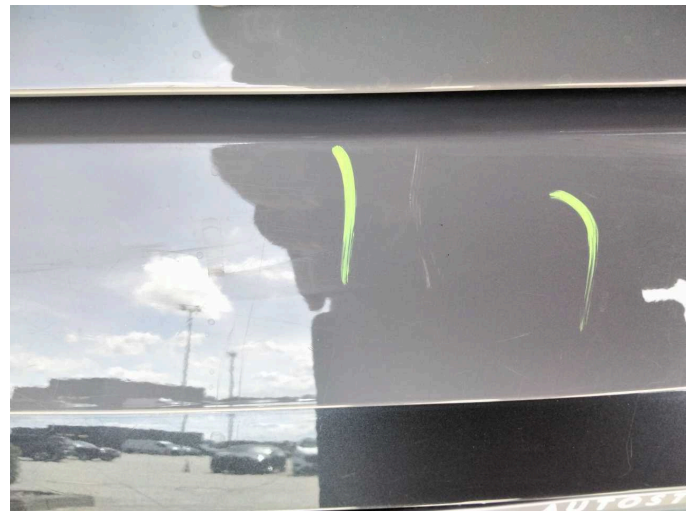
Damage 4: Rear bumper: Rear bumper - Scratch(es) - Smart repair

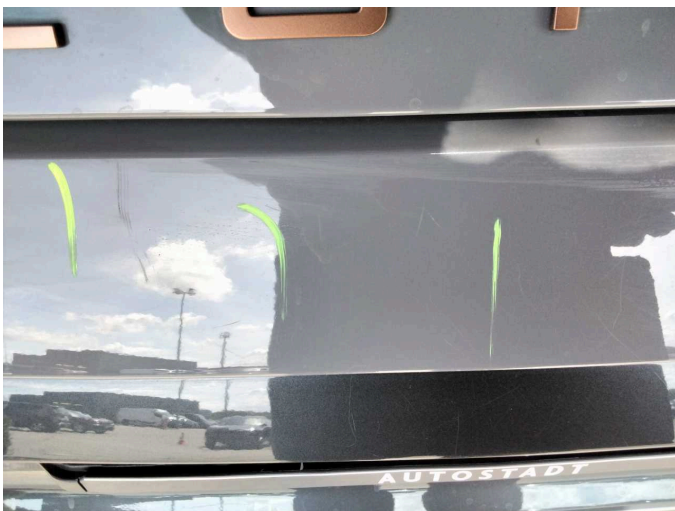
Damage 4: Rear bumper: Rear bumper - Scratch(es) - Smart repair

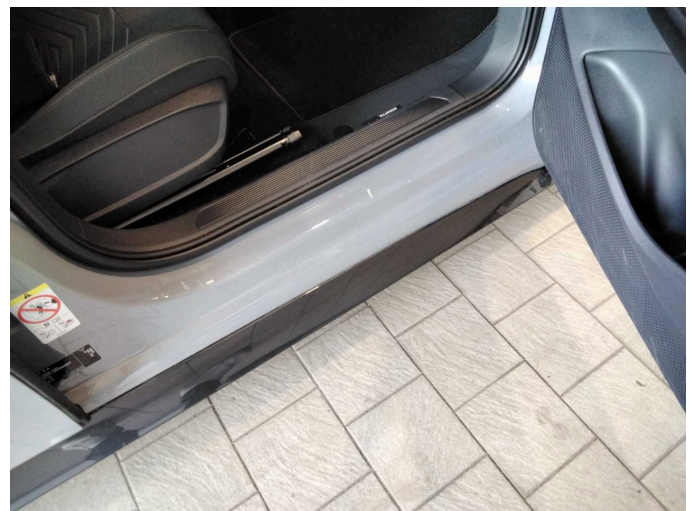
Damage 5: Sill - right side: Sill - Scratch(es) - Smart repair

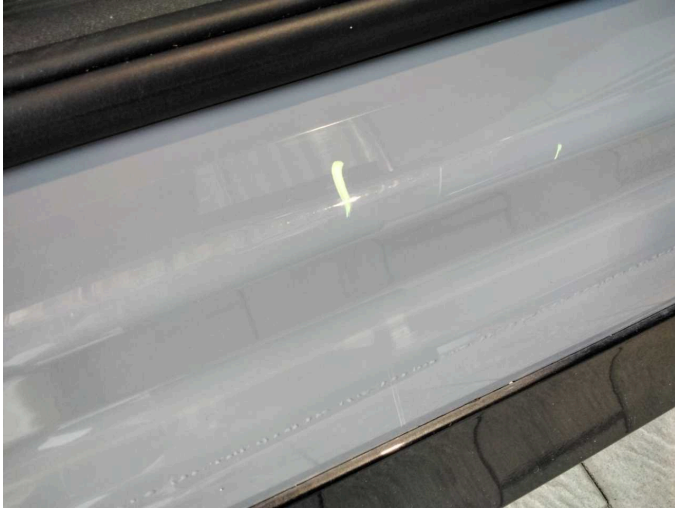
Damage 5: Sill - right side: Sill - Scratch(es) - Smart repair

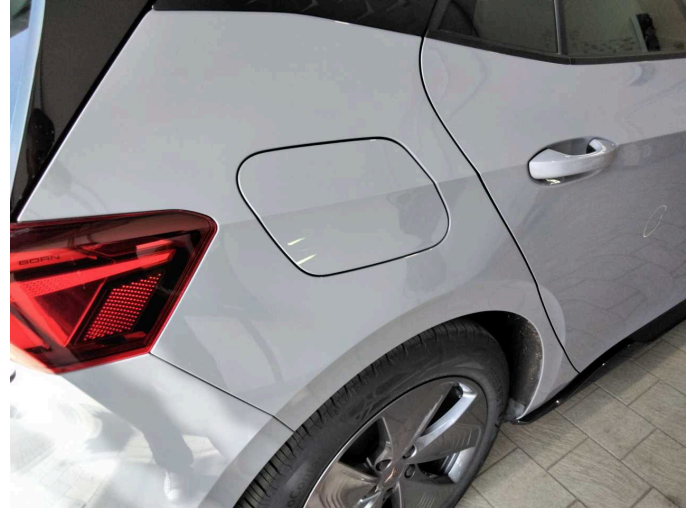
Damage 6: Fuel system: Tank cap - Scratch(es) - Smart repair

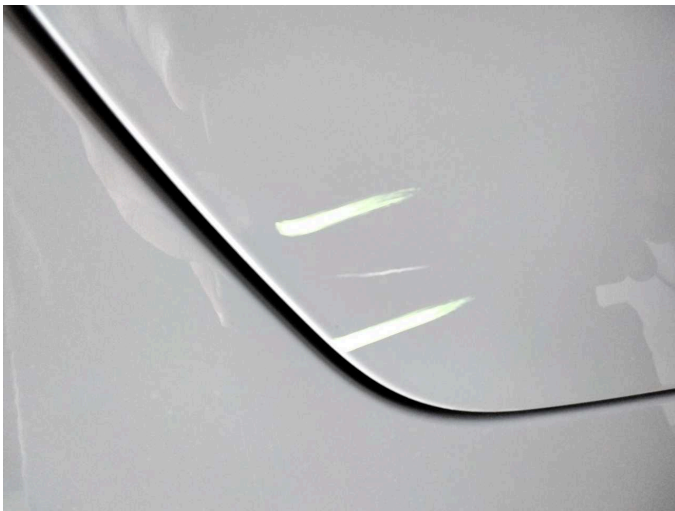
Damage 6: Fuel system: Tank cap - Scratch(es) - Smart repair

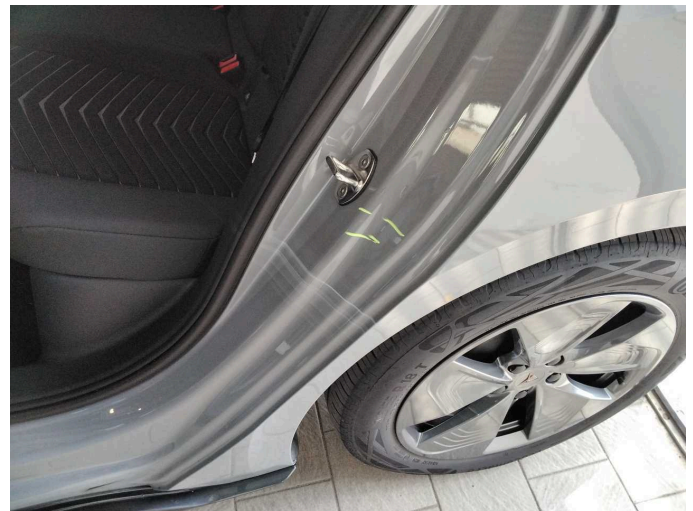
Damage 7: Body: C-pillar - left side - Scratch(es) - Smart repair

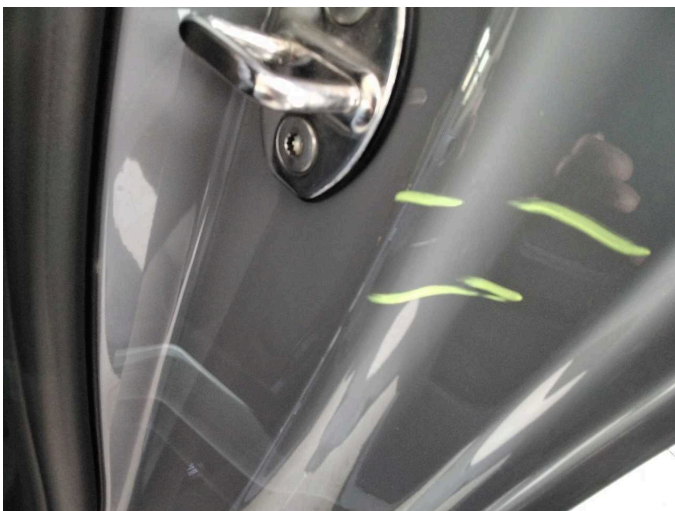
Damage 7: Body: C-pillar - left side - Scratch(es) - Smart repair

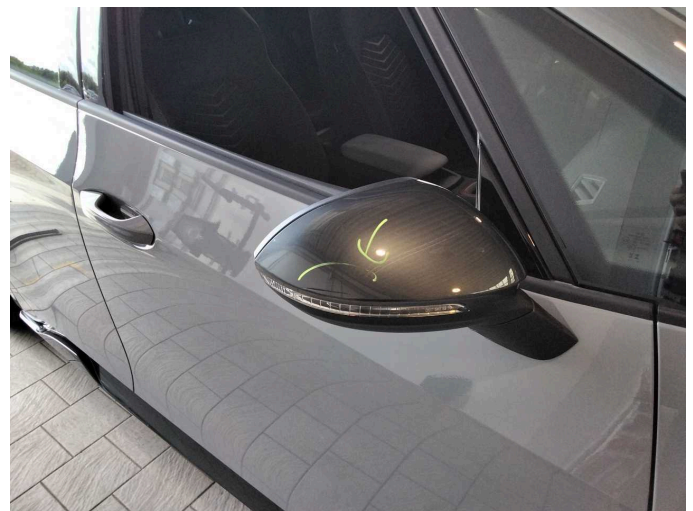
Damage 8: Wing mirror - right side: Cap - Scratch(es) - Paint

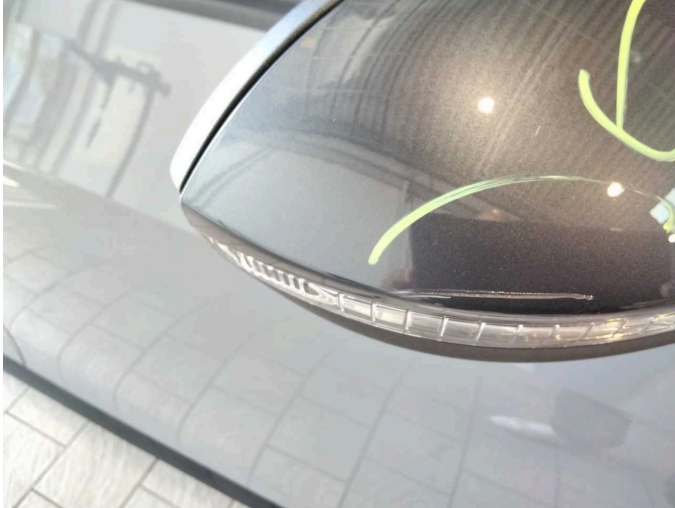
Damage 8: Wing mirror - right side: Cap - Scratch(es) - Paint

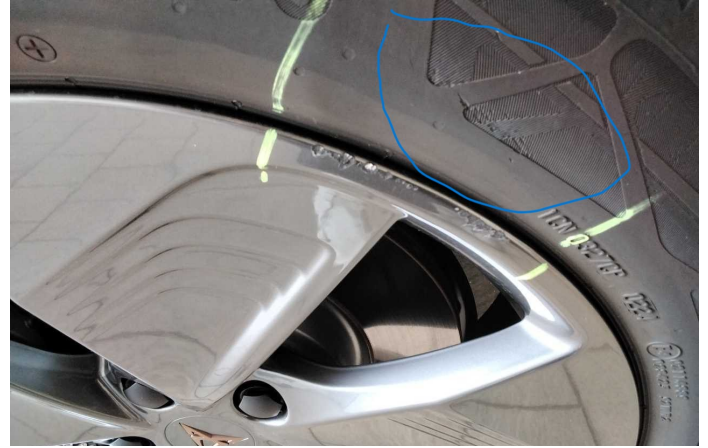
Damage 9: Wheel / tyres: Tyre - front right side - Damaged - Replace

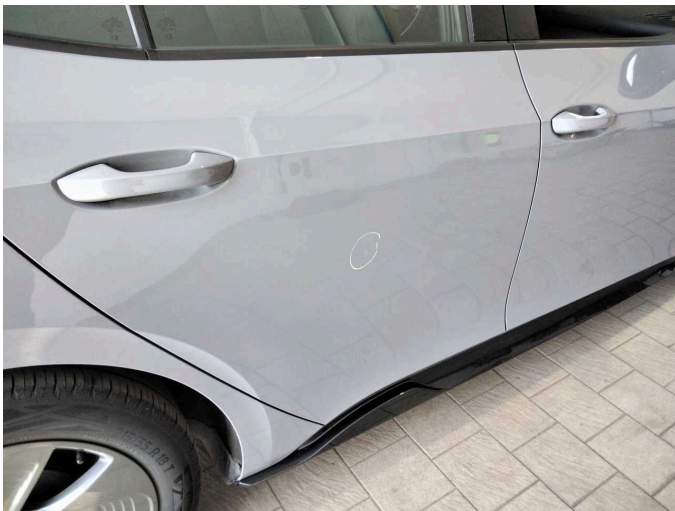
Damage 10: Door - rear right side: Door - Scratch(es) - Smart repair

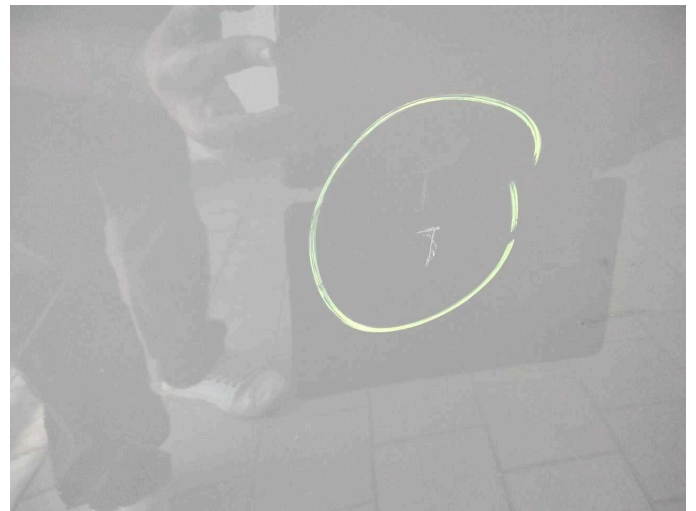
Damage 10: Door - rear right side: Door - Scratch(es) - Smart repair

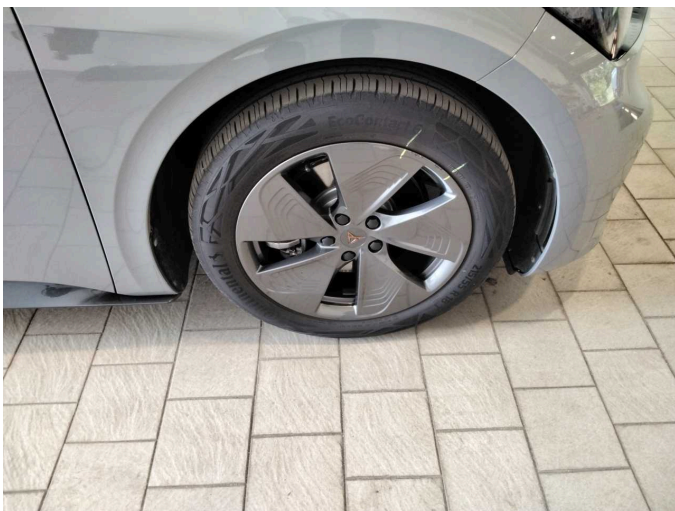
Damage 11: Wheel / tyres: Alloy rim - front right side - Scratch(es) - Loss in value

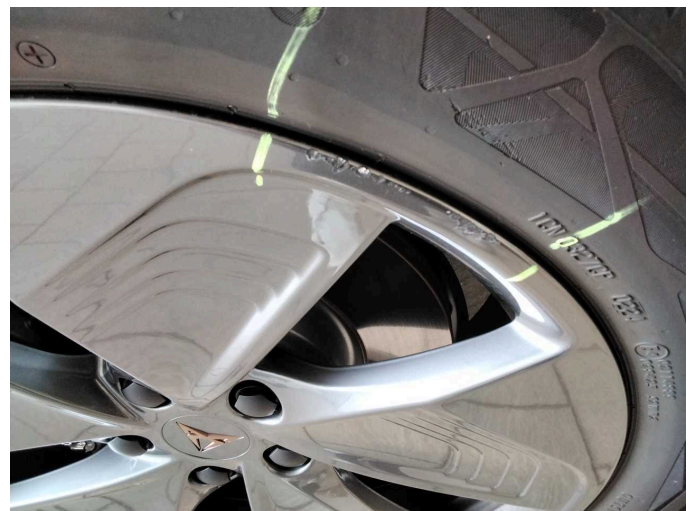
Damage 11: Wheel / tyres: Alloy rim - front right side - Scratch(es) - Loss in value

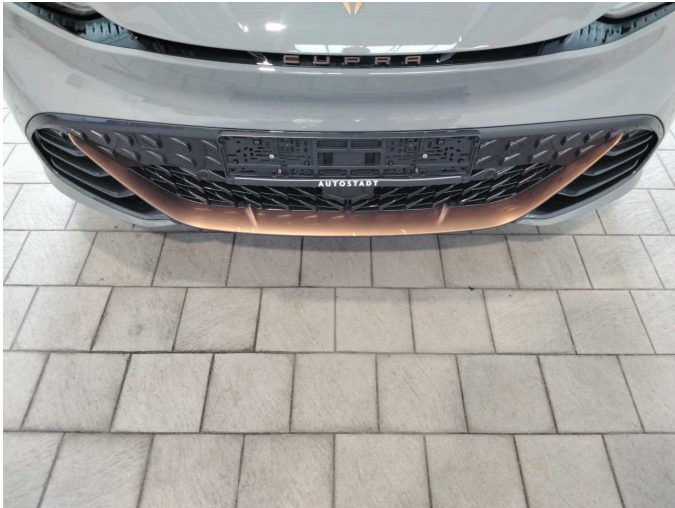
Damage 12: Front bumper: Spoiler - Scratch(es) - Paint

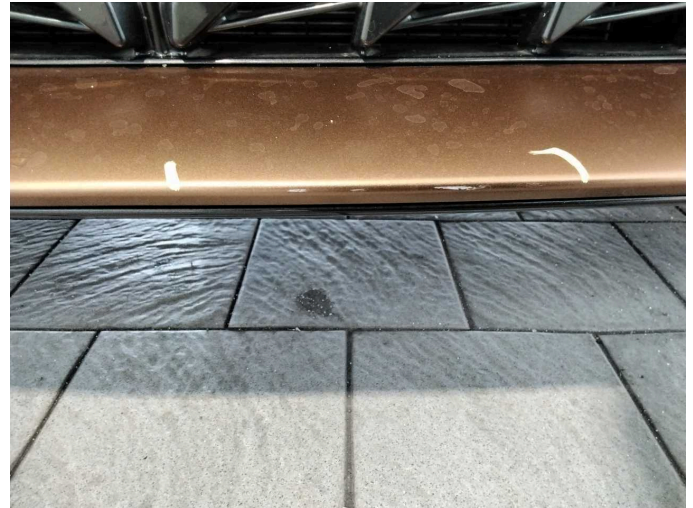
Damage 12: Front bumper: Spoiler - Scratch(es) - Paint

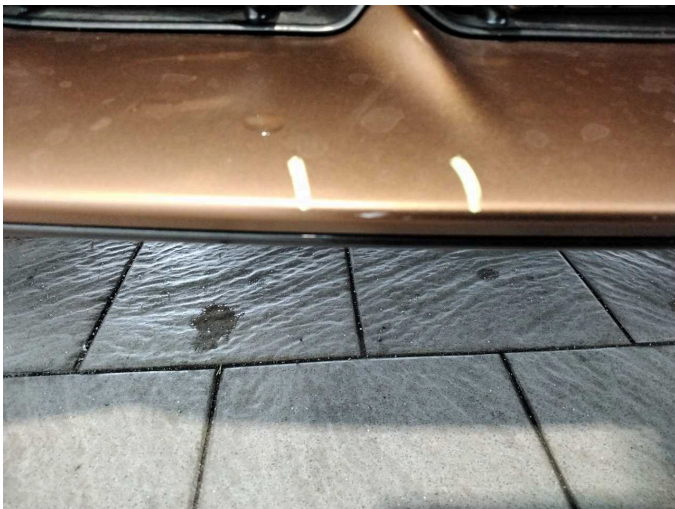
Damage 12: Front bumper: Spoiler - Scratch(es) - Paint

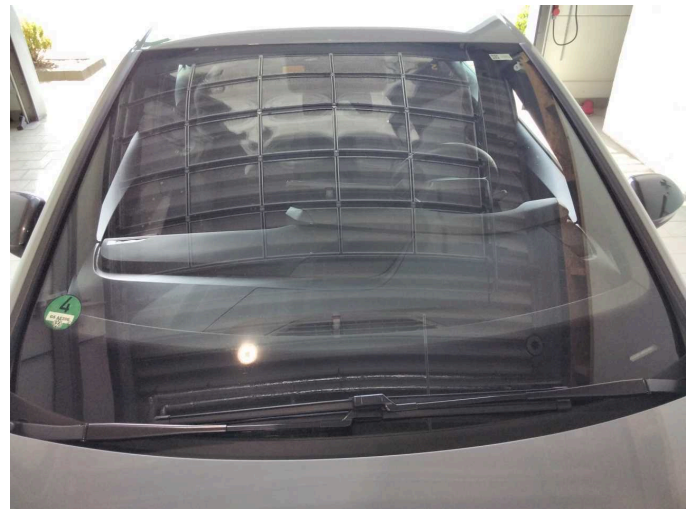
Wear and tear 1: Vehicle glazing: Windscreen - Stone chips - No deduction

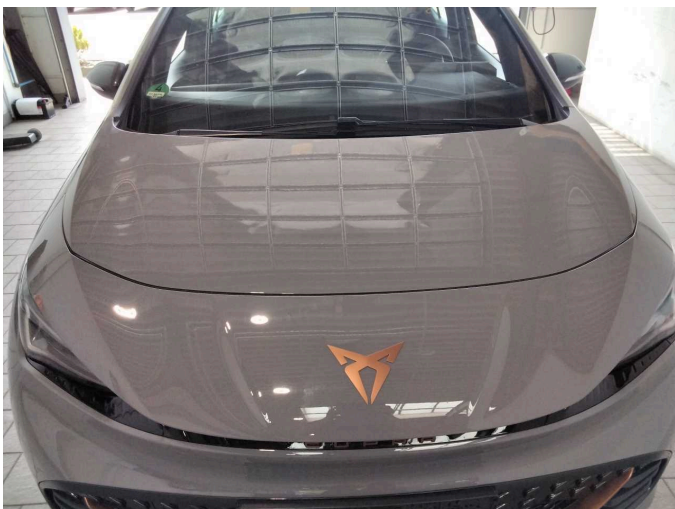
Wear and tear 2: Bonnet: Bonnet - Stone chips - No deduction

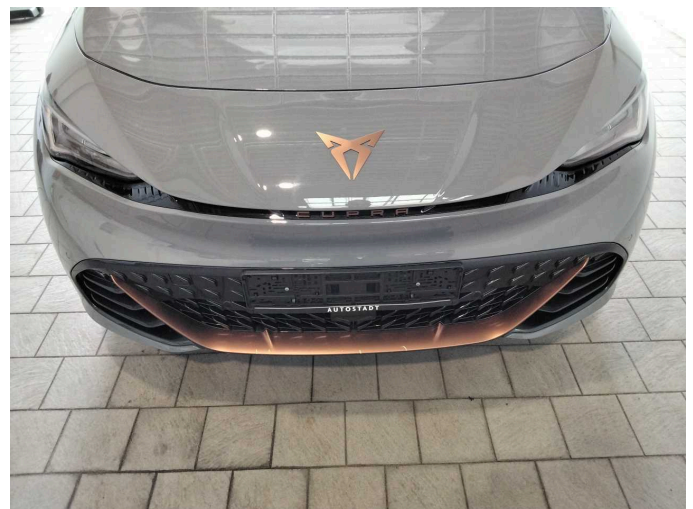
Wear and tear 3: Front bumper: Front bumper - Stone chips - No deduction
