Expertise

Protocol number: 46611606  
Order No. / Reference: 26715947  
Inspection date: 21 Jul 2026

Manufacturer: MAN  
VIN: WMA03VUYXP9016400

Model: TGE 3.140 4X2F SB

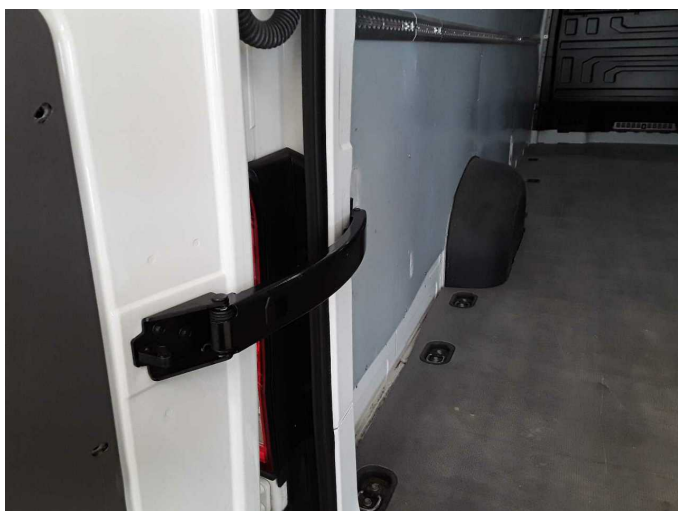
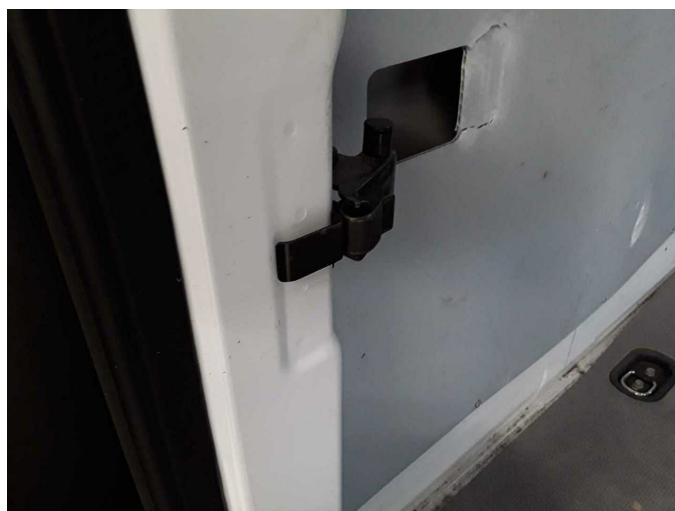
| No. | Component group | Description |
|---|---|---|
| 1 | Boot lid / rear door | Door check strap / arrestor (links) - Defective - Replace |

**Damage 1:** Boot lid / rear door: Door check strap / arrestor (links) - Defective - Replace

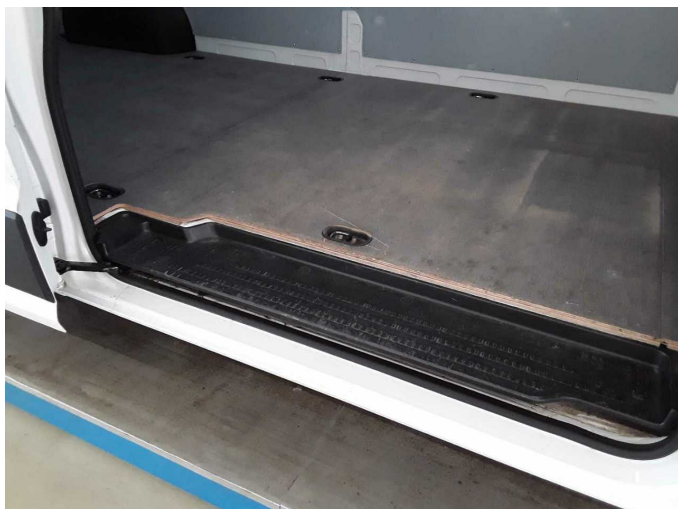
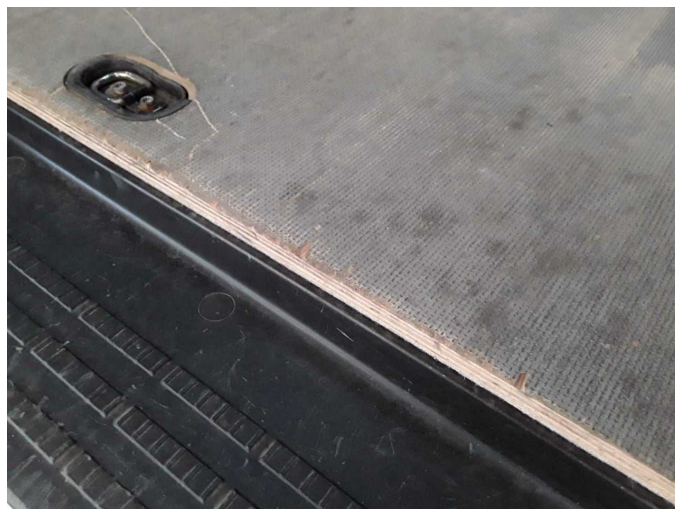
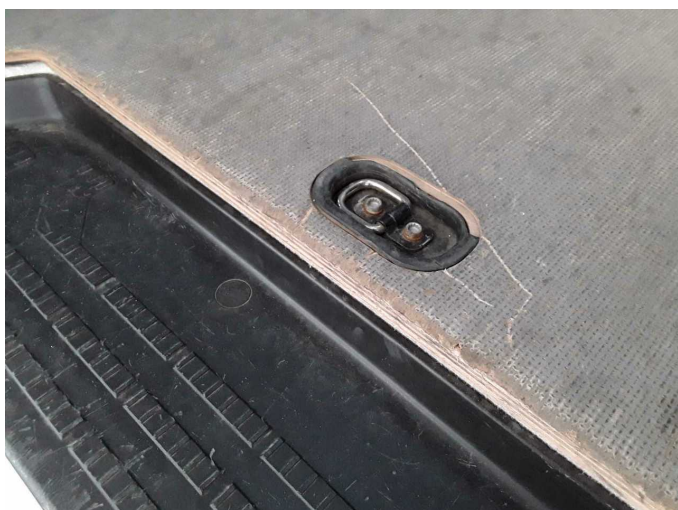
| No. | Component group | Description |
|---|---|---|
| 2 | Rear of vehicle | Wooden floor - Scratched - Loss in value |

**Damage 2:** Rear of vehicle: Wooden floor - Scratched - Loss in value

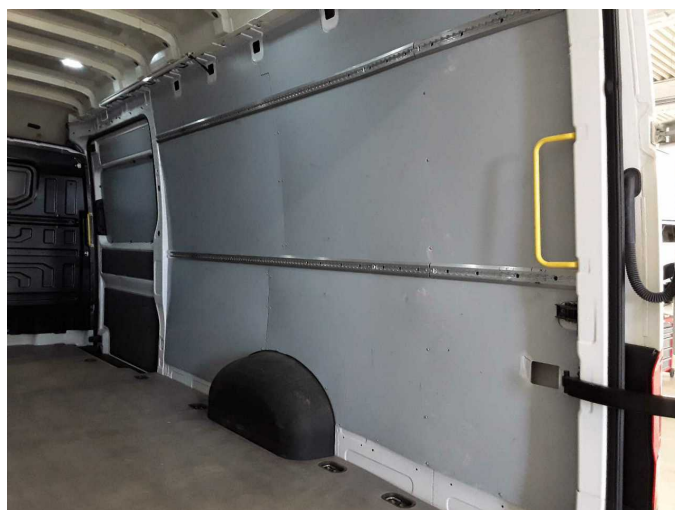
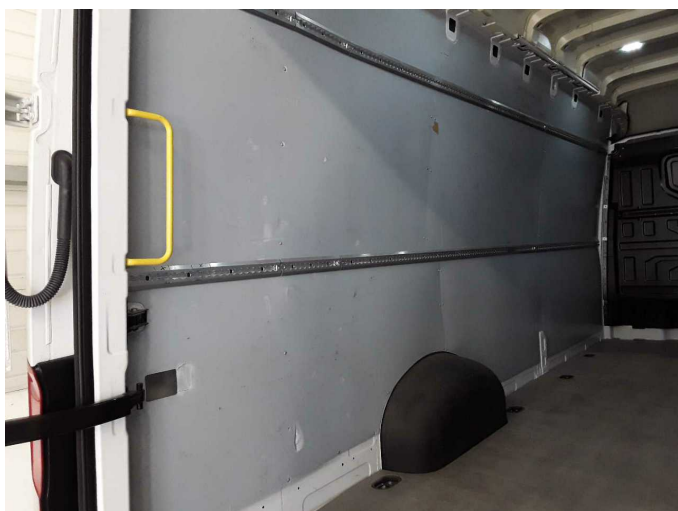
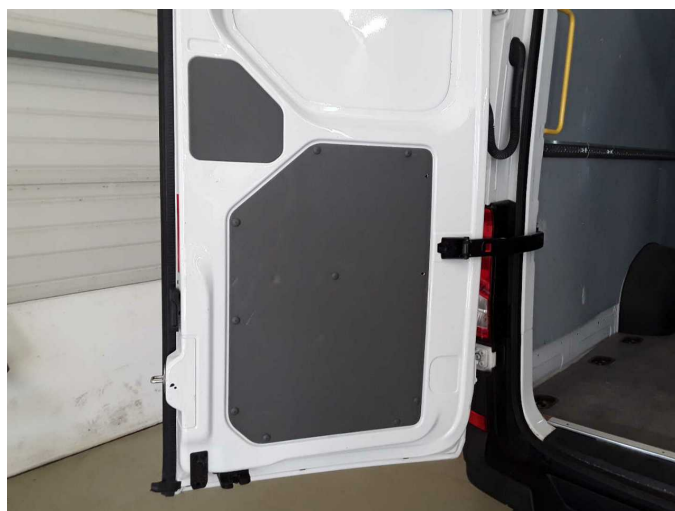
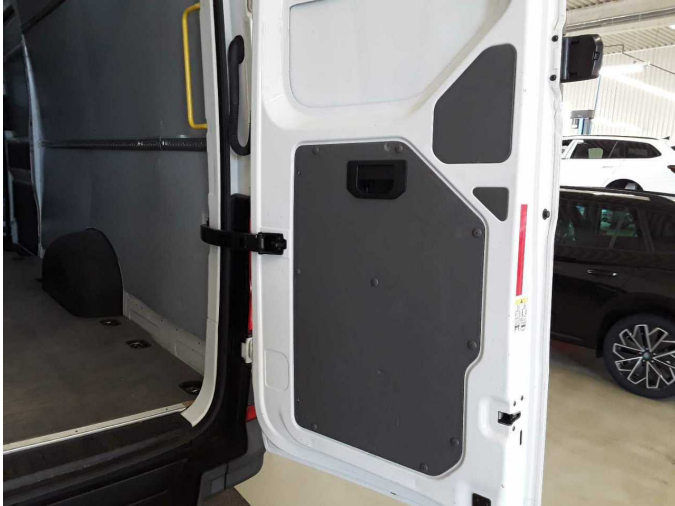
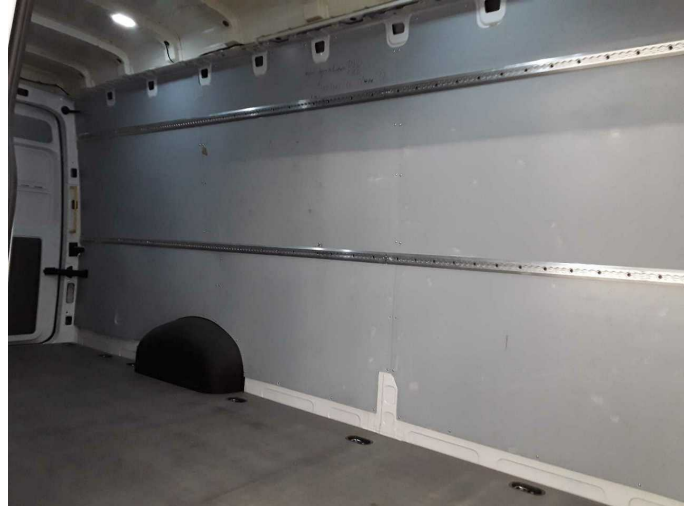
| No. | Component group | Description |
|---|---|---|
| 3 | Interior | Interior (Laderaumverkleidungen-Kratzer, Dellen) - Differs from the original configuration - Loss in value |

**Damage 3:** Interior: Interior (Laderaumverkleidungen-Kratzer, Dellen) - Differs from the original configuration - Loss in value

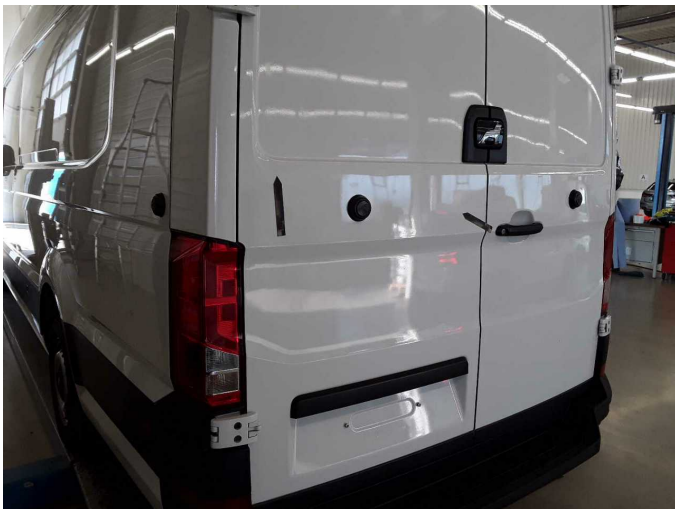
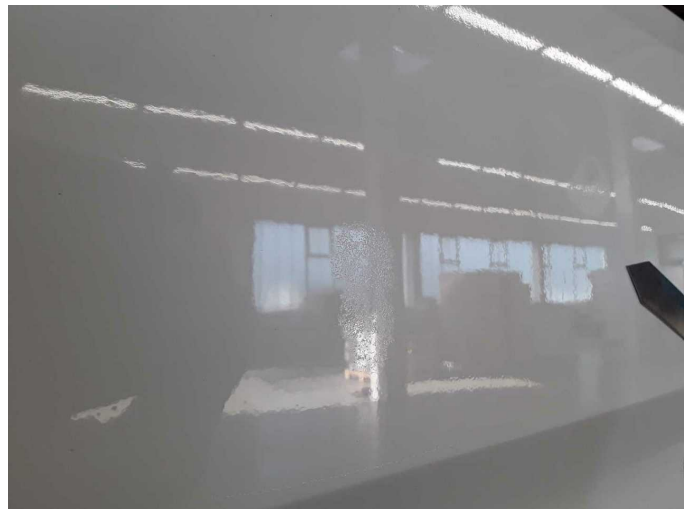
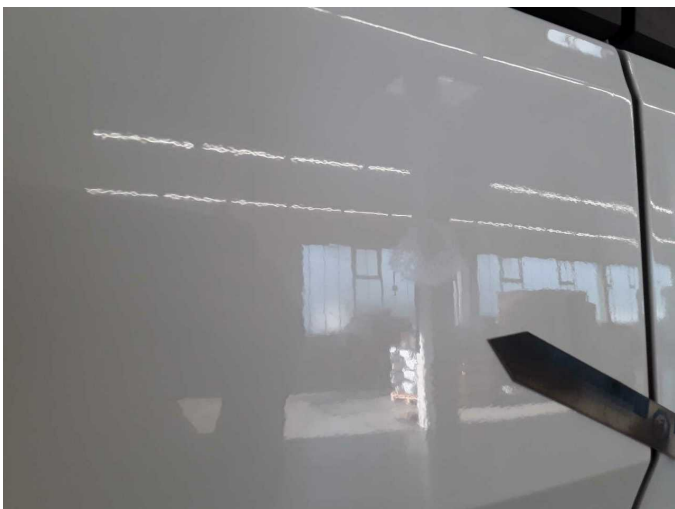
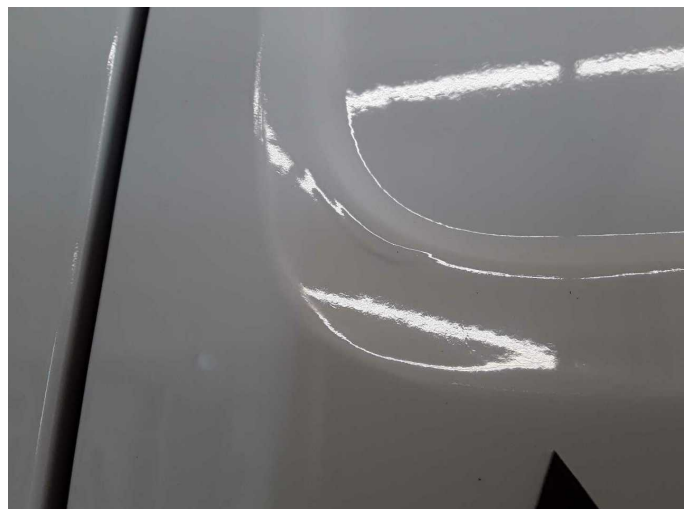
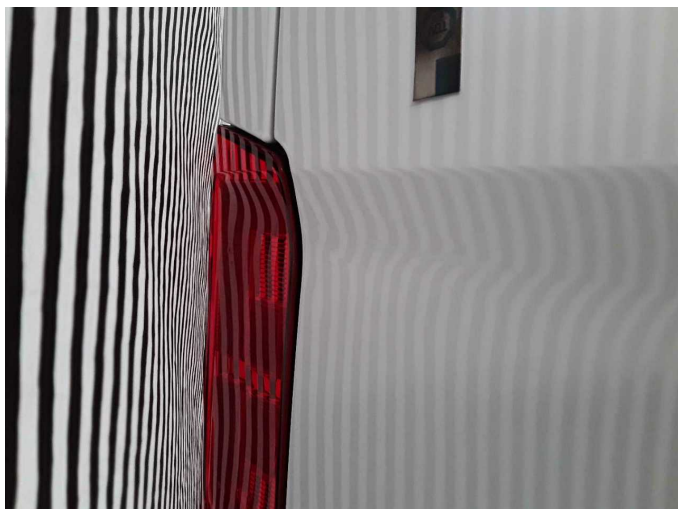
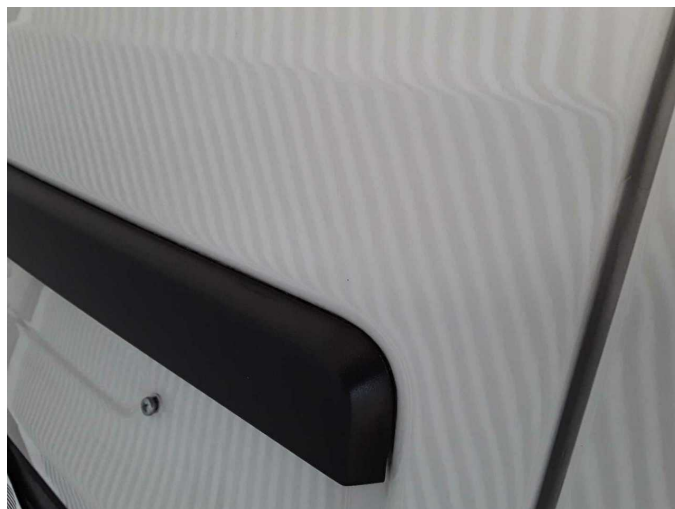
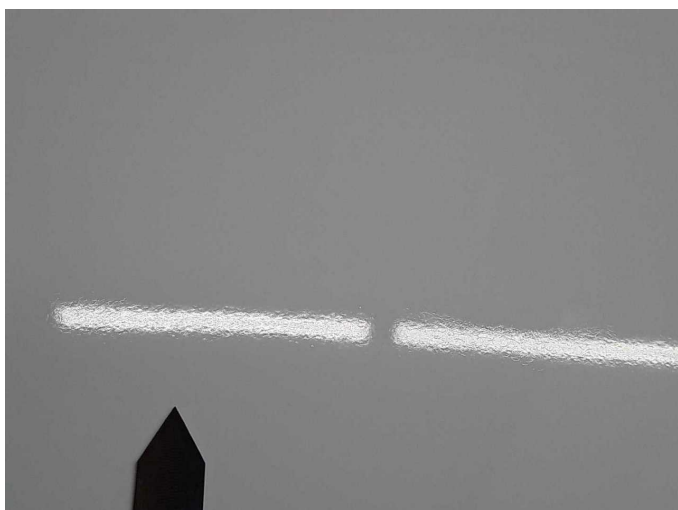
| No. | Component group | Description |
|---|---|---|
| 4 | Boot lid / rear door | Rear door - left side (Schleifspuren sichtbar) - Unprofessionally repaired - Repair and paint |

**Damage 4:** Boot lid / rear door: Rear door - left side (Schleifspuren sichtbar) - Unprofessionally repaired - Repair and paint

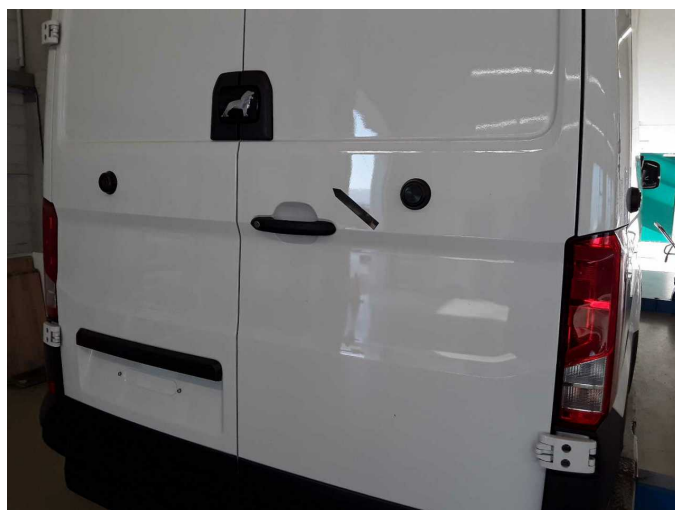
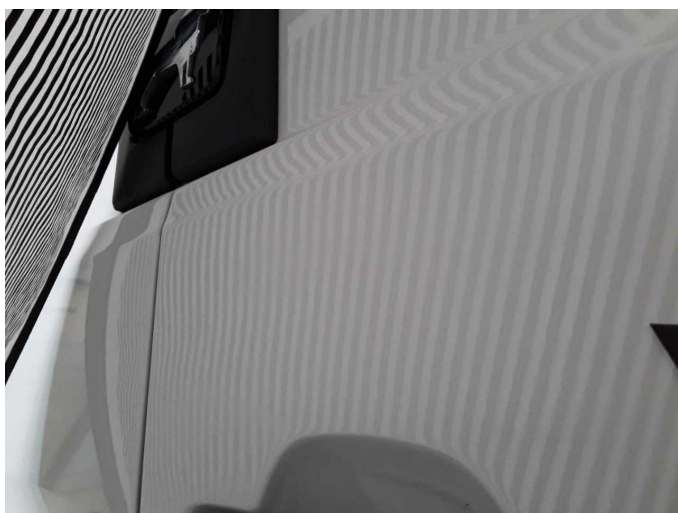
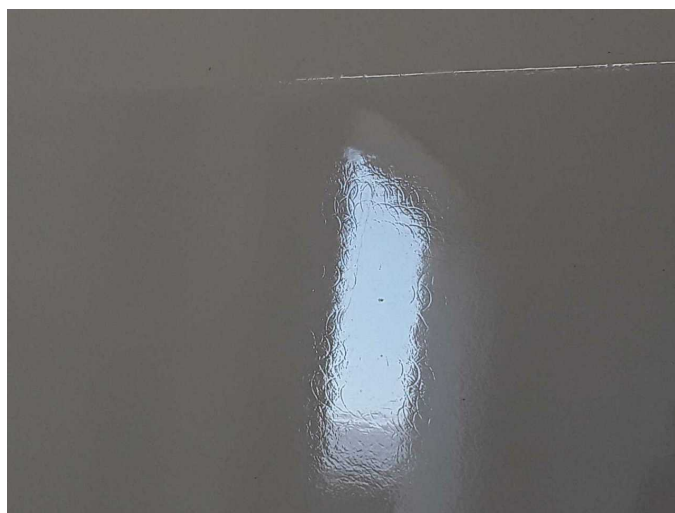
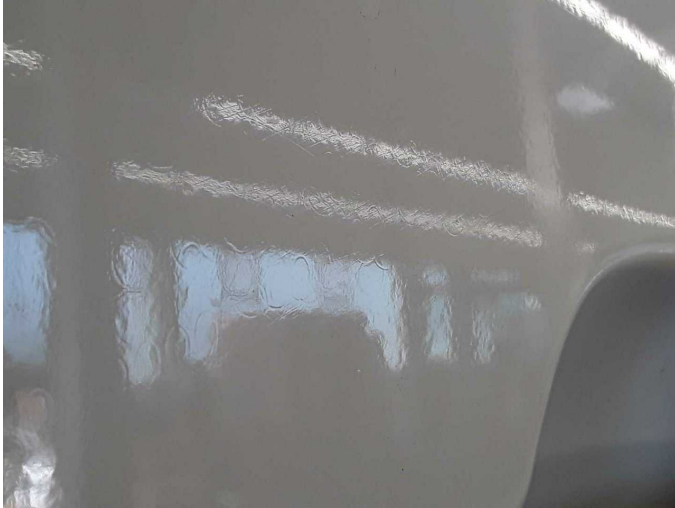
| No. | Component group | Description |
|---|---|---|
| 5 | Boot lid / rear door | Rear door - right side (Schleifspuren sichtbar) - Unprofessionally repaired - Paint |

**Damage 5:** Boot lid / rear door: Rear door - right side (Schleifspuren sichtbar) - Unprofessionally repaired - Paint

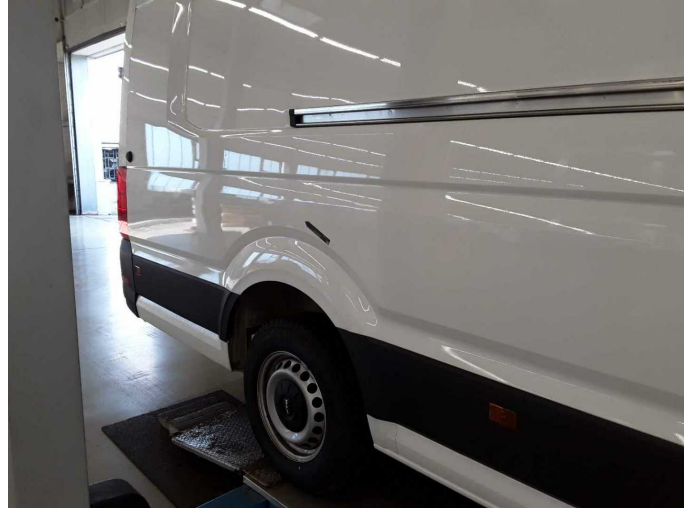
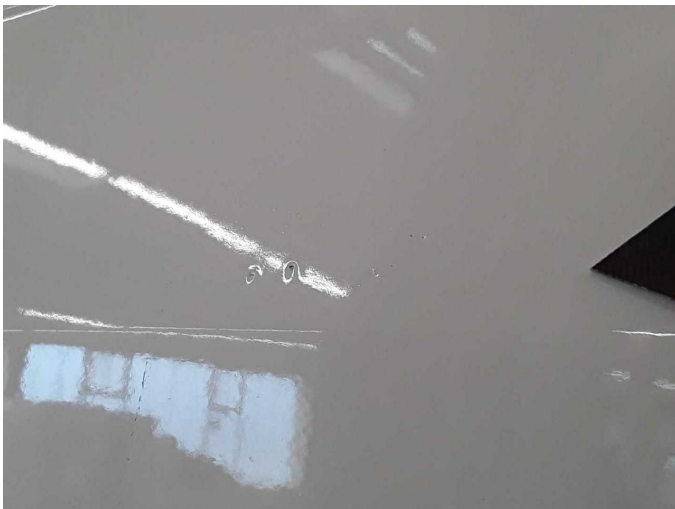
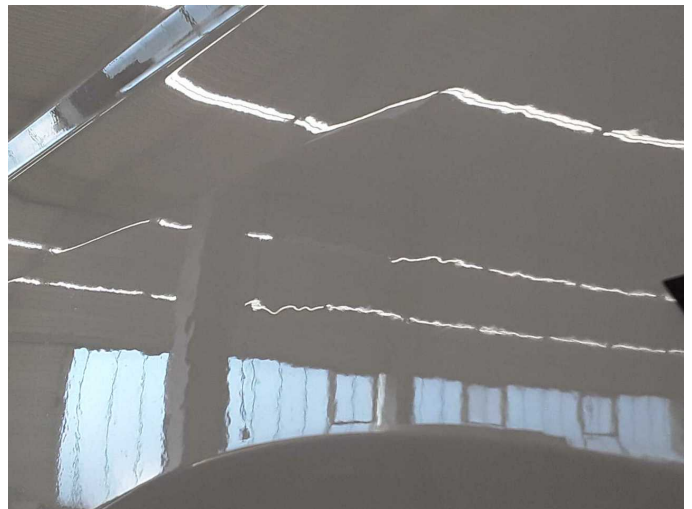
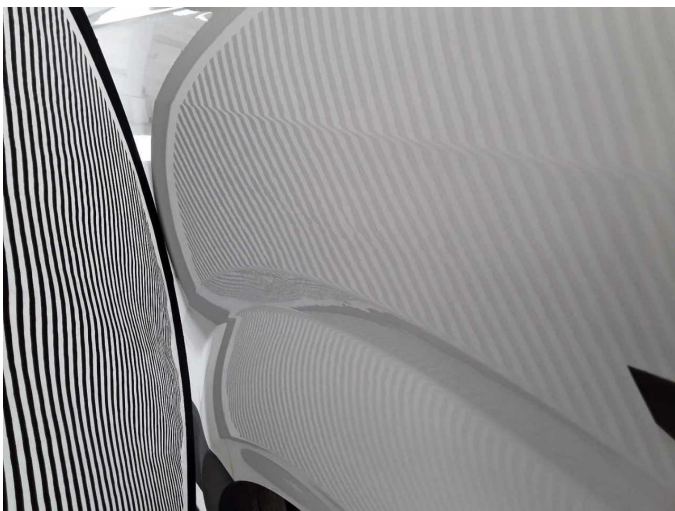
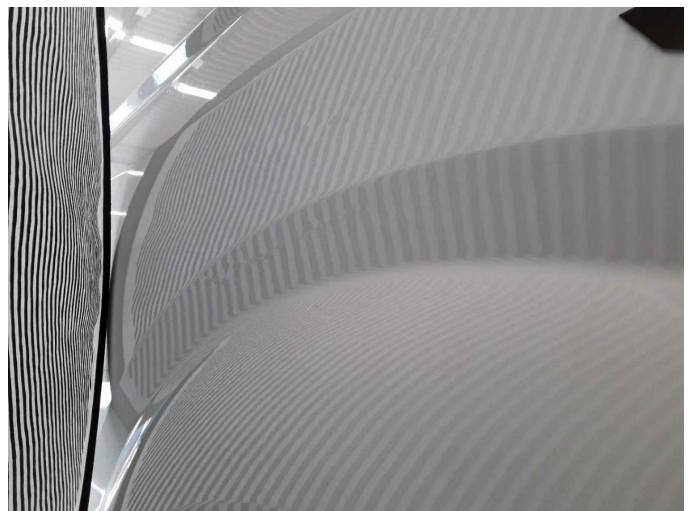
| No. | Component group | Description |
|---|---|---|
| 6 | Side panel - rear right side | Side panel - Unprofessionally repaired - repair according to calculation |

**Damage 6:** Side panel - rear right side: Side panel - Unprofessionally repaired - repair according to calculation

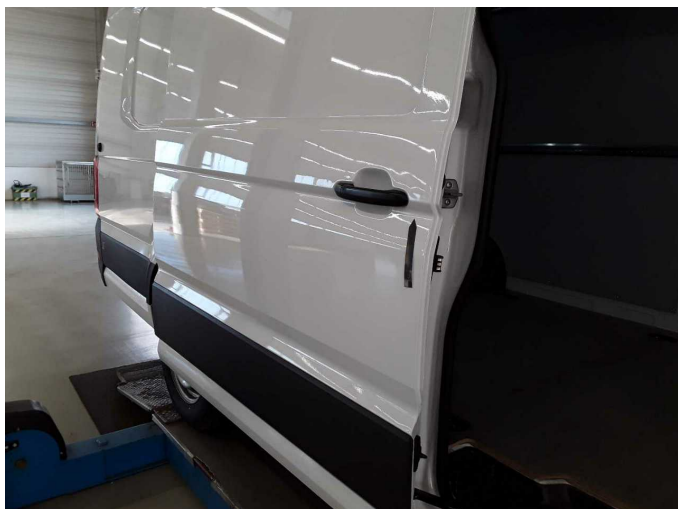
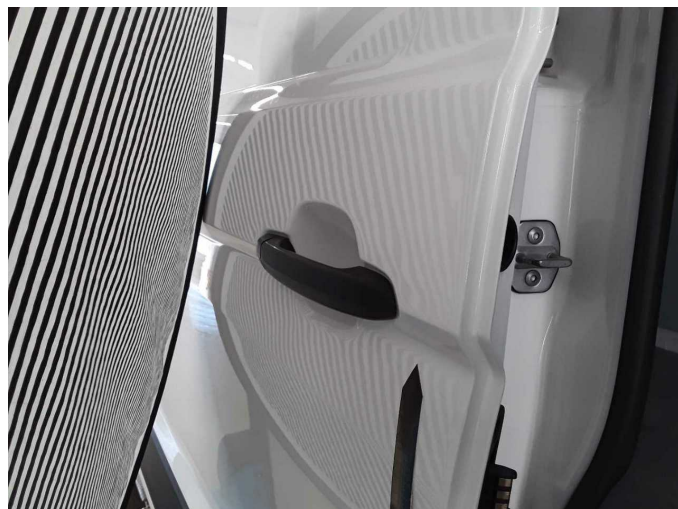
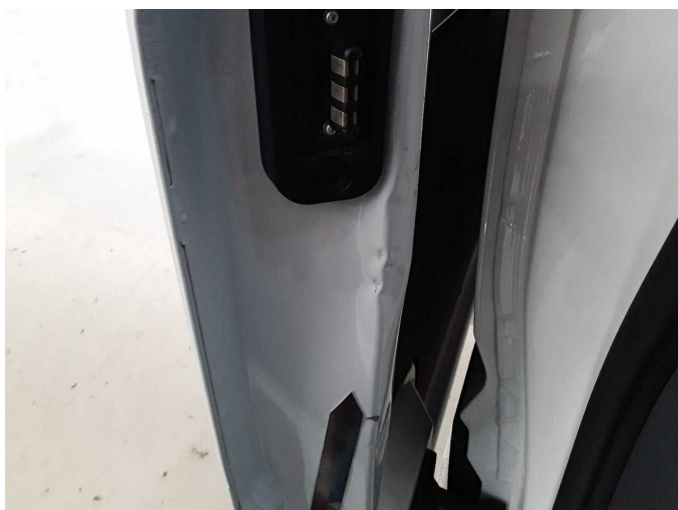
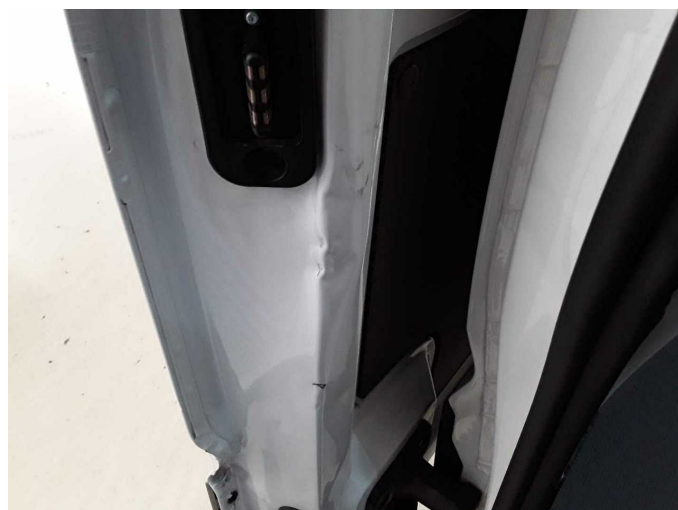
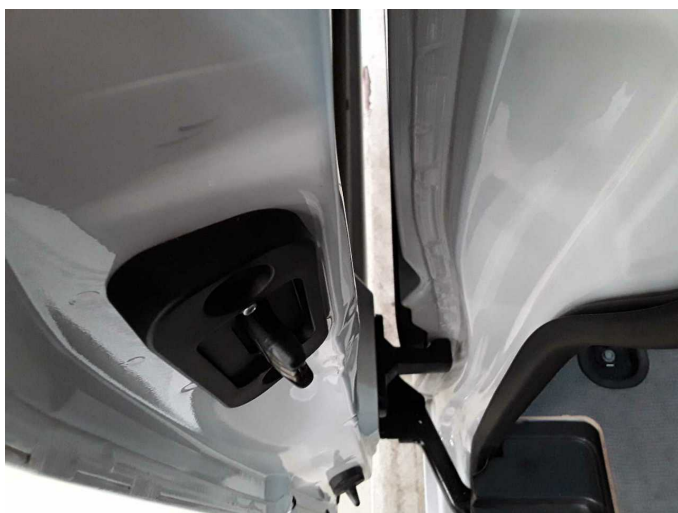
| No. | Component group | Description |
|---|---|---|
| 7 | Sliding door, right | Sliding door (innen stark verformt) - Unprofessionally repaired - repair according to calculation |

**Damage 7:** Sliding door, right: Sliding door (innen stark verformt) - Unprofessionally repaired - repair according to calculation

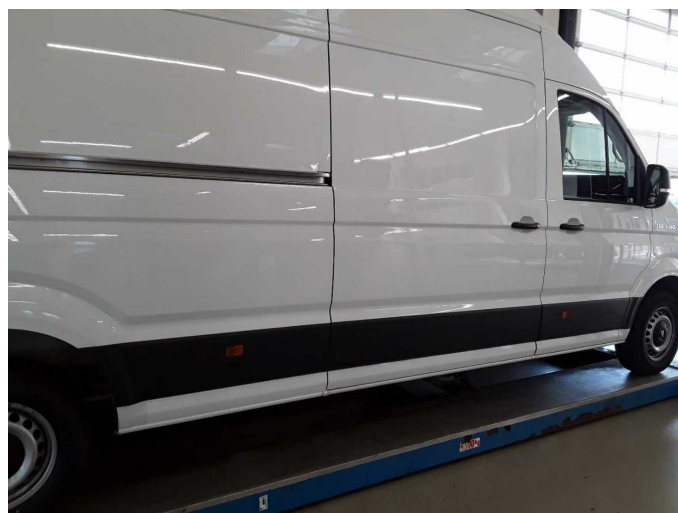
| No. | Previous damage | Extent of damage (Net) |
|---|---|---|
| 1 | Side right, not professionally repaired | |

An unprofessionally repaired previous damage was found at the vehicle.

**Previous damage 1:** Side right

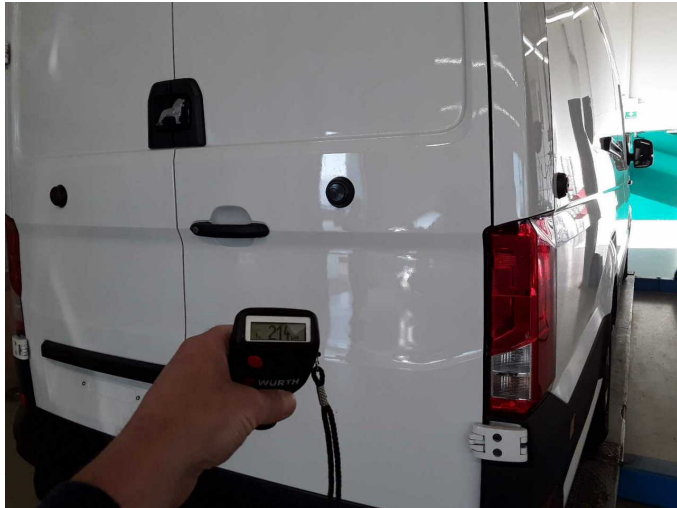
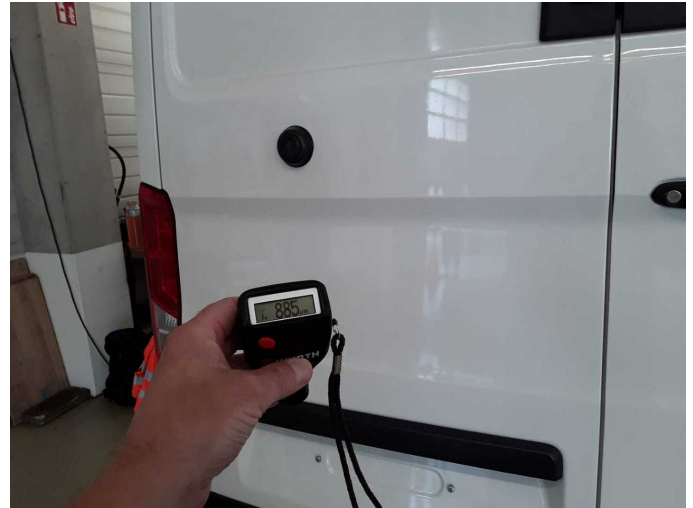
| No. | Repainting |
|---|---|
| 2 | Boot lid / rear door, Side panel - rear right side, Door - rear right side, Unprofessionally carried out |

Boot lid / rear door: 885  $\mu\text{m}$

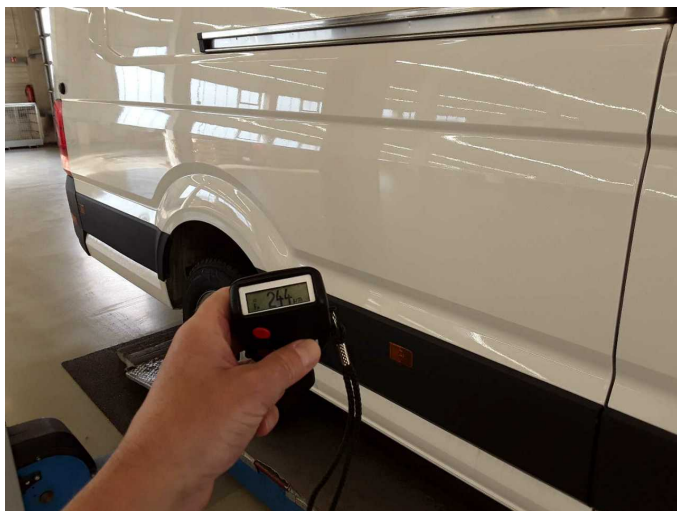
Side panel - rear right side: 244  $\mu\text{m}$

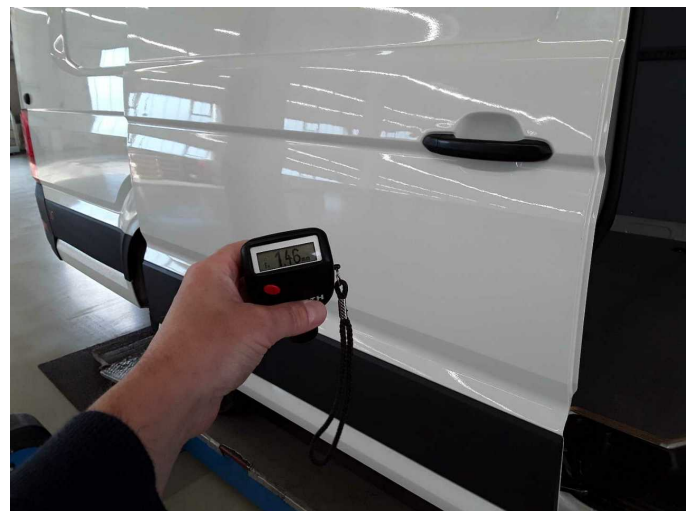
Door - rear right side: 1,460  $\mu\text{m}$

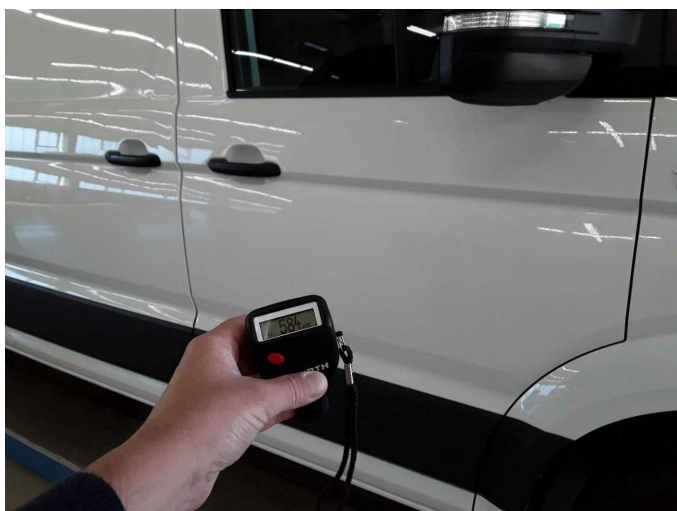
| No. | Repainting |
|---|---|
| 1 | Door - front right side, Professionally carried out |

Door - front right side: 584  $\mu\text{m}$
