Expertise

Protocol number: 46478638  
Order No. / Reference: 26053750  
Inspection date: 9 Jul 2026

Manufacturer: Mercedes-Benz  
VIN: W1V3KBFZ9TP859083

Model: 317 CDI KAWA Sprinter Standard HA PRO

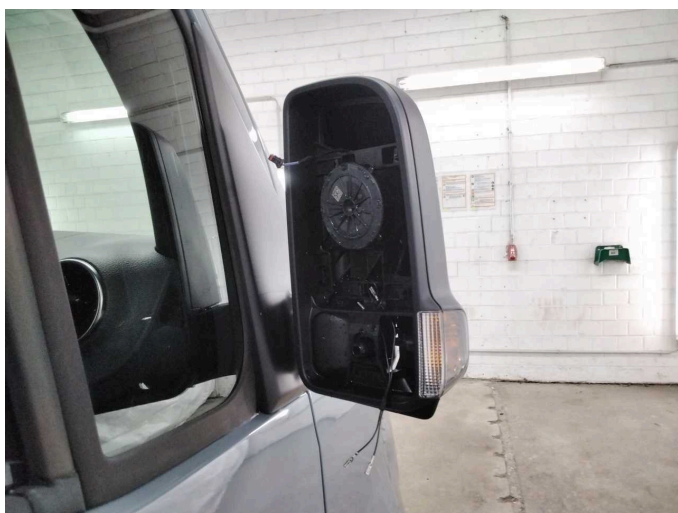
| No. | Component group | Description |
|---|---|---|
| 1 | Wing mirror - right side | Wing mirror - Damaged - Replace |

Damage 1: Wing mirror - right side: Wing mirror - Damaged - Replace

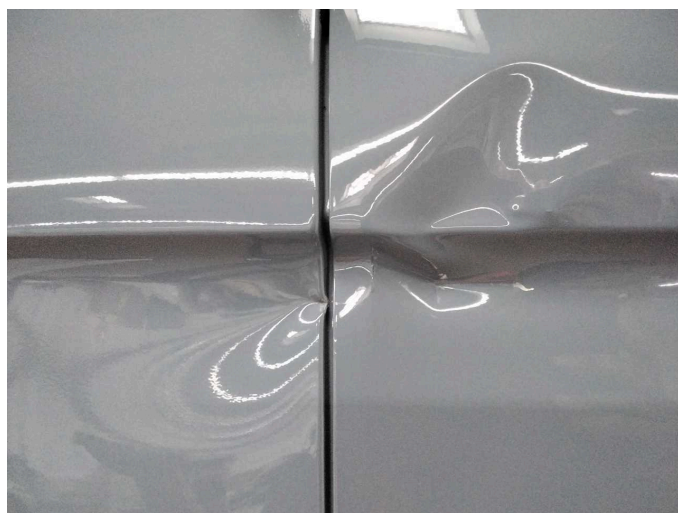
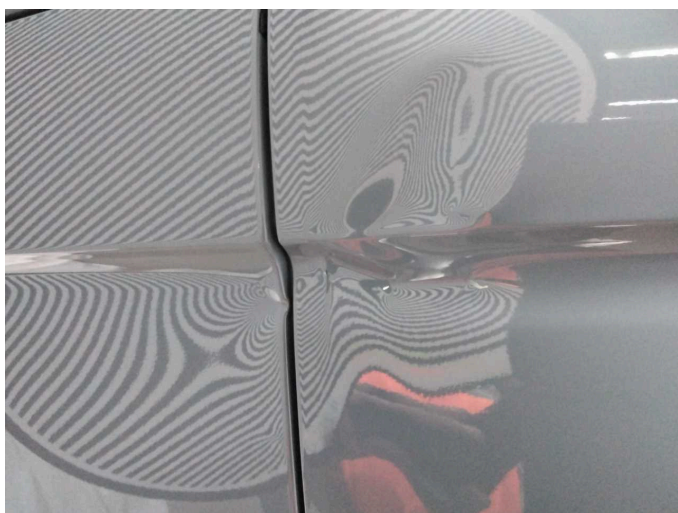
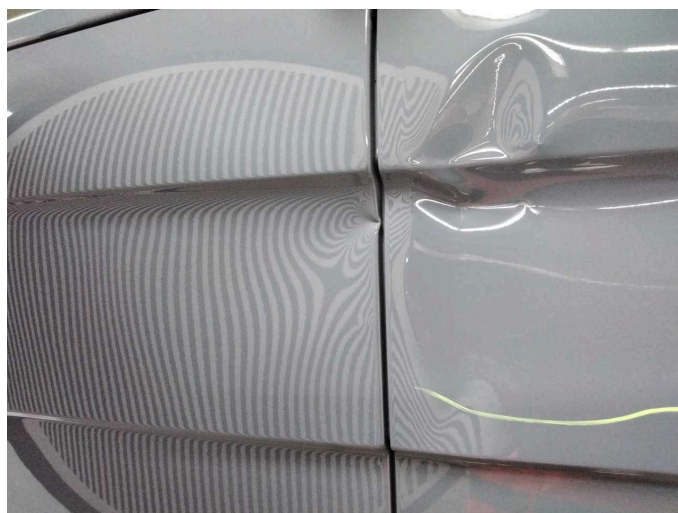
| No. | Component group | Description |
|---|---|---|
| 2 | Boot lid / rear door | Rear door - left side (Teillackierung) - Dent / paintcoat damage - Repair and paint |

Damage 2: Boot lid / rear door: Rear door - left side (Teillackierung) - Dent / paintcoat damage - Repair and paint

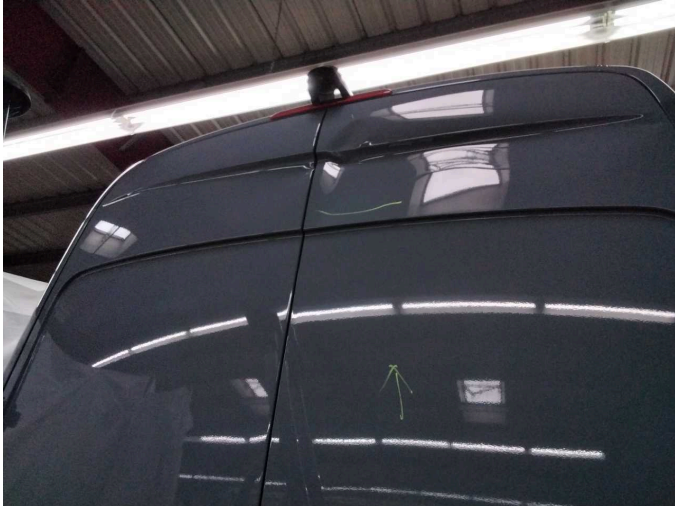
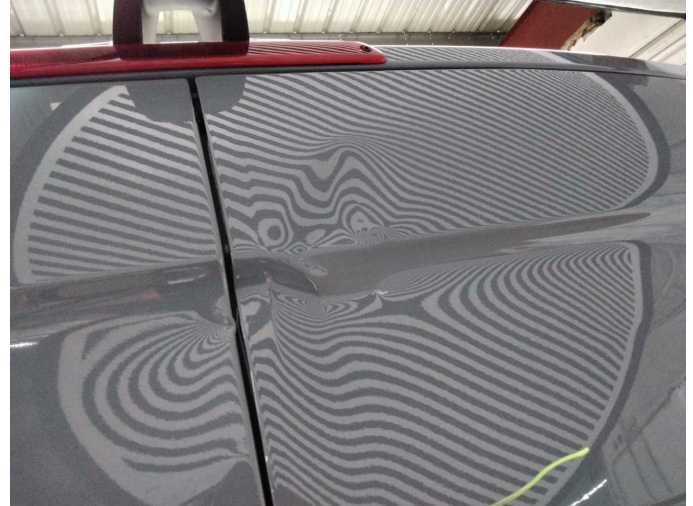
| No. | Component group | Description |
|---|---|---|
| 3 | Boot lid / rear door | Rear door - right side (Teillackierung) - Dent / paintcoat damage - Repair and paint |

**Damage 3:** Boot lid / rear door: Rear door - right side (Teillackierung) - Dent / paintcoat damage - Repair and paint

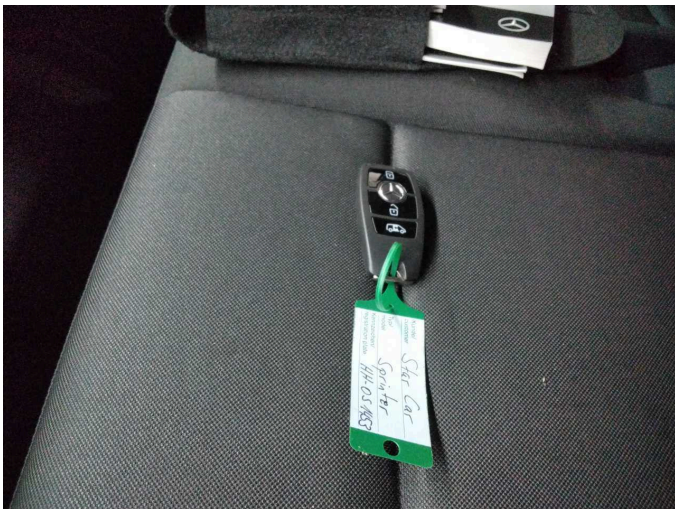
Equipment - Vehicle key

**Missing part 1:** Equipment: Vehicle key - Missing - Replace

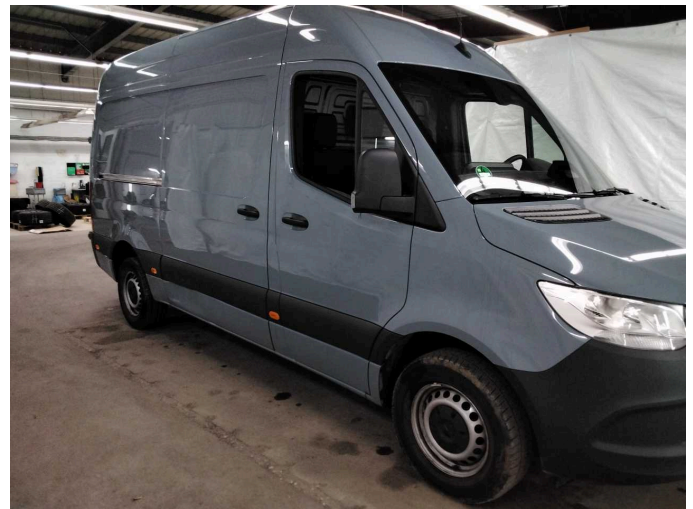
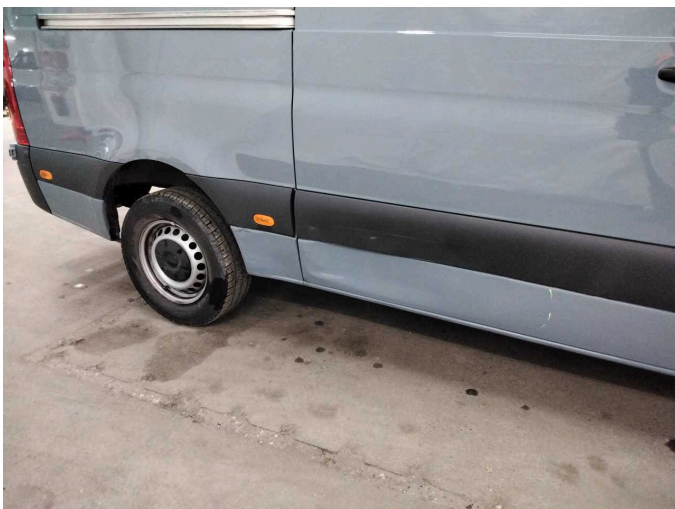
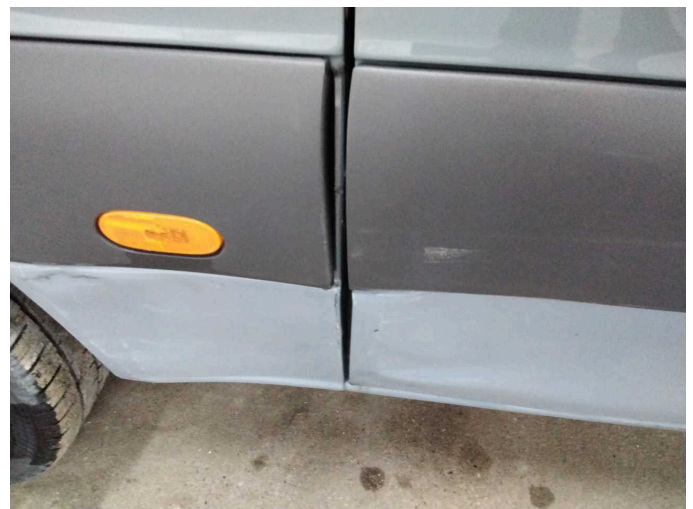
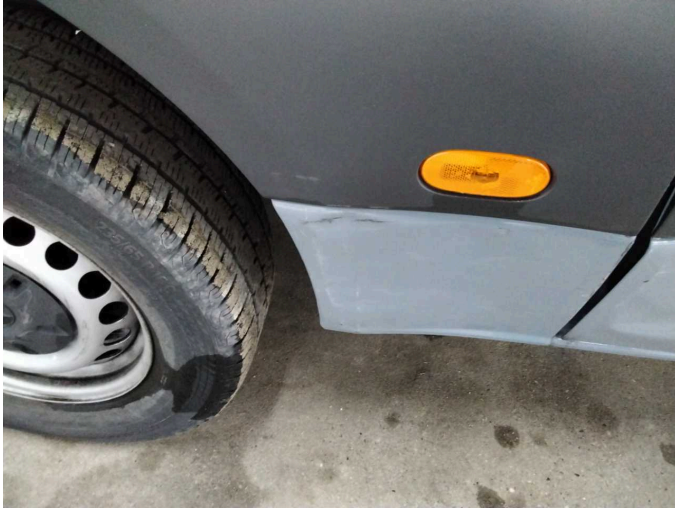
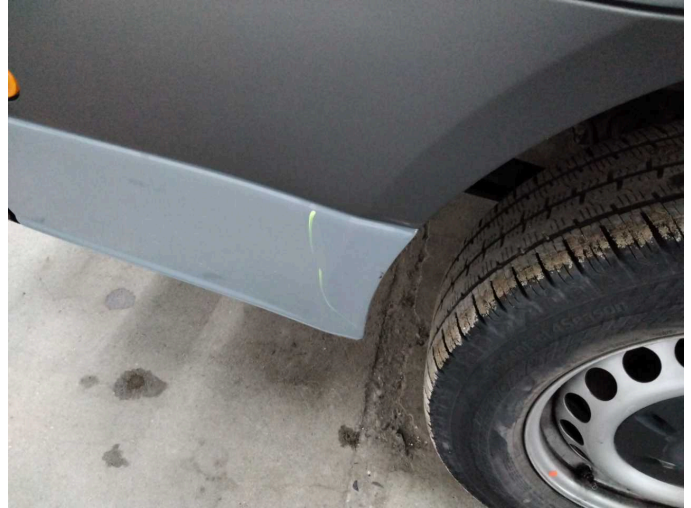
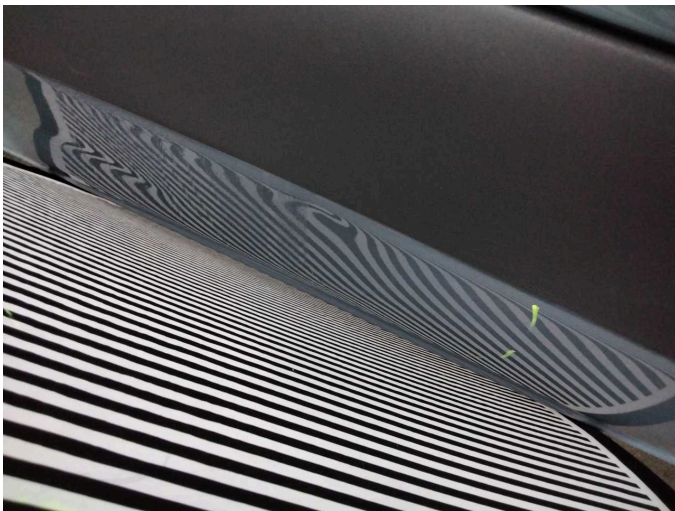
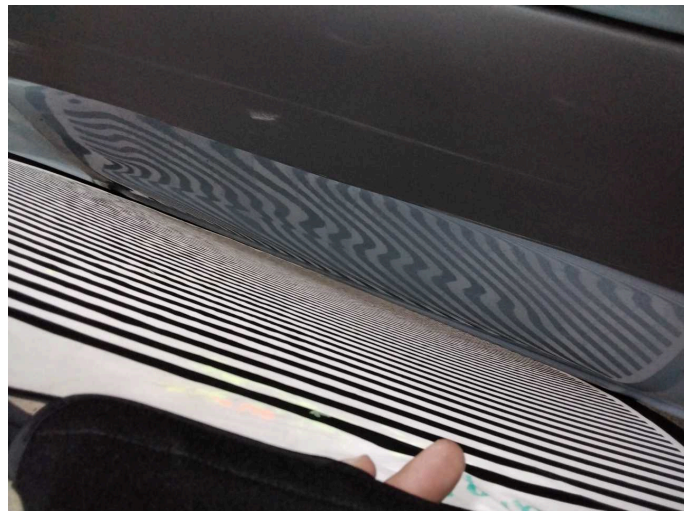
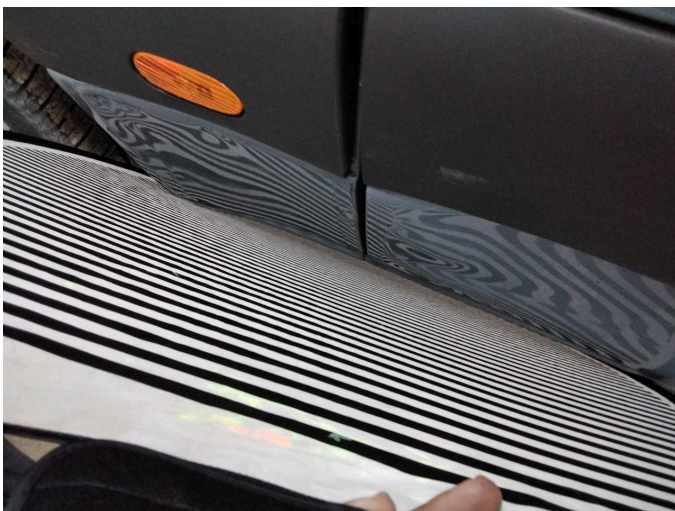
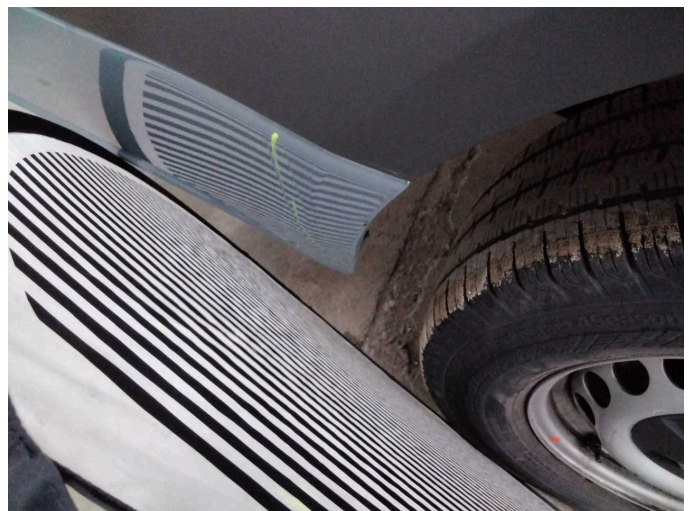
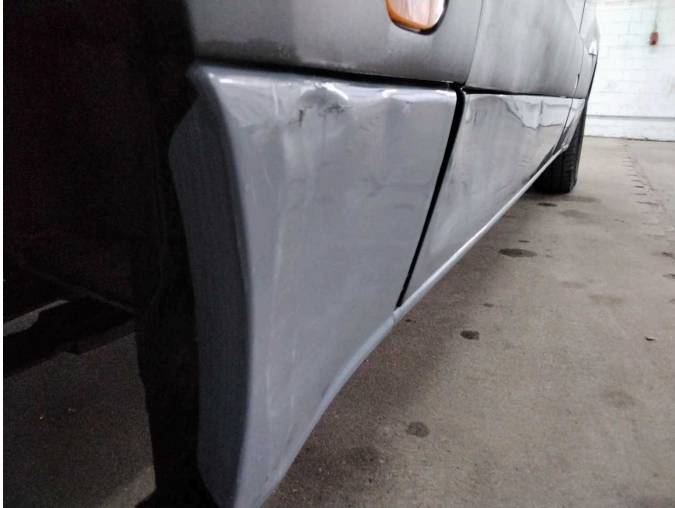
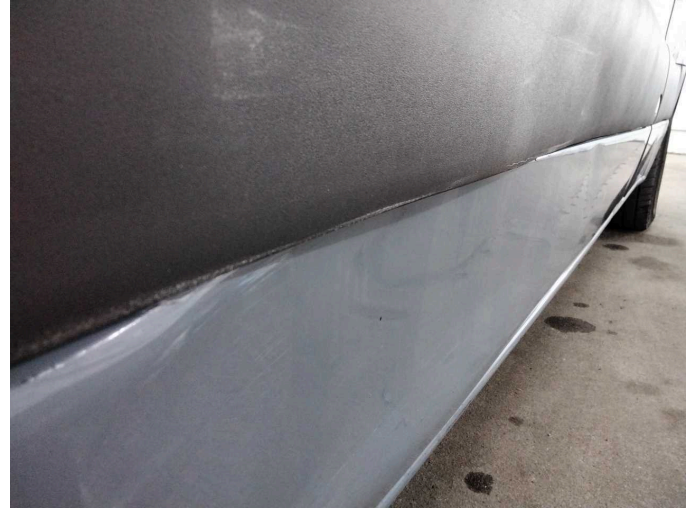
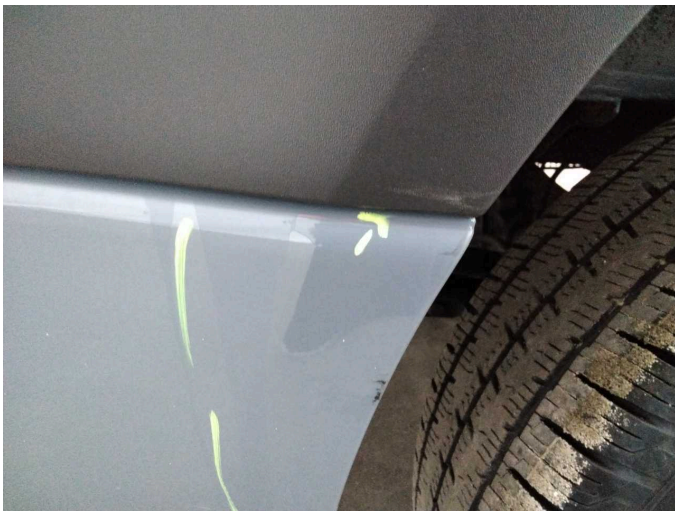
1 Side right

Non-repaired previous damages were found at the vehicle. The necessary repair costs are listed in the expert report or if necessary, are listed in detail in a separately enclosed repair cost calculation.

**Accident 1:** Side right
