Expertise

Protocol number: 46249499
Order No. / Reference: 26471942
Inspection date: 30 Jun 2026

Model: Astra 1.5 D Start/Stop Sports Tourer Automatik Edition

VIN: W0VBD8EV7N8043085

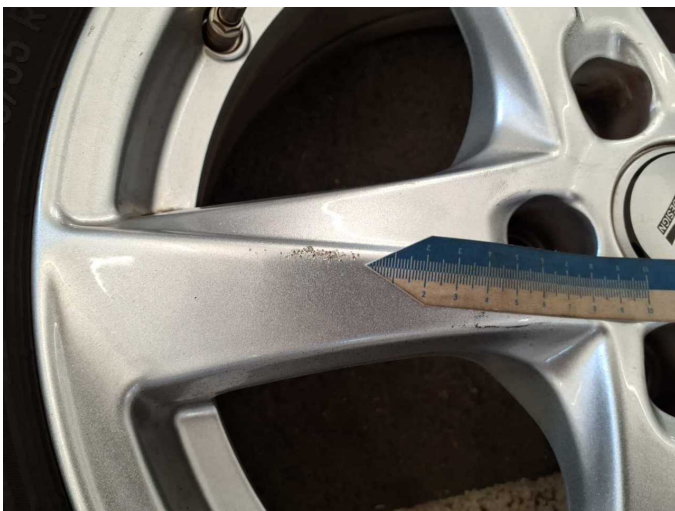
Damage 1: 2nd wheel set: 1 alloy rim - Scratch(es) - Loss in value

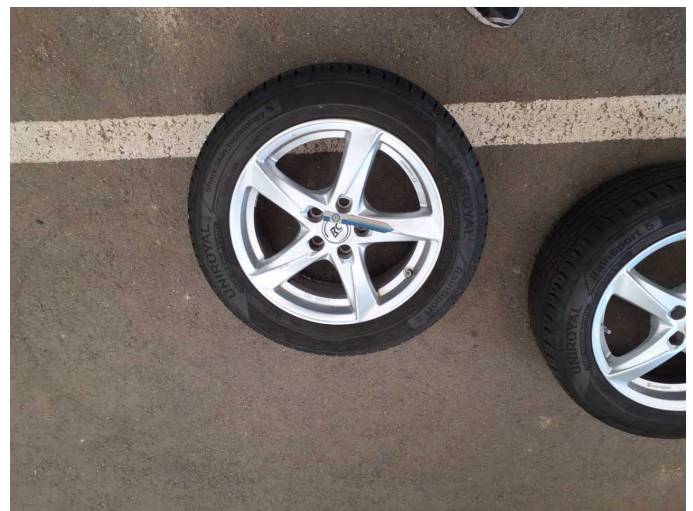
Damage 1: 2nd wheel set: 1 alloy rim - Scratch(es) - Loss in value

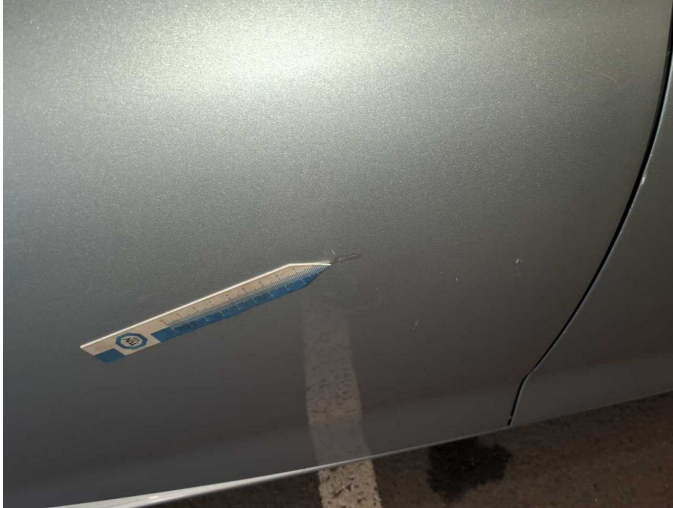
Damage 2: Door - rear right side: Door - Scratch(es) - Smart repair

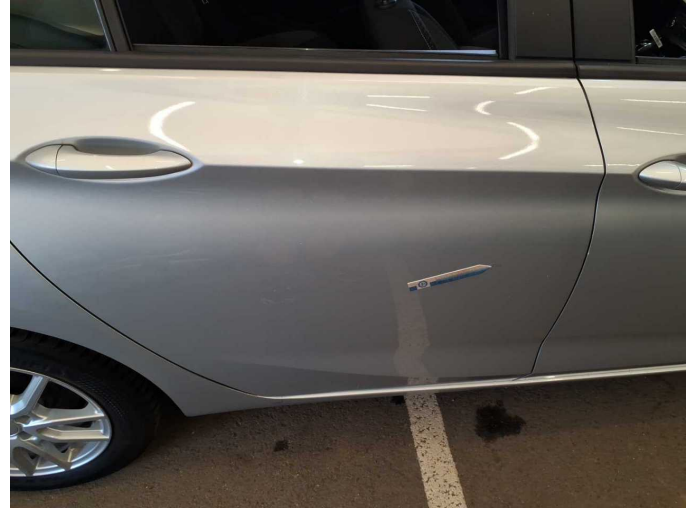
Damage 2: Door - rear right side: Door - Scratch(es) - Smart repair

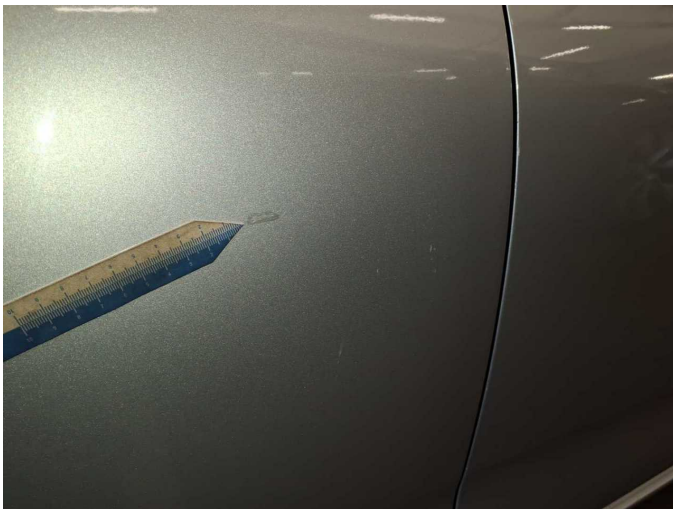
Damage 2: Door - rear right side: Door - Scratch(es) - Smart repair

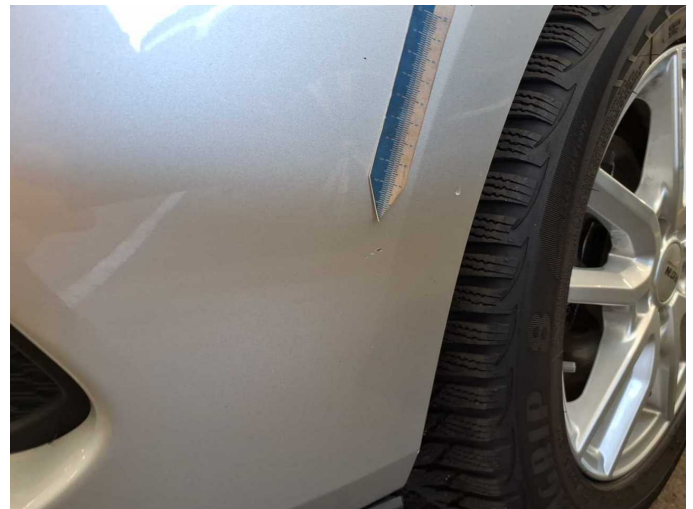
Damage 3: Front bumper: Front bumper - Scratched - Smart repair

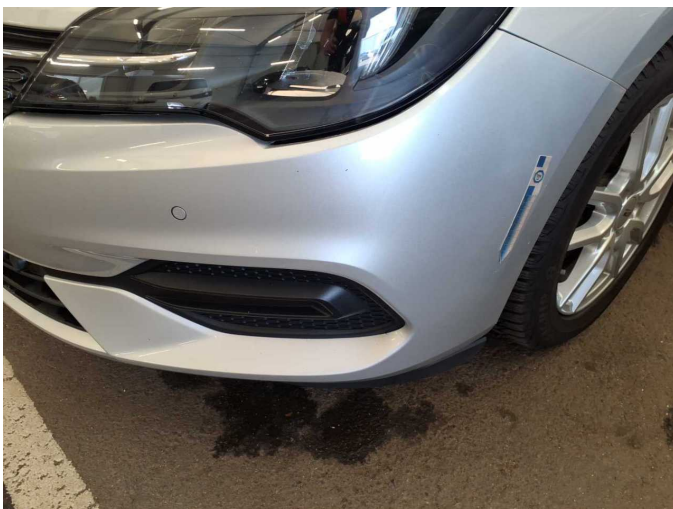
Damage 3: Front bumper: Front bumper - Scratched - Smart repair

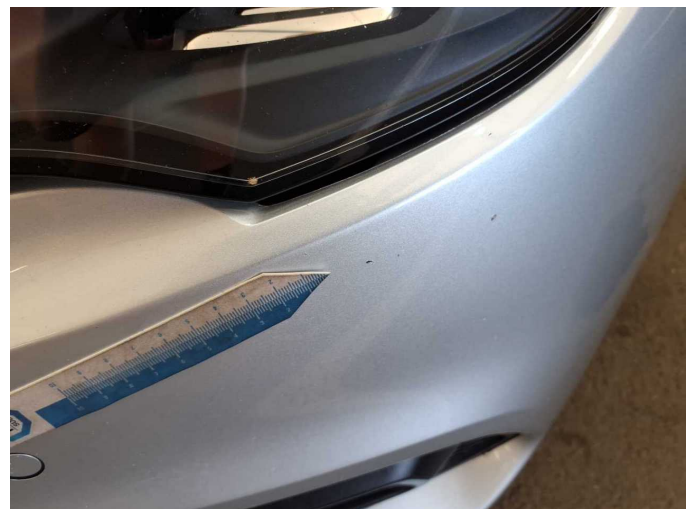
Damage 3: Front bumper: Front bumper - Scratched - Smart repair

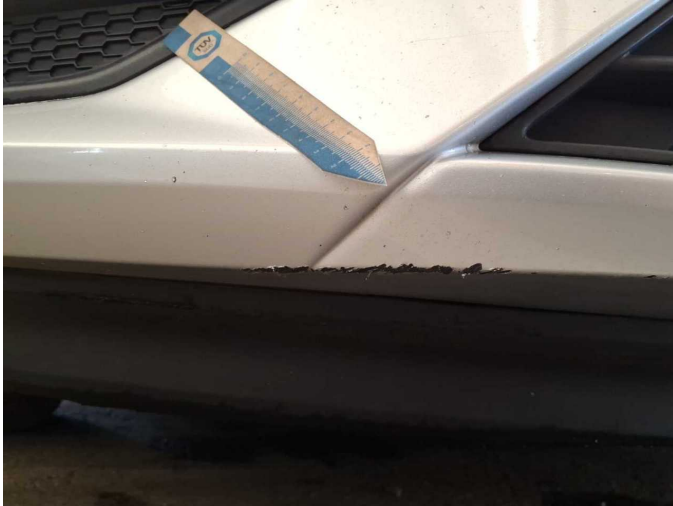
Damage 3: Front bumper: Front bumper - Scratched - Smart repair

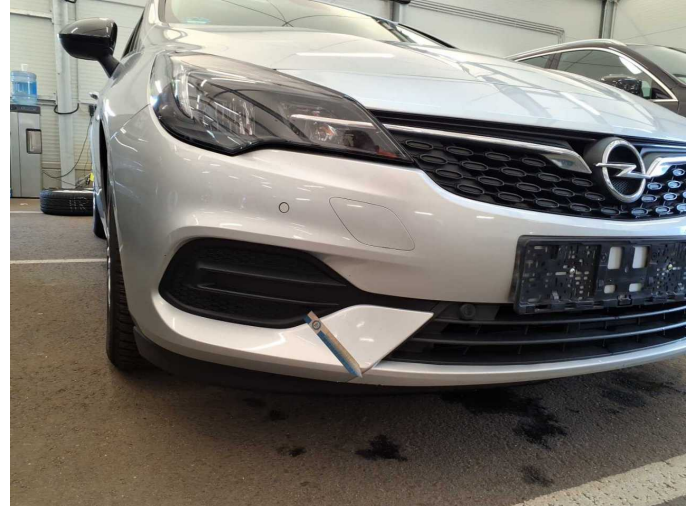
Damage 3: Front bumper: Front bumper - Scratched - Smart repair

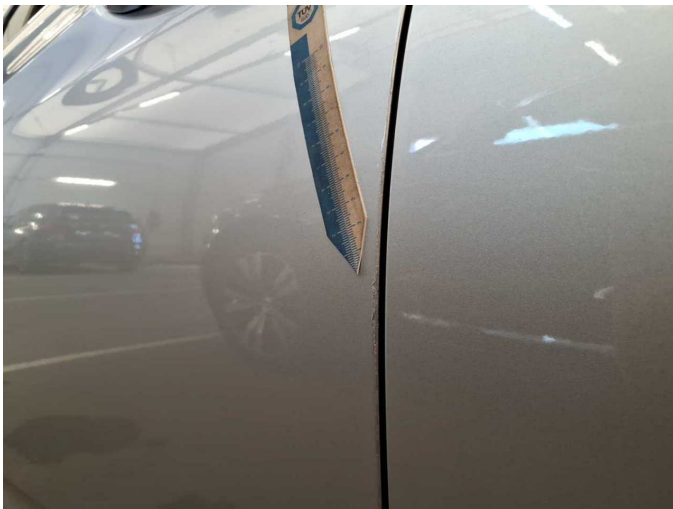
Damage 4: Door - front left side: Door - Scratch(es) - Smart repair

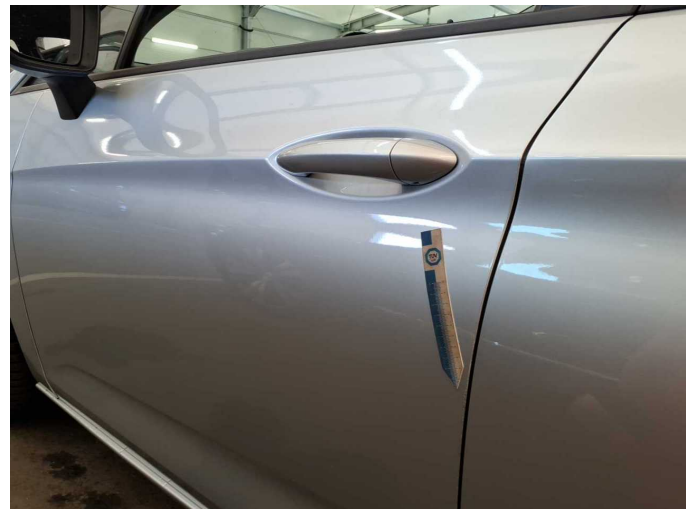
Damage 4: Door - front left side: Door - Scratch(es) - Smart repair

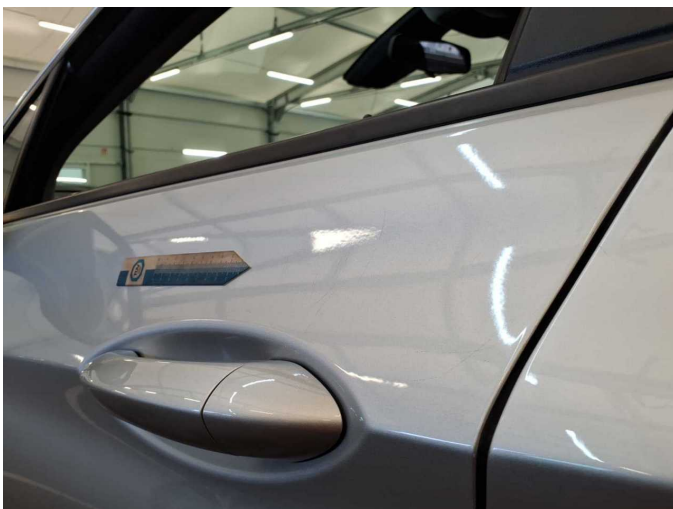
Damage 4: Door - front left side: Door - Scratch(es) - Smart repair

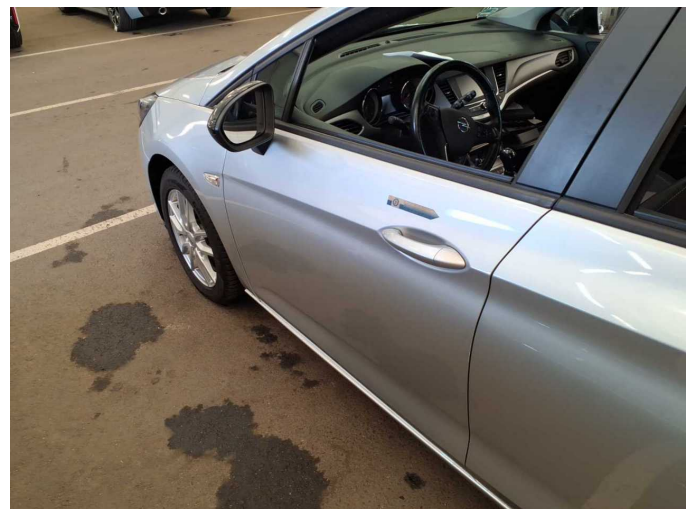
Damage 4: Door - front left side: Door - Scratch(es) - Smart repair

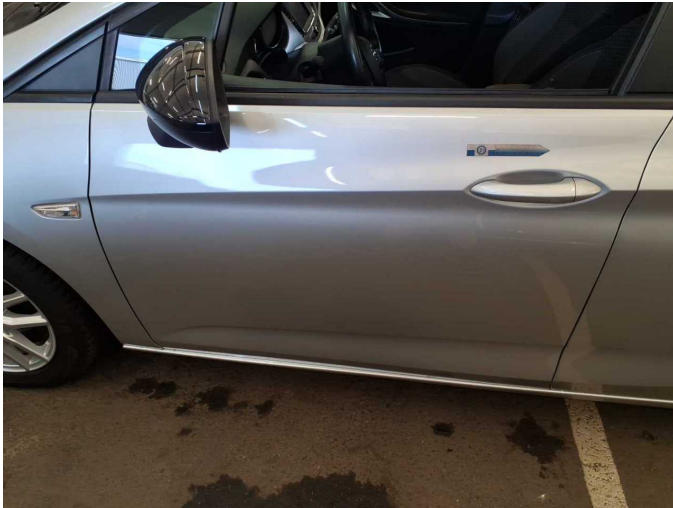
Damage 4: Door - front left side: Door - Scratch(es) - Smart repair

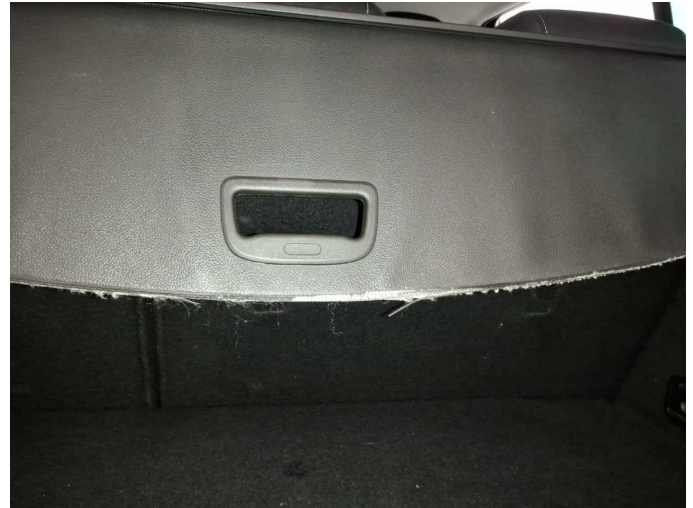
Damage 5: Interior: Rear shelf - Broken / torn - Replace

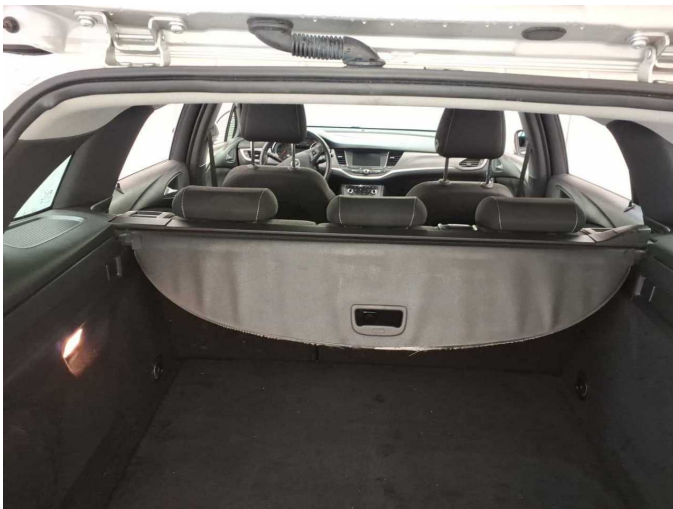
Damage 5: Interior: Rear shelf - Broken / torn - Replace

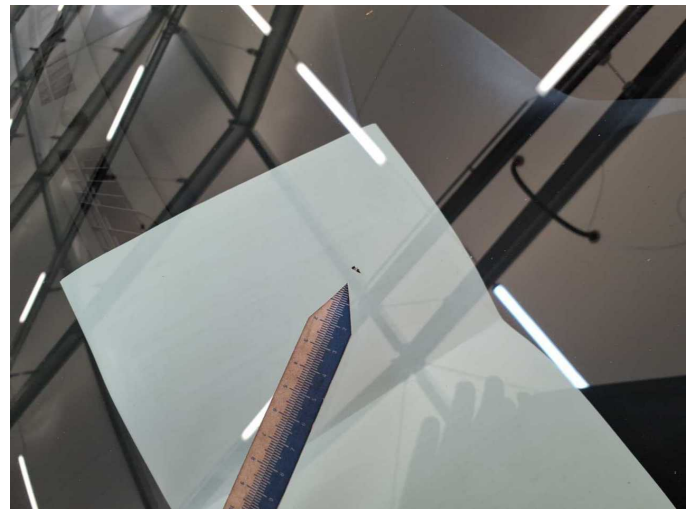
Damage 6: Vehicle glazing: Windscreen (Steinschlag im Sichtfeld-Blendwirkung) - Stone chips - Replace

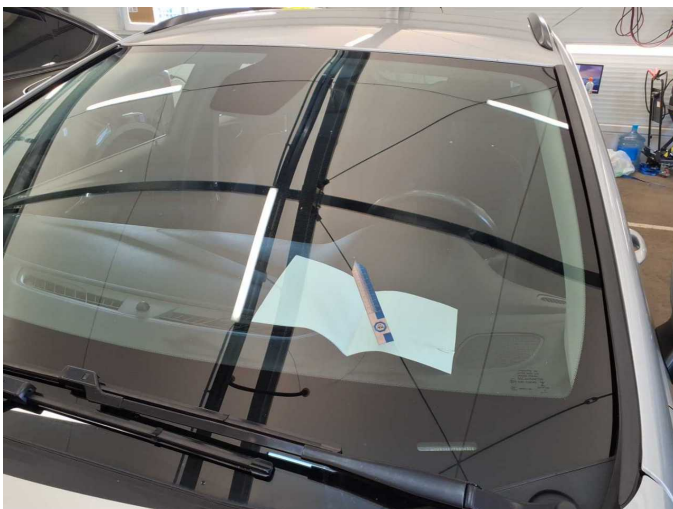
Damage 6: Vehicle glazing: Windscreen (Steinschlag im Sichtfeld-Blendwirkung) - Stone chips - Replace

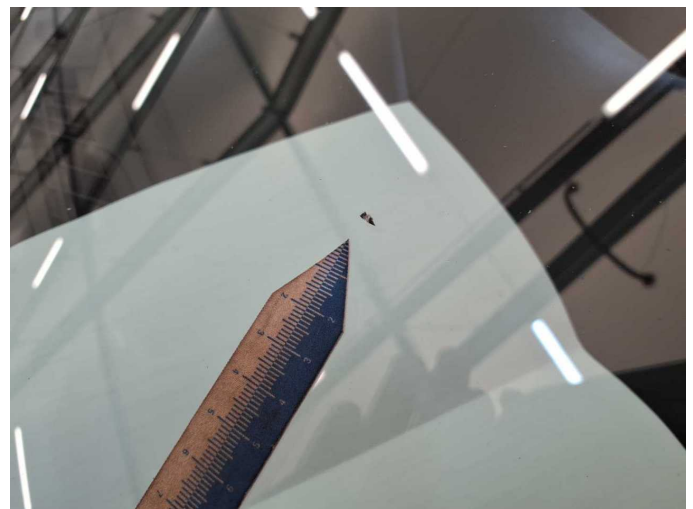
Damage 6: Vehicle glazing: Windscreen (Steinschlag im Sichtfeld-Blendwirkung) - Stone chips - Replace

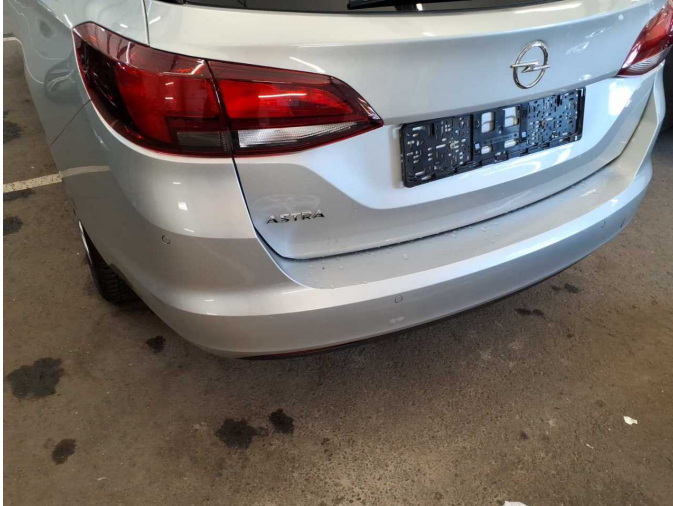
Wear and tear 1: Rear bumper: Rear bumper - Scratch(es) - No deduction

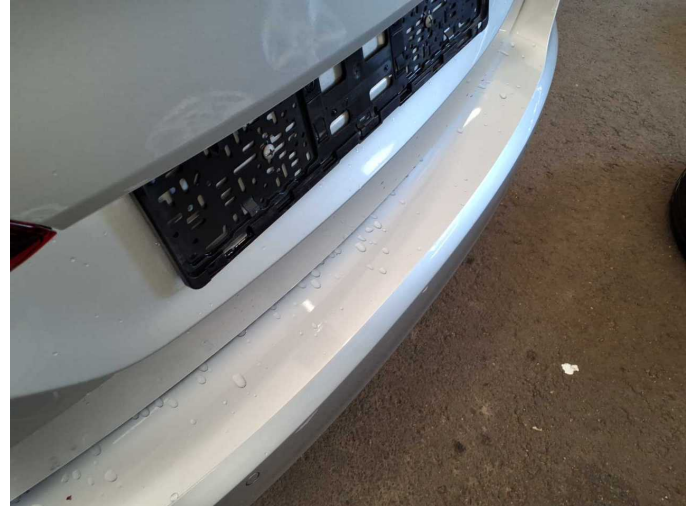
Wear and tear 1: Rear bumper: Rear bumper - Scratch(es) - No deduction

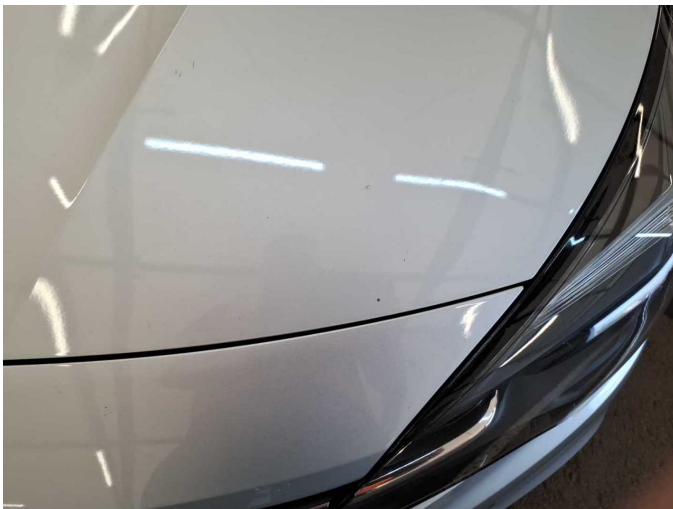
Wear and tear 2: Bonnet: Bonnet - Stone chips - No deduction

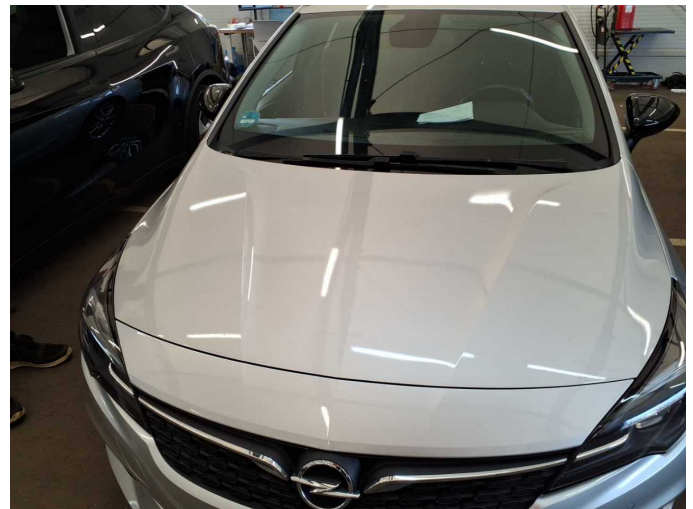
Wear and tear 2: Bonnet: Bonnet - Stone chips - No deduction

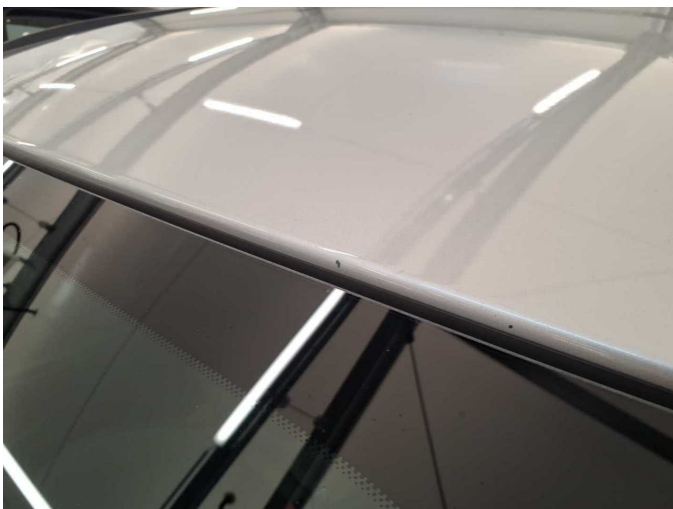
Wear and tear 3: Roof: Roof - Stone chips - No deduction

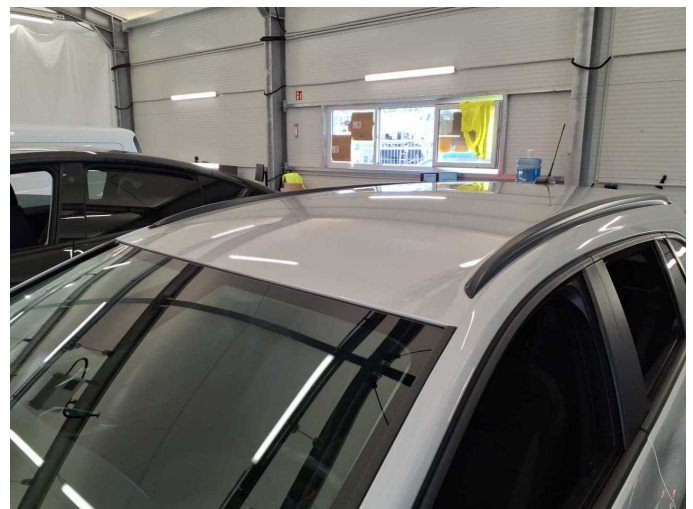
Wear and tear 3: Roof: Roof - Stone chips - No deduction

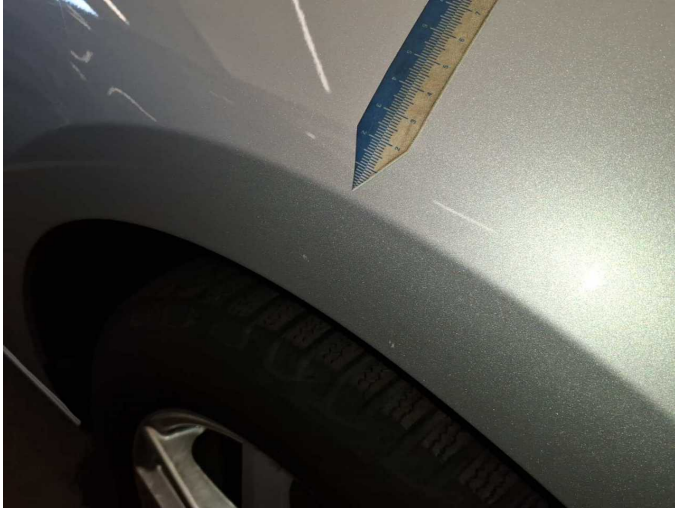
Wear and tear 5: Mudguard - right side: Mudguard - right side - Scratch(es) - No deduction

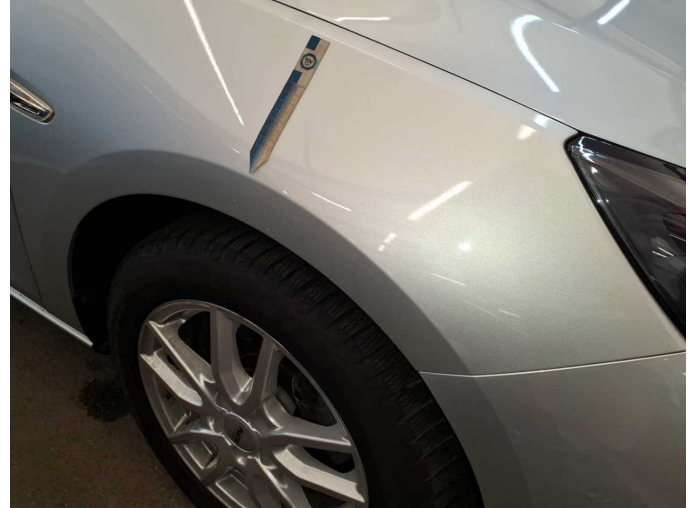
Wear and tear 5: Mudguard - right side: Mudguard - right side - Scratch(es) - No deduction

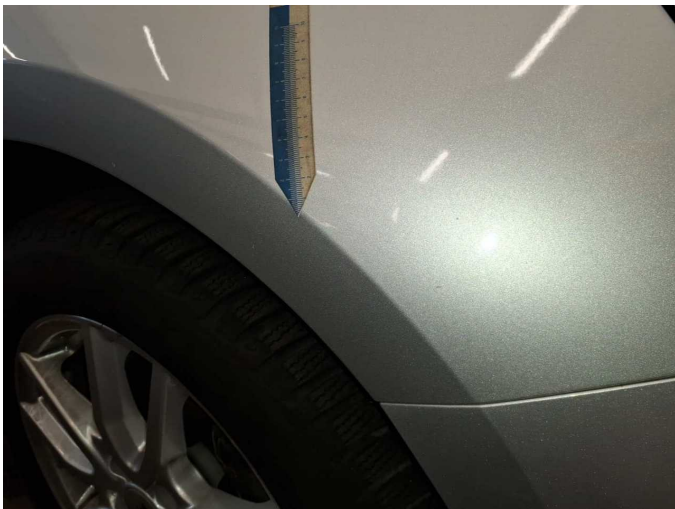
Wear and tear 5: Mudguard - right side: Mudguard - right side - Scratch(es) - No deduction

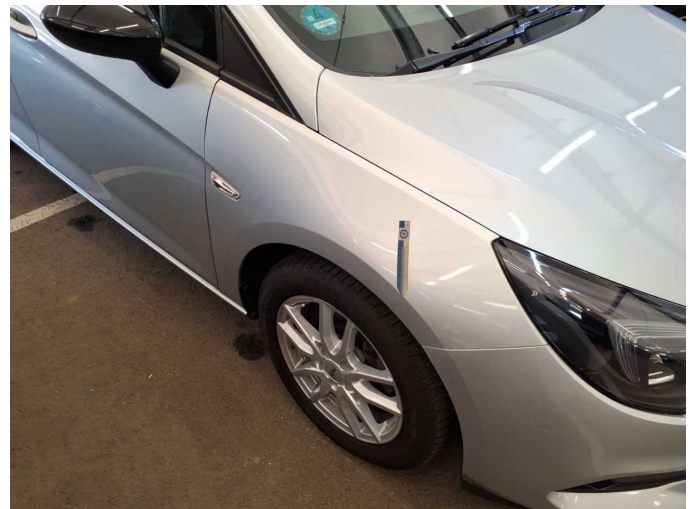
Wear and tear 5: Mudguard - right side: Mudguard - right side - Scratch(es) - No deduction

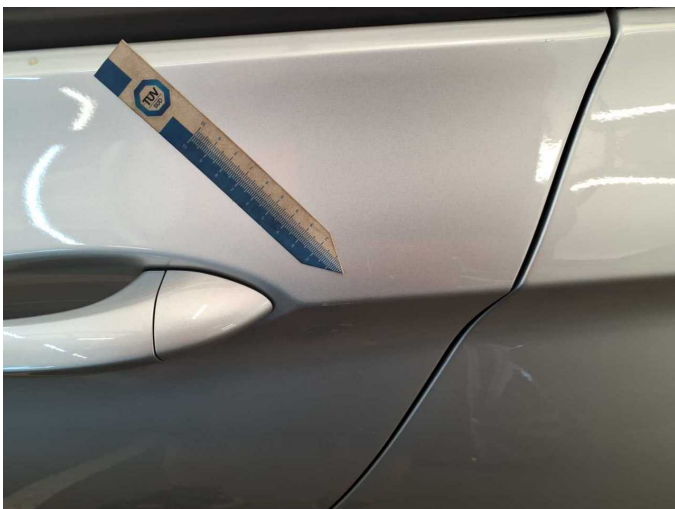
Wear and tear 6: Door - rear left side: Door - Scratch(es) - No deduction

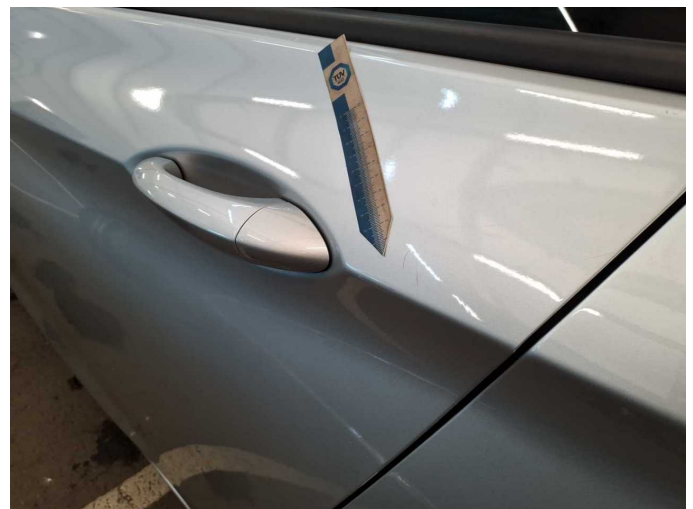
Wear and tear 6: Door - rear left side: Door - Scratch(es) - No deduction

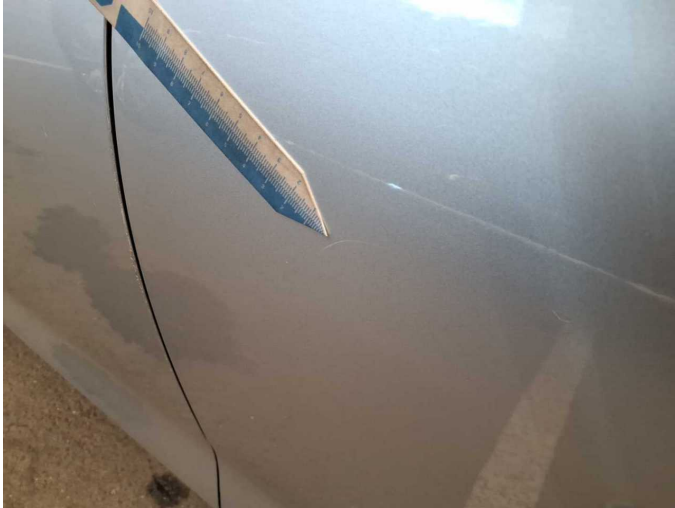
Wear and tear 6: Door - rear left side: Door - Scratch(es) - No deduction

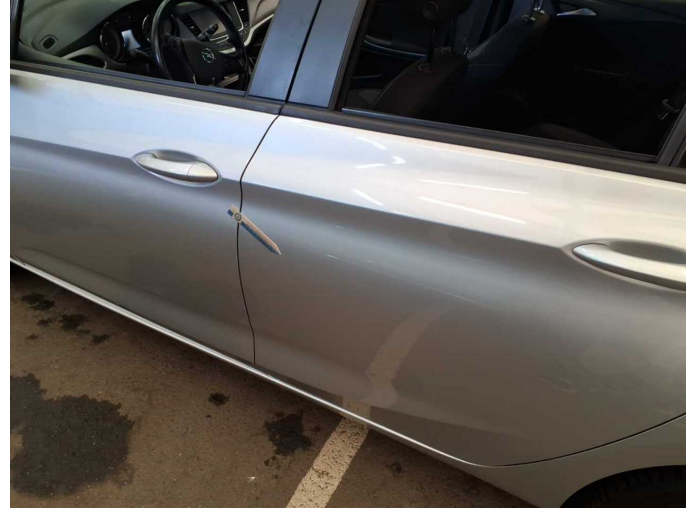
Wear and tear 6: Door - rear left side: Door - Scratch(es) - No deduction

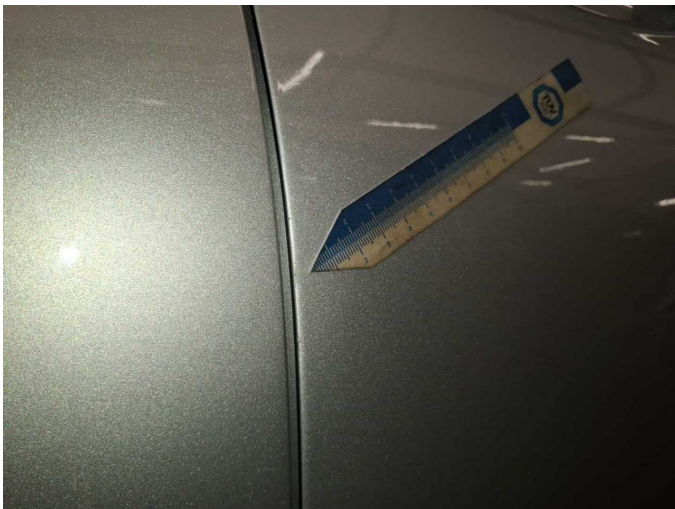
Wear and tear 7: Door - front right side: Door - Scratch(es) - No deduction

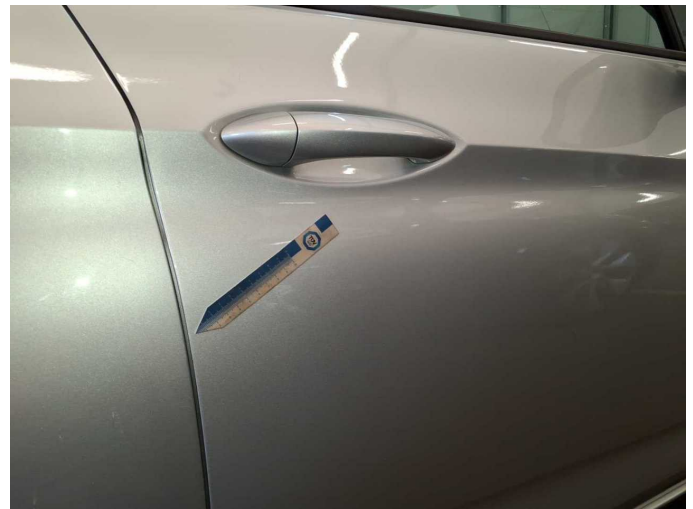
Wear and tear 7: Door - front right side: Door - Scratch(es) - No deduction

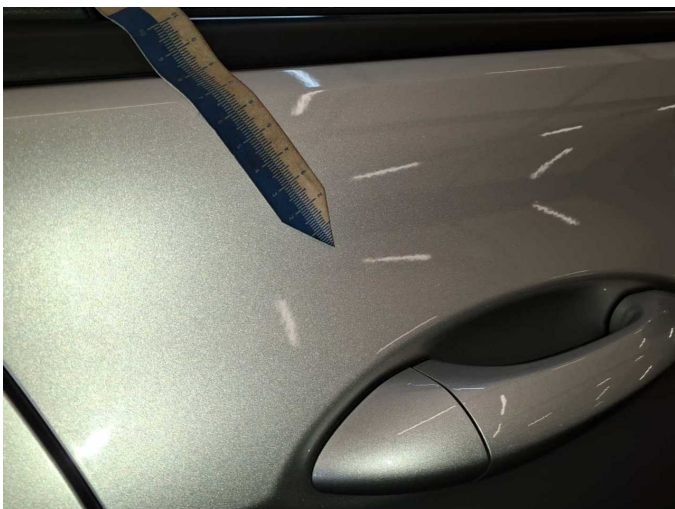
Wear and tear 7: Door - front right side: Door - Scratch(es) - No deduction

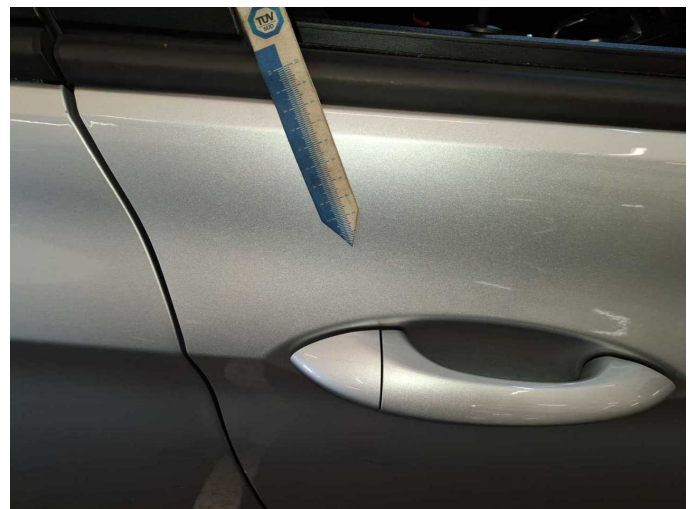
Wear and tear 7: Door - front right side: Door - Scratch(es) - No deduction

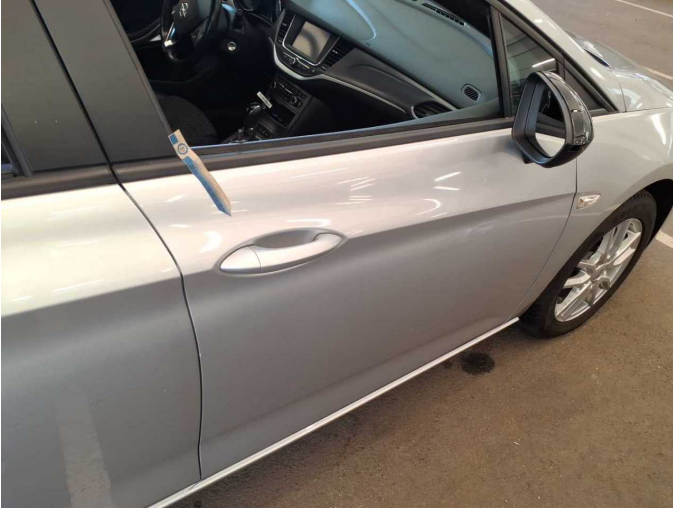
Wear and tear 7: Door - front right side: Door - Scratch(es) - No deduction
