Expertise

Protocol number: 46256837
Order No. / Reference: 26300799
Inspection date: 23 Jun 2026

Model: Transit Connect 210 L2 S&S Trend

VIN: WF0SXXWPGSMK86953

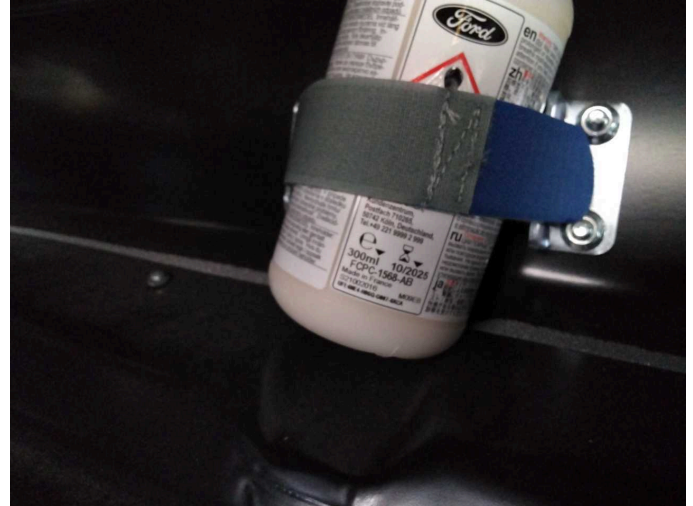
Damage 1: Equipment: Tirefit filler - Expired - Replace

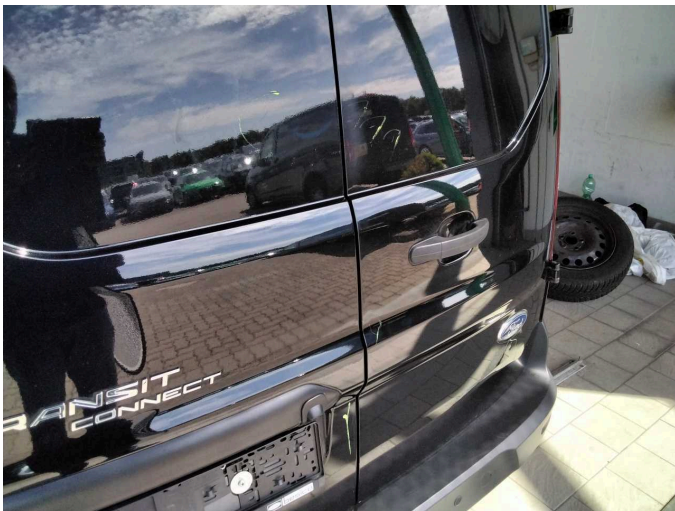
Damage 2: Boot lid / rear door: Rear door - left side - Scratch(es) - Smart repair

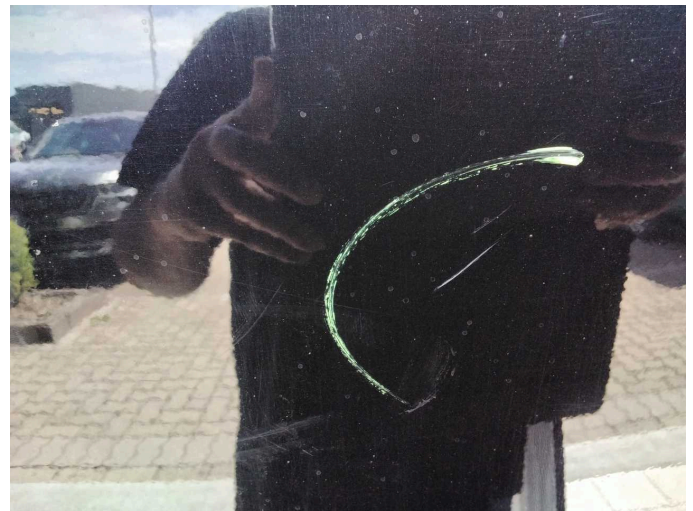
Damage 2: Boot lid / rear door: Rear door - left side - Scratch(es) - Smart repair

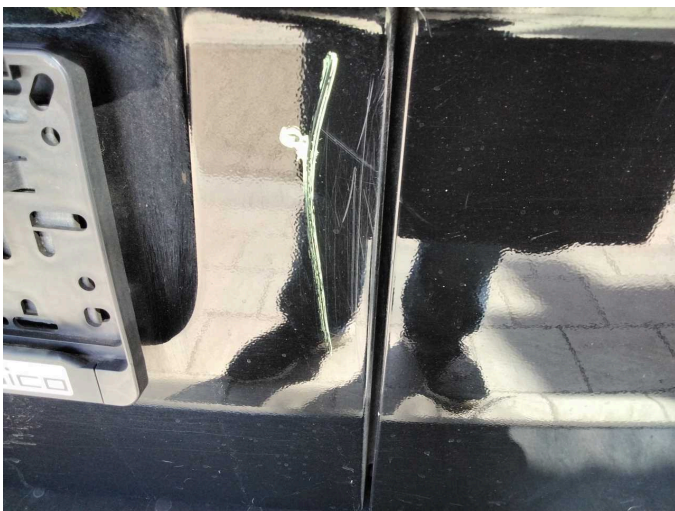
Damage 2: Boot lid / rear door: Rear door - left side - Scratch(es) - Smart repair

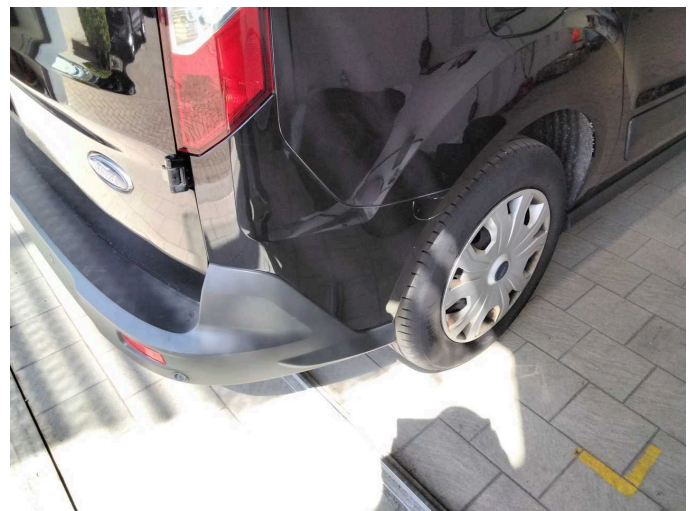
Damage 3: Rear bumper: Bumper - rear right side - Scratched - Smart repair

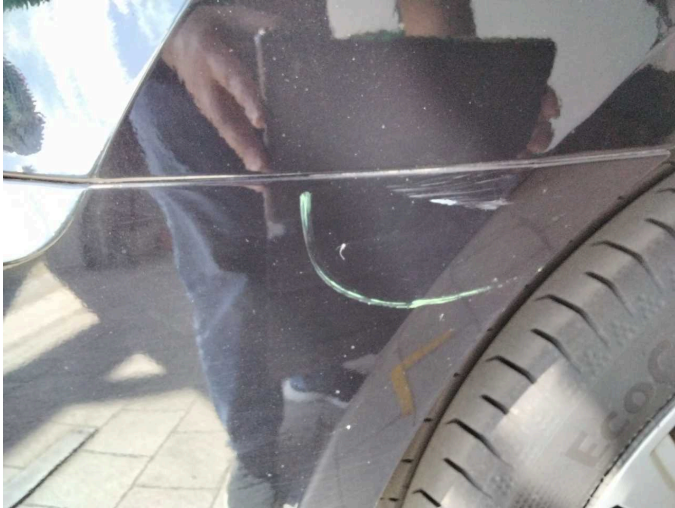
Damage 3: Rear bumper: Bumper - rear right side - Scratched - Smart repair

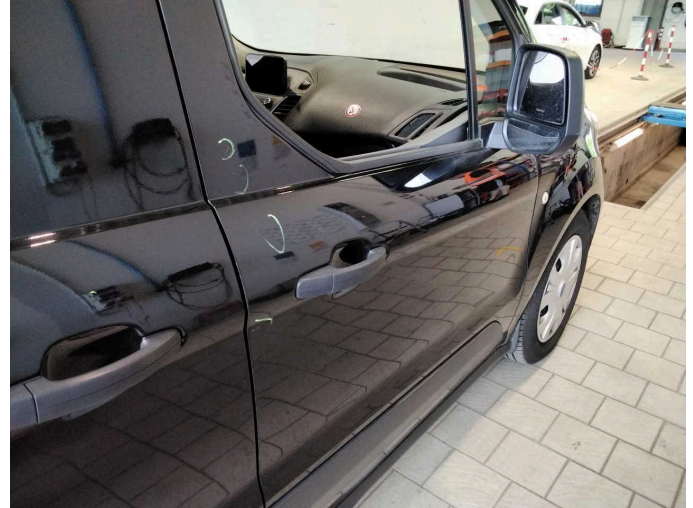
Damage 4: Door - front right side: Door - Scratch(es) - Paint

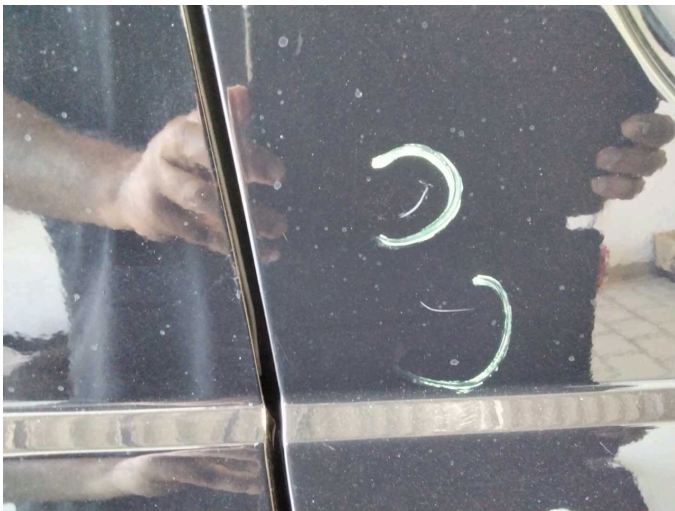
Damage 4: Door - front right side: Door - Scratch(es) - Paint

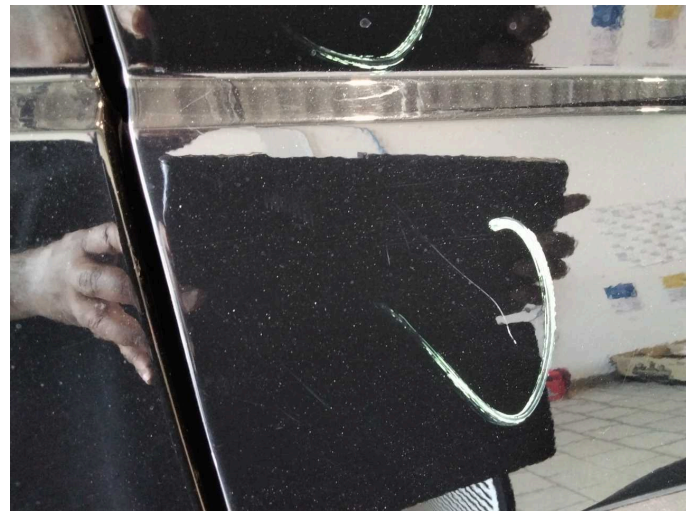
Damage 4: Door - front right side: Door - Scratch(es) - Paint

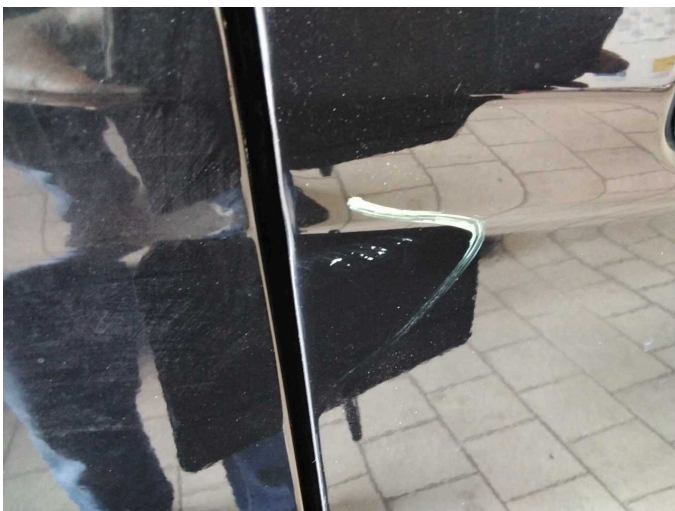
Damage 4: Door - front right side: Door - Scratch(es) - Paint

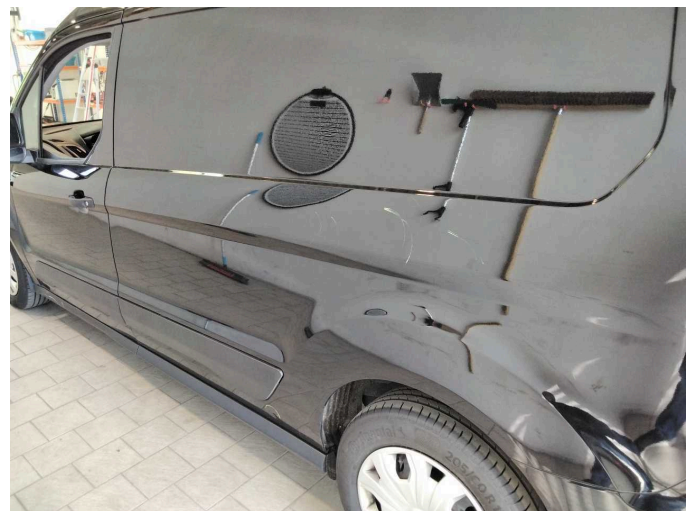
Damage 5: Side panel - rear left side: Side panel - Dent / paintcoat damage - Repair and paint

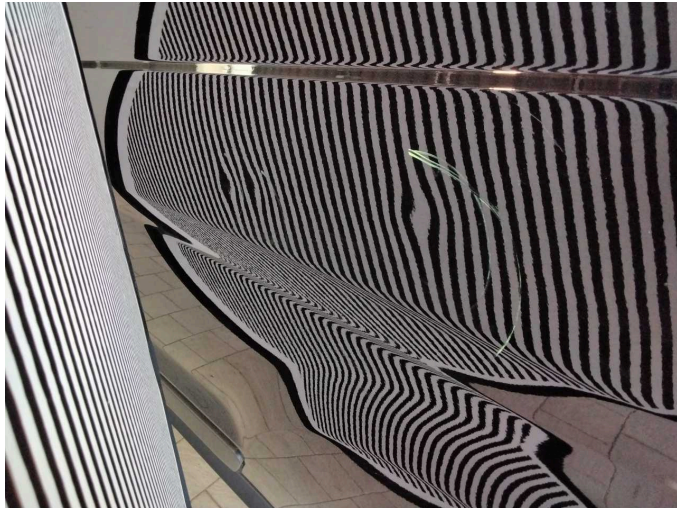
Damage 5: Side panel - rear left side: Side panel - Dent / paintcoat damage - Repair and paint

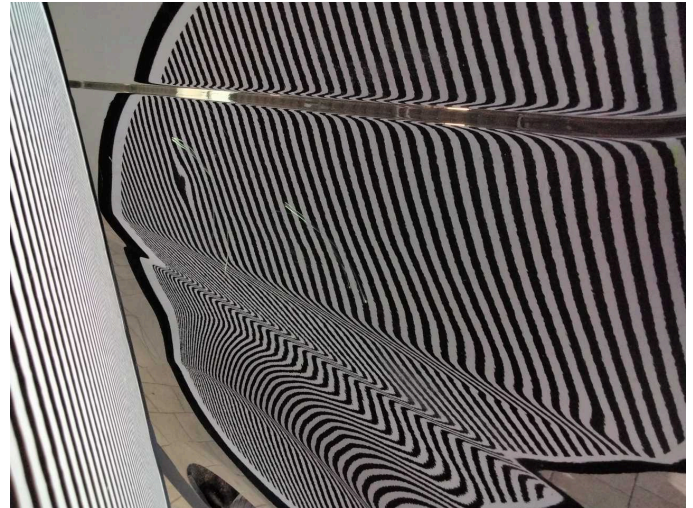
Damage 5: Side panel - rear left side: Side panel - Dent / paintcoat damage - Repair and paint

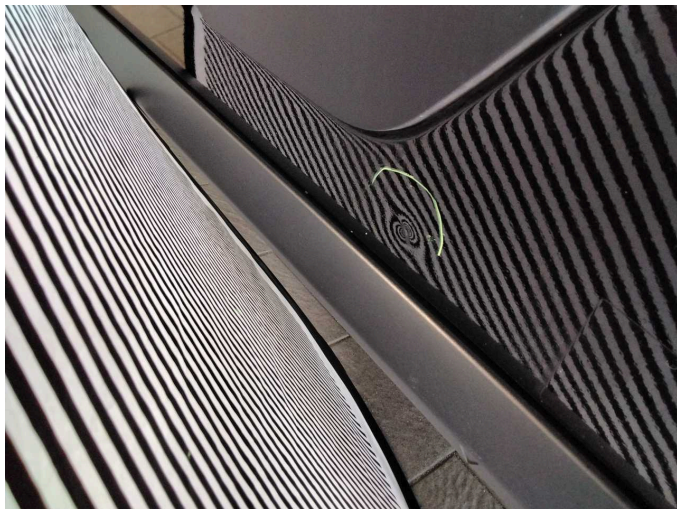
Damage 5: Side panel - rear left side: Side panel - Dent / paintcoat damage - Repair and paint

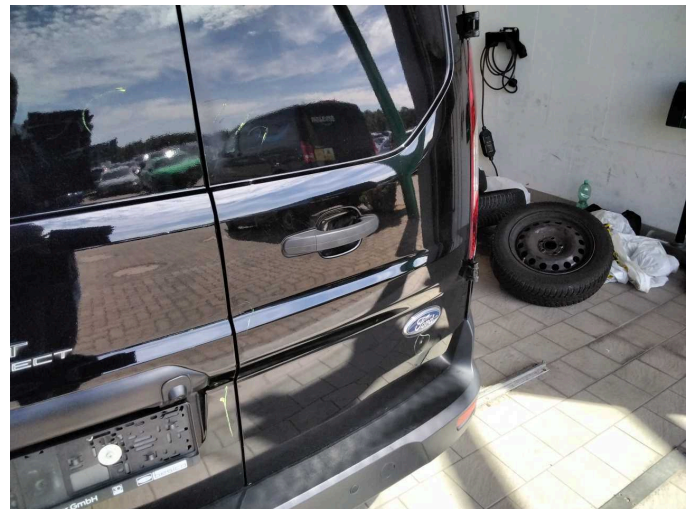
Damage 6: Boot lid / rear door: Rear door - right side - Dent / paintcoat damage - Repair and paint

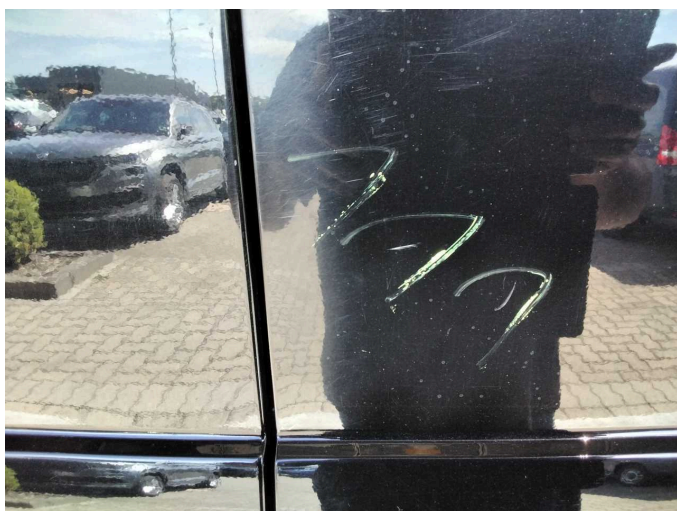
Damage 6: Boot lid / rear door: Rear door - right side - Dent / paintcoat damage - Repair and paint

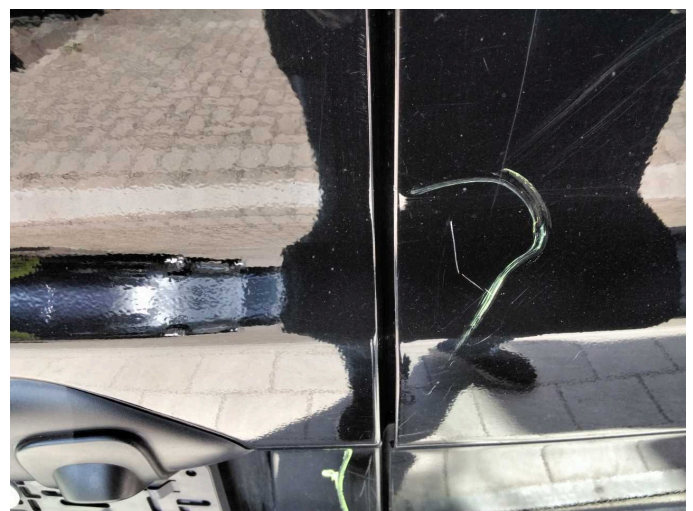
Damage 6: Boot lid / rear door: Rear door - right side - Dent / paintcoat damage - Repair and paint

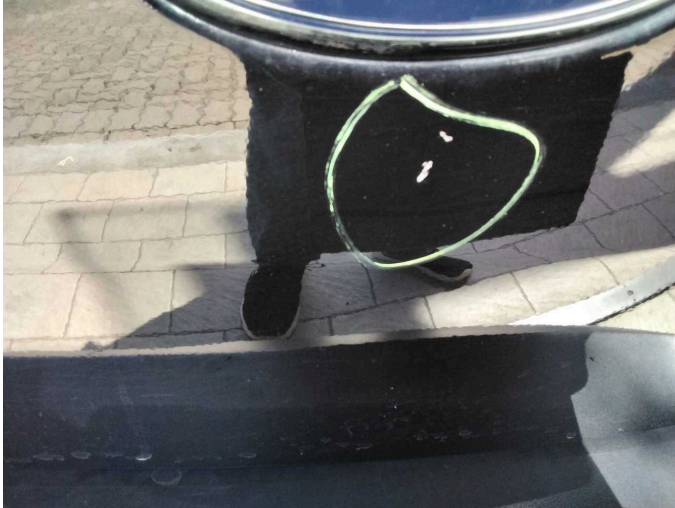
Damage 6: Boot lid / rear door: Rear door - right side - Dent / paintcoat damage - Repair and paint

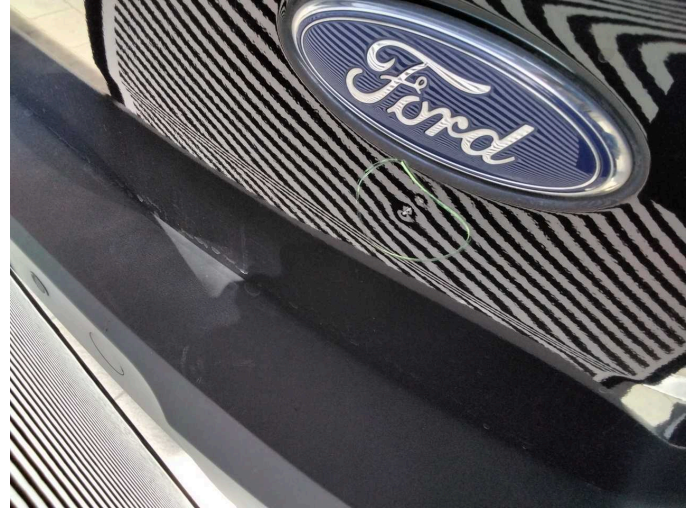
Damage 6: Boot lid / rear door: Rear door - right side - Dent / paintcoat damage - Repair and paint

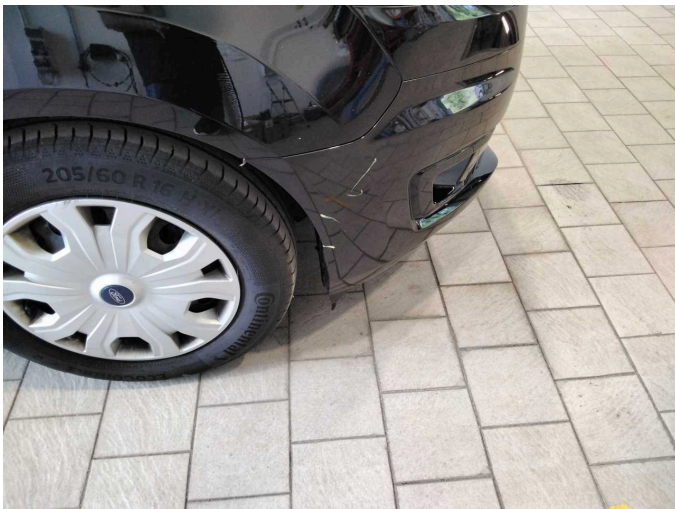
Wear and tear 4: Front bumper: Front bumper - dent(s) - No deduction

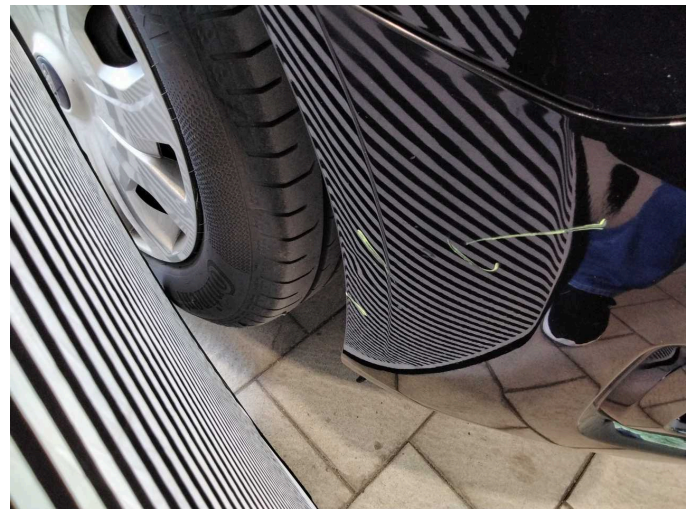
Wear and tear 4: Front bumper: Front bumper - dent(s) - No deduction

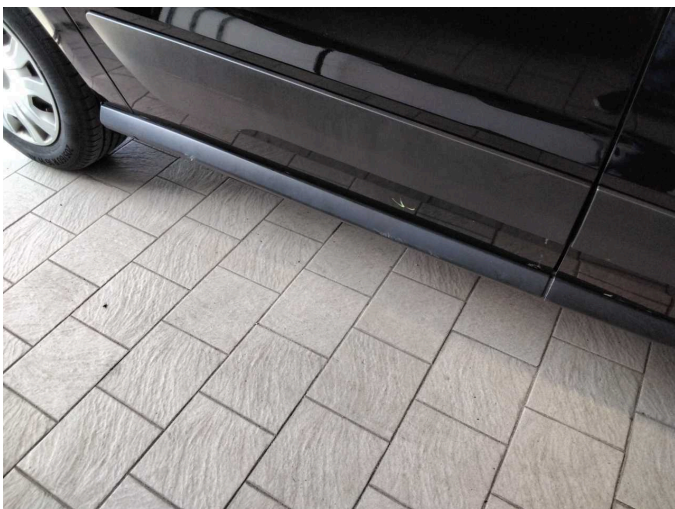
Wear and tear 6: Sill - right side: Trim - Scratch(es) - No deduction

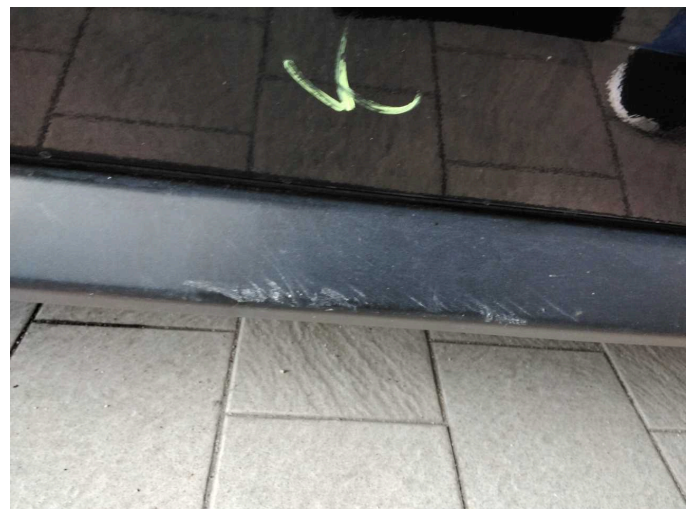
Wear and tear 6: Sill - right side: Trim - Scratch(es) - No deduction

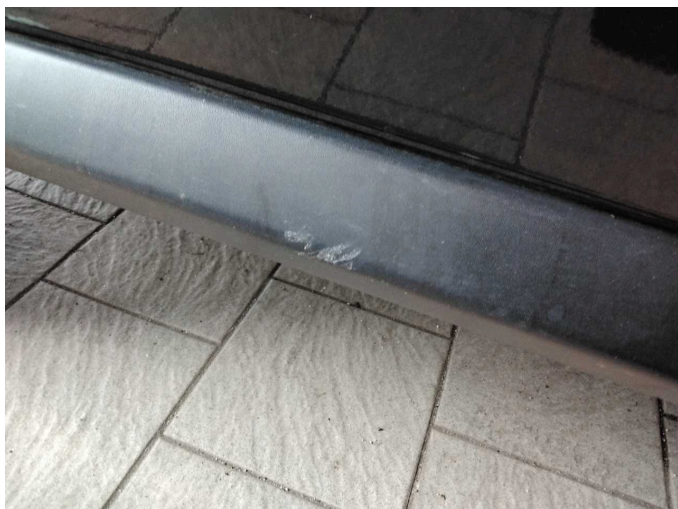
Wear and tear 6: Sill - right side: Trim - Scratch(es) - No deduction
