Expertise

Protocol number: 46541992  
Order No. / Reference: 26621348  
Inspection date: 14 Jul 2026

Model: Vito 110 CDI Kompakt HA BASE

VIN: W1V44760114123609

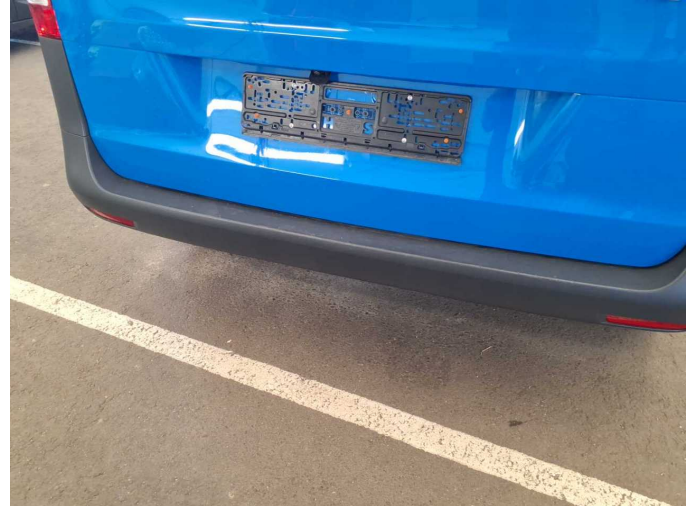
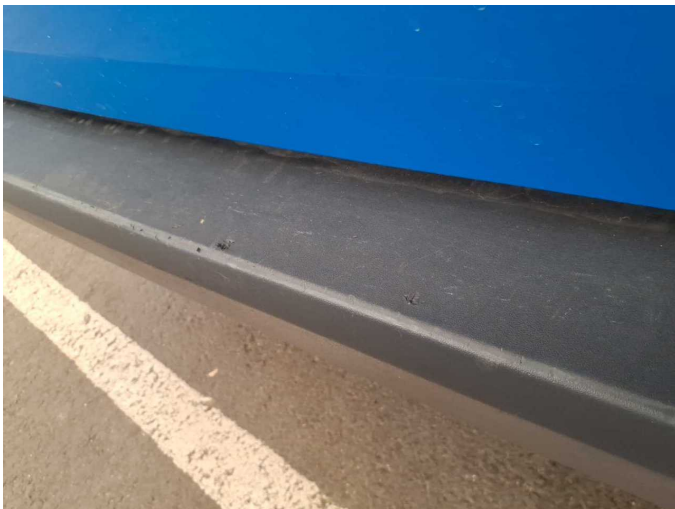
| No. | Component group | Description |
|---|---|---|
| 1 | Rear bumper | Rear bumper (Unlackiertes Kunststoffbauteil) - Scratch(es) - Loss in value |

**Damage 1:** Rear bumper: Rear bumper (Unlackiertes Kunststoffbauteil) - Scratch(es) - Loss in value

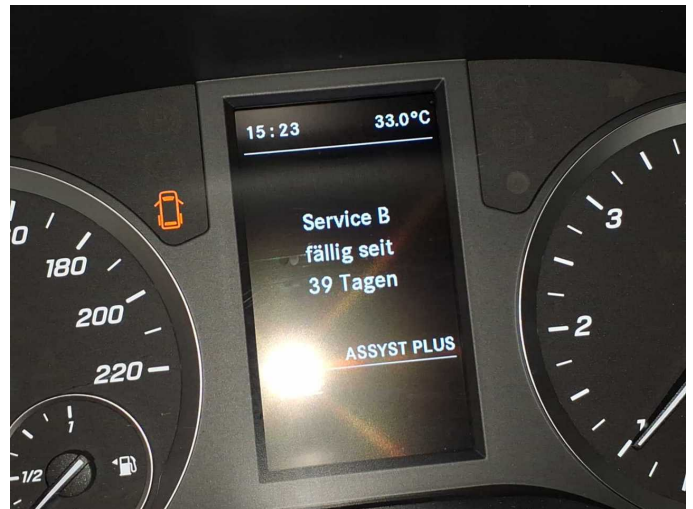
| No. | Component group | Description |
|---|---|---|
| 2 | Misc. | Inspection / maintenance (Service B) - Due - Perform |

**Damage 2:** Misc.: Inspection / maintenance (Service B) - Due - Perform

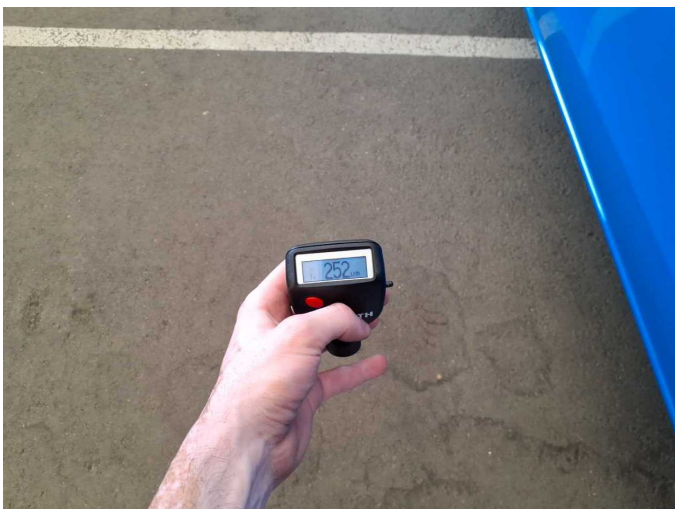
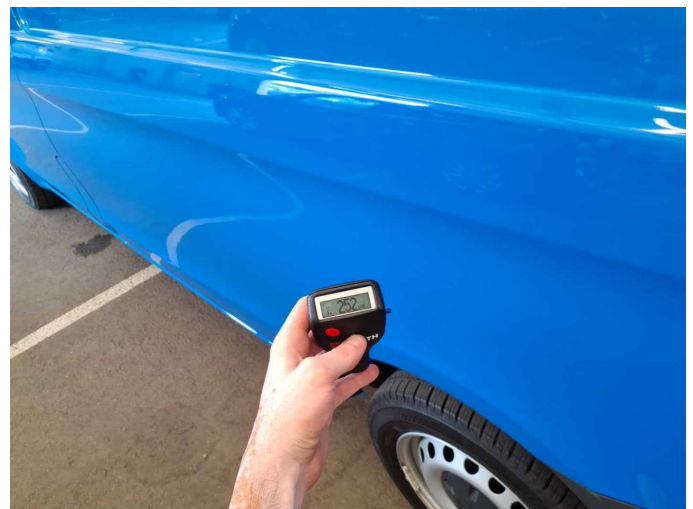
1 Side panel - rear left side, Professionally carried out, Invoice of repair done Non-existent

Side panel - rear left side 252 µm |

**Repainting 1:** Side panel - rear left side
