Expertise

Protocol number: 46569326  
Order No. / Reference: 26723462  
Inspection date: 15 Jul 2026

Manufacturer: Volkswagen

Model: Caddy Cargo 2.0 TDI BMT DSG Maxi

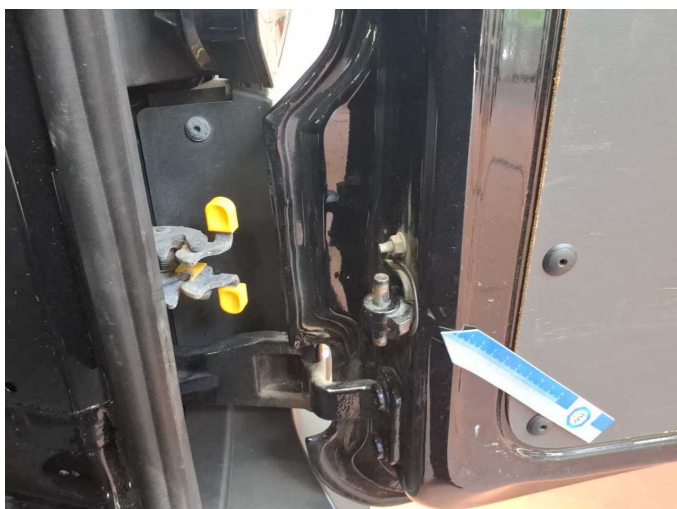
| No. | Component group | Description |
|---|---|---|
| 1 | Boot lid / rear door | Rear door glazed - right side (Lässt sich nicht bewegen) - Malposition - Diagnosed and repair if necessary |

**Damage 1:** Boot lid / rear door: Rear door glazed - right side (Lässt sich nicht bewegen) - Malposition - Diagnosed and repair if necessary

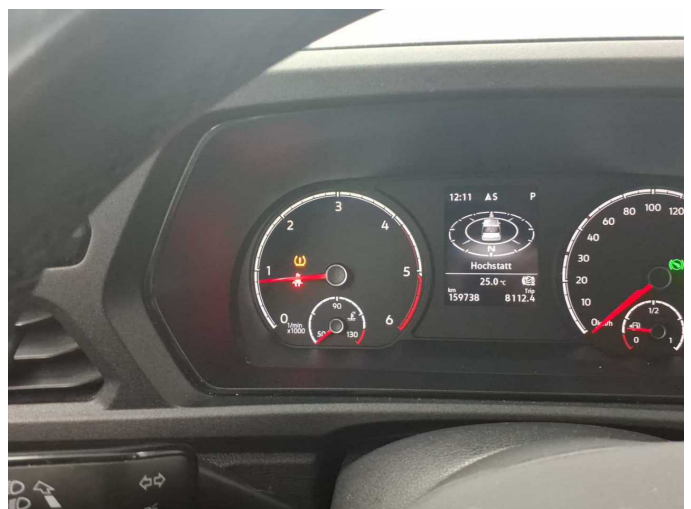
| No. | Component group | Description |
|---|---|---|
| 2 | Instrument panel | Indicator light (RDKS) - on - Diagnosed and repair if necessary |

**Damage 2:** Instrument panel: Indicator light (RDKS) - on - Diagnosed and repair if necessary

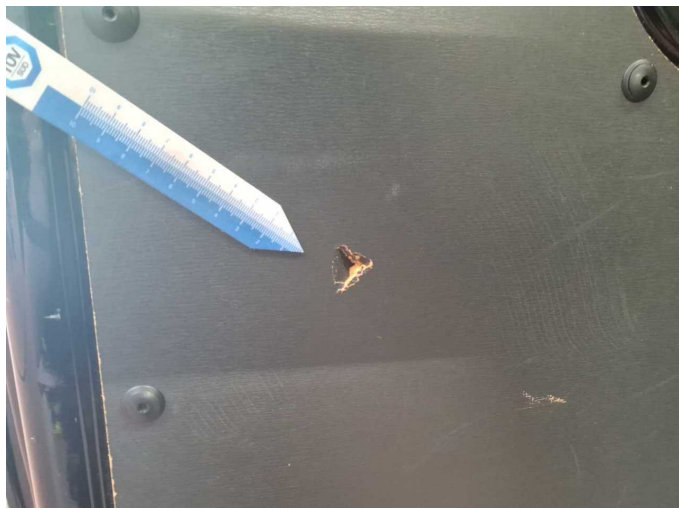
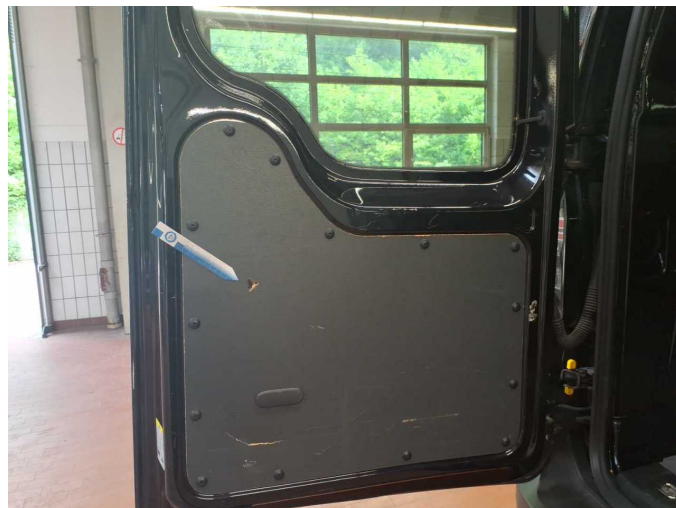
| No. | Component group | Description |
|---|---|---|
| 3 | Boot lid / rear door | Trim rear door - plywood - lower - Broken / torn - Replace |

**Damage 3:** Boot lid / rear door: Trim rear door - plywood - lower - Broken / torn - Replace

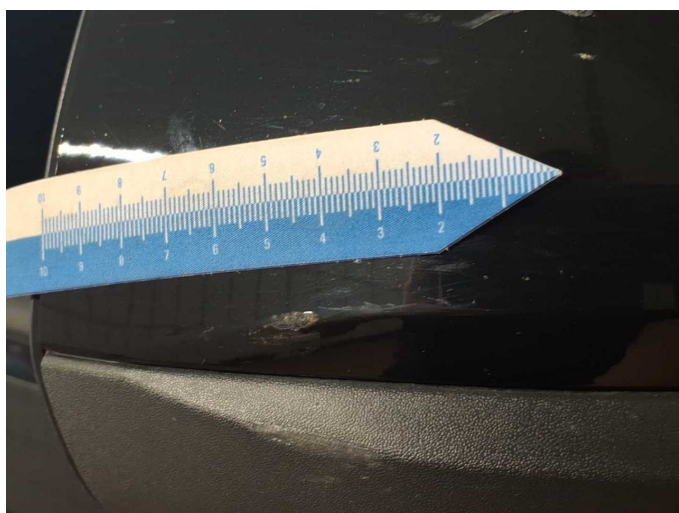
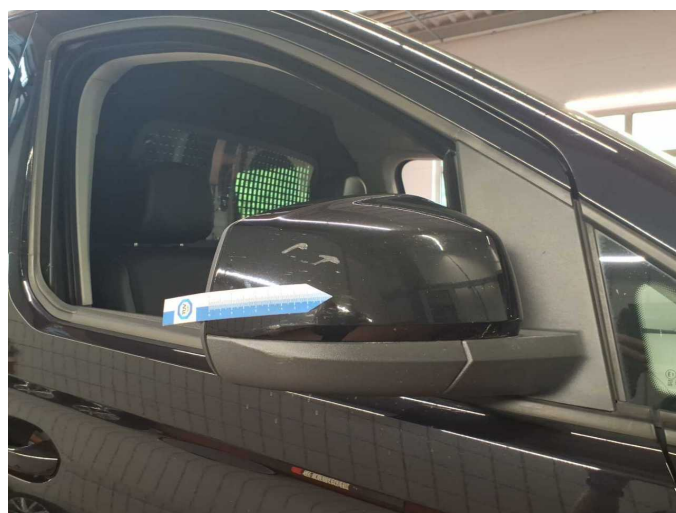
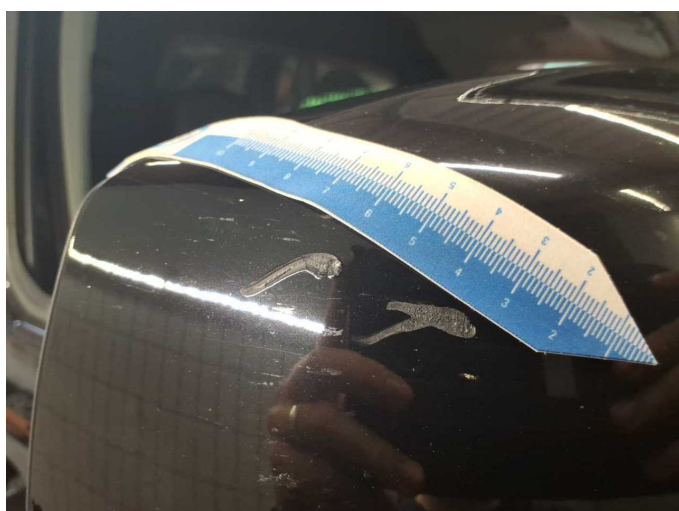
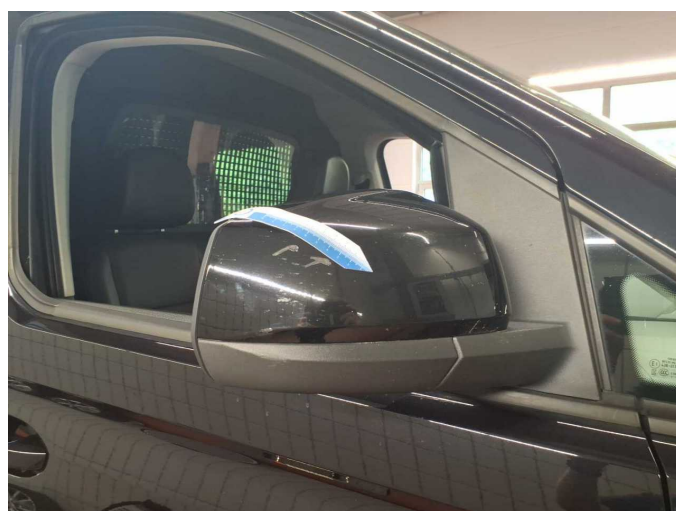
| No. | Component group | Description |
|---|---|---|
| 4 | Wing mirror - right side | Cap - Scratched - Replace |

**Damage 4:** Wing mirror - right side: Cap - Scratched - Replace

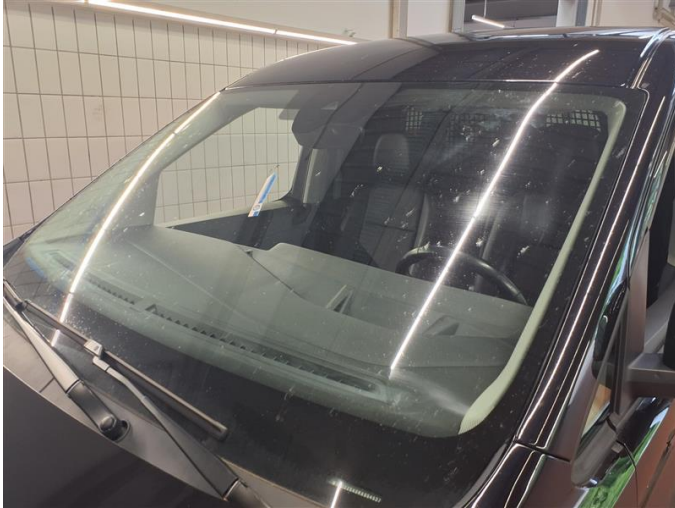
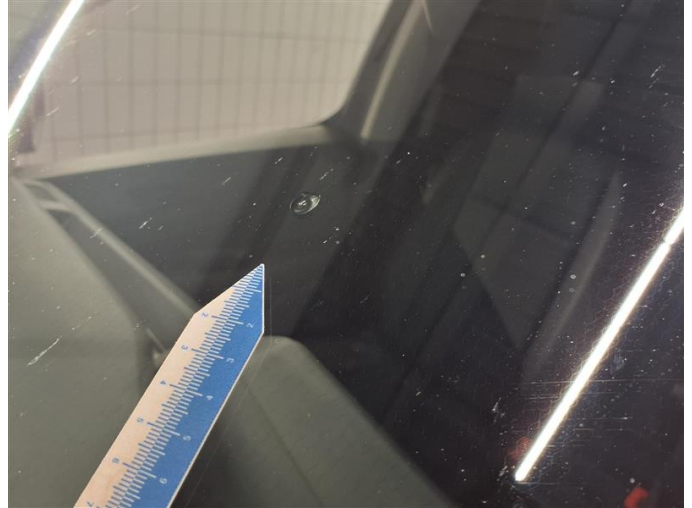
| No. | Component group | Description |
|---|---|---|
| 5 | Vehicle glazing | Windscreen - Stone chips - Smart repair |

**Damage 5:** Vehicle glazing: Windscreen - Stone chips - Smart repair

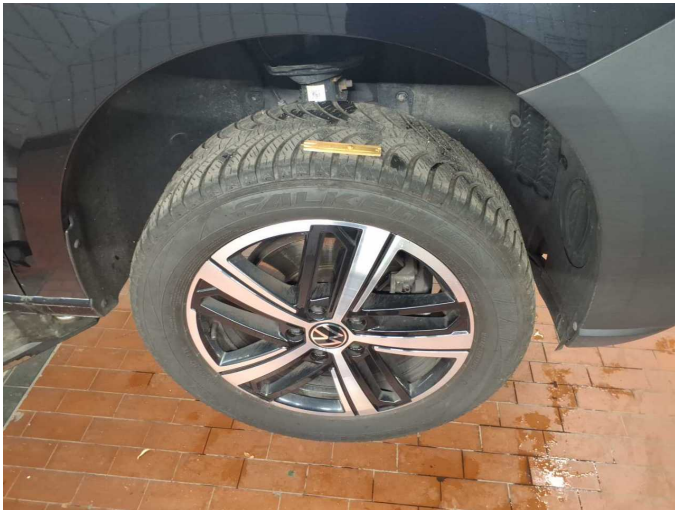
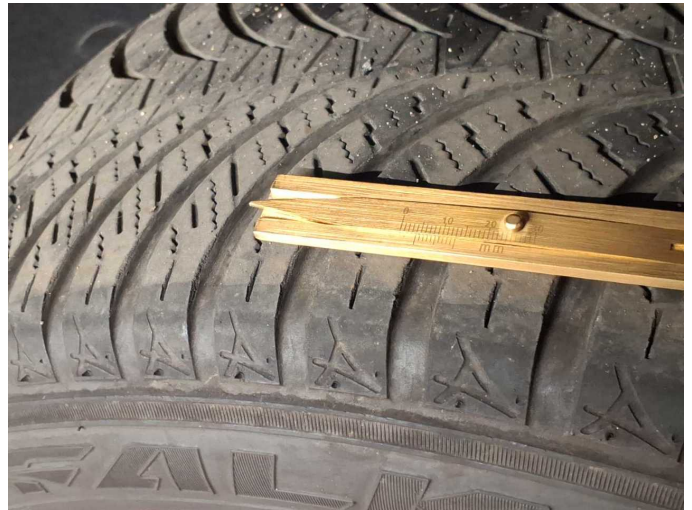
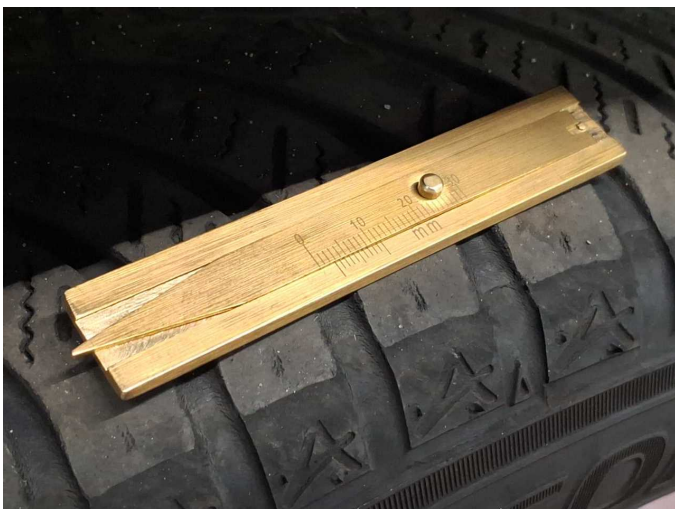
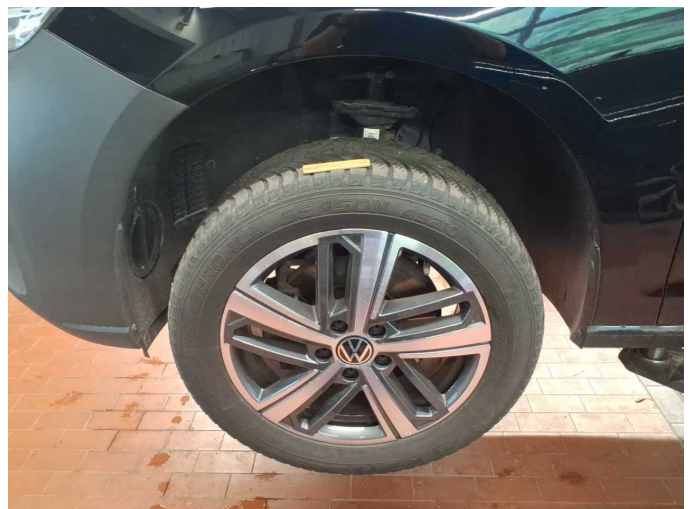
| # | Tyre size | Type of tyre | Manufacturer | Tread depth |
|---|---|---|---|---|
| 1) | 215/55 R17 98V | All-season tyres on Light alloy | Falken | 3mm / 4mm |

| No. | Component group | Description |
|---|---|---|
| 6 | Wheel / tyres | Tyre - front (Unter 4mm) - Does not meet the leasing specifications - Replace |

**Damage 6:** Wheel / tyres: Tyre - front (Unter 4mm) - Does not meet the leasing specifications - Replace

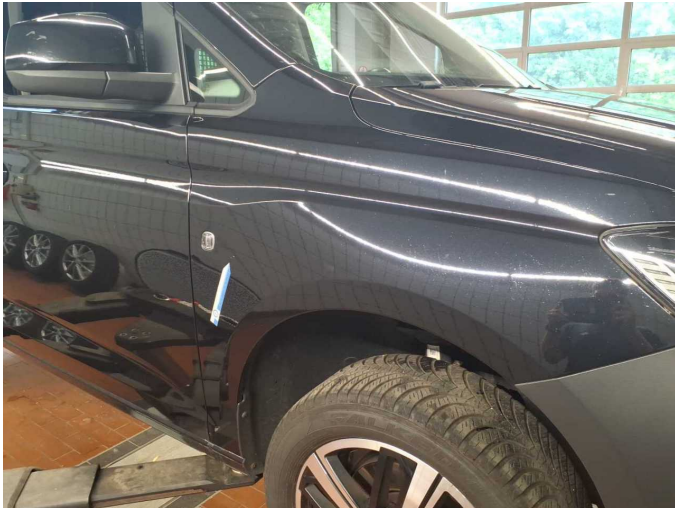
| No. | Component group | Description |
|---|---|---|
| 1 | Mudguard - right side | Mudguard - right side - Scratch(es) - No deduction |

**Wear and tear 1:** Mudguard - right side: Mudguard - right side - Scratch(es) - No deduction

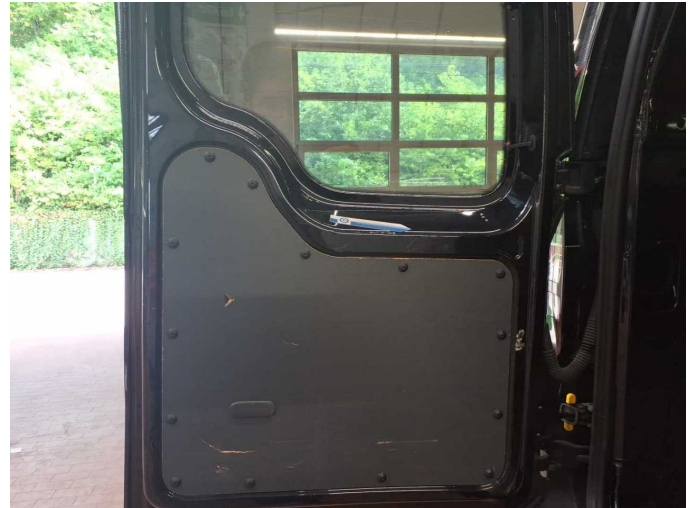
| No. | Component group | Description |
|---|---|---|
| 3 | Boot lid / rear door | Rear door - left side - Scratch(es) - No deduction |

**Wear and tear 3:** Boot lid / rear door: Rear door - left side - Scratch(es) - No deduction

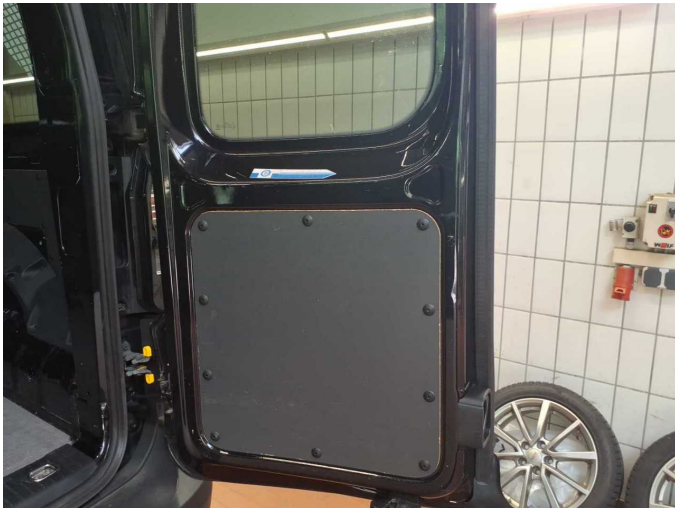
| No. | Component group | Description |
|---|---|---|
| 4 | Boot lid / rear door | Rear door - right side - Dent / paintcoat damage - No deduction |

**Wear and tear 4:** Boot lid / rear door: Rear door - right side - Dent / paintcoat damage - No deduction

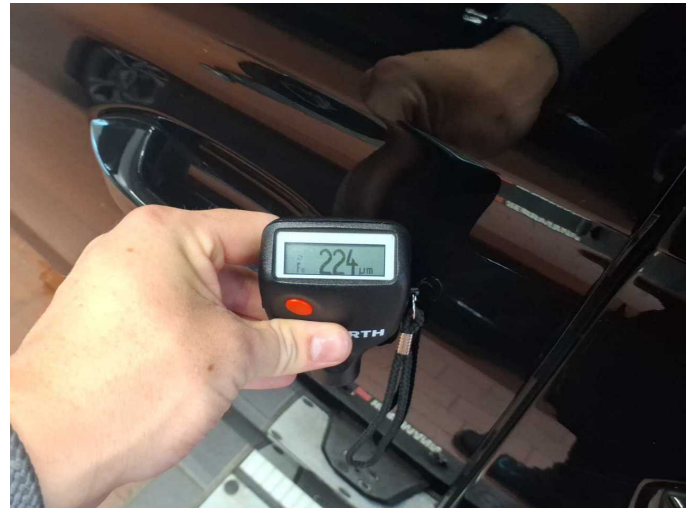
1 Door - front left side, Professionally carried out, Invoice of repair done Non-existent

Door - front left side 224 µm |

**Repainting 1:** Door - front left side
