## Expertise

Protocol number: 46341781  
Order No. / Reference: 26611977  
Inspection date: 2 Jul 2026

Manufacturer: Opel

Model: Combo Life 1.5 D Start/Stop Edition

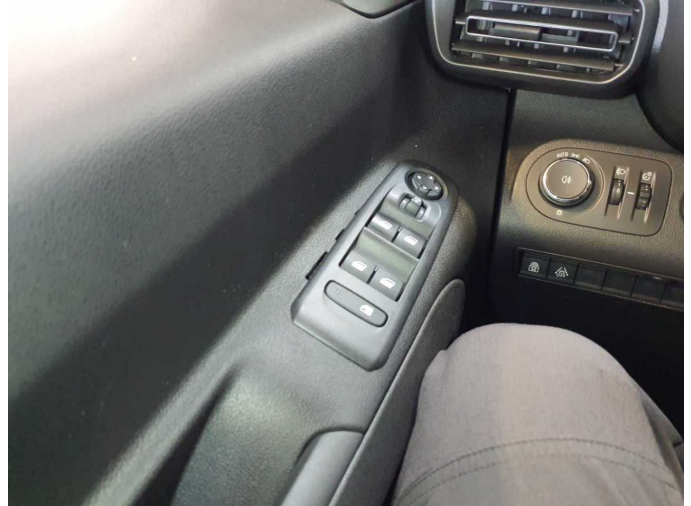
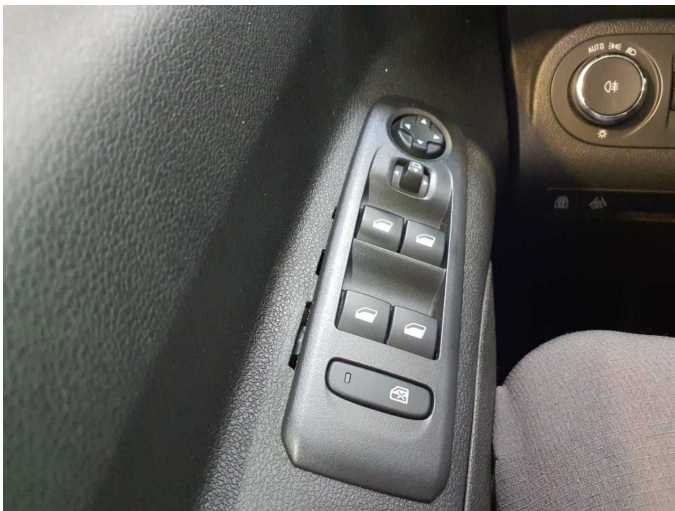
| No. | Component group | Description |
|---|---|--|
| 1 | Trim / covers | Door trim - front left side - Malposition - Diagnosed and repair if necessary |

Damage 1: Trim / covers: Door trim - front left side - Malposition - Diagnosed and repair if necessary

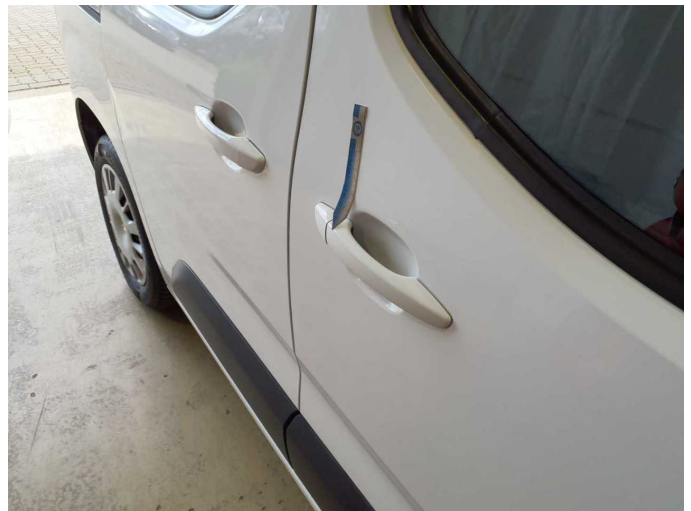
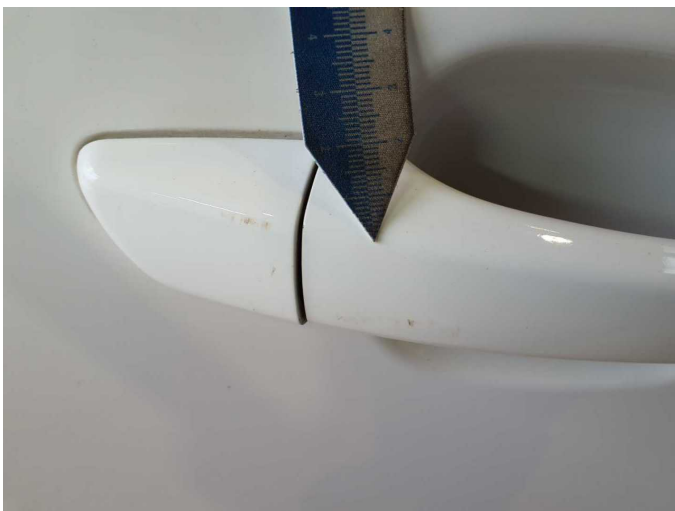
| No. | Component group | Description |
|---|---|--|
| 2 | Door - front right side | Door handle - outside - Scratch(es) - Smart repair |

Damage 2: Door - front right side: Door handle - outside - Scratch(es) - Smart repair

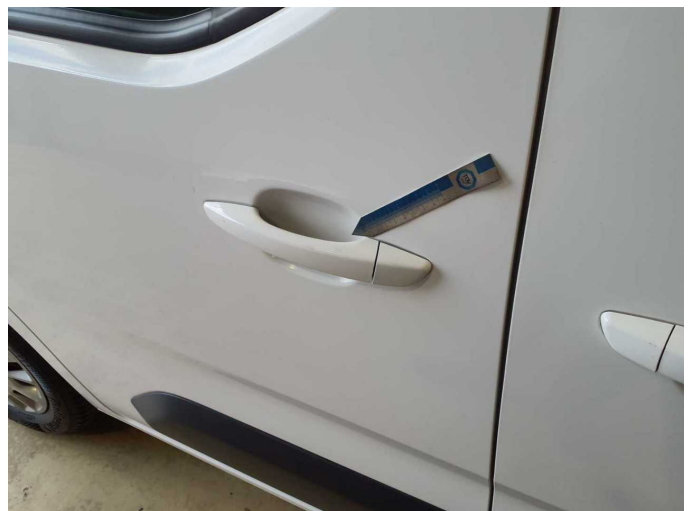
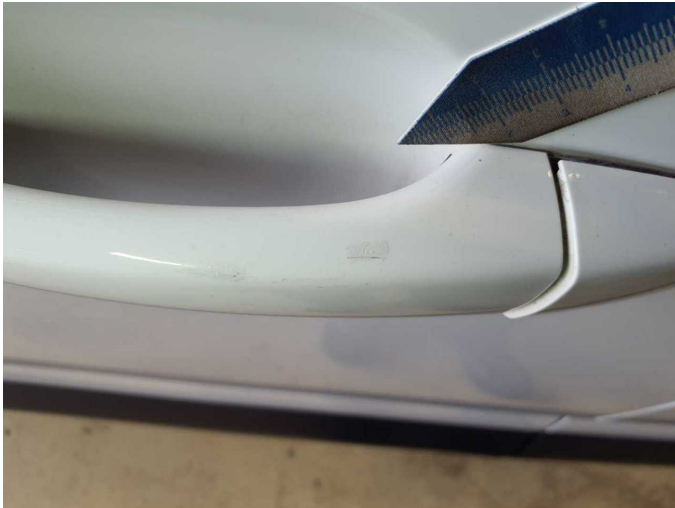
| No. | Component group | Description |
|---|---|--|
| 3 | Door - rear right side | Door handle - outside - Scratch(es) - Smart repair |

Damage 3: Door - rear right side: Door handle - outside - Scratch(es) - Smart repair

**Damage 3:** Door - rear right side: Door handle - outside - Scratch(es) - Smart repair

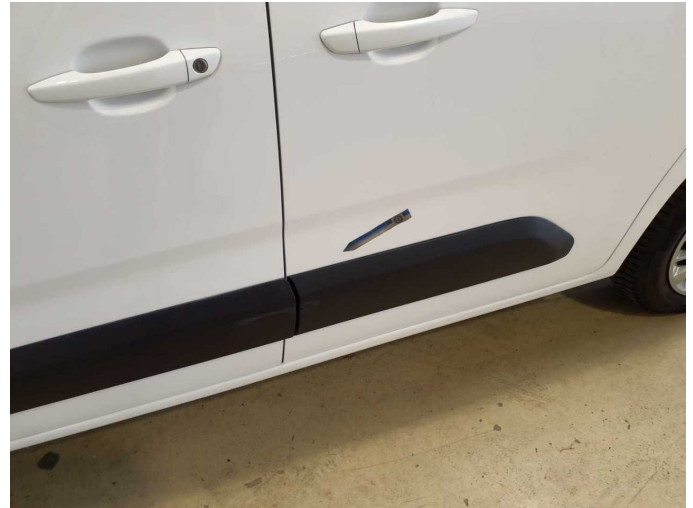
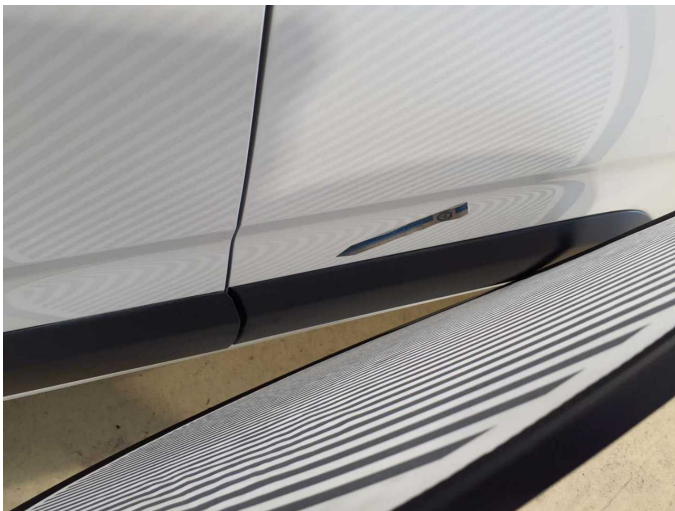
| No. | Component group | Description |
|---|---|--|
| 4 | Door - rear left side | Door - dent(s) - Smooth repair work |

**Damage 4:** Door - rear left side: Door - dent(s) - Smooth repair work

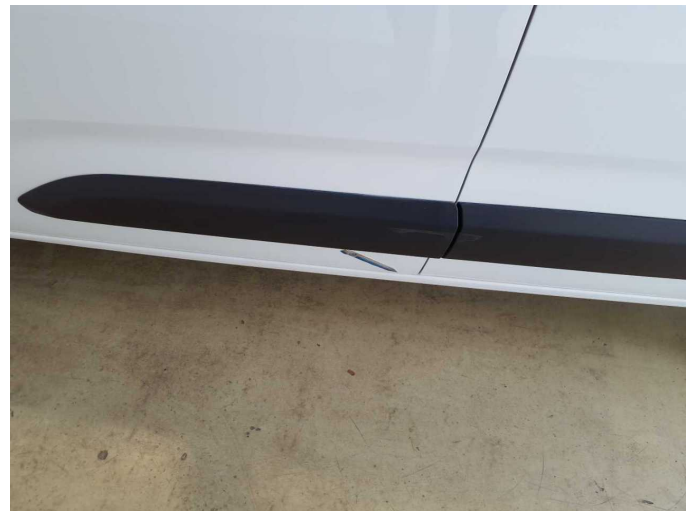
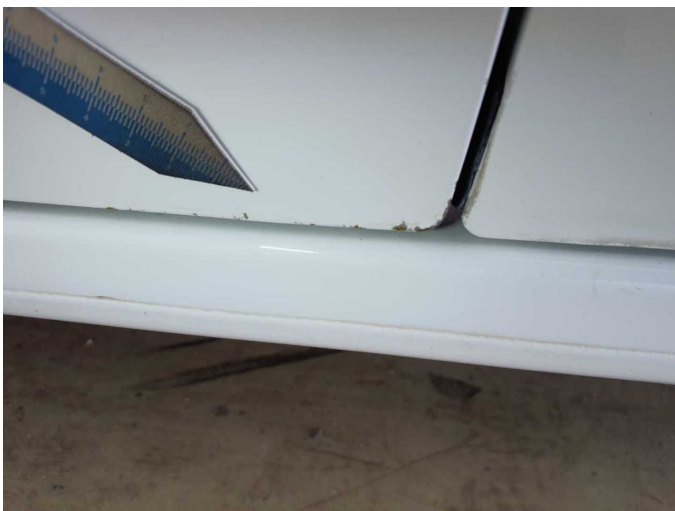
| No. | Component group | Description |
|---|---|--|
| 5 | Door - front left side | Door edge - Scratch(es) - Smart repair |

**Damage 5:** Door - front left side: Door edge - Scratch(es) - Smart repair

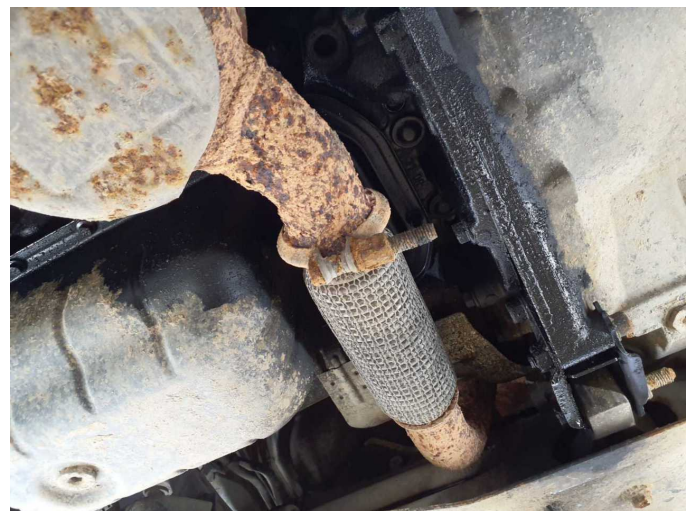
| No. | Component group | Description |
|---|---|--|
| 6 | Engine | Engine (Mehrkosten möglich) - Leaking - Perform diagnosis |

**Damage 6:** Engine: Engine (Mehrkosten möglich) - Leaking - Perform diagnosis

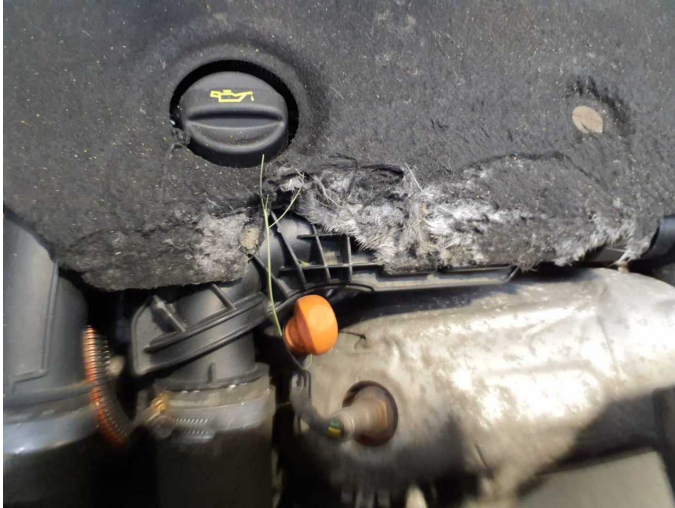
| No. | Component group | Description |
|---|---|--|
| 7 | Engine | Engine cover (Mehrkosten möglich) - Damage caused by marten / rodent - Replace |

**Damage 7:** Engine: Engine cover (Mehrkosten möglich) - Damage caused by marten / rodent - Replace

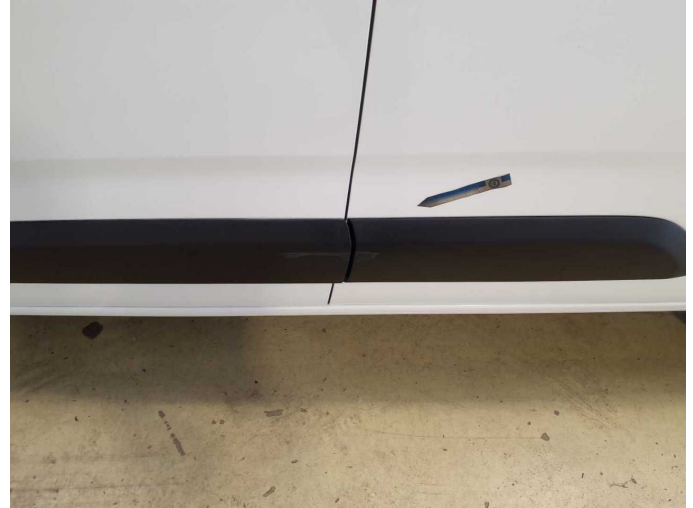
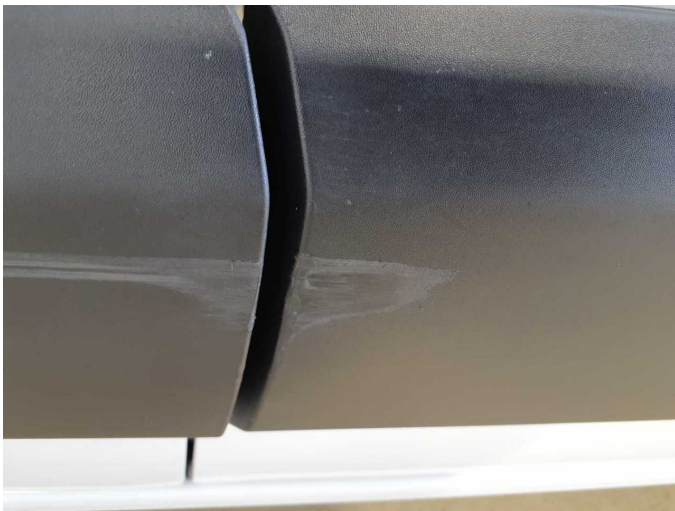
| No. | Component group | Description |
|---|---|--|
| 8 | Door - rear left side | Brightware - lower - Scratch(es) - Replace |

**Damage 8:** Door - rear left side: Brightware - lower - Scratch(es) - Replace

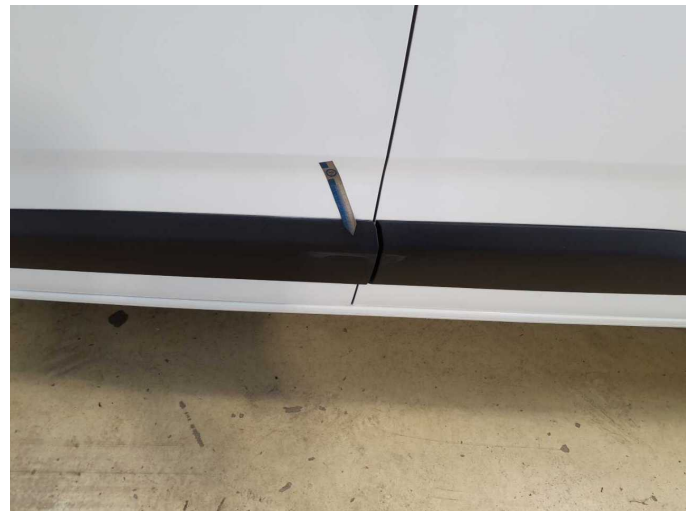
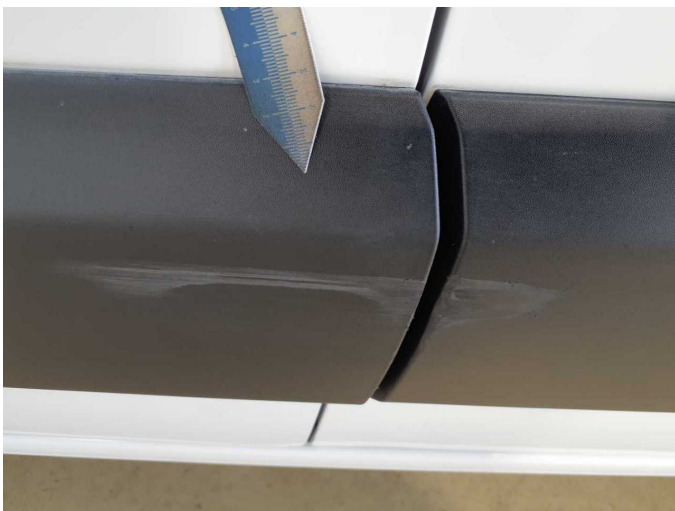
| No. | Component group | Description |
|---|---|--|
| 9 | Door - front left side | Brightware - lower - Scratch(es) - Replace |

**Damage 9:** Door - front left side: Brightware - lower - Scratch(es) - Replace

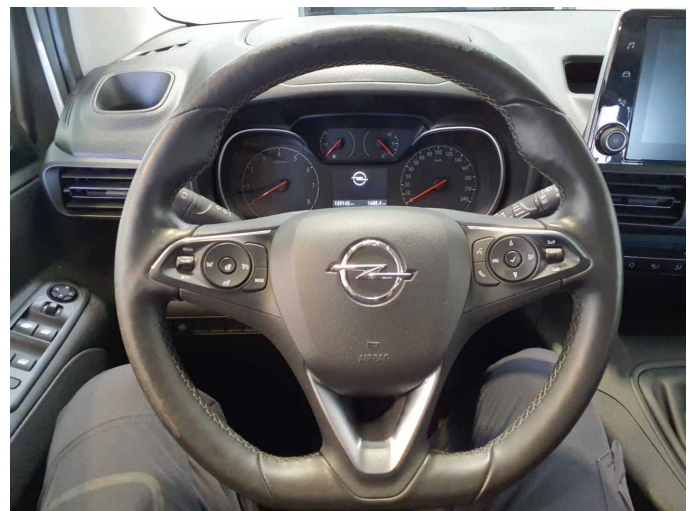
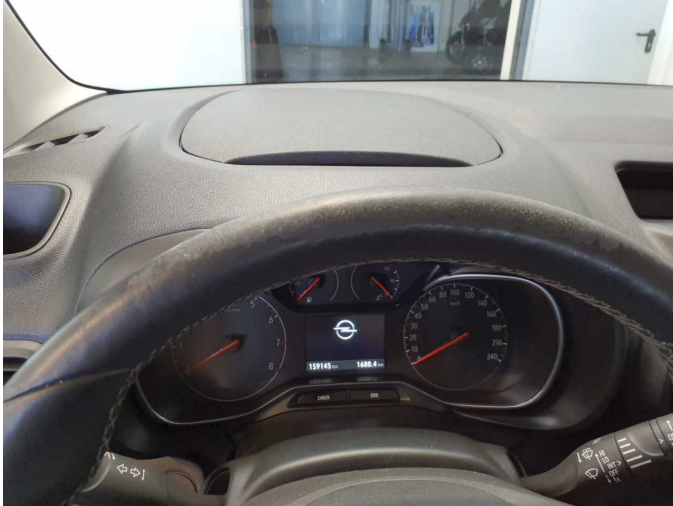
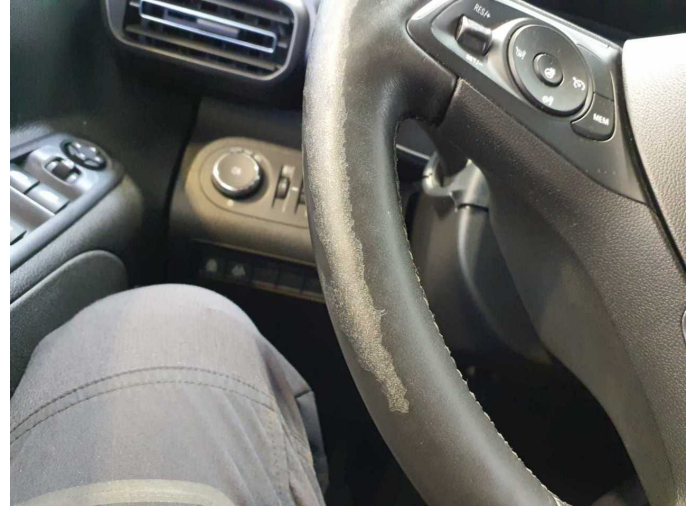
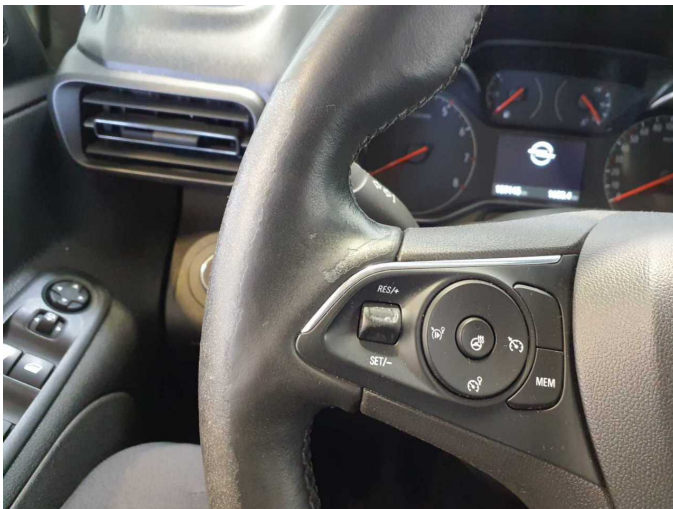
| No. | Component group | Description |
|---|---|--|
| 10 | Steering system | Steering wheel - Worn - Loss in value |

**Damage 10:** Steering system: Steering wheel - Worn - Loss in value

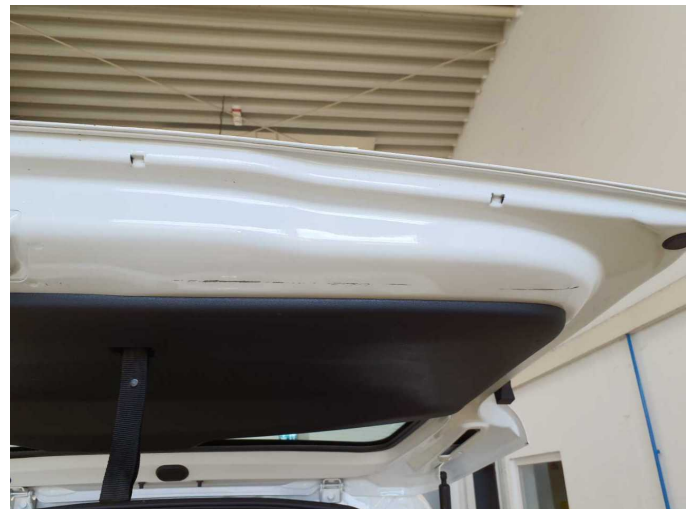
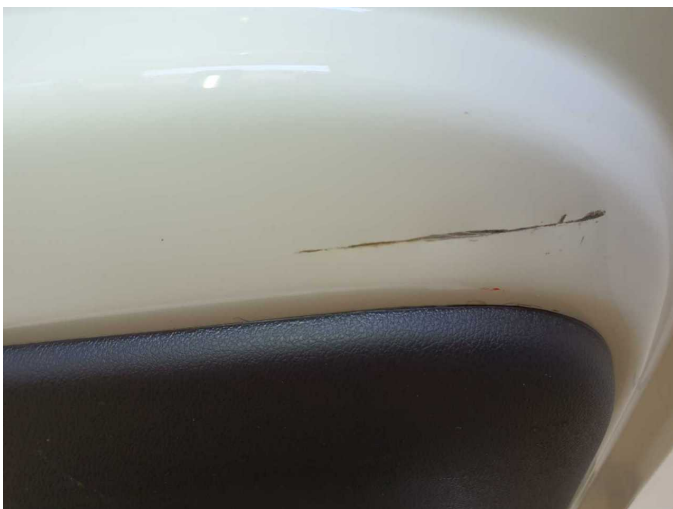
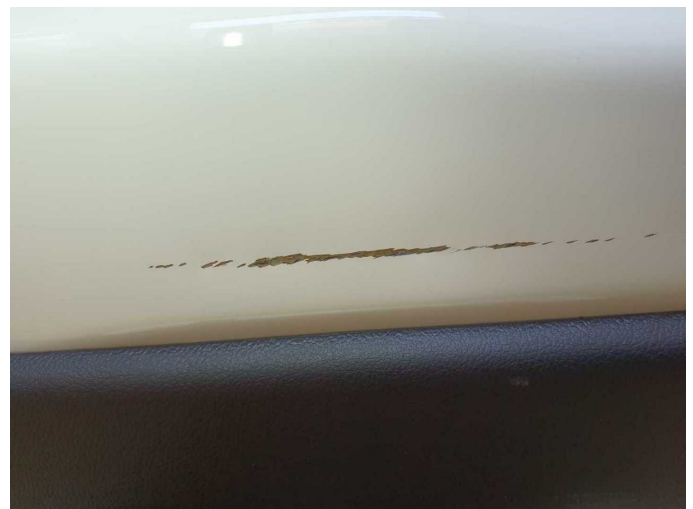
| No. | Component group | Description |
|---|---|--|
| 11 | Boot lid / rear door | Boot lid - Corrosion - Repair and paint |

**Damage 11:** Boot lid / rear door: Boot lid - Corrosion - Repair and paint

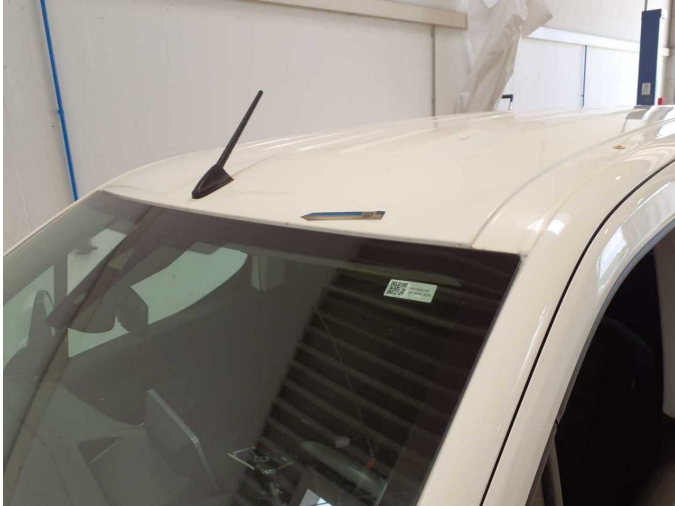
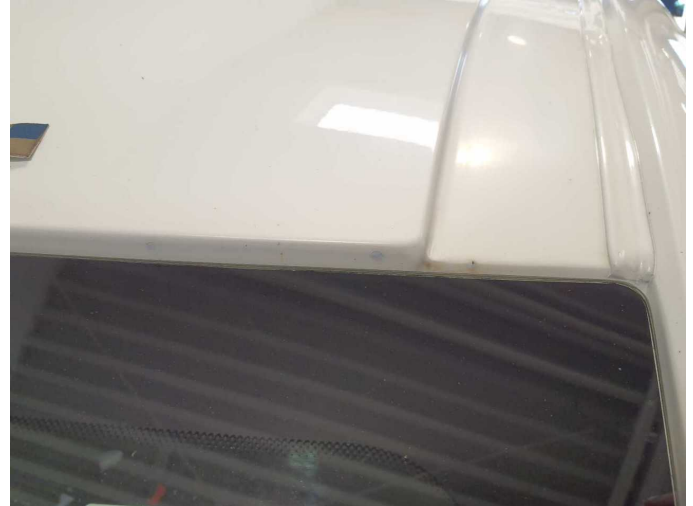
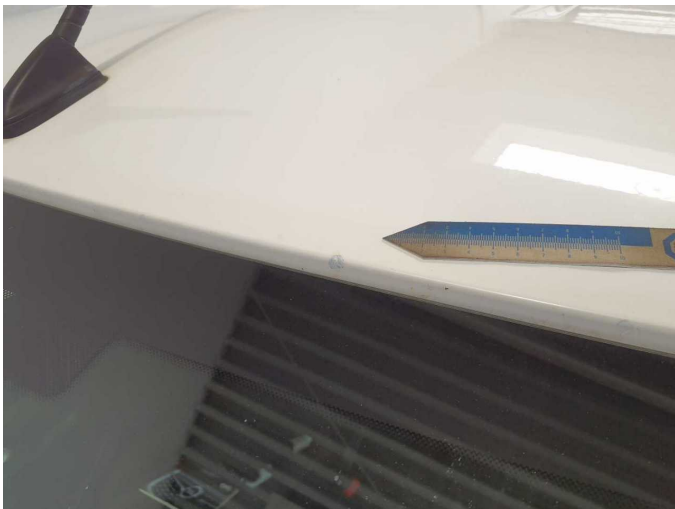
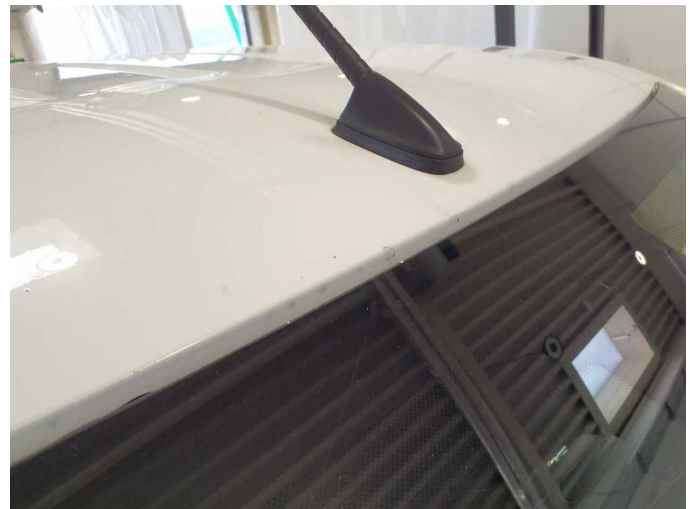
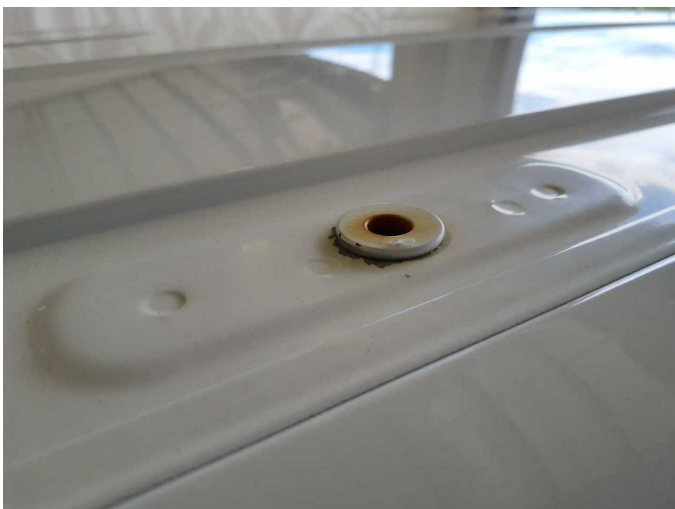
| No. | Component group | Description |
|---|---|--|
| 12 | Roof | Roof (Korrosionsbildung) - Scratched - Paint |

**Damage 12:** Roof: Roof (Korrosionsbildung) - Scratched - Paint

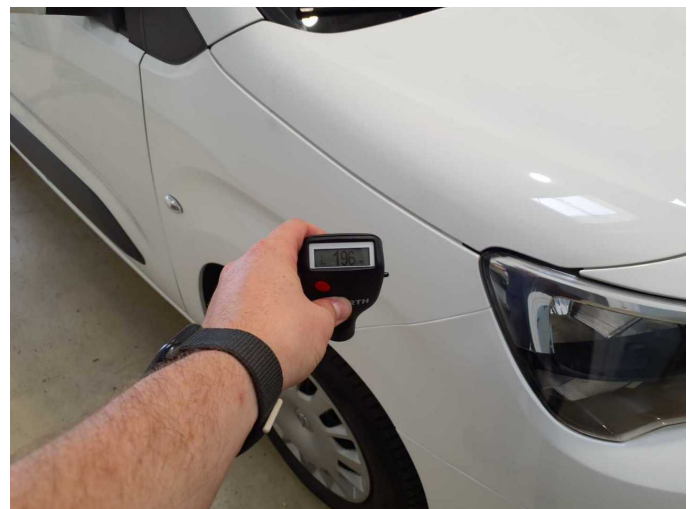
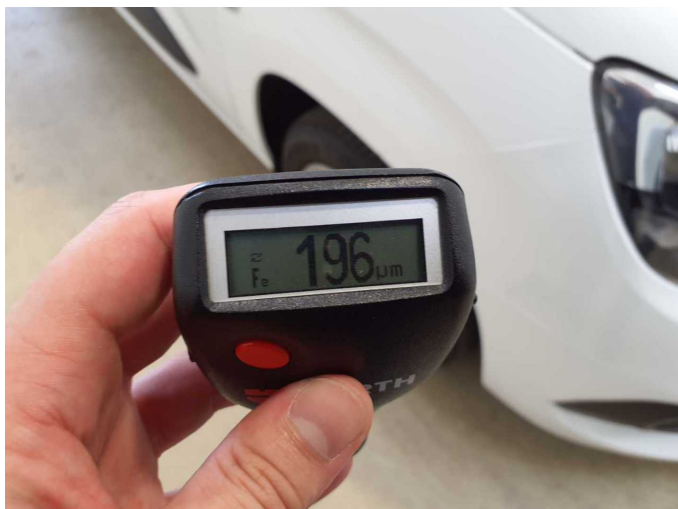
| No. | Repainting |
|---|--|
| 1 | Mudguard - right side, Professionally carried out, Invoice of repair done Non-existent |

| Mudguard - right side | 196 µm |

**Repainting 1:** Mudguard - right side
