Expertise

Protocol number: 46206129
Order No. / Reference: 26500992
Inspection date: 19 Jun 2026

Manufacturer: Volkswagen

Model: up!

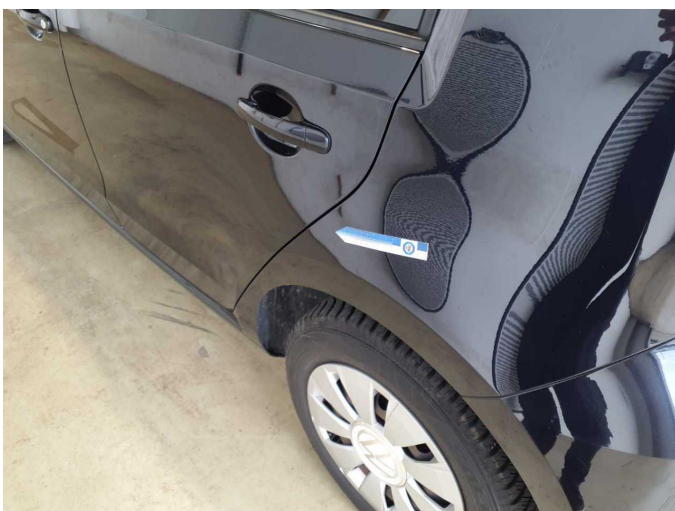
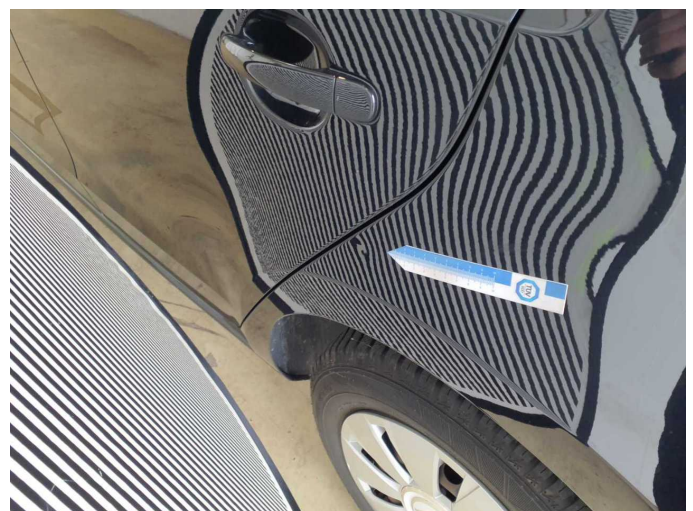
Damage 2: Side panel - rear left side: Side panel - dent(s) - Smooth repair work

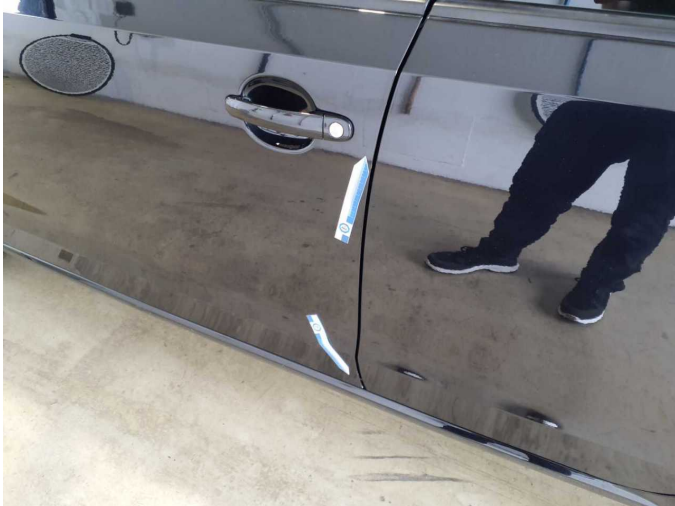
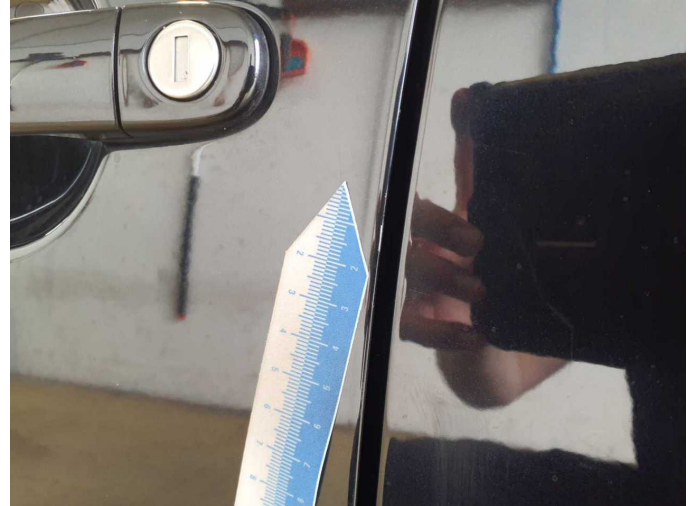
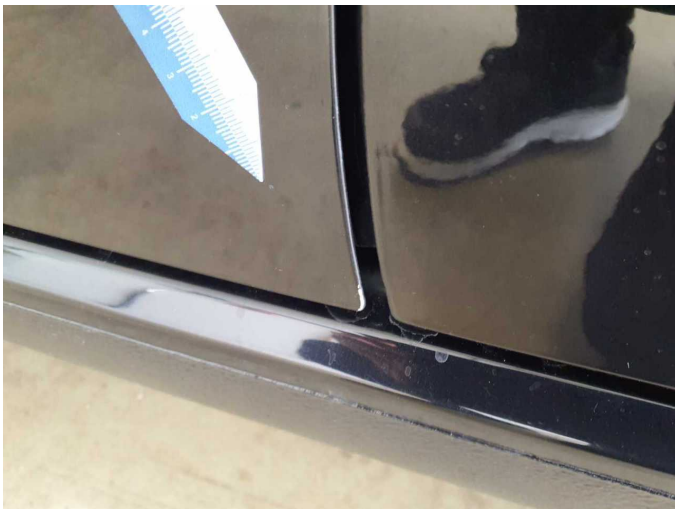
Damage 3: Door - front left side: Door edge - Scratch(es) - Smart repair

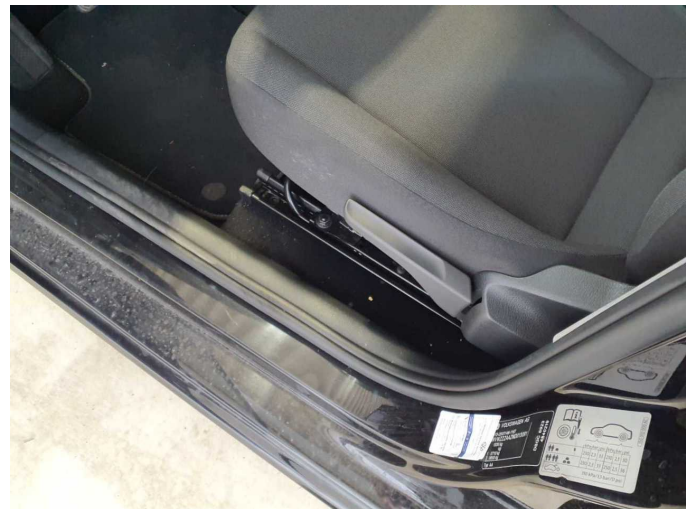
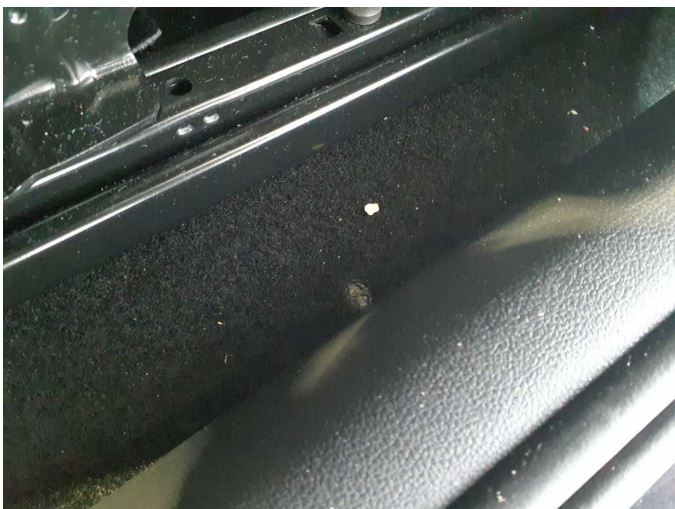
Damage 4: Trim / covers: Carpet - front left side - Damaged - Smart repair

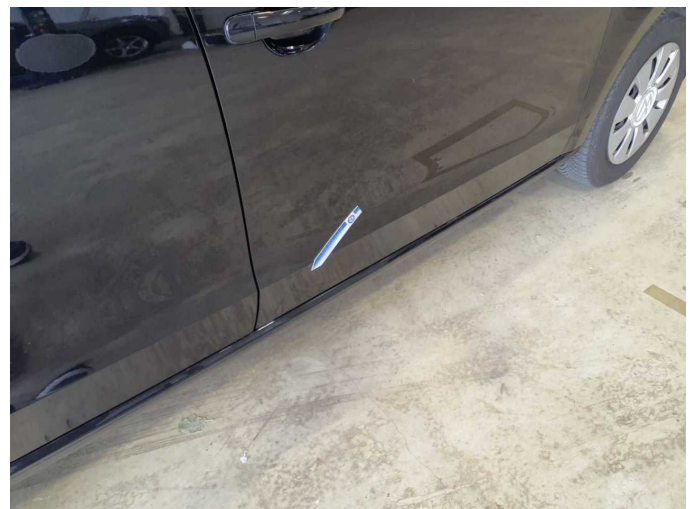
Damage 5: Door - front right side: Door - Scratch(es) - Smart repair

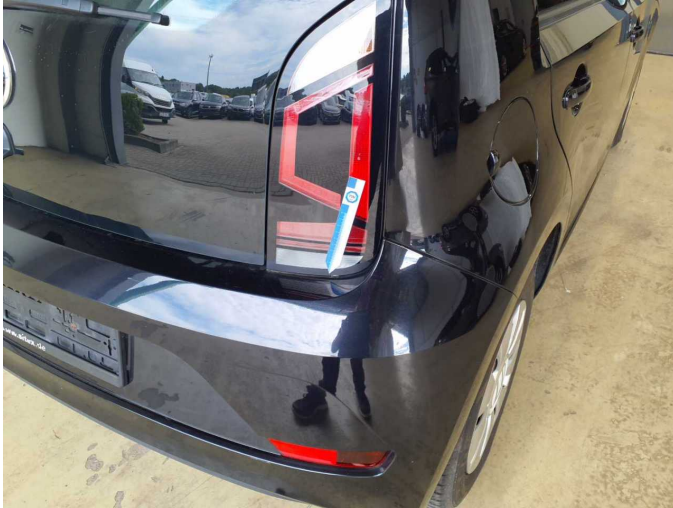
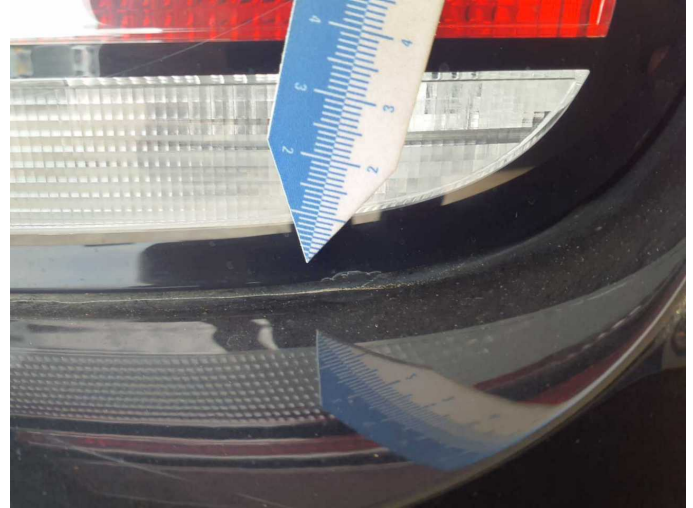
Damage 9: Tail light: Tail lamp - right side - Broken / torn - Replace

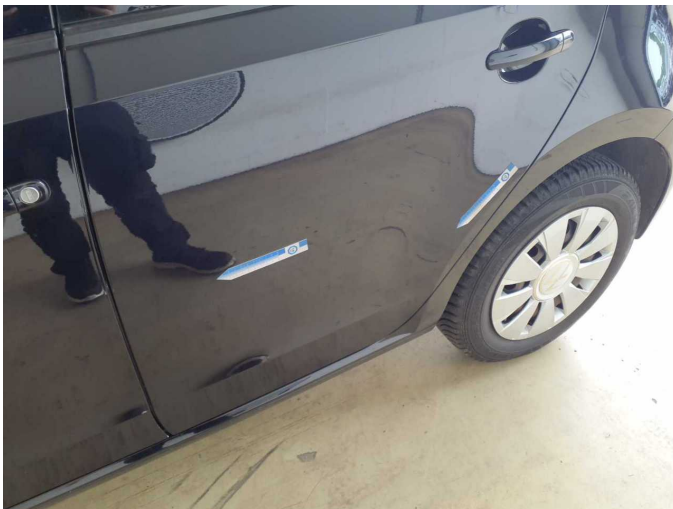
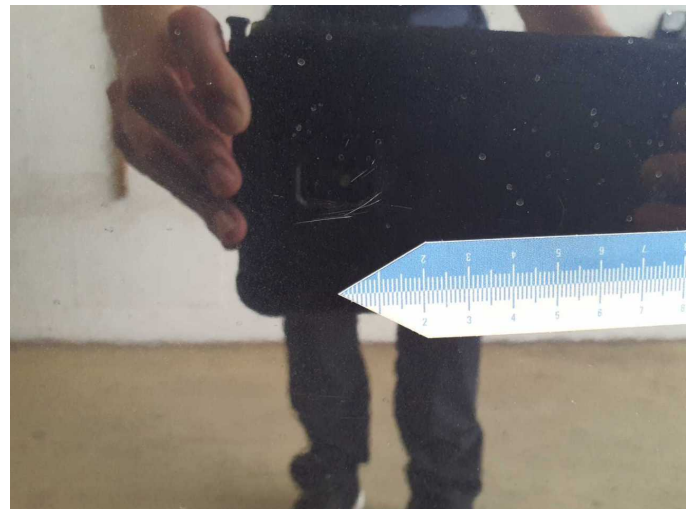
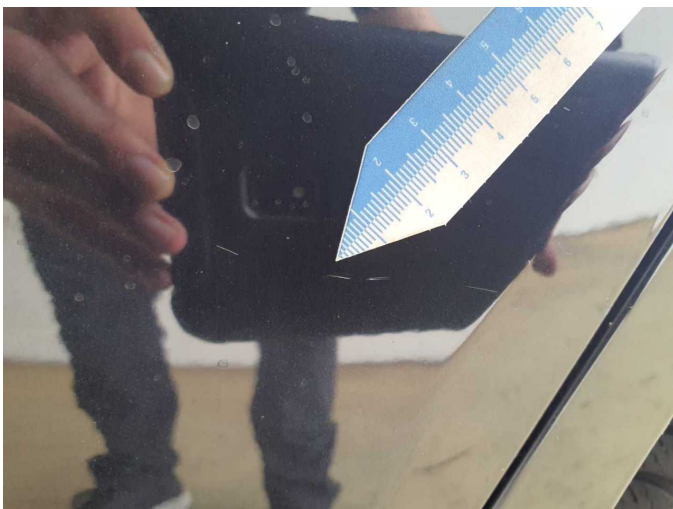
Damage 10: Door - rear left side: Door - Scratch(es) - Paint

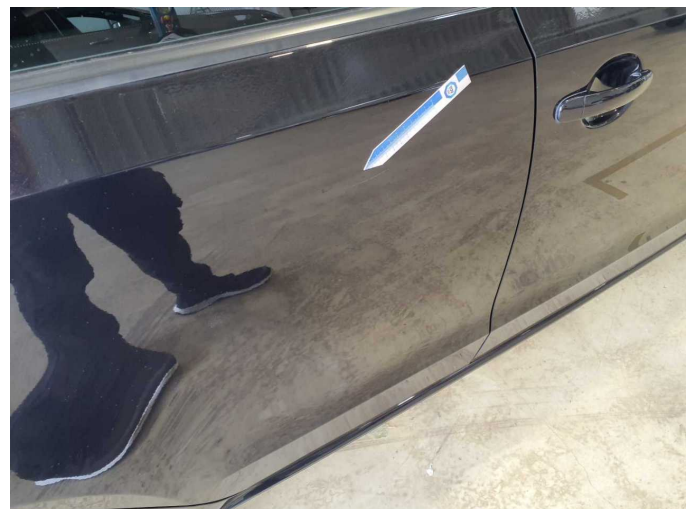
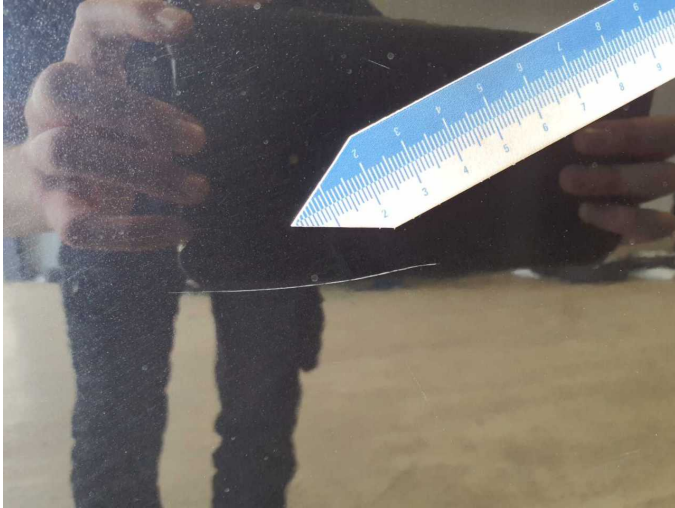
Damage 11: Door - rear right side: Door - Scratch(es) - Paint

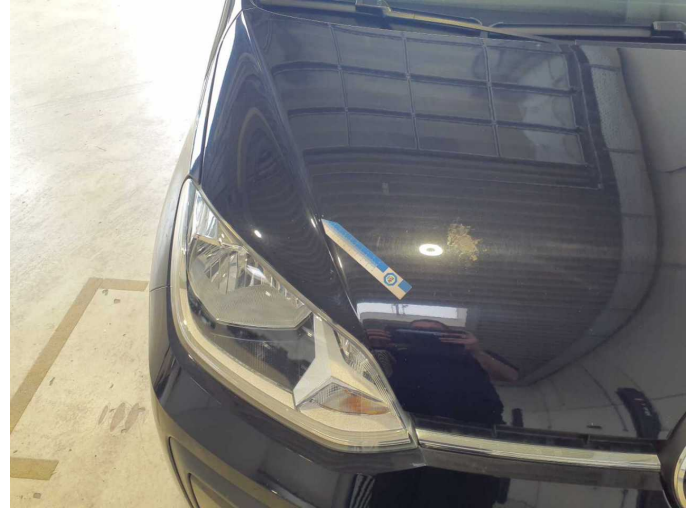
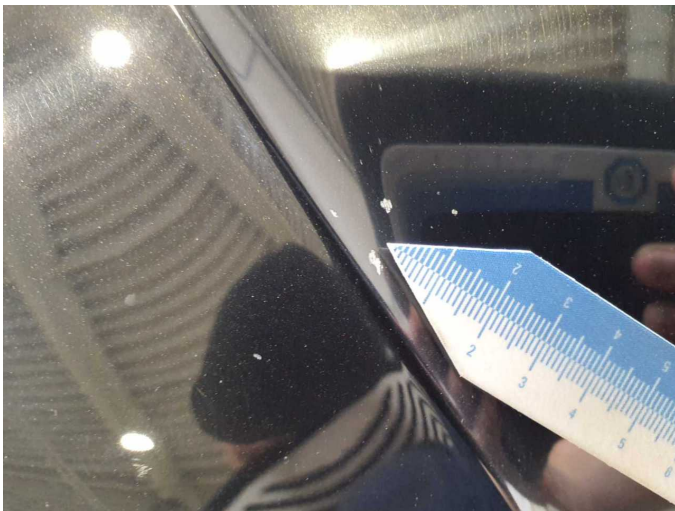
Damage 12: Bonnet: Bonnet - Stone chips - Paint

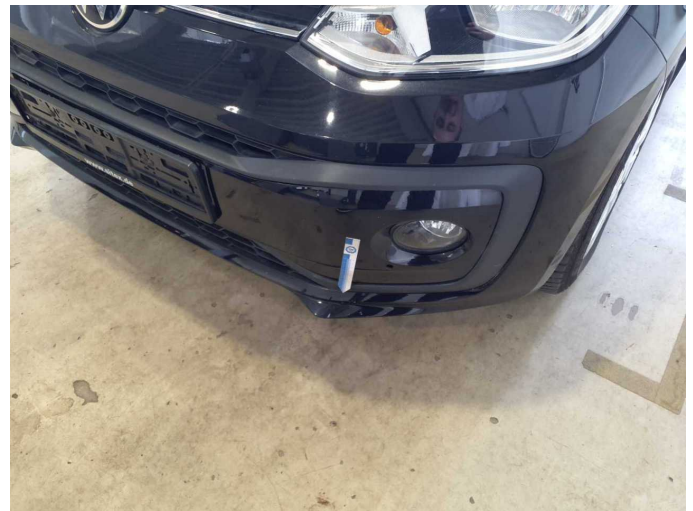
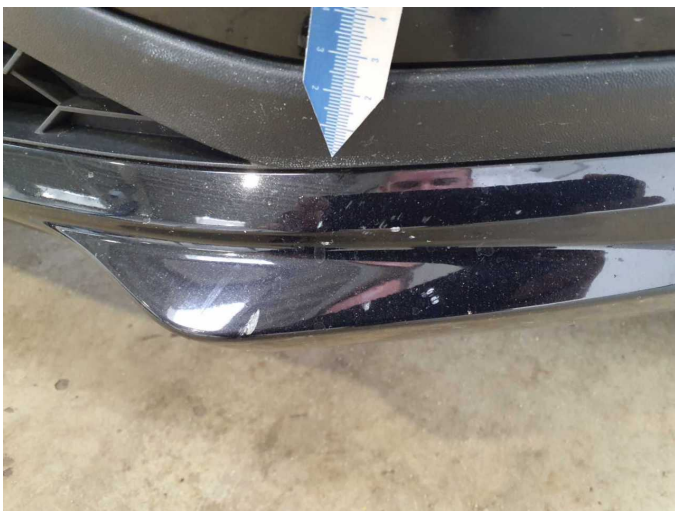
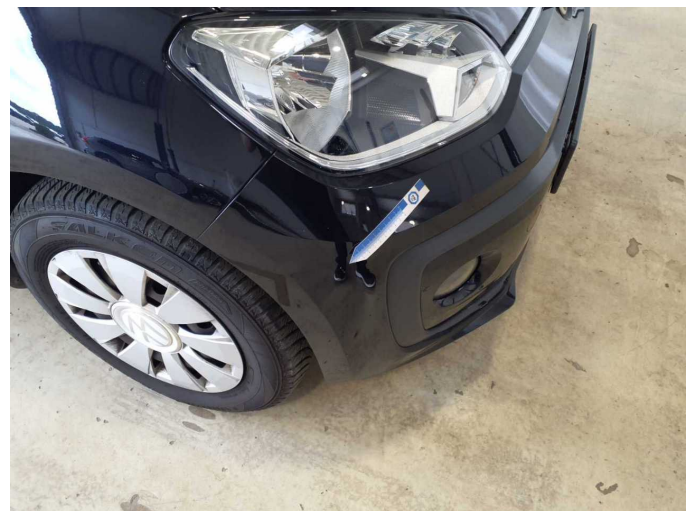
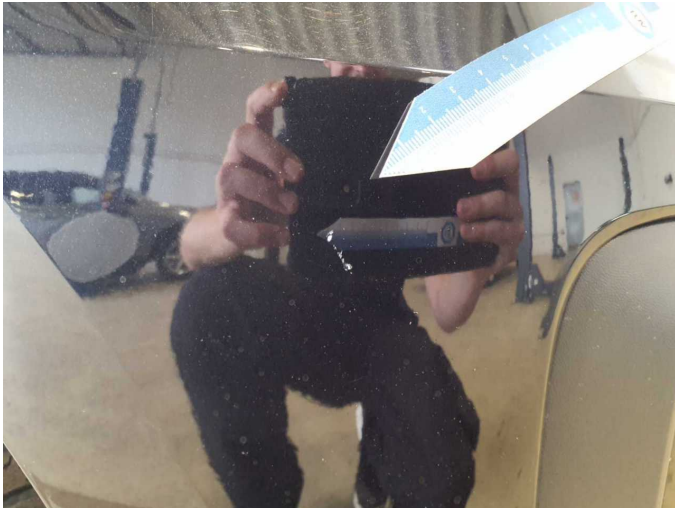
Damage 13: Front bumper: Front bumper - Scratched - Paint

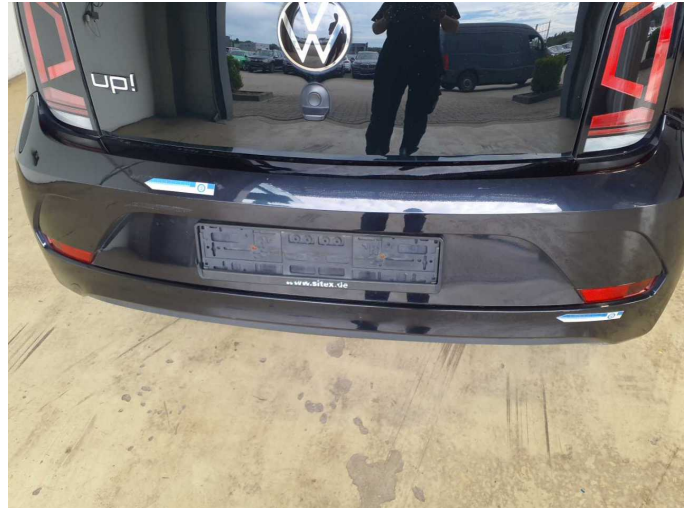
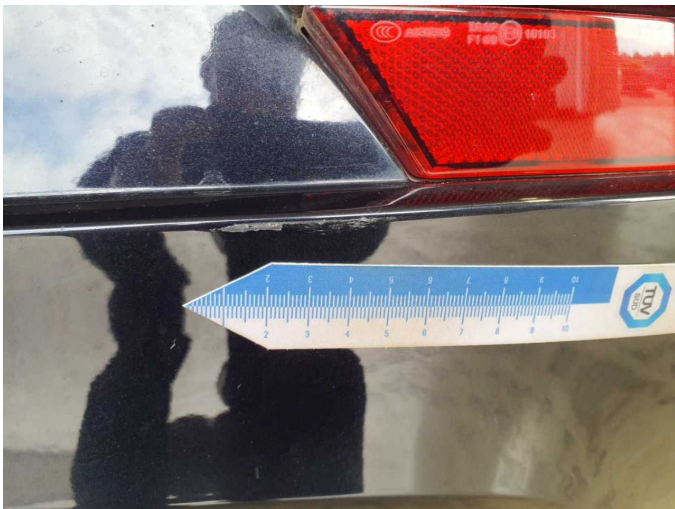
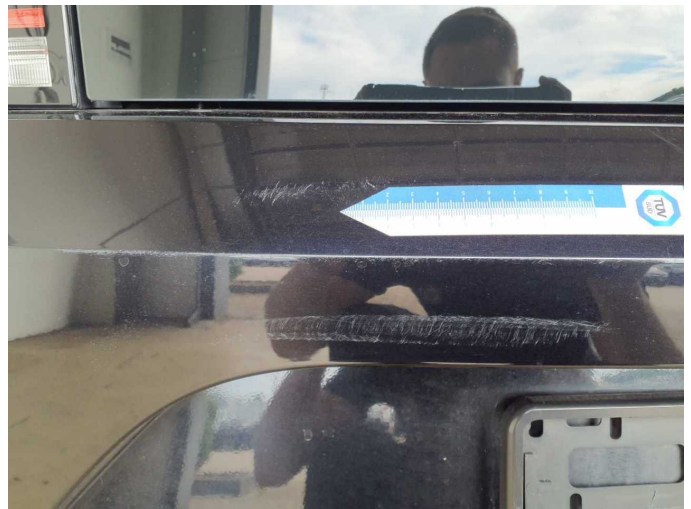
Damage 14: Rear bumper: Rear bumper - Scratched - Paint

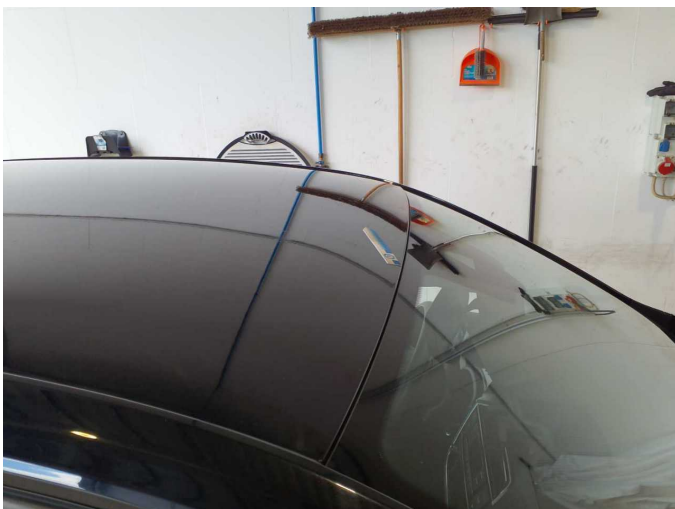
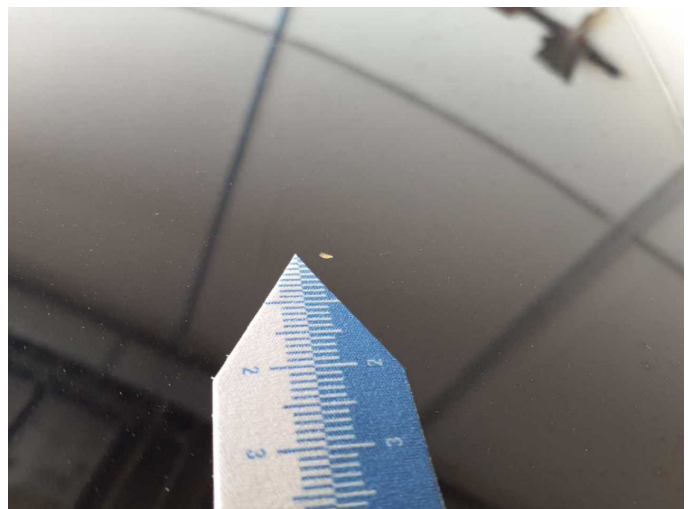
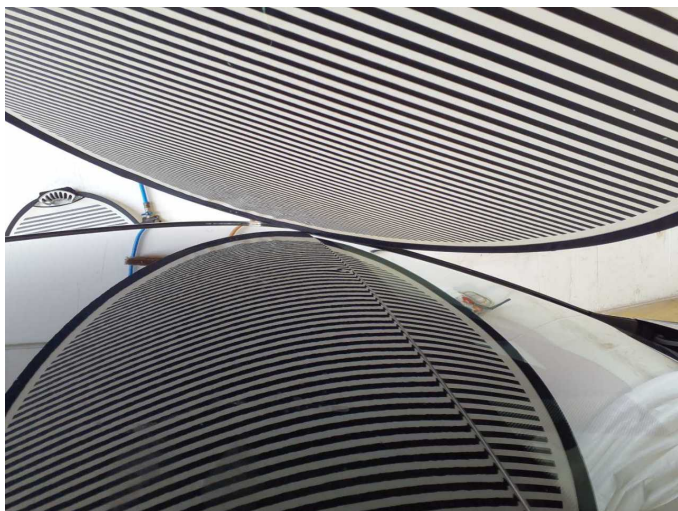
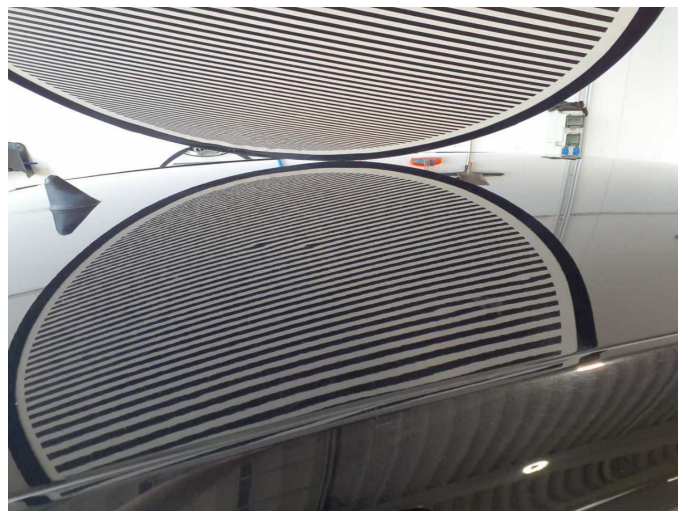
Damage 15: Roof: Roof (Korrosion) - Dent / paintcoat damage - Repair and paint
