Expertise

Protocol number: 46396744  
Order No. / Reference: 26562525  
Inspection date: 1 Jul 2026

Model: Transit Connect Kombi 230 L2 S&S Trend

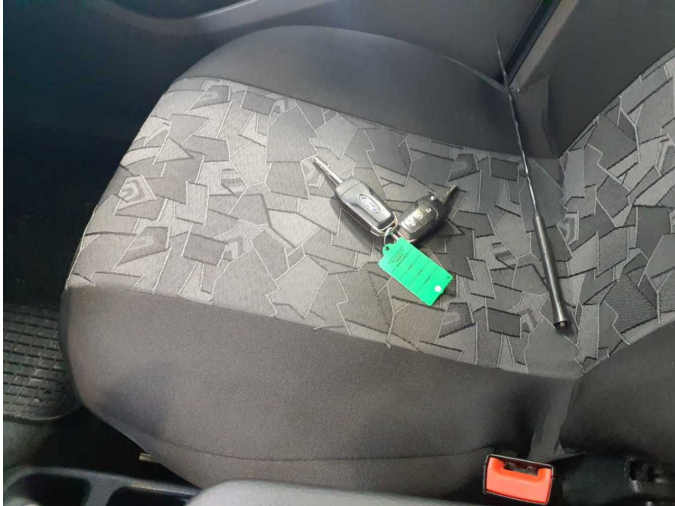
| No. | Component group | Description |
|---|---|---|
| 1 | Seat - front | Seat cover - left side (Sitzschoner vorn) - Differs from the original configuration - Remove |

**Damage 1:** Seat - front: Seat cover - left side (Sitzschoner vorn) - Differs from the original configuration - Remove

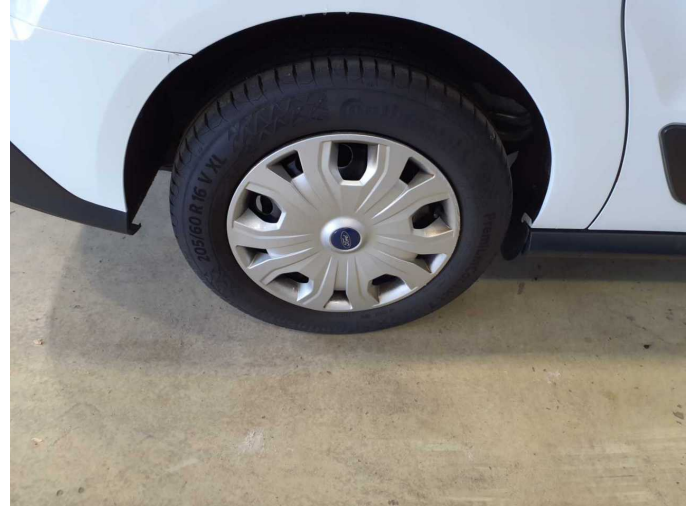
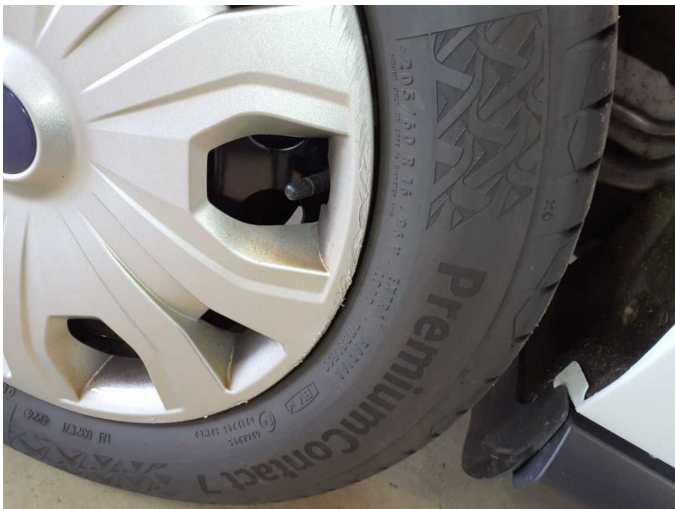
| No. | Component group | Description |
|---|---|---|
| 2 | Wheel / tyres | Wheel cover - rear right side - Scratch(es) - Replace |

**Damage 2:** Wheel / tyres: Wheel cover - rear right side - Scratch(es) - Replace

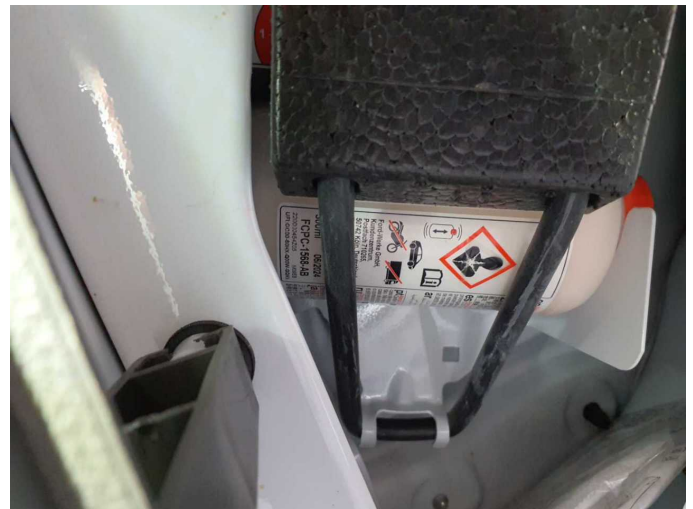
| No. | Component group | Description |
|---|---|---|
| 3 | Equipment | Tirefit filler - Expired - Replace |

**Damage 3:** Equipment: Tirefit filler - Expired - Replace

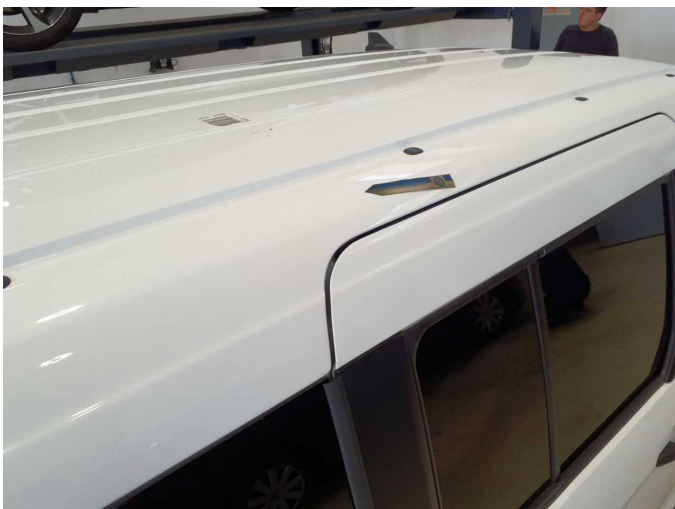
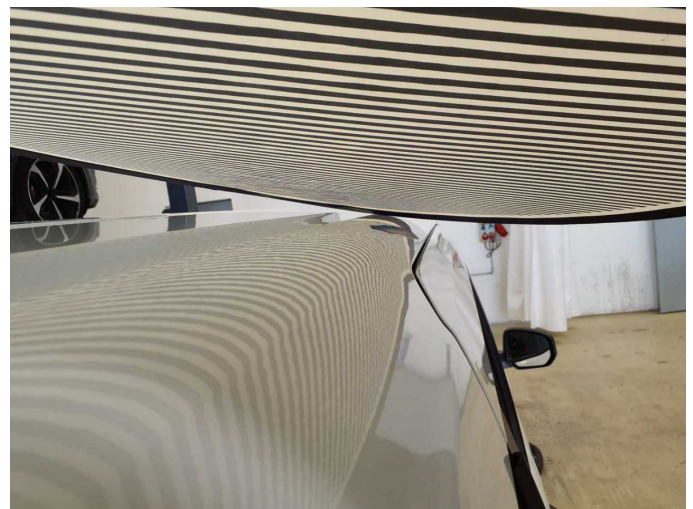
| No. | Component group | Description |
|---|---|---|
| 4 | Roof | Roof rail - right side - dent(s) - Smooth repair work |

**Damage 4:** Roof: Roof rail - right side - dent(s) - Smooth repair work

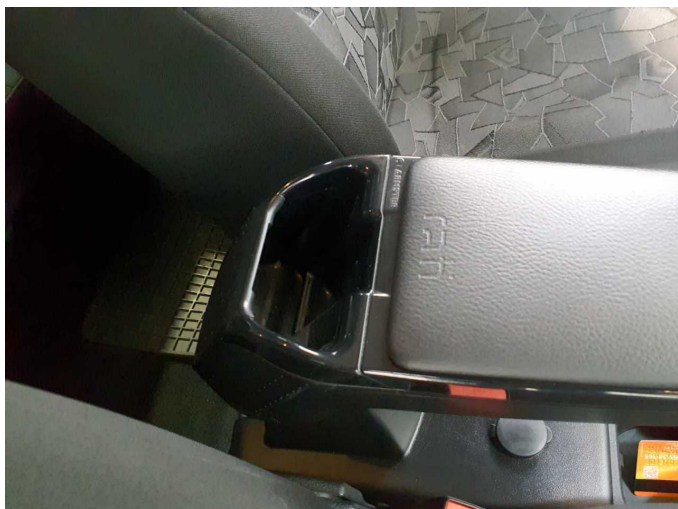
| No. | Component group | Description |
|---|---|---|
| 5 | Trim / covers | Trim / covers - Missing - Replace |

**Damage 5:** Trim / covers: Trim / covers - Missing - Replace

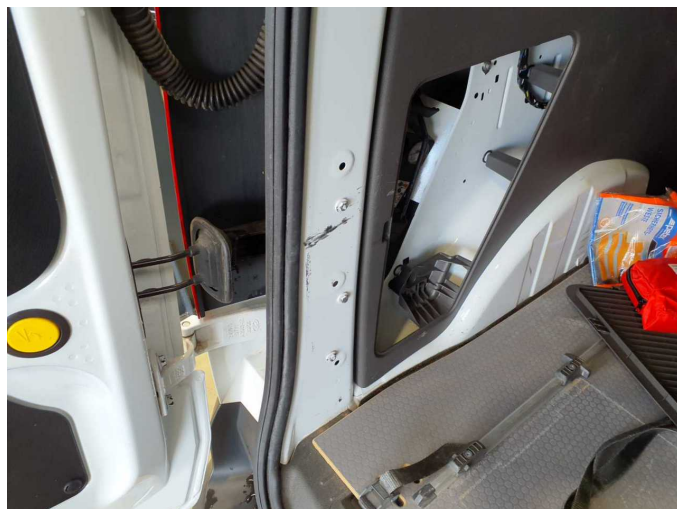
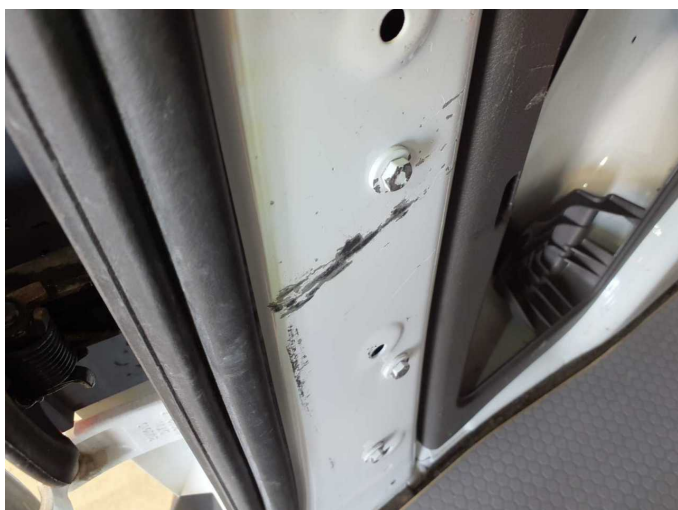
| No. | Component group | Description |
|---|---|---|
| 6 | Body | D-pillar - left side - Scratch(es) - Smart repair |

**Damage 6:** Body: D-pillar - left side - Scratch(es) - Smart repair

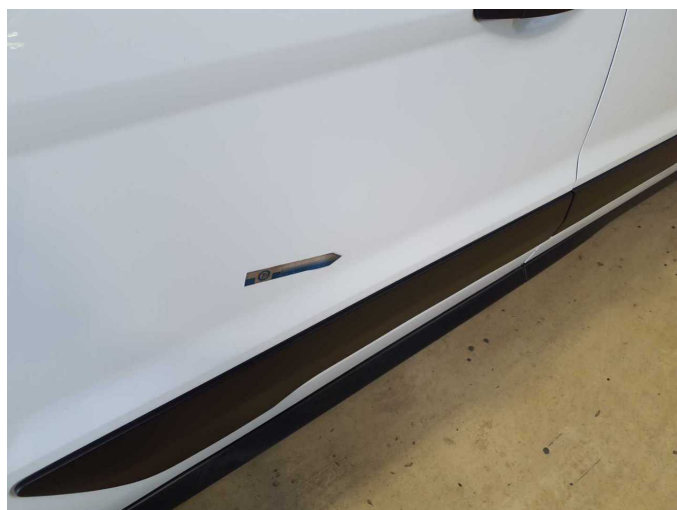
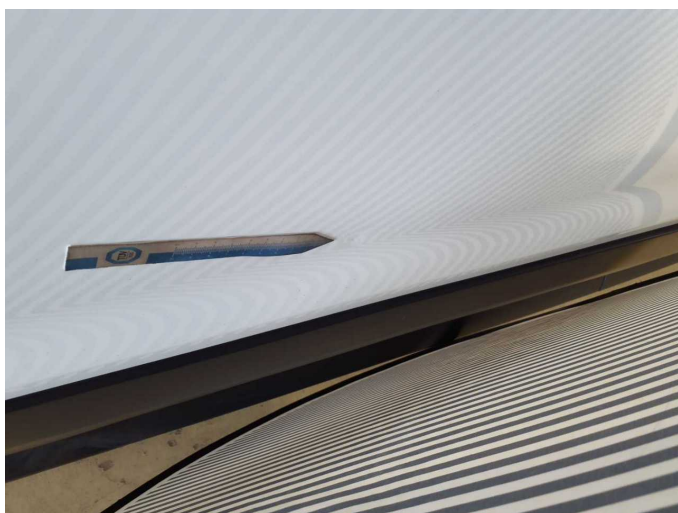
| No. | Component group | Description |
|---|---|---|
| 7 | Sliding door, right | Sliding door - Dent / paintcoat damage - Smart repair |

**Damage 7:** Sliding door, right: Sliding door - Dent / paintcoat damage - Smart repair

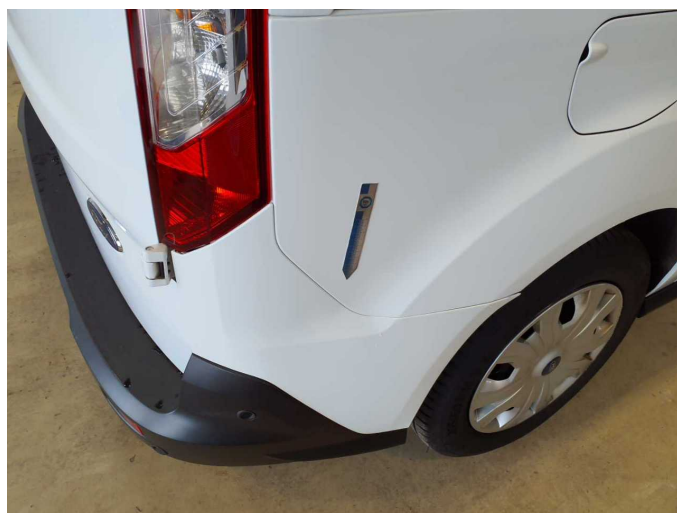
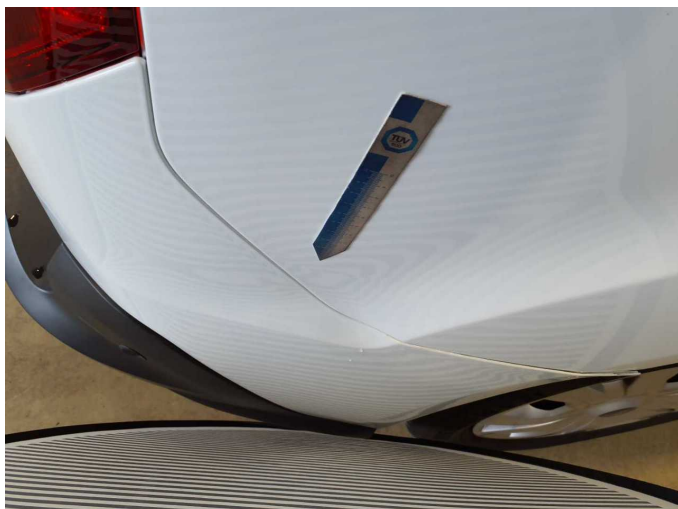
| No. | Component group | Description |
|---|---|---|
| 8 | Side panel - rear right side | Side panel - dent(s) - Smart repair |

**Damage 8:** Side panel - rear right side: Side panel - dent(s) - Smart repair

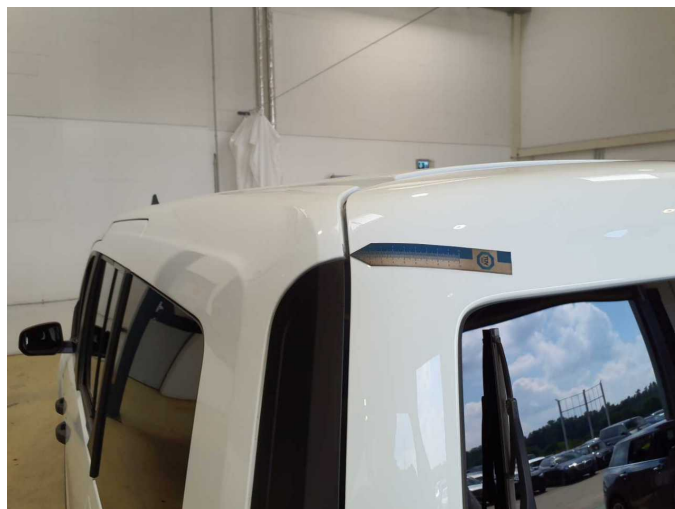
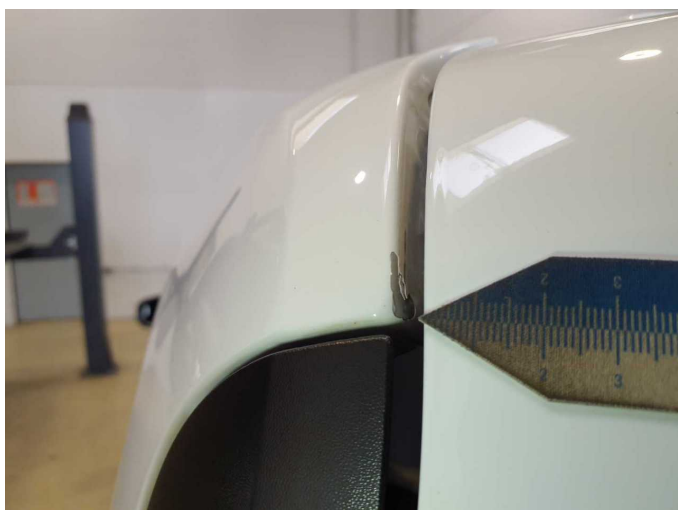
| No. | Component group | Description |
|---|---|---|
| 9 | Side panel - rear left side | Side panel - Scratch(es) - Smart repair |

**Damage 9:** Side panel - rear left side: Side panel - Scratch(es) - Smart repair

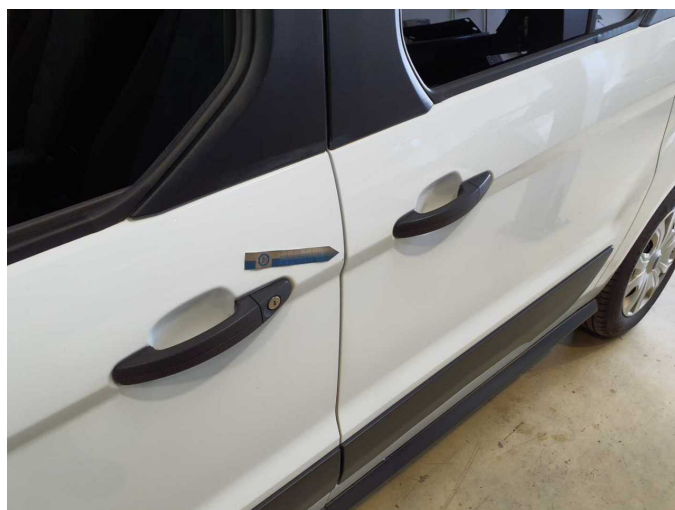
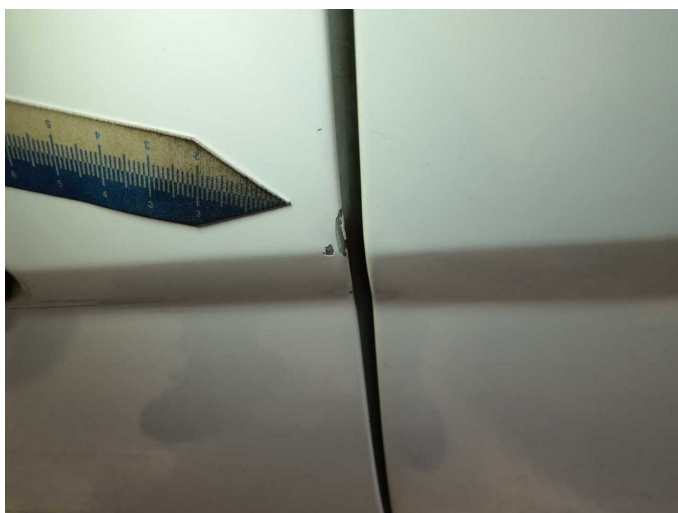
| No. | Component group | Description |
|---|---|---|
| 10 | Door - front left side | Door seal - Dent / paintcoat damage - Smart repair |

**Damage 10:** Door - front left side: Door seal - Dent / paintcoat damage - Smart repair

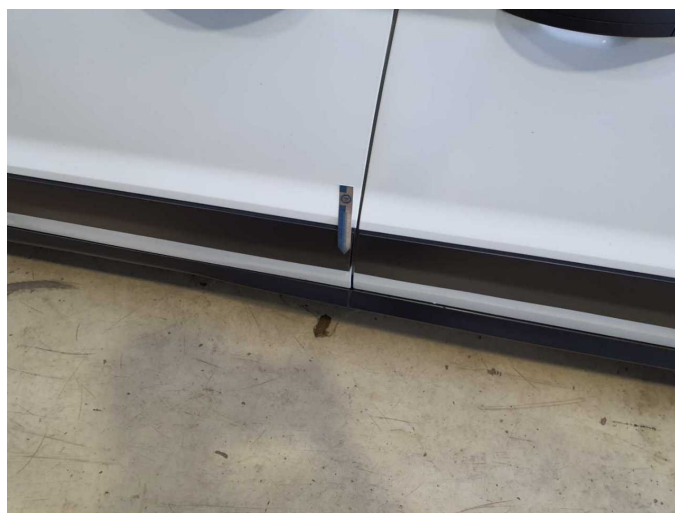
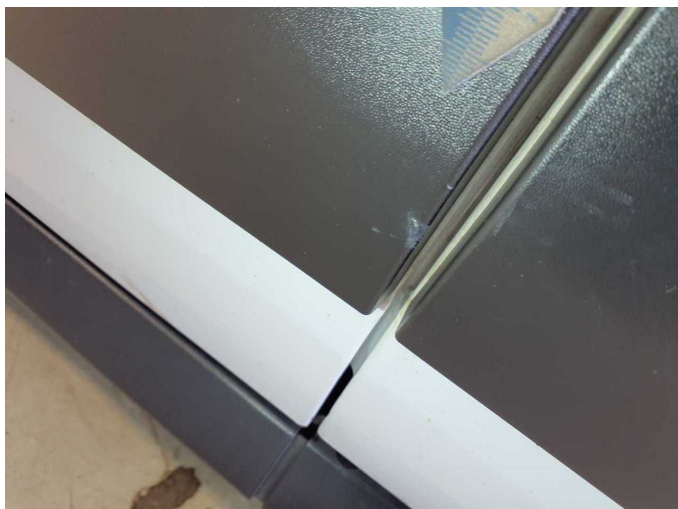
| No. | Component group | Description |
|---|---|---|
| 11 | Door - front left side | Brightware - lower - Scratch(es) - Smart repair |

**Damage 11:** Door - front left side: Brightware - lower - Scratch(es) - Smart repair

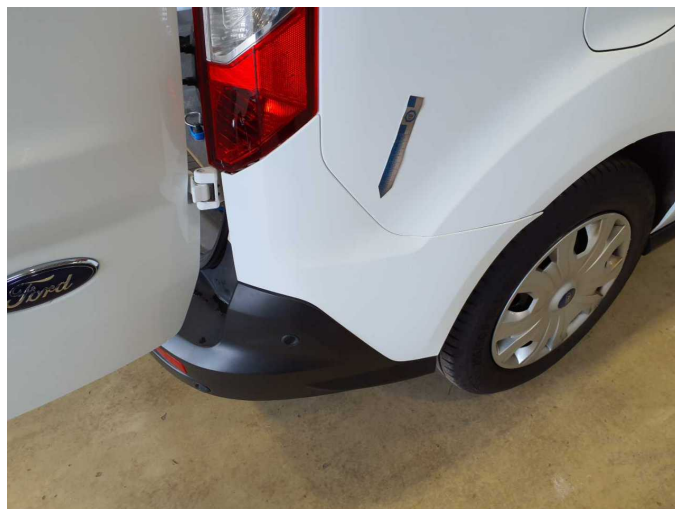
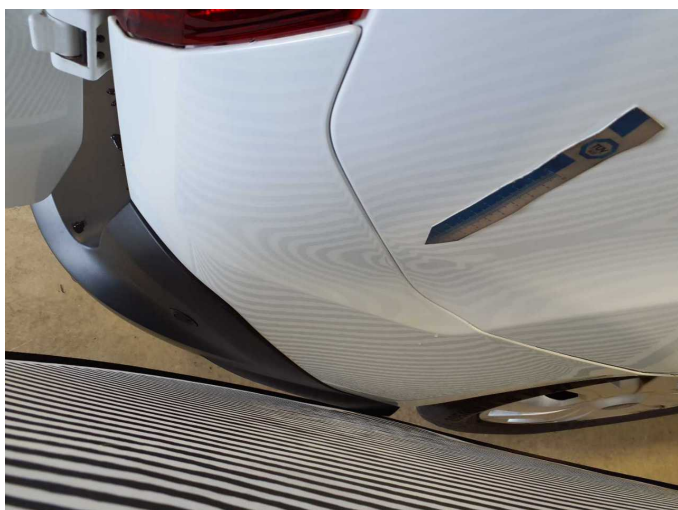
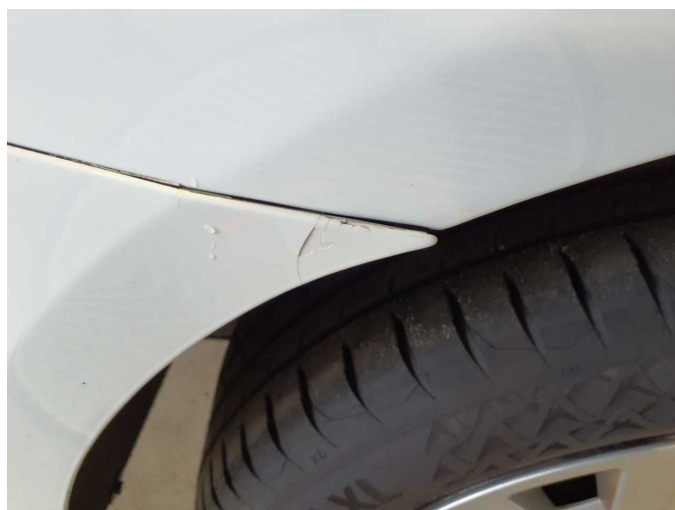
| No. | Component group | Description |
|---|---|---|
| 12 | Rear bumper | Bumper - rear right side - Dent / paintcoat damage - Replace |

**Damage 12:** Rear bumper: Bumper - rear right side - Dent / paintcoat damage - Replace

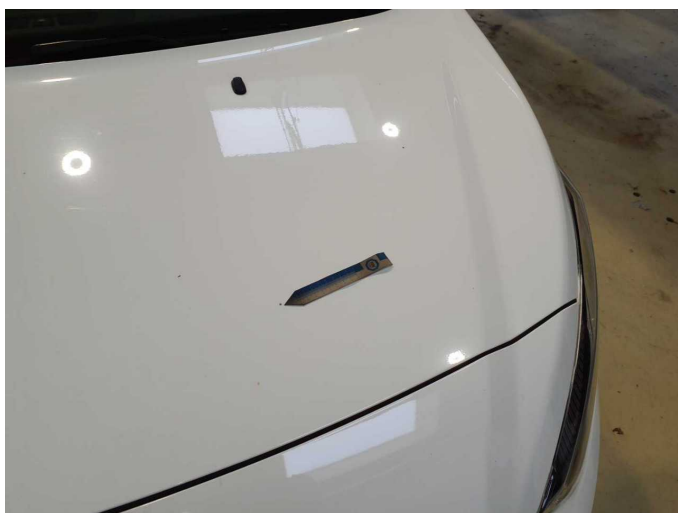
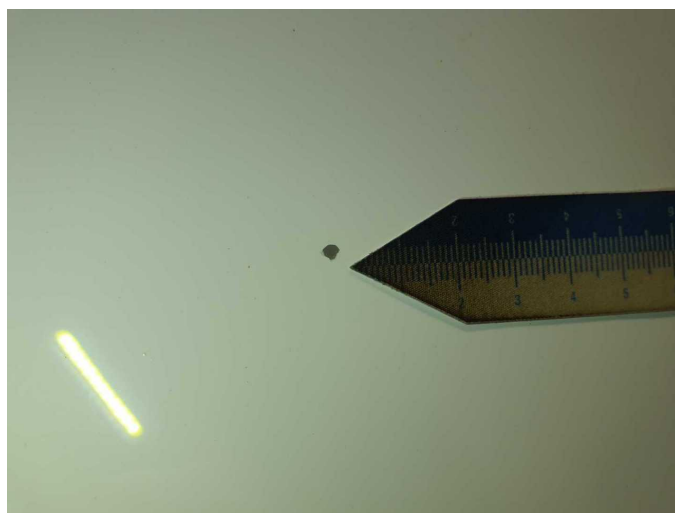
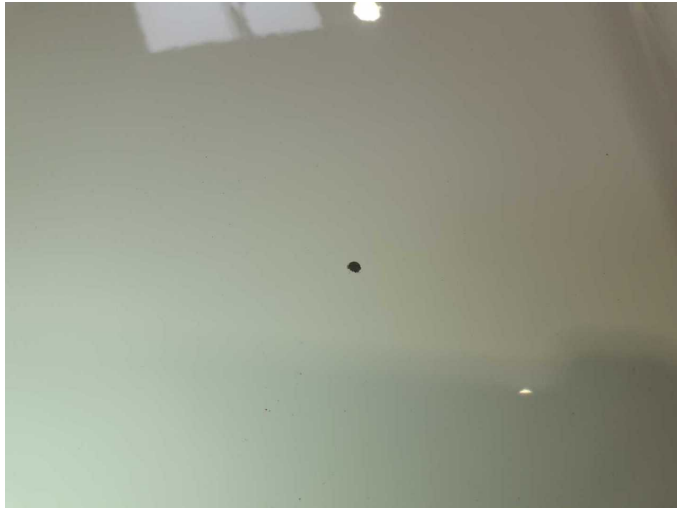
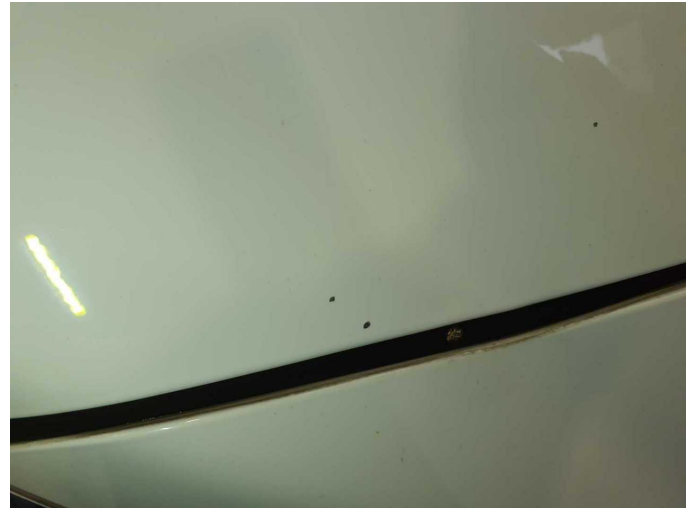
| No. | Component group | Description |
|---|---|---|
| 13 | Bonnet | Bonnet - Stone chips - Paint |

**Damage 13:** Bonnet: Bonnet - Stone chips - Paint

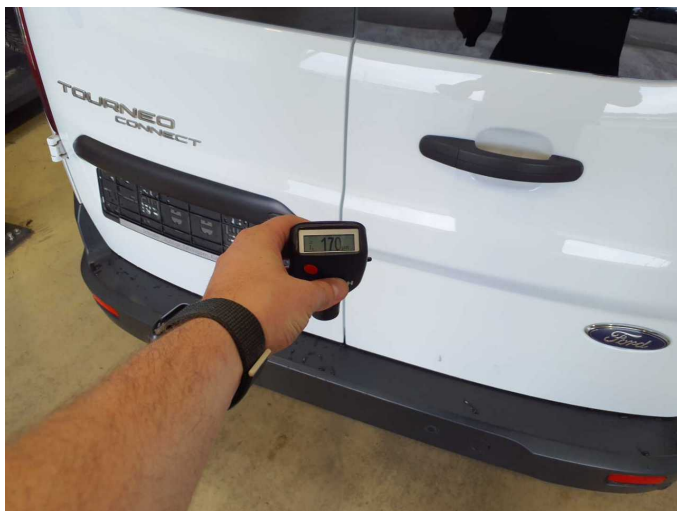
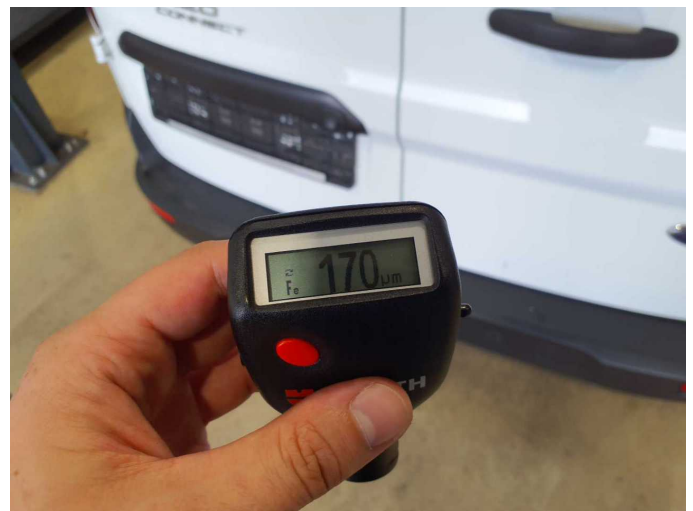
| No. | Repainting |
|---|---|
| 1 | Boot lid / rear door, Professionally carried out, Invoice of repair done Non-existent |

| Boot lid / rear door | 170 µm | Side panel - rear right side | 662 µm |

**Repainting 1:** Boot lid / rear door

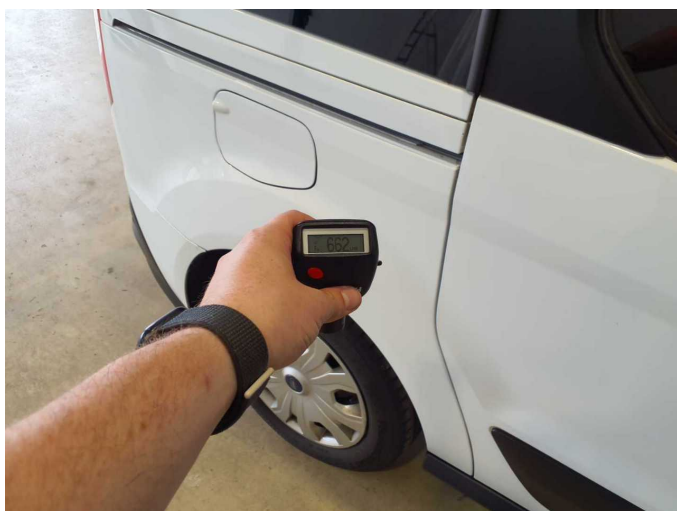
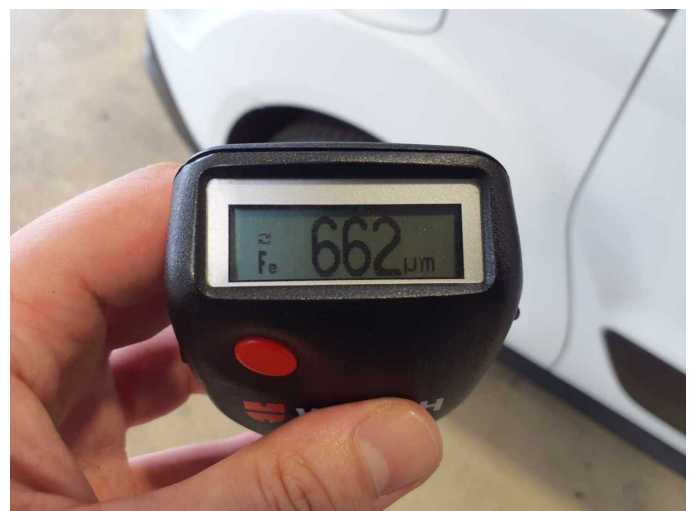
| No. | Repainting |
|---|---|
| 2 | Side panel - rear right side, Professionally carried out, Invoice of repair done Non-existent |

**Repainting 2:** Side panel - rear right side
