| SKODA OCTAVIA COMBI | | | |
| Vinnumber: | TMBJJ7NE8L0125699 | Versionname: | 2.0 CRTDI 110kW GreenTec Ambition |
| Expertise Mileage: | 147739 | Power Kw: | 110 |

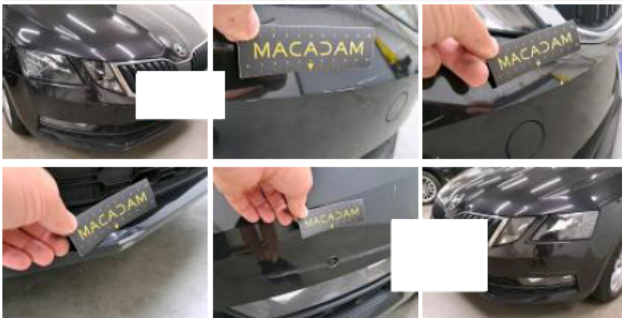
| Bumper F, Scratch(es), Repair and paint (complete) | 296,58 |

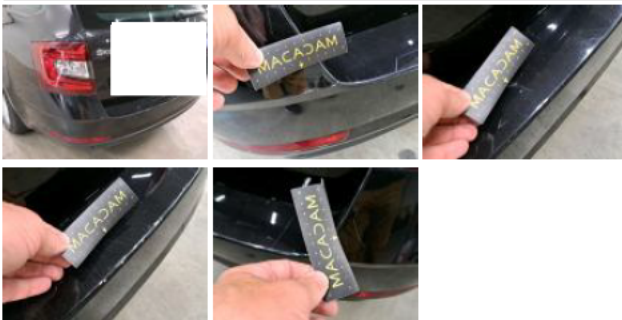
| Bumper R, Scratch(es), Acceptable | 0,00 |

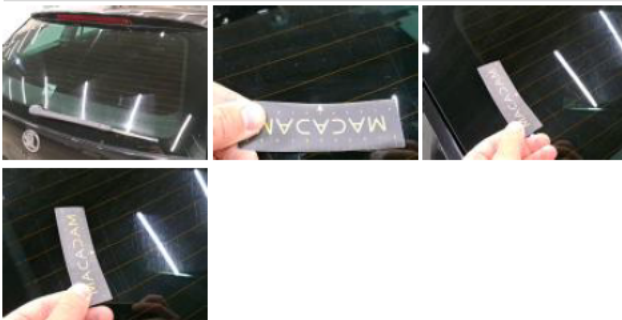
| Rear window, Scratch(es), Replace | 0,00 |

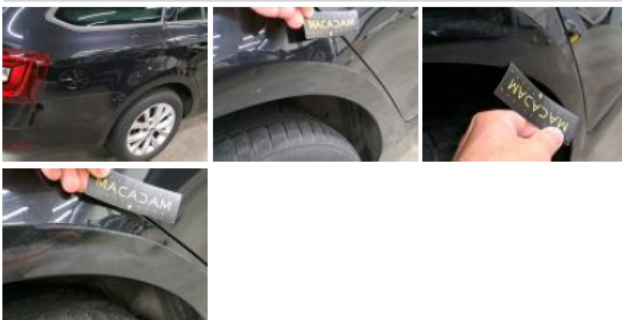
| Wing RR, Dent(s) and scratch(es), Repair and paint (complete) | 431,58 |
