Expertise

Protocol number: 46002250  
Order No. / Reference: 26418210  
Inspection date: 16 Jun 2026

Manufacturer: Ford  
VIN: WF0TK1E76NMA51490

Model: Mustang Mach-E

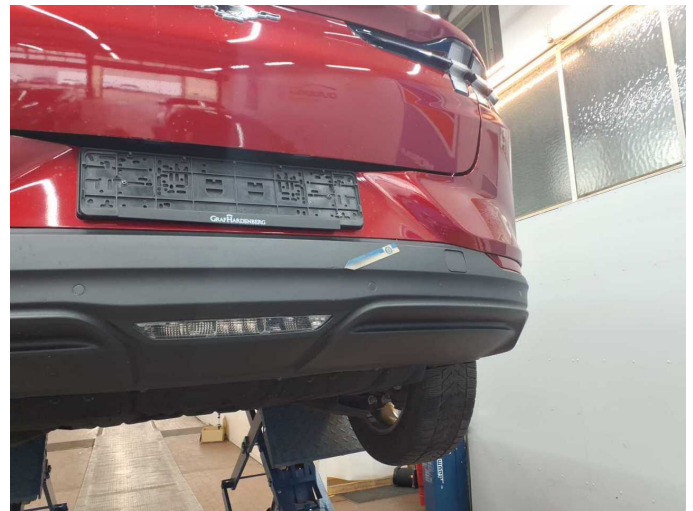
| No. | Component group | Description |
|---|---|---|
| 1 | Rear bumper | Rear bumper - Scratch(es) - Loss in value |

**Damage 1:** Rear bumper: Rear bumper - Scratch(es) - Loss in value

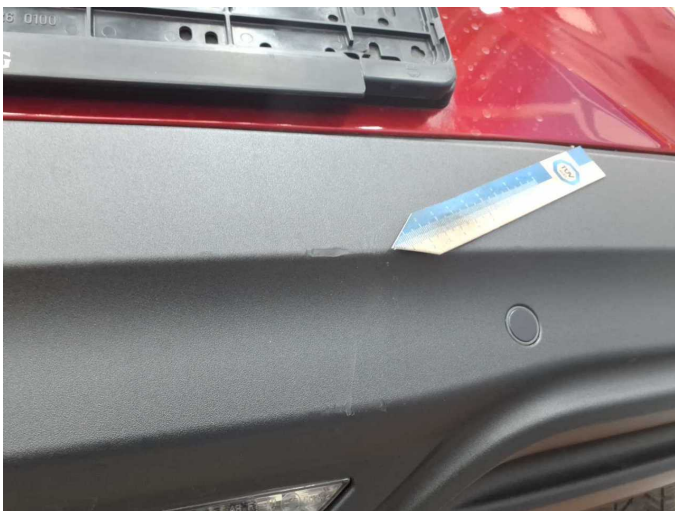
**Damage 1:** Rear bumper: Rear bumper - Scratch(es) - Loss in value

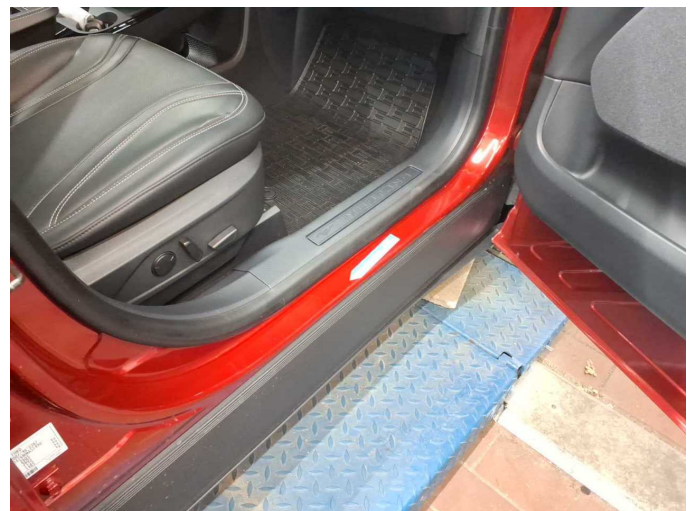
| No. | Component group | Description |
|---|---|---|
| 2 | Sill - right side | Sill - dent(s) - Smart repair |

**Damage 2:** Sill - right side: Sill - dent(s) - Smart repair

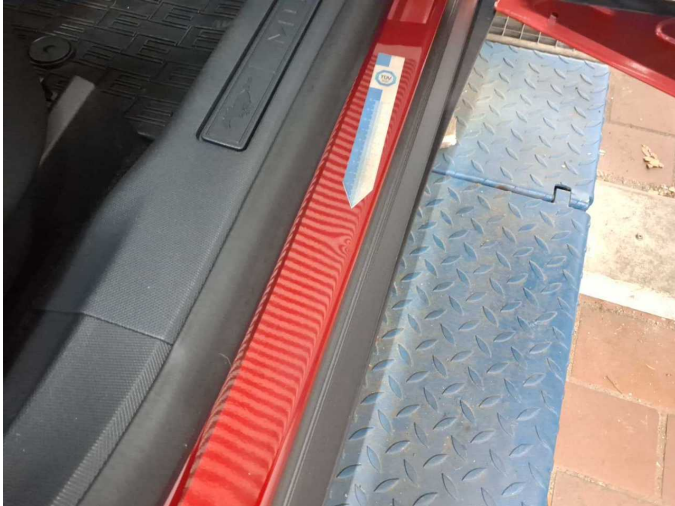
**Damage 2:** Sill - right side: Sill - dent(s) - Smart repair

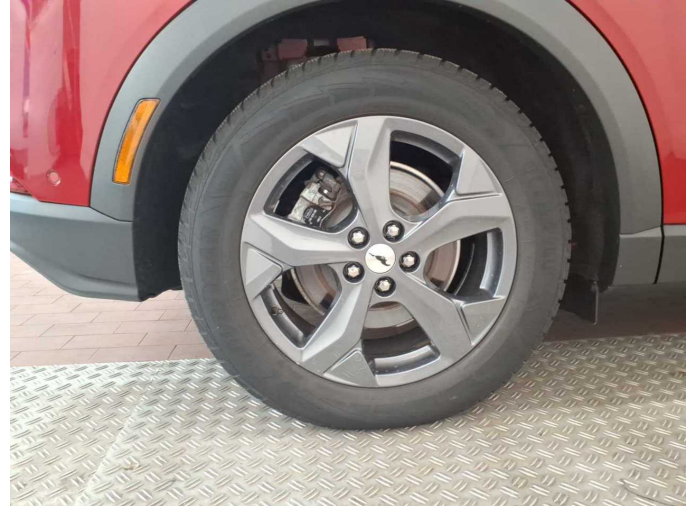
| No. | Component group | Description |
|---|---|---|
| 3 | Wheel / tyres | Alloy rim - rear right side - Scratch(es) - Loss in value |

**Damage 3:** Wheel / tyres: Alloy rim - rear right side - Scratch(es) - Loss in value

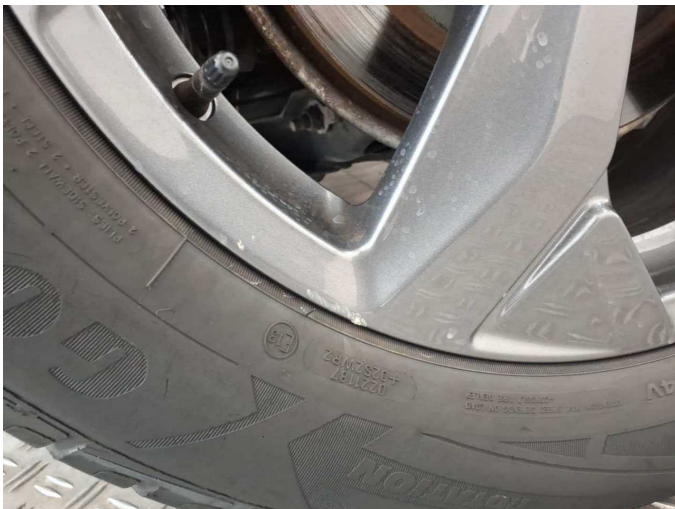
**Damage 3:** Wheel / tyres: Alloy rim - rear right side - Scratch(es) - Loss in value

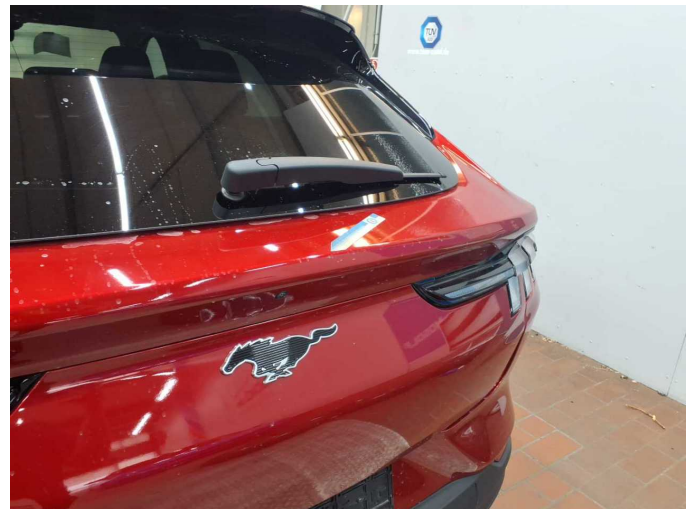
| No. | Component group | Description |
|---|---|---|
| 4 | Boot lid / rear door | Boot lid - Scratch(es) - Smart repair |

**Damage 4:** Boot lid / rear door: Boot lid - Scratch(es) - Smart repair

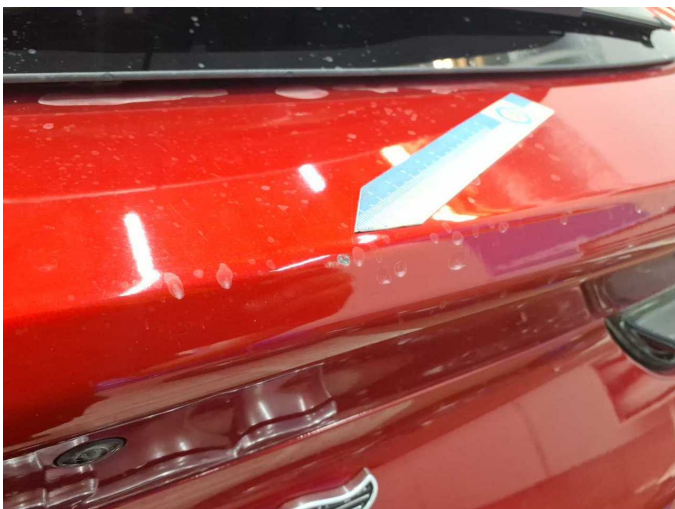
**Damage 4:** Boot lid / rear door: Boot lid - Scratch(es) - Smart repair

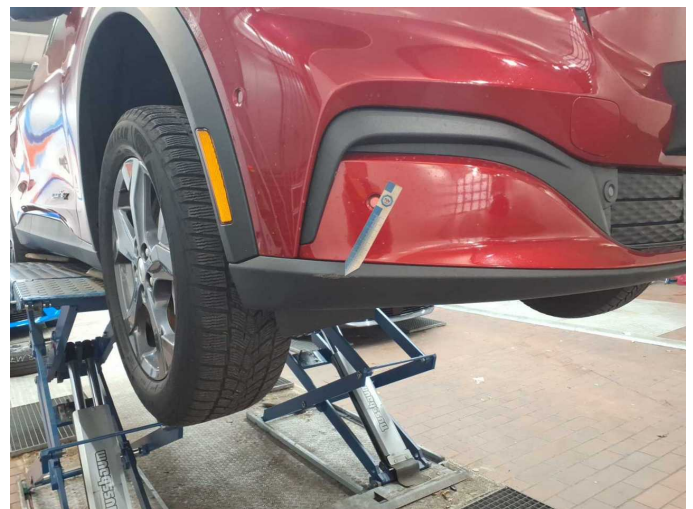
| No. | Component group | Description |
|---|---|---|
| 5 | Front bumper | Spoiler - Scratch(es) - Loss in value |

**Damage 5:** Front bumper: Spoiler - Scratch(es) - Loss in value

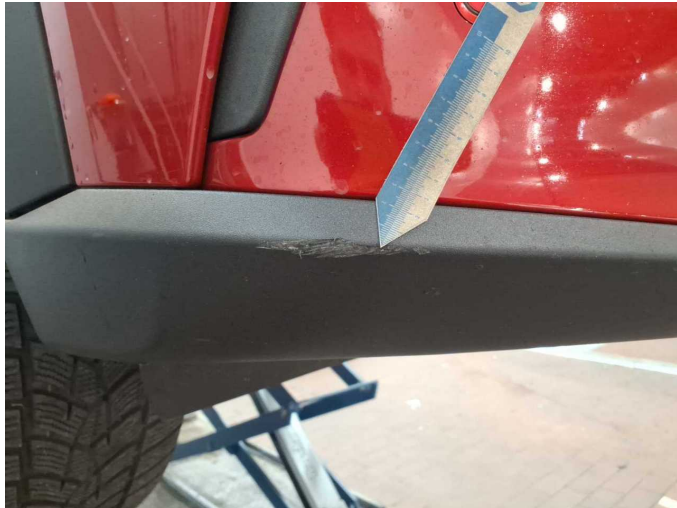
**Damage 5:** Front bumper: Spoiler - Scratch(es) - Loss in value

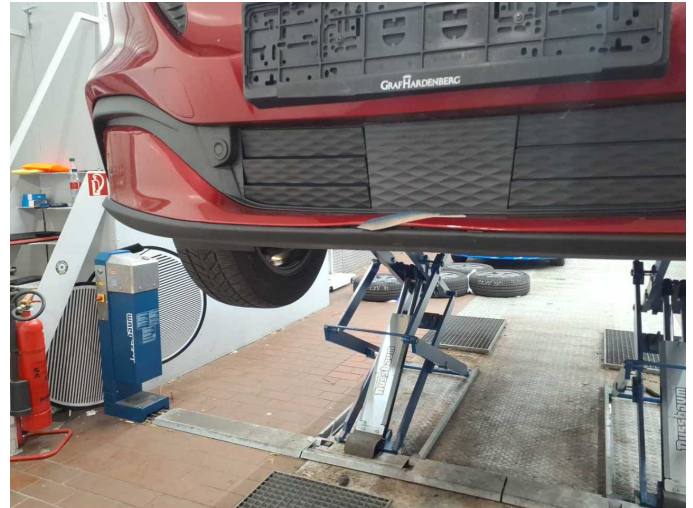
**Damage 5:** Front bumper: Spoiler - Scratch(es) - Loss in value

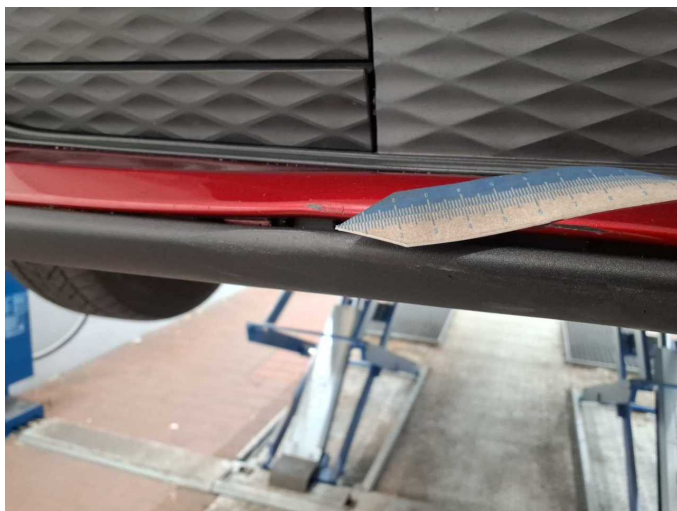
**Damage 5:** Front bumper: Spoiler - Scratch(es) - Loss in value

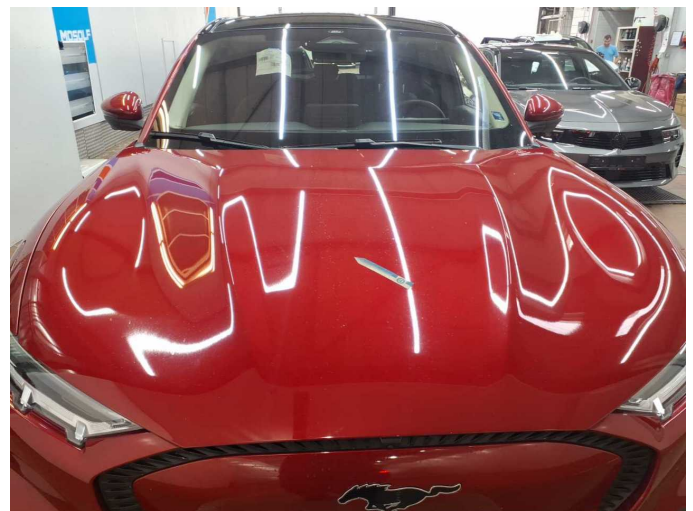
| No. | Component group | Description |
|---|---|---|
| 7 | Bonnet | Bonnet (Verätzungen / mit Kratzer) - Paint defect - Paint |

**Damage 7:** Bonnet: Bonnet (Verätzungen / mit Kratzer) - Paint defect - Paint

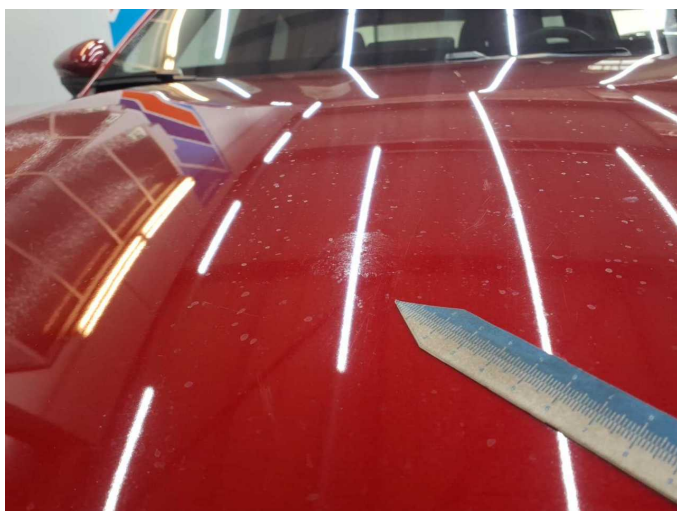
**Damage 7:** Bonnet: Bonnet (Verätzungen / mit Kratzer) - Paint defect - Paint

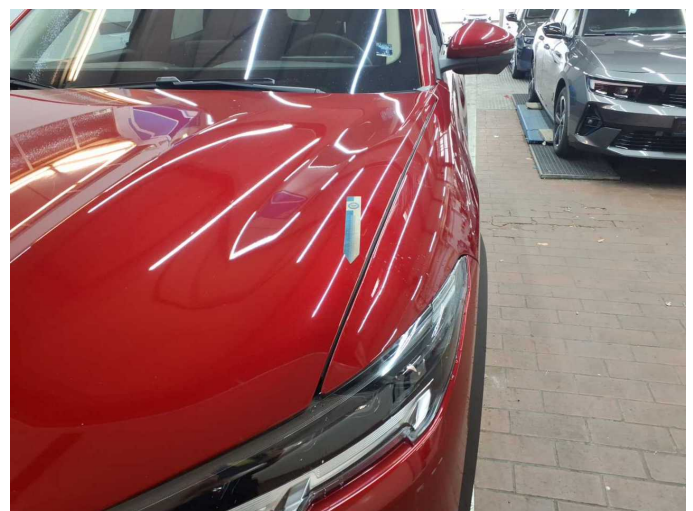
**Damage 7:** Bonnet: Bonnet (Verätzungen / mit Kratzer) - Paint defect - Paint

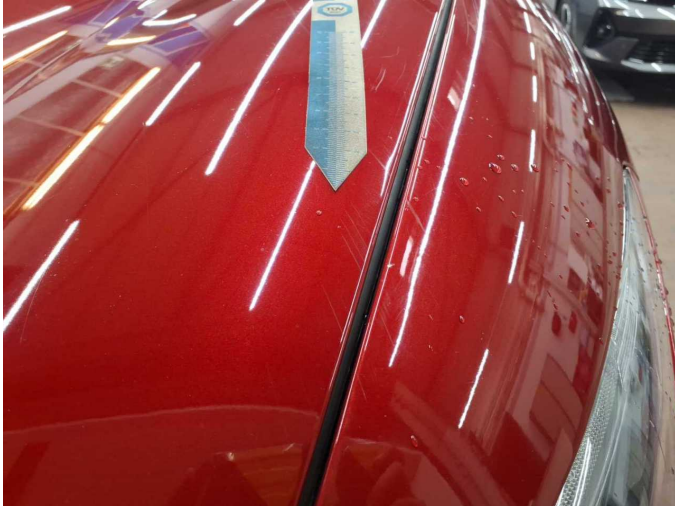
**Damage 7:** Bonnet: Bonnet (Verätzungen / mit Kratzer) - Paint defect - Paint

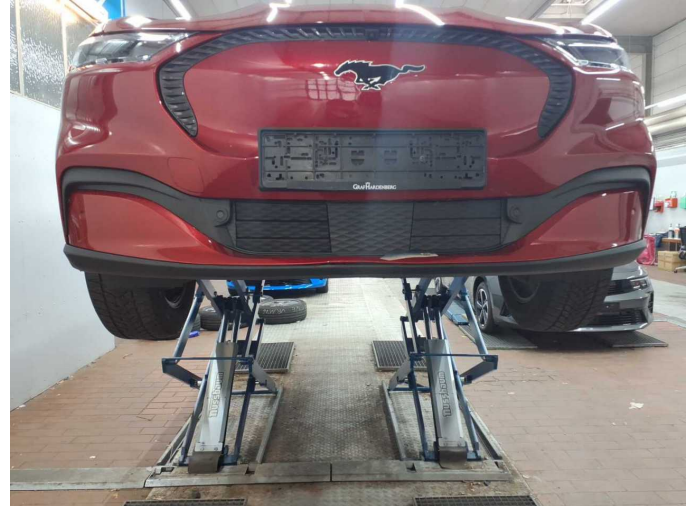
| No. | Component group | Description |
|---|---|---|
| 8 | Front bumper | Front bumper (Zierleiste) - Deformed - Replace |

**Damage 8:** Front bumper: Front bumper (Zierleiste) - Deformed - Replace

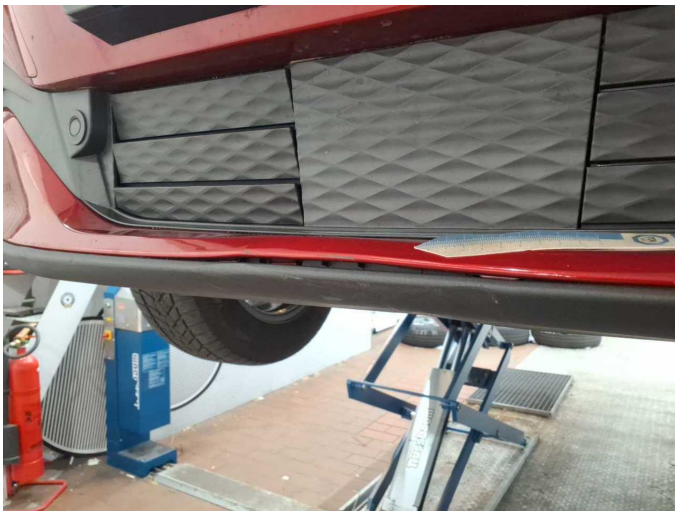
**Damage 8:** Front bumper: Front bumper (Zierleiste) - Deformed - Replace

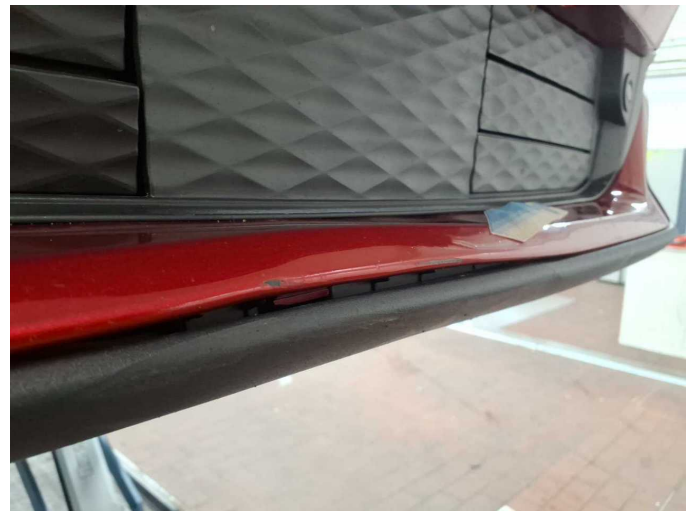
**Damage 8:** Front bumper: Front bumper (Zierleiste) - Deformed - Replace

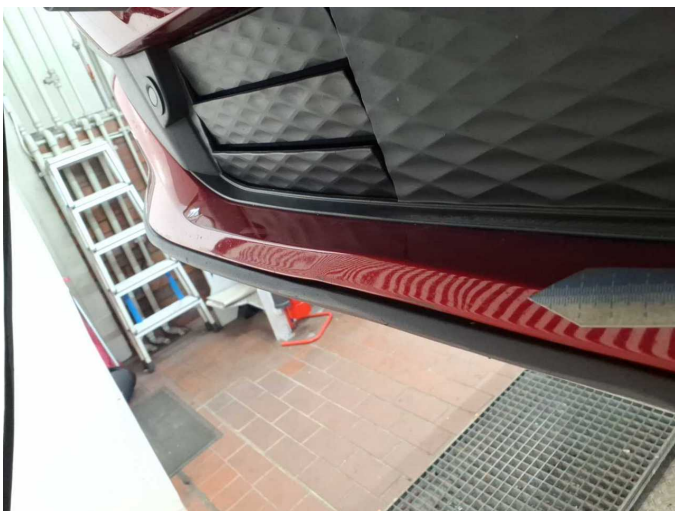
**Damage 8:** Front bumper: Front bumper (Zierleiste) - Deformed - Replace

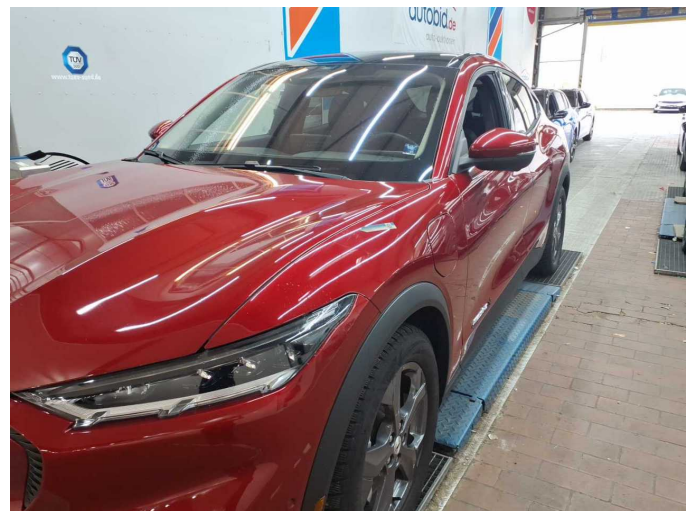
| No. | Component group | Description |
|---|---|---|
| 9 | Mudguard - right side | Mudguard - right side - Scratch(es) - Paint |

**Damage 9:** Mudguard - right side: Mudguard - right side - Scratch(es) - Paint

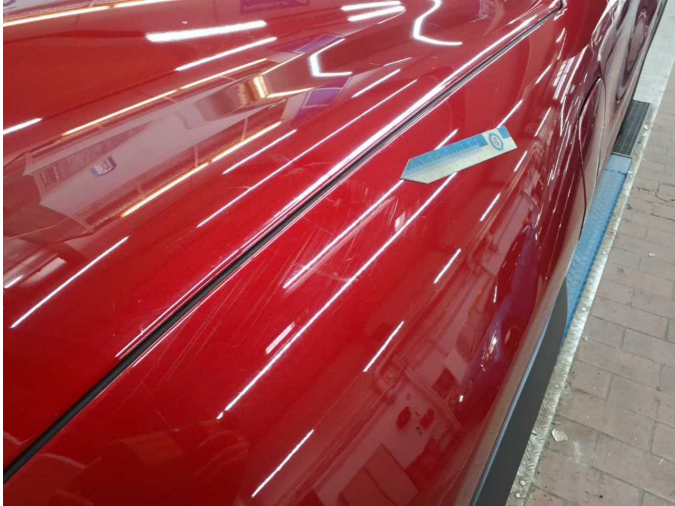
**Damage 9:** Mudguard - right side: Mudguard - right side - Scratch(es) - Paint

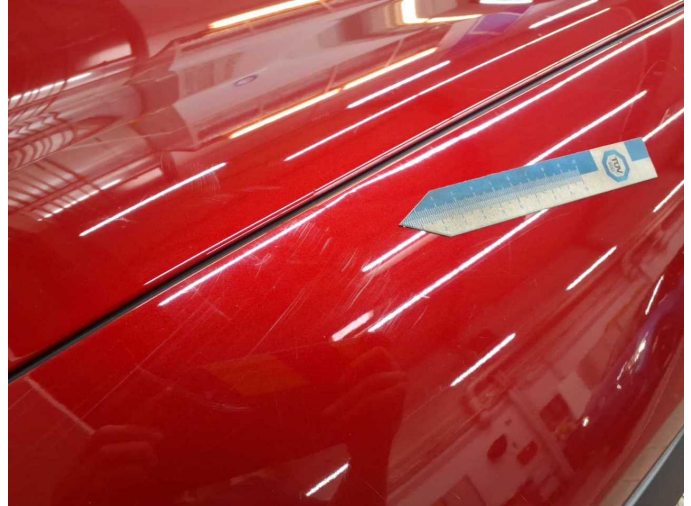
**Damage 9:** Mudguard - right side: Mudguard - right side - Scratch(es) - Paint

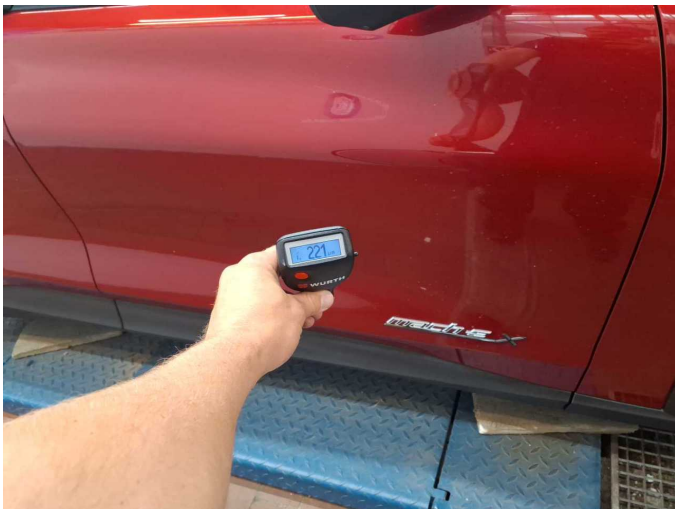
| No. | Repainting |
|---|---|
| 1 | Door - rear right side, Door - front right side, Professionally carried out, Invoice of repair done Non-existent |

| Door - rear right side | 192 µm | Door - front right side | 221 µm |

**Repainting 1:** Door - rear right side, Door - front right side

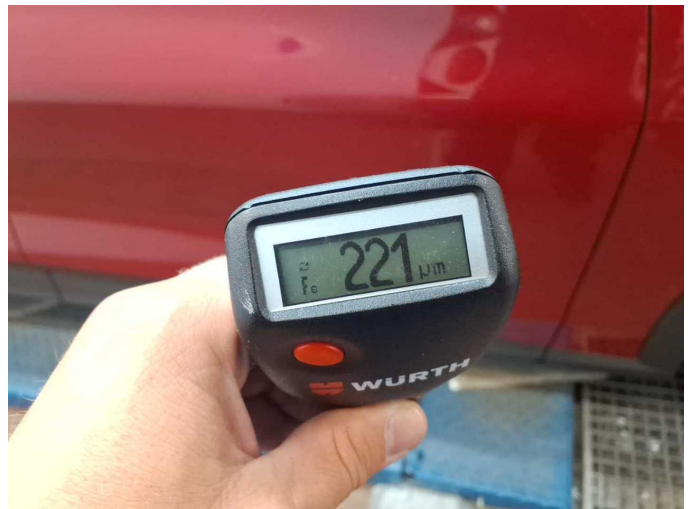
**Repainting 1:** Door - rear right side, Door - front right side

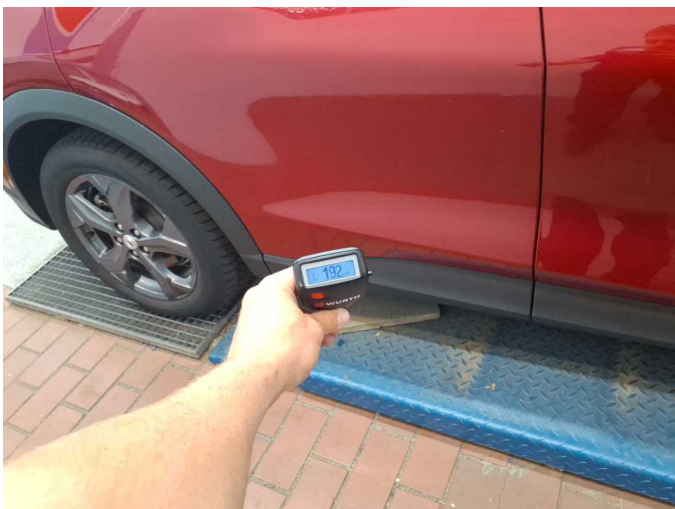
**Repainting 1:** Door - rear right side, Door - front right side

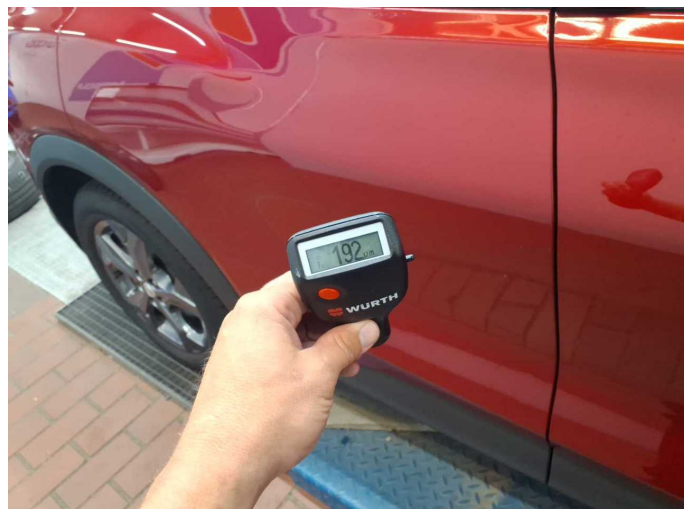
**Repainting 1:** Door - rear right side, Door - front right side
