Expertise

Protocol number: 46629531  
Order No. / Reference: 26601110  
Inspection date: 21 Jul 2026

Manufacturer: Iveco

Model: Daily Kasten 35 S 14N Aut.8 V Blue Power

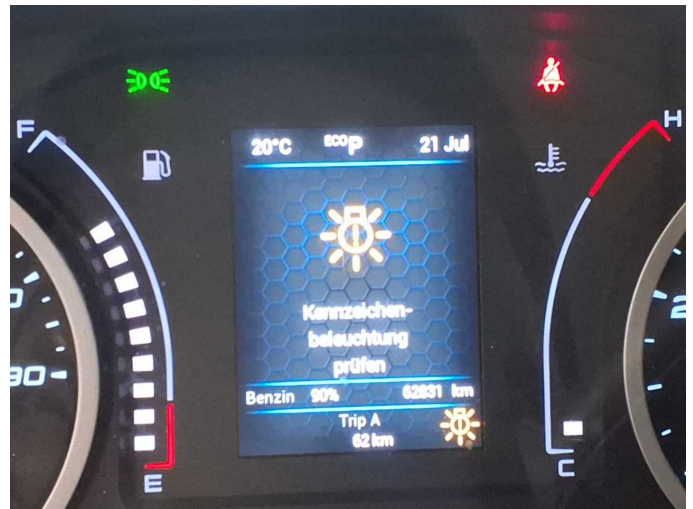
| No. | Component group | Description |
|---|---|---|
| 1 | Tail light | License plate lamp - left side - Specify findings - Perform diagnosis |

Damage 1: Tail light: License plate lamp - left side - Specify findings - Perform diagnosis

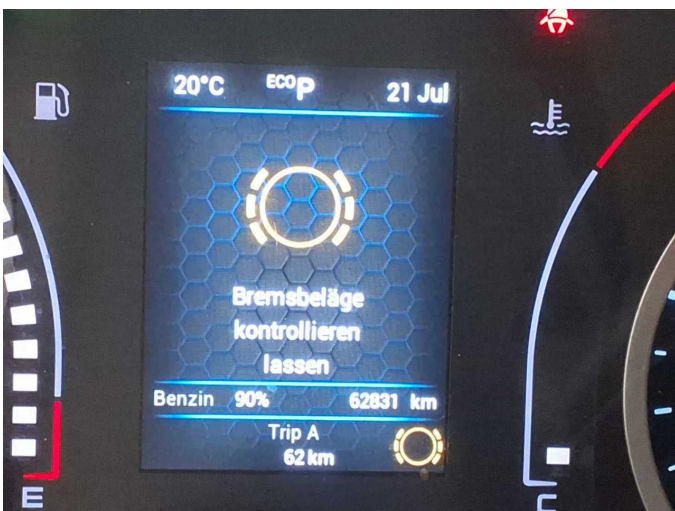
| No. | Component group | Description |
|---|---|---|
| 3 | Braking system | Braking system (Bremsbelag Verschleißsensor aktiv, Mehrkosten wahrscheinlich) - Specify findings - Perform diagnosis |

Damage 3: Braking system: Braking system (Bremsbelag Verschleißsensor aktiv, Mehrkosten wahrscheinlich) - Specify findings - Perform diagnosis

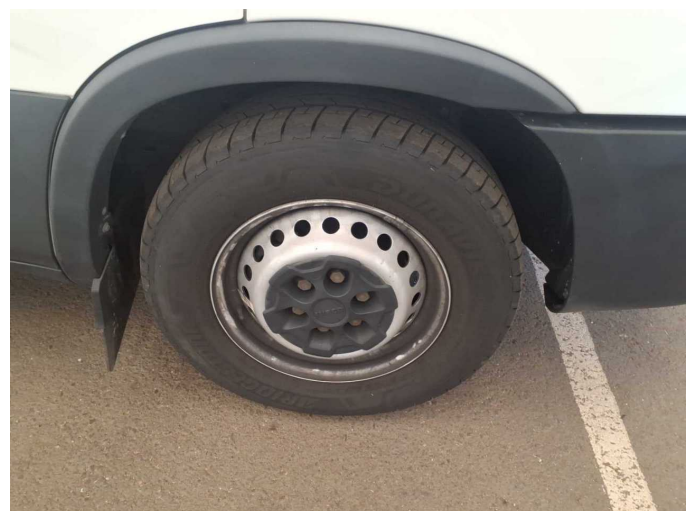
Damage 3: Braking system: Braking system (Bremsbelag Verschleißsensor aktiv, Mehrkosten wahrscheinlich) - Specify findings - Perform diagnosis

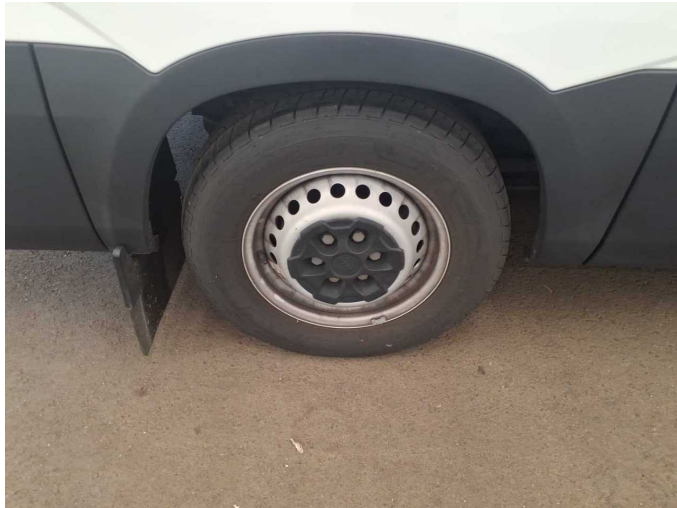
**Damage 3:** Braking system: Braking system (Bremsbelag Verschleißsensor aktiv, Mehrkosten wahrscheinlich) - Specify findings - Perform diagnosis

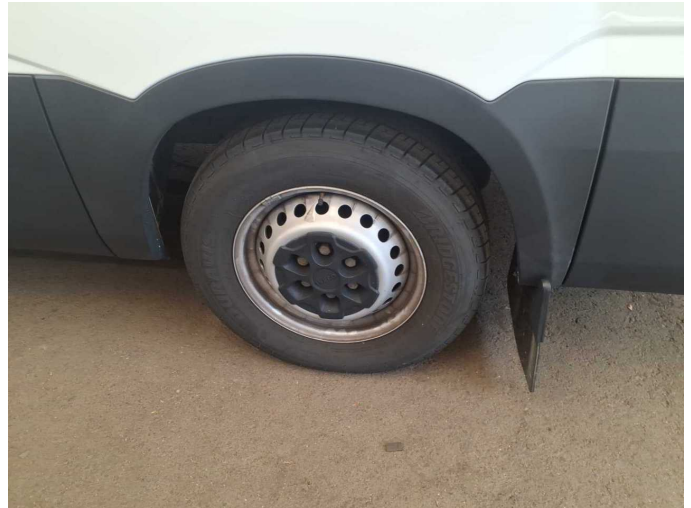
**Damage 3:** Braking system: Braking system (Bremsbelag Verschleißsensor aktiv, Mehrkosten wahrscheinlich) - Specify findings - Perform diagnosis

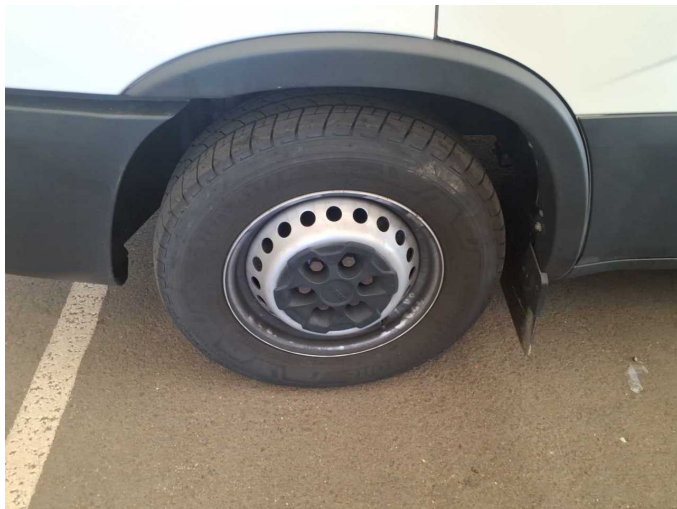
**Damage 3:** Braking system: Braking system (Bremsbelag Verschleißsensor aktiv, Mehrkosten wahrscheinlich) - Specify findings - Perform diagnosis

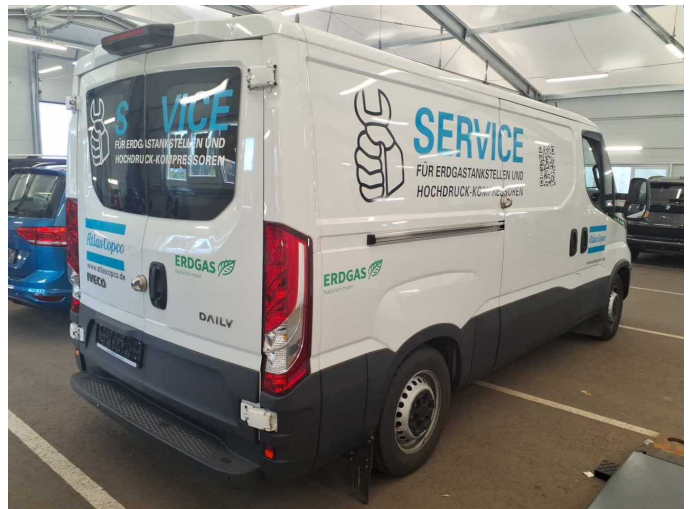
| No. | Component group | Description |
|---|---|---|
| 4 | Body | Body - Glued / labelled - De-glue / neutralise |

**Damage 4:** Body: Body - Glued / labelled - De-glue / neutralise

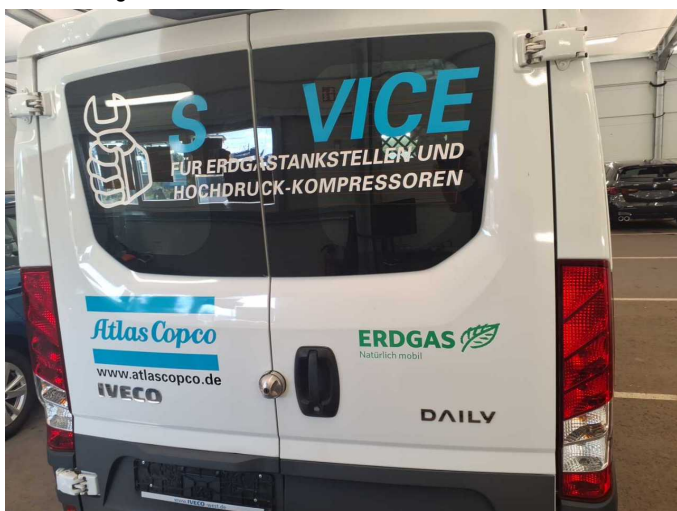
**Damage 4:** Body: Body - Glued / labelled - De-glue / neutralise

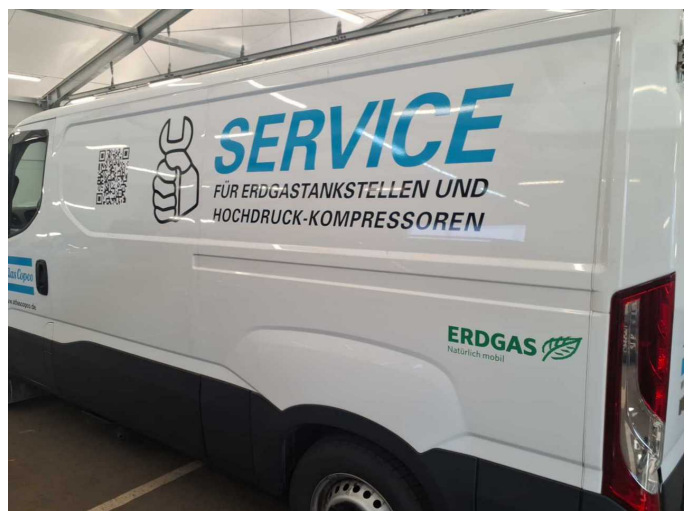
**Damage 4:** Body: Body - Glued / labelled - De-glue / neutralise

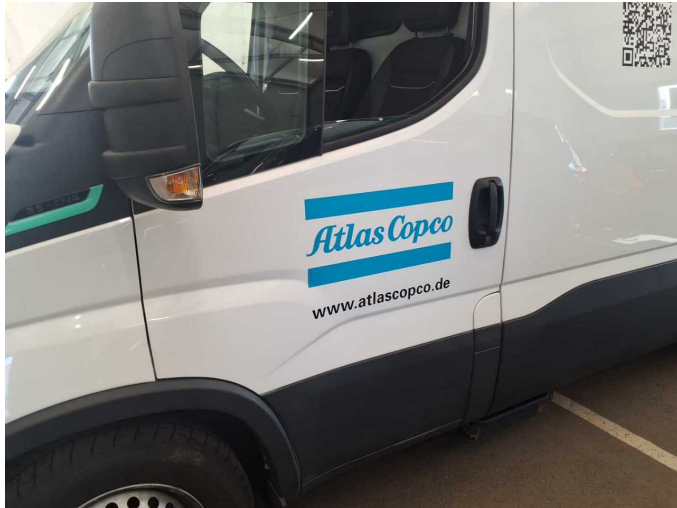
**Damage 4:** Body: Body - Glued / labelled - De-glue / neutralise

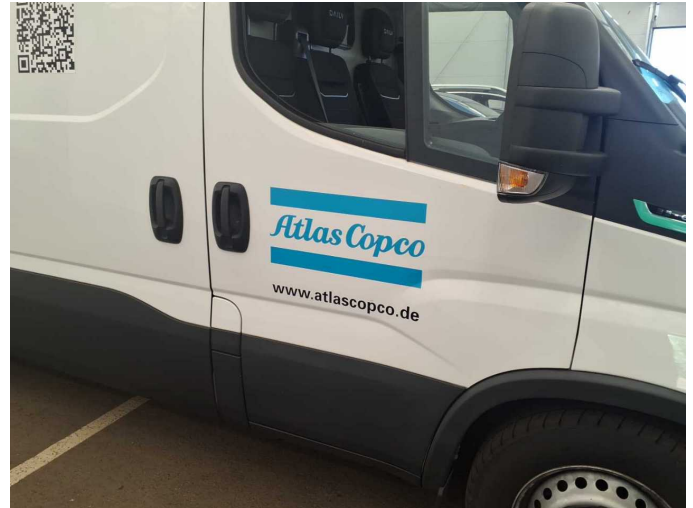
**Damage 4:** Body: Body - Glued / labelled - De-glue / neutralise

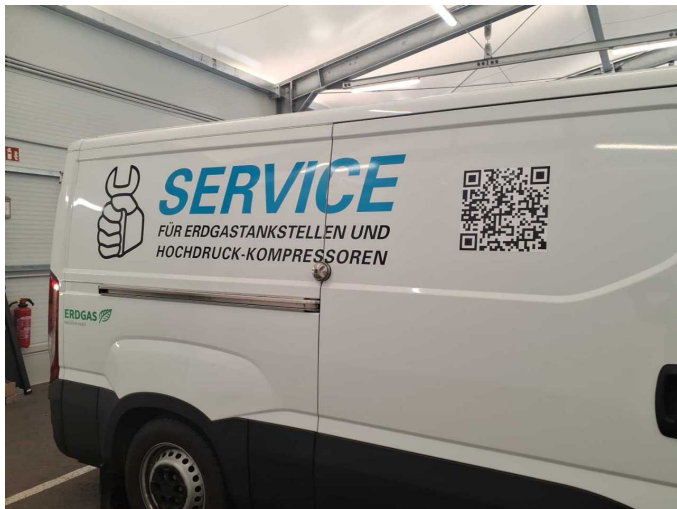
**Damage 4:** Body: Body - Glued / labelled - De-glue / neutralise

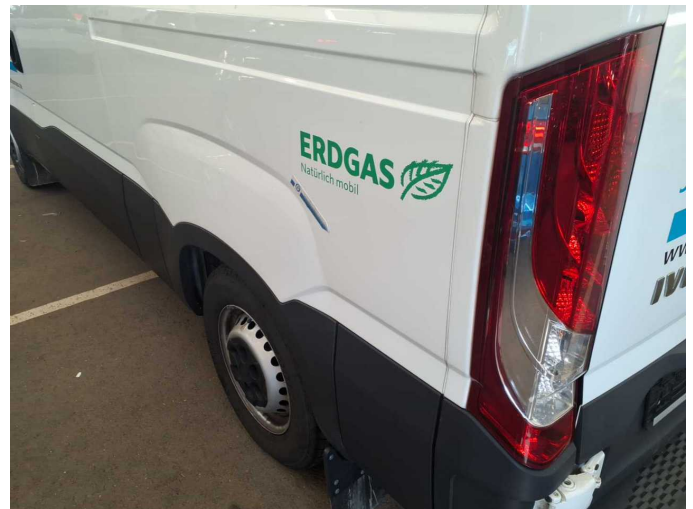
| No. | Component group | Description |
|---|---|---|
| 5 | Side panel - rear left side | Side panel - Dent / paintcoat damage - Repair and paint |

**Damage 5:** Side panel - rear left side: Side panel - Dent / paintcoat damage - Repair and paint

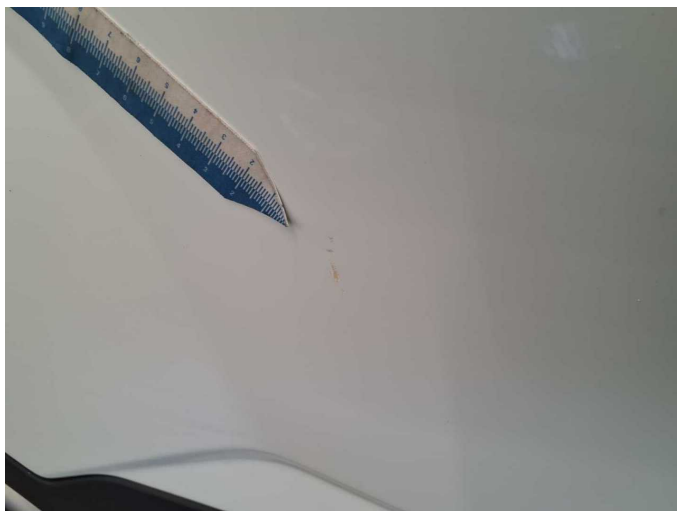
**Damage 5:** Side panel - rear left side: Side panel - Dent / paintcoat damage - Repair and paint

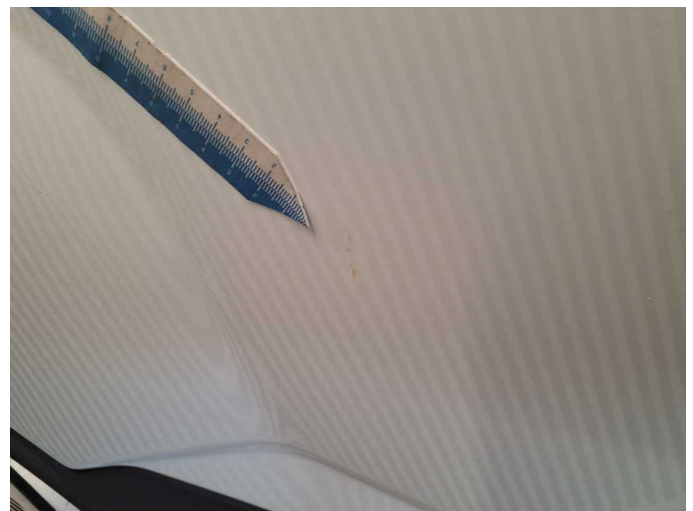
**Damage 5:** Side panel - rear left side: Side panel - Dent / paintcoat damage - Repair and paint

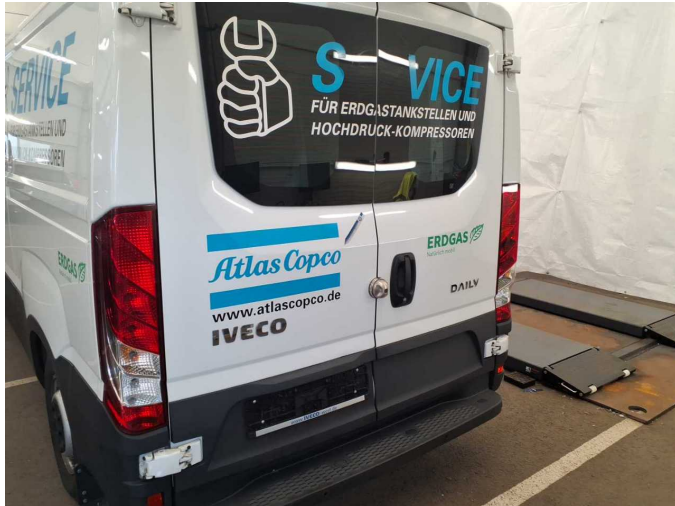
| No. | Component group | Description |
|---|---|---|
| 6 | Boot lid / rear door | Rear door - left side - Deformed - Repair and paint |

**Damage 6:** Boot lid / rear door: Rear door - left side - Deformed - Repair and paint

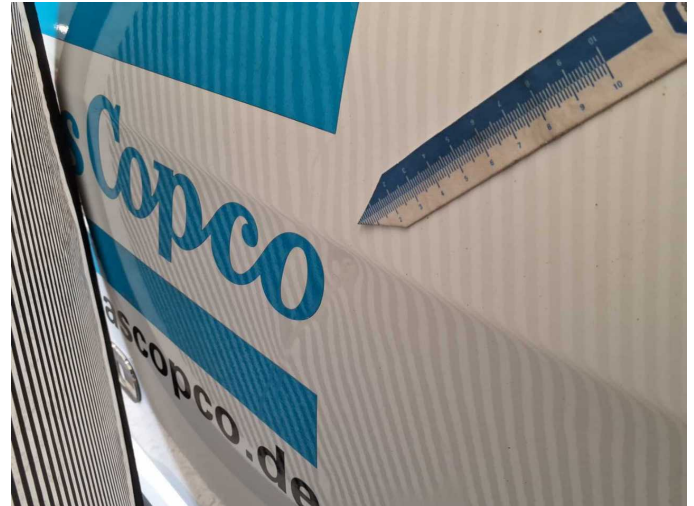
**Damage 6:** Boot lid / rear door: Rear door - left side - Deformed - Repair and paint

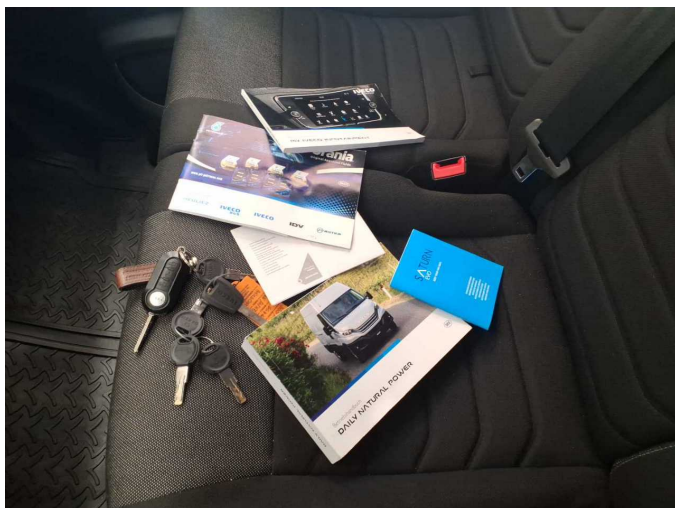
**Missing part 1:** Documents: Service book - Missing - Replace
