Expertise

Protocol number: 46532533  
Order No. / Reference: 26587673  
Inspection date: 10 Jul 2026

Manufacturer: Volkswagen

Model: Touran 2.0 TDI SCR DSG Comfortline

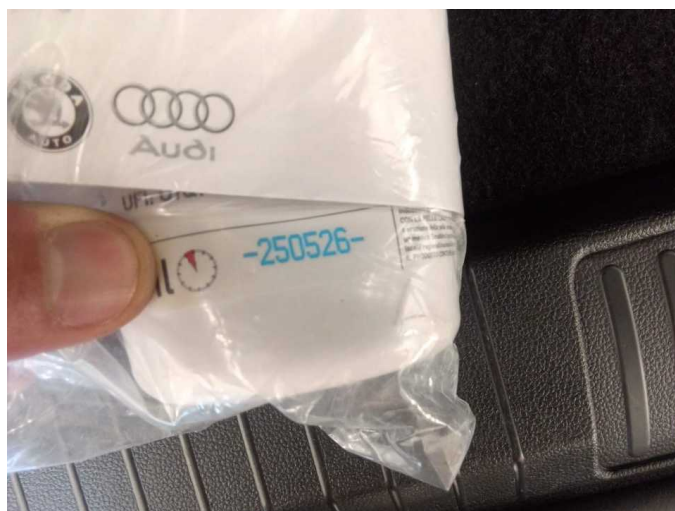
| No. | Component group | Description |
|---|---|---|
| 1 | Equipment | Tirefit filler - Expired - Replace |

Damage 1: Equipment: Tirefit filler - Expired - Replace

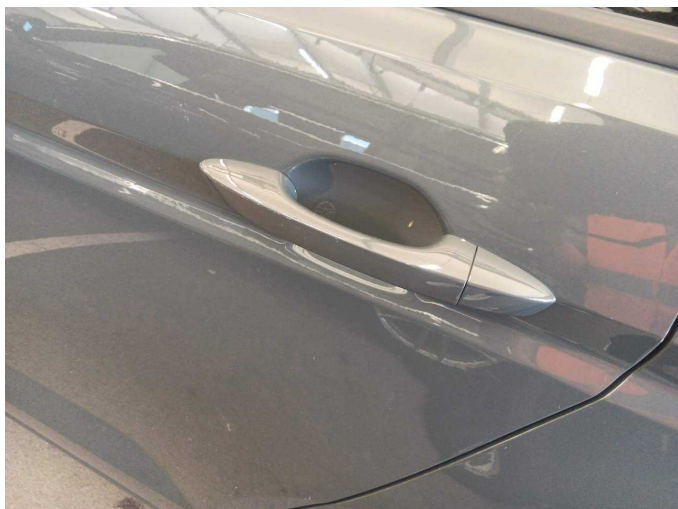
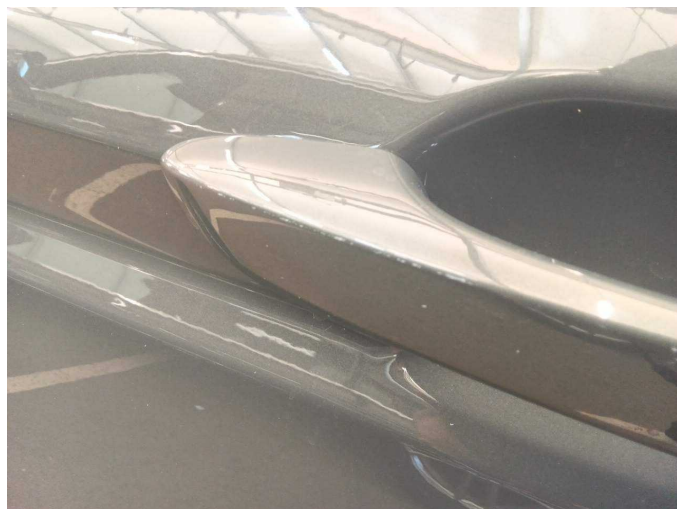
| No. | Component group | Description |
|---|---|---|
| 2 | Door - rear left side | Door handle - outside - Scratch(es) - Smart repair |

**Damage 2:** Door - rear left side: Door handle - outside - Scratch(es) - Smart repair

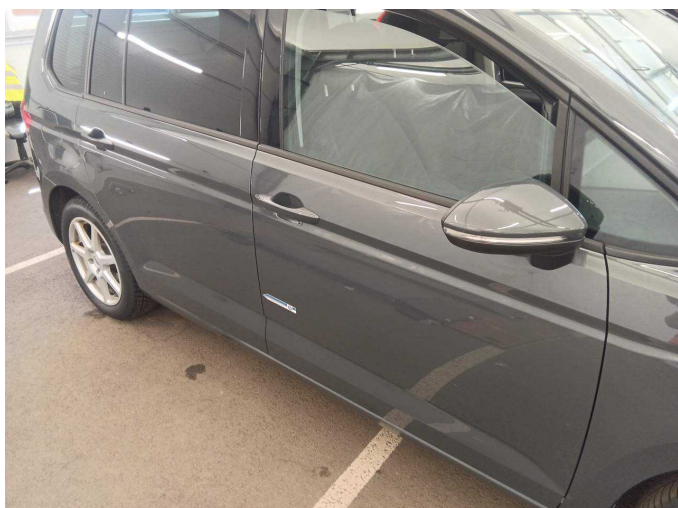
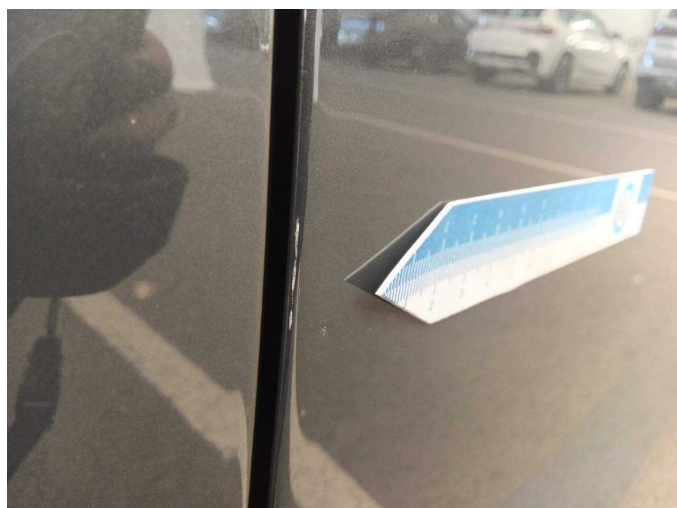
| No. | Component group | Description |
|---|---|---|
| 3 | Door - front right side | Door edge - Scratch(es) - Smart repair |

**Damage 3:** Door - front right side: Door edge - Scratch(es) - Smart repair

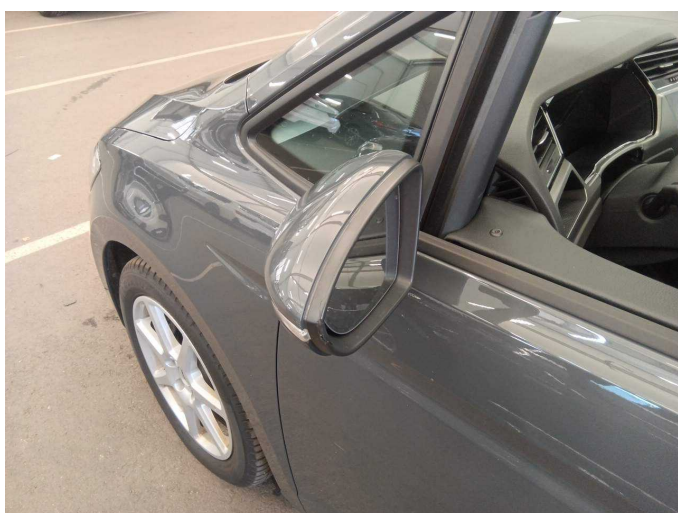
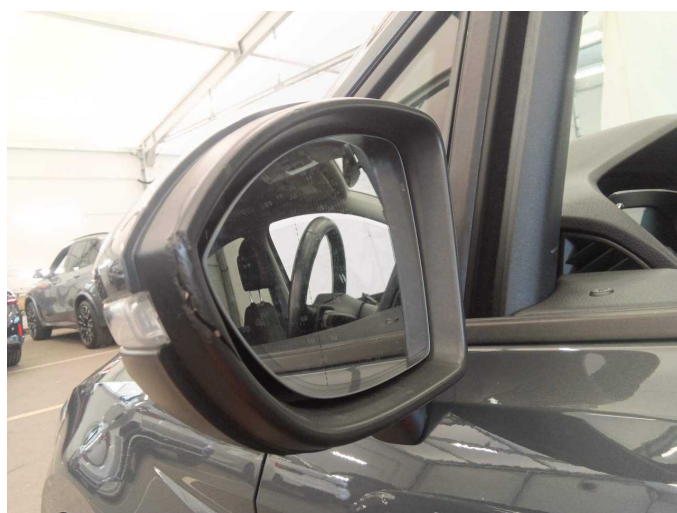
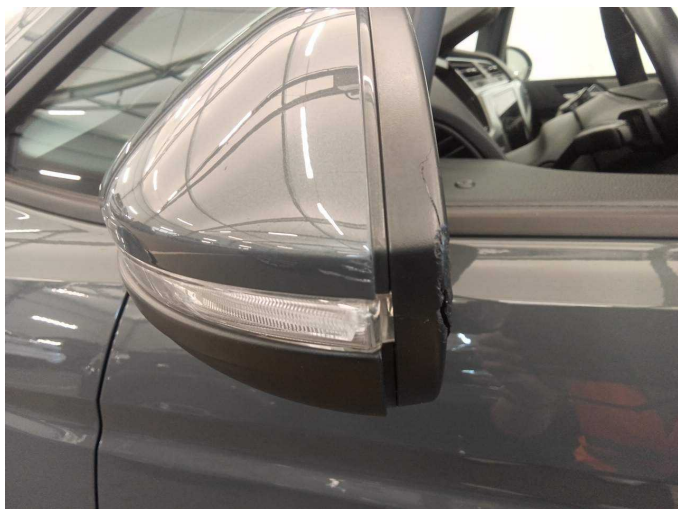
| No. | Component group | Description |
|---|---|---|
| 4 | Wing mirror - left side | Chassis - Broken / torn - Replace |

**Damage 4:** Wing mirror - left side: Chassis - Broken / torn - Replace

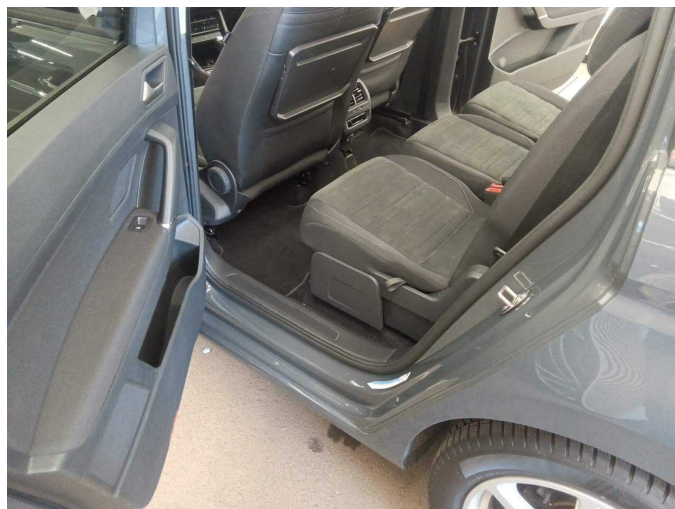
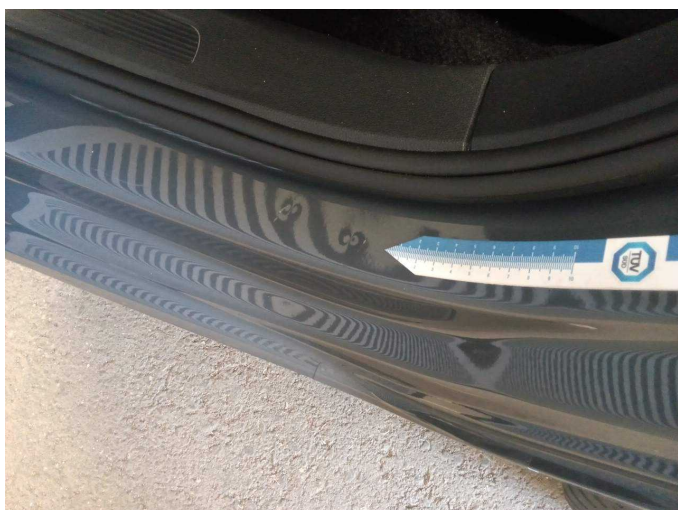
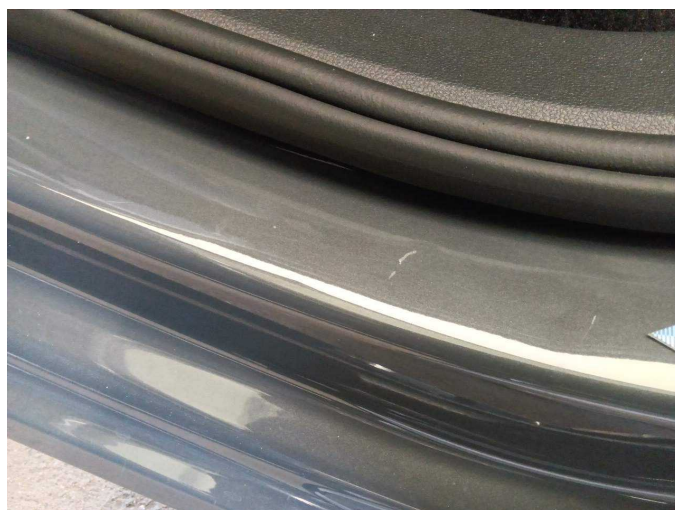
| No. | Component group | Description |
|---|---|---|
| 5 | Side panel - rear left side | Sill - Dent / paintcoat damage - Smart repair |

**Damage 5:** Side panel - rear left side: Sill - Dent / paintcoat damage - Smart repair

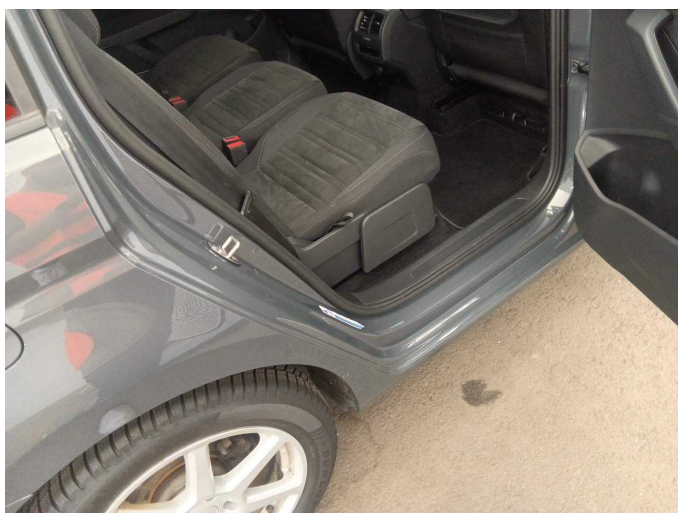
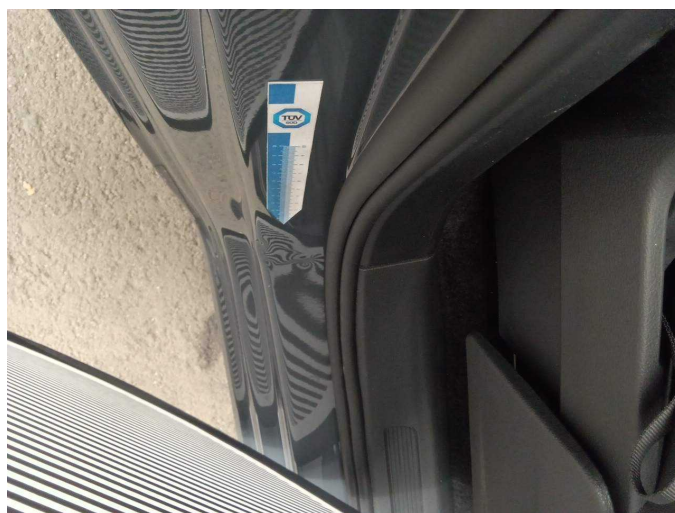
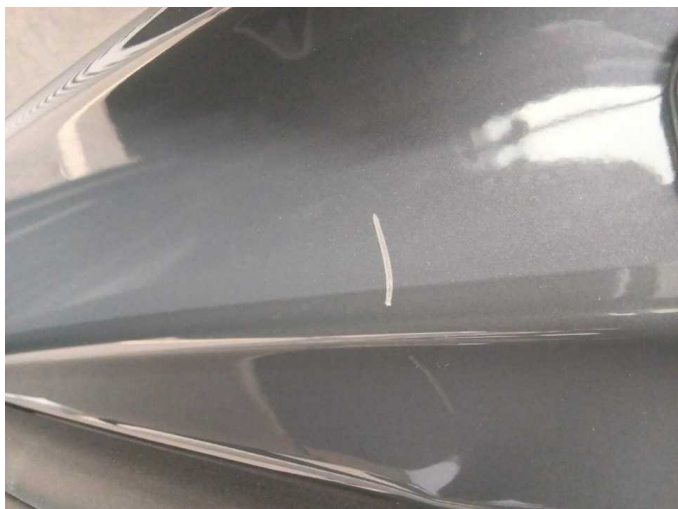
| No. | Component group | Description |
|---|---|---|
| 6 | Side panel - rear right side | Sill - Dent / paintcoat damage - Smart repair |

**Damage 6:** Side panel - rear right side: Sill - Dent / paintcoat damage - Smart repair

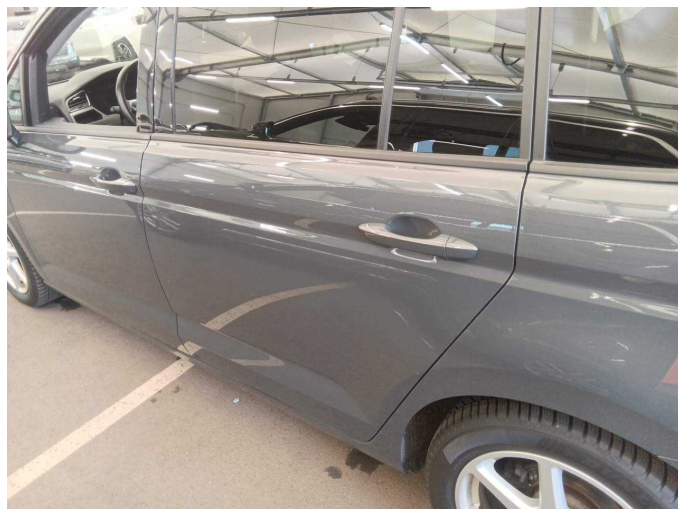
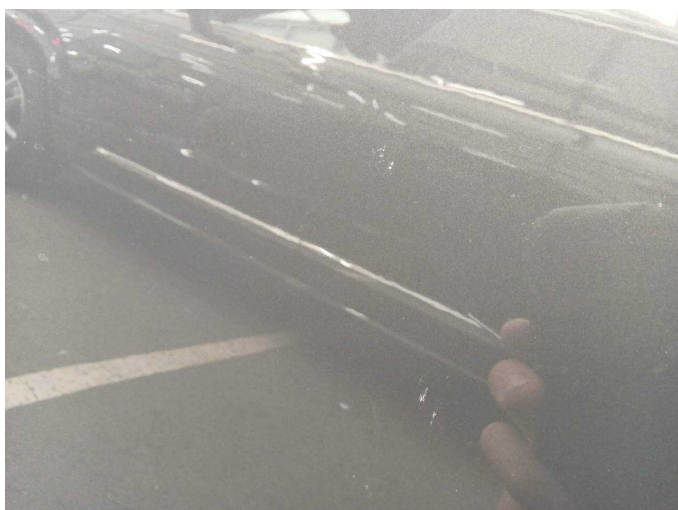
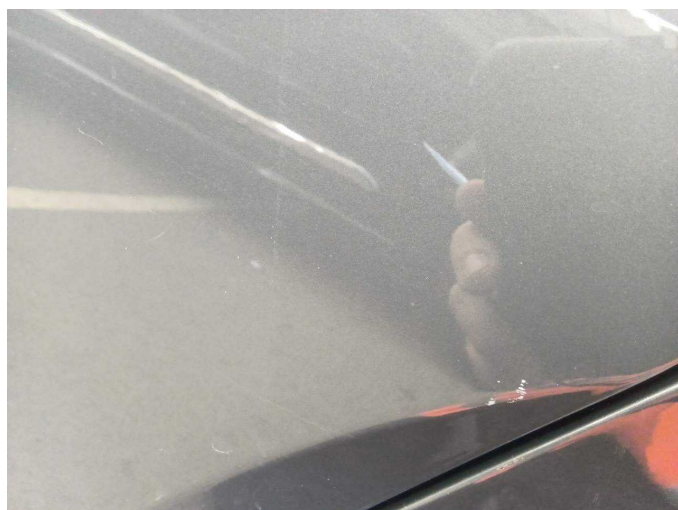
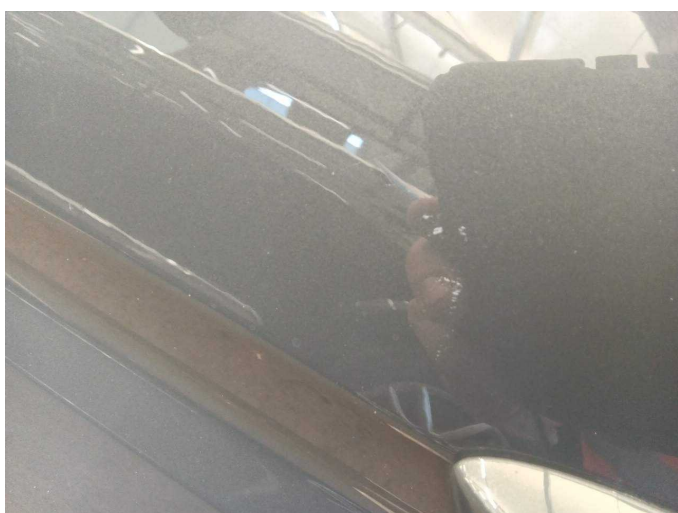
| No. | Component group | Description |
|---|---|---|
| 7 | Door - rear left side | Door - Scratch(es) - Paint |

**Damage 7:** Door - rear left side: Door - Scratch(es) - Paint

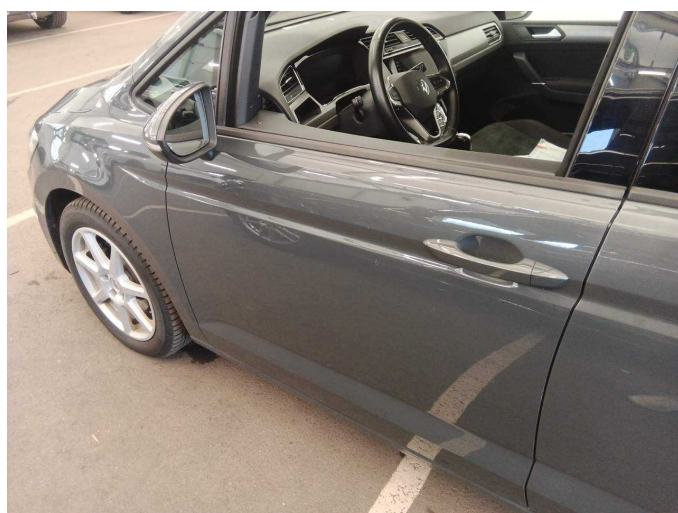
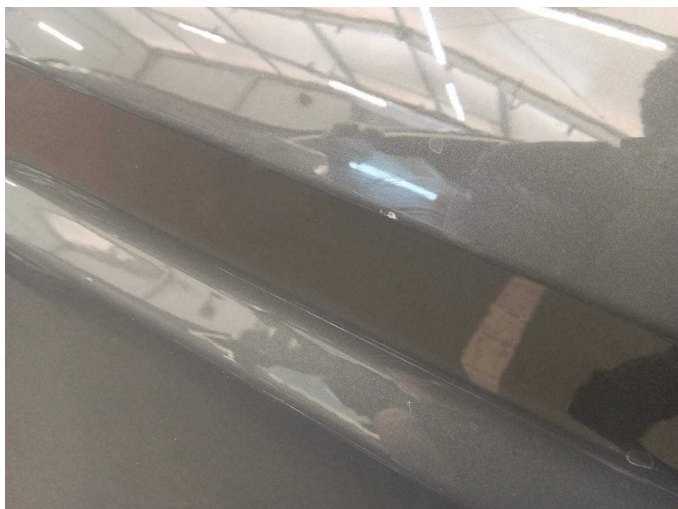
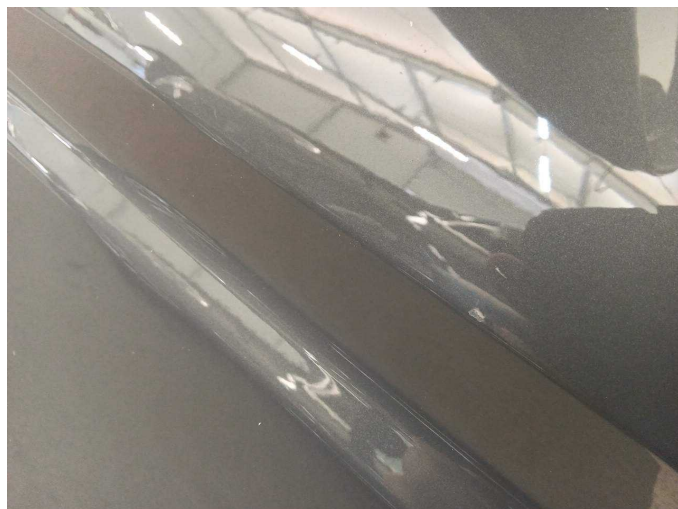
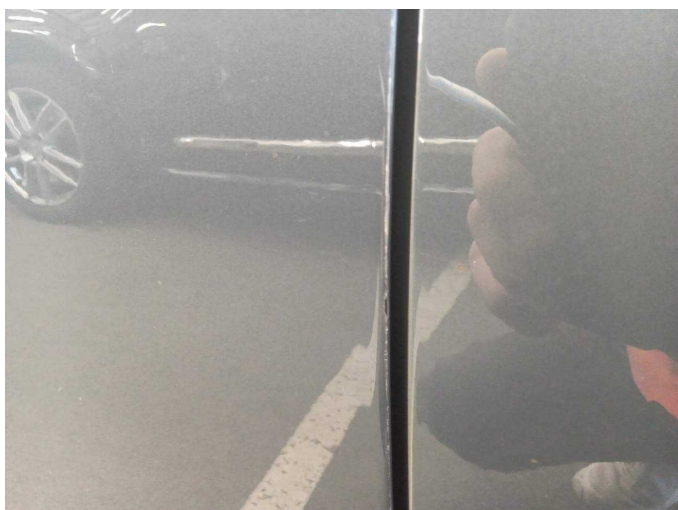
| No. | Component group | Description |
|---|---|---|
| 8 | Door - front left side | Door - Scratch(es) - Paint |

**Damage 8:** Door - front left side: Door - Scratch(es) - Paint

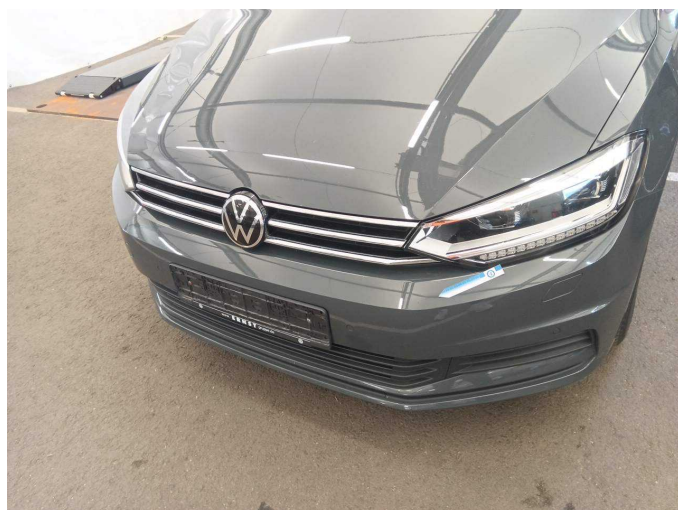
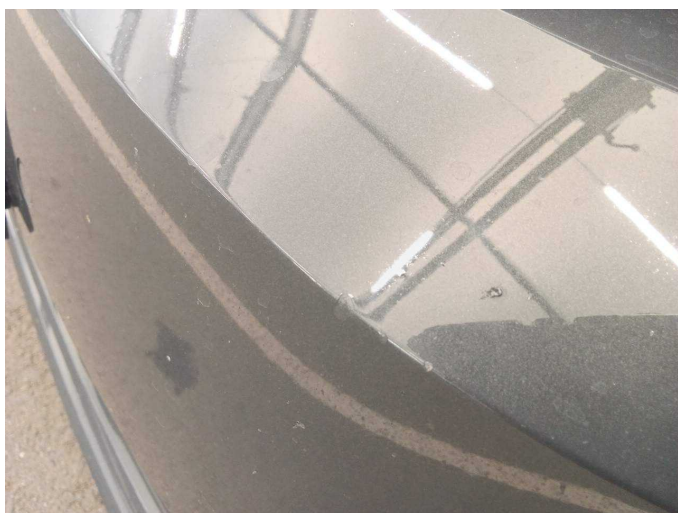
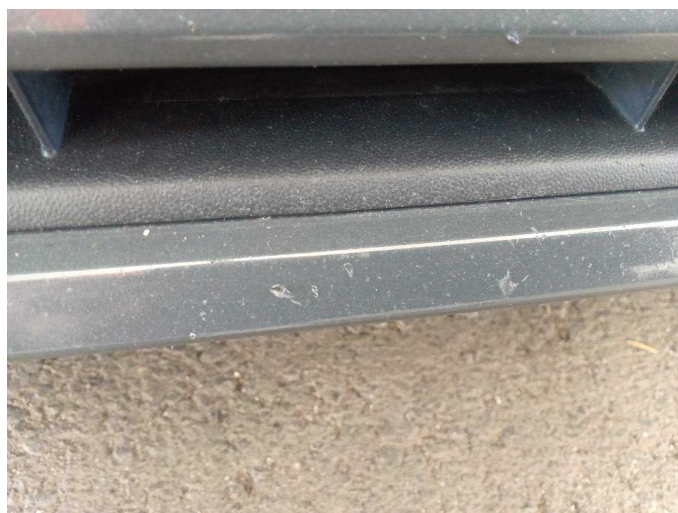
| No. | Component group | Description |
|---|---|---|
| 9 | Front bumper | Front bumper (Sandstrahleffekt) - Stone chips - Paint |

**Damage 9:** Front bumper: Front bumper (Sandstrahleffekt) - Stone chips - Paint

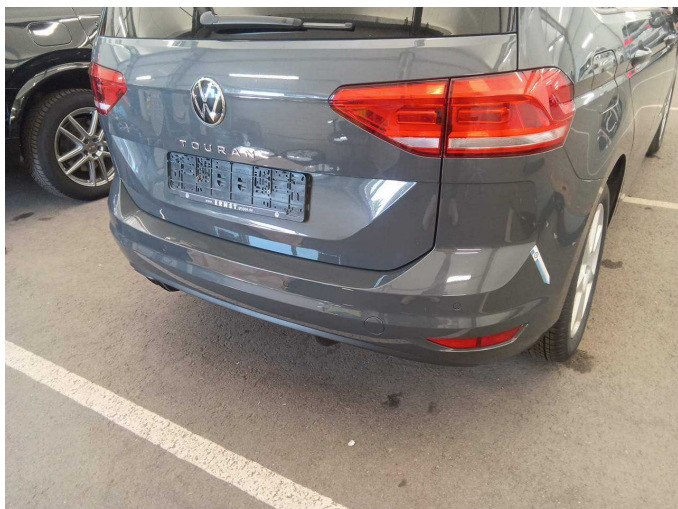
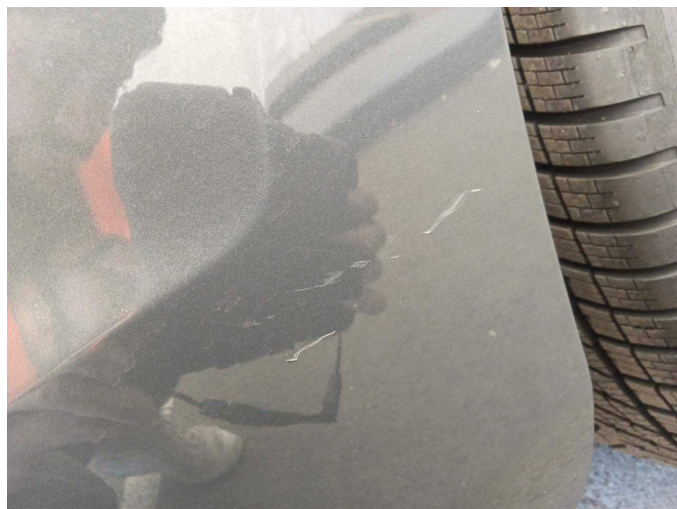
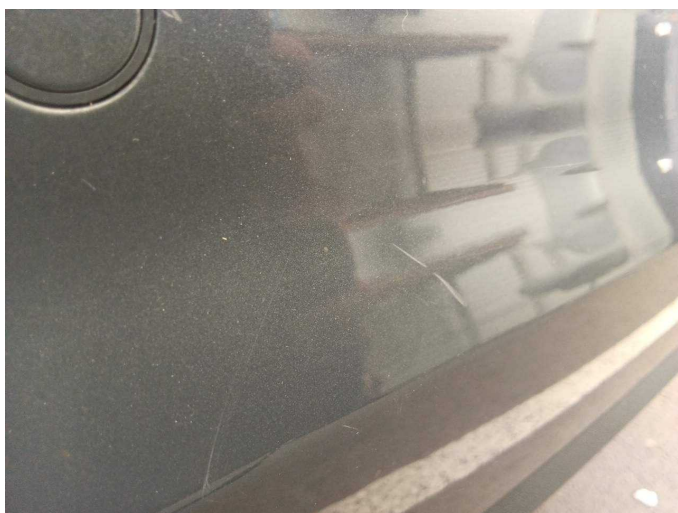
| No. | Component group | Description |
|---|---|---|
| 10 | Rear bumper | Rear bumper - Scratch(es) - Paint |

**Damage 10:** Rear bumper: Rear bumper - Scratch(es) - Paint

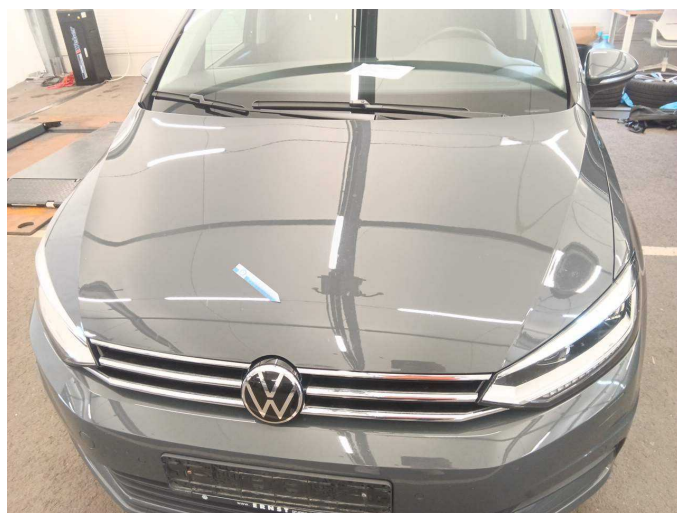
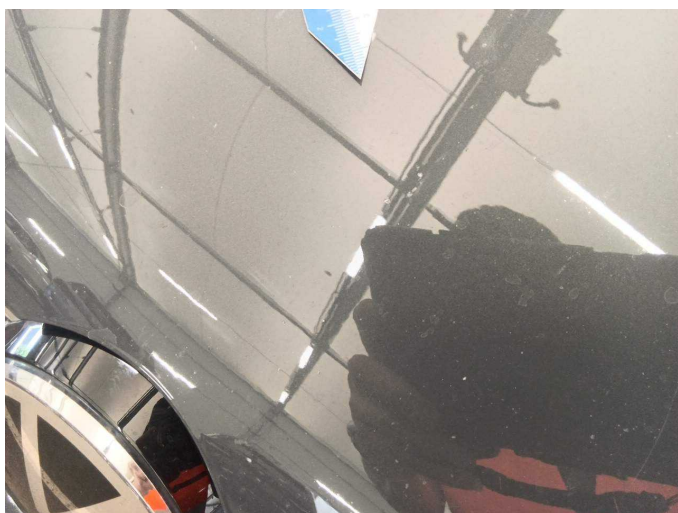
| No. | Component group | Description |
|---|---|---|
| 1 | Bonnet | Bonnet - Stone chips - No deduction |

**Wear and tear 1:** Bonnet: Bonnet - Stone chips - No deduction

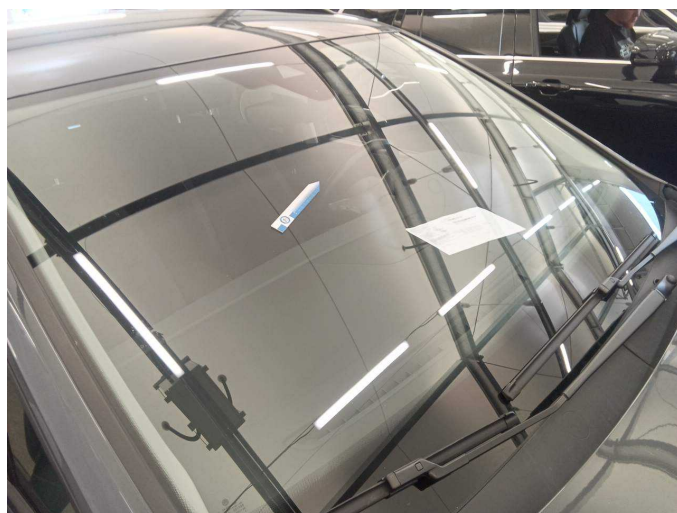
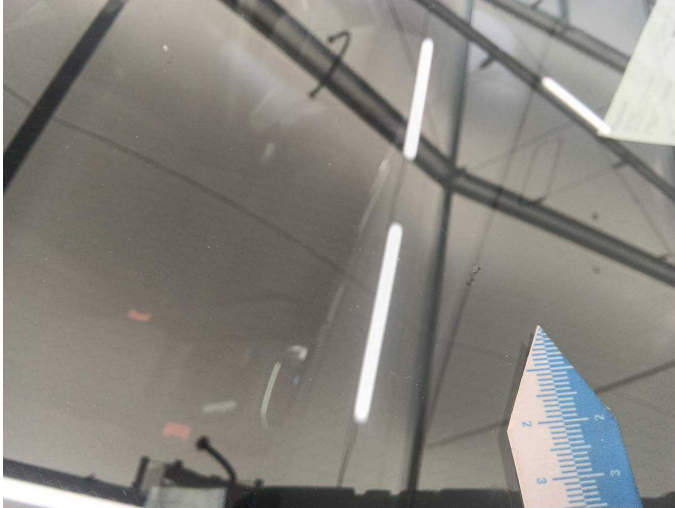
| No. | Component group | Description |
|---|---|---|
| 2 | Vehicle glazing | Windscreen - Stone chips - No deduction |

**Wear and tear 2:** Vehicle glazing: Windscreen - Stone chips - No deduction
