Expertise

Protocol number: 45857347
Order No. / Reference: 26472159
Inspection date: 9 Jun 2026

Manufacturer: Ford

Model: Mondeo 2.0 EcoBlue Aut. Trend

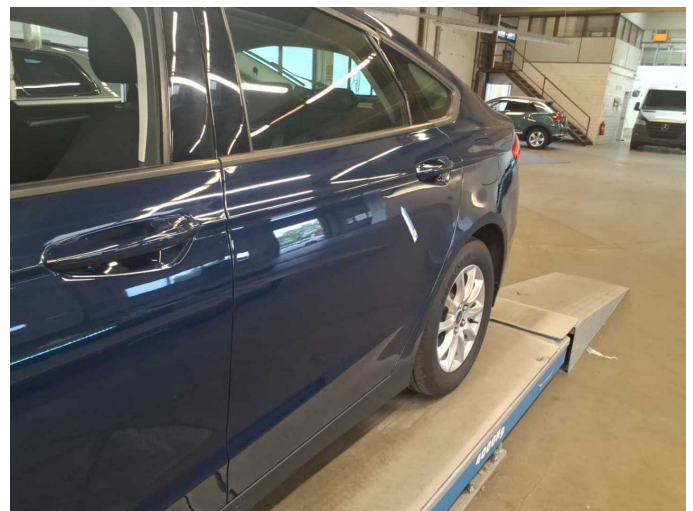
Damage 1: Door - rear left side: Door - dent(s) - Smooth repair work

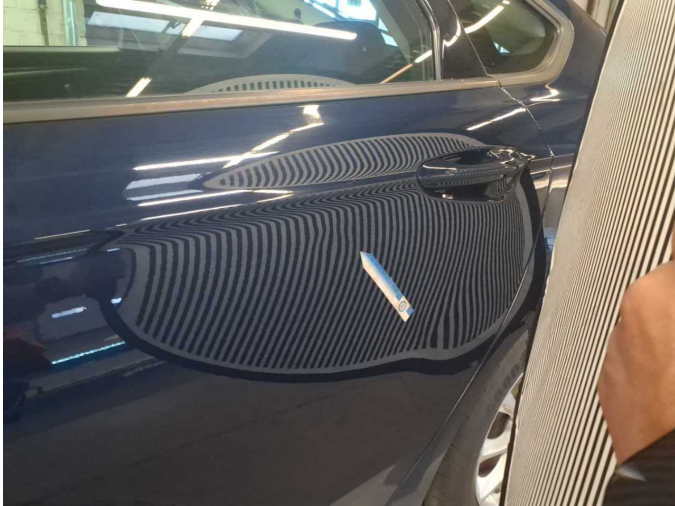
Damage 1: Door - rear left side: Door - dent(s) - Smooth repair work

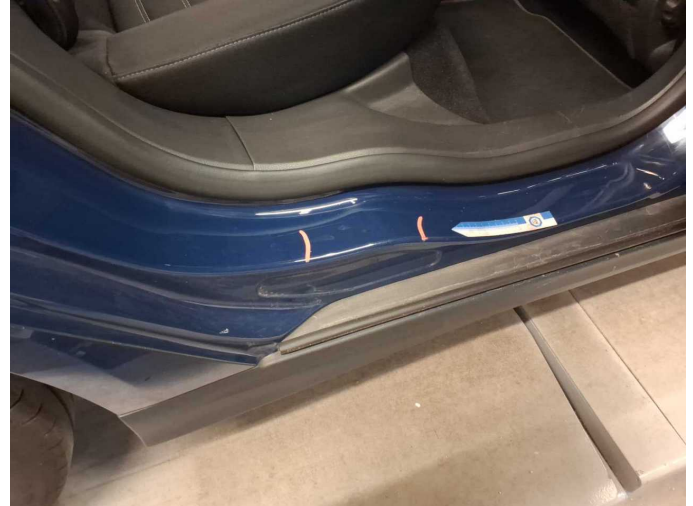
Damage 2: Side panel - rear right side: Sill - dent(s) - Smooth repair work

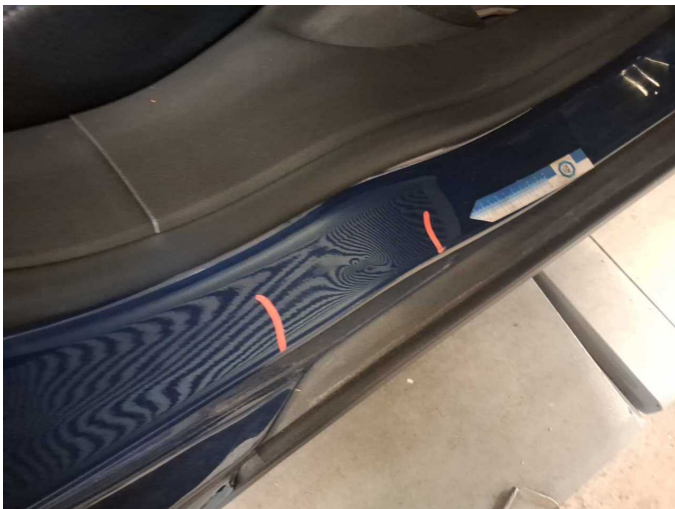
Damage 2: Side panel - rear right side: Sill - dent(s) - Smooth repair work

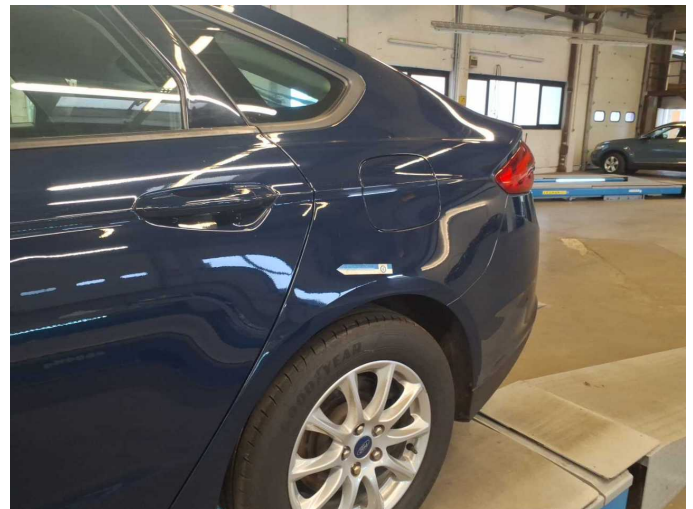
Damage 3: Side panel - rear left side: Side panel (Aufpolieren) - Scratch(es) - Smart repair

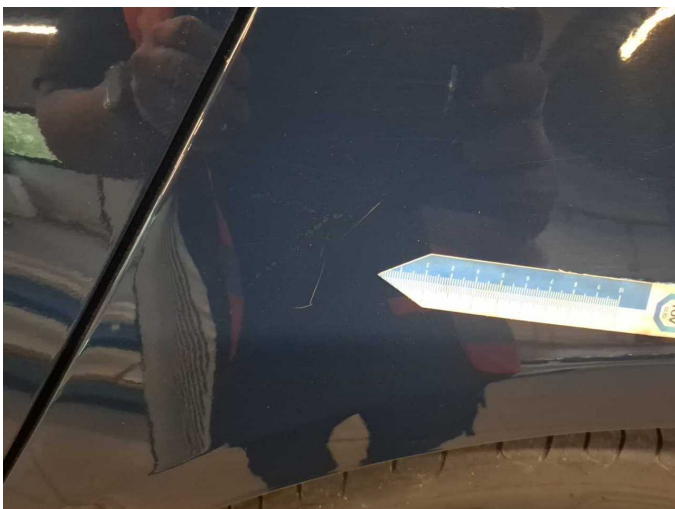
Damage 3: Side panel - rear left side: Side panel (Aufpolieren) - Scratch(es) - Smart repair

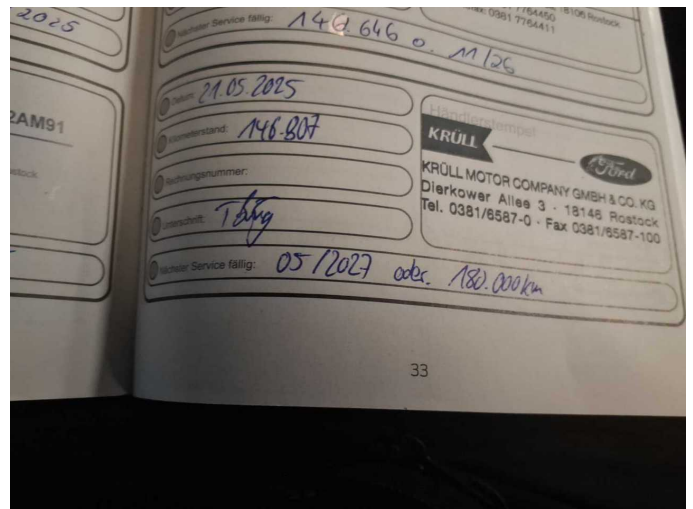
Restlaufzeit bis zum nächsten Service nicht anzeigbar!

Damage 4: Misc.: Inspection / maintenance - Due - Perform

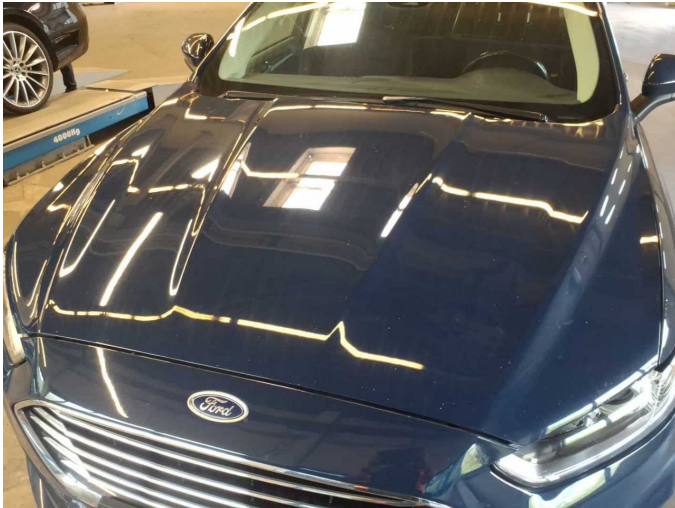
Wear and tear 1: Bonnet: Bonnet - Stone chips - No deduction

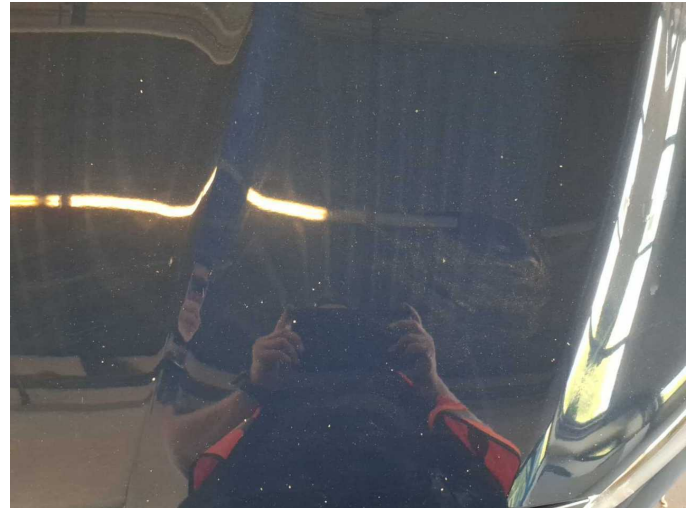
Wear and tear 1: Bonnet: Bonnet - Stone chips - No deduction

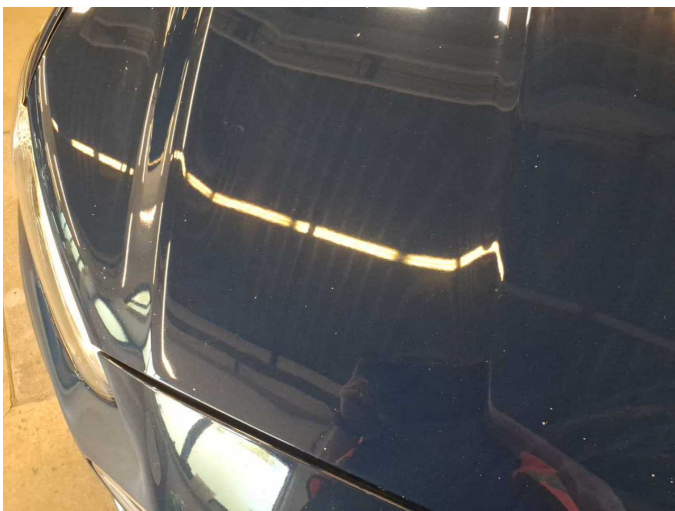
Wear and tear 1: Bonnet: Bonnet - Stone chips - No deduction

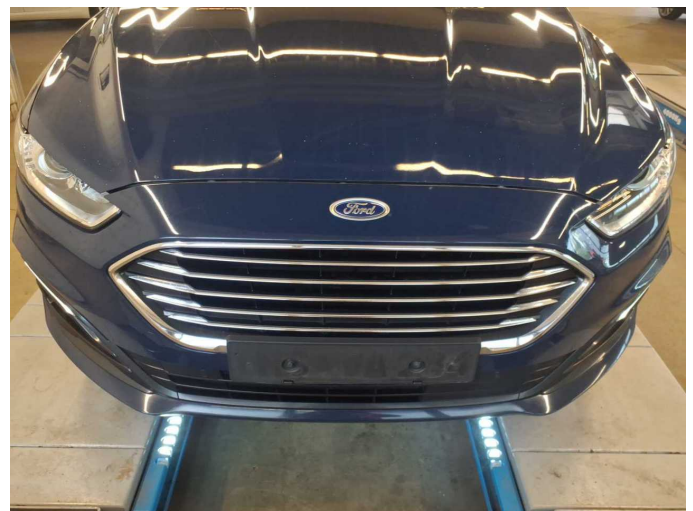
Wear and tear 2: Front bumper: Front bumper - Stone chips - No deduction

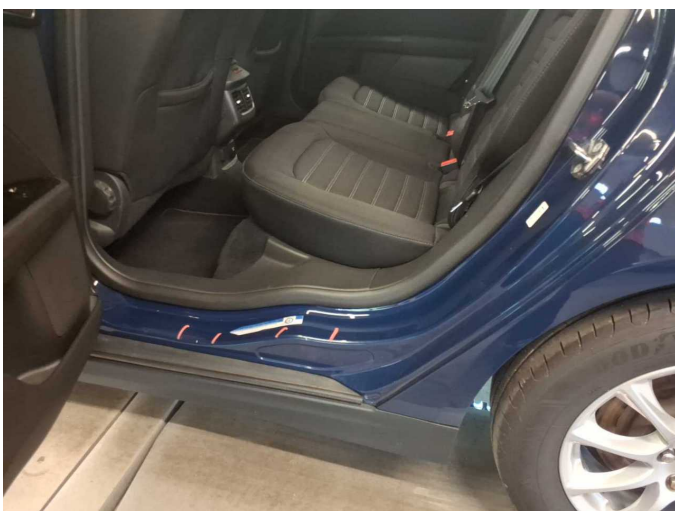
Wear and tear 3: Side panel - rear left side: Sill - Scratch(es) - No deduction

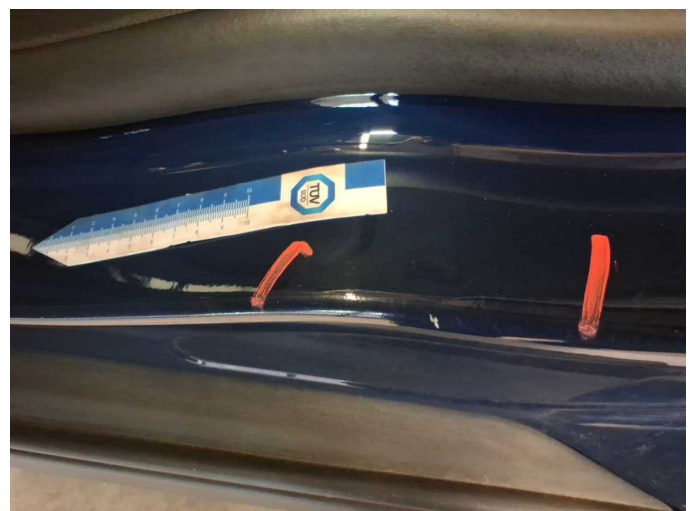
Wear and tear 3: Side panel - rear left side: Sill - Scratch(es) - No deduction

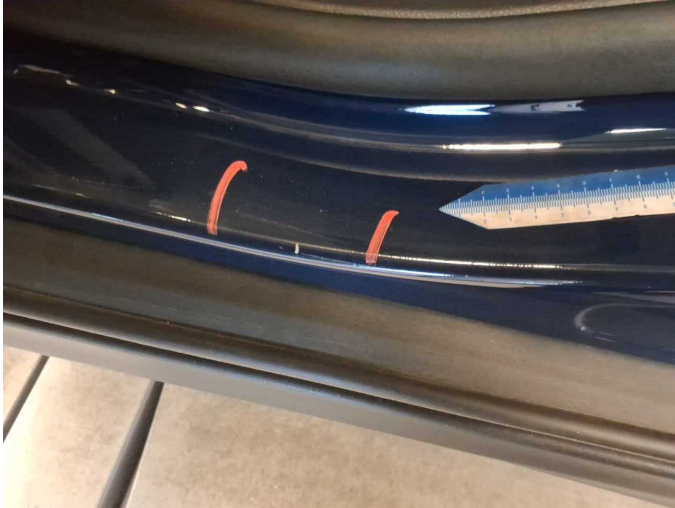
Wear and tear 3: Side panel - rear left side: Sill - Scratch(es) - No deduction

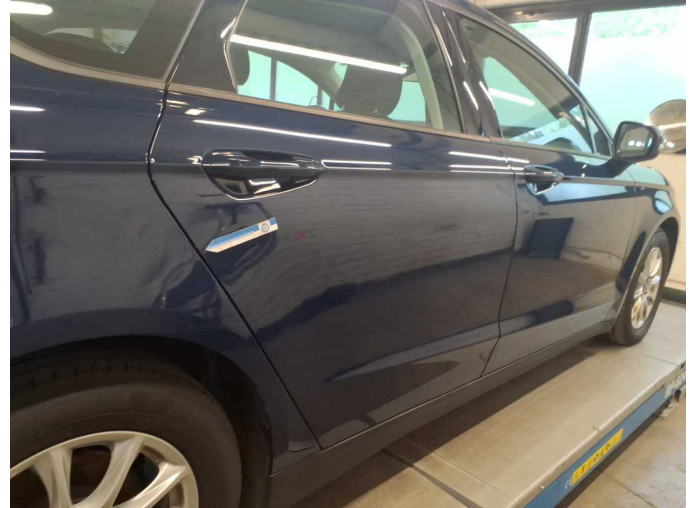
Wear and tear 4: Door - rear right side: Door edge - Scratch(es) - No deduction

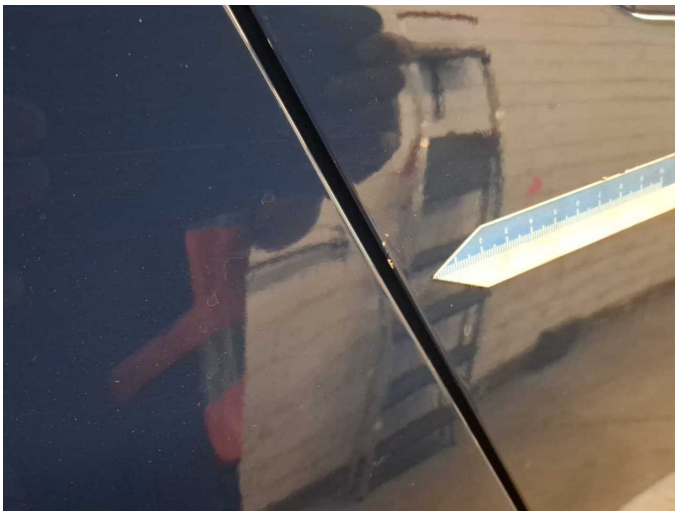
Wear and tear 4: Door - rear right side: Door edge - Scratch(es) - No deduction

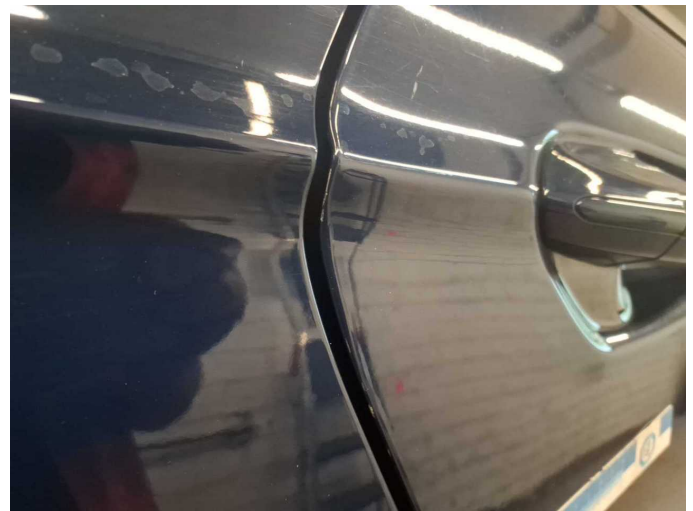
Wear and tear 4: Door - rear right side: Door edge - Scratch(es) - No deduction

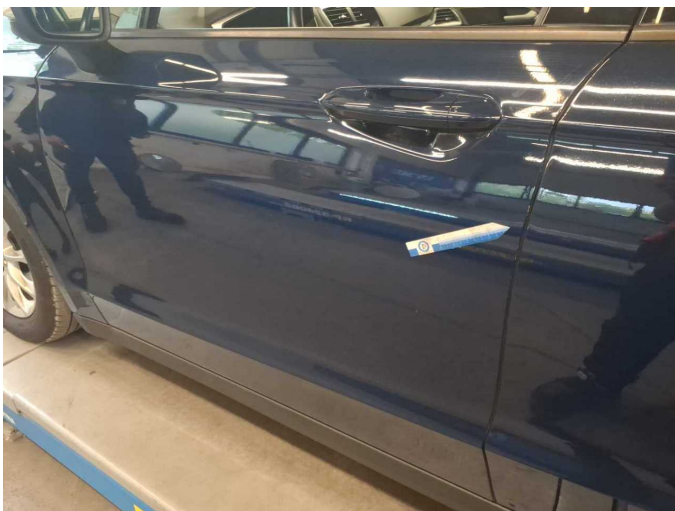
Wear and tear 5: Door - front left side: Door - Scratch(es) - No deduction

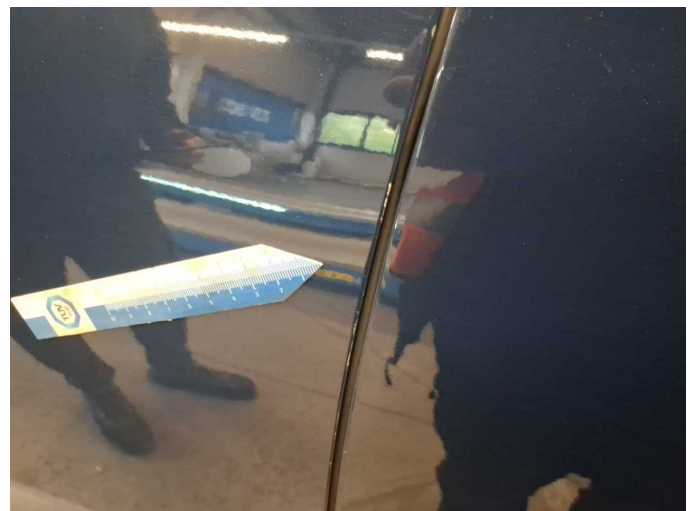
Wear and tear 5: Door - front left side: Door - Scratch(es) - No deduction

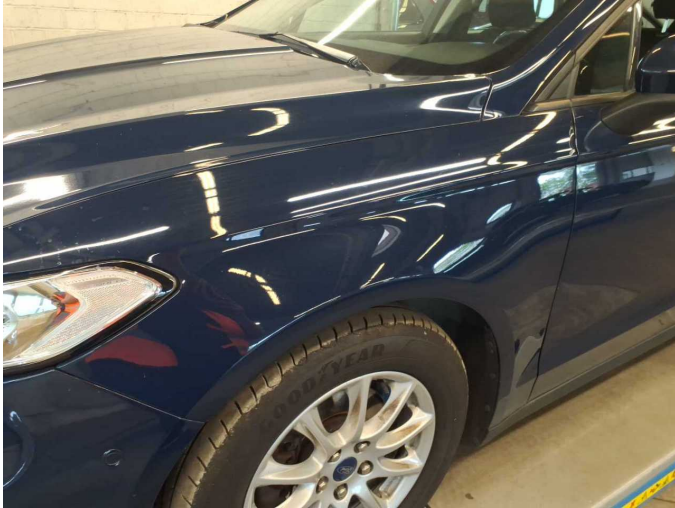
Mudguard - left side	167 µm	Side panel - rear left side	325 µm
----------------------	--------	-----------------------------	--------

Repainting 1: Mudguard - left side, Side panel - rear left side

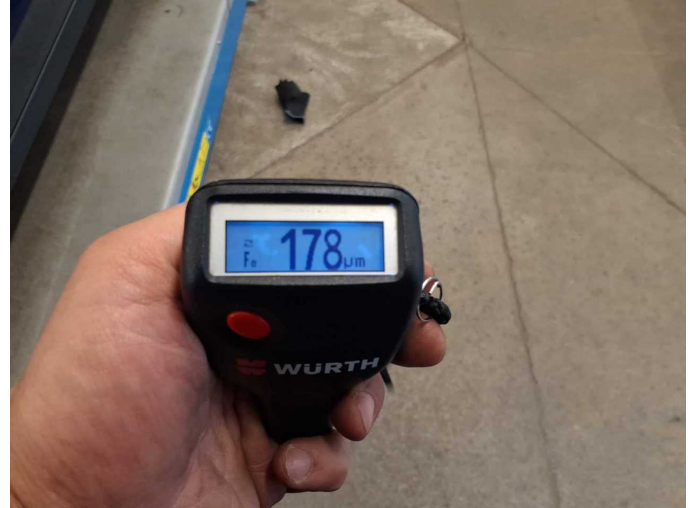
Repainting 1: Mudguard - left side, Side panel - rear left side

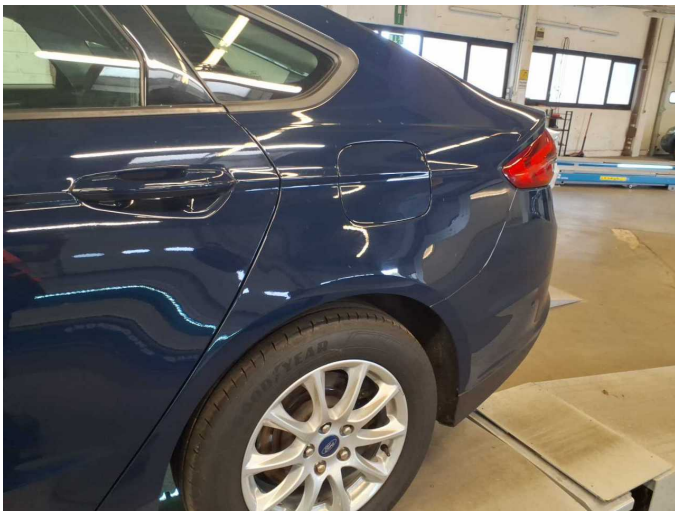
Repainting 1: Mudguard - left side, Side panel - rear left side

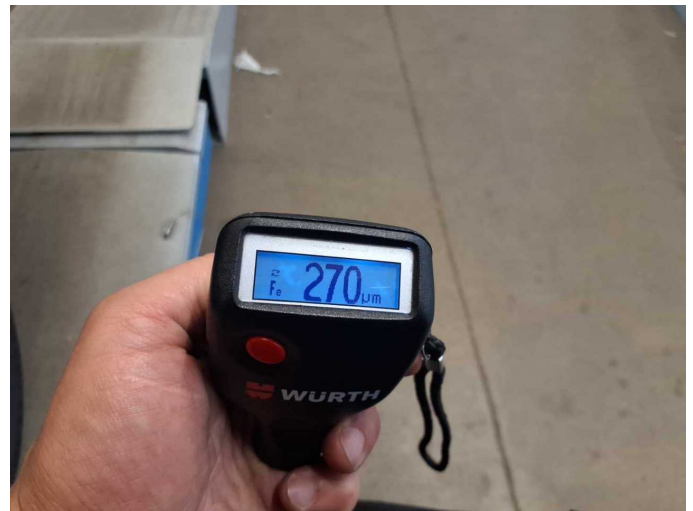
Repainting 1: Mudguard - left side, Side panel - rear left side
