## Expertise

Protocol number: 45581039  
Order No. / Reference: 26385196  
Inspection date: 22 May 2026

Model: Focus Turnier 1.5 EcoBlue Start-Stopp-System Aut. ST-LINE

VIN: WF0PXXGCHPPD63431

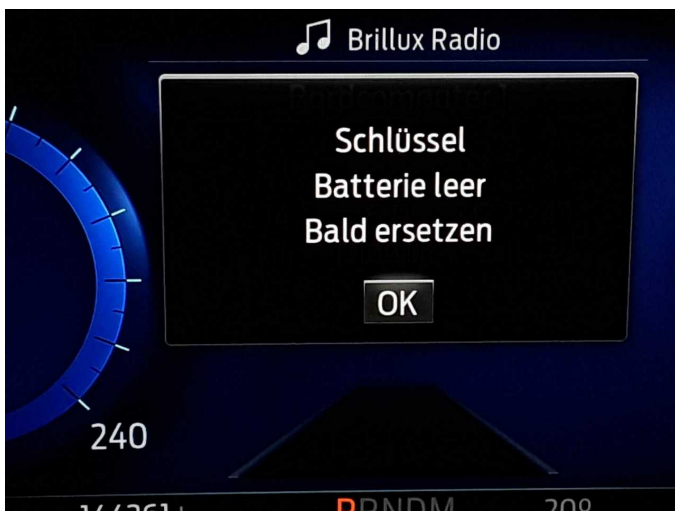
No.	Component group	Description
1	Equipment	Vehicle key - Empty - Replace
2	Bonnet	Insulation lining (Marderschaden) - Damage caused by marten / rodent - Replace
3	Sill - left side	Trim - Scratched - Smart repair
4	Boot lid / rear door	Boot lid - Dent / paintcoat damage - Repair and paint

Damage 1: Equipment: Vehicle key - Empty - Replace

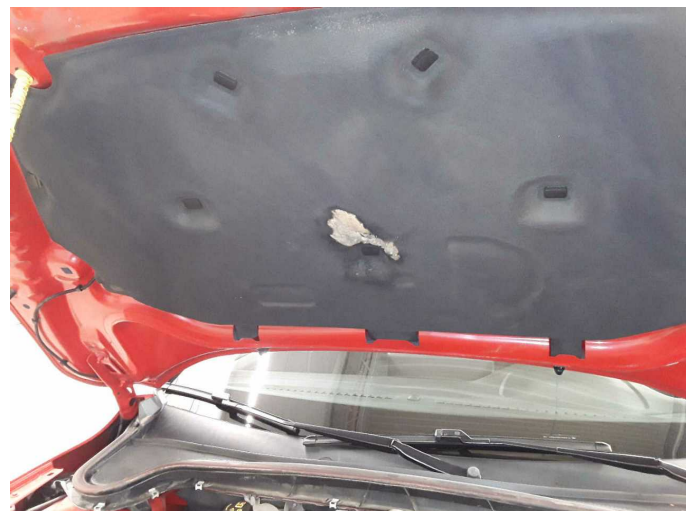
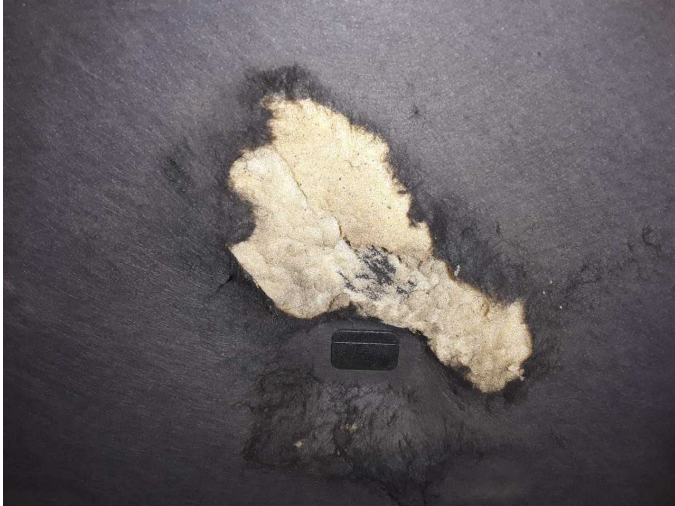
Damage 2: Bonnet: Insulation lining (Marderschaden) - Damage caused by marten / rodent - Replace

**Damage 2:** Bonnet: Insulation lining (Marderschaden) - Damage caused by marten / rodent - Replace

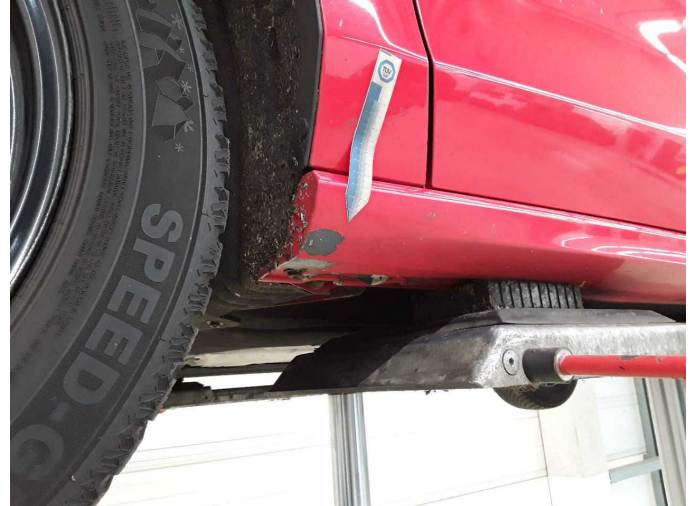
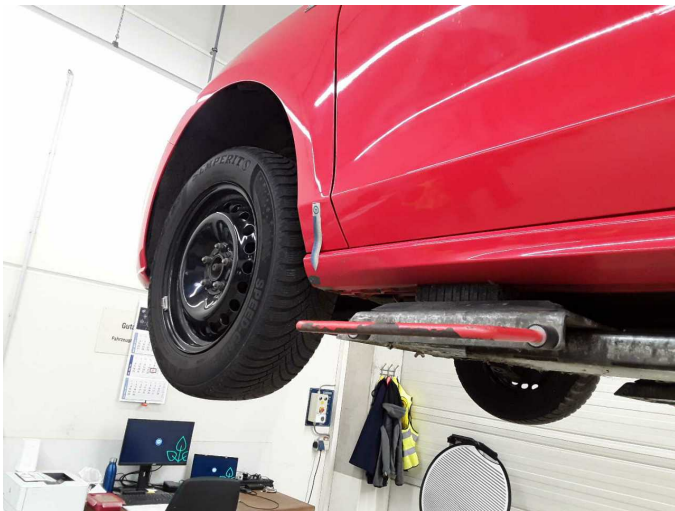
**Damage 3:** Sill - left side: Trim - Scratched - Smart repair

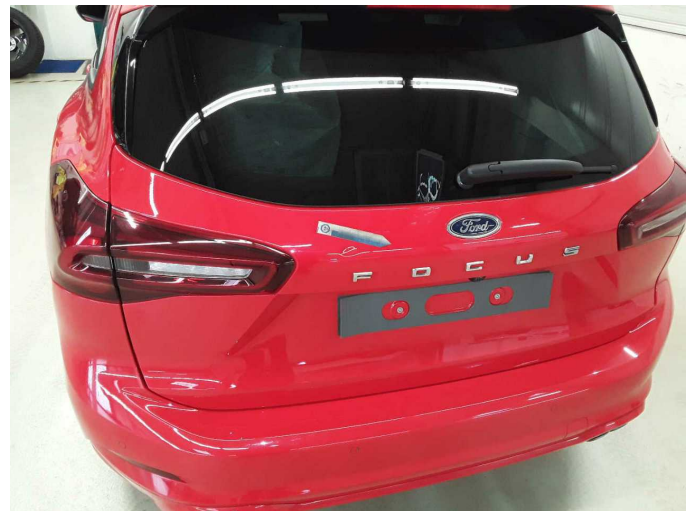
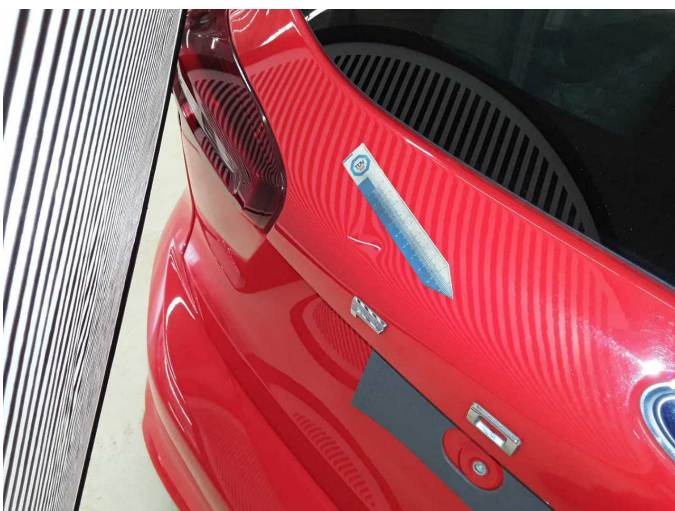
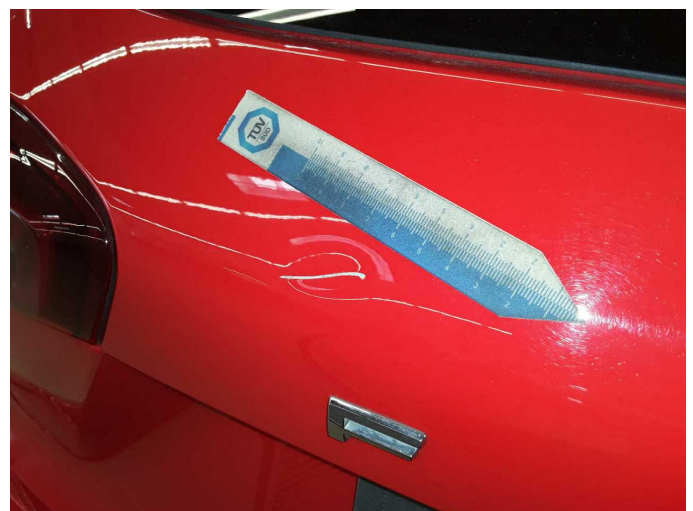
**Damage 4:** Boot lid / rear door: Boot lid - Dent / paintcoat damage - Repair and paint

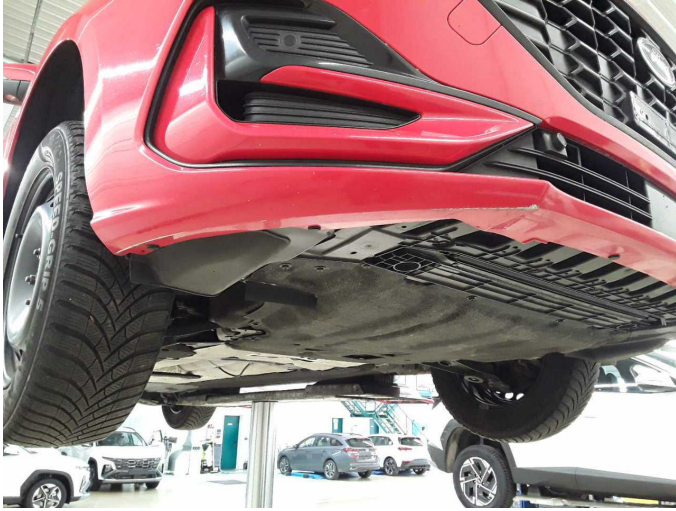
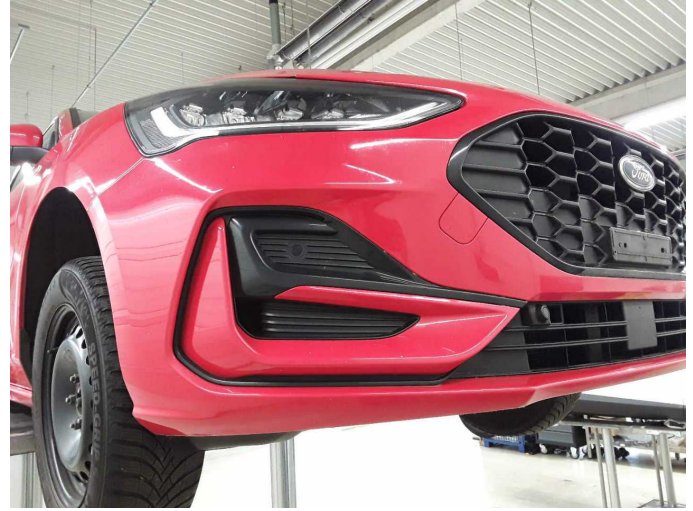
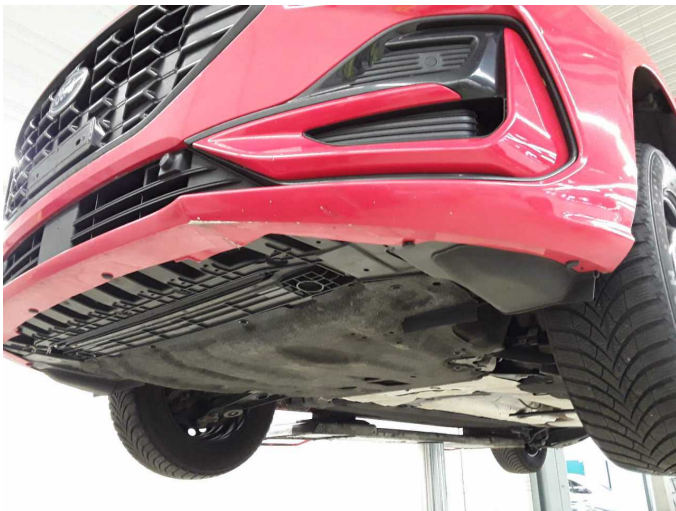
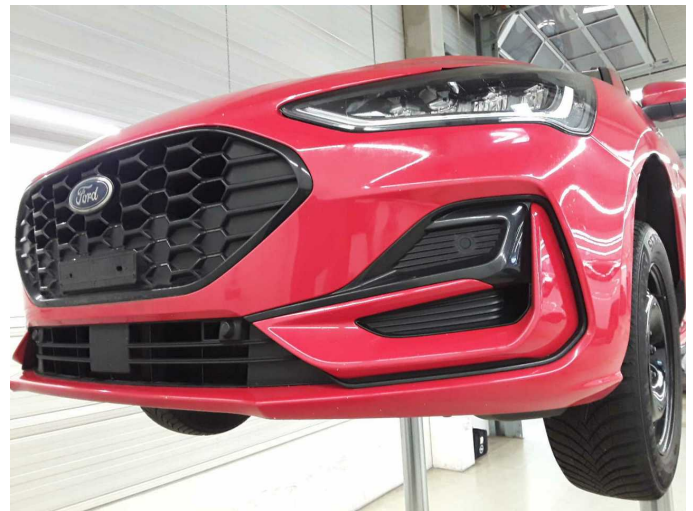
No.	Component group	Description
1	Front bumper	Front bumper (Unten) - Scratch(es) - No deduction

**Wear and tear 1:** Front bumper: Front bumper (Unten) - Scratch(es) - No deduction

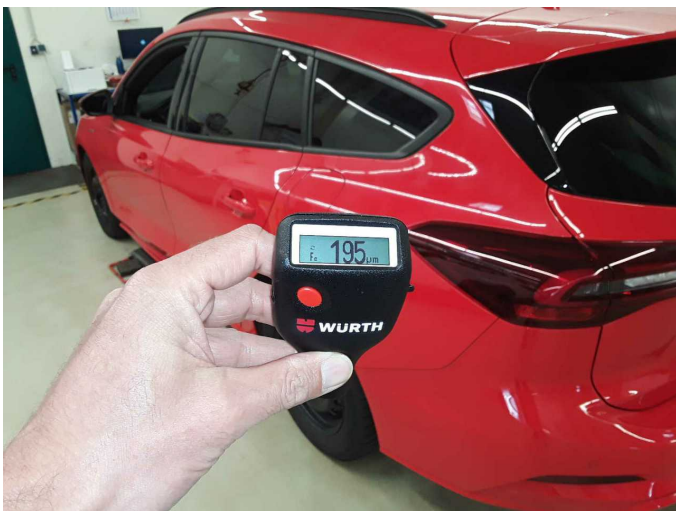
No.	Repainting
1	Side panel - rear left side, Professionally carried out

Side panel - rear left side 195 µm |

**Side panel - rear left side:** 195 µm
